REPORT NUMBER: SINCAP-MGA-2019-033

**NEW CAR ASSESSMENT PROGRAM (NCAP)
Moving Deformable Barrier Side Impact Test**

**GENERAL MOTORS LLC
2019 Chevrolet Silverado 1500 LT Crew Cab Truck
NHTSA No.: M20190108**

**MGA RESEARCH CORPORATION
5000 Warren Road
Burlington, WI 53105**

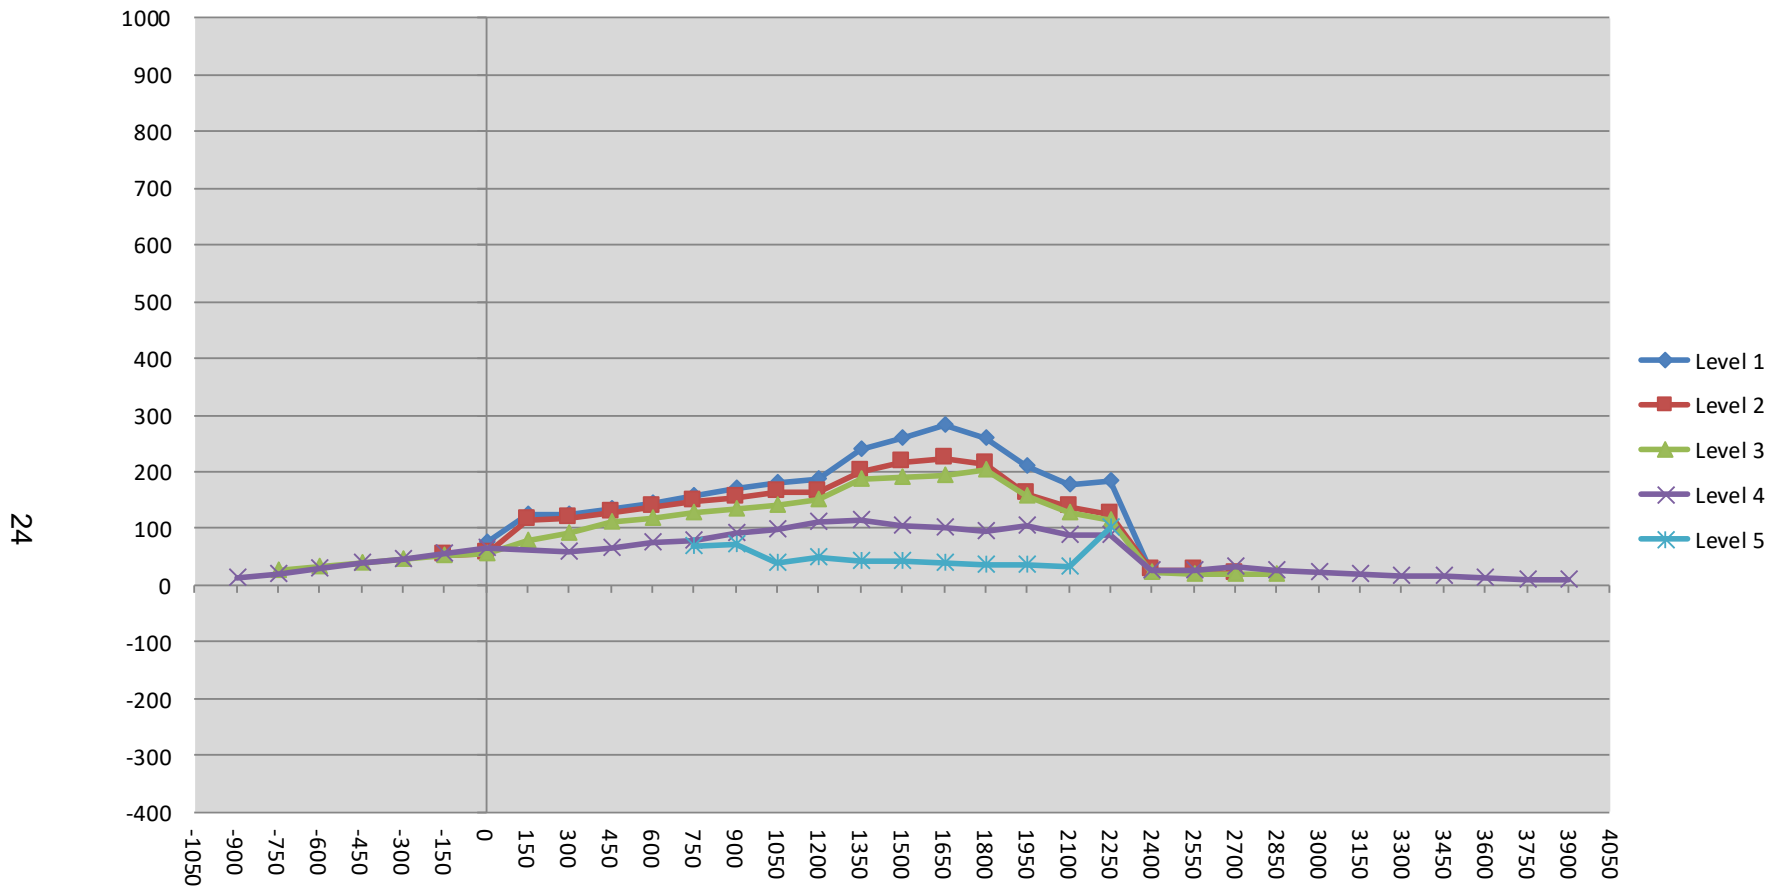
DATA SHEET NO. 12
MDB EXTERIOR STATIC CRUSH MEASUREMENTS

NOTE: Pre-test measurements are taken when the vehicle is in the "As Tested" weight condition. Vehicle measurements forward of the vertical impact reference line are negative. The crush profile grid is established prior to the test based on an estimated impact point.

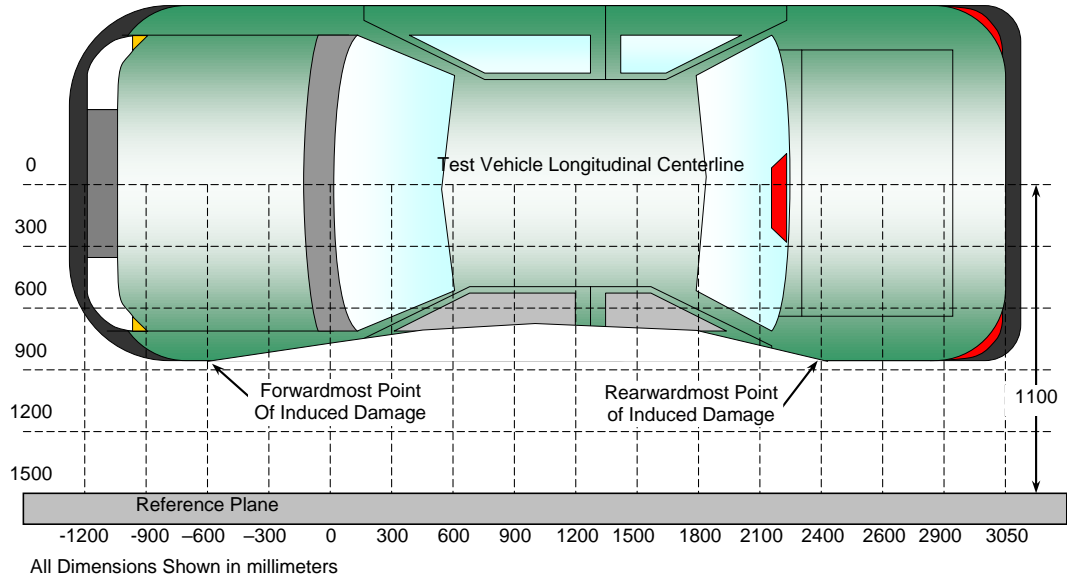
**DATA SHEET NO. 13
VEHICLE AND MDB DAMAGE PROFILE DISTANCES**

VEHICLE DAMAGE PROFILE DISTANCES

MDB DAMAGE PROFILE DISTANCES

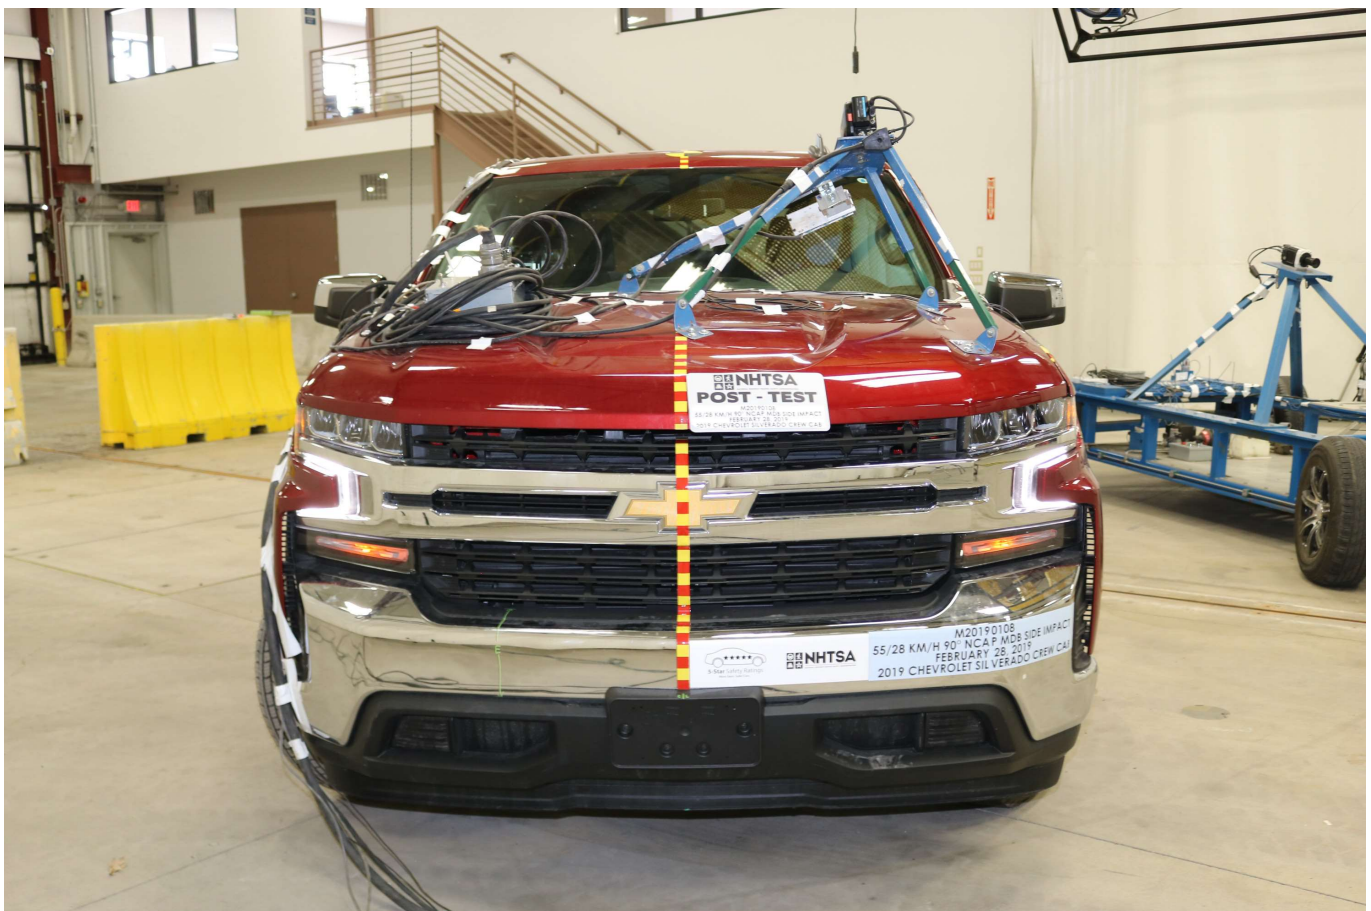
Photo No. 004 - Post-Test Frontal View of Test Vehicle

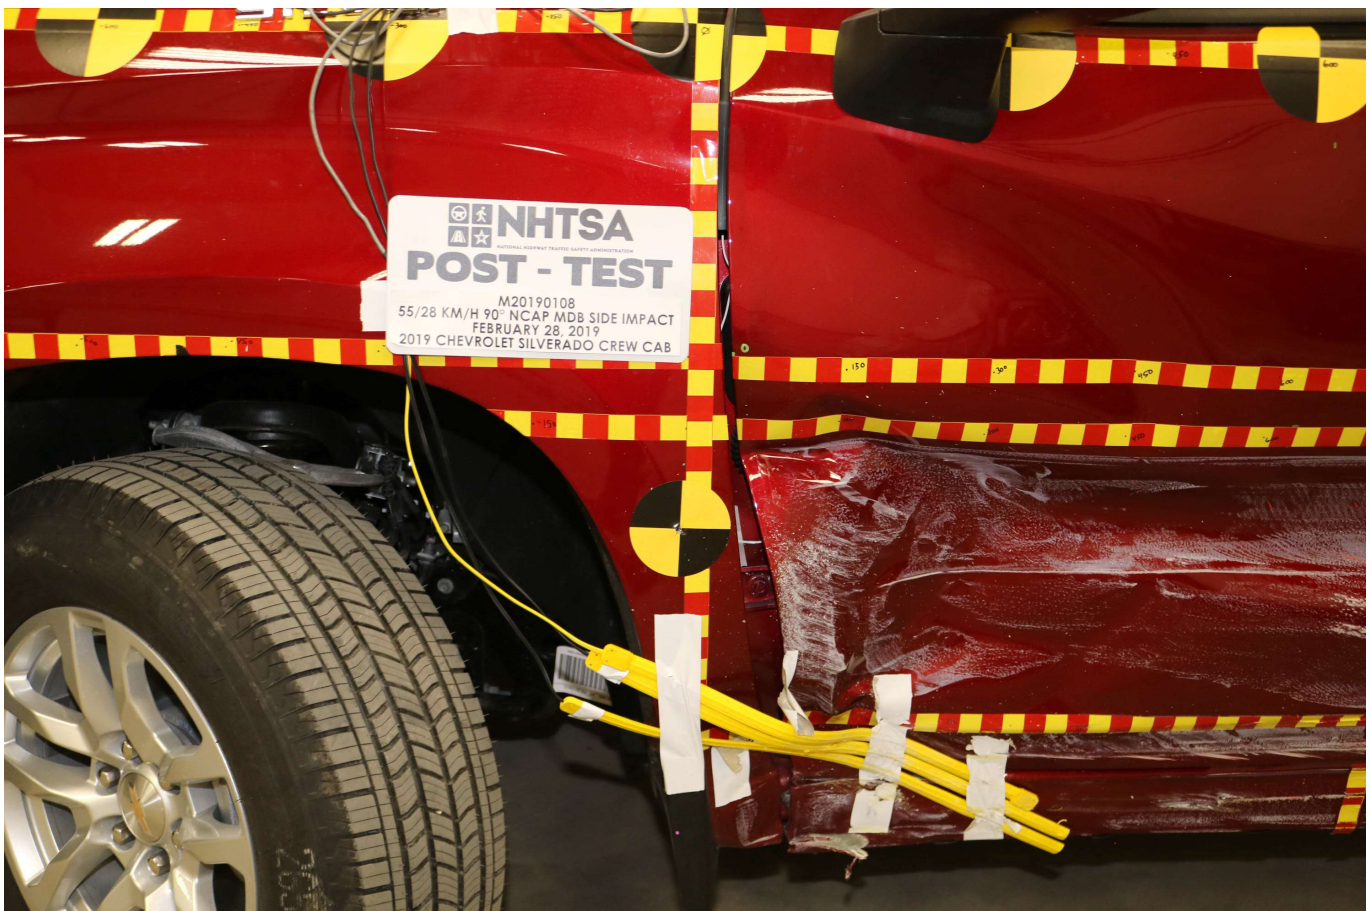
Photo No. 020 - Post-Test Close-Up View of Impact Point Target

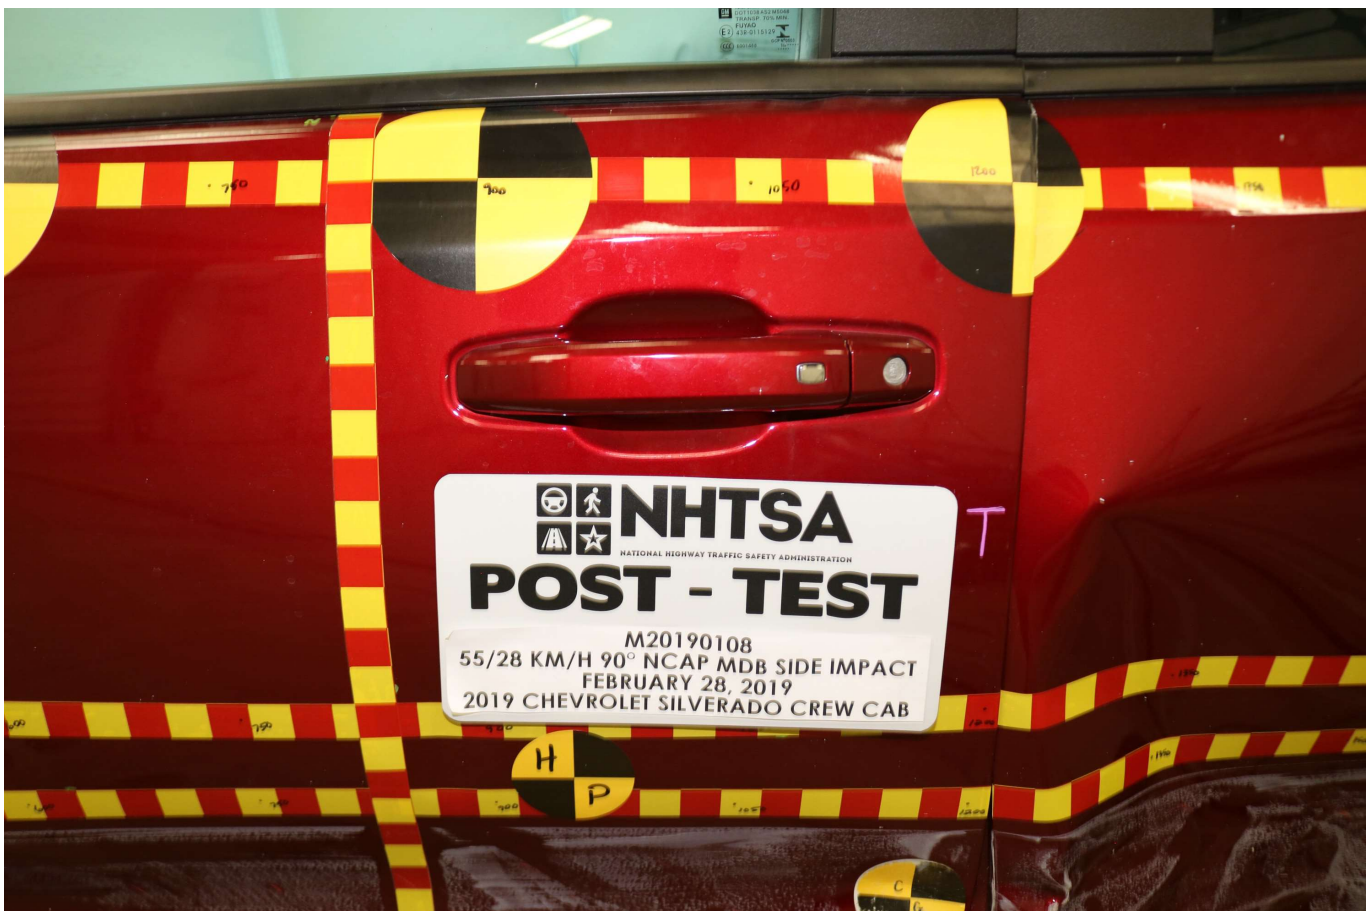
Photo No. 022 - Post-Test Left Front Door Latch Close-Up

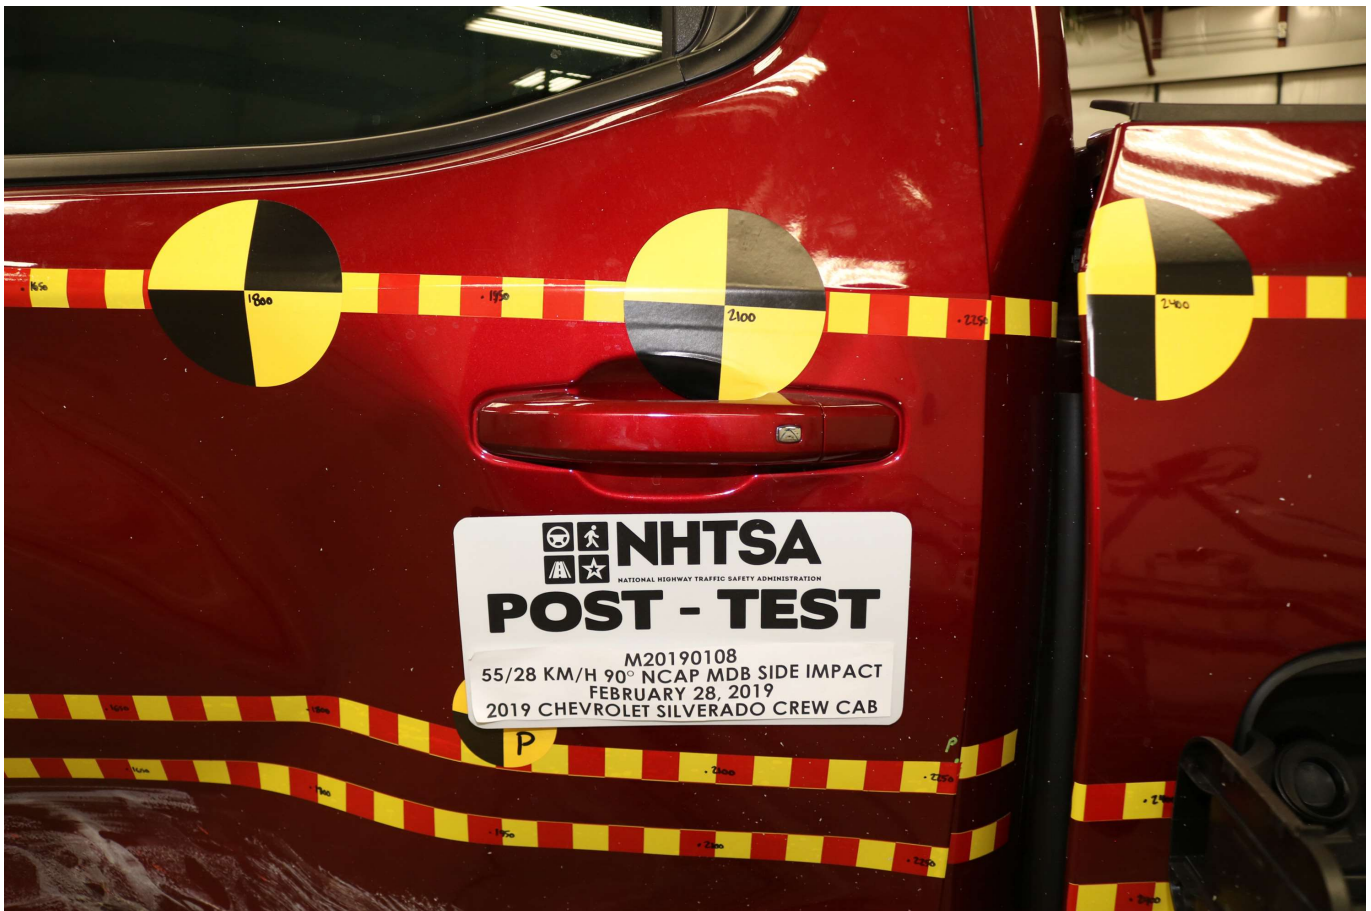
Photo No. 024 - Post-Test Left Rear Door Latch Close-Up

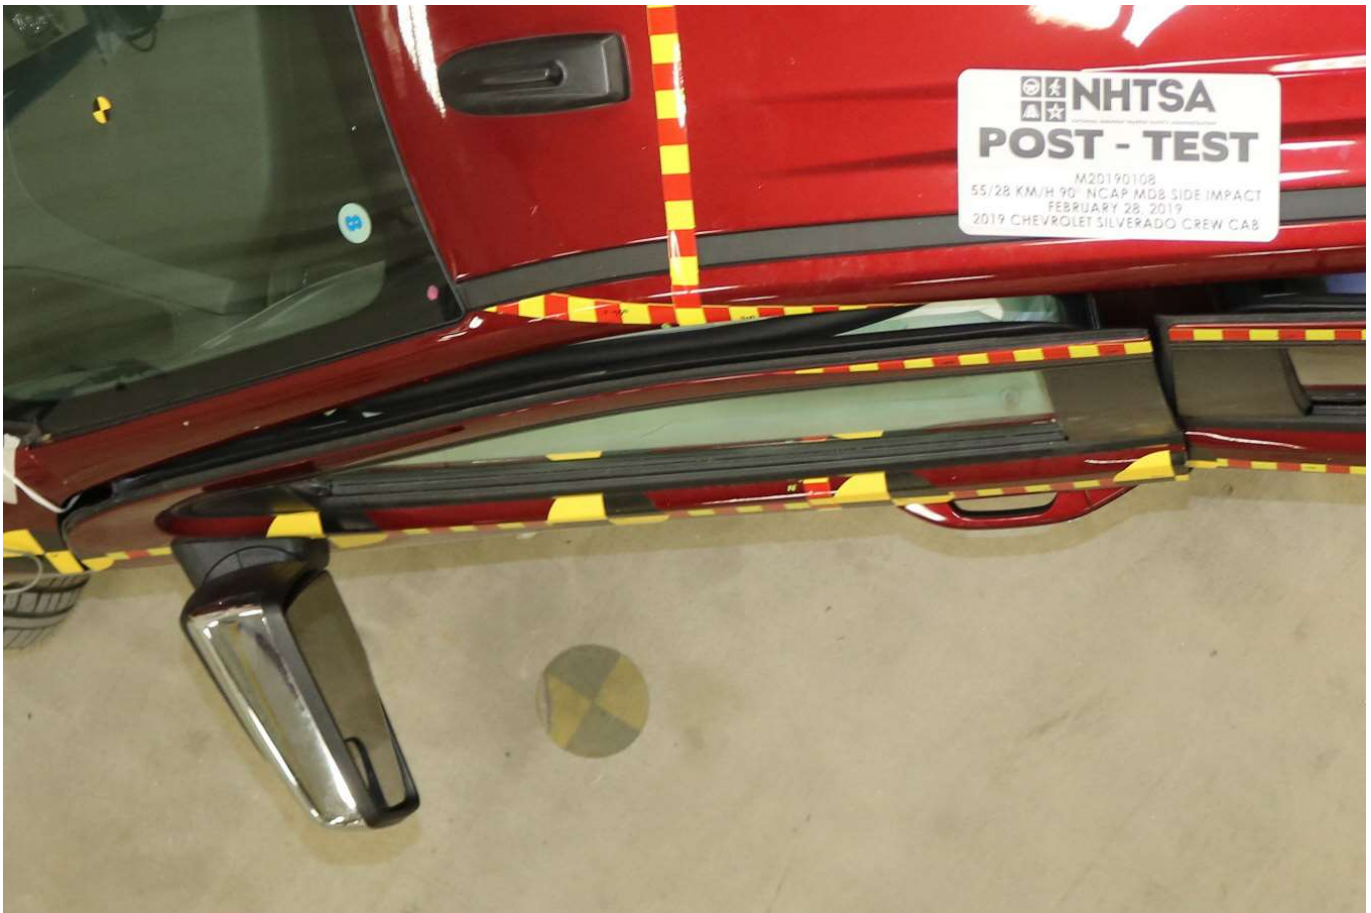
Photo No. 043 - Post-Test Driver Dummy and Door Clearance View

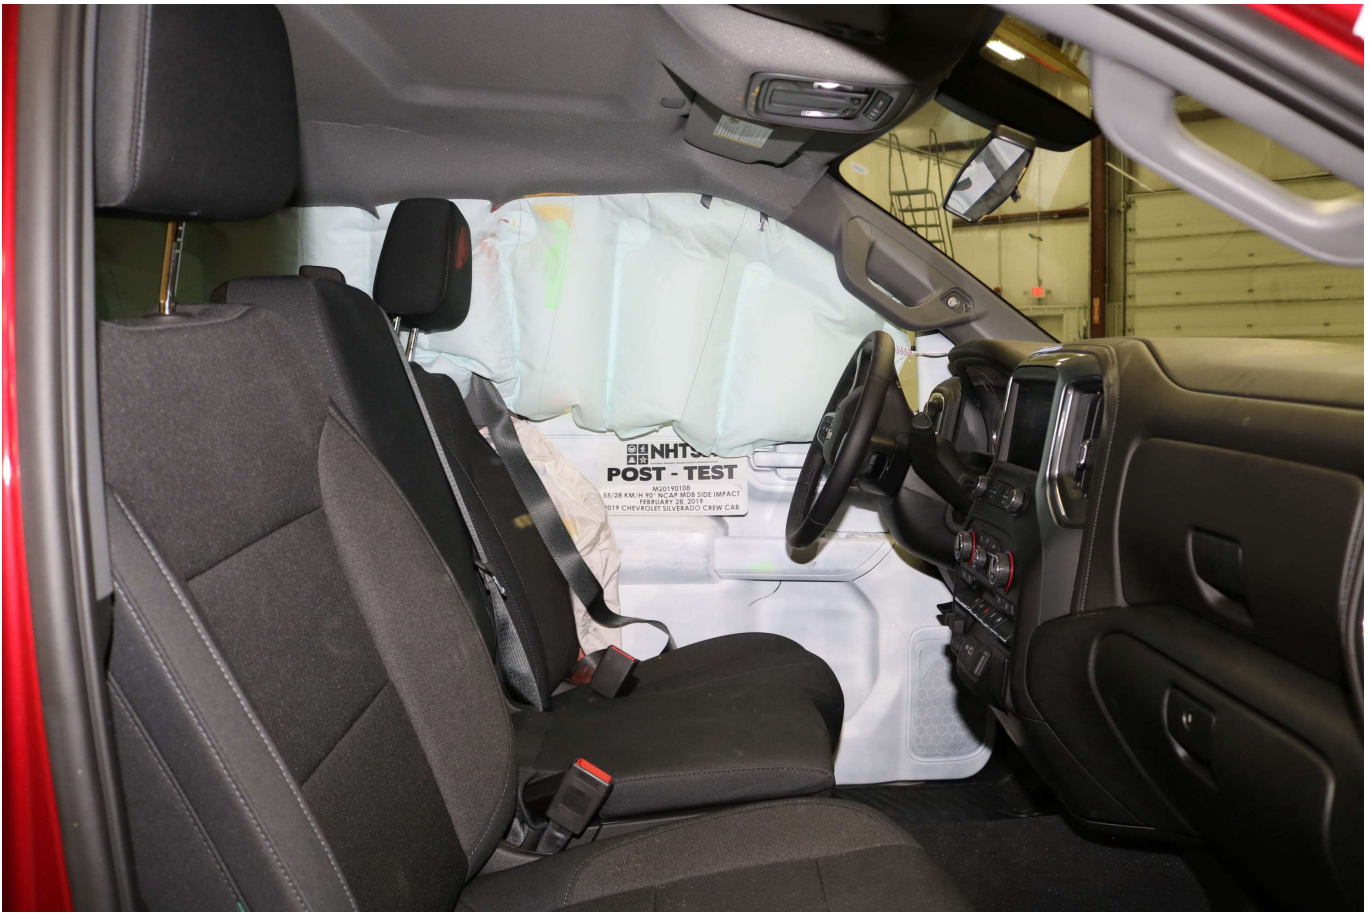
Photo No. 047 - Post-Test Driver Inner Door Panel View

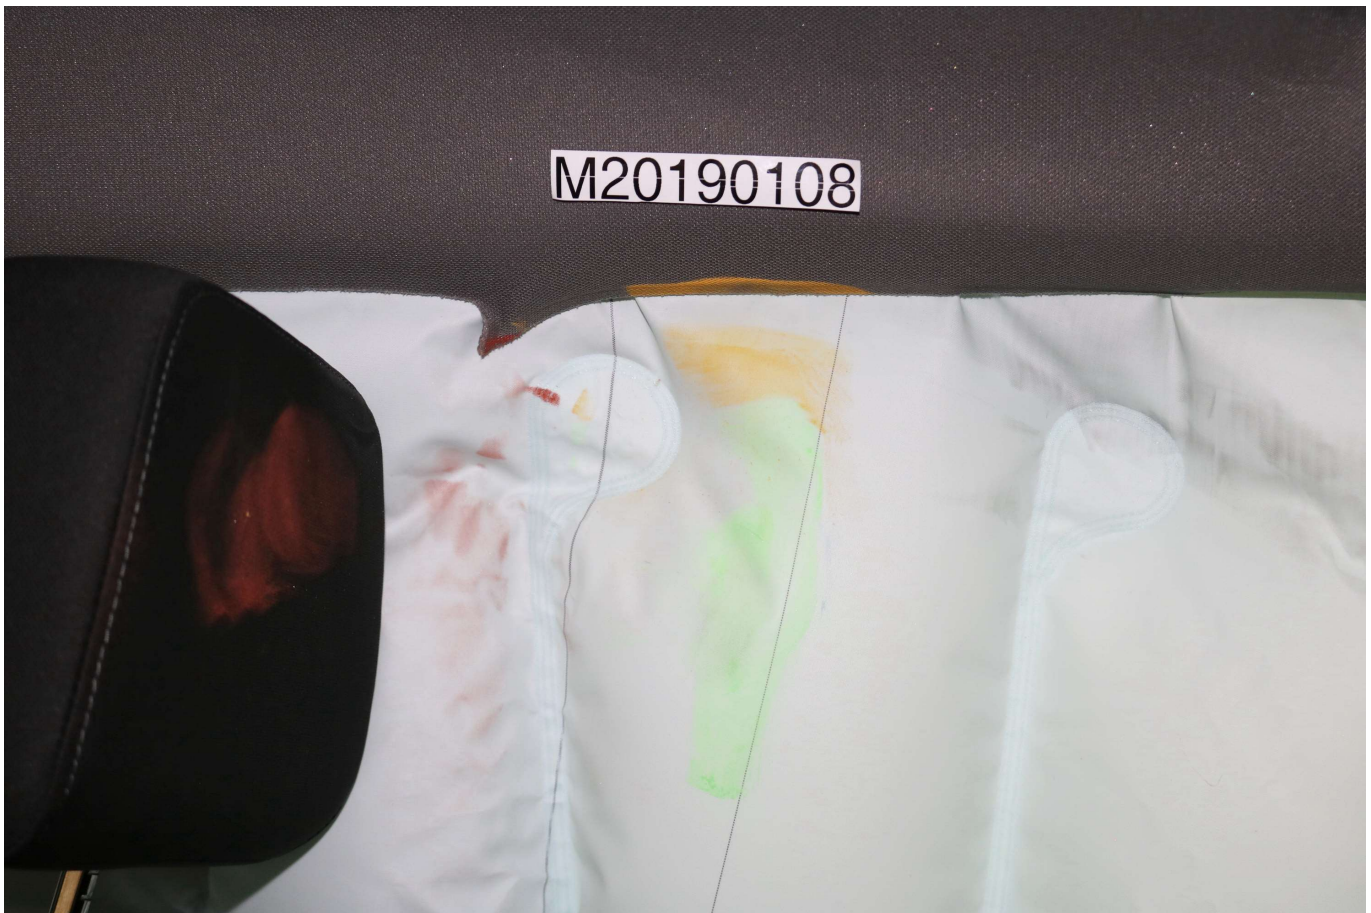
Photo No. 049 - Post-Test Driver Dummy Close-up Head Contact with Side Airbag View

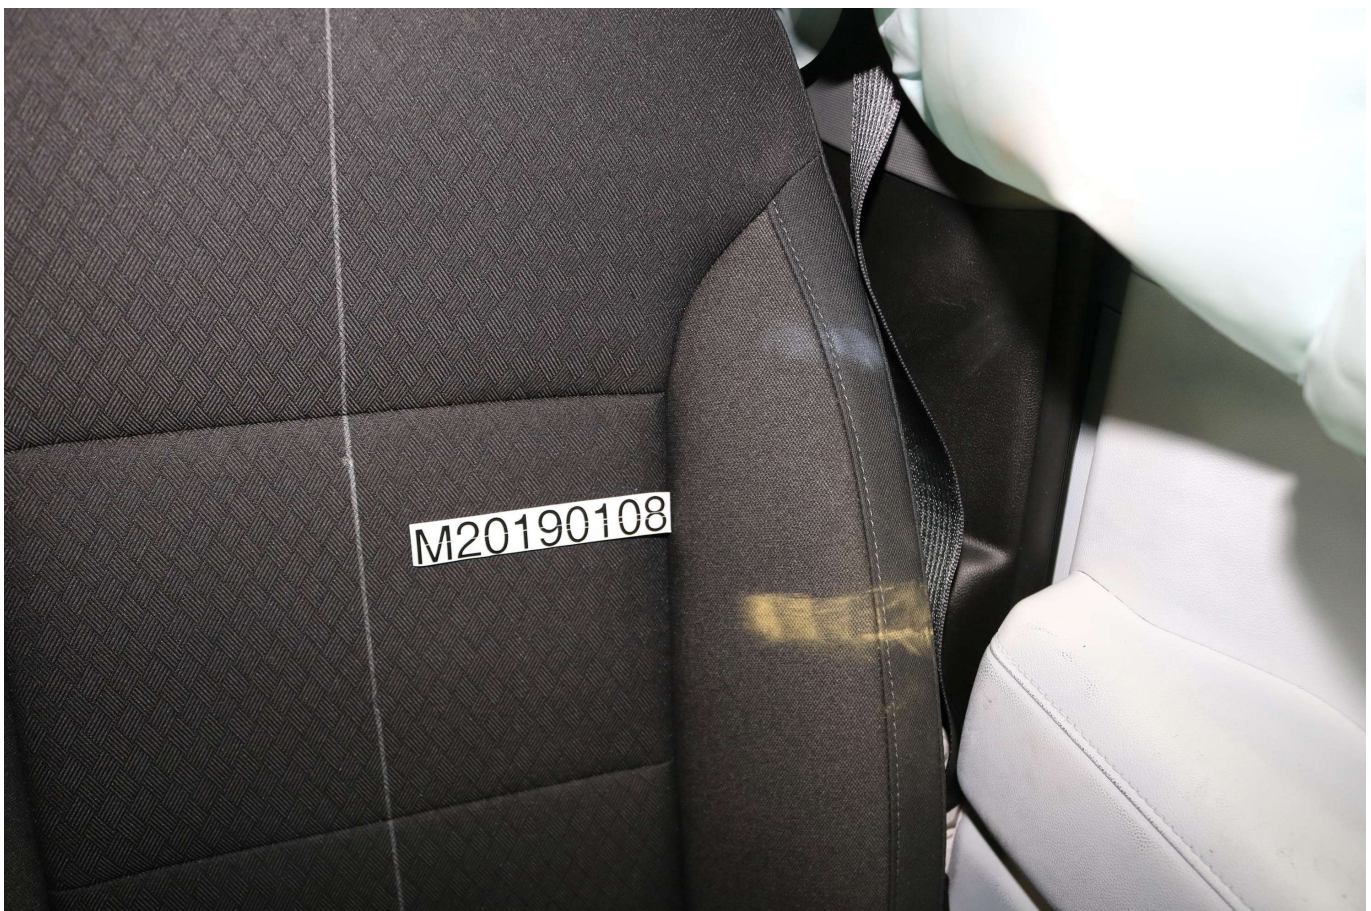
Photo No. 050 - Post-Test Driver Dummy Close-up Torso Contact with Vehicle Interior View

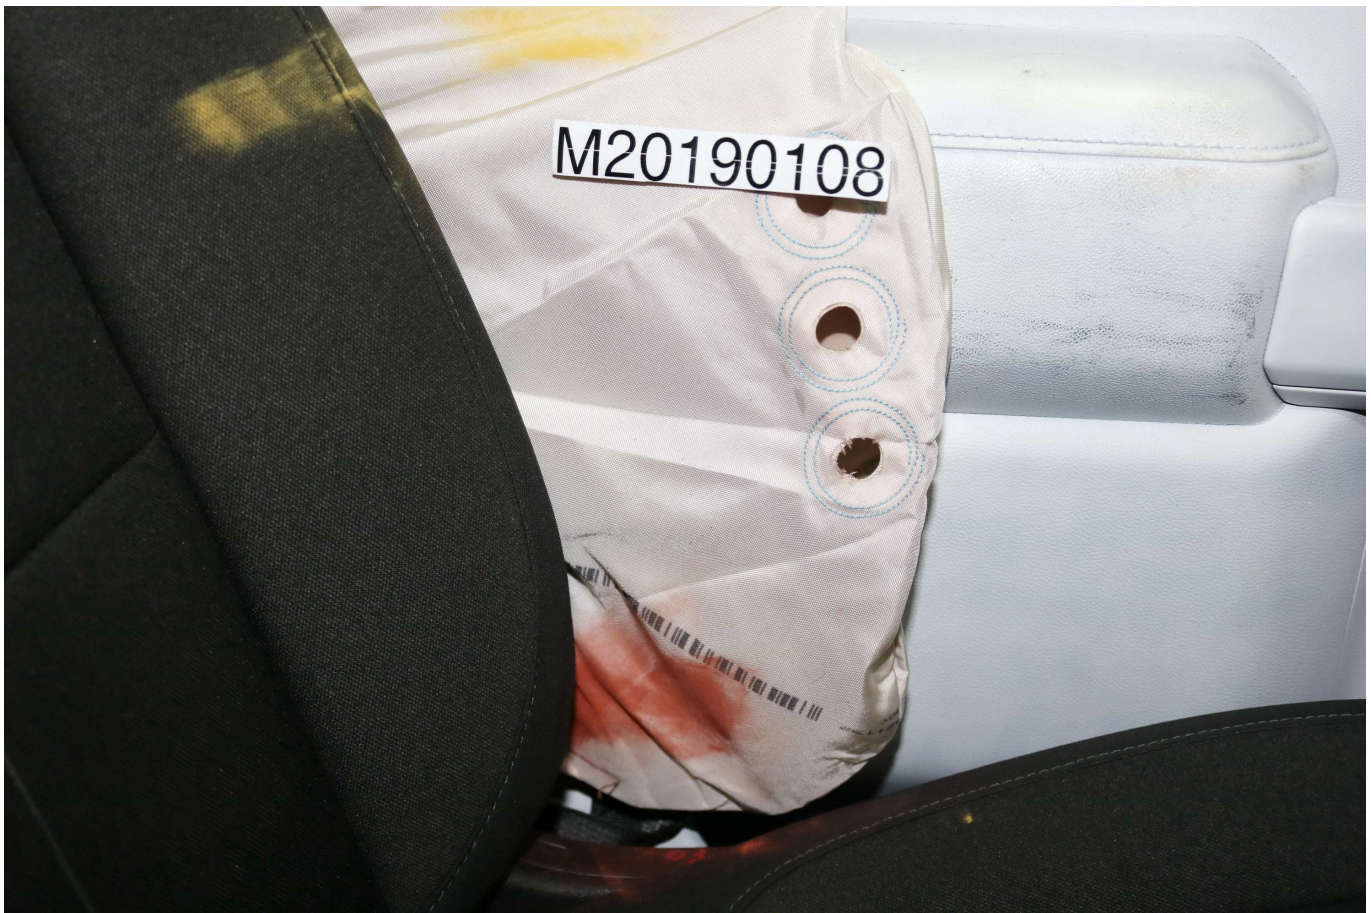
Photo No. 053 - Post-Test Driver Dummy Close-up Pelvis Contact with Side Airbag View

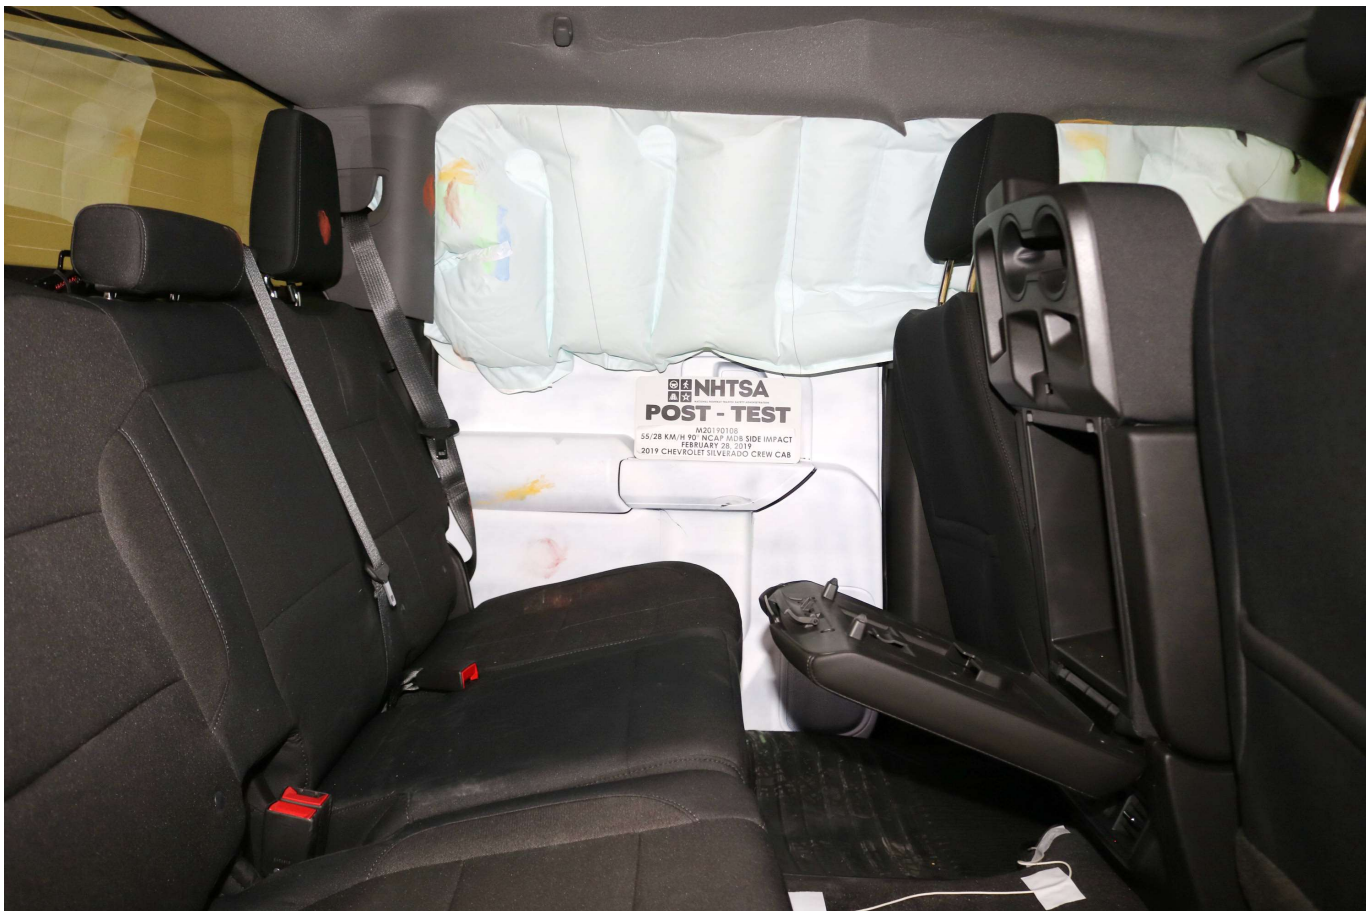
Photo No. 074 - Post-Test Rear Passenger Inner Door Panel View

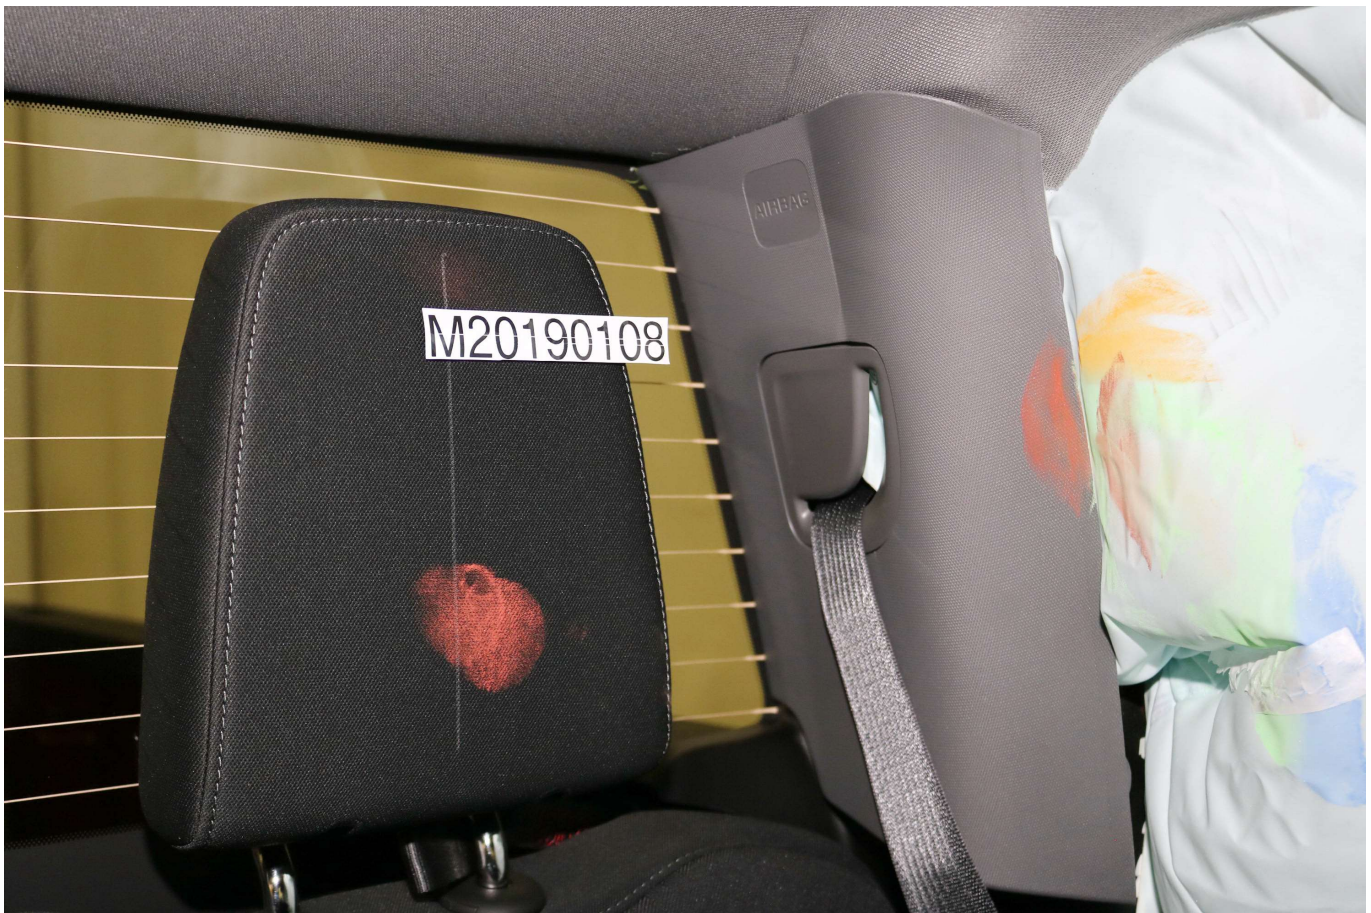
Photo No. 075 - Post-Test Rear Passenger Dummy Close-up Head Contact with Vehicle Interior View

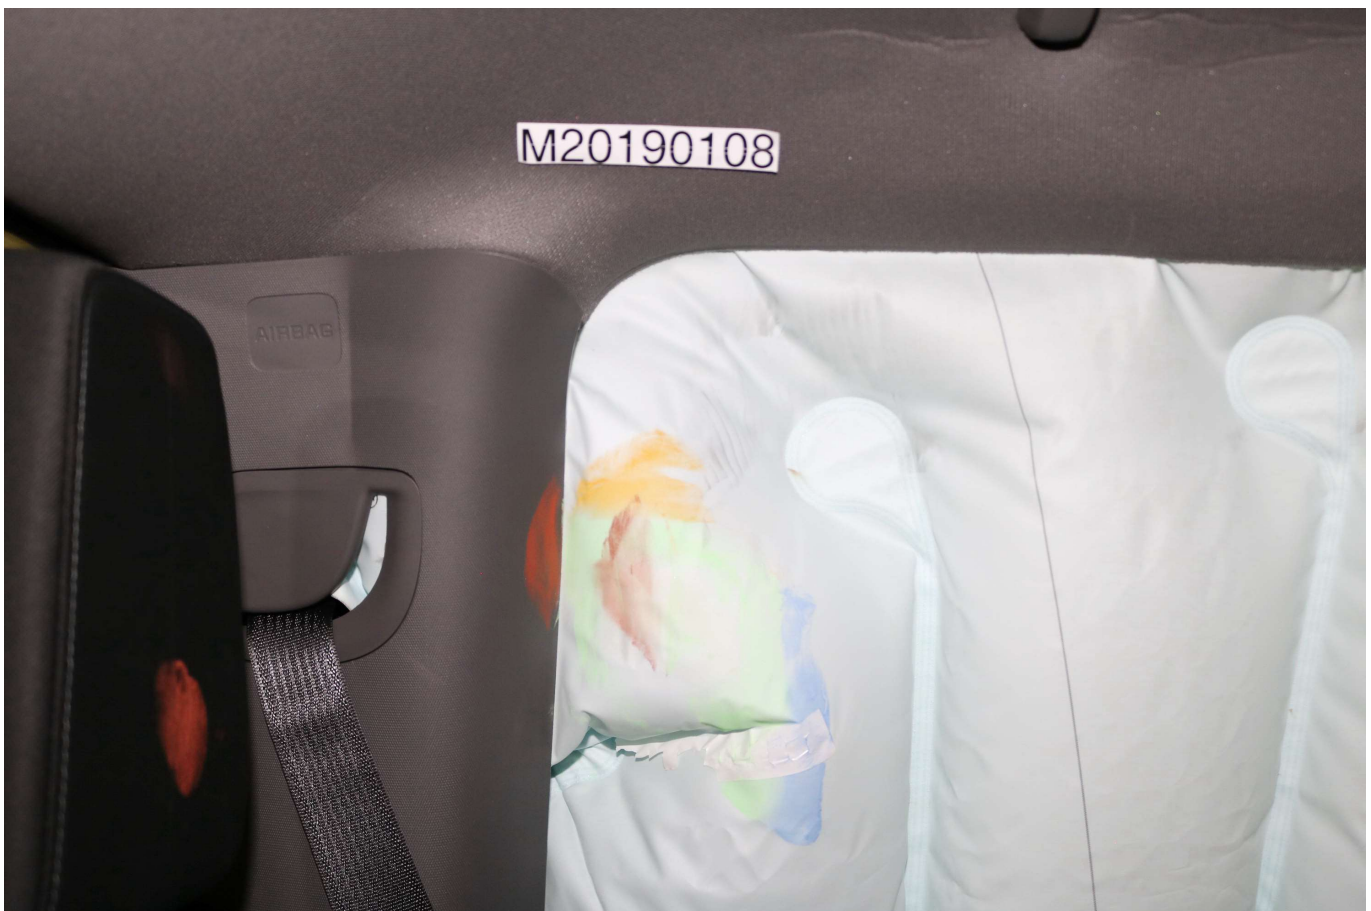
Photo No. 076 - Post-Test Rear Passenger Dummy Close-up Head Contact with Side Airbag View

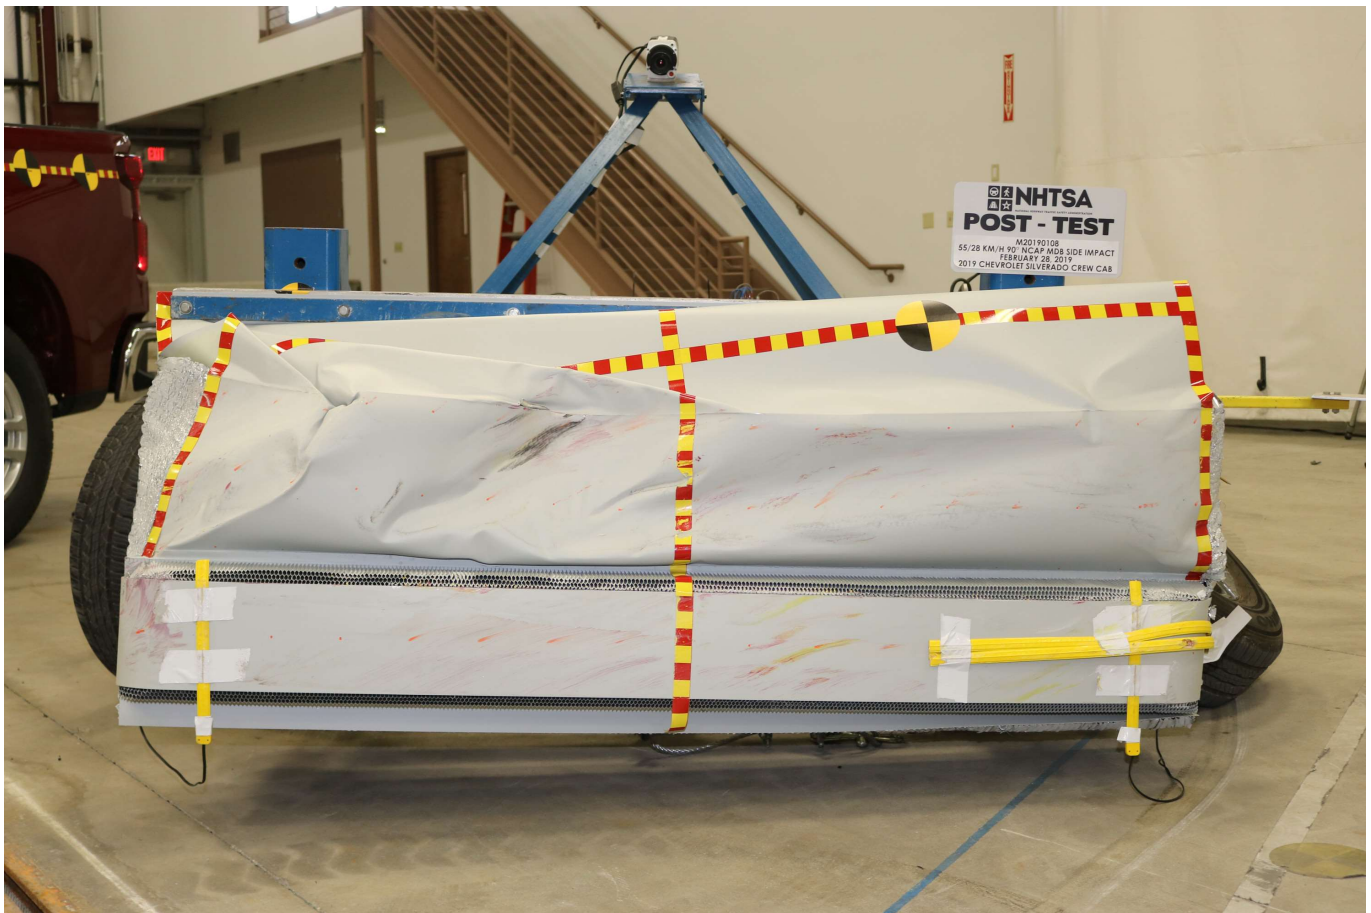
Photo No. 085 - Post-Test Front View of MDB Impactor Face

Critical Areas of Performance	Observations and Conclusions
Pillar Performance	No Separation
Sill Separation	None
Windshield Damage	None
Side Window Damage	None
Other Notable Effects	LF wheel hub separated from MDB during impact

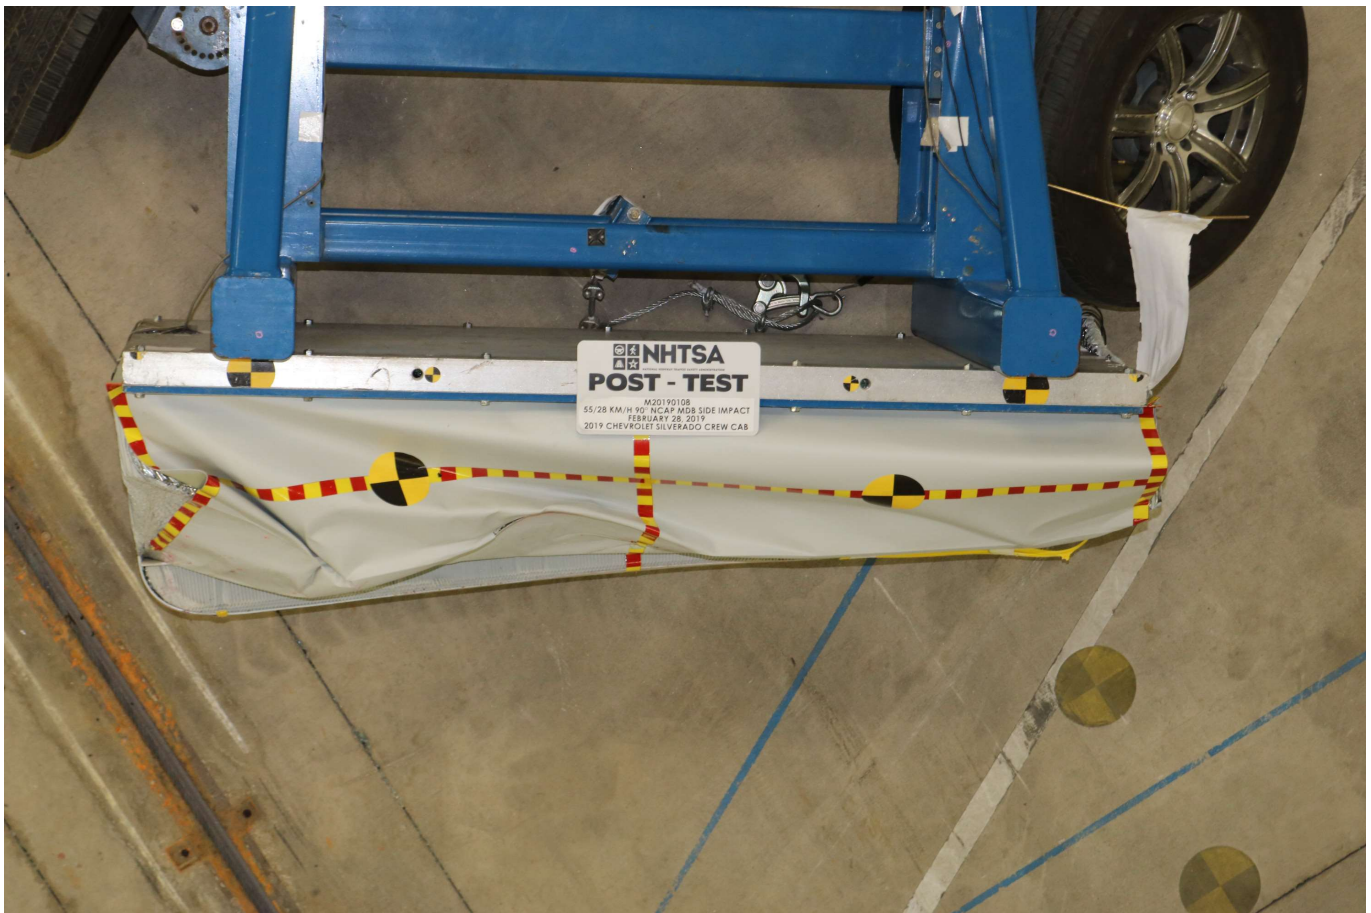
Photo No. 087 - Post-Test Top View of MDB Impactor Face

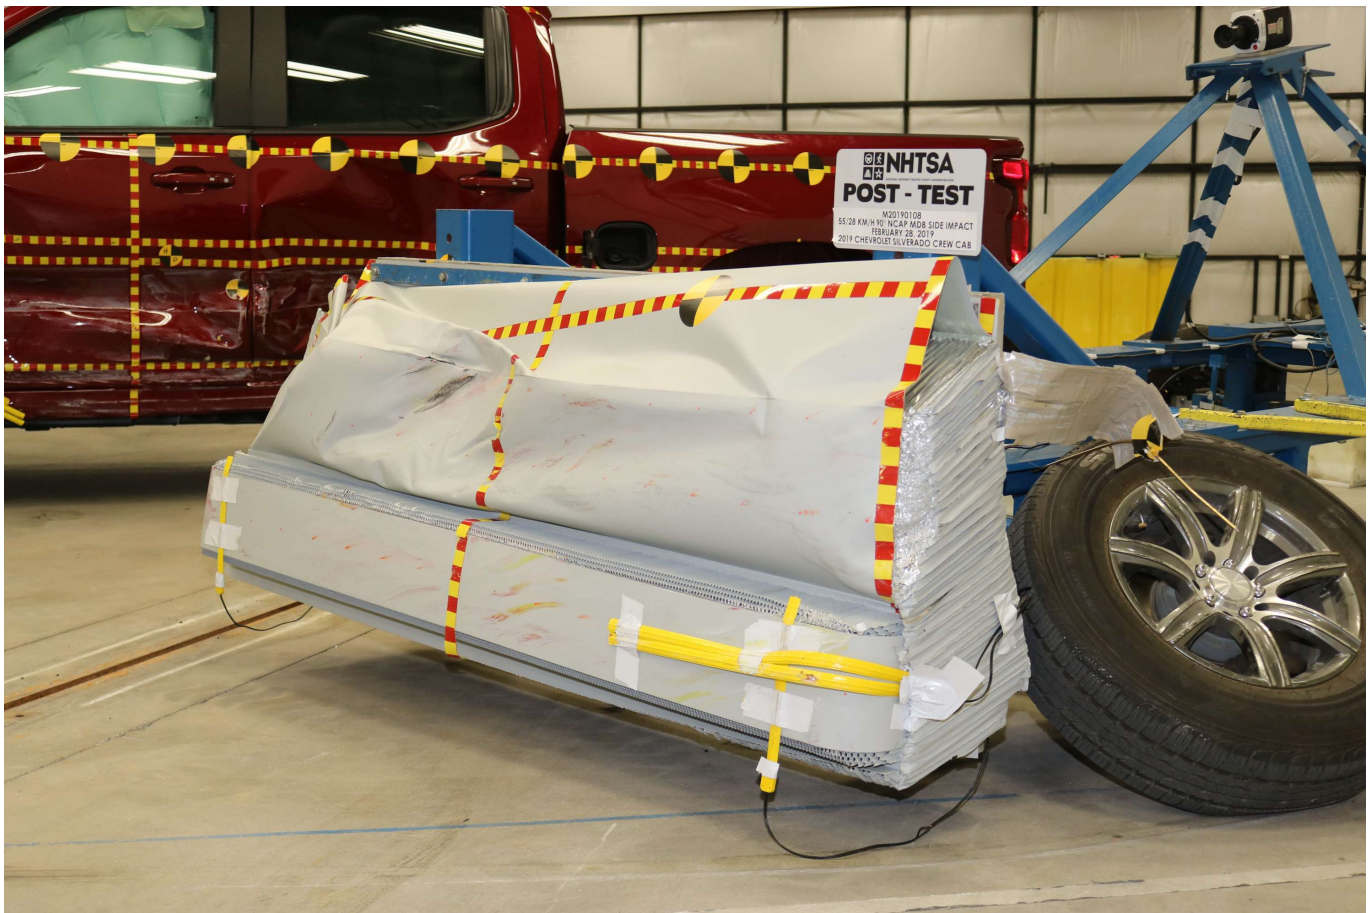
Photo No. 089 - Post-Test Left Side View of MDB Impactor Face

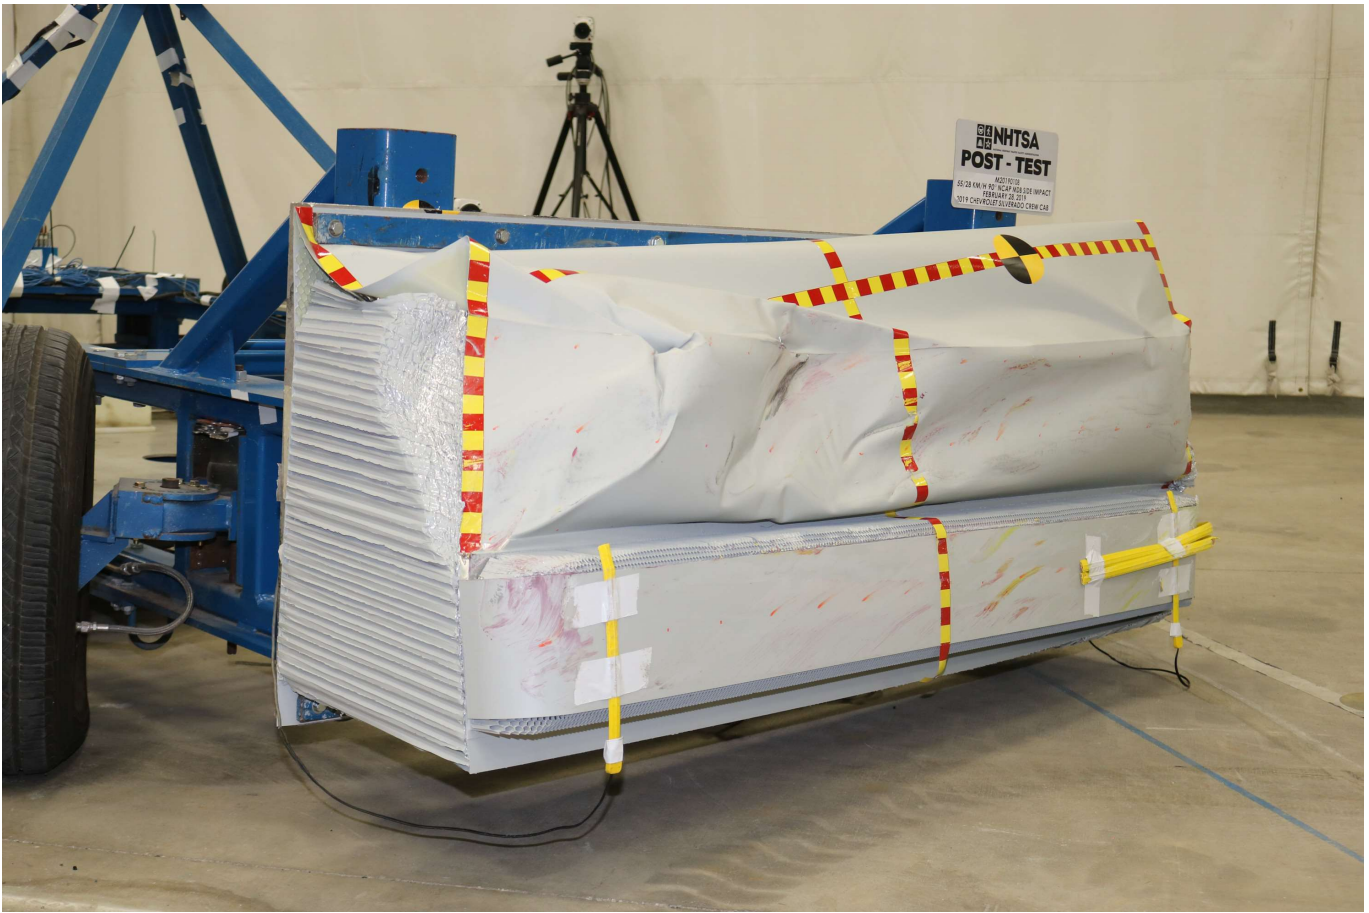
Photo No. 091 - Post-Test Right Side View of MDB Impactor Face
