REPORT NUMBER: SINCAP-MGA-2019-033

**NEW CAR ASSESSMENT PROGRAM (NCAP)
Moving Deformable Barrier Side Impact Test**

**GENERAL MOTORS LLC
2019 Chevrolet Silverado 1500 LT Crew Cab Truck
NHTSA No.: M20190108**

**MGA RESEARCH CORPORATION
5000 Warren Road
Burlington, WI 53105**

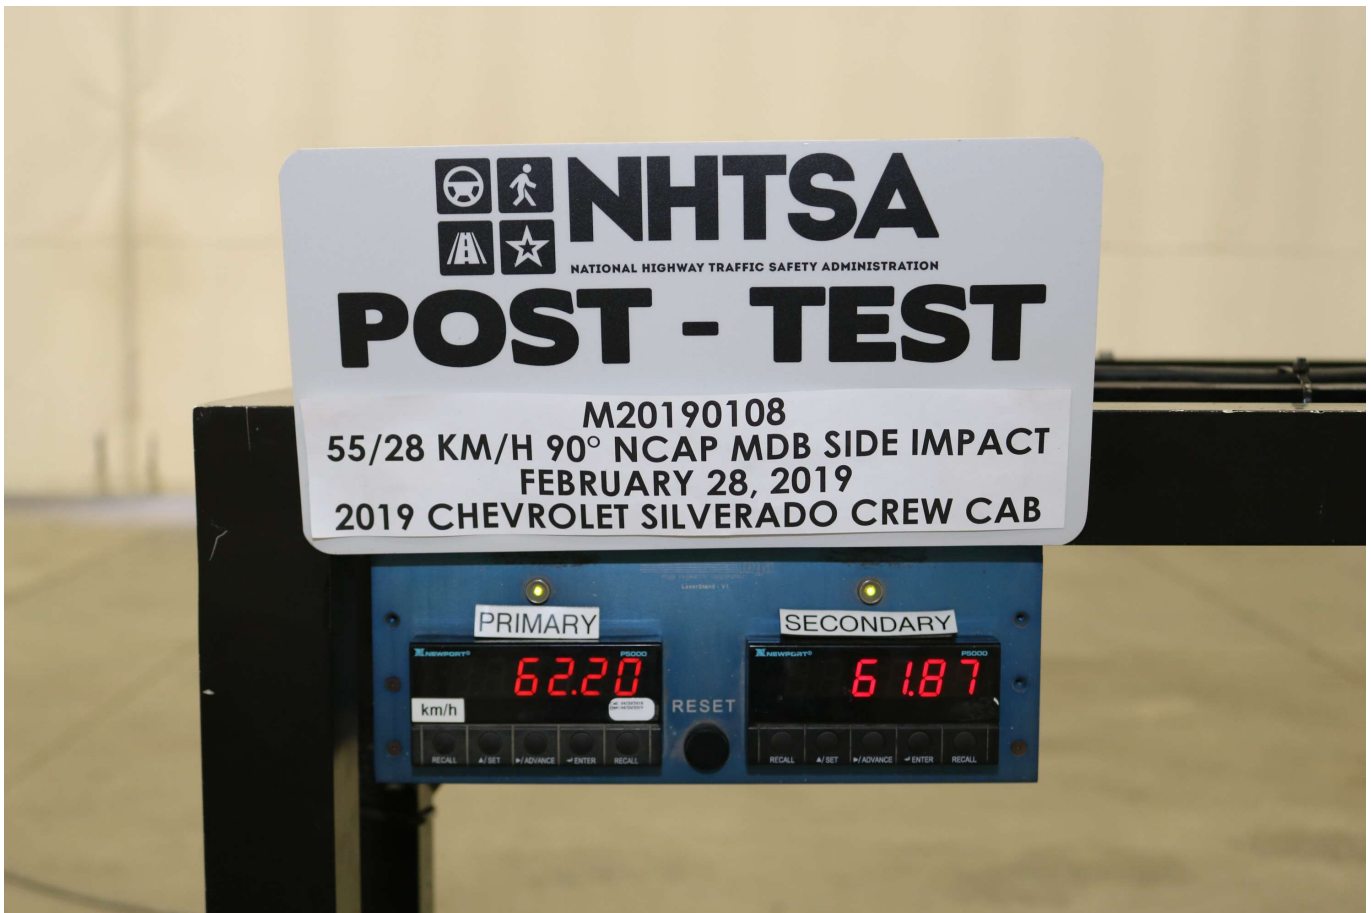
Photo No. 095 - Post-Test Primary and Redundant Speed Trap Read-Out

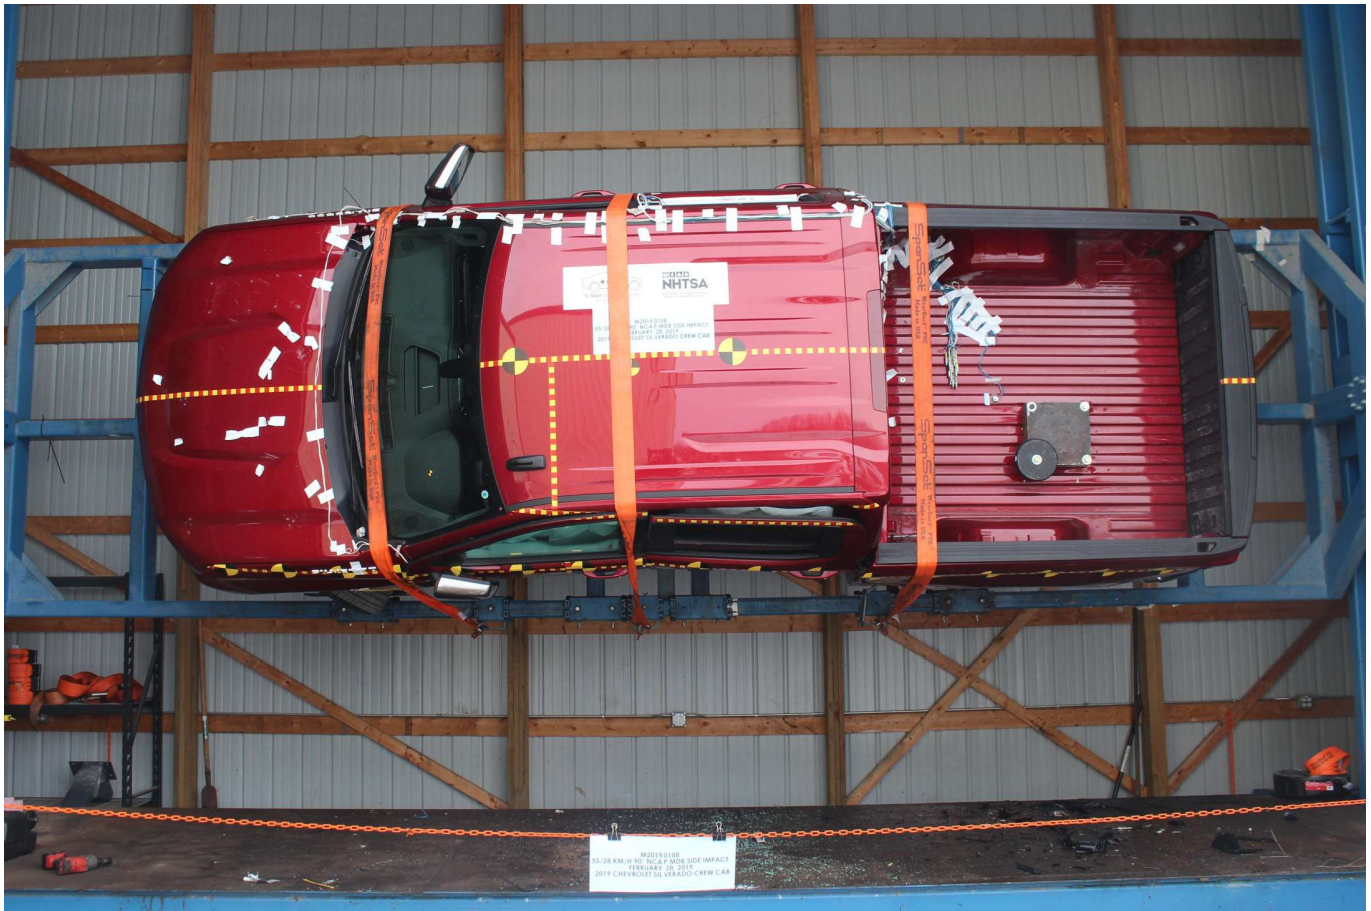
Photo No. 097 - FMVSS Photo No. 301 Static Rollover 90 Degrees

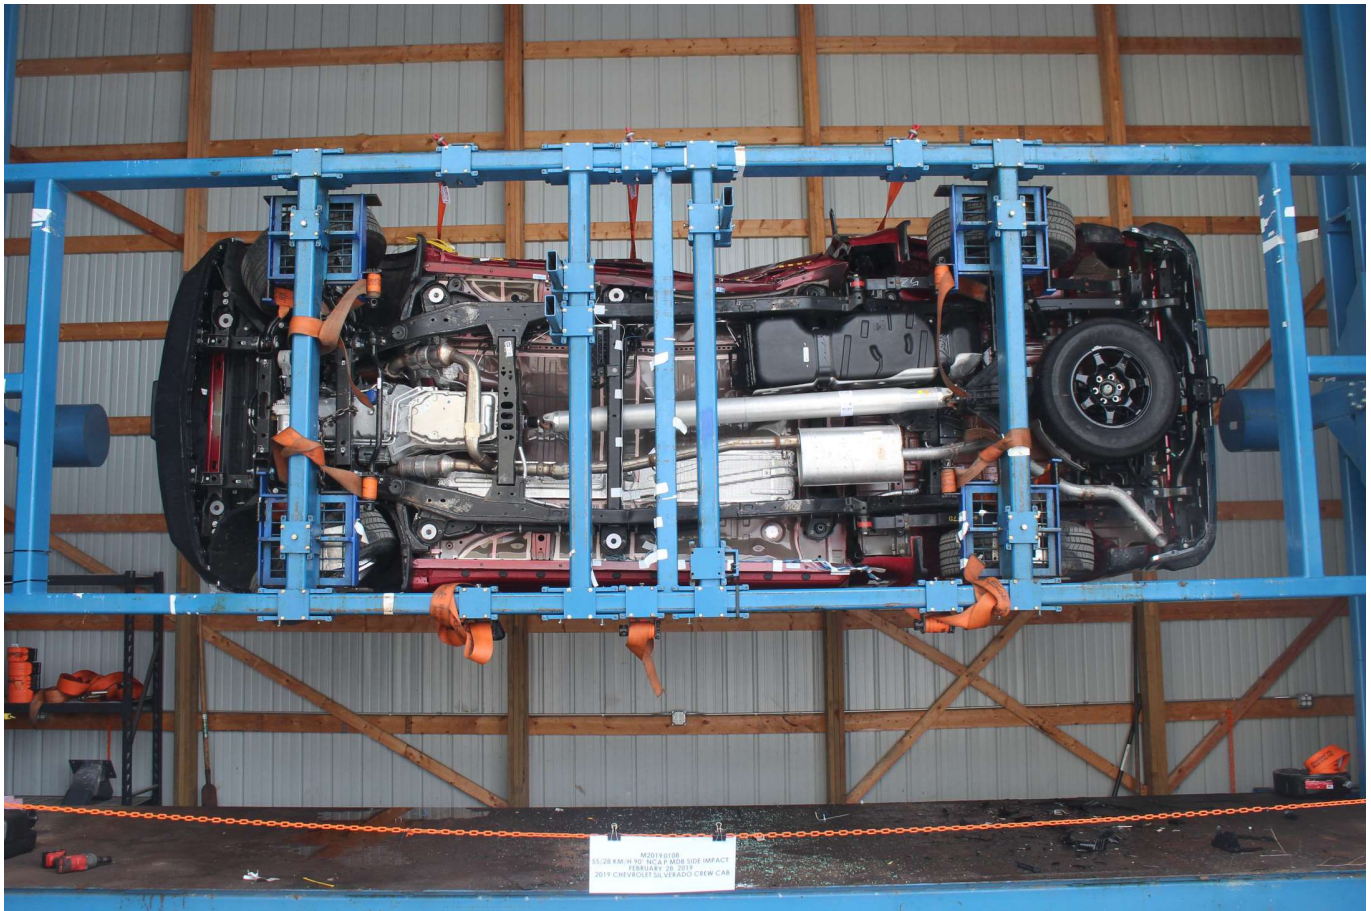
Photo No. 099 - FMVSS Photo No. 301 Static Rollover 270 Degrees

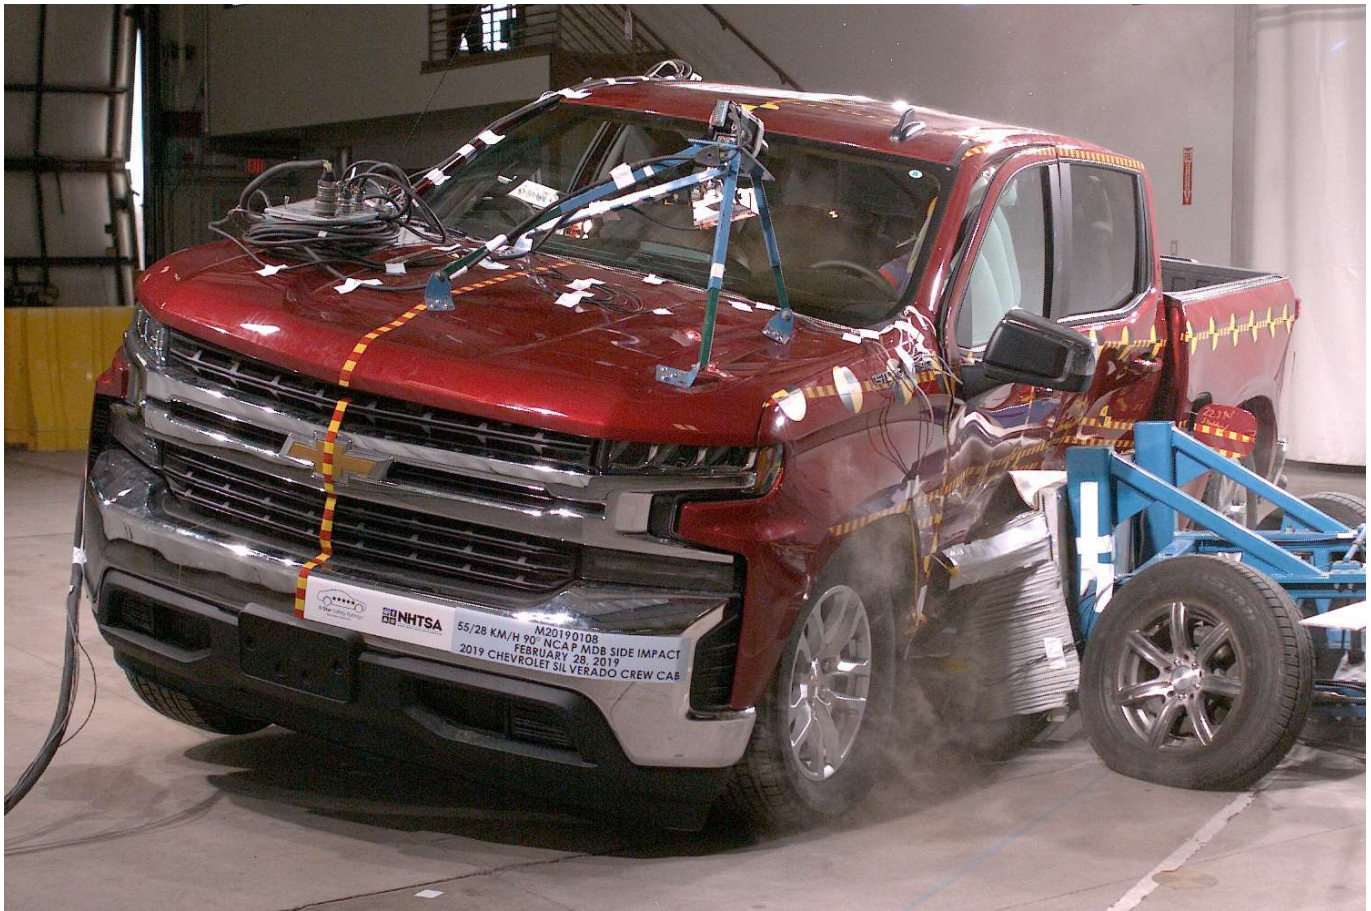
Photo No. 101 - Impact Event
