**REPORT NUMBER: SPNCAP-KAR-19-021  
NEW CAR ASSESSMENT PROGRAM (NCAP)  
SIDE IMPACT POLE TEST**

**NISSAN MOTOR CO., LTD.  
2019 NISSAN KICKS S 5-DOOR SUV**

**NHTSA No: M20195207**

**FINAL REPORT**

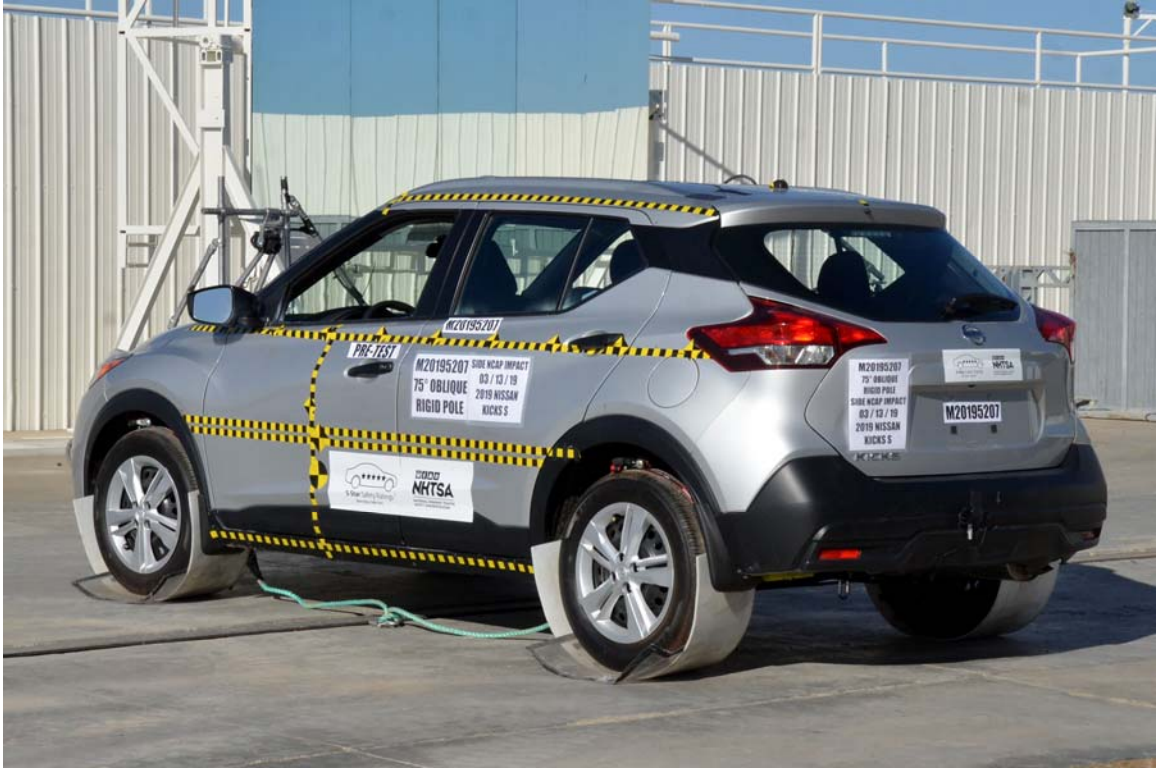
FIGURE 8. Post-Test Left Side View of Test Vehicle

The struck side doors of the vehicle were jammed shut. There was no separation at the hinges or latches. The remaining doors remained closed and latched. There were no ATD values that exceeded limits. The Left B-Post At Sill Y, Left Lower B-Post Y, and Left Mid B-Post Y channels were not installed on the test vehicle. Load Cell Pole #3 FY had questionable data.

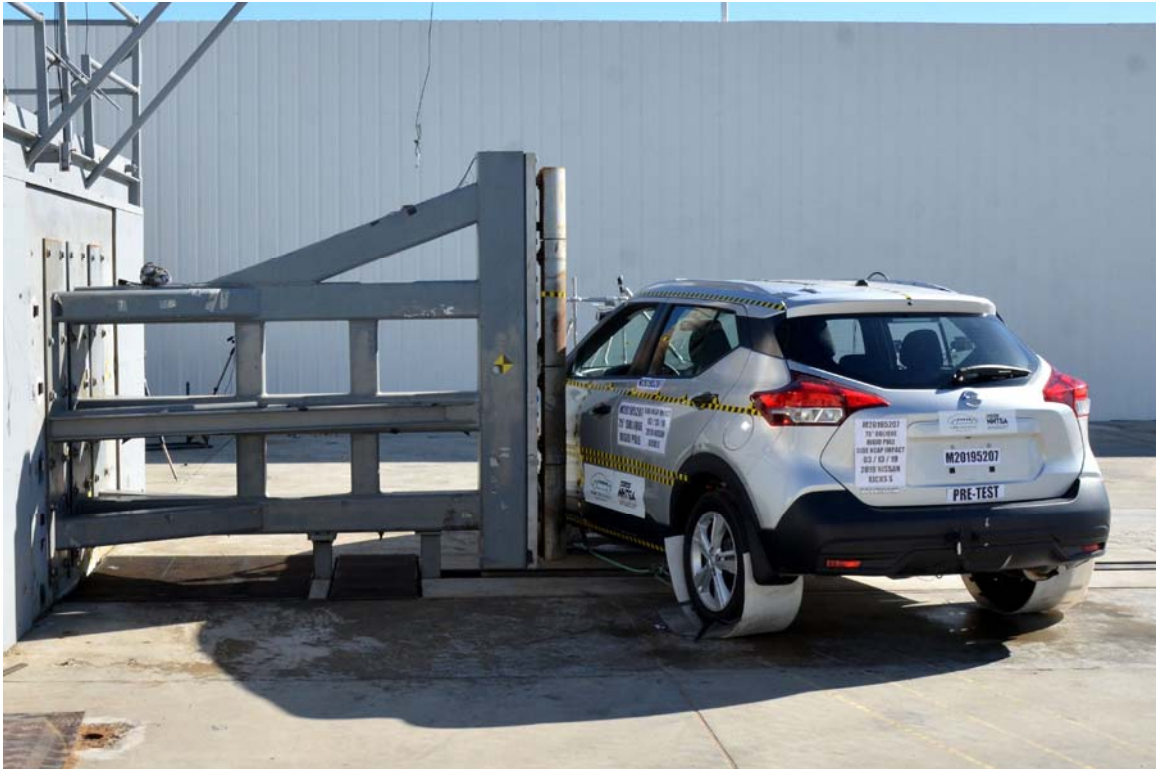
FIGURE 17. Pre-Test Left Side View of Pole Positioned Against Side of Vehicle

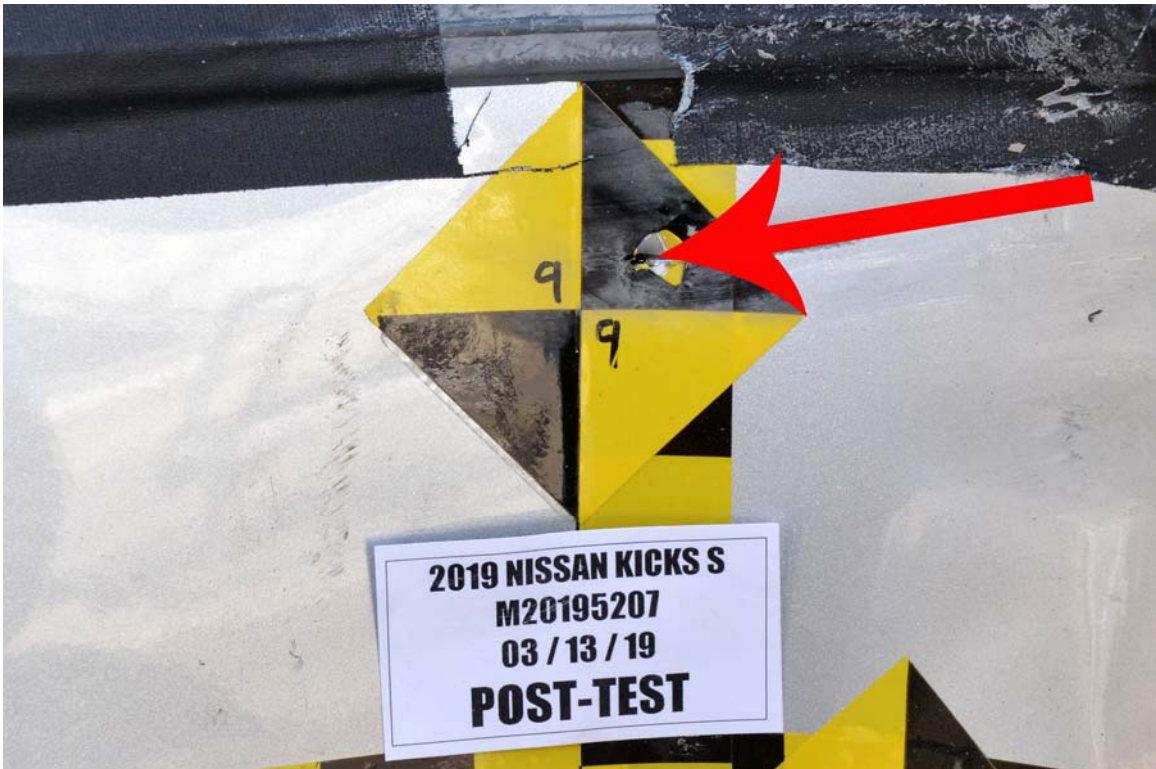
FIGURE 19. Pre-Test Close-Up View of Impact Point Target

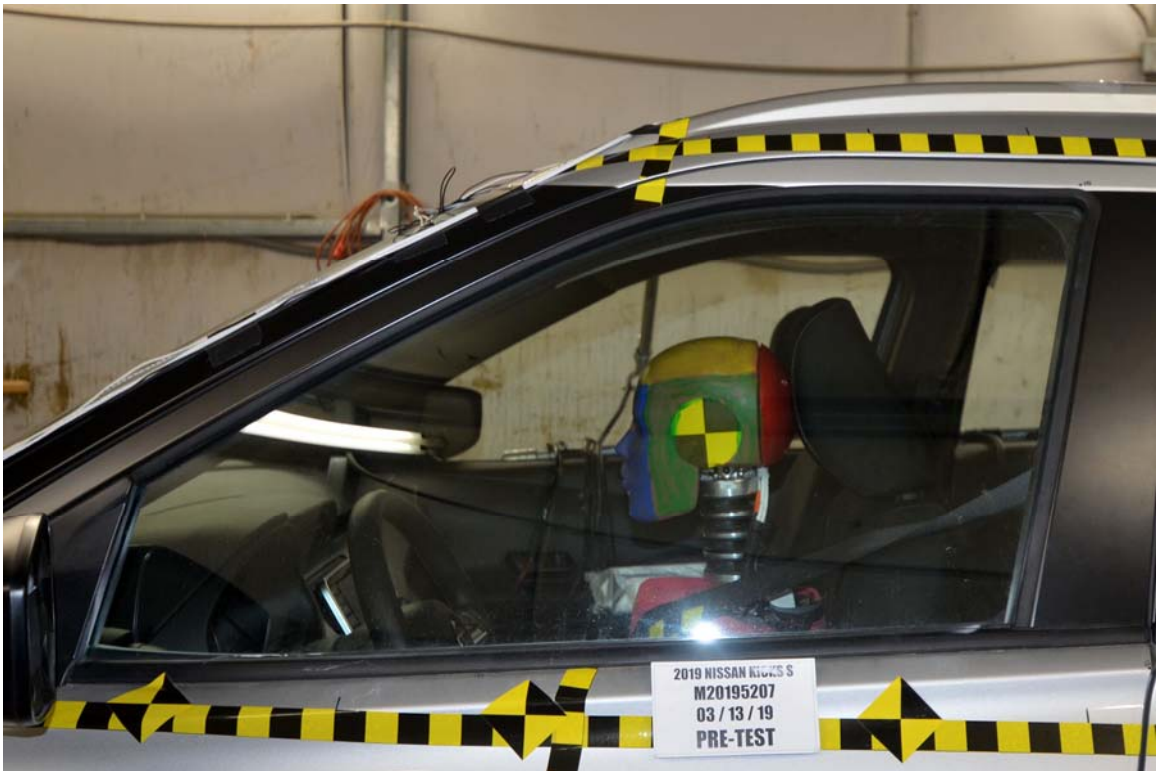
FIGURE 23. Pre-Test Left Side View of Dummy Showing Belt and Chalking

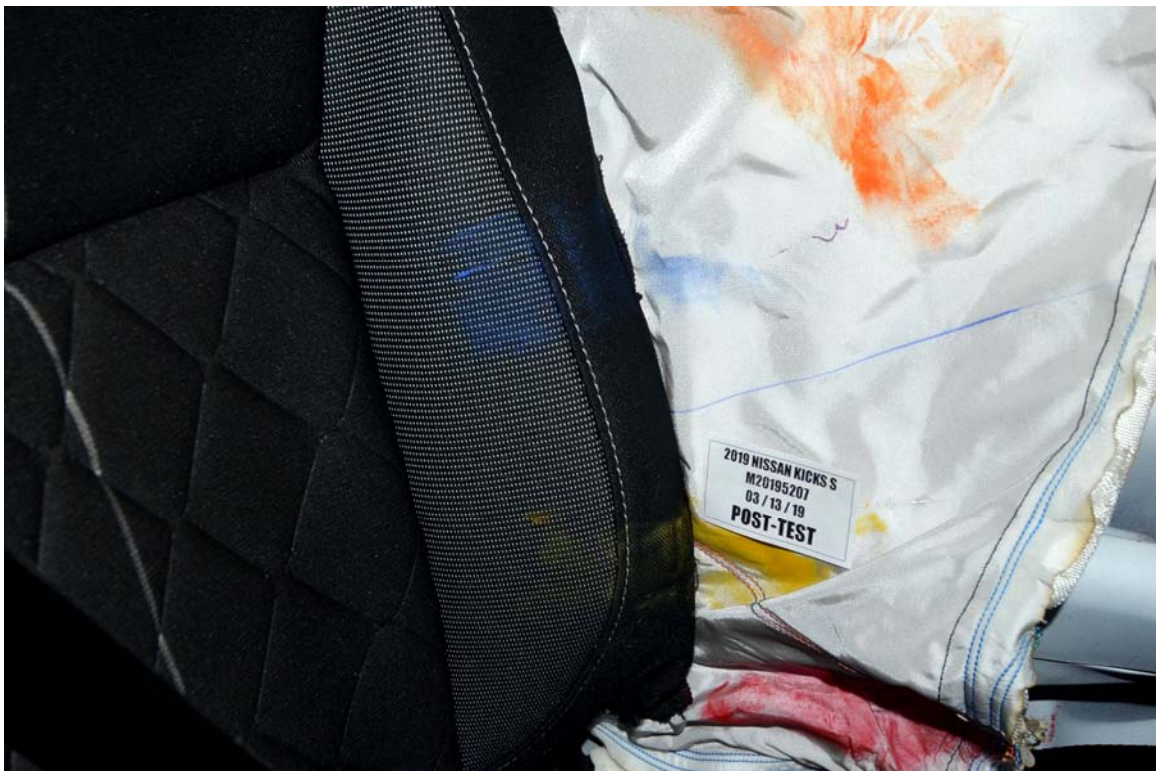
FIGURE 47. Post-Test Dummy Close-Up Head Contact With Side Airbag View

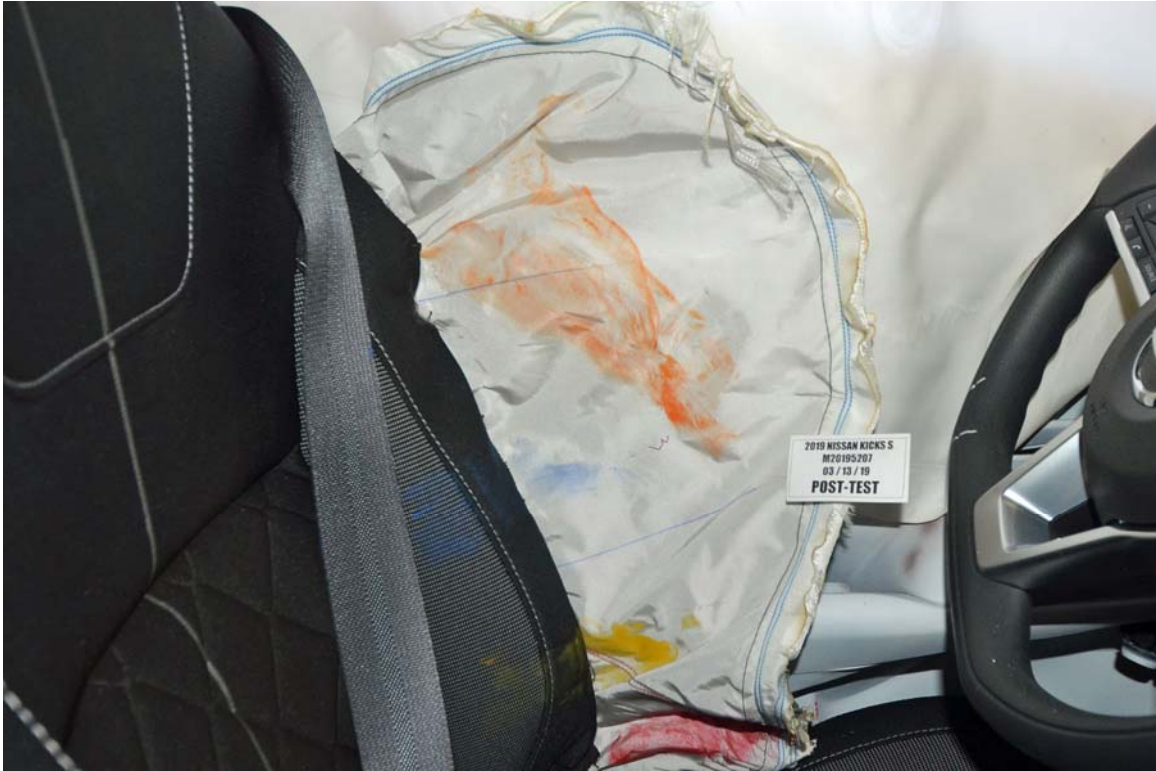
FIGURE 48. Post-Test Dummy Close-Up Torso Contact With Vehicle Interior View

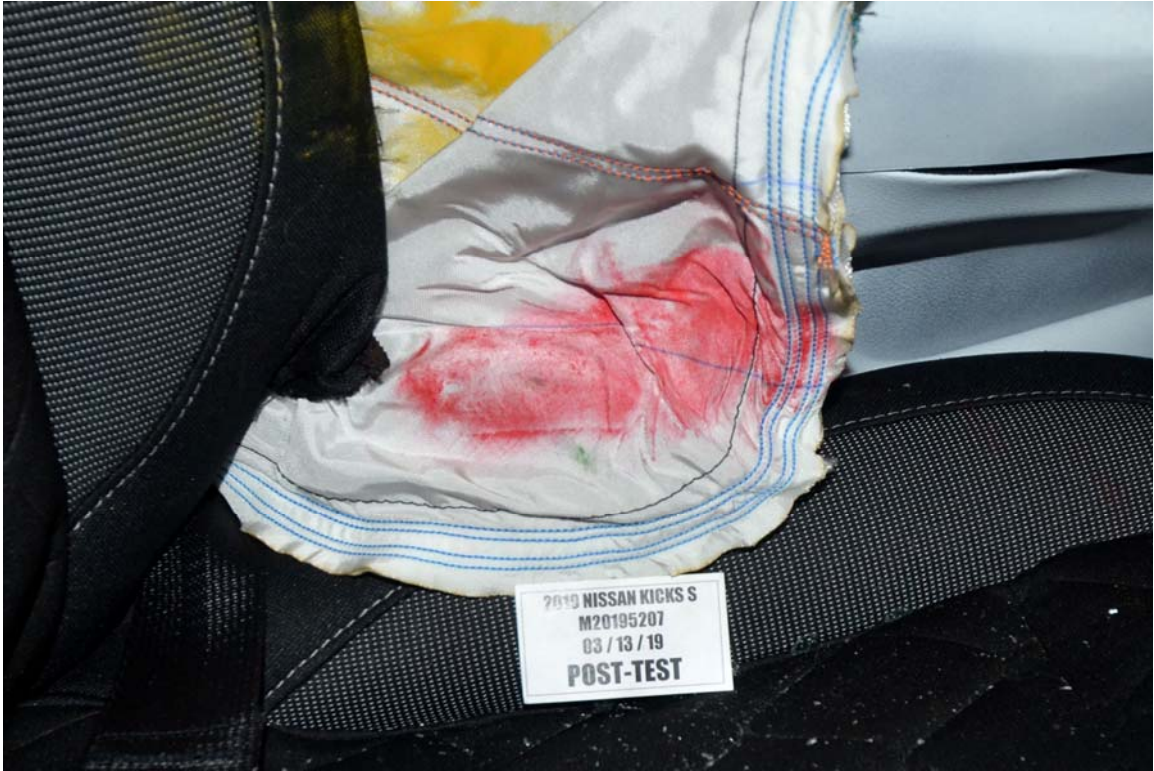
FIGURE 50. Post-Test Dummy Close-Up Pelvis Contact With Vehicle Interior View
