**REPORT NUMBER: SINCAP-KAR-19-020**

**NEW CAR ASSESSMENT PROGRAM (NCAP)  
MOVING DEFORMABLE BARRIER SIDE IMPACT TEST**

**NISSAN MOTOR CO., LTD.  
2019 NISSAN KICKS S 5-DOOR SUV**

**NHTSA No: M20195208**

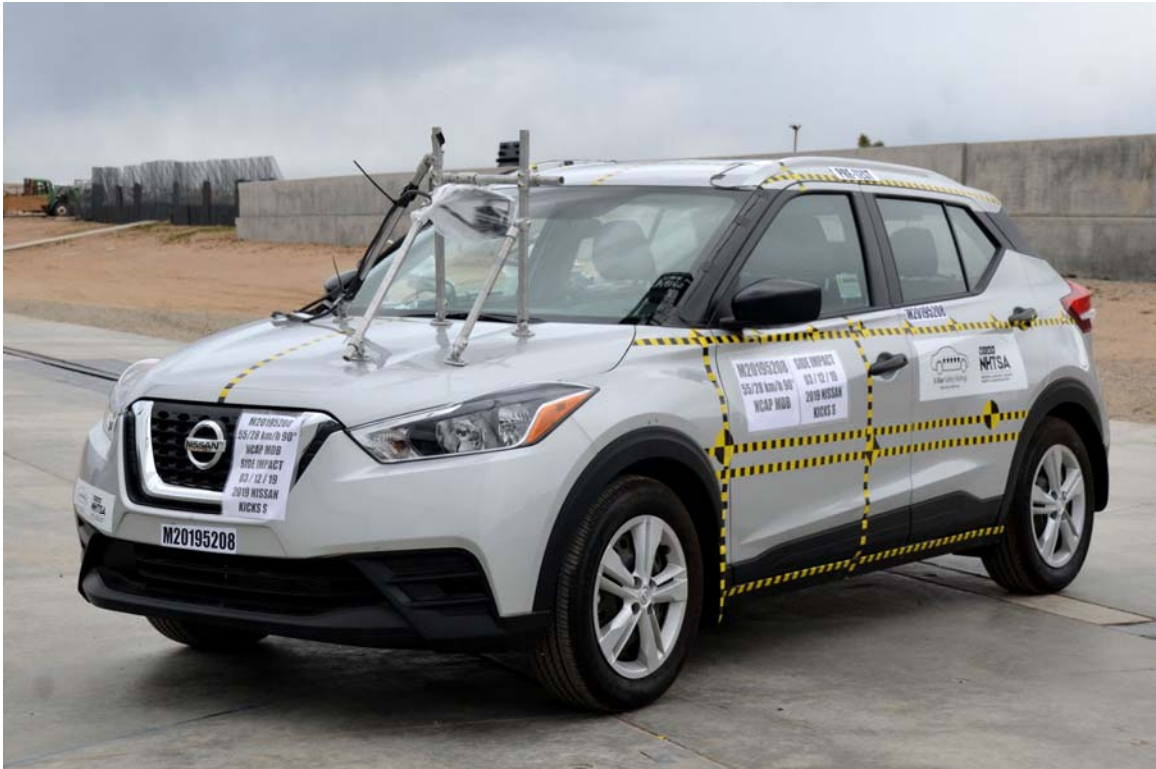
FIGURE 4. Post-Test Frontal View of Test Vehicle

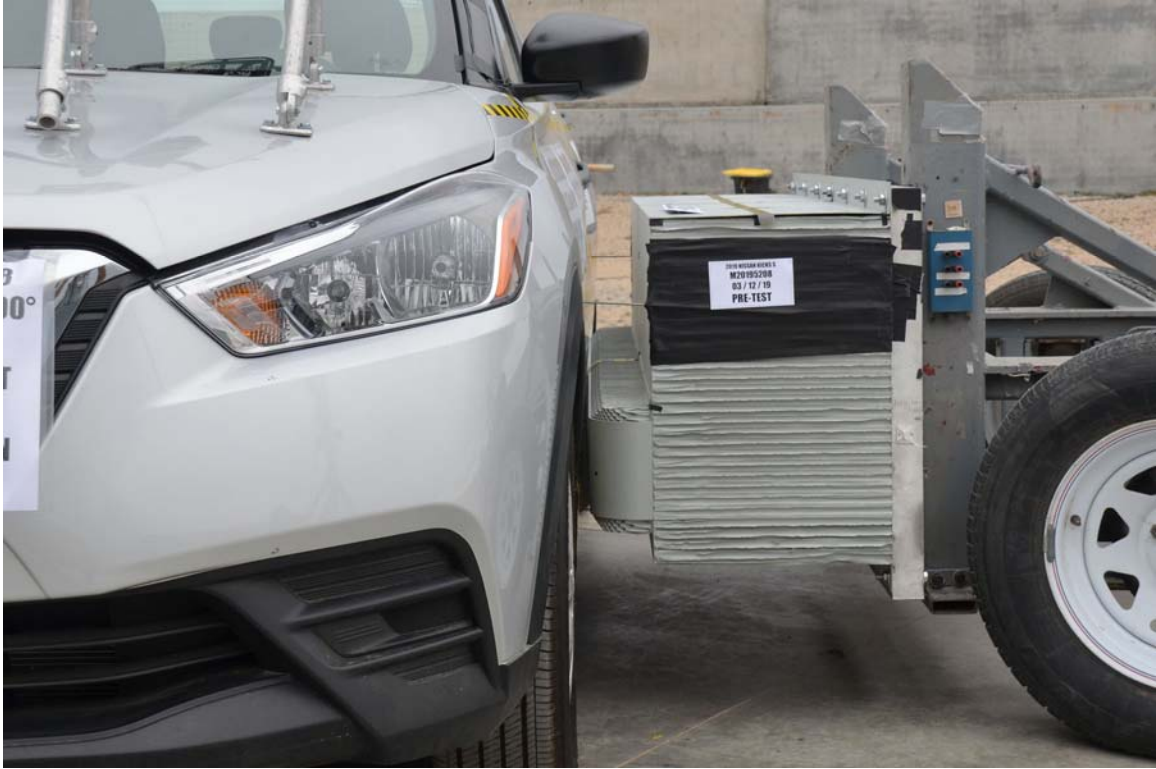
FIGURE 17. Pre-Test Left Side View of MDB Positioned  
Against Side of Test Vehicle

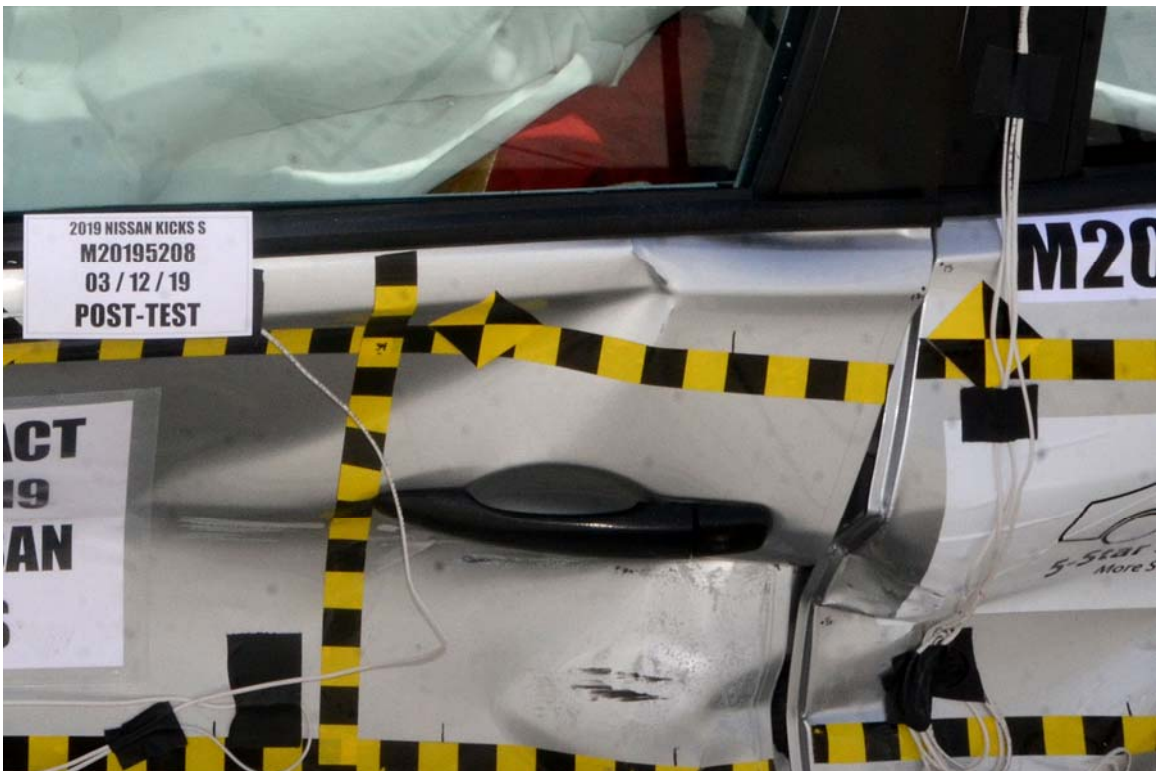
FIGURE 22. Post-Test Left Front Door Latch Close-Up

The doors on the struck side of the vehicle remained closed and latched. There was no separation at the hinges or latches. The doors on the non-struck side remained closed and latched. There was no ATD value that exceeded its limit. The Left Lower B-Post Y and Left Mid B-Post Y channels were not installed on the test vehicle. The Right Rear Sill channel failed, and no data was collected.

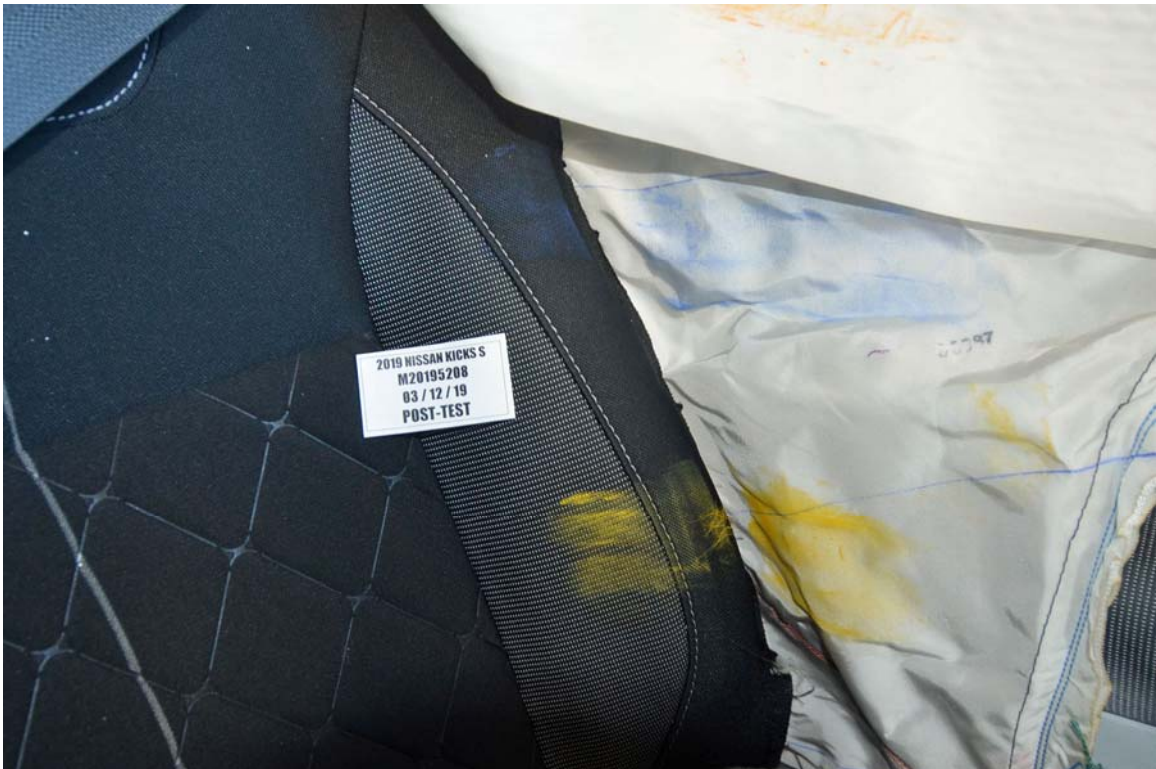
FIGURE 50. Post-Test Driver Dummy Close-Up Torso Contact with Vehicle Interior View

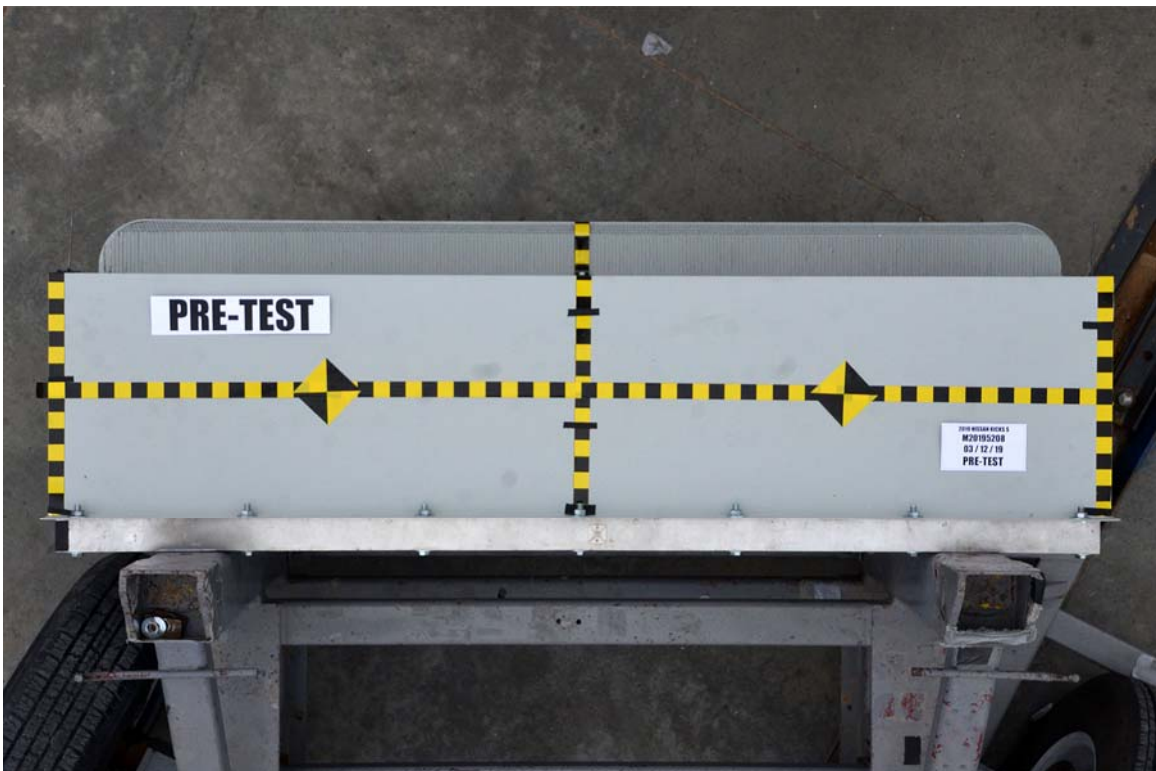
FIGURE 86. Pre-Test Top View of MDB Impactor Face
