**REPORT NUMBER: SPNCAP-MGA-2019-035**

**NEW CAR ASSESSMENT PROGRAM (NCAP) Side  
Impact Pole Test**

**GENERAL MOTORS LLC  
2019 Chevrolet Silverado 1500 LT Crew Cab Truck  
NHTSA No.: M20190107**

**FINAL REPORT**

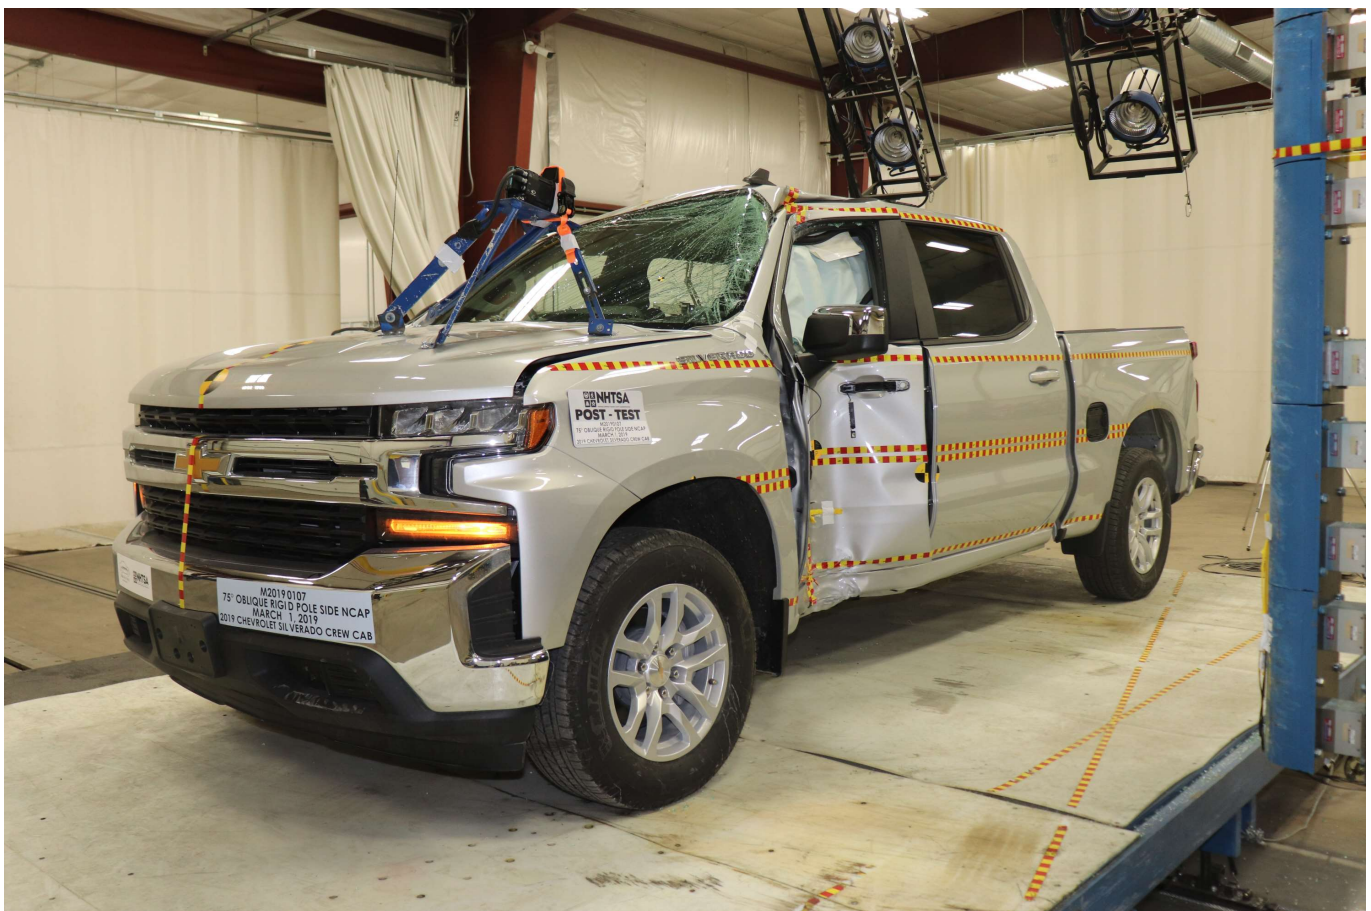
Photo No. 006 - Post-Test Left Front Three-Quarter View of Test Vehicle

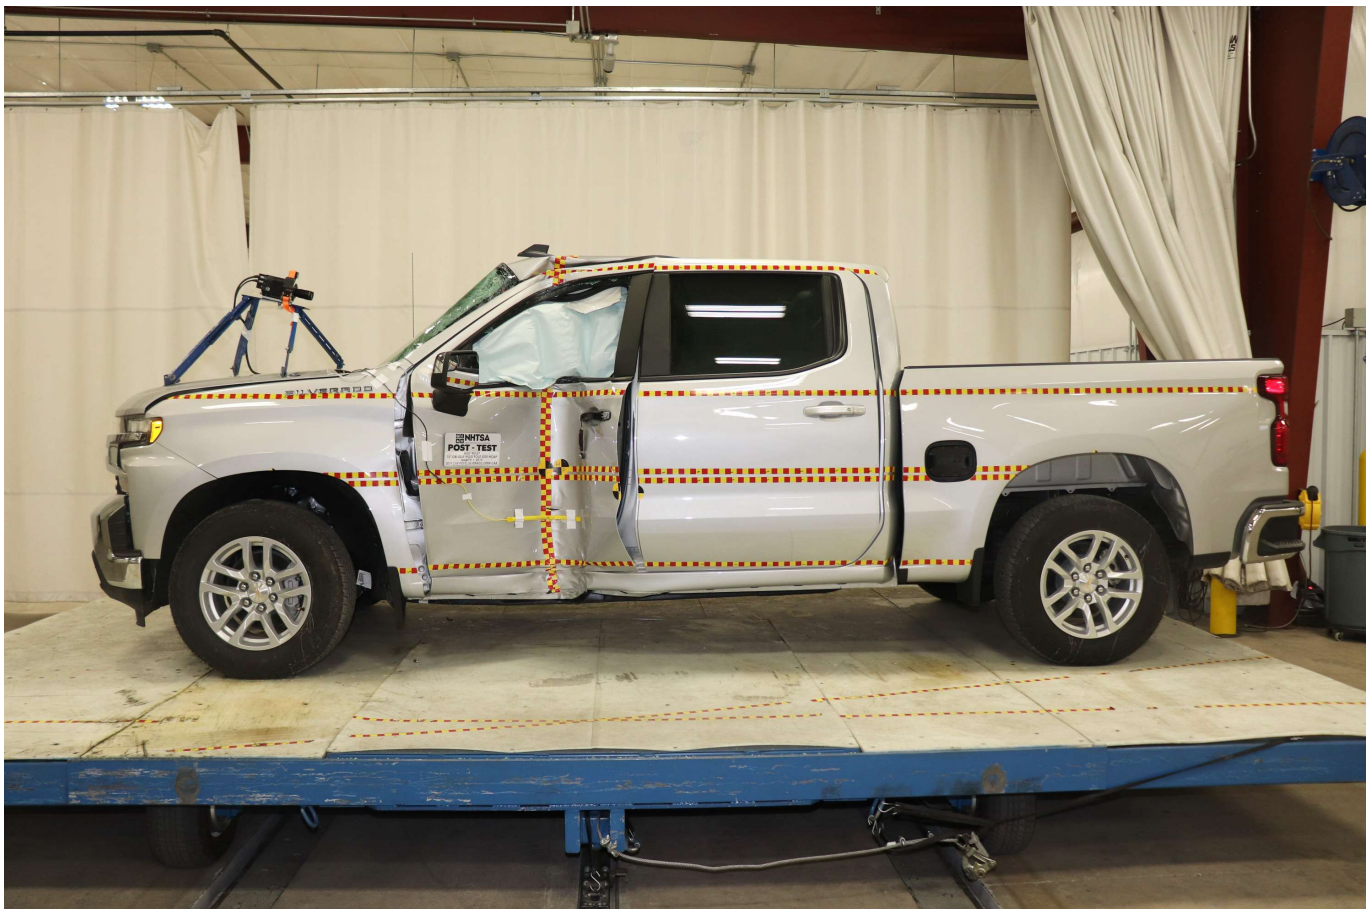
Photo No. 008 - Post-Test Left Side View of Test Vehicle

| Critical Areas of Performance | Observations and Conclusions |
|---|---|
| Windshield Damage | Cracked |
| Side Window Damage | LF window broken |

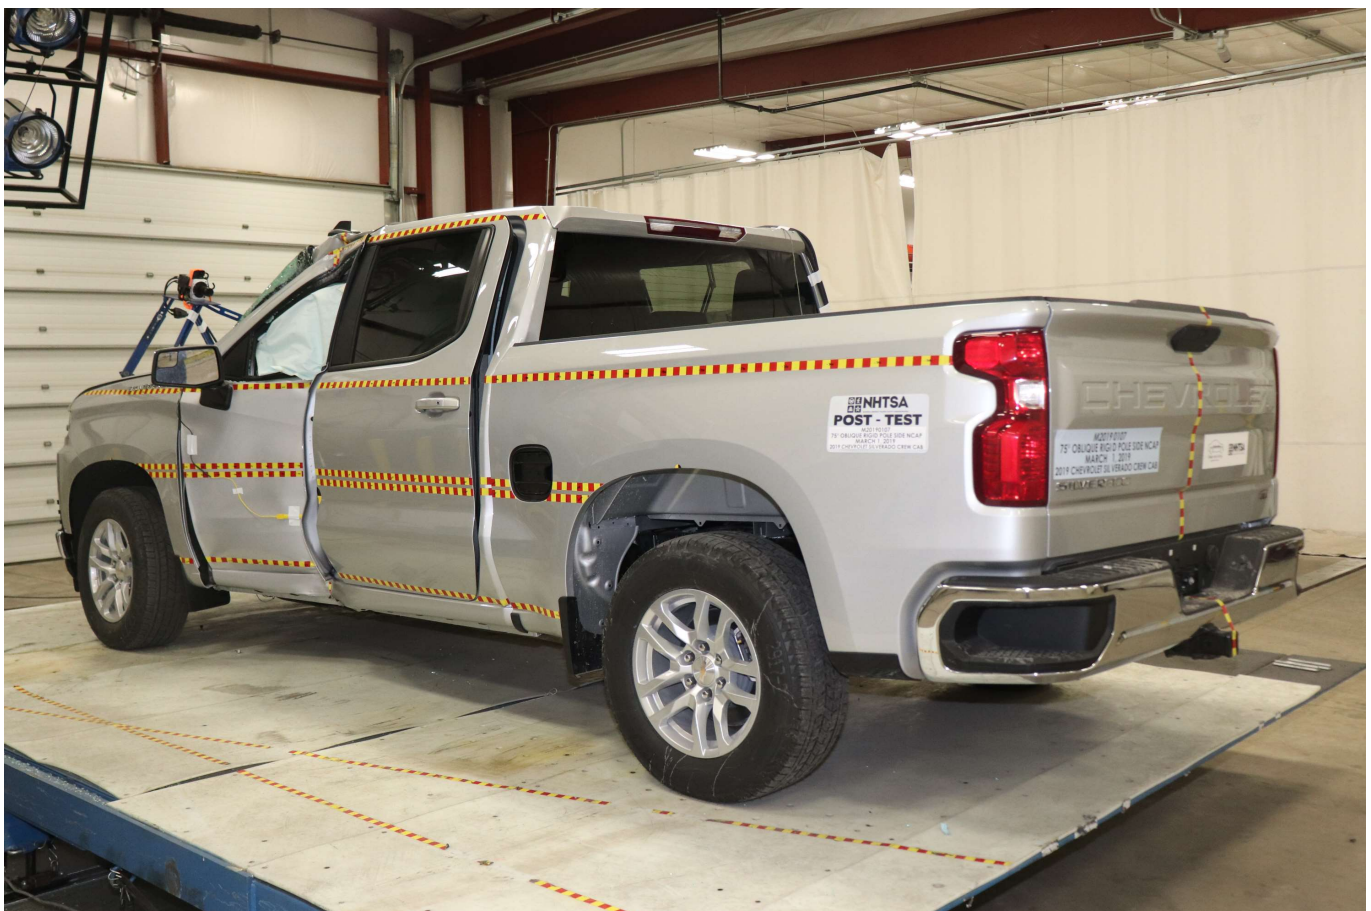
Photo No. 010 - Post-Test Left Rear Three-Quarter View of Test Vehicle

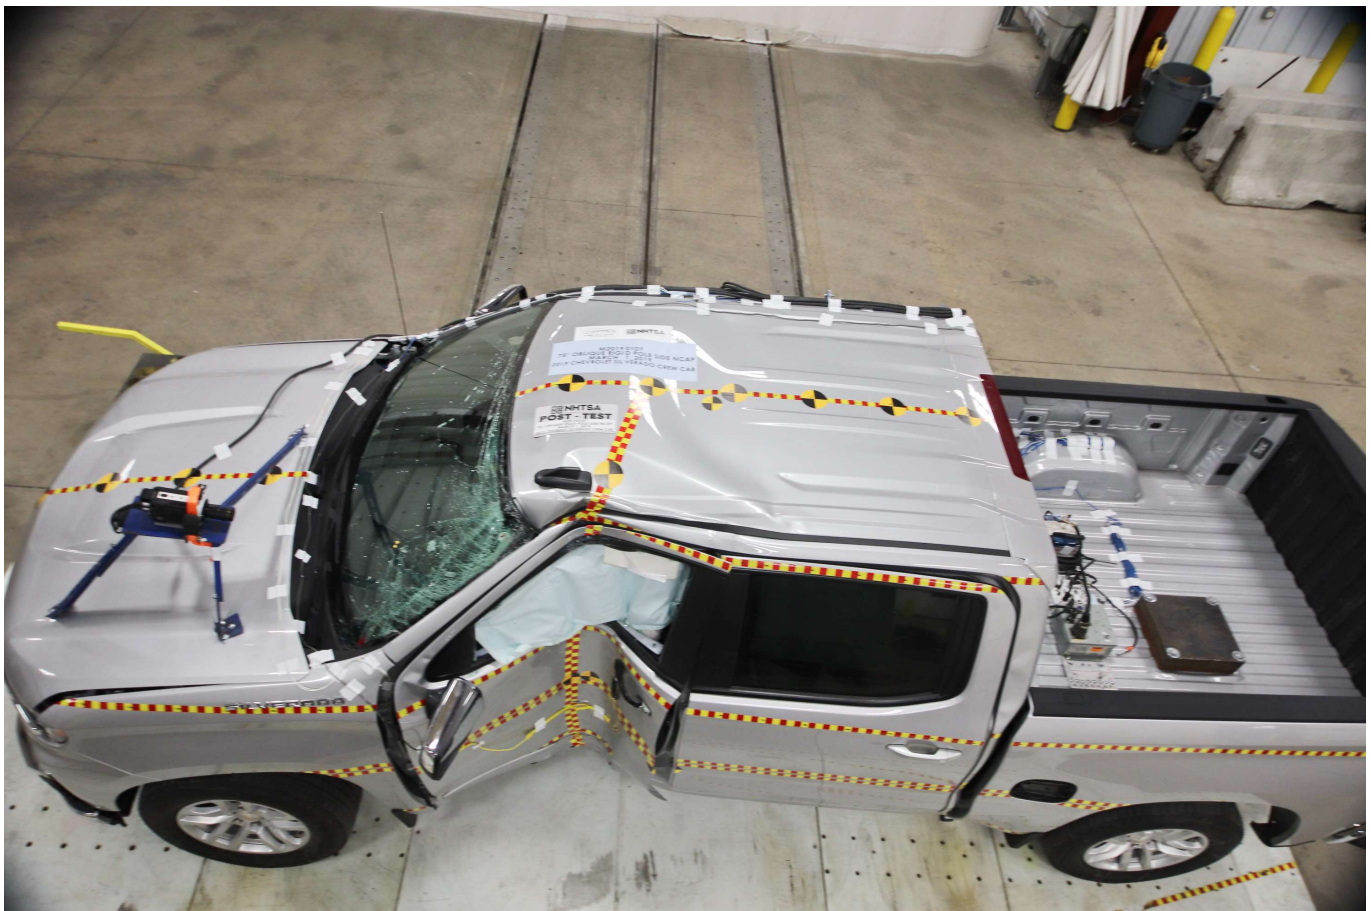
Photo No. 016 - Post-Test Overhead View of Test Area

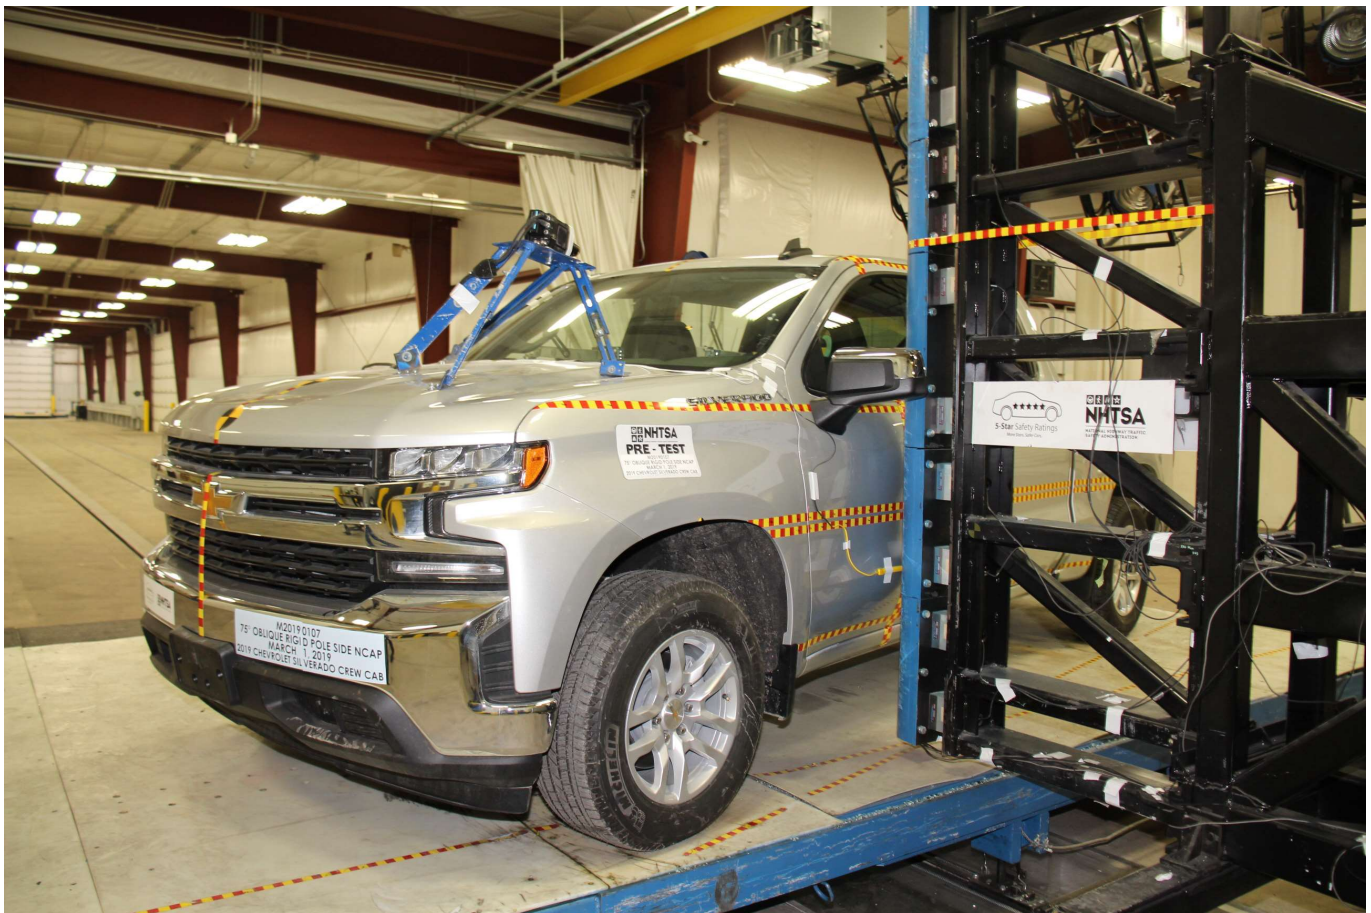
Photo No. 017 - Pre-Test Left Side View of Pole Positioned Against Side of Vehicle

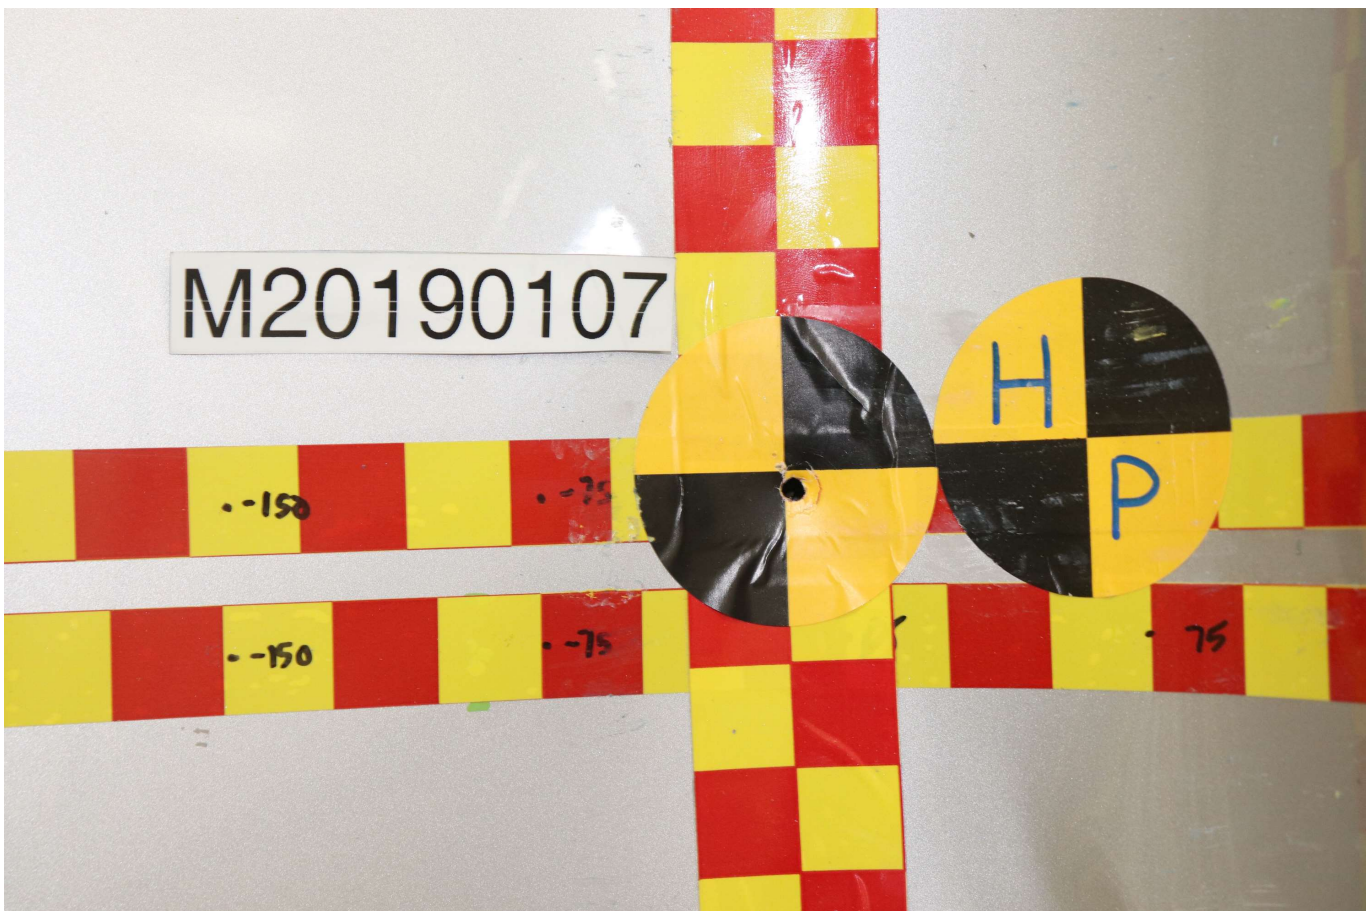
Photo No. 020 - Post-Test Close-Up View of Impact Point Target Showing Impact Location

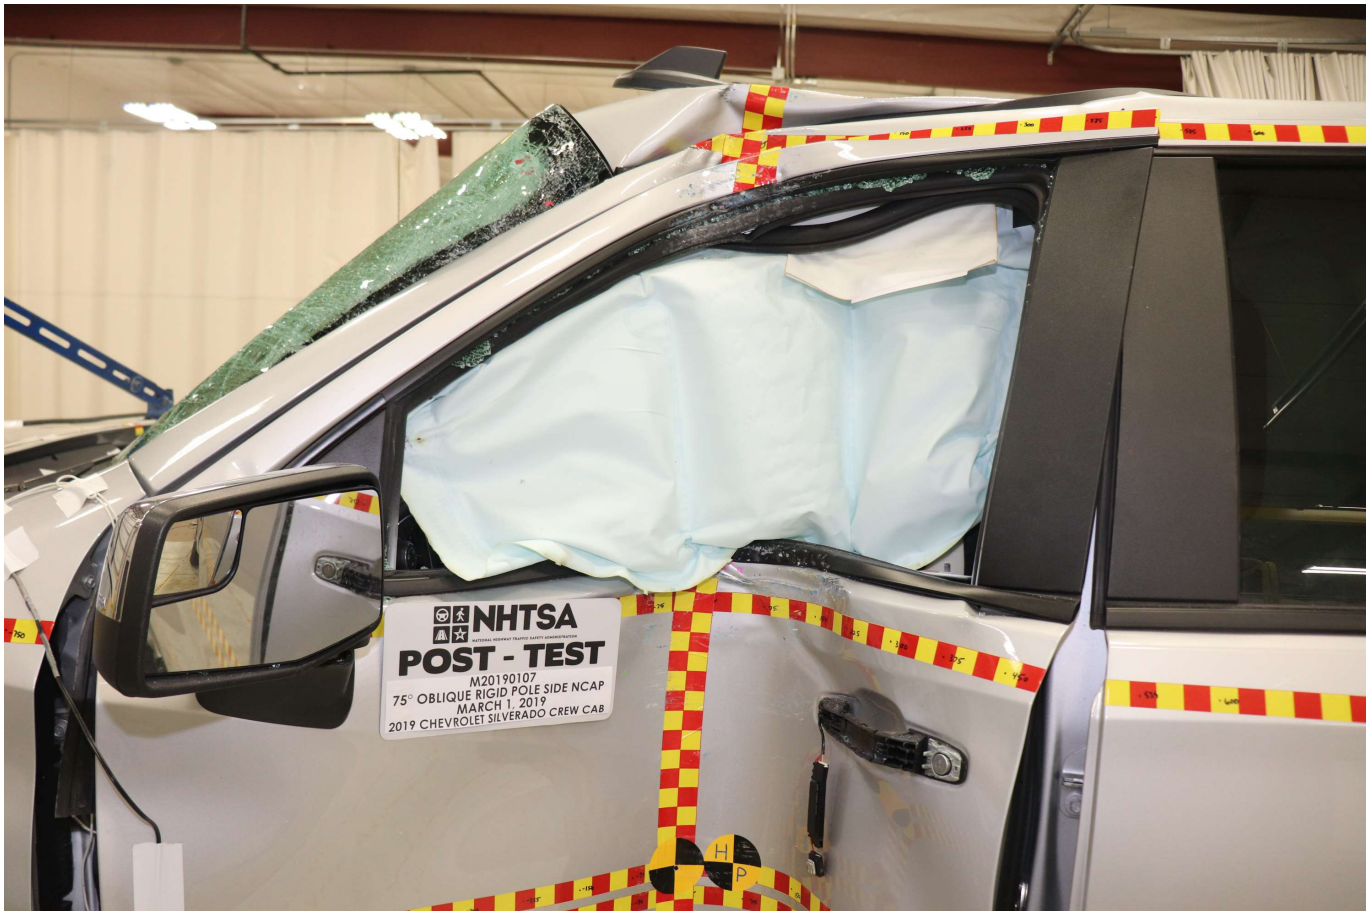
Photo No. 025 - Post-Test Left Side View of Dummy Shoulder and Door Top View

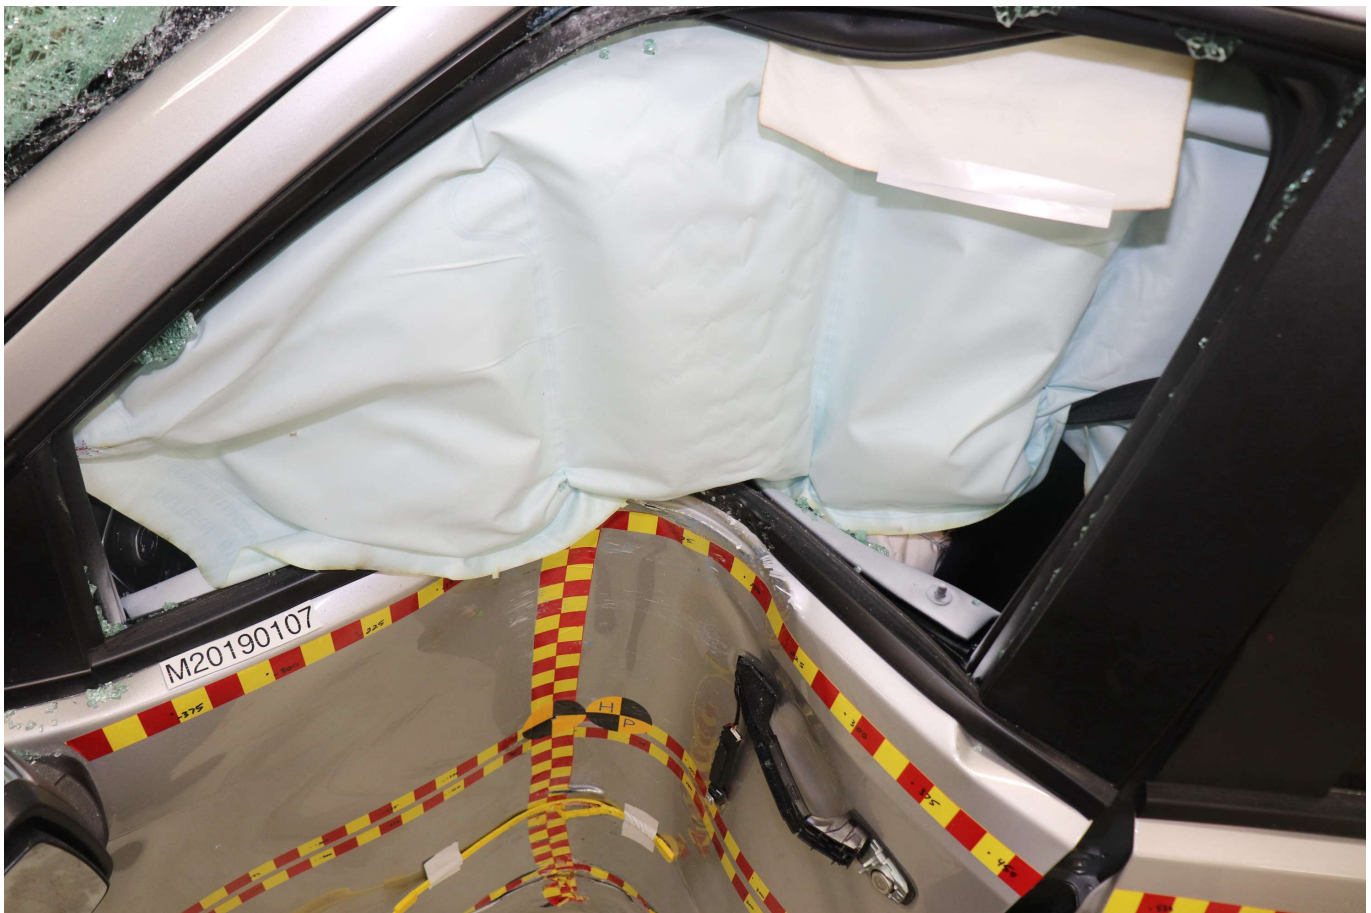
Photo No. 041 - Post-Test Dummy and Door Clearance View

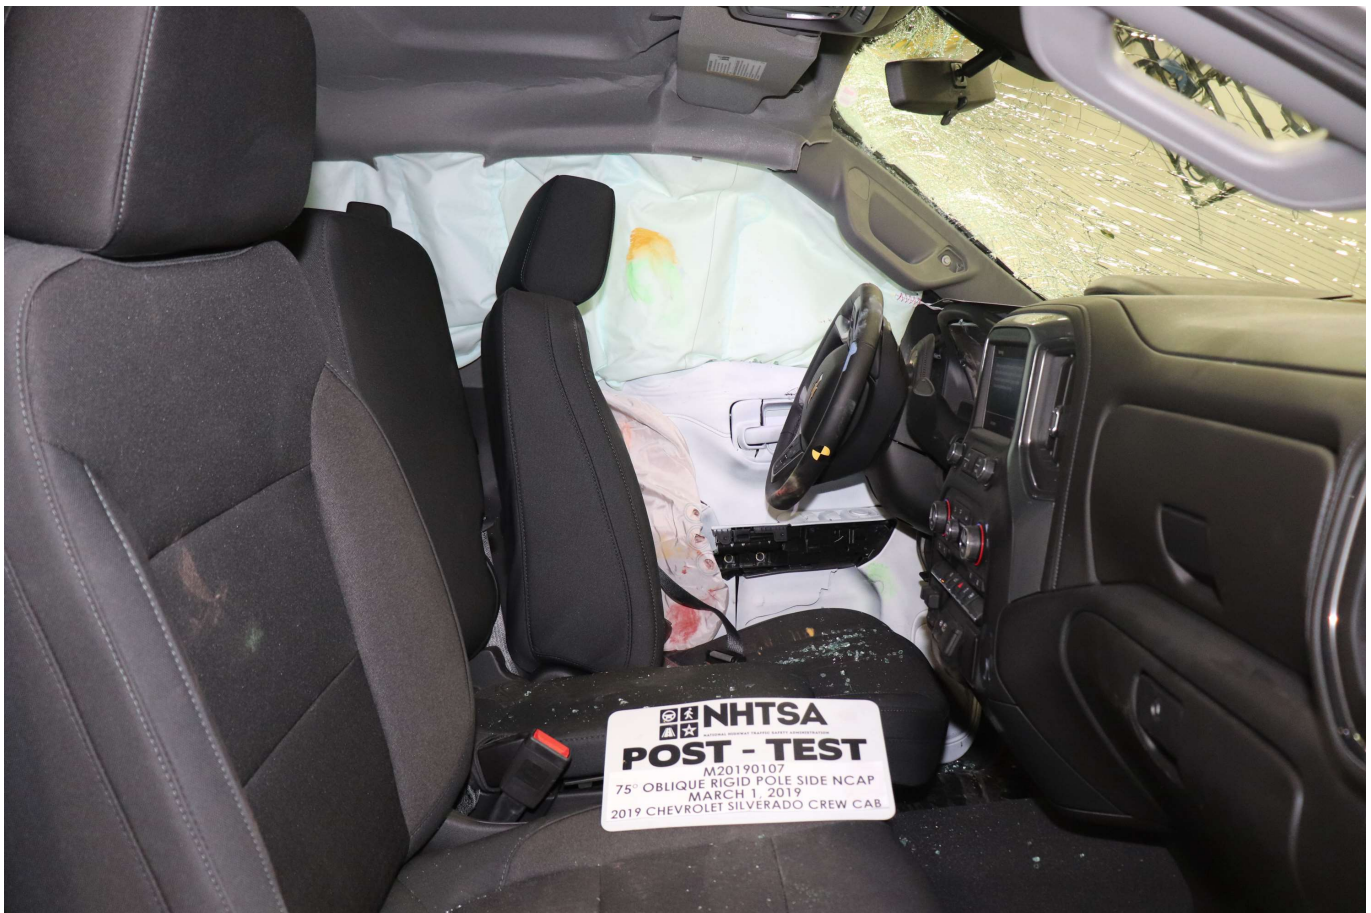
Photo No. 045 - Post-Test Inner Door Panel View Showing Dummy Contact Location

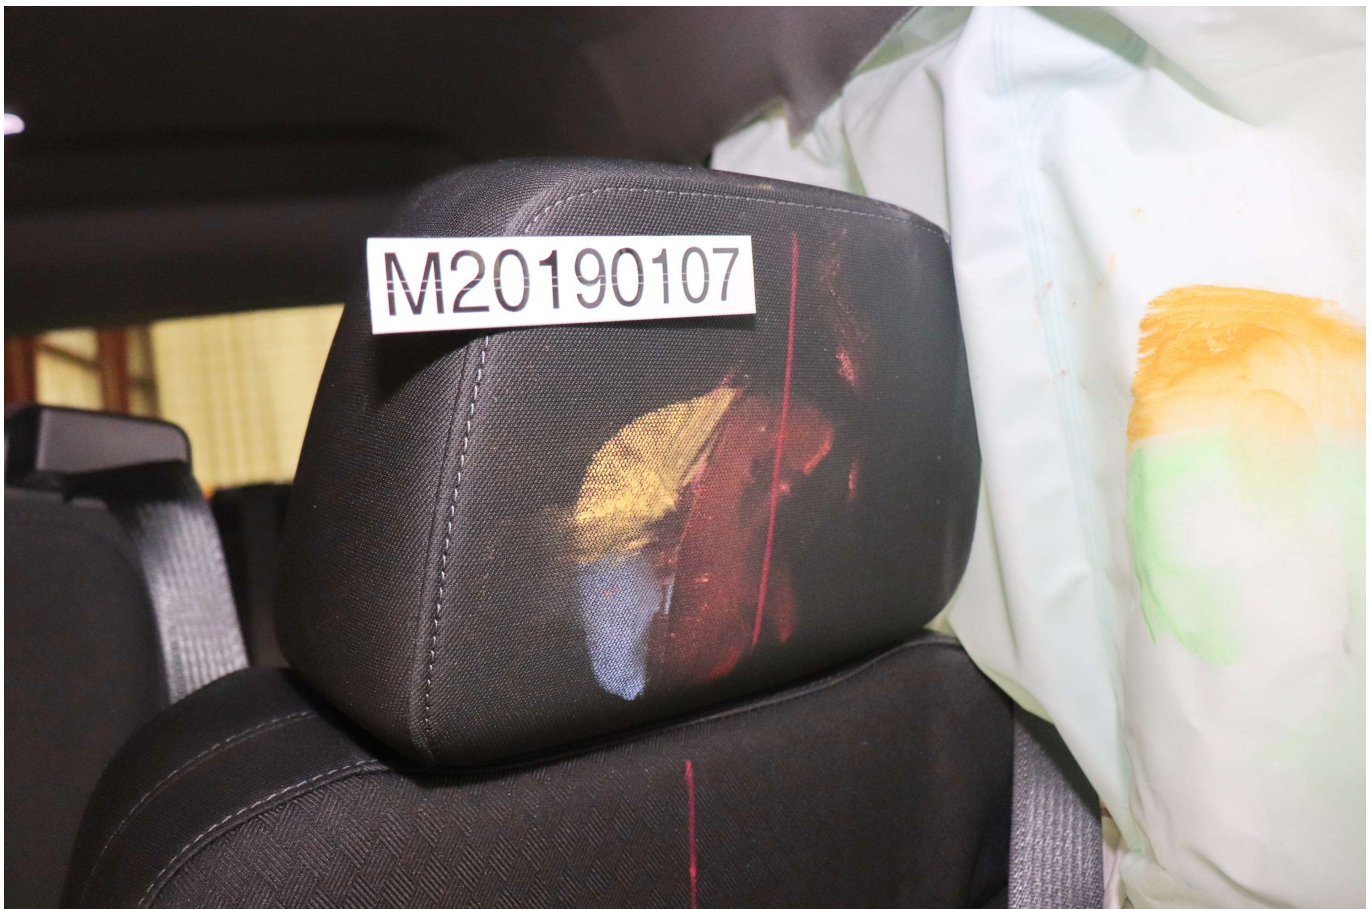
Photo No. 046 - Post-Test Dummy Close-Up Head Contact with Vehicle Interior View

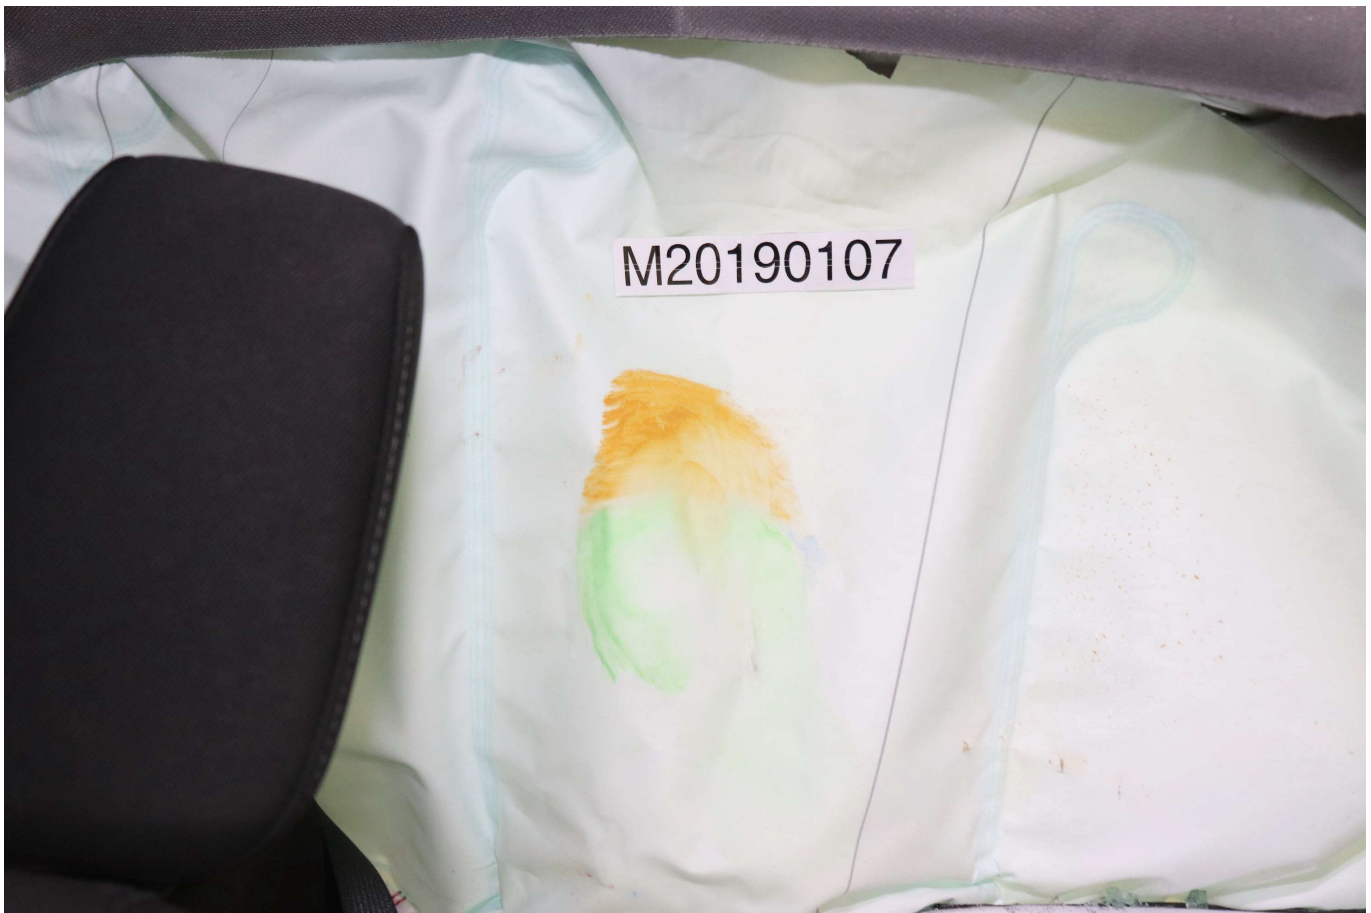
Photo No. 047 - Post-Test Dummy Close-Up Head Contact with Side Air Bag View

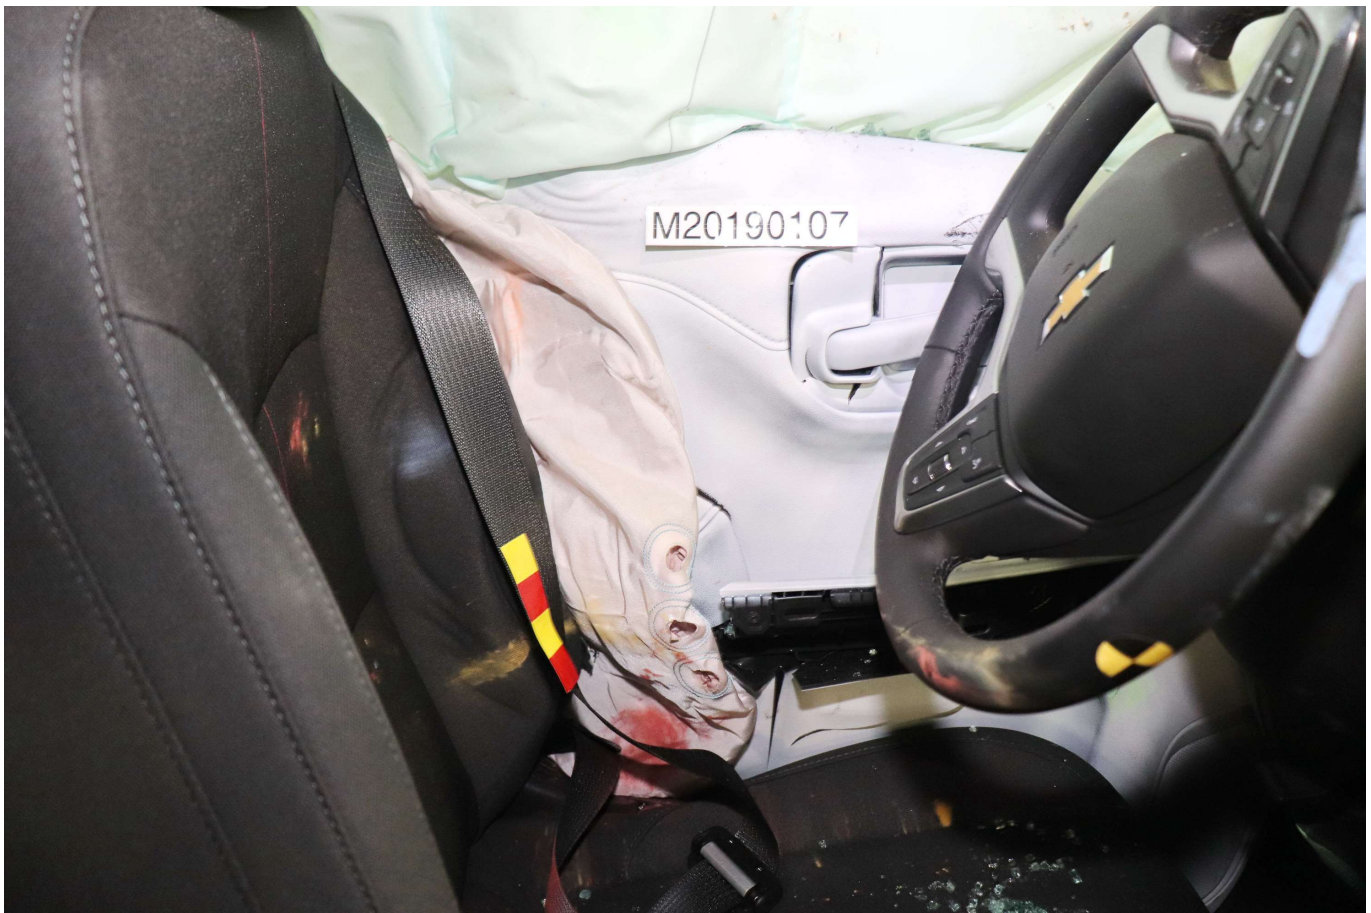
Photo No. 049 - Post-Test Dummy Close-Up Torso Contact with Side Air Bag View

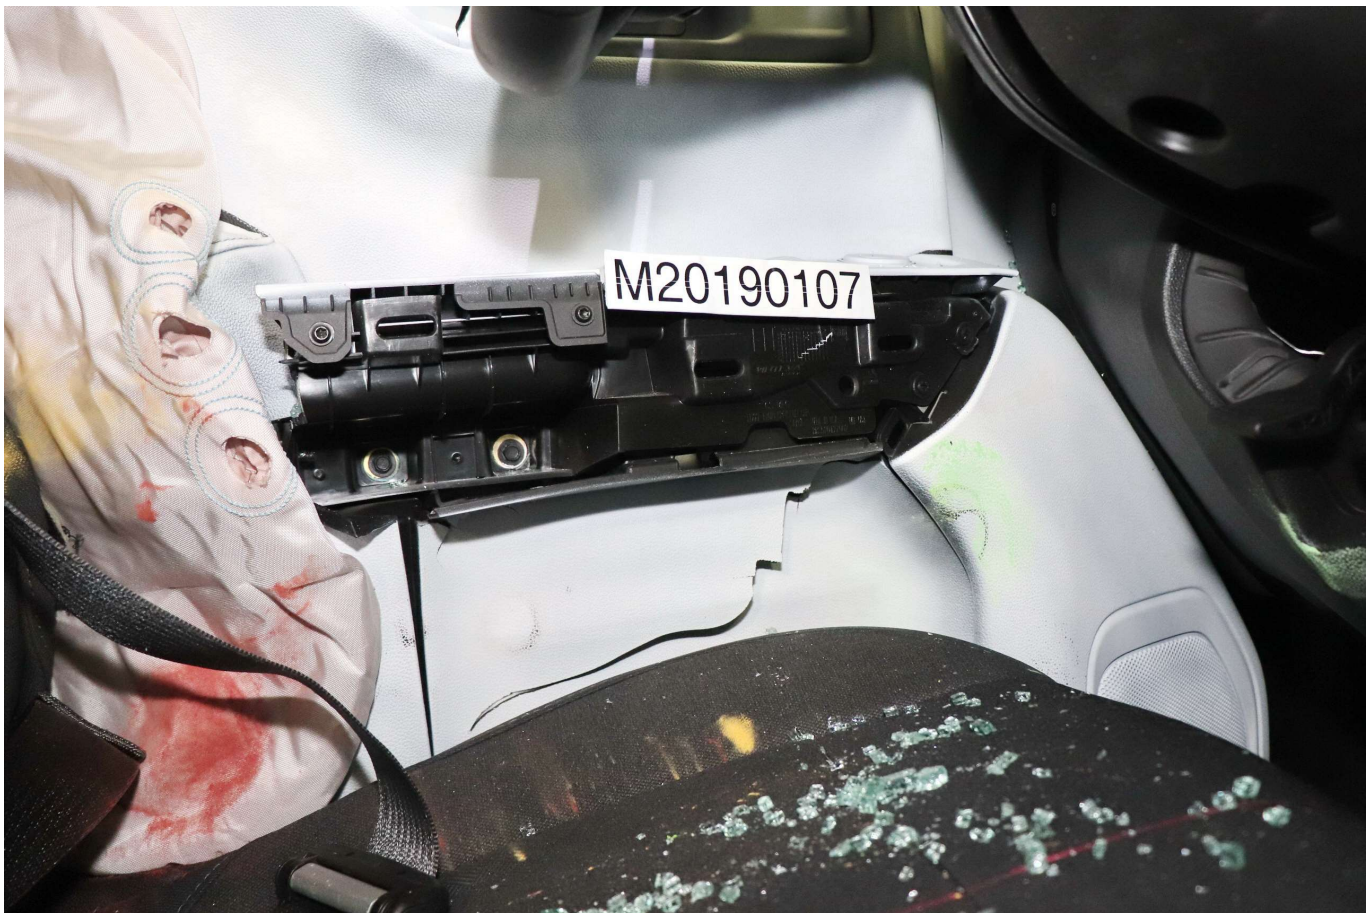
Photo No. 051 - Post-Test Dummy Close-Up Pelvis Contact with Side Air Bag View

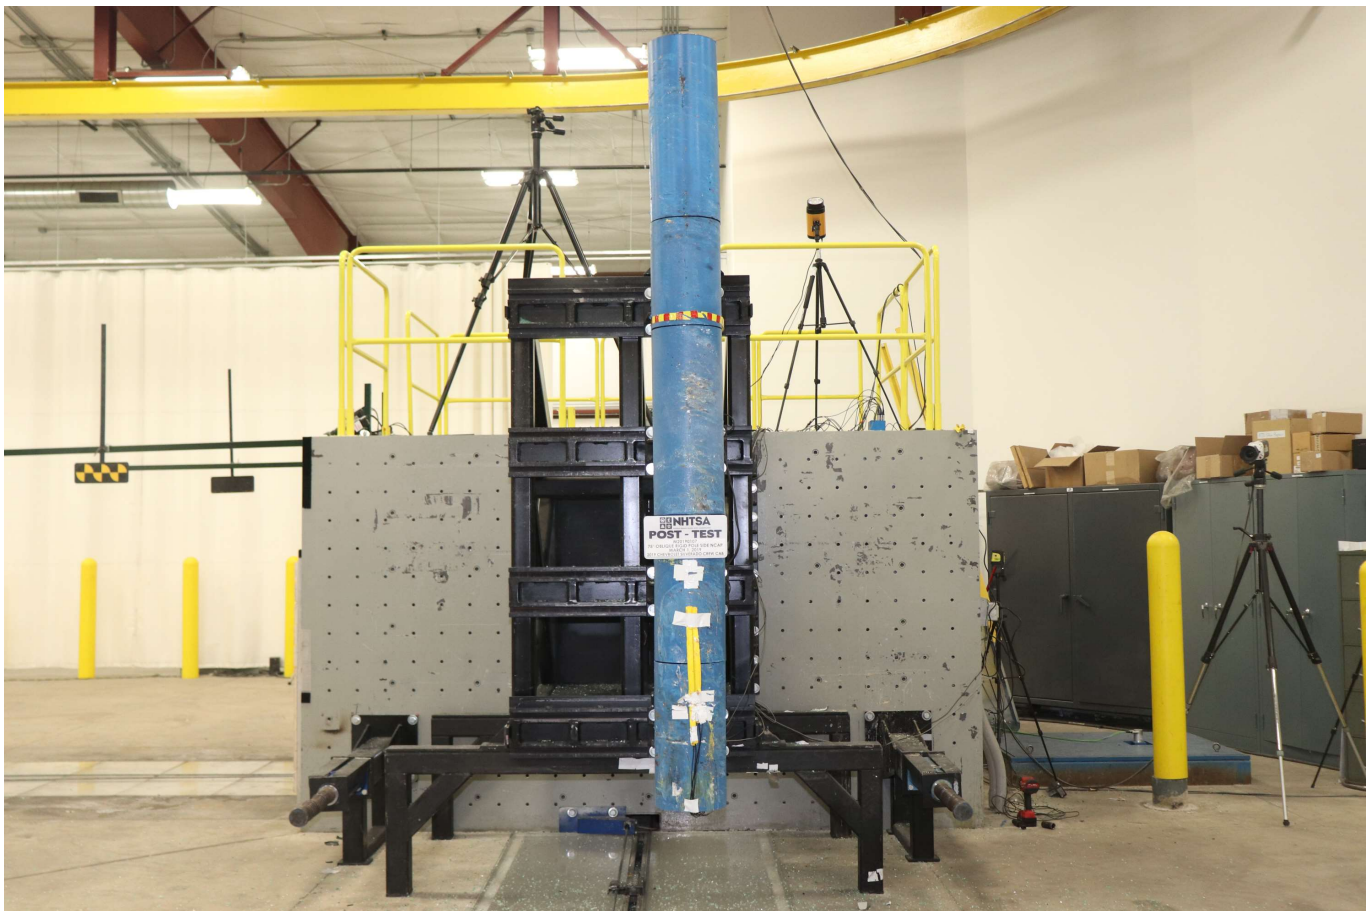
Photo No. 058 - Post-Test Pole Barrier Front View

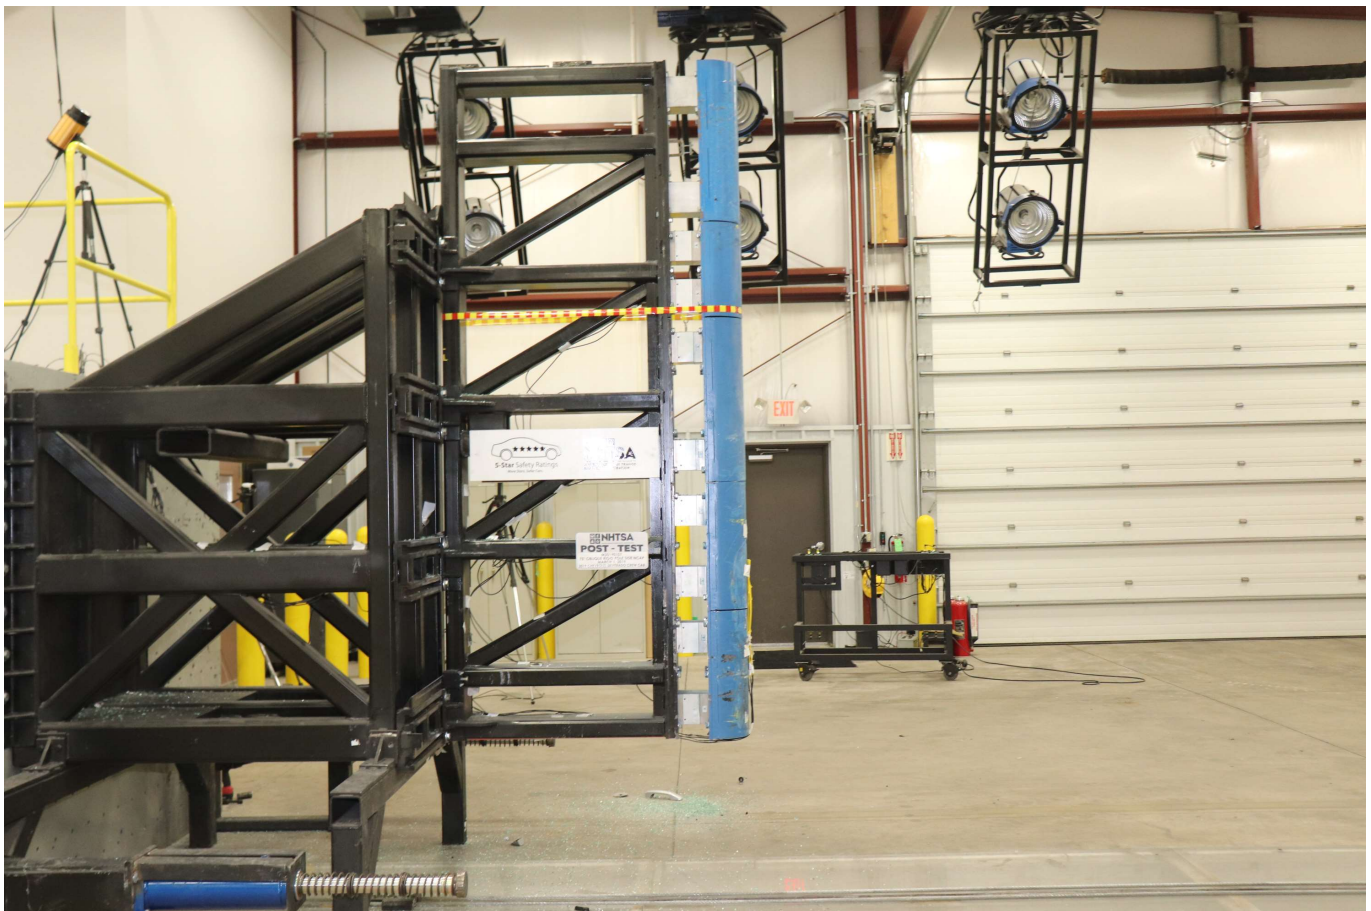
Photo No. 060 - Post-Test Pole Barrier Side View

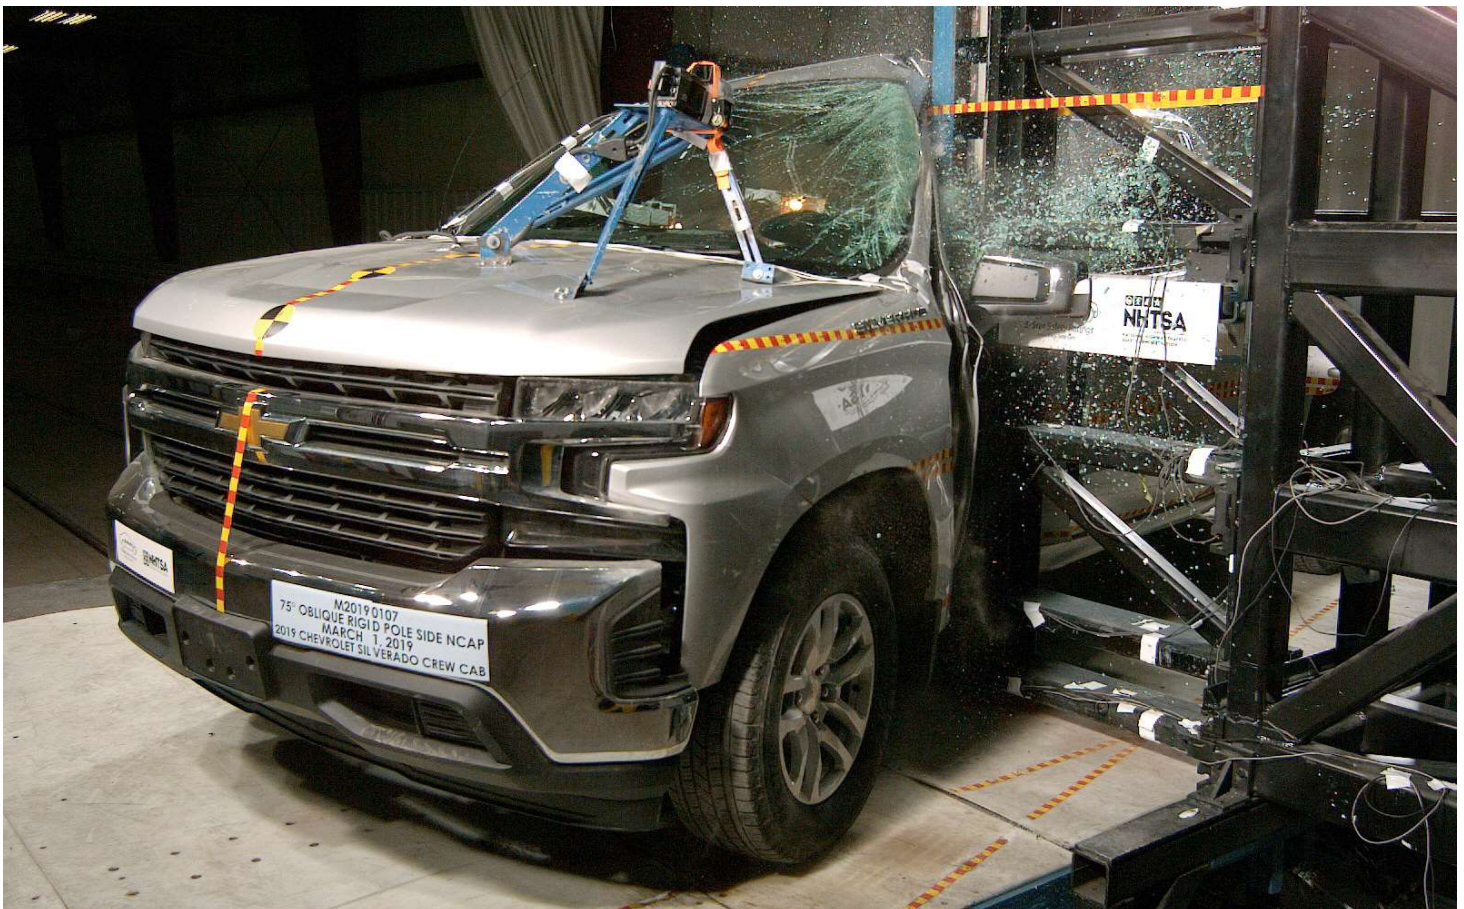
Photo No. 068 - Impact Event

A rigid pole side impact test was conducted on a 2019 Chevrolet Silverado 1500 LT Crew Cab Truck. The subject vehicle was towed into the rigid pole at an angle of 75° and a velocity of 32.29 km/h. The test was conducted by MGA Research Corporation in Burlington, Wisconsin on March 1, 2019. Pre-test and post-test photographs of the test vehicle and side impact dummy (SID-IIs) are included in Appendix A of this report.

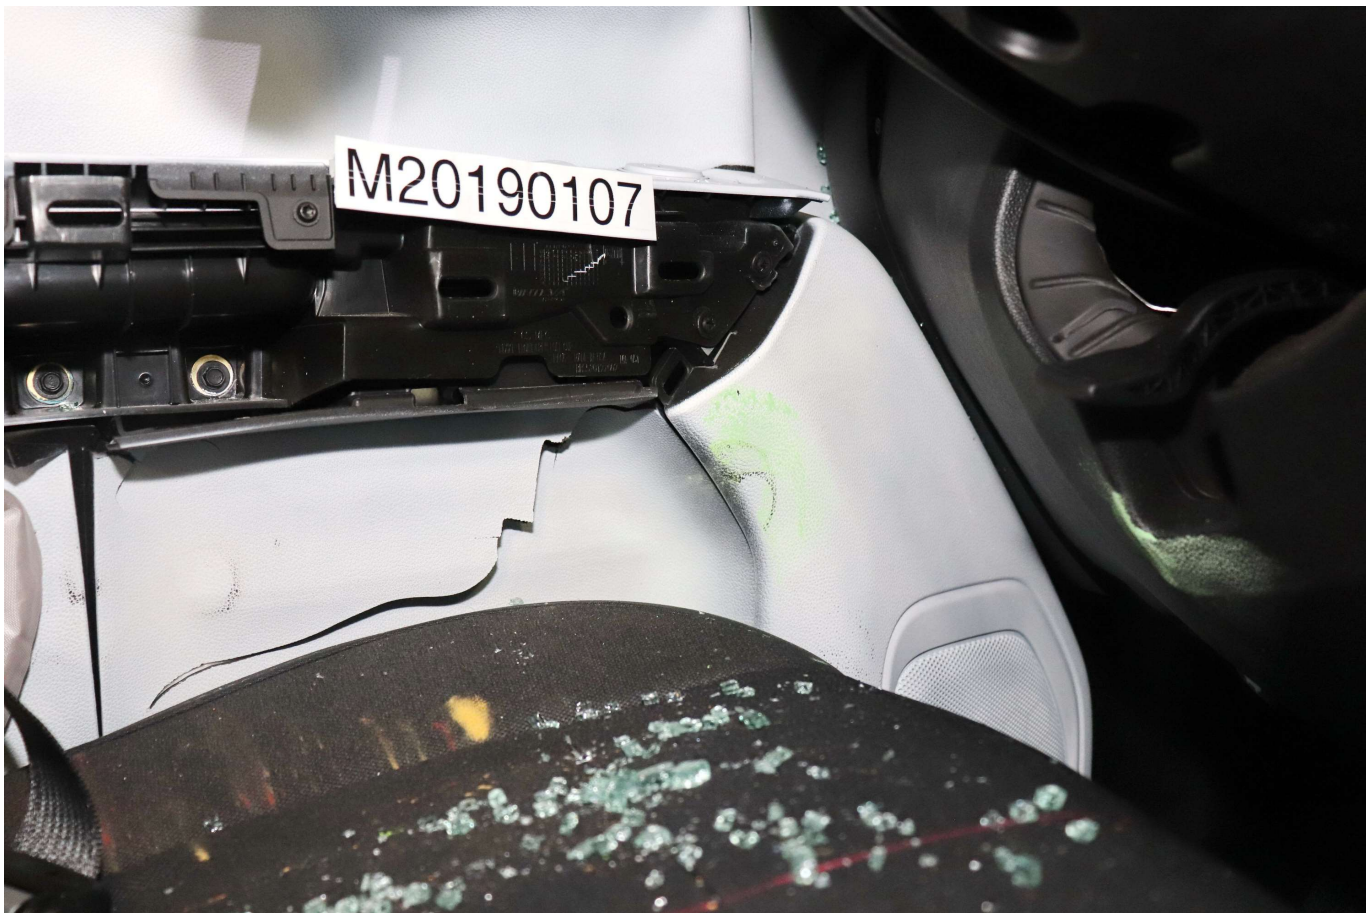
Photo No. 071 - Post-Test View of Shattered Vehicle Inner Door Panel
