**Final Report Number: NCAP-TRC-19-006**

**New Car Assessment Program (NCAP)  
Frontal Barrier Impact Test**

**FCA US LLC  
2019 Ram 1500 Crew Cab  
NHTSA Number: M20190310**

**PREPARED BY:  
Transportation Research Center Inc.  
10820 State Route 347  
P. O. Box B-67  
East Liberty, OH 43319**

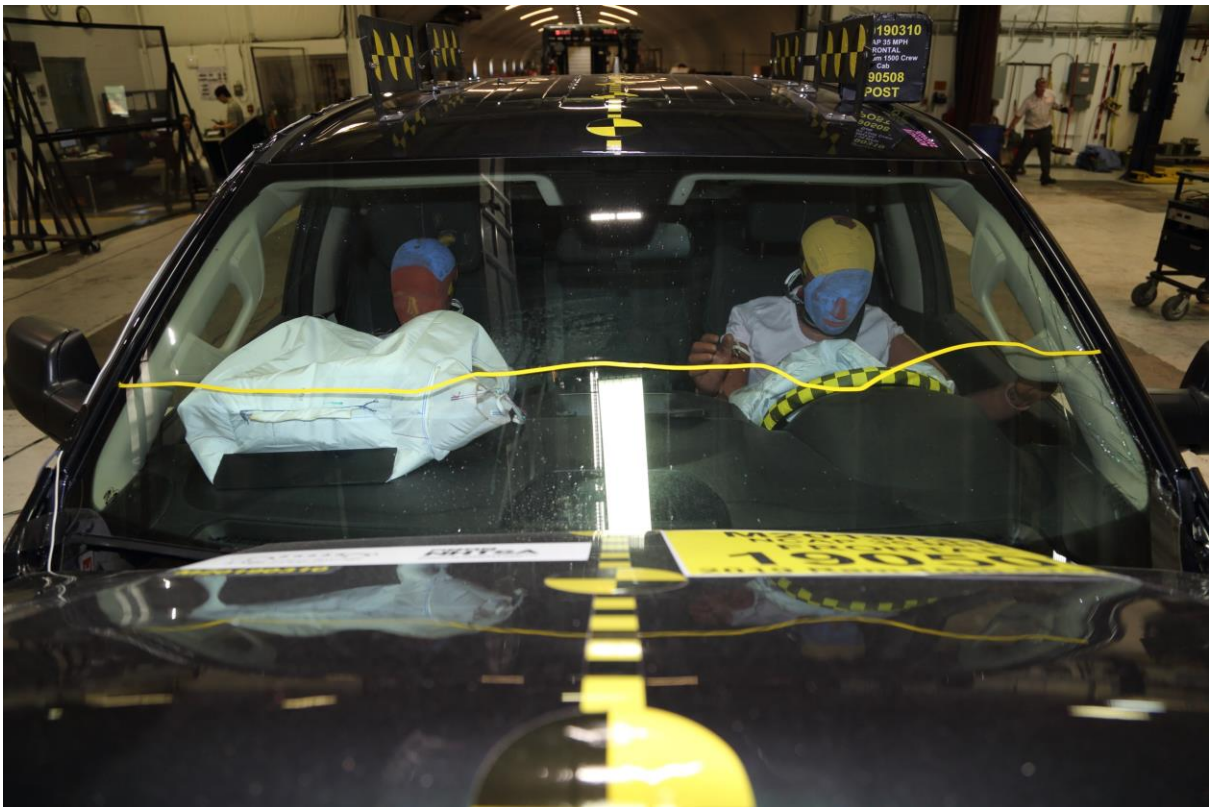
**019 Post-Test Windshield View**

| Critical Areas of Performance | Observations |
|---|---|
| Windshield Damage | Small crack lower left A pillar |

There was 100.0 percent windshield retention and no intrusion into the protected zone of the windshield during the event. There was no Stoddard solvent leakage (or electrolyte spillage) after the event or during any phase of the static rollover.
