REPORT NUMBER: SINCAP-CAL-19-007

**NEW CAR ASSESSMENT PROGRAM (NCAP)
MOVING DEFORMABLE BARRIER SIDE IMPACT TEST**

**FCA US LLC
2019 Ram 1500 Quad Cab
Four Door Truck**

NHTSA No: M20190317

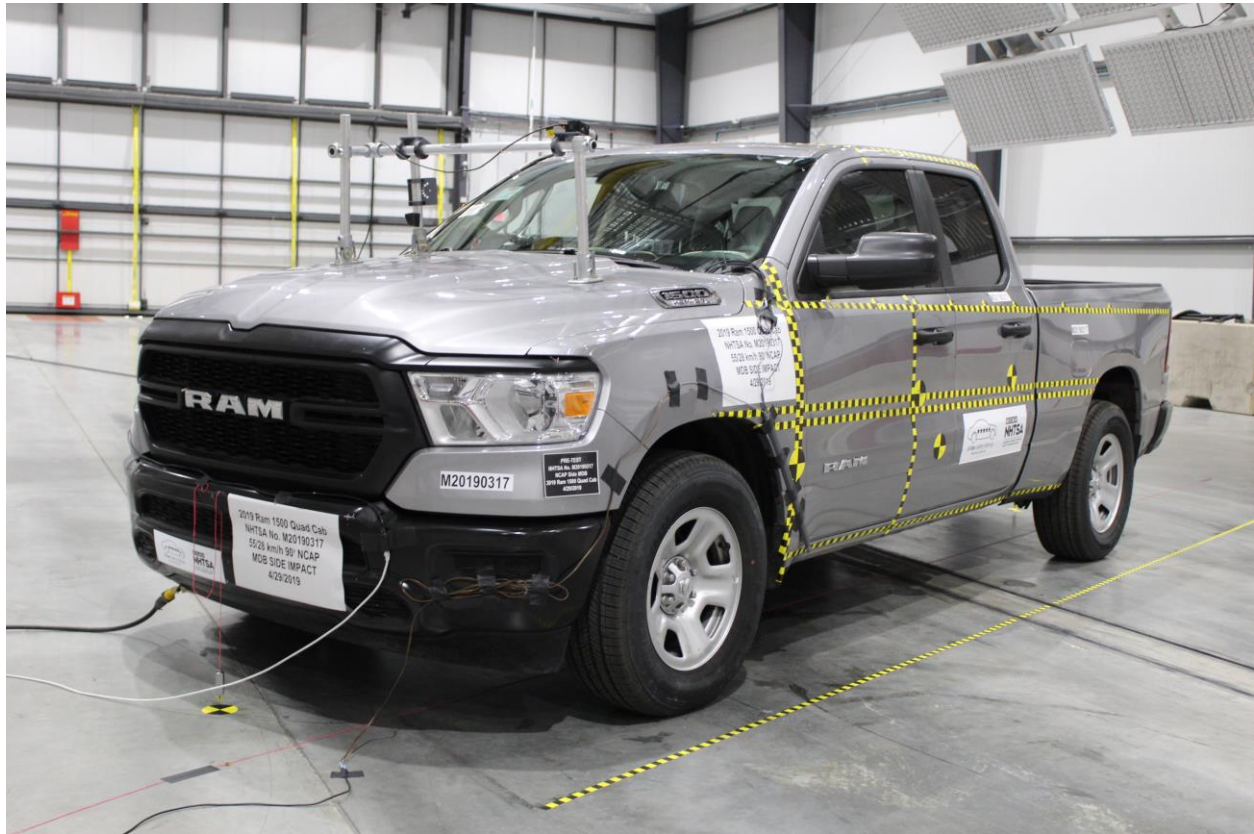
Figure A-5: Pre-Test Left Front $\frac{3}{4}$ View of Test Vehicle

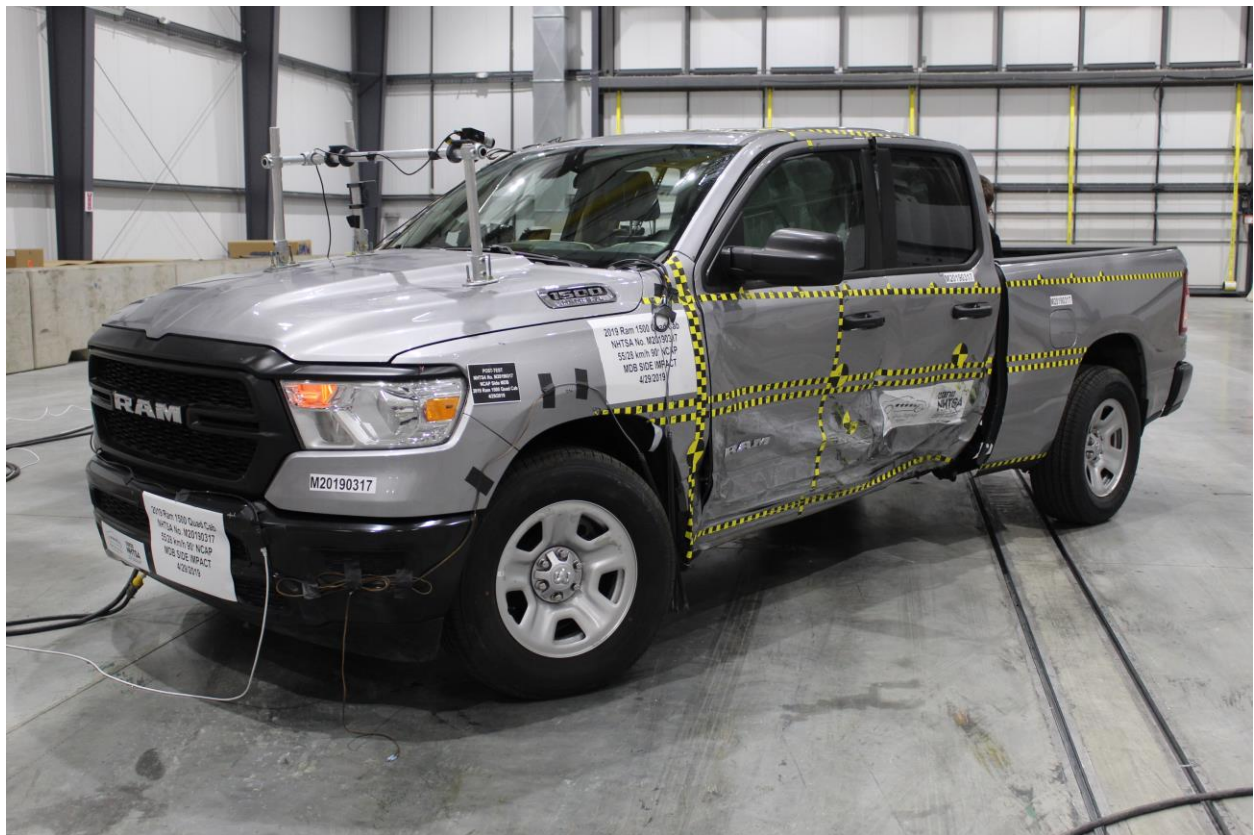
Figure A-6: Post-Test Left Front $\frac{3}{4}$ View of Test Vehicle

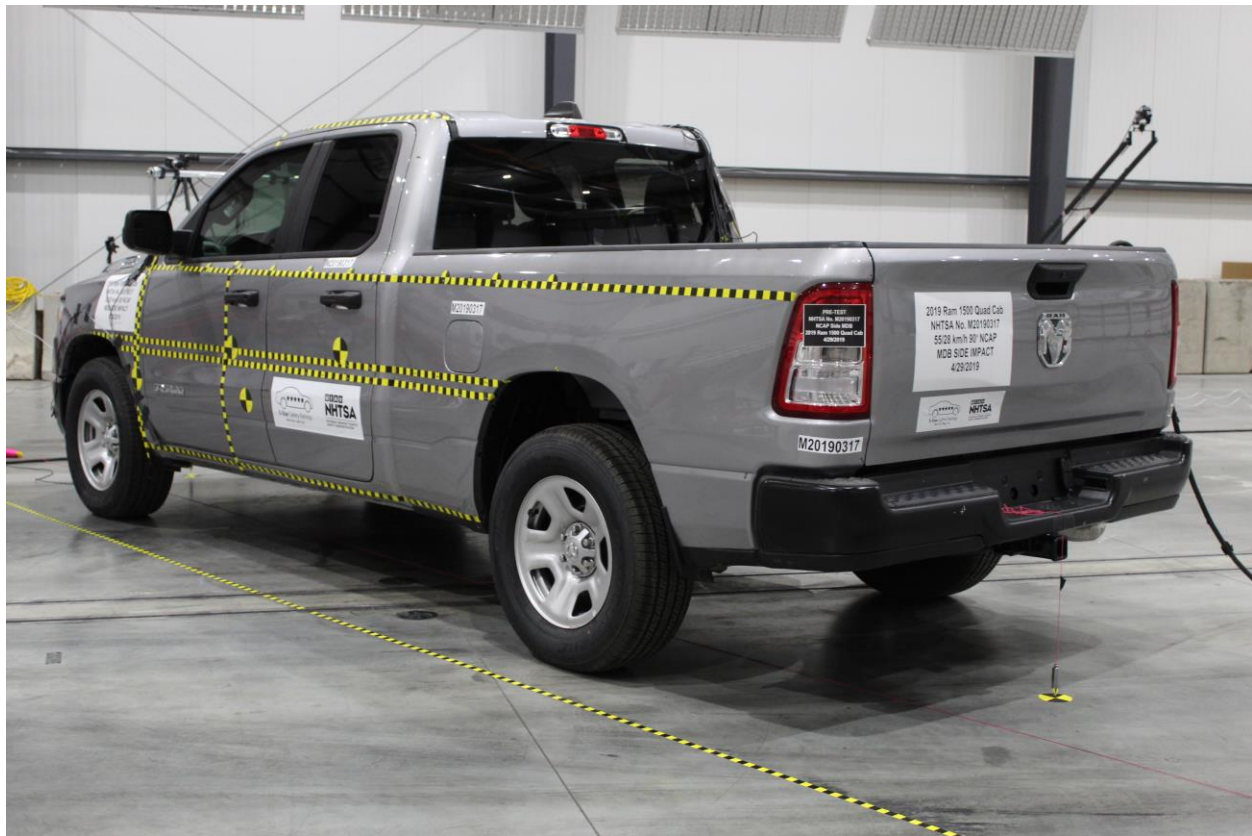
Figure A-9: Pre-Test Left Rear $\frac{3}{4}$ View of Test Vehicle

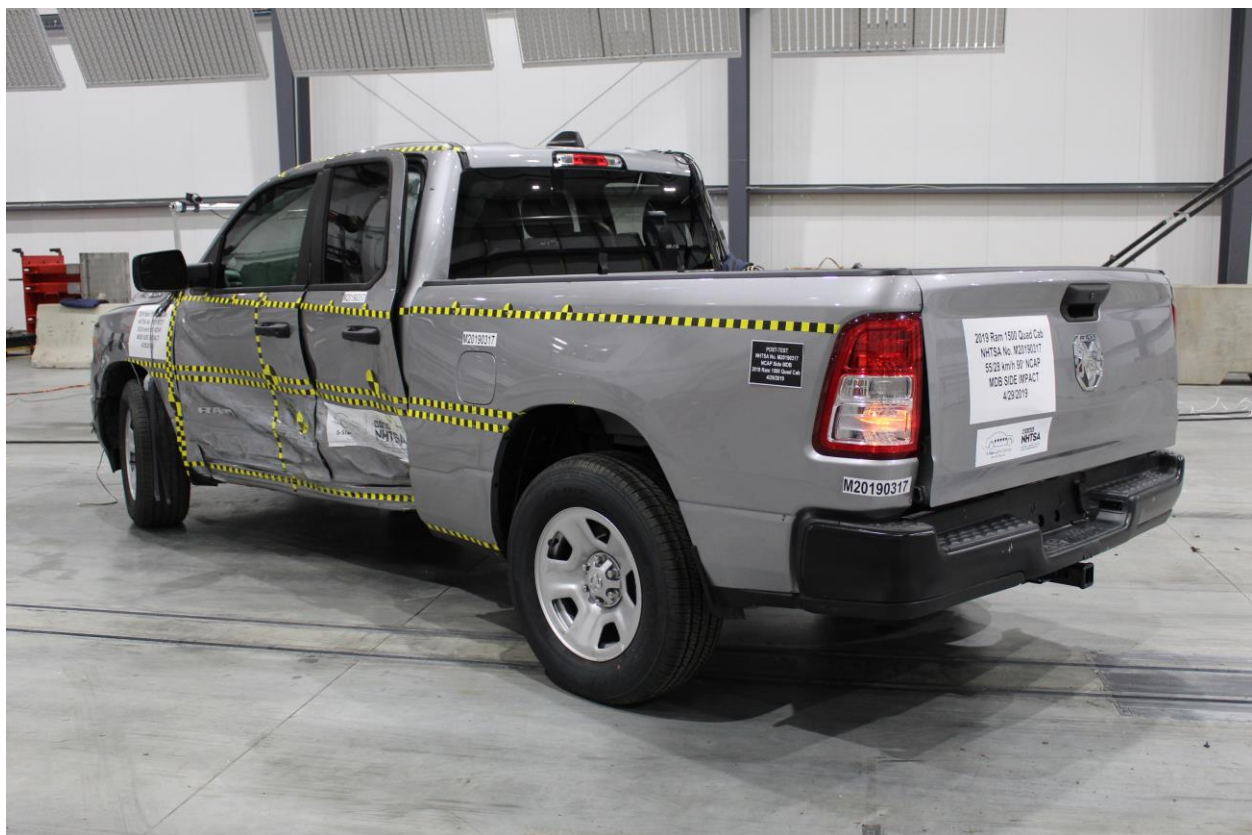
Figure A-10: Post-Test Left Rear $\frac{3}{4}$ View of Test Vehicle

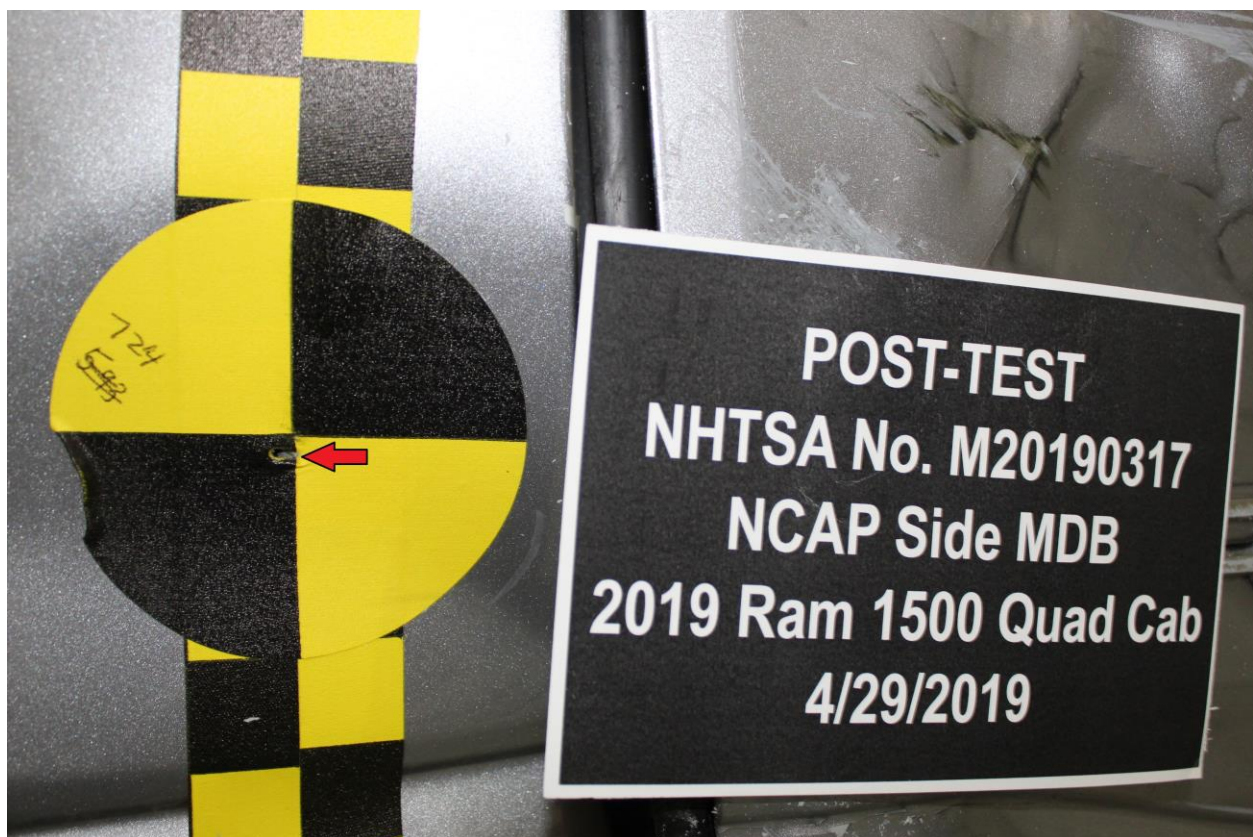
Figure A-20: Post-Test Close-up View of Impact Point Target

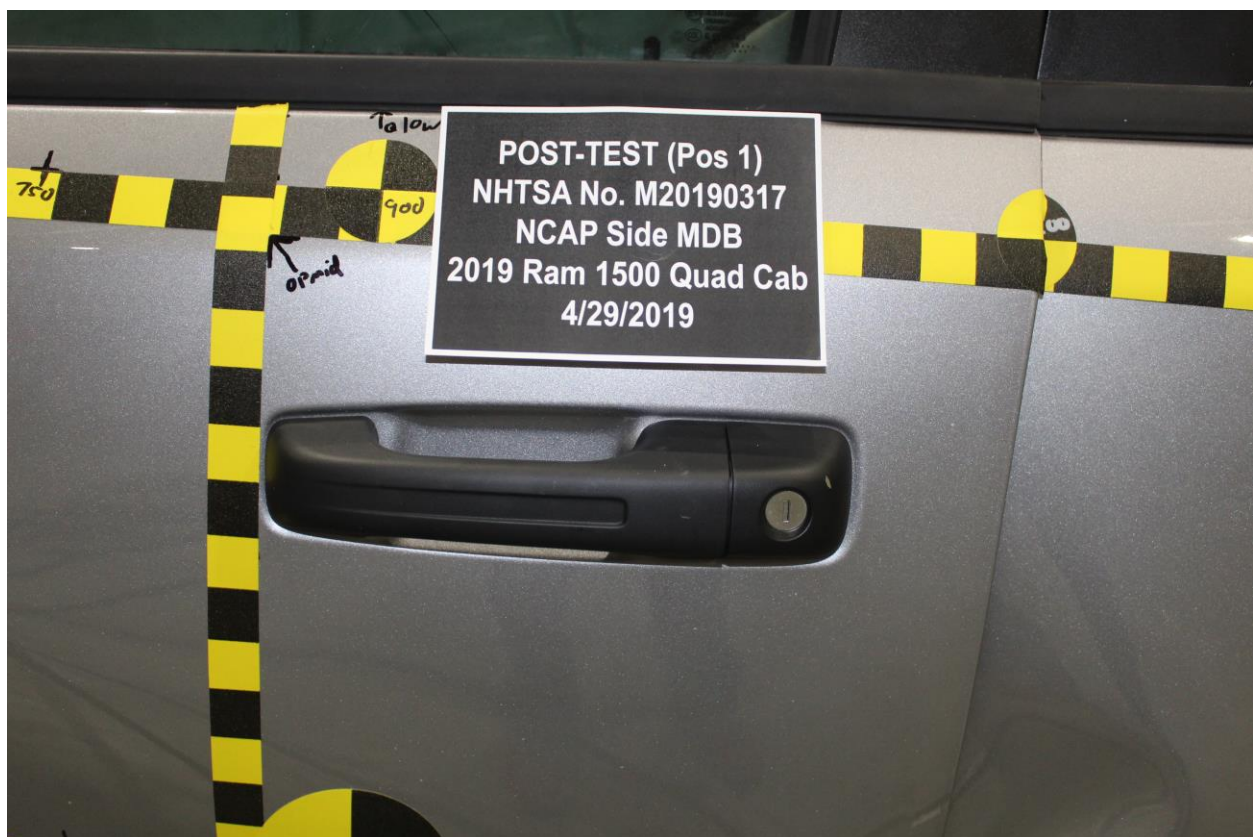
Figure A-22: Post-Test Left Front Door Latch Close-Up

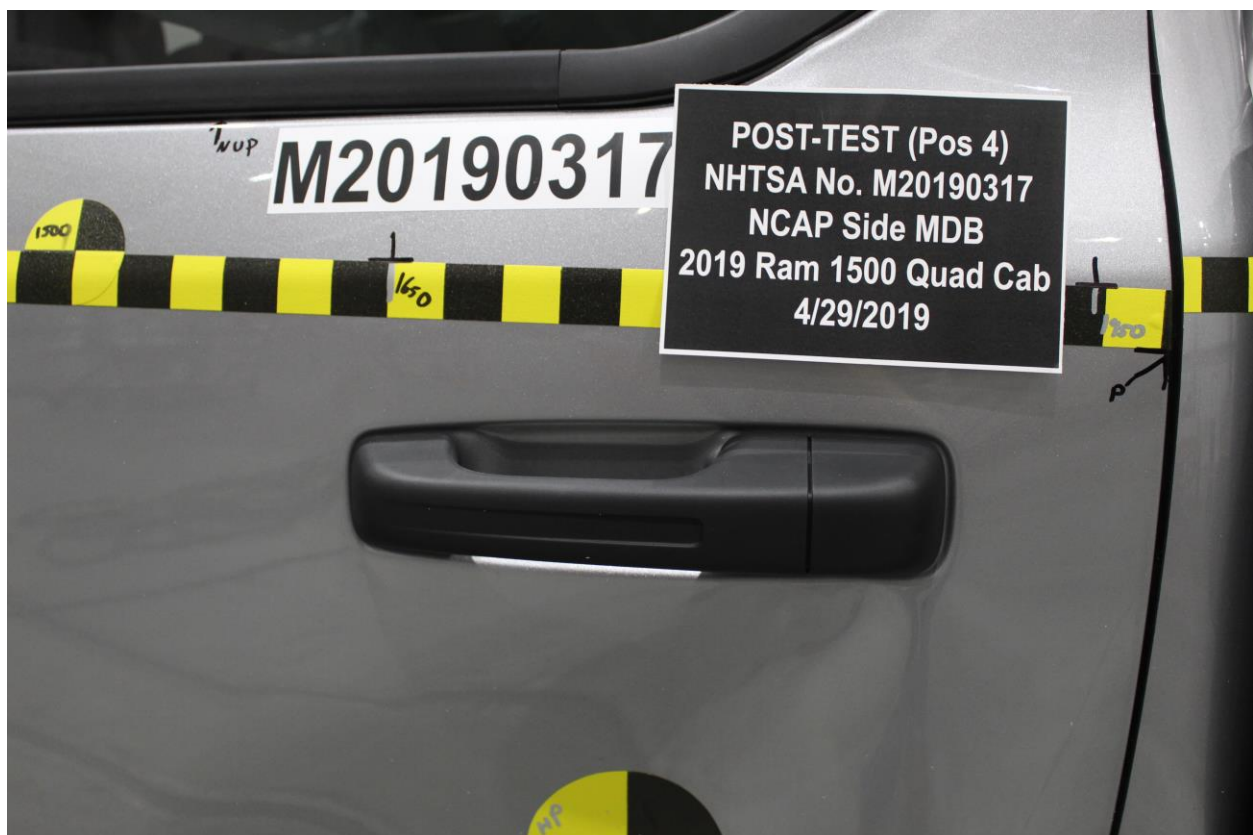
Figure A-24: Post-Test Left Rear Door Latch Close-Up

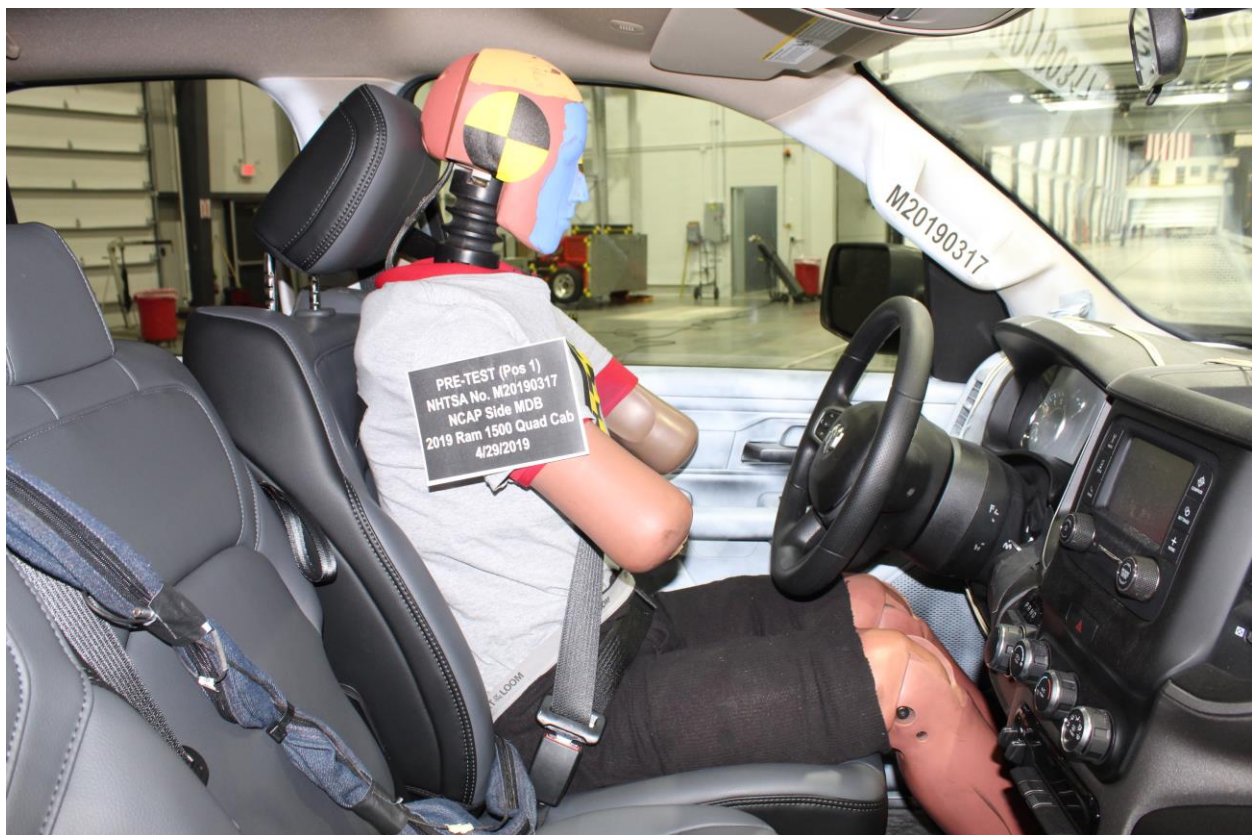
Figure A-44: Pre-Test Right Side View of Driver Dummy and Front Seat of Occupant Compartment

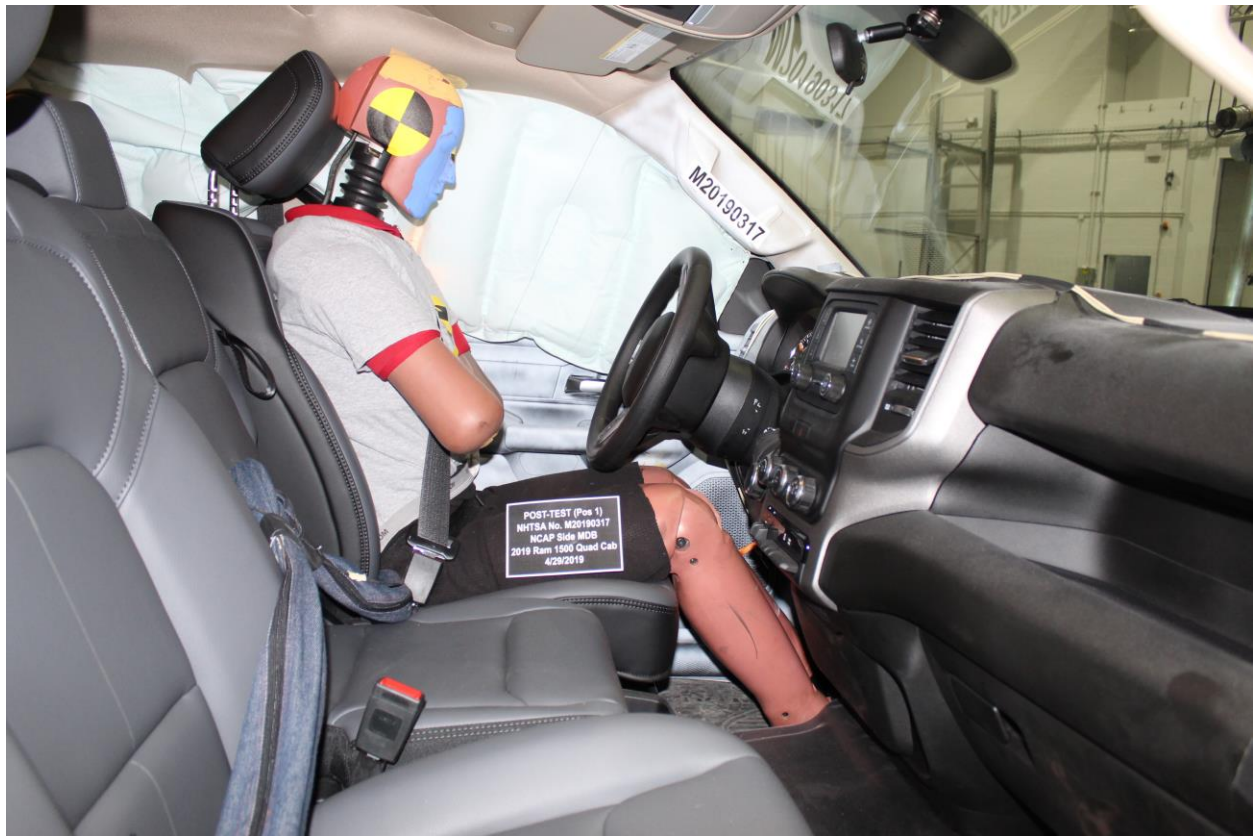
Figure A-45: Post-Test Right Side View of Driver Dummy and Front Seat of Occupant Compartment

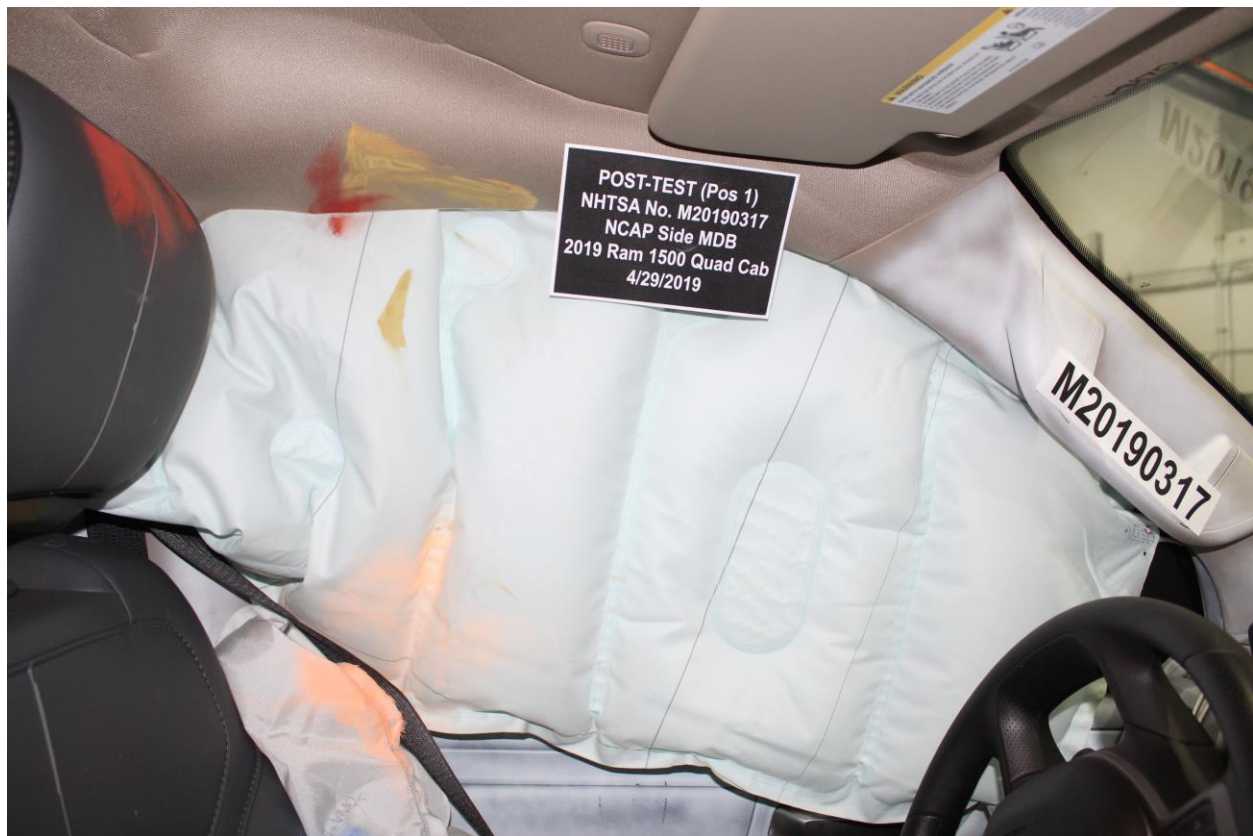
Figure A-49: Post-Test Driver Dummy Close-Up Head Contact with Side Air bag View

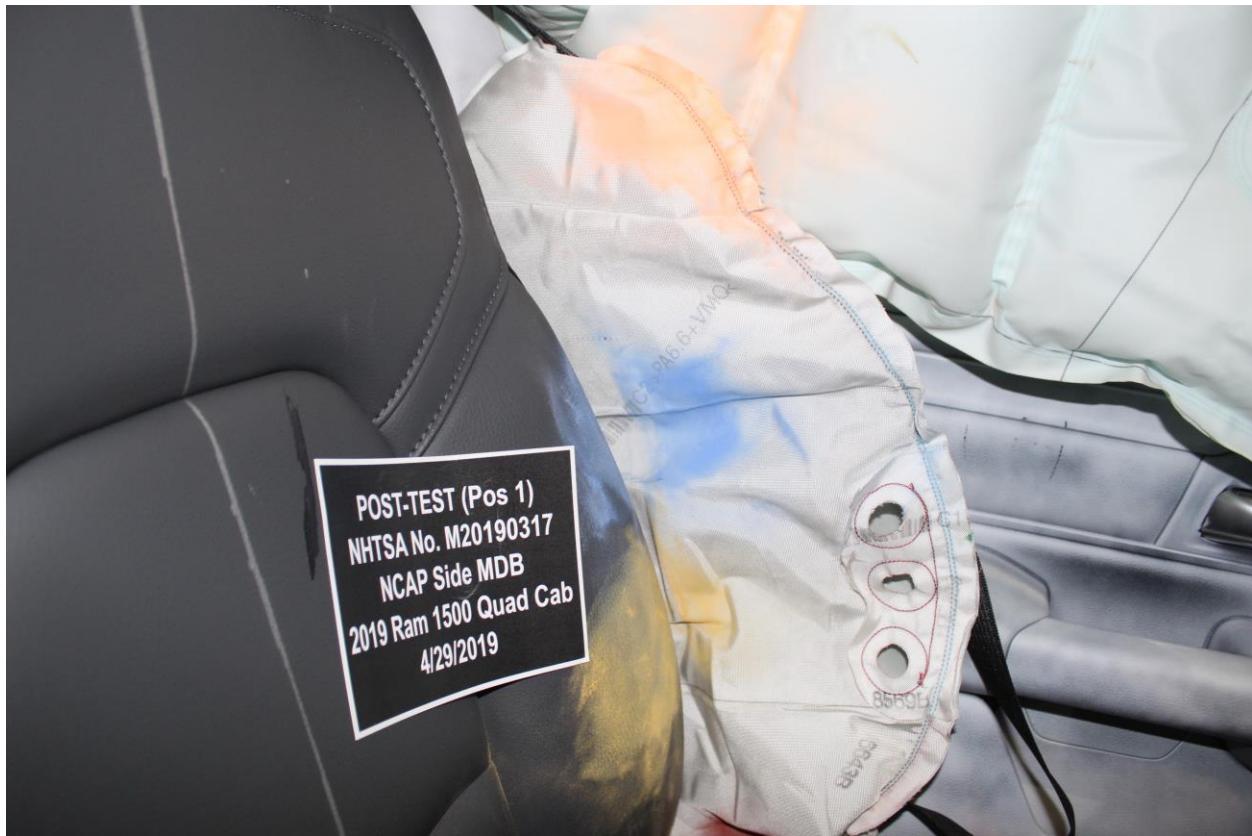
Figure A-51: Post-Test Driver Dummy Close-Up Torso Contact with Side Air bag View

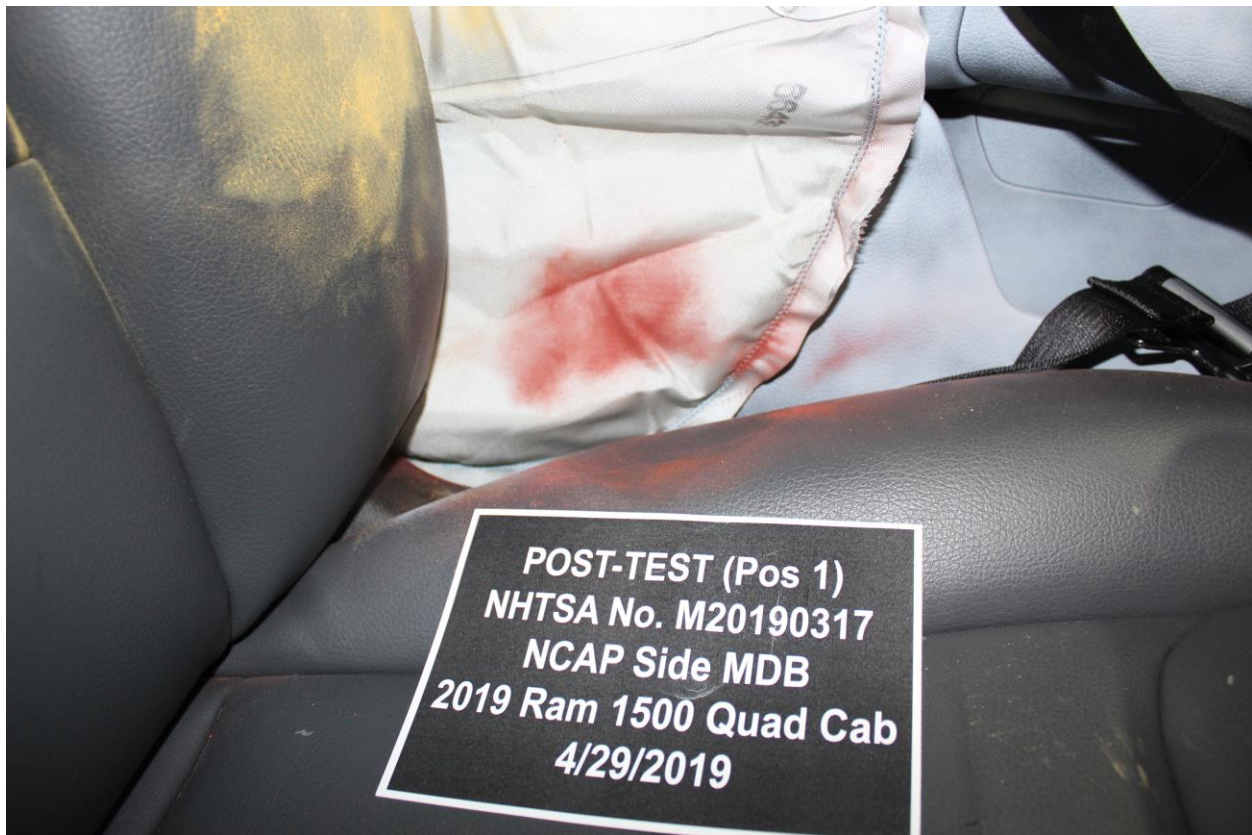
Figure A-52: Post-Test Driver Dummy Close-Up Pelvis Contact View

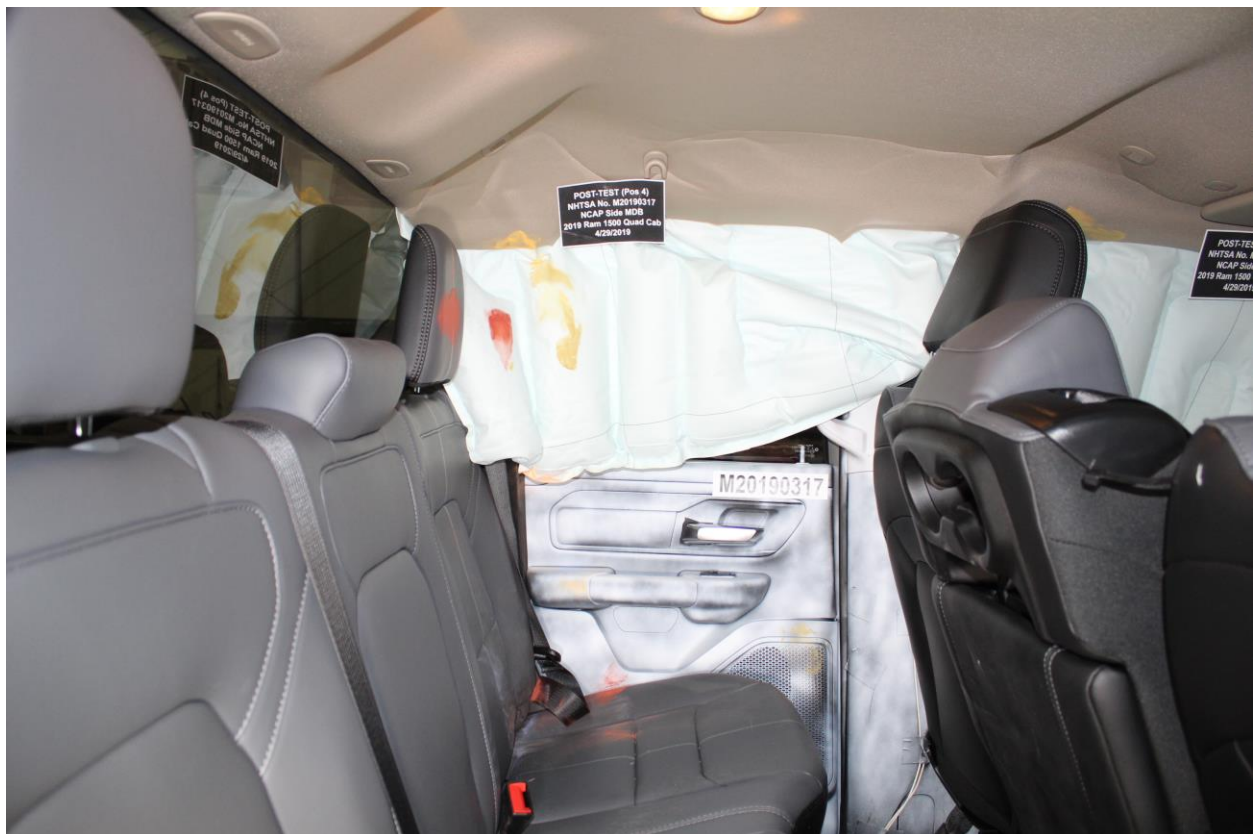
Figure A-74: Post-Test Rear Passenger Inner Door Panel View Showing Rear Passenger Dummy Contact Locations

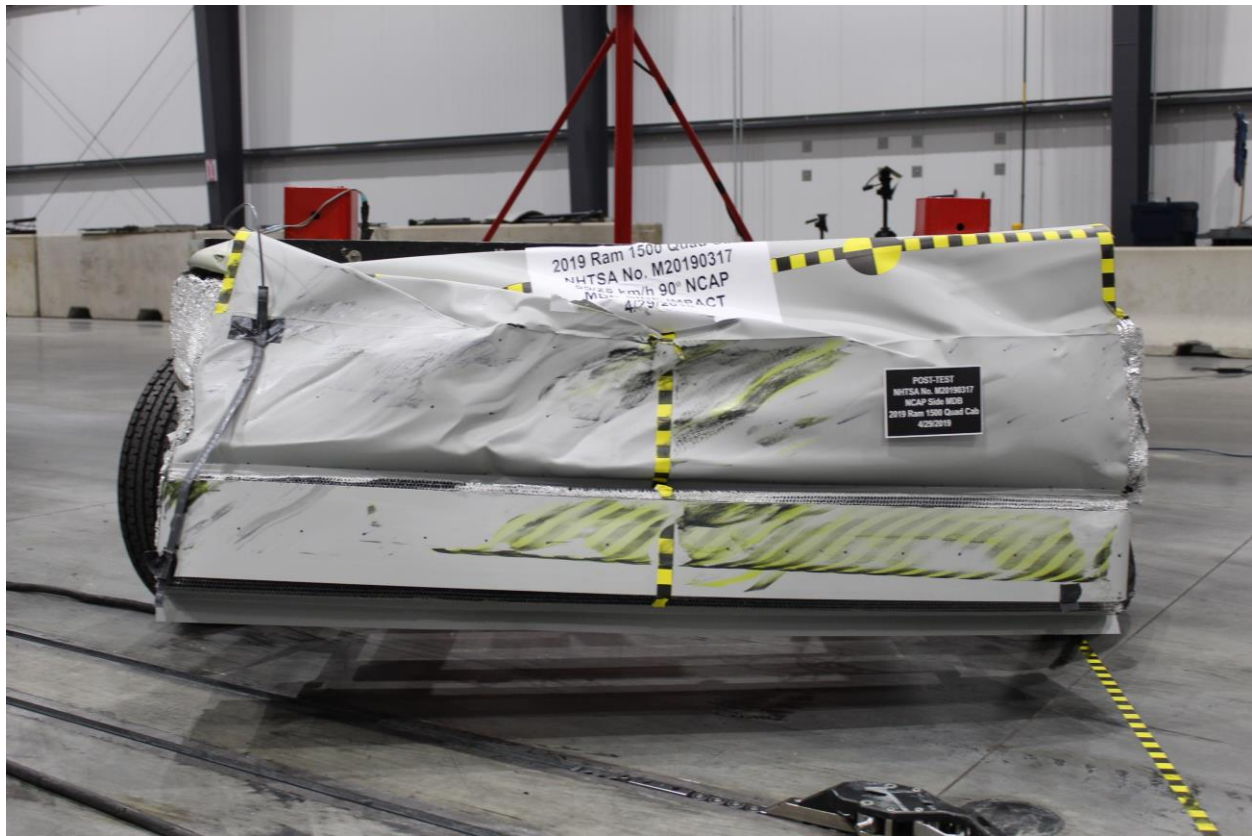
Figure A-85: Post-Test Front View of MDB Impactor Face

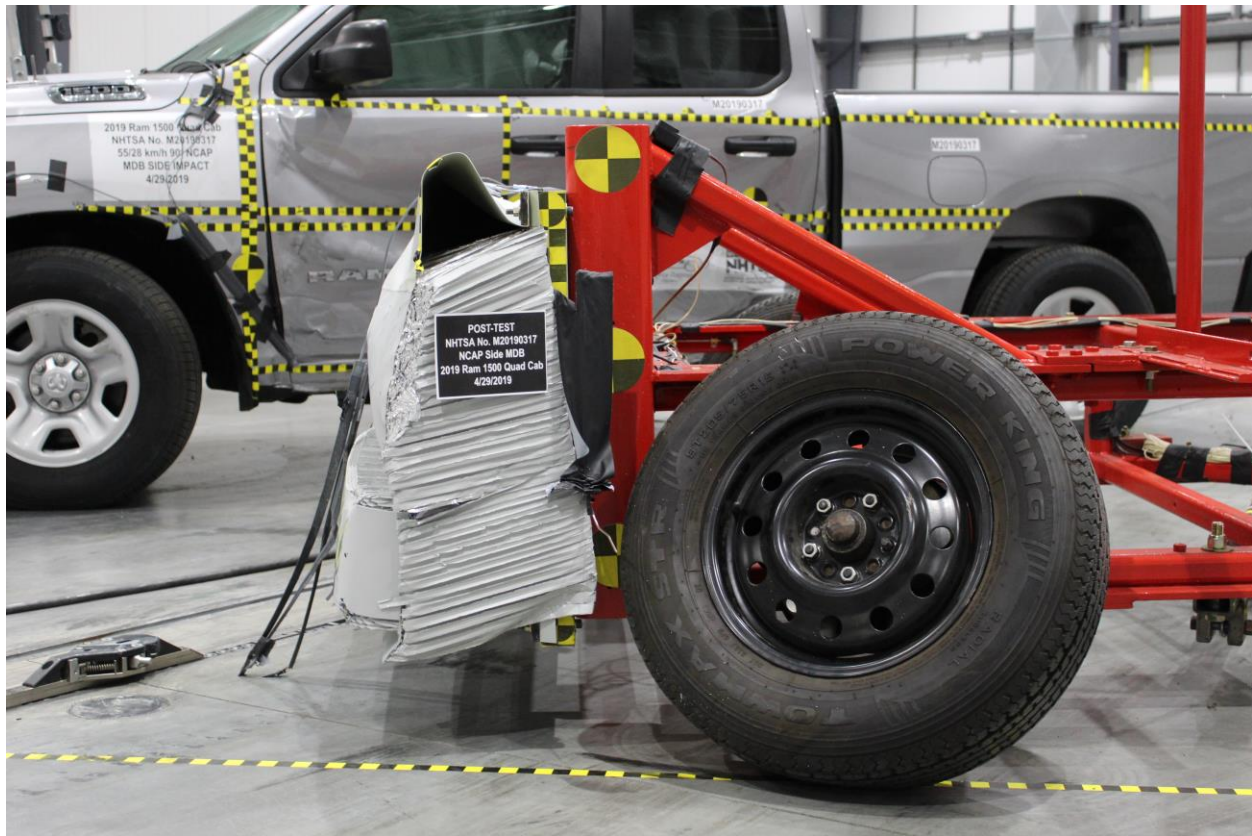
Figure A-89: Post-Test Left Side View of MDB Impactor Face

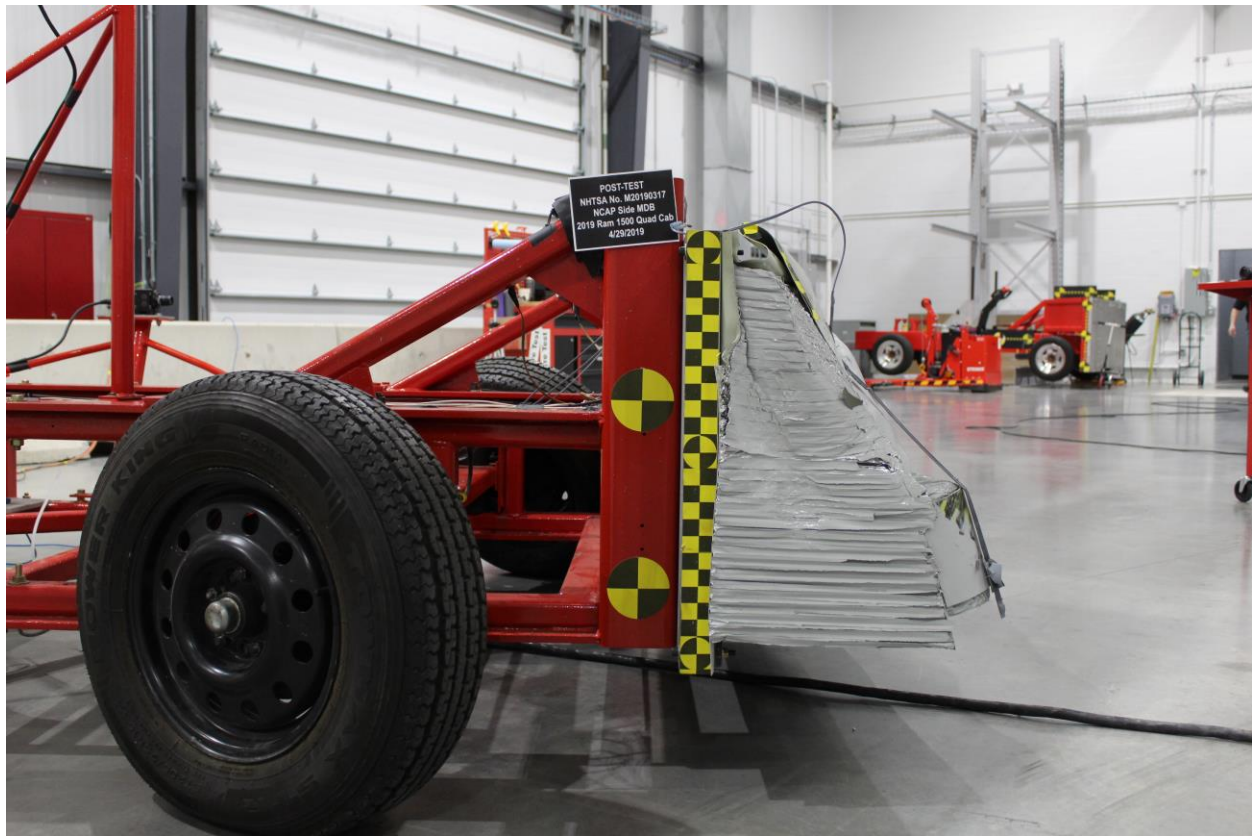
Figure A-91: Post-Test Right Side View of MDB Impactor Face

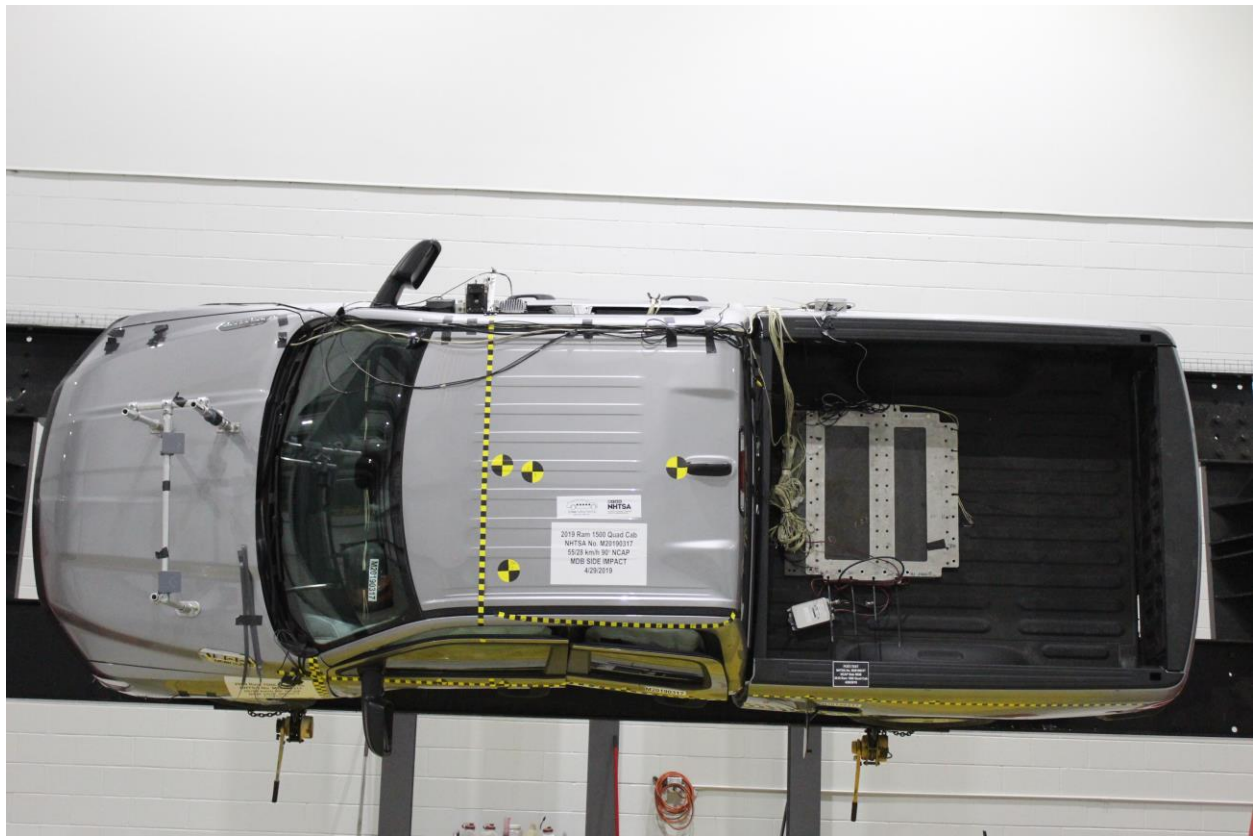
Figure A-97: FMVSS No. 301 Static Rollover 90 Degrees

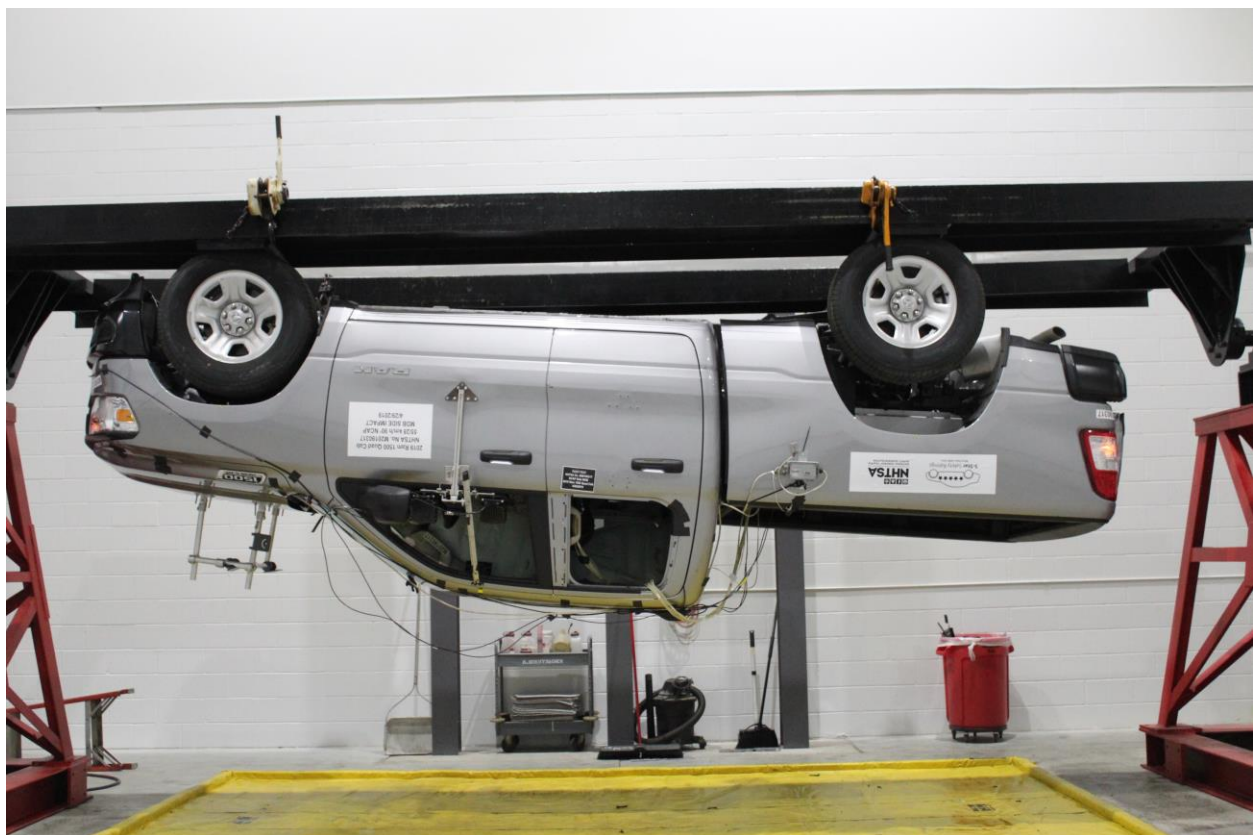
Figure A-98: FMVSS No. 301 Static Rollover 180 Degrees

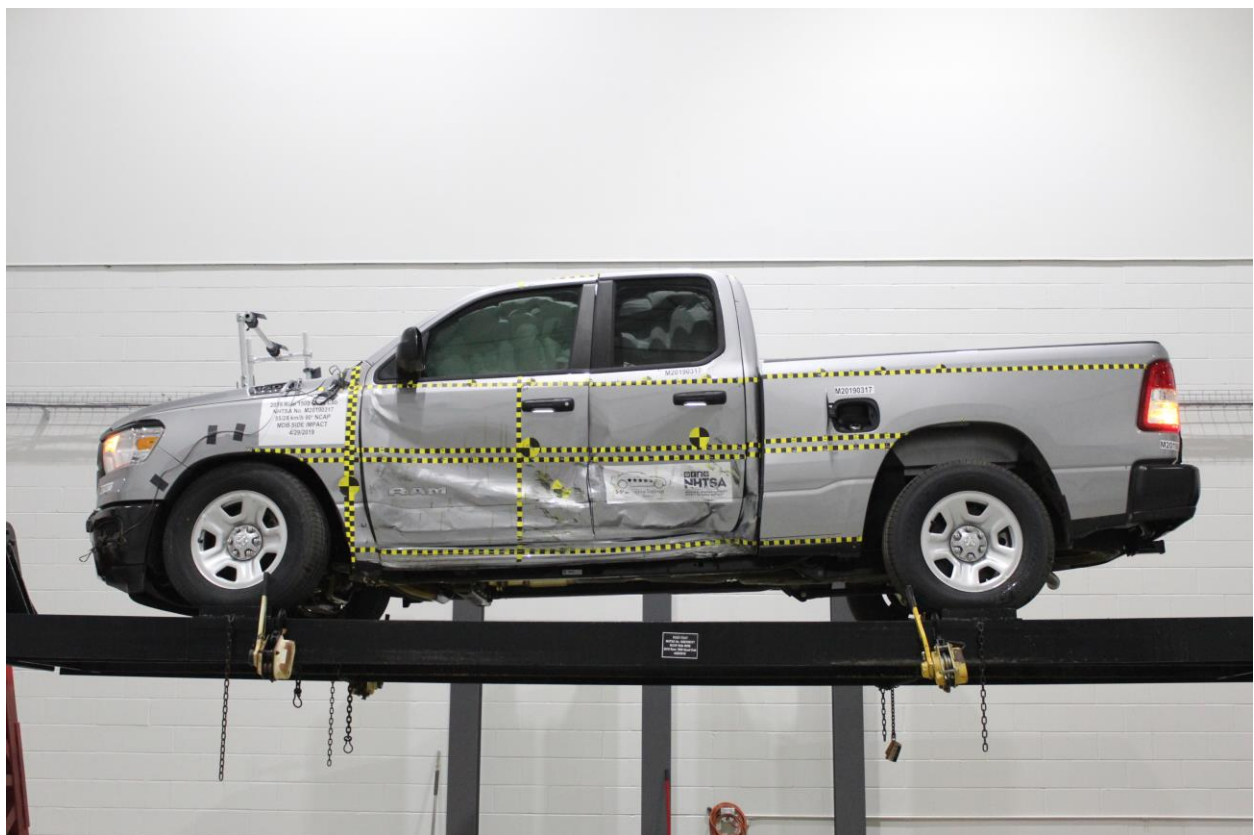
Figure A-100: FMVSS No. 301 Static Rollover 360 Degrees
