FINAL REPORT NUMBER: SPNCAP-TRC-19-004

**NEW CAR ASSESSMENT PROGRAM (NCAP)
SIDE IMPACT POLE TEST**

**FCA US LLC
2019 Ram 1500 Crew Cab
NHTSA NUMBER: M20190311**

**PREPARED BY:
Transportation Research Center Inc.
10820 State Route 347
P. O. Box B-67
East Liberty, OH 43319**

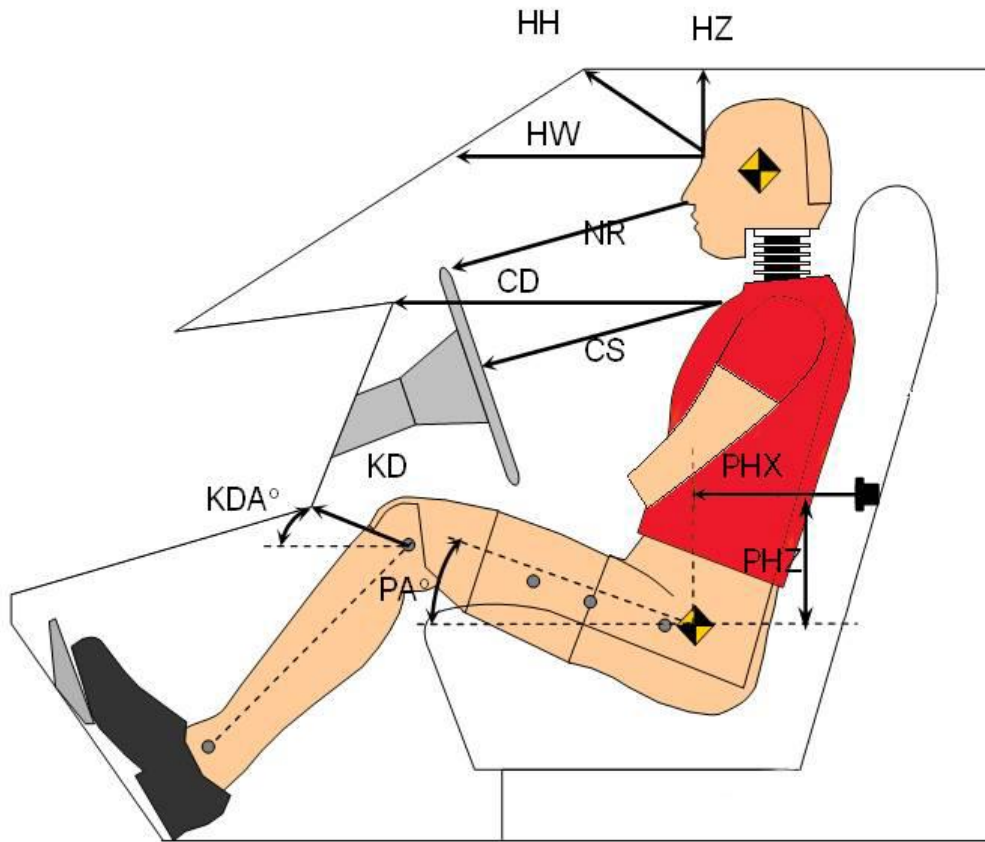
Code	Measurement Description	Driver	
		Length (mm)	Angle (°)
HH	Head to Header	271	
HW	Head to Windshield	732	
HZ	Head to Visor	417	
NR	Nose to Rim	304	
CD	Chest to Dashboard	477	
CS	Chest to Steering Wheel	231	
KDL/KDLA°	Left Knee to Dash	90	25.8
KDR/KDRA°	Right Knee to Dash	87	25.1
PAX°	Pelvic Tilt Angle (X-axis)		0.2
PAY°	Pelvic Tilt Angle (Y-axis)		20.5
PHX	Hip Point to Striker (X-Axis)	336	
PHZ	Hip Point to Striker (Z-Axis)	21

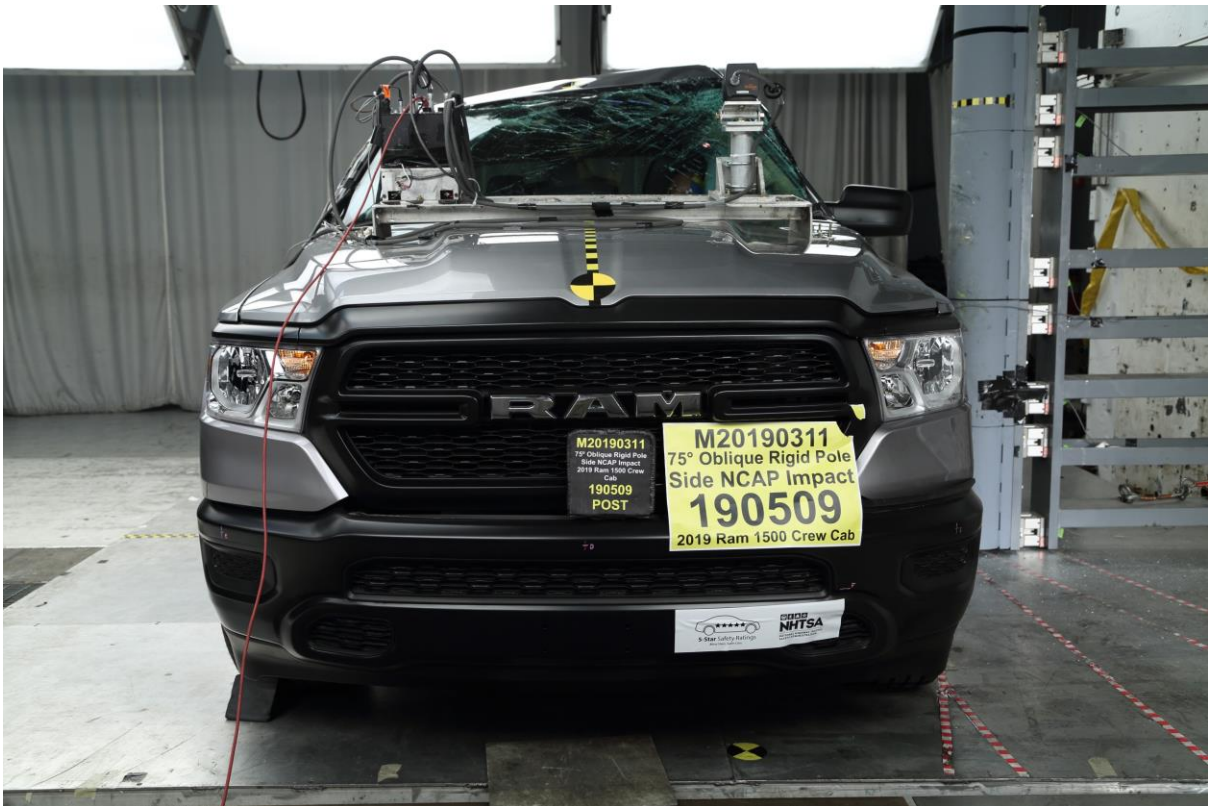
No. 004 Post-Test Frontal View of Test Vehicle

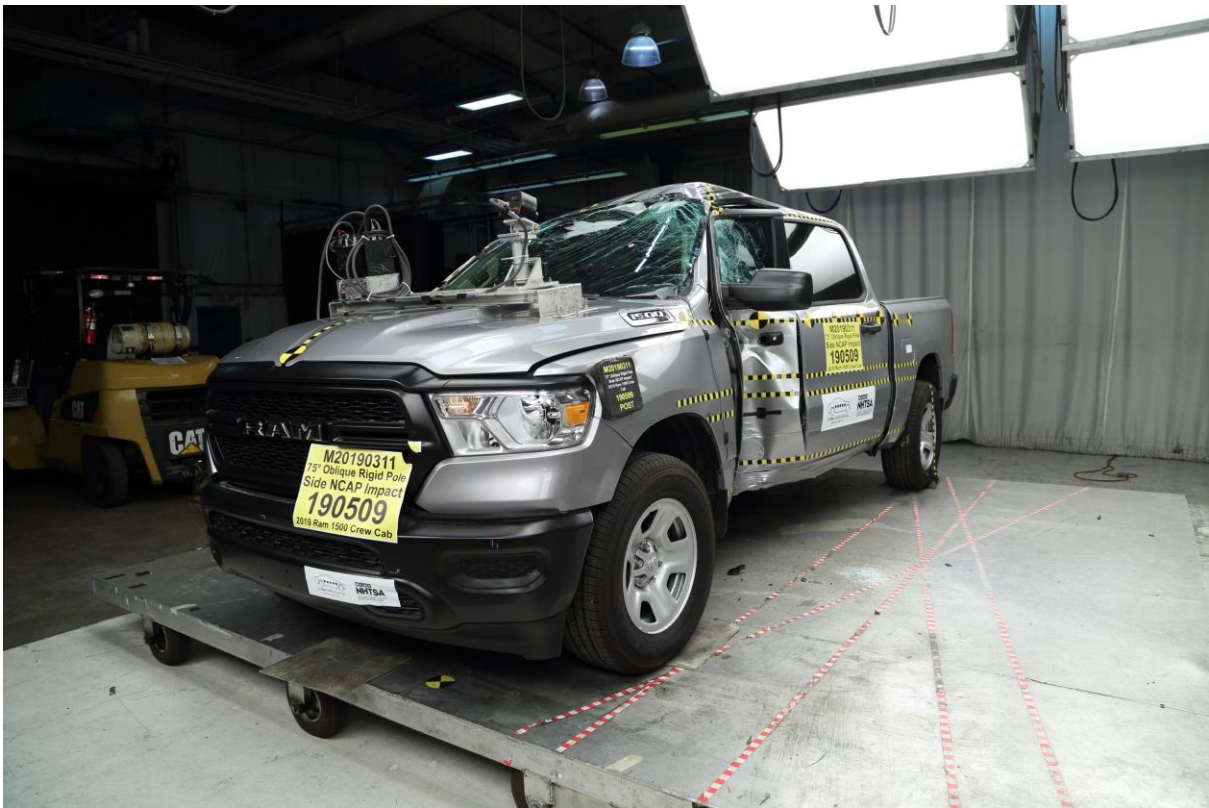
No. 006 Post-Test Left Front $\frac{3}{4}$ View of Test Vehicle

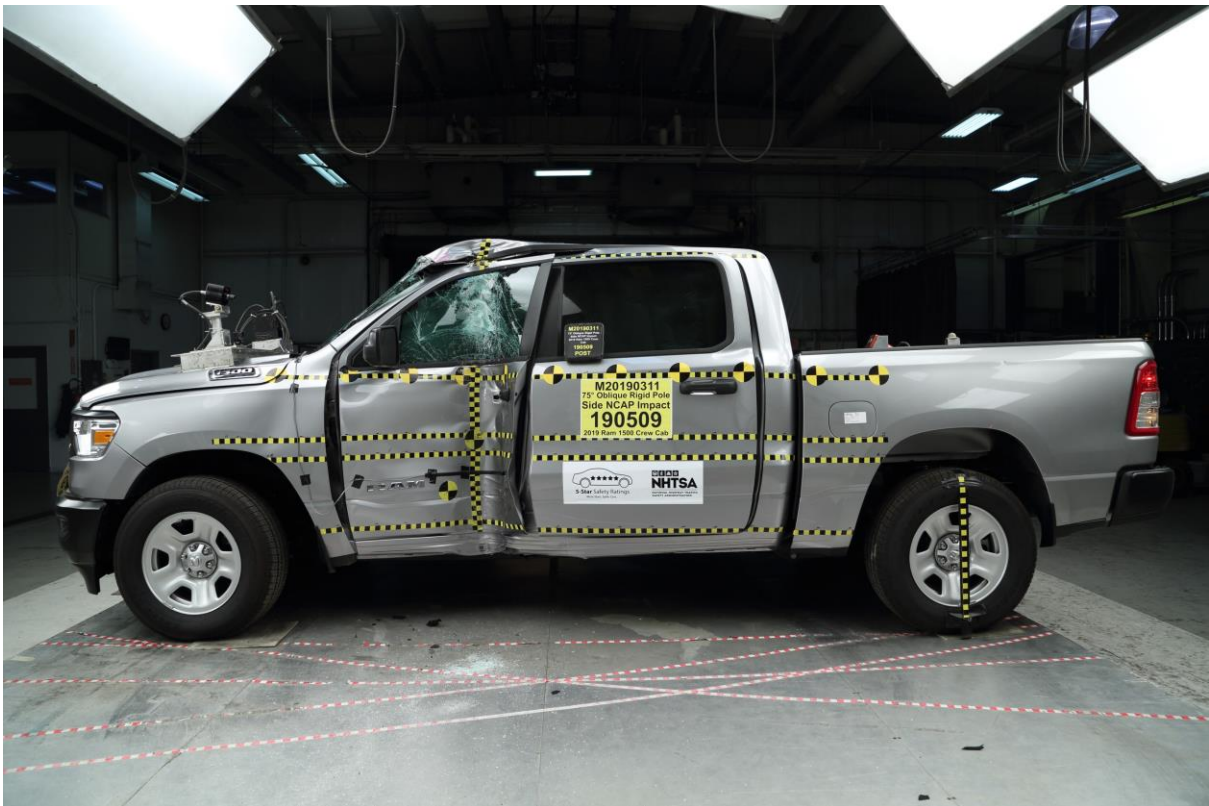
No. 008 Post-Test Left Side View of Test Vehicle

Critical Areas of Performance	Observations and Conclusions
Pillar Performance	Good
Sill Separation	None
Windshield Damage	Completely broken
Side Window Damage	Driver window shattered but intact
Other Notable Effects	None

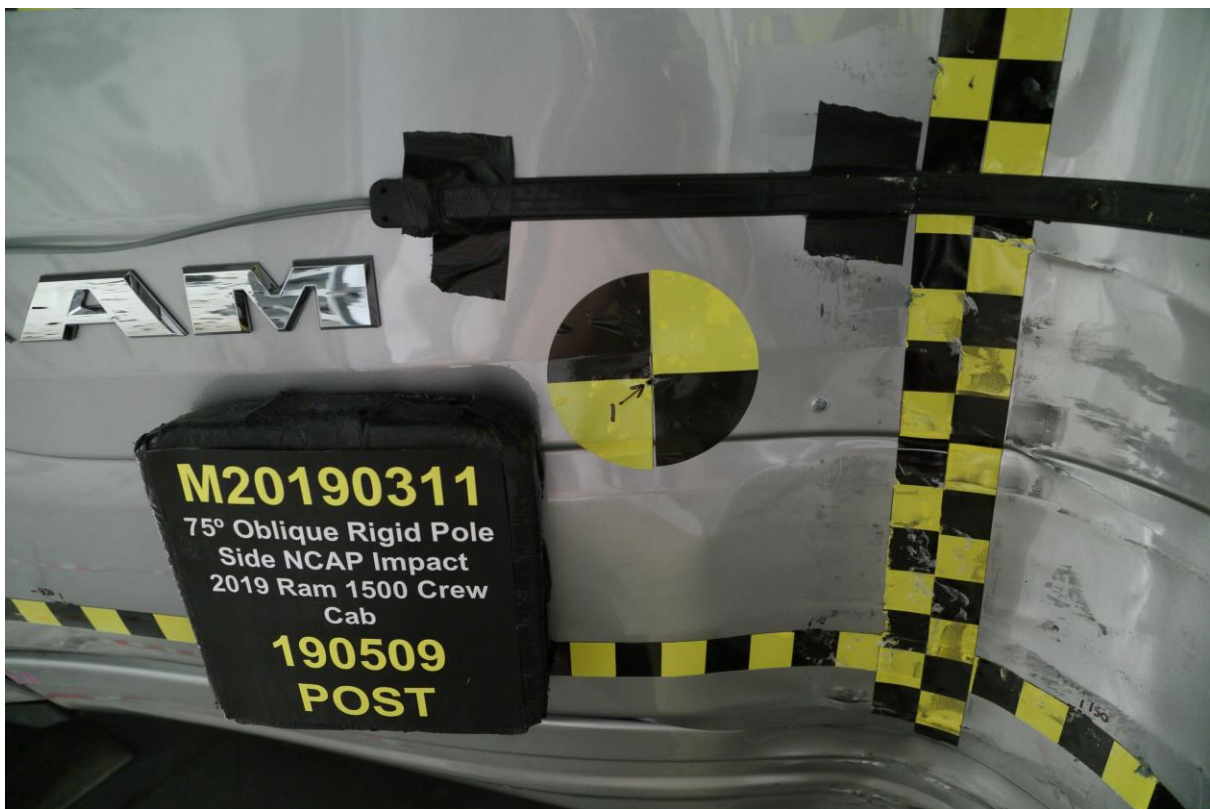
No. 020 Post-Test Close-Up View of Impact Point Target Showing Impact Location

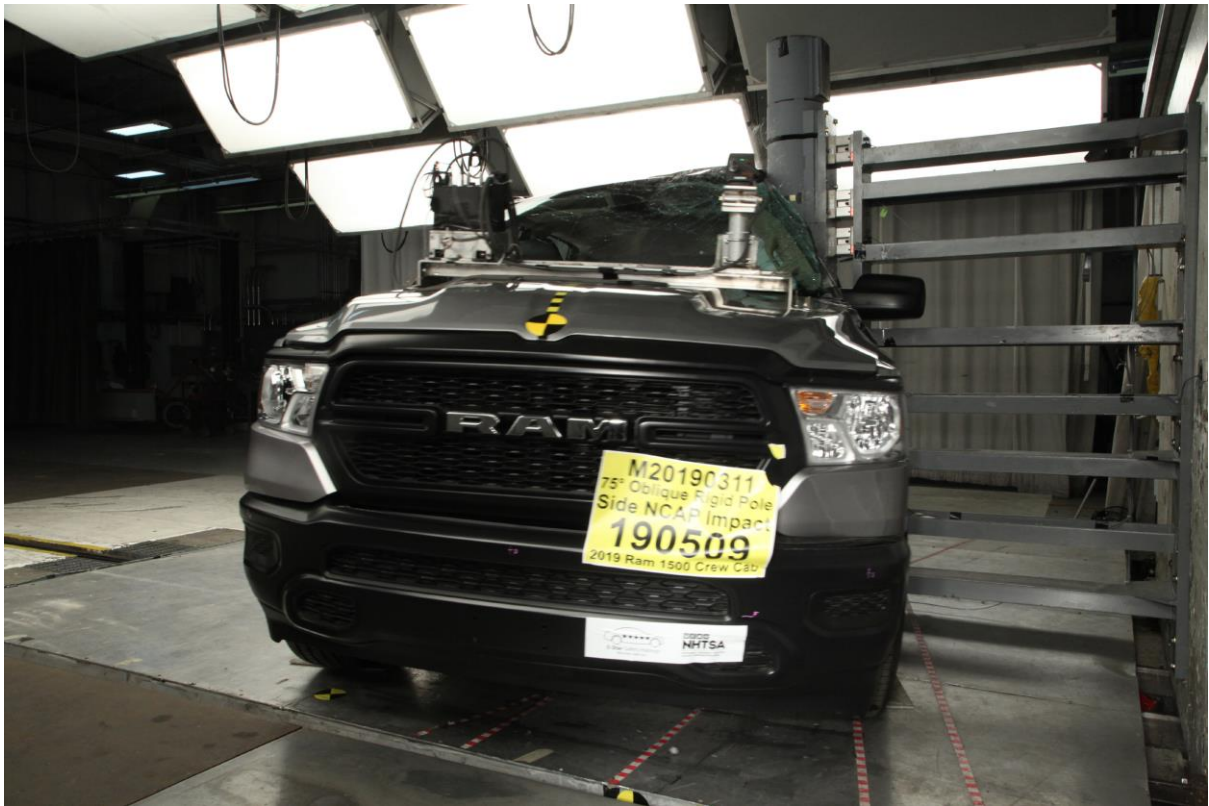
No. 068 Impact Event
