REPORT NUMBER: NCAP-MGA-2019-037

**NEW CAR ASSESSMENT PROGRAM (NCAP)
Frontal Barrier Impact Test**

**GENERAL MOTORS LLC
2019 Chevrolet Silverado 4WD Custom TB Double Cab Truck
NHTSA No.: M20190109**

**MGA RESEARCH CORPORATION
5000 Warren Road
Burlington, WI 53105**

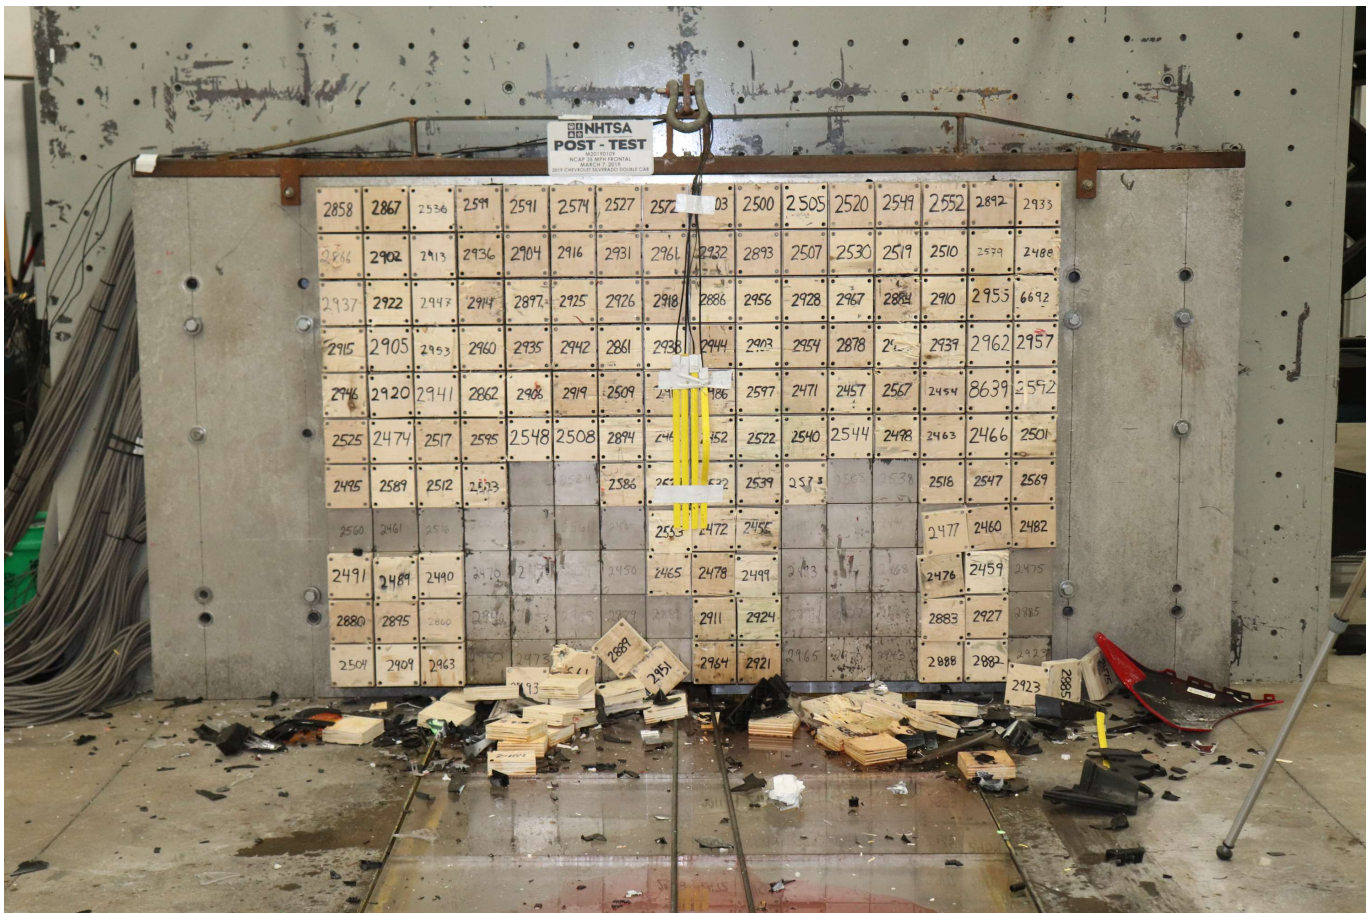
Photo No. 003 - Post-Test Load Cell Wall

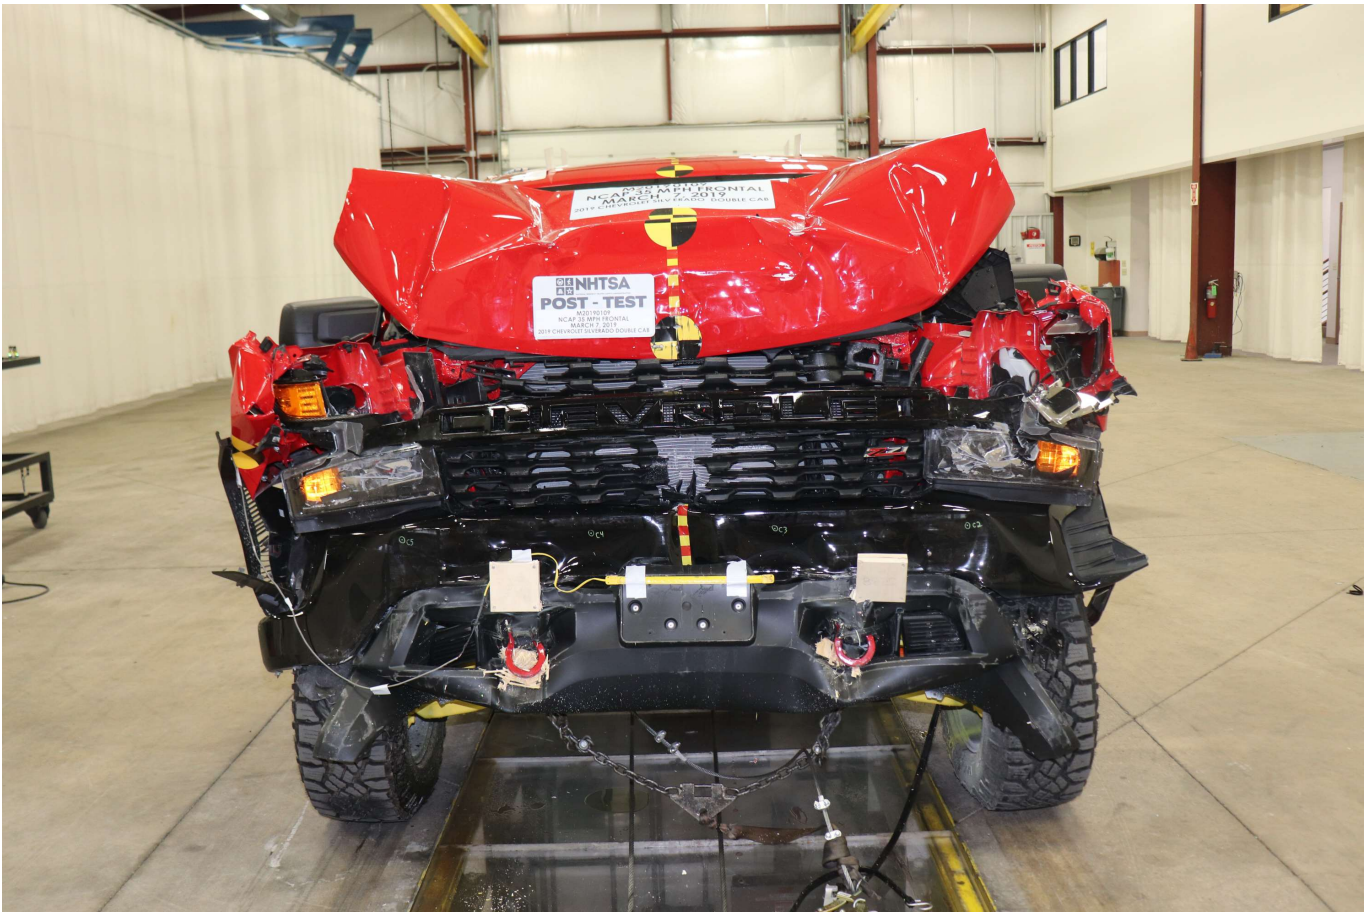
Photo No. 009 - Post-Test Front View of Test Vehicle

The maximum static crush of the vehicle was 681 mm located at the vehicle centerline and both the driver and passenger side doors remained closed during the impact event and were operable after the impact.

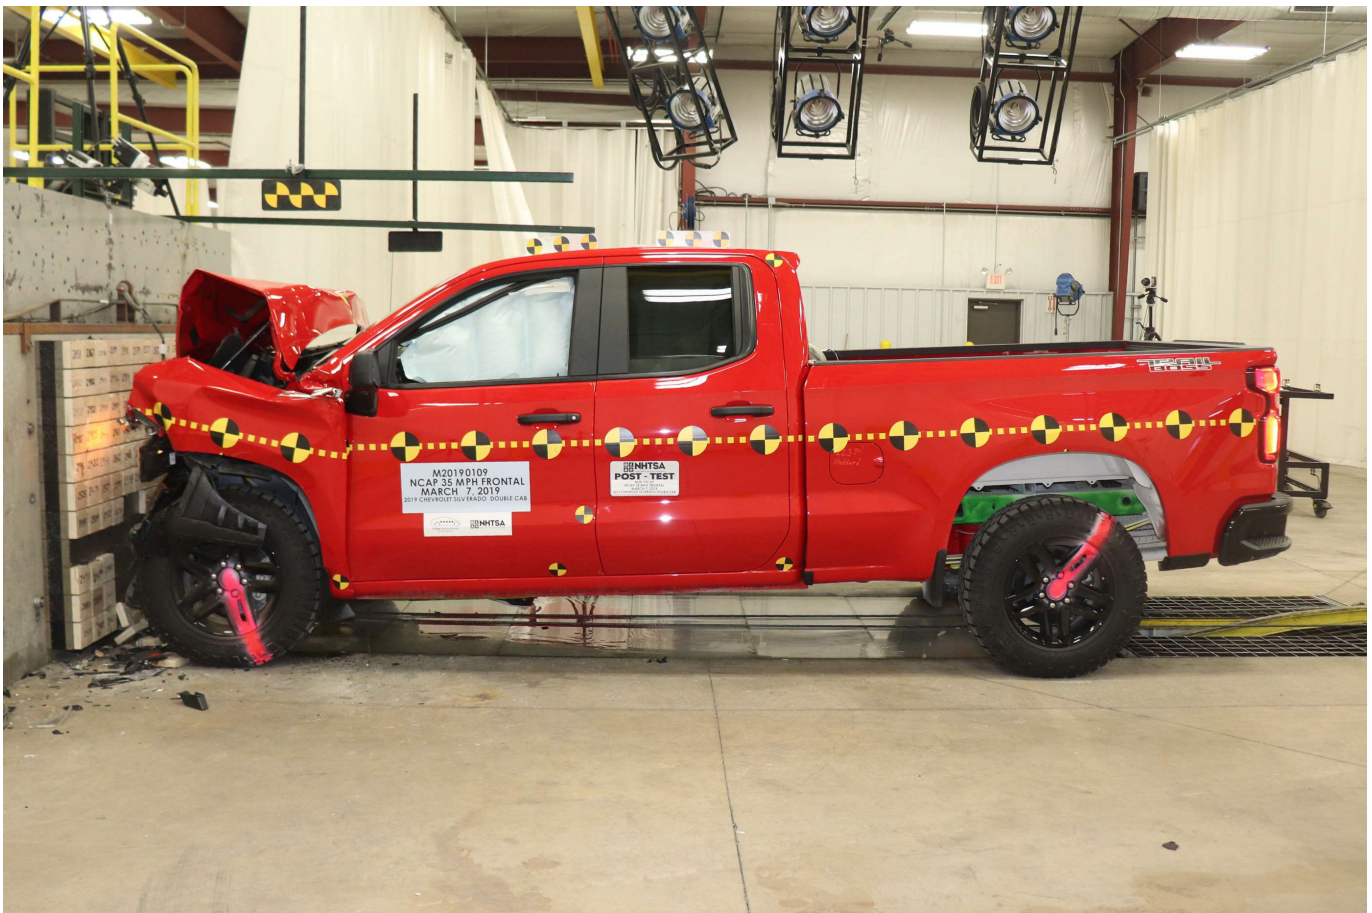
Photo No. 011 - Post-Test Left View of Test Vehicle

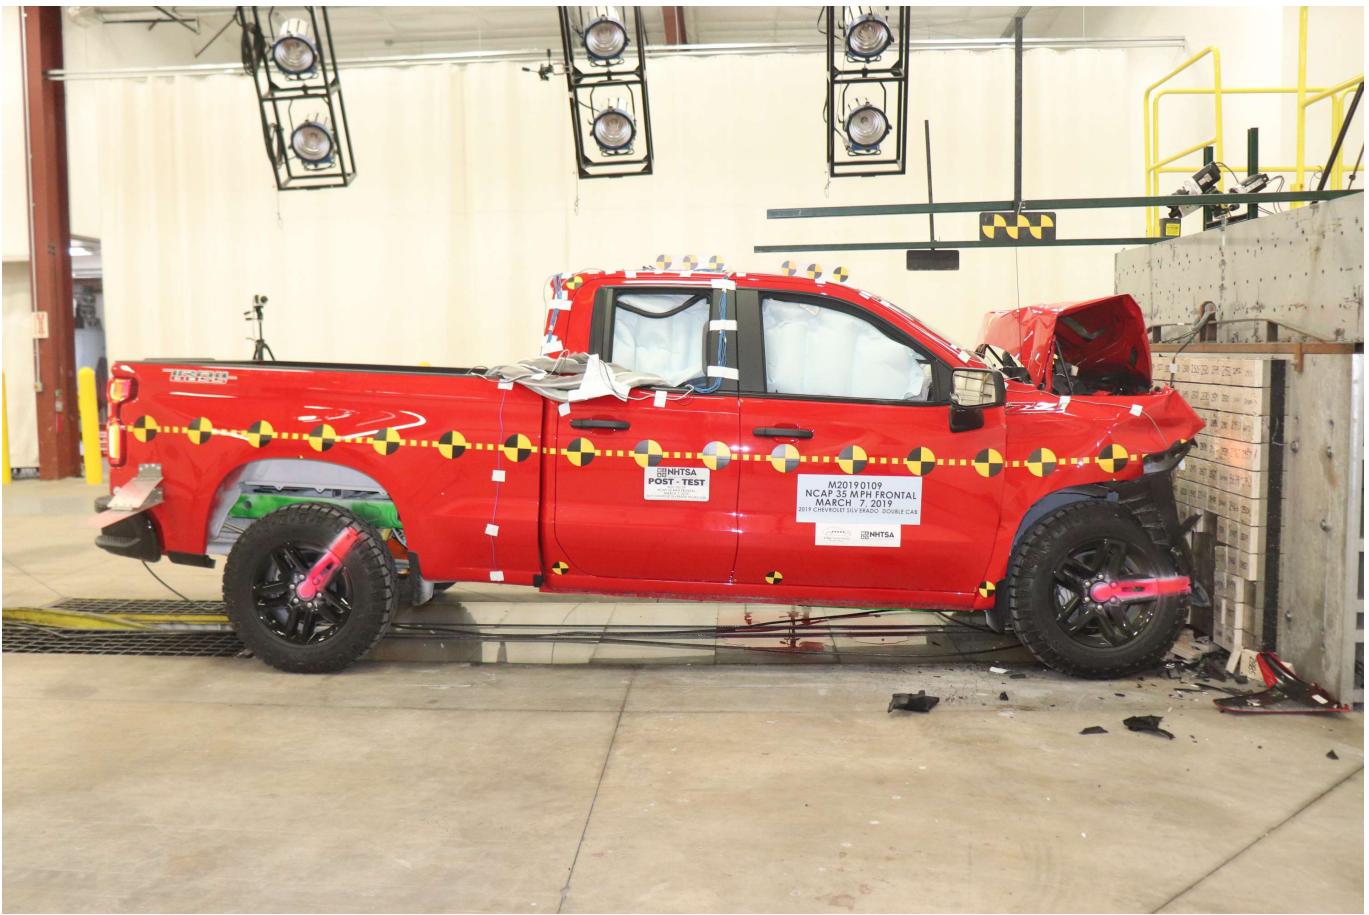
Photo No. 013 - Post-Test Right View of Test Vehicle

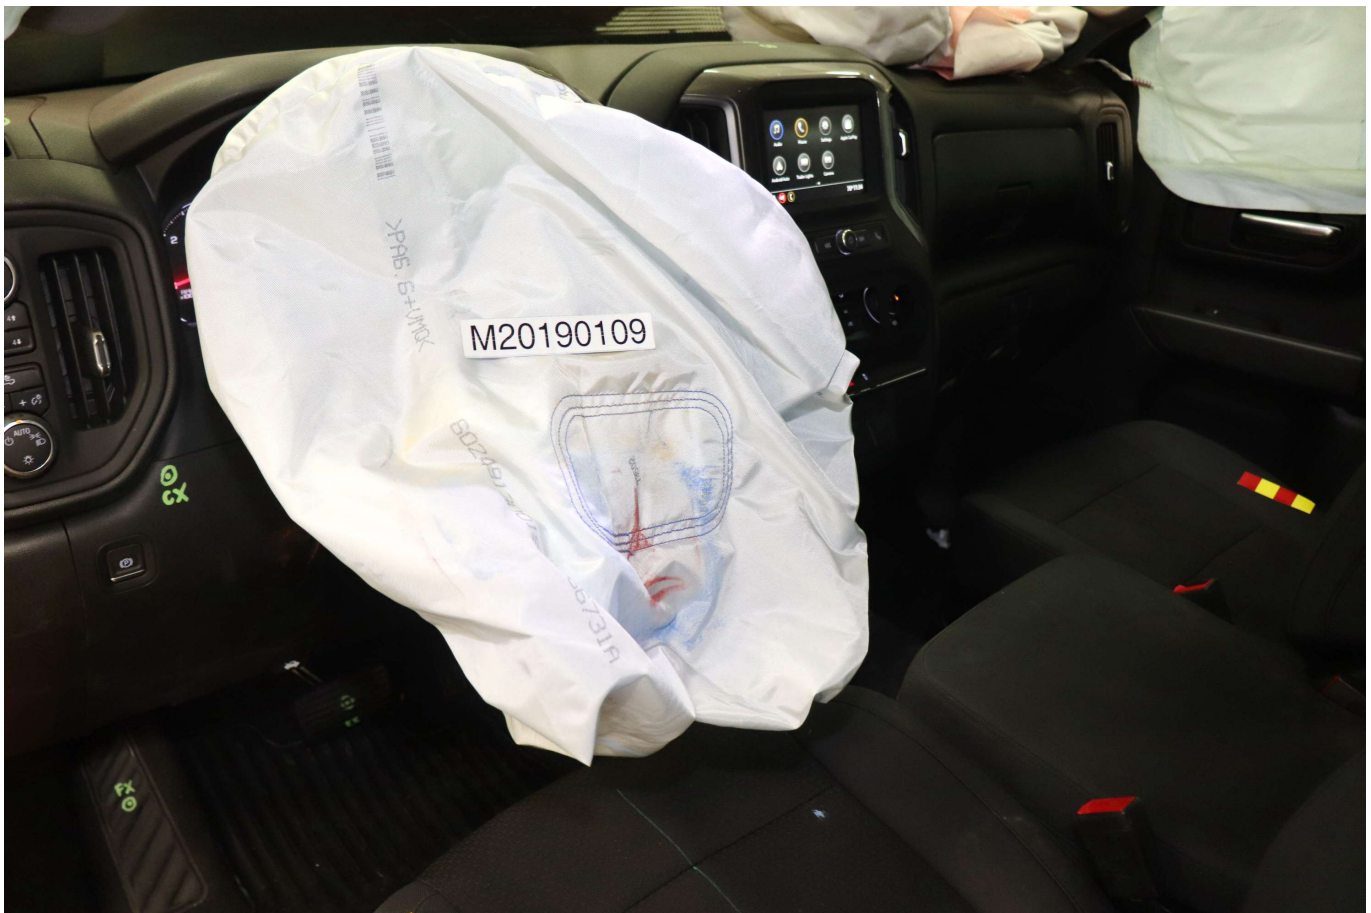
Photo No. 047 - Post-Test Driver Dummy Contact with Airbag

The driver's visible contact points were as follows: The driver's head contacted the airbag. The driver's head also contacted the headrest. The driver's knees contacted the knee bolster. The passenger's visible contact points were as follows: The passenger's head contacted the airbag. The passenger's head also contacted the headrest. The passenger's knees contacted the glove box.

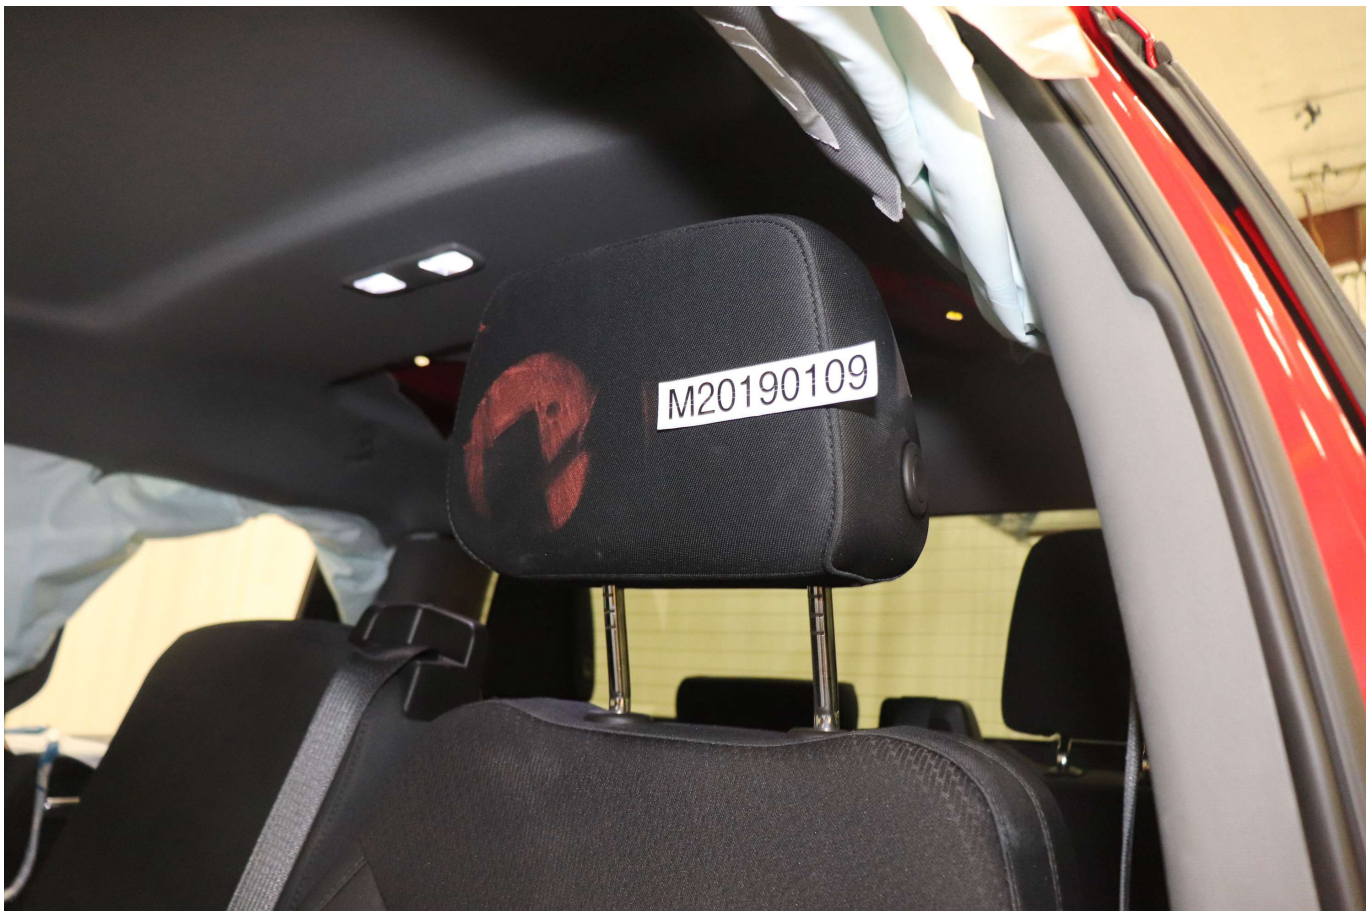
Photo No. 048 - Post-Test Driver Dummy Contact with Headrest

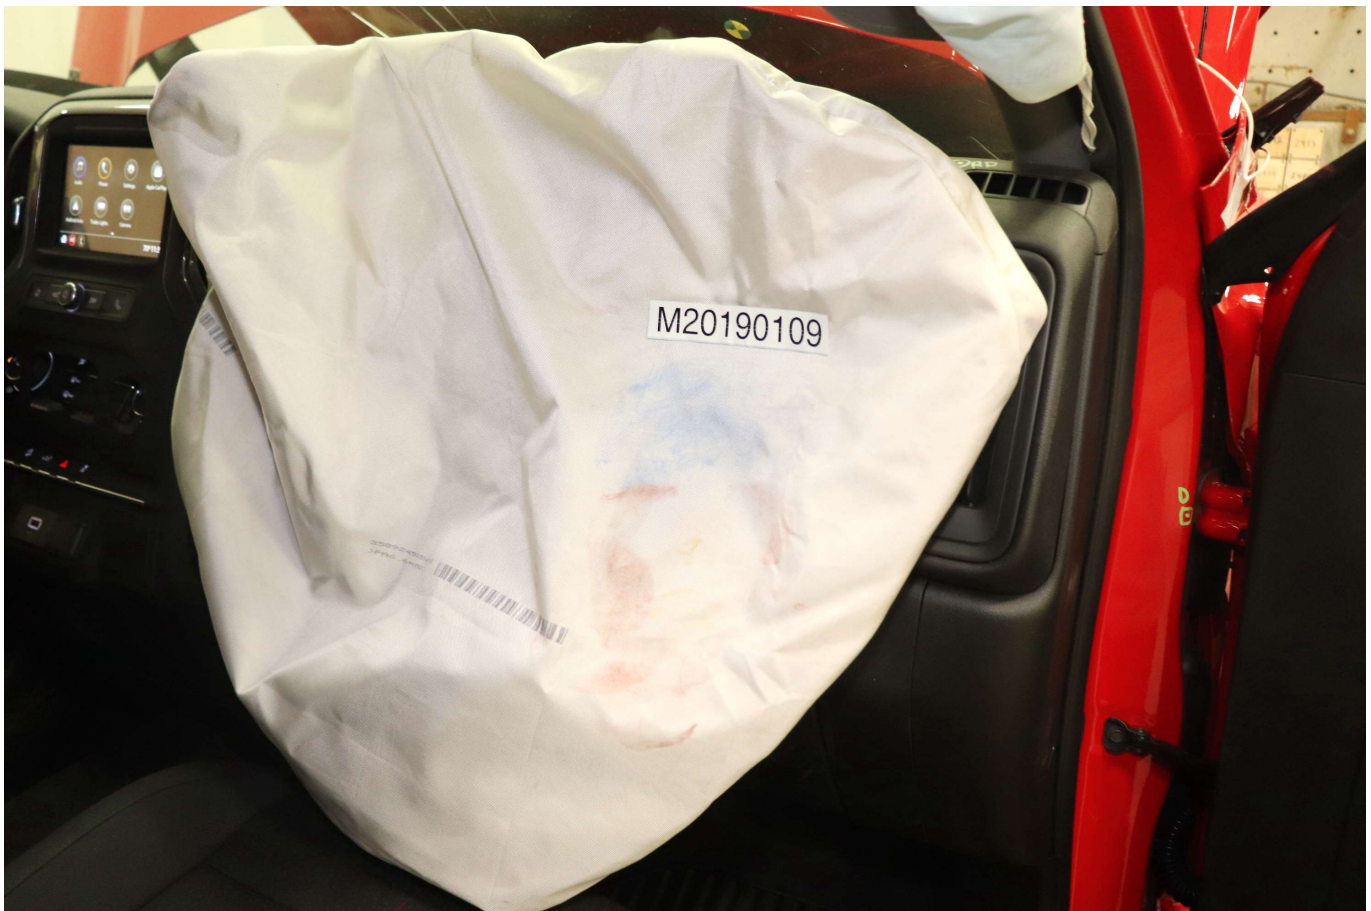
Photo No. 068 - Post-Test Passenger Dummy Contact with Airbag

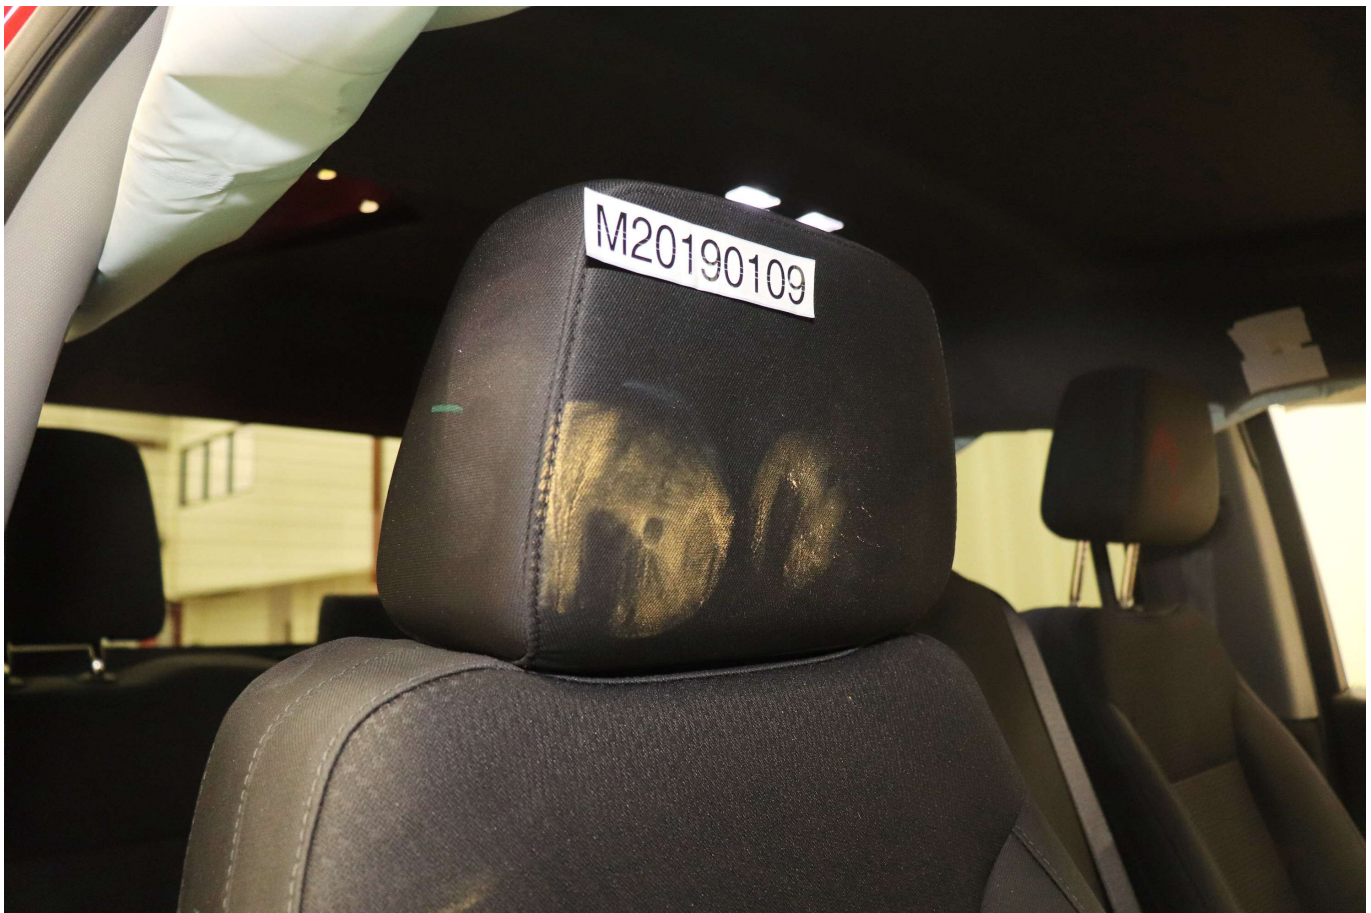
Photo No. 069 - Post-Test Passenger Dummy Contact with Headrest

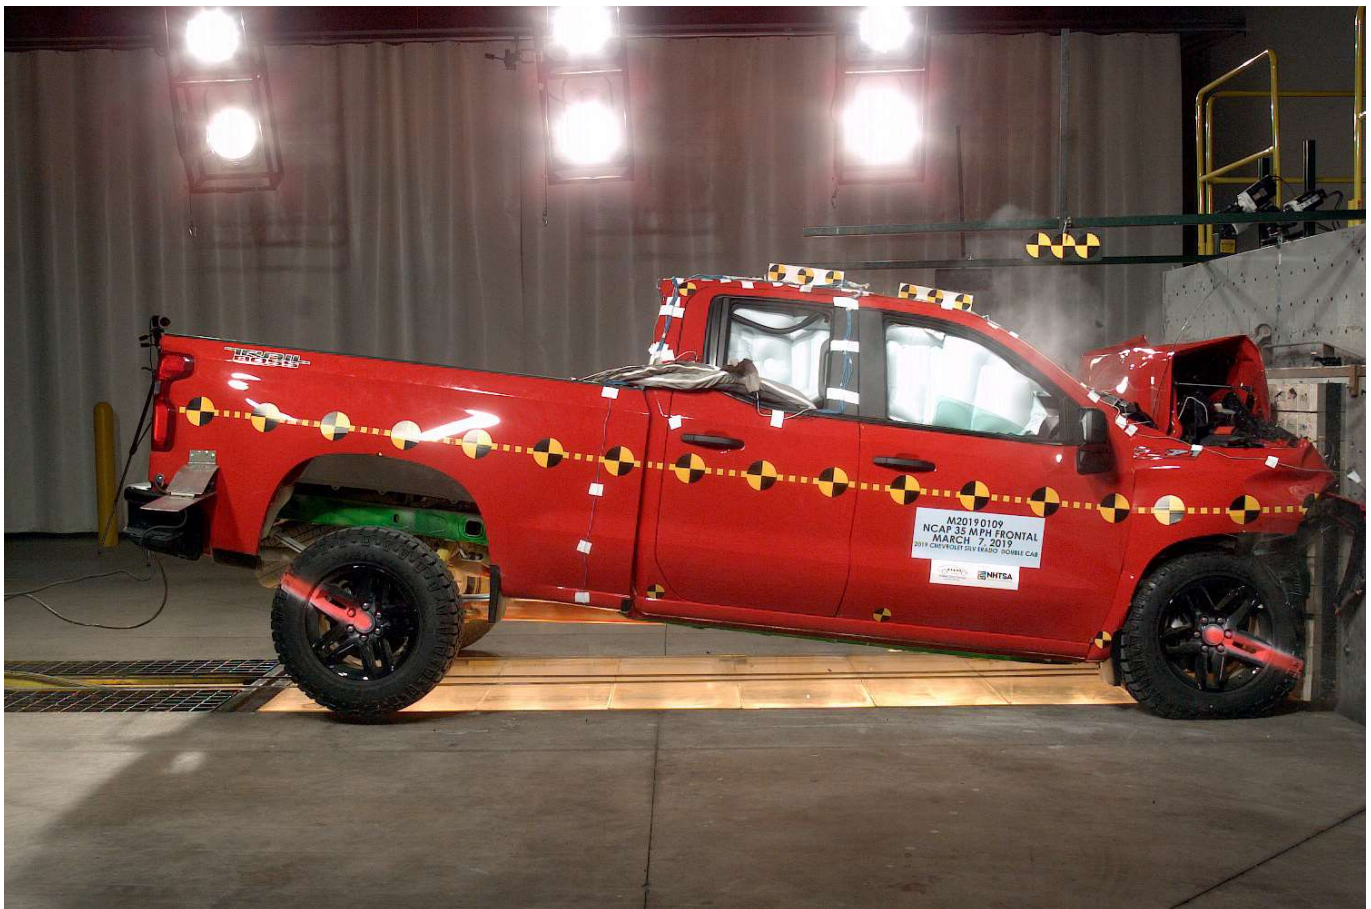
Photo No. 078 - 2019 Chevrolet Silverado Custom TB Double Cab Truck Frontal Impact Event

A load cell barrier consisting of 176 load cells was impacted by a 2019 Chevrolet Silverado 4WD Custom TB Double Cab Truck at a velocity of 56.53 km/h. The test was performed at MGA Research Corporation on March 7, 2019. Pre-test and post-test photographs of the vehicle and dummies can be found in Appendix A.
