REPORT NUMBER: SPNCAP-CAL-19-006

**NEW CAR ASSESSMENT PROGRAM (NCAP)
SIDE IMPACT POLE TEST**

**FCA US LLC
2019 Ram 1500 Quad Cab
Truck**

NHTSA No: M20190316

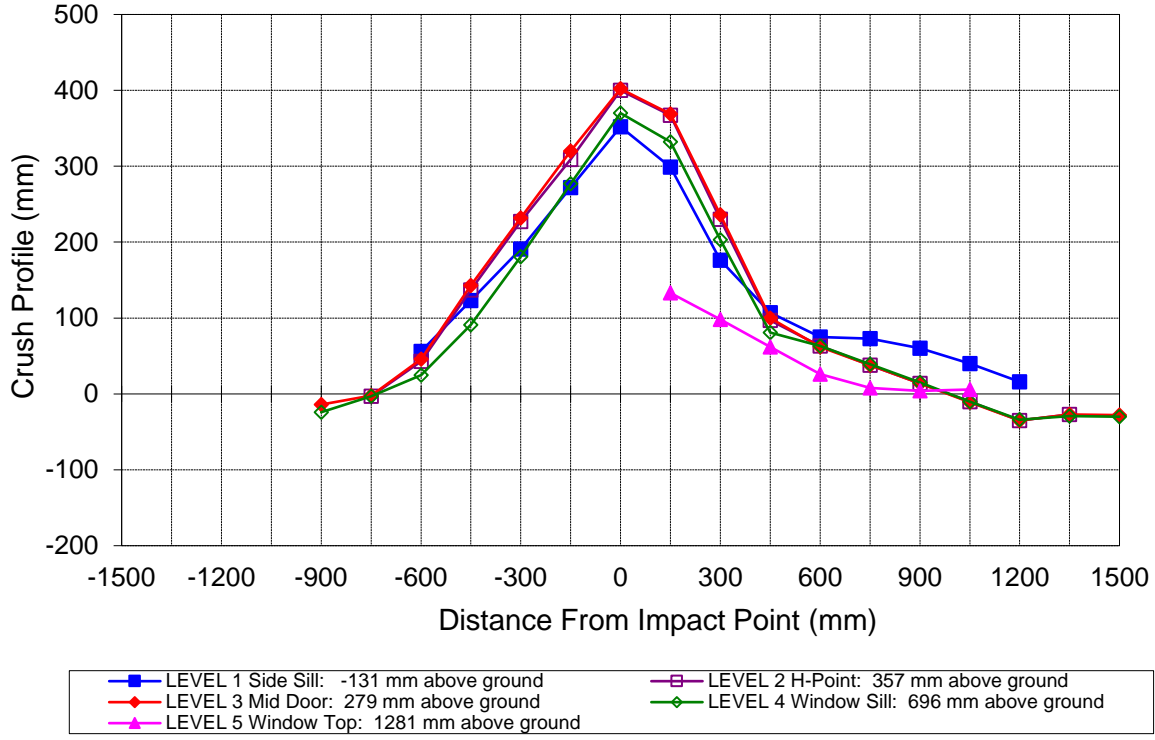
Vehicle Exterior Crush Measurements - Visual Representation

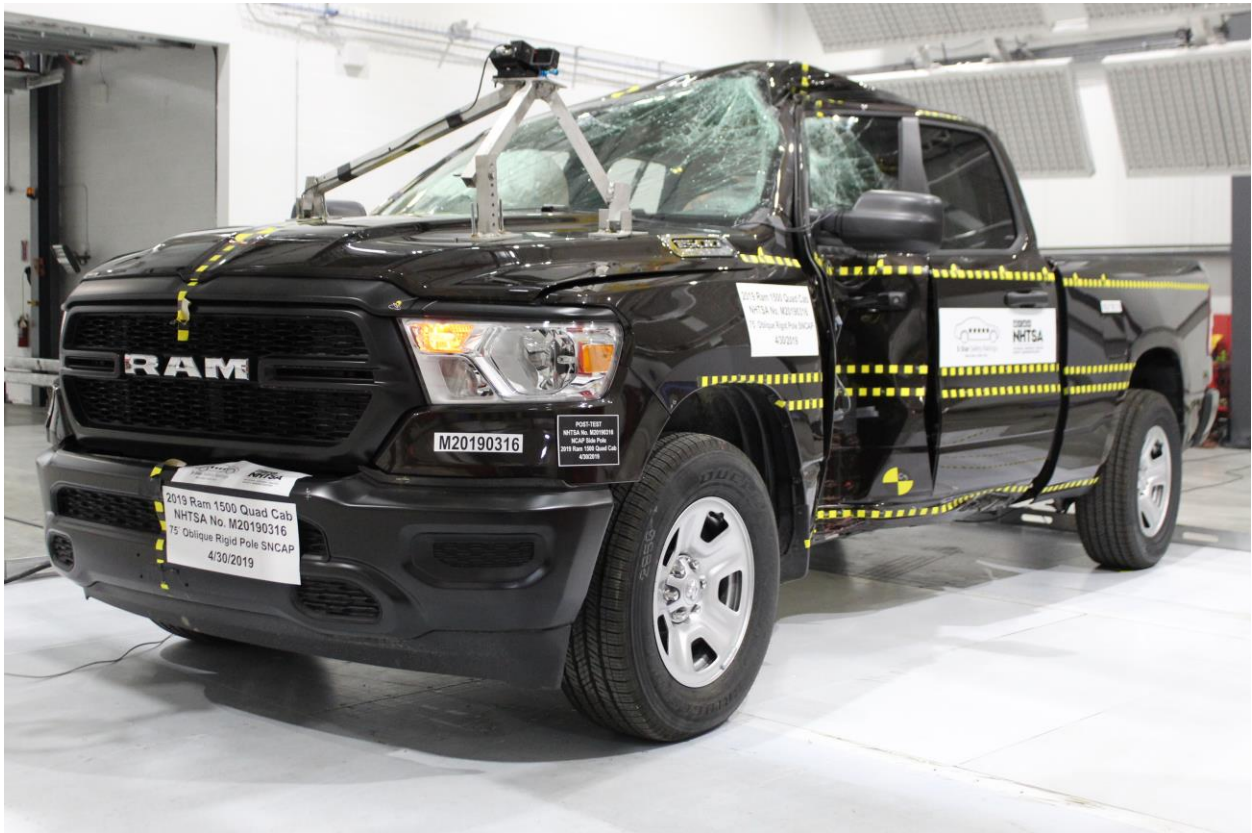
Figure A-6: Post-Test Left Front ¾ View of Test Vehicle

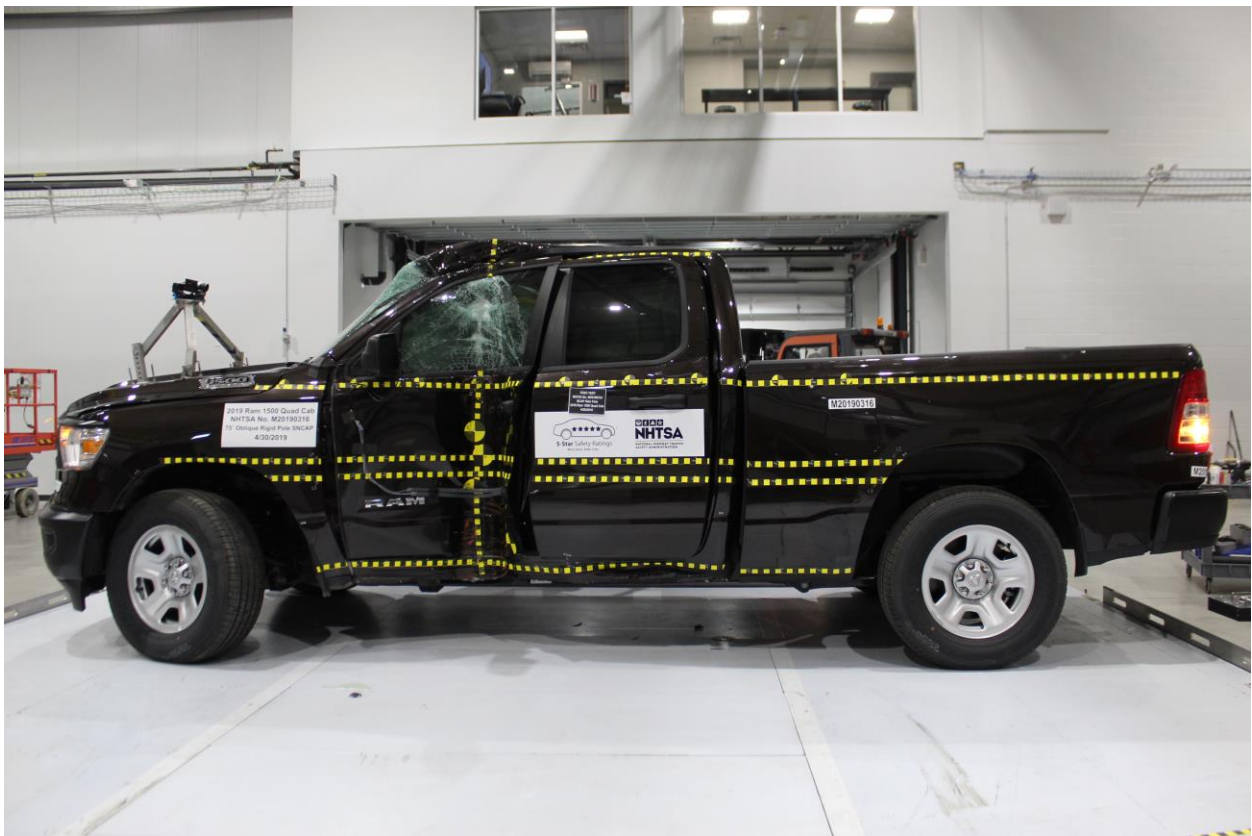
Figure A-8: Post-Test Left Side View of Test Vehicle

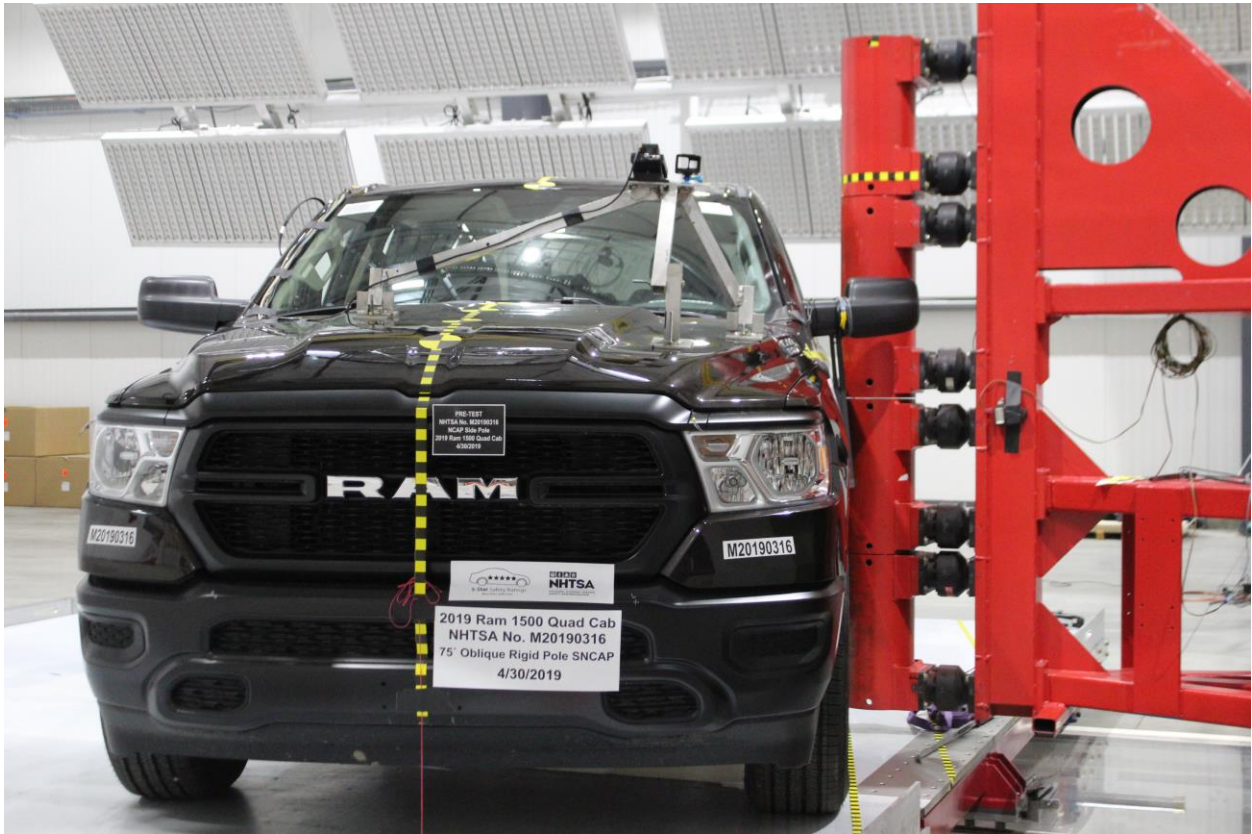
Figure A-17: Pre-Test Left Side View of Pole Positioned Against Side of Vehicle

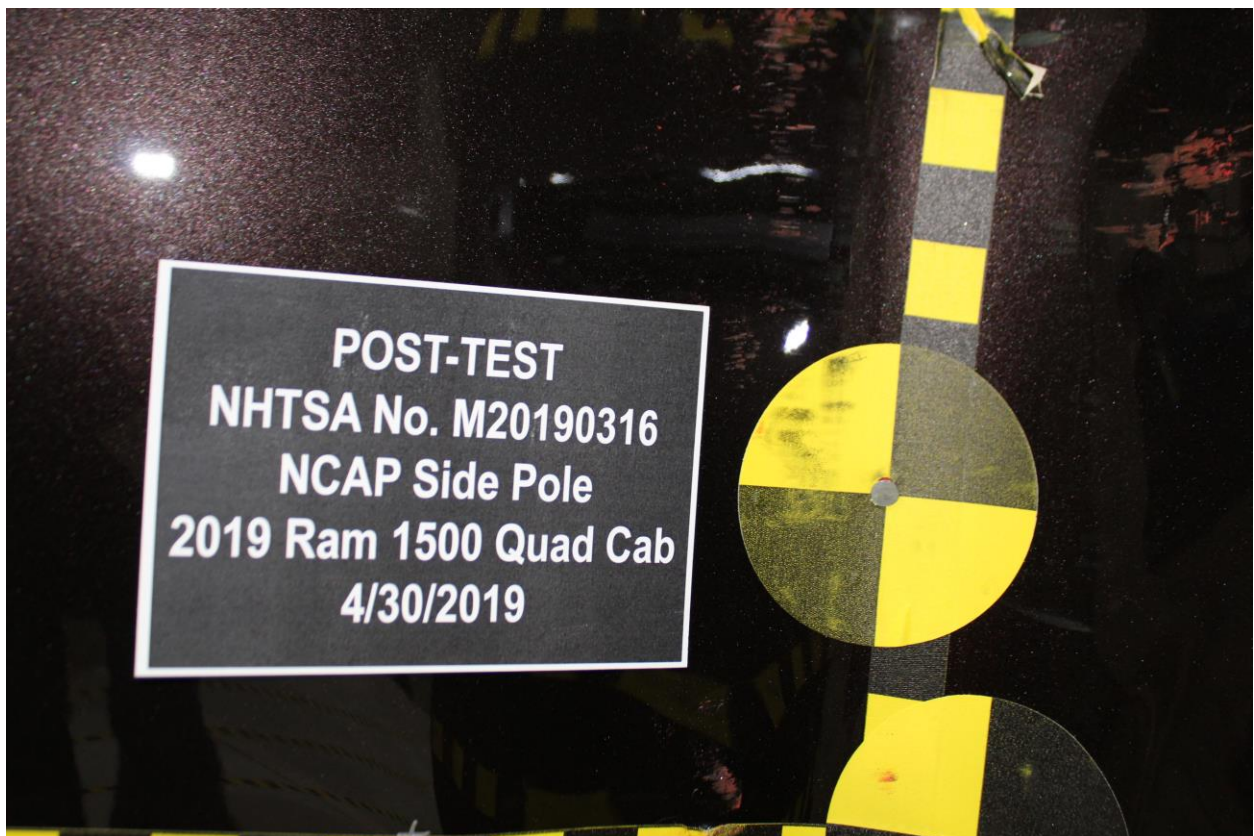
Figure A-20: Post-Test Close-Up View of Impact Point Target Showing Impact Location

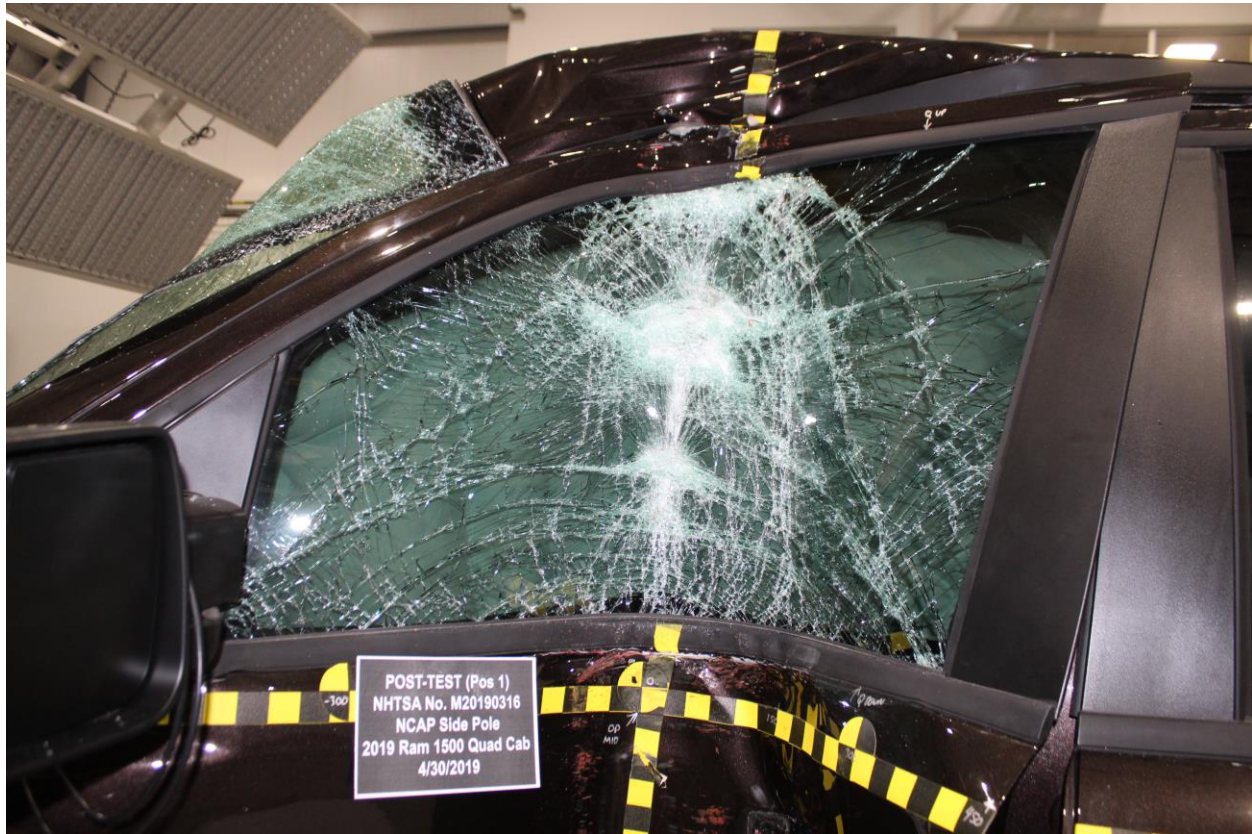
Figure A-25: Post-Test Left Side View of Dummy Shoulder and Door Top View

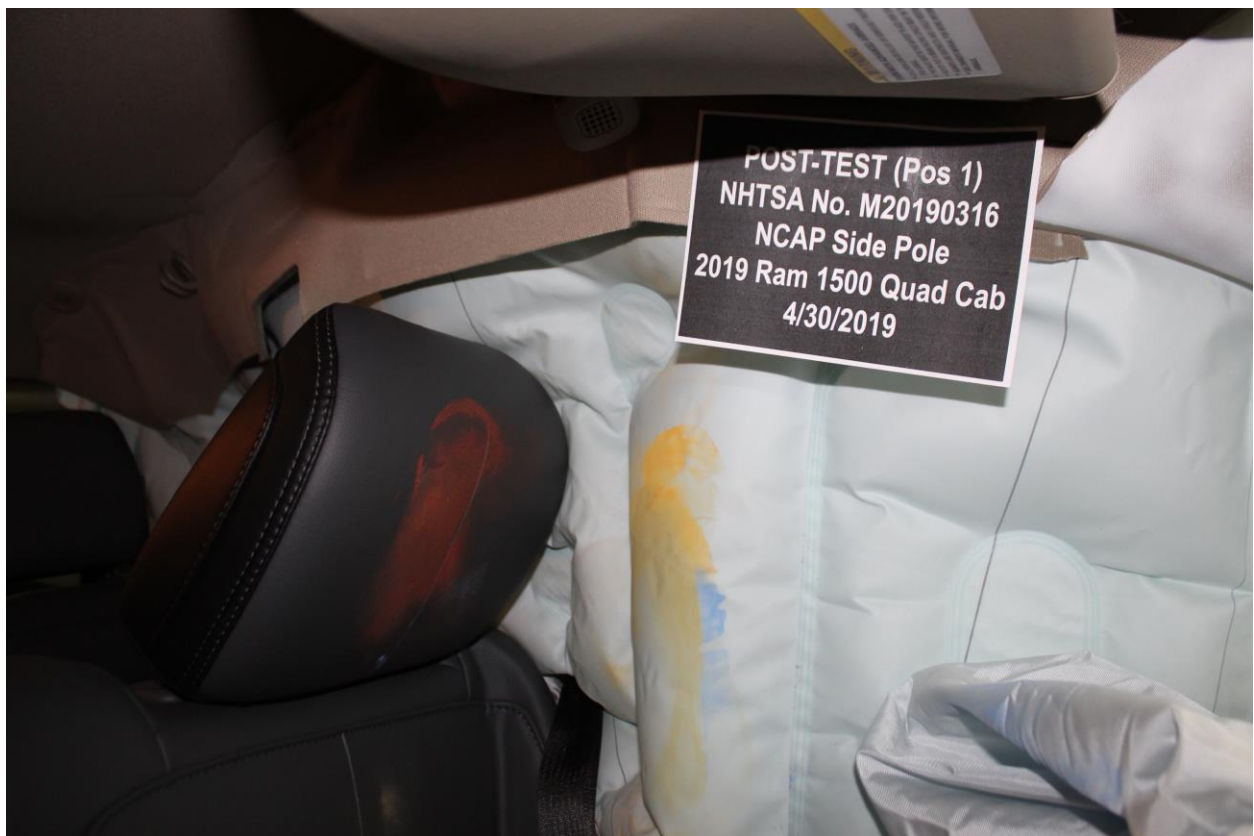
Figure A-46: Post-Test Dummy Close-Up Head Contact with Vehicle Interior View

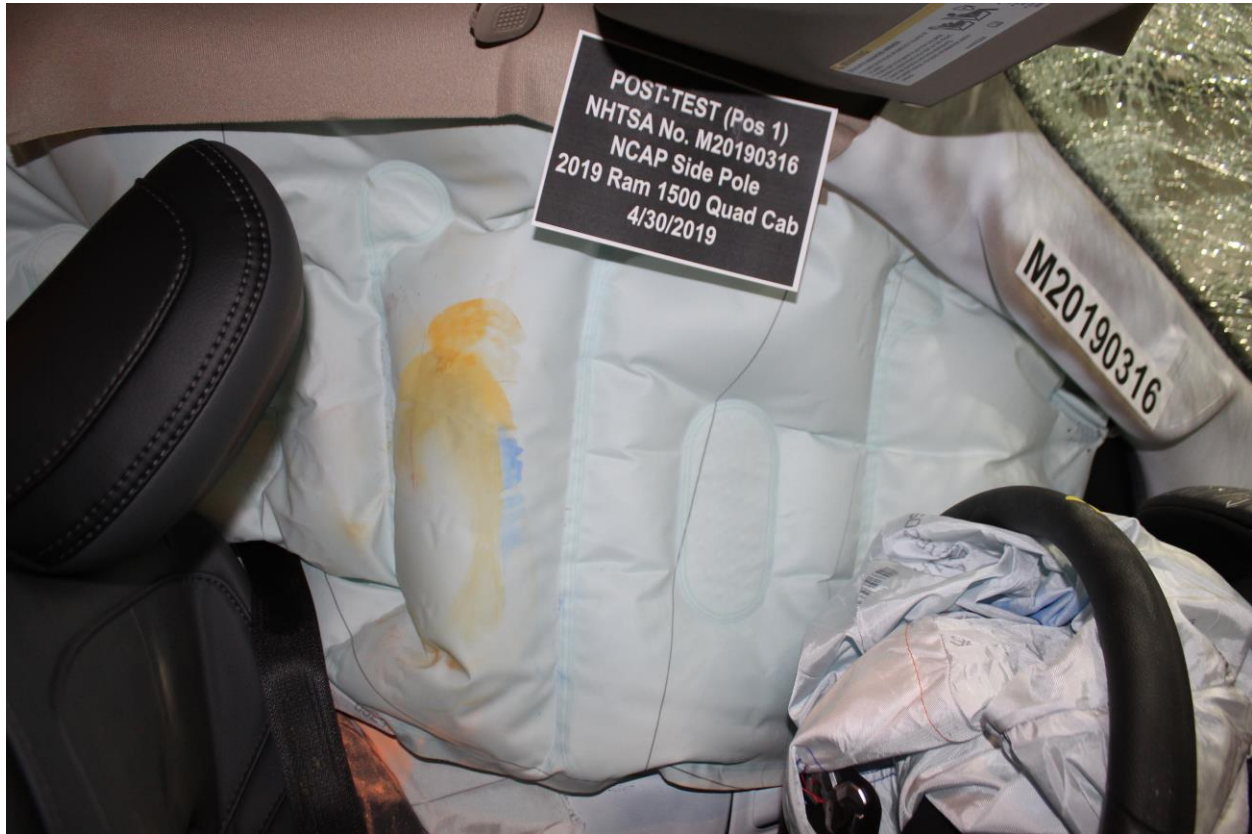
Figure A-47: Post-Test Dummy Close-Up Head Contact with Side Airbag View

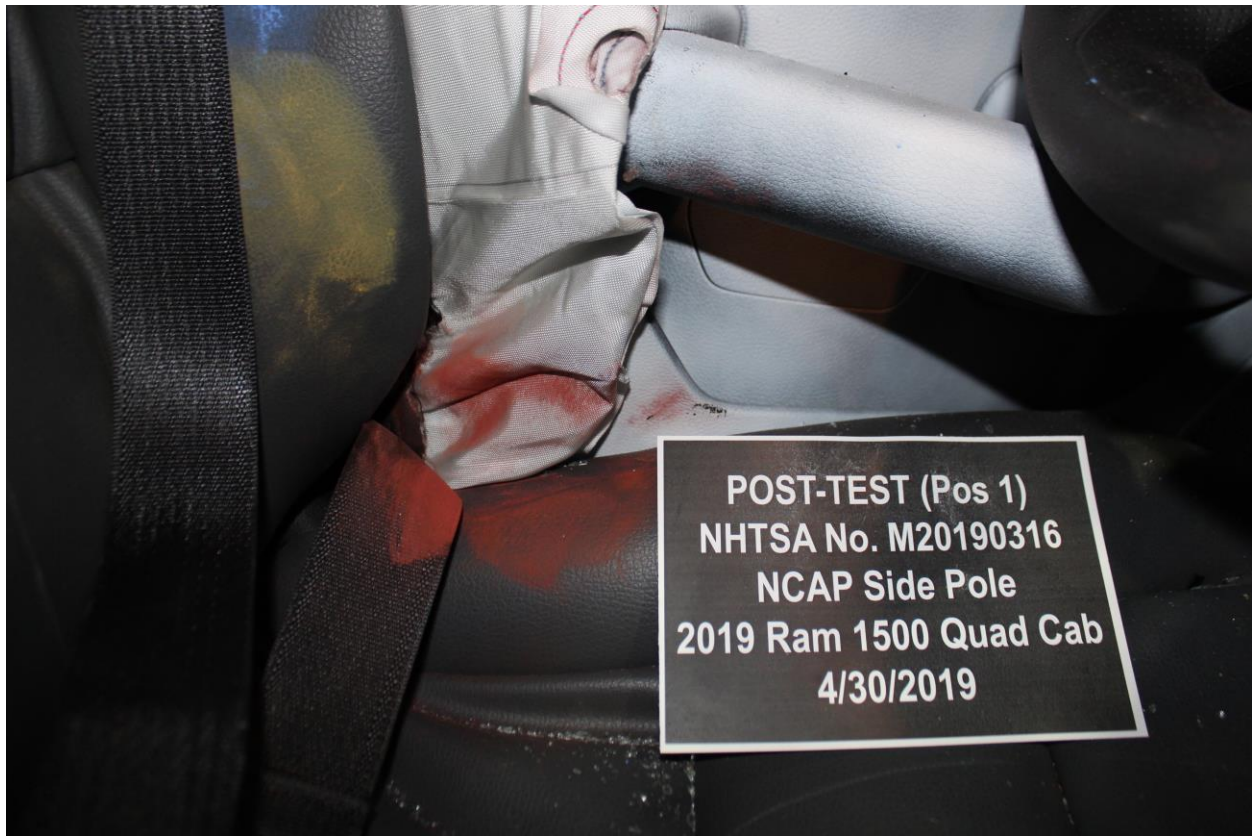
Figure A-51: Post-Test Dummy Close-Up Pelvis Contact with Side Airbag View

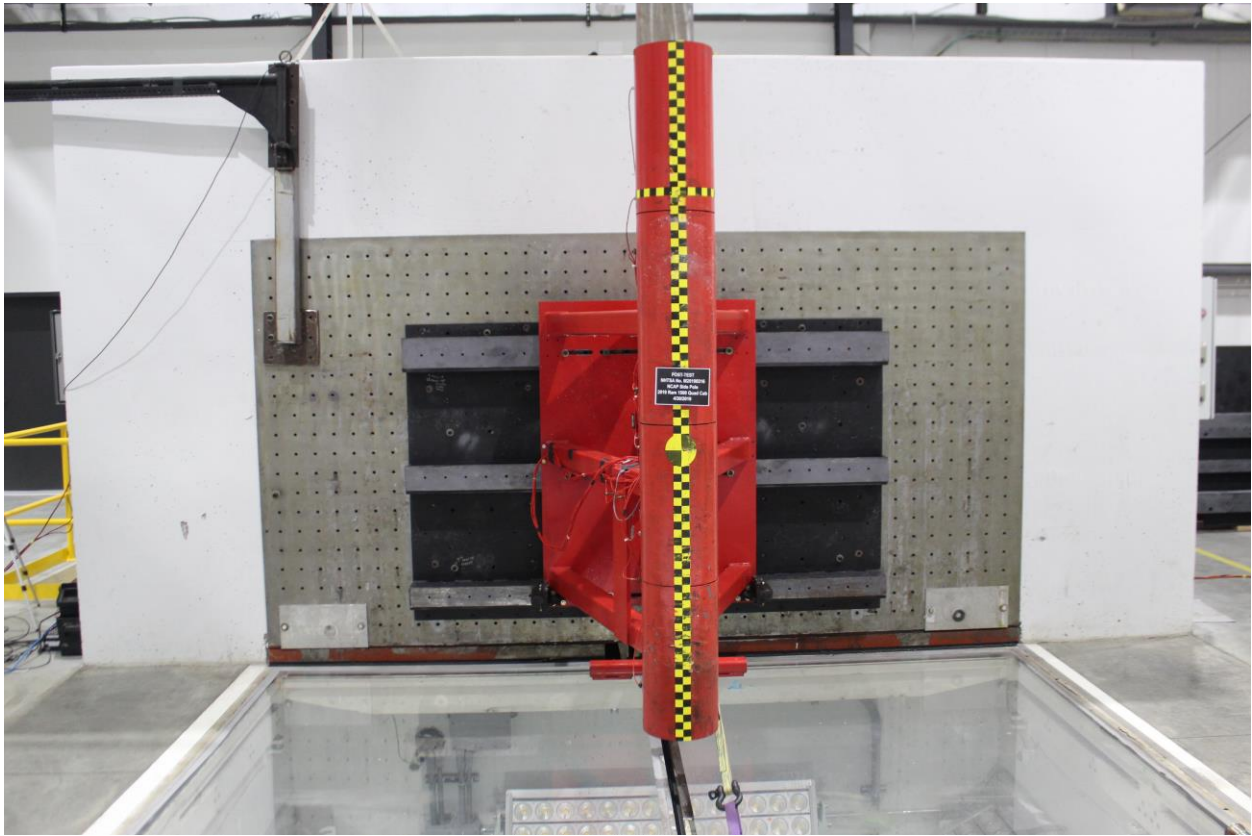
Figure A-58: Post-Test Pole Barrier Front View

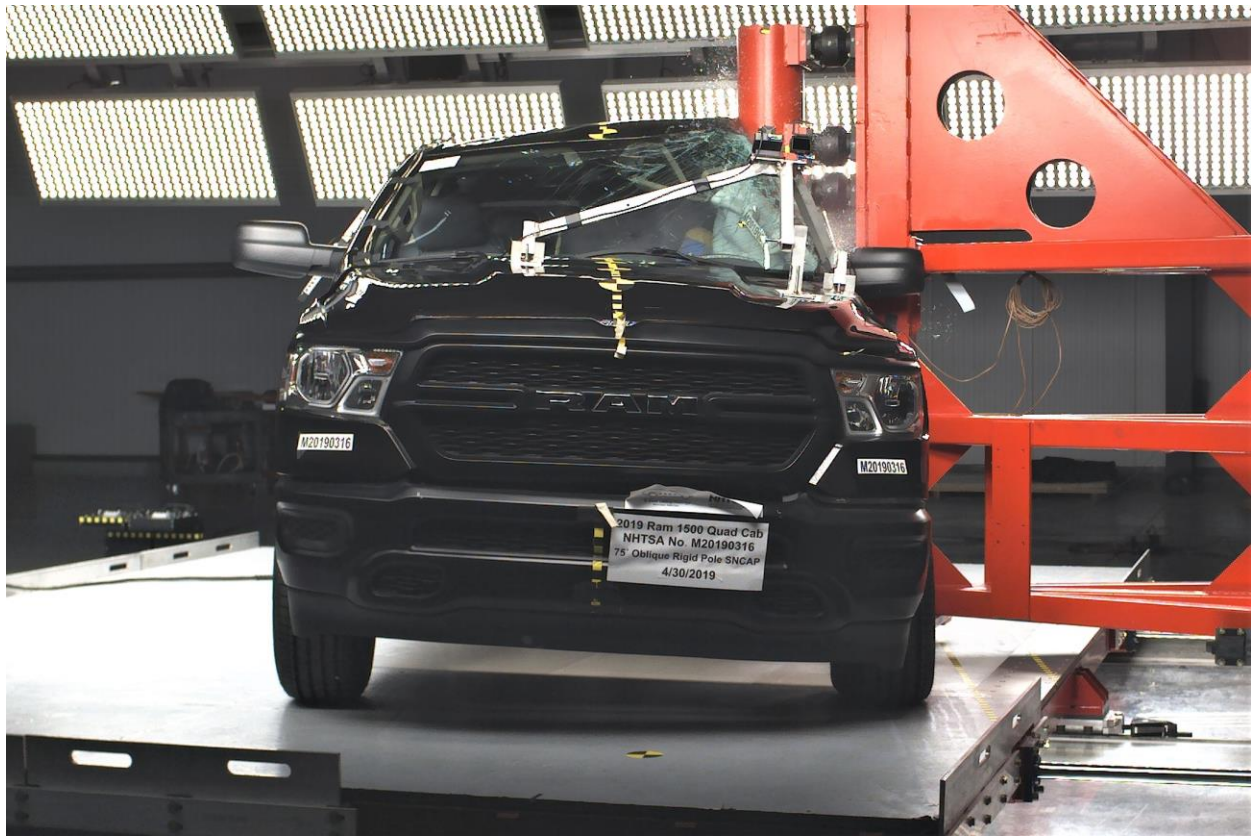
Figure A-68: Impact Event

A rigid pole side impact test was conducted on a 2019 Ram 1500 Quad Cab Truck. The subject vehicle was towed into the rigid pole at an angle of 75° and a velocity of 32.22 km/h. The test was conducted by Calspan Corporation's Transportation Test Operations facility in Buffalo, New York on April 30, 2019. Pre-test and post-test photographs of the test vehicle and side impact dummy (SID-IIs) are included in Appendix A of this report.

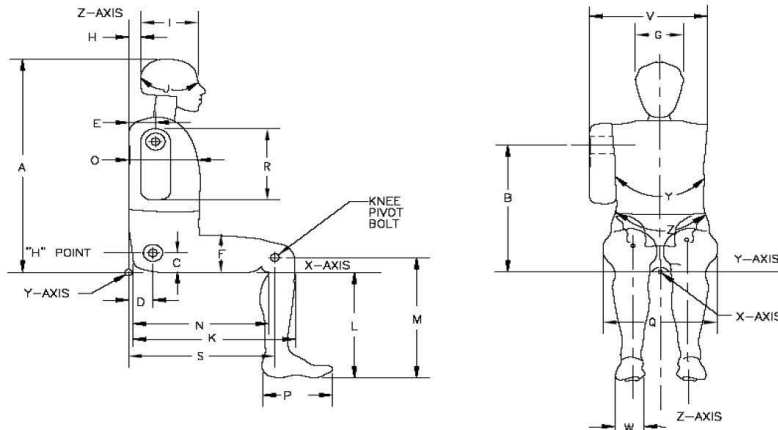
Symbol	Description	Specification (mm)		Result (mm)	Pass/Fail
A	Sitting Height	772	788	779	Pass
B	Shoulder Pivot Height	437	453	450	Pass
C	H-point Height	79	89	85	Pass
D	H-point from seatback	141	151	145	Pass
E	Shoulder Pivot from Backline	97	107	103	Pass
F	Thigh Clearance	119	135	125	Pass
G	Head Breadth	140	148	145	Pass
H	Head Back from Backline	40	46	43	Pass
I	Head Depth	178	188	185	Pass
J	Head Circumference	541	551	546	Pass
K	Buttock to Knee Length	514	540	530	Pass
L	Popliteal Height	343	369	356	Pass
M	Knee Pivot to floor height	392	409	401	Pass
N	Buttock Popliteal Length	416	442	431	Pass
O	Chest Depth w/o jacket	195	211	203	Pass
P	Foot Length	216	232	222	Pass
Q	Hip Breadth (w/pelvic plugs)	313	323	319	Pass
R	Arm Length	249	259	253	Pass
S	Knee Joint to seatback	477	493	485	Pass
V	Shoulder Width	341	357	351	Pass
W	Foot Width	78	94	84	Pass
Y	Chest Circumference w/jacket	851	881	870	Pass
Z	Waist Circumference	761	791	769	Pass
