REPORT NUMBER: SPNCAP-MGA-2019-038

**NEW CAR ASSESSMENT PROGRAM (NCAP)
Side Impact Pole Test**

**GENERAL MOTORS LLC
2019 Chevrolet Silverado WT Double Cab Truck
NHTSA No.: M20190110**

**MGA RESEARCH CORPORATION
5000 Warren Road
Burlington, WI 53105**

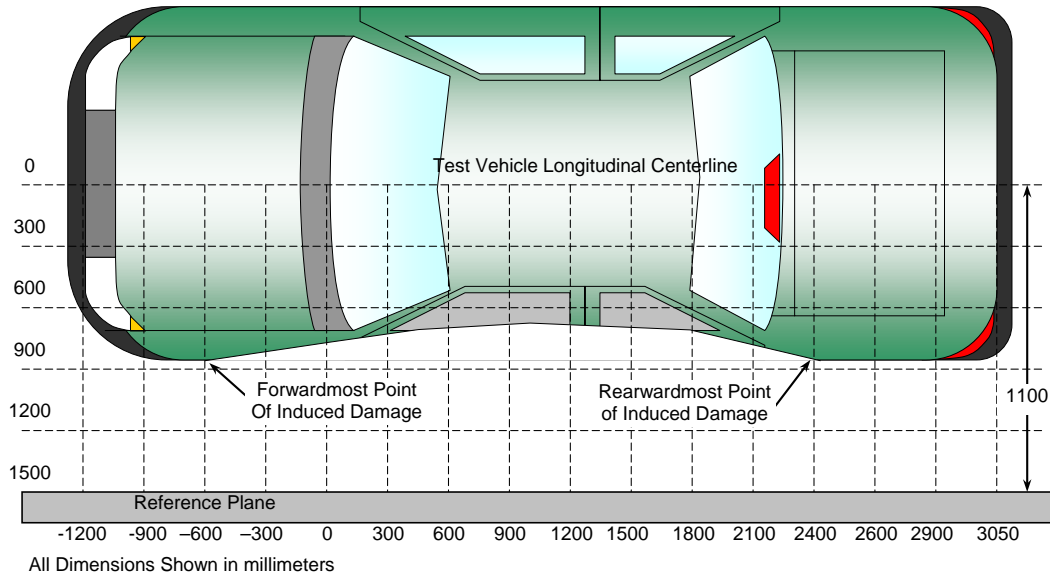
**DATA SHEET NO. 11
VEHICLE DAMAGE PROFILE DISTANCES**

TOP VIEW

DAMAGE PROFILE DISTANCES

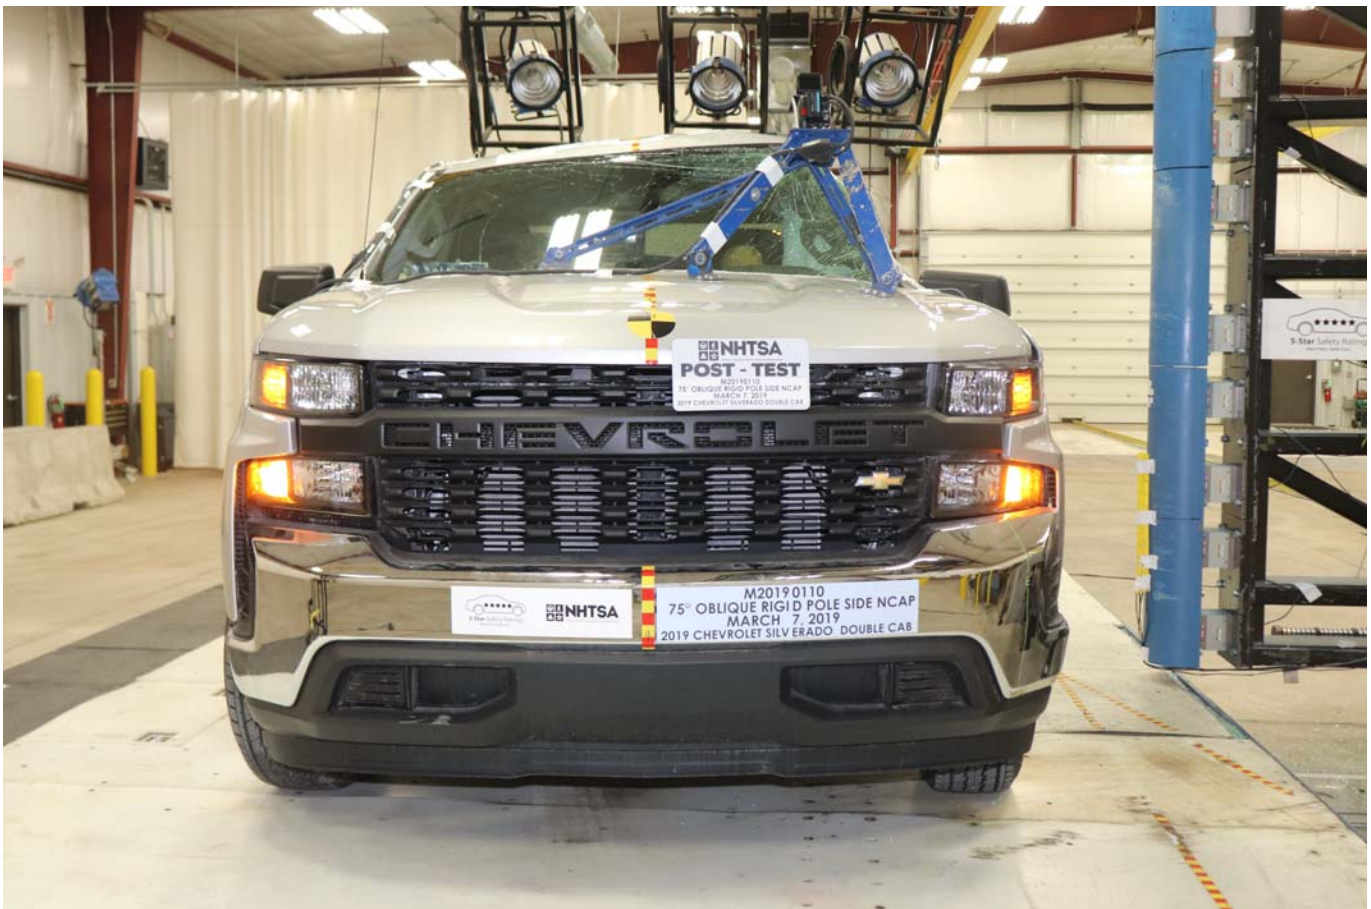
Photo No. 004 - Post-Test Frontal View of Test Vehicle

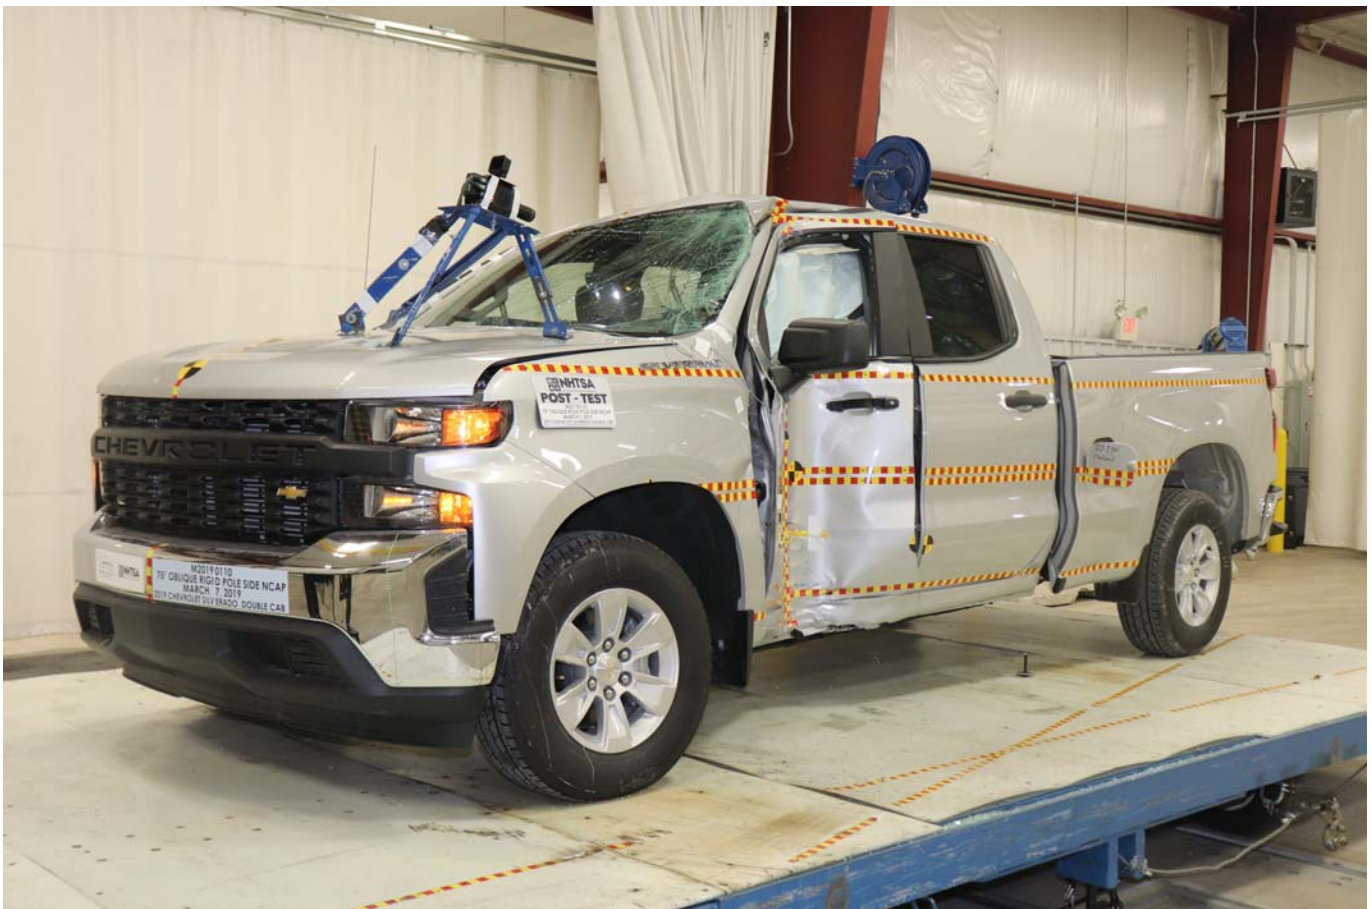
Photo No. 006 - Post-Test Left Front Three-Quarter View of Test Vehicle

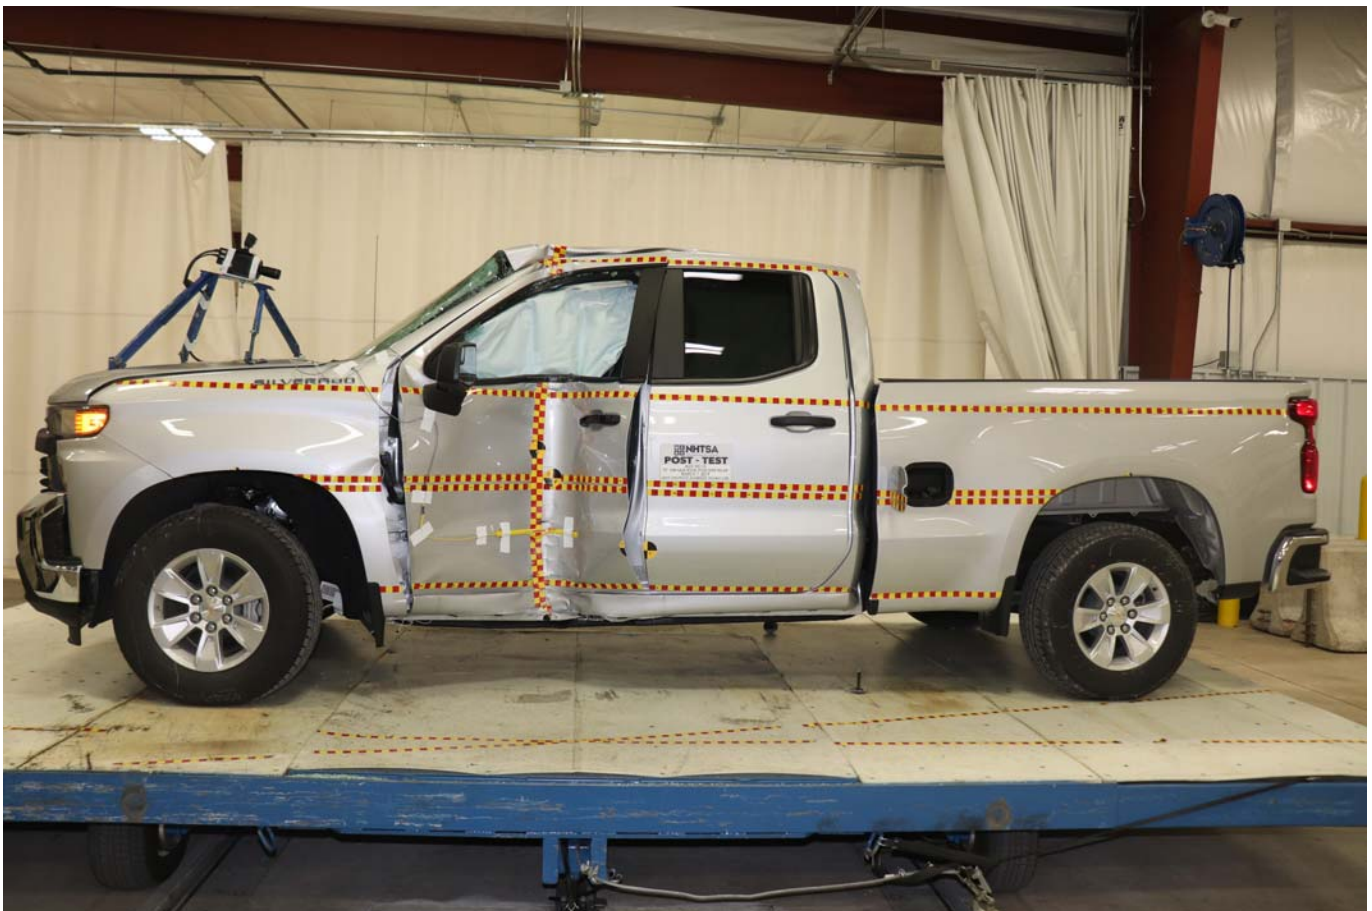
Photo No. 008 - Post-Test Left Side View of Test Vehicle

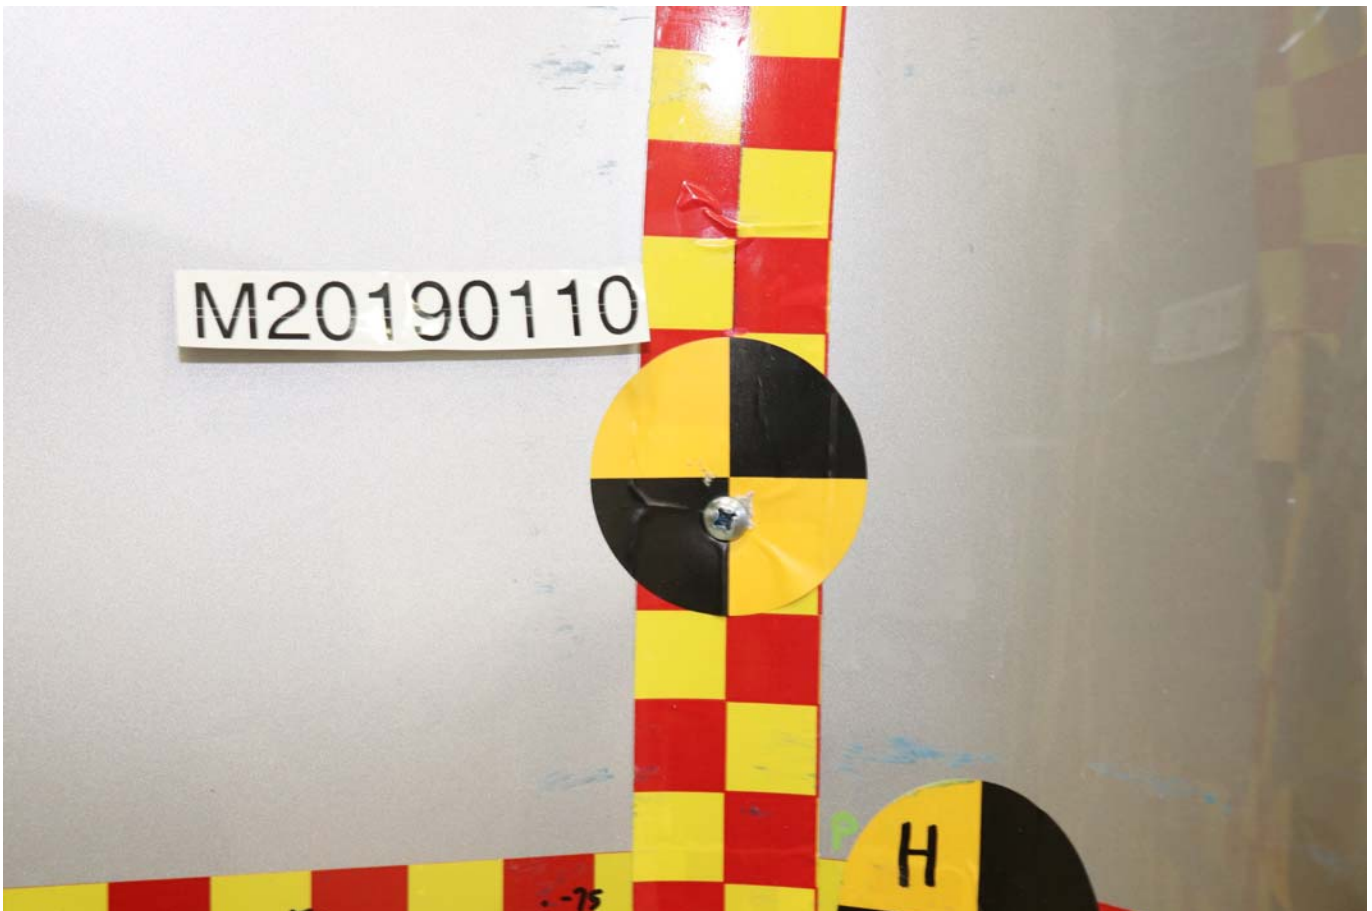
Photo No. 020 - Post-Test Close-Up View of Impact Point Target Showing Impact Location

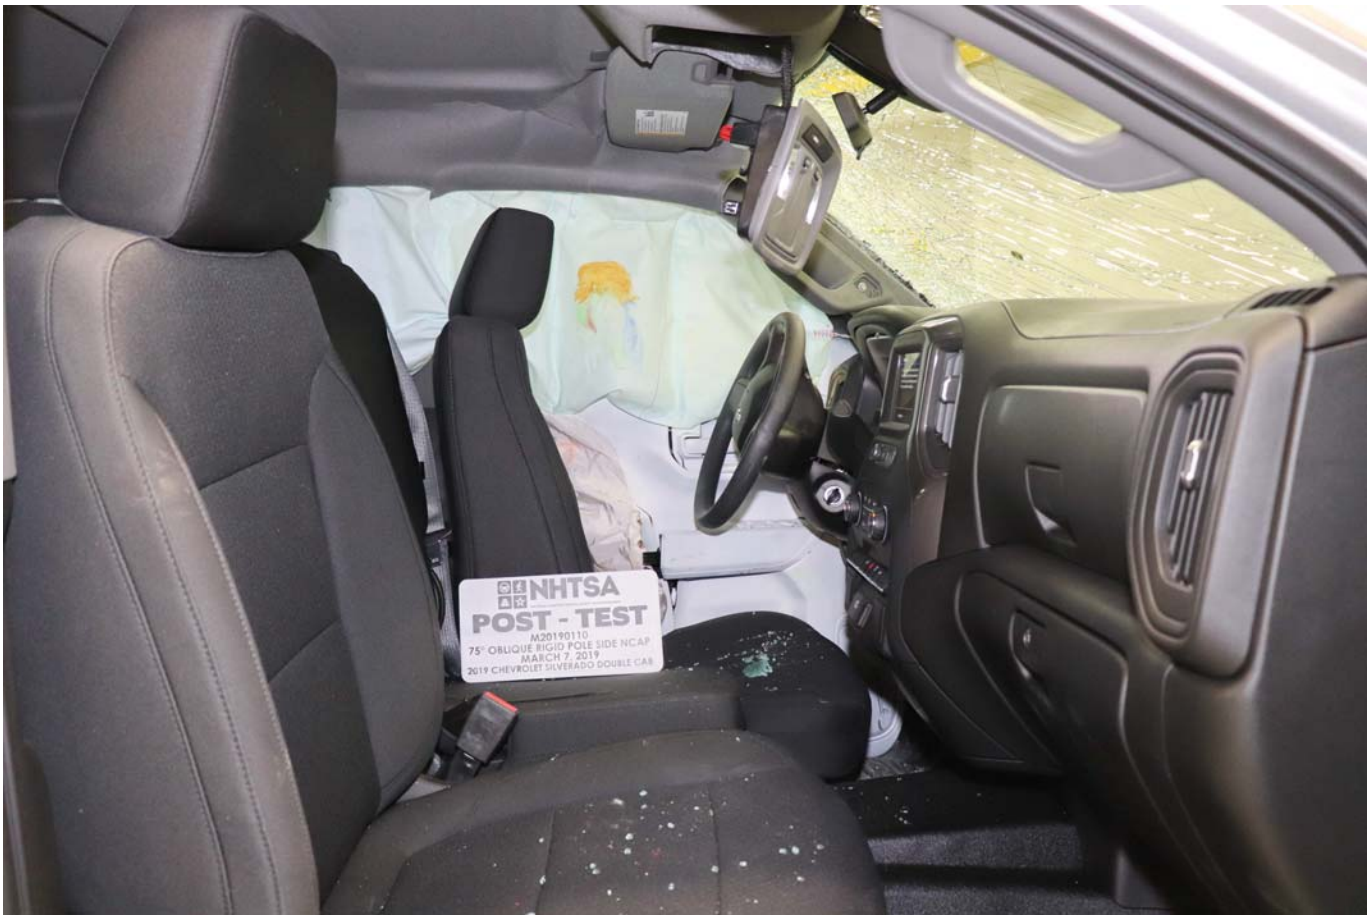
Photo No. 045 - Post-Test Inner Door Panel View Showing Dummy Contact Location

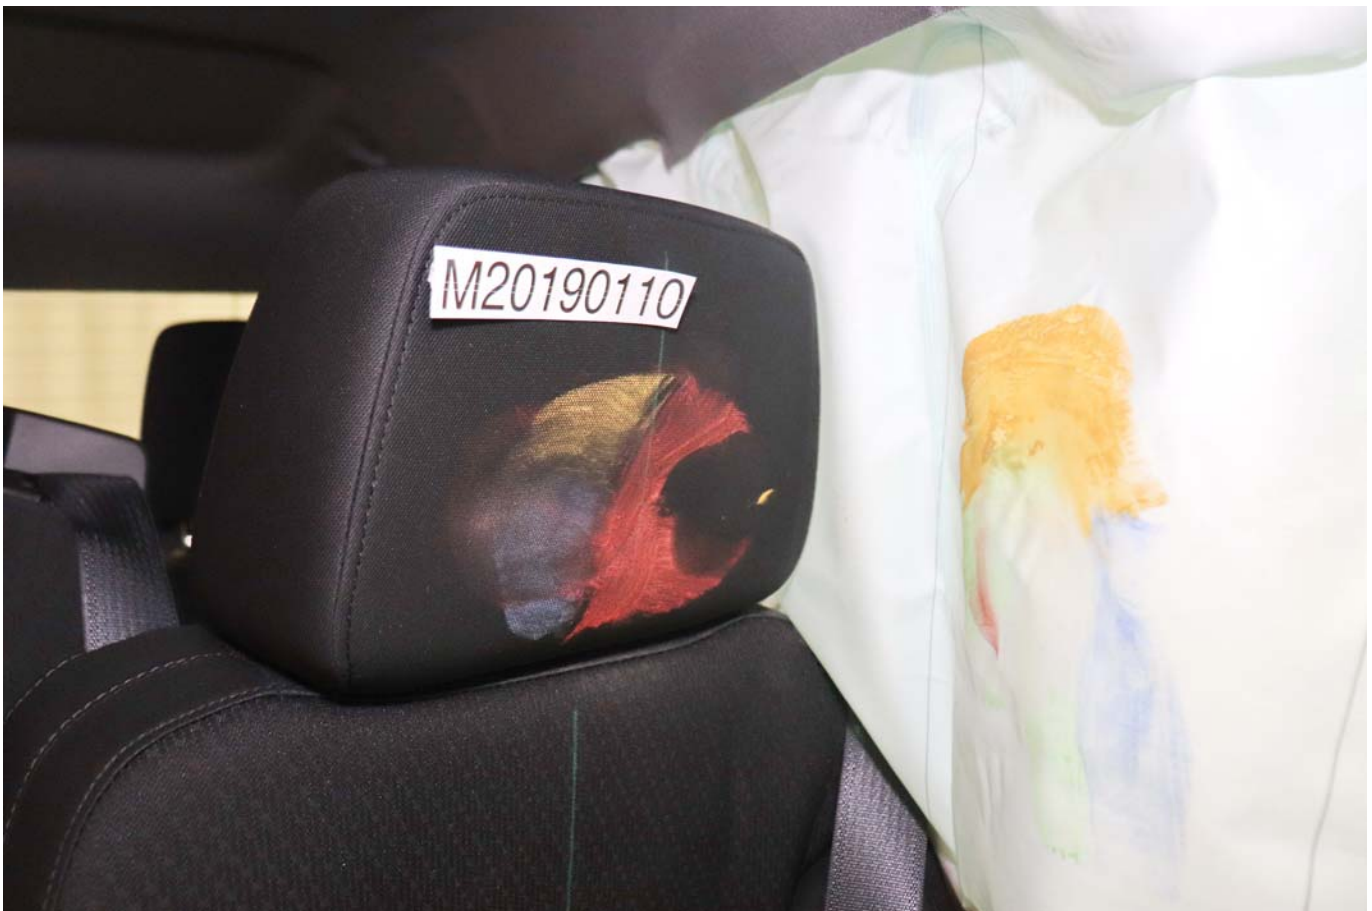
Photo No. 046 - Post-Test Dummy Close-Up Head Contact with Vehicle Interior View

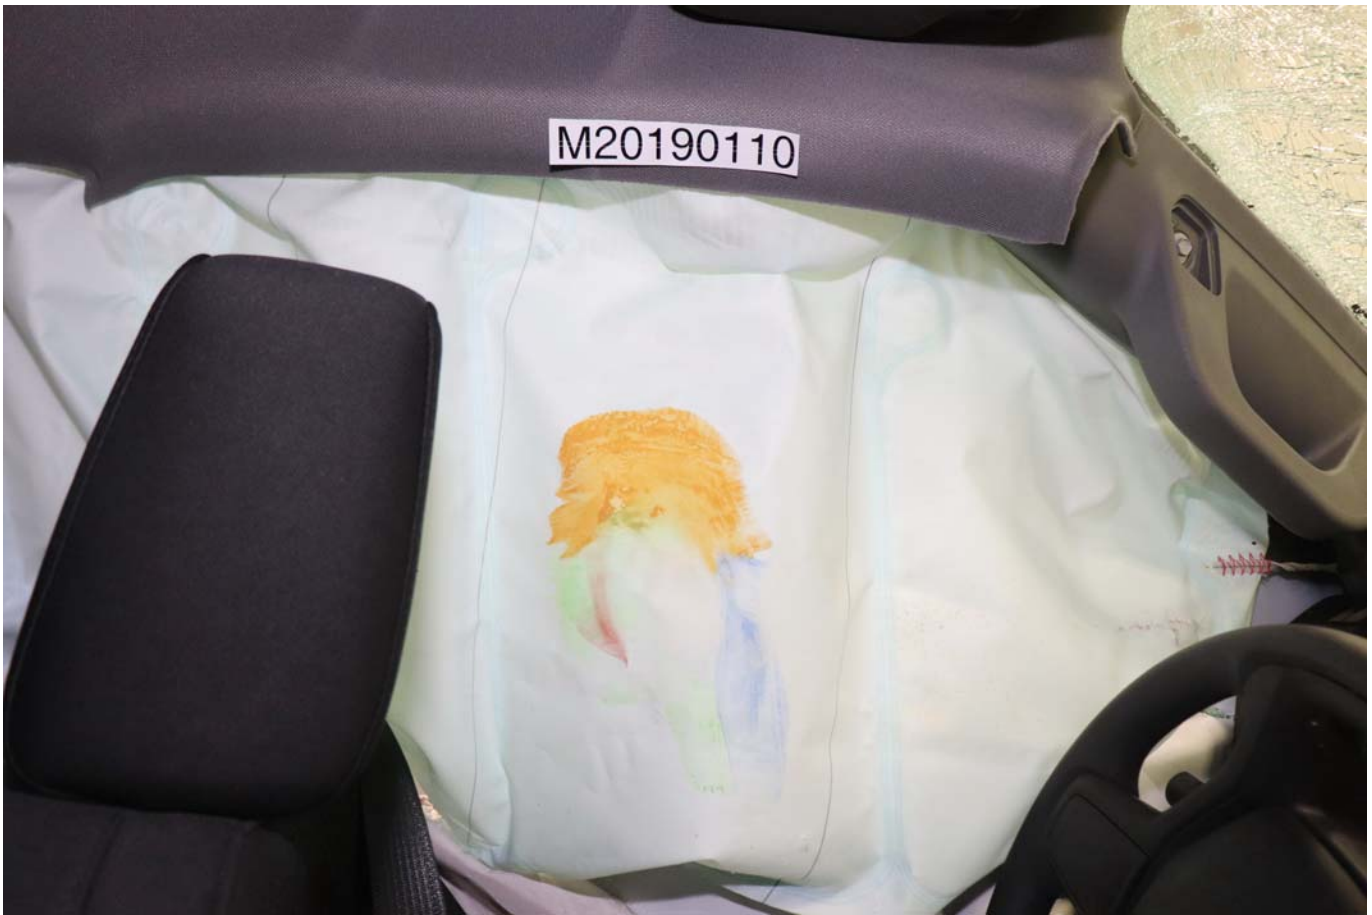
Photo No. 047 - Post-Test Dummy Close-Up Head Contact with Side Air Bag View

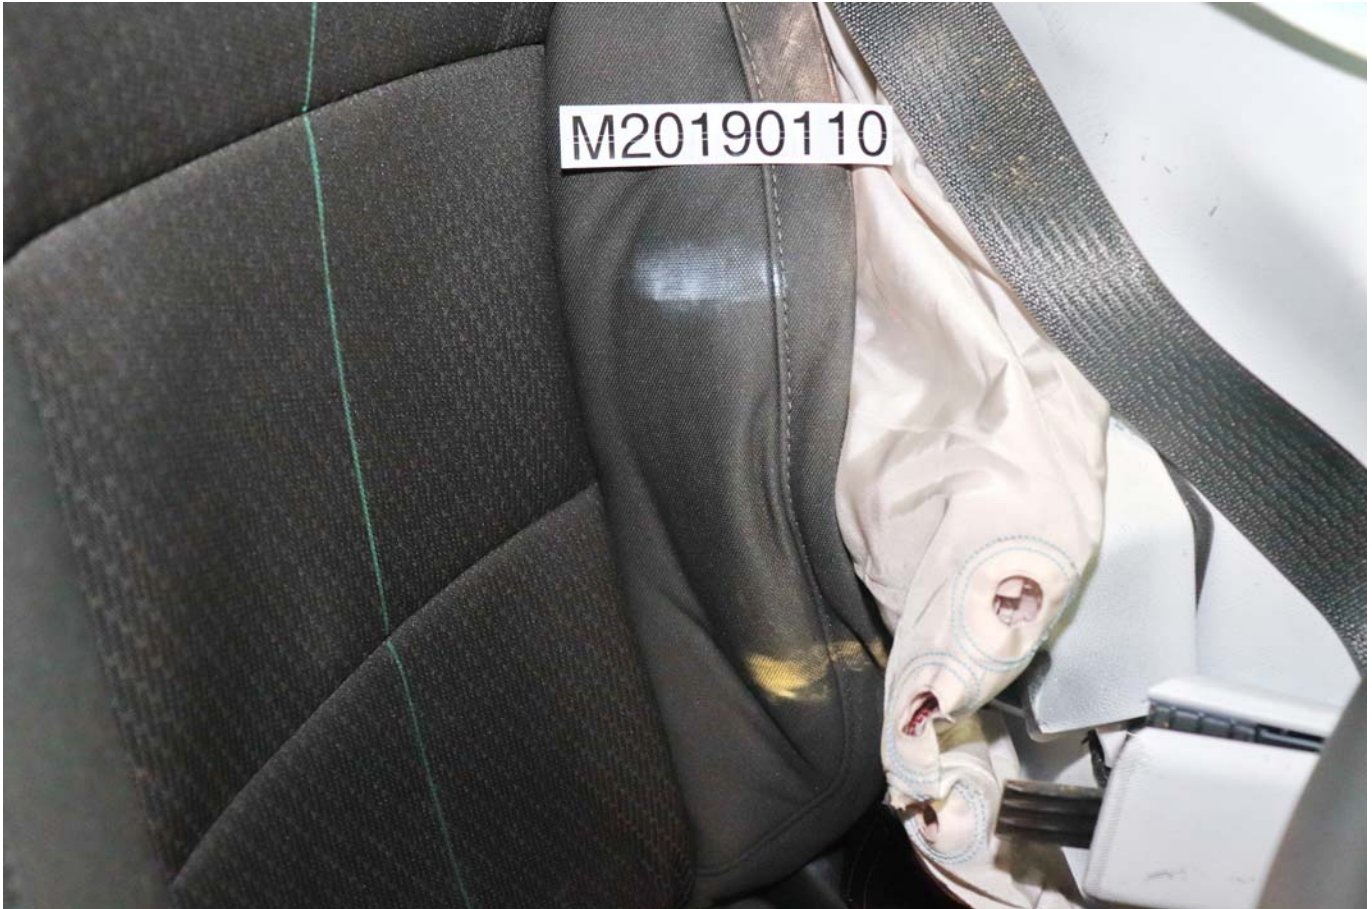
Photo No. 048 - Post-Test Dummy Close-Up Torso Contact with Vehicle Interior View

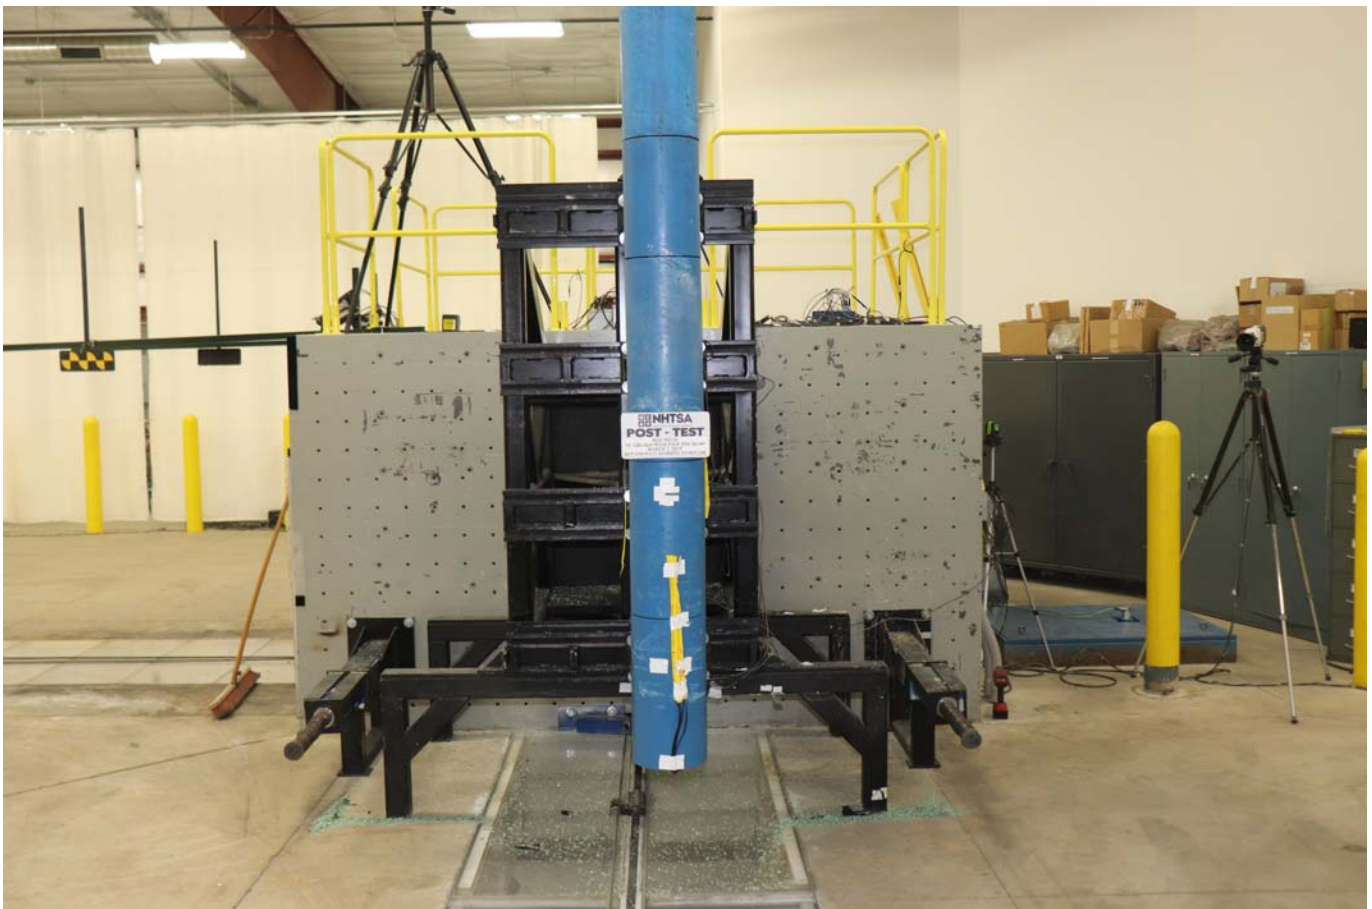
Photo No. 058 - Post-Test Pole Barrier Front View

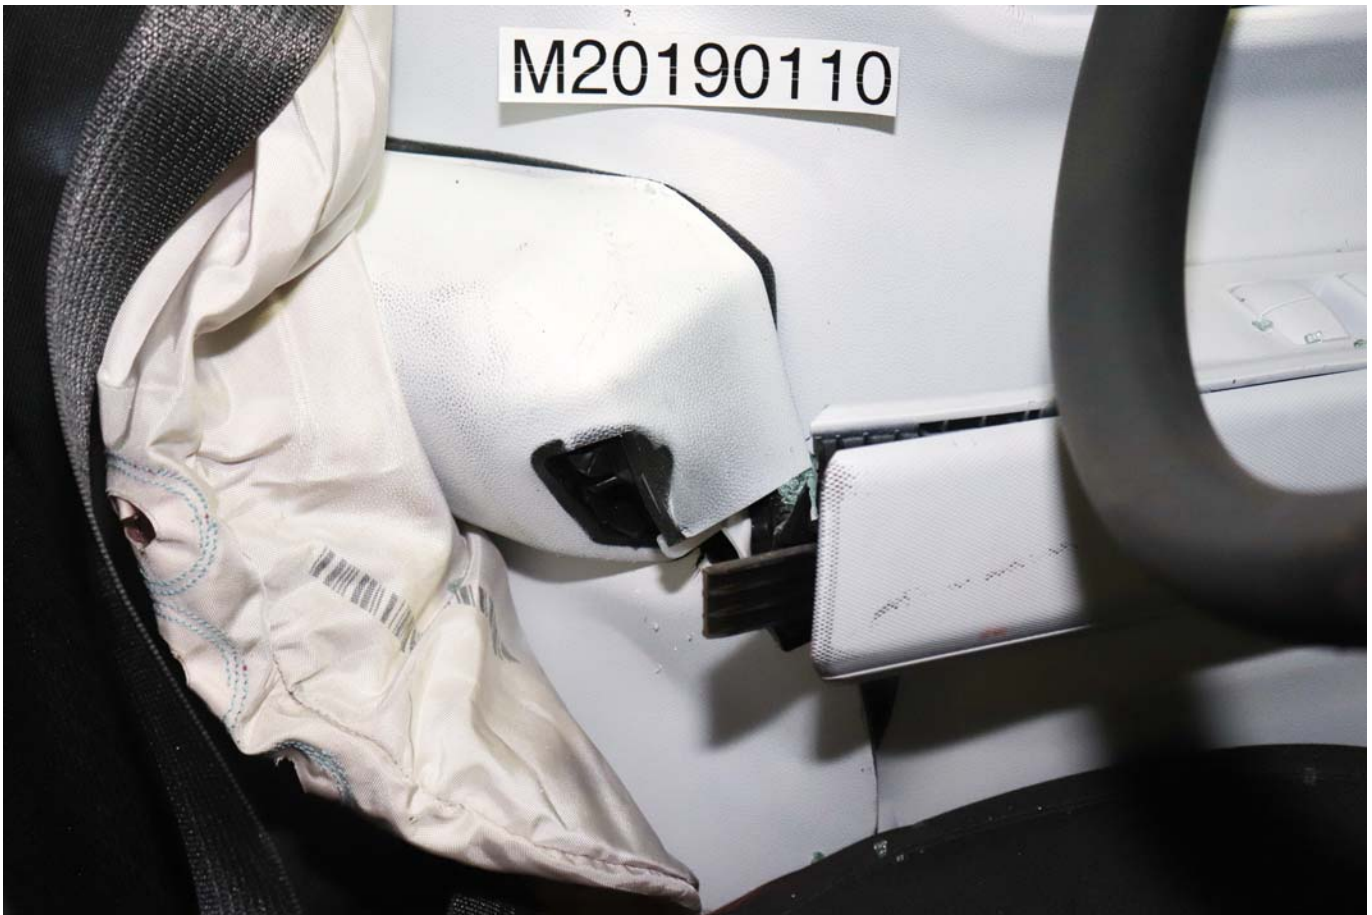
Photo No. 071 - Post-Test View of Shattered Vehicle Inner Door Panel

Critical Areas of Performance	Observations and Conclusions
Pillar Performance	No Separation
Sill Separation	None
Windshield Damage	None
Side Window Damage	LF window broken
Other Notable Effects	None
