REPORT NUMBER: SINCAP-MGA-2019-043

**NEW CAR ASSESSMENT PROGRAM (NCAP)
Moving Deformable Barrier Side Impact Test**

**NISSAN MOTOR CO., LTD.
2019 Nissan Frontier SL Crew Cab Truck
NHTSA No.: O20195203**

**MGA RESEARCH CORPORATION
5000 Warren Road
Burlington, WI 53105**

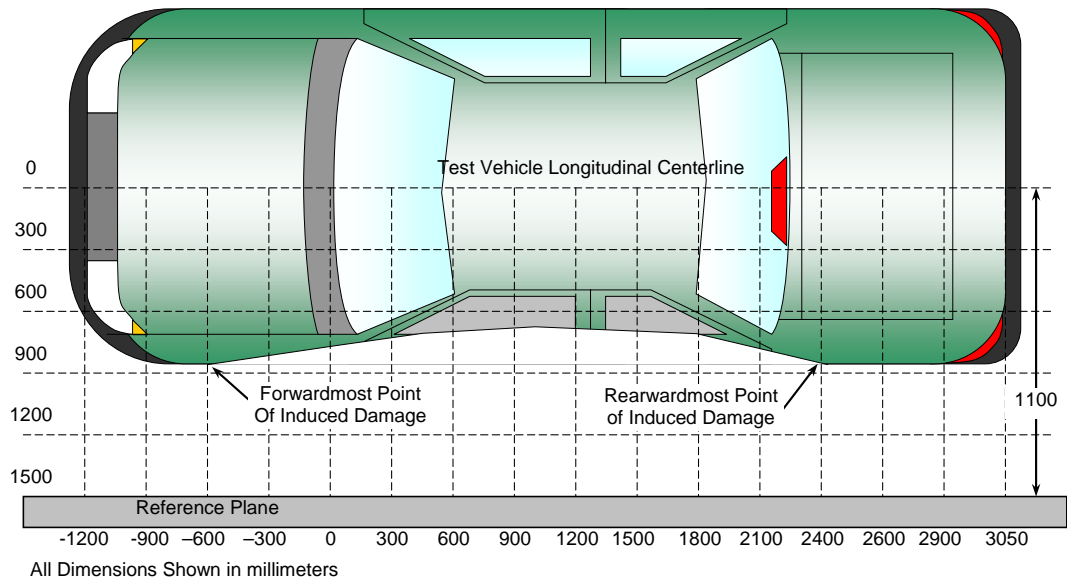
DATA SHEET NO. 13
VEHICLE AND MDB DAMAGE PROFILE DISTANCES

TOP VIEW

VEHICLE DAMAGE PROFILE DISTANCES

MDB DAMAGE PROFILE DISTANCES
