OCAS-DRI-CIB-19-19 NEW CAR ASSESSMENT PROGRAM CRASH IMMINENT BRAKE SYSTEM CONFIRMATION TEST

2019 Nissan Kicks

DYNAMIC RESEARCH, INC.

Final Report

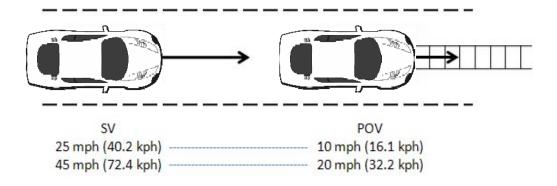
Figure 2. Depiction of Test 2

This test evaluates the ability of the CIB system to detect and respond to a slower-moving lead vehicle traveling at a constant speed in the immediate forward path of the SV, as depicted in Figure 2.

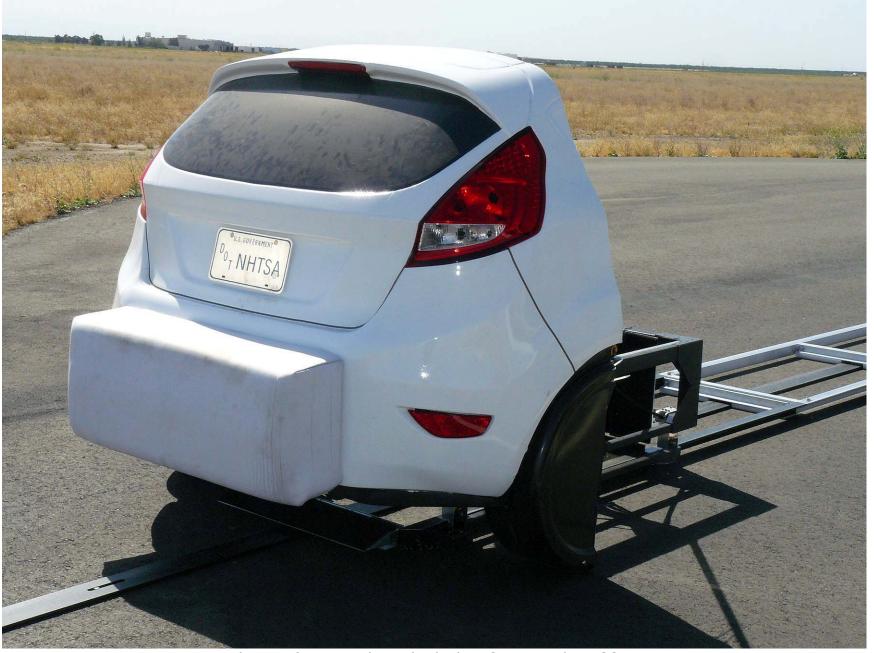
Figure A6. Rear View of Principal Other Vehicle (SSV)

CIB testing requires a POV that realistically represents typical vehicles, does not suffer damage or cause damage to a test vehicle in the event of collision, and can be accurately positioned and moved during the tests. The tests reported herein made use of the NHTSA developed Strikeable Surrogate Vehicle (SSV).

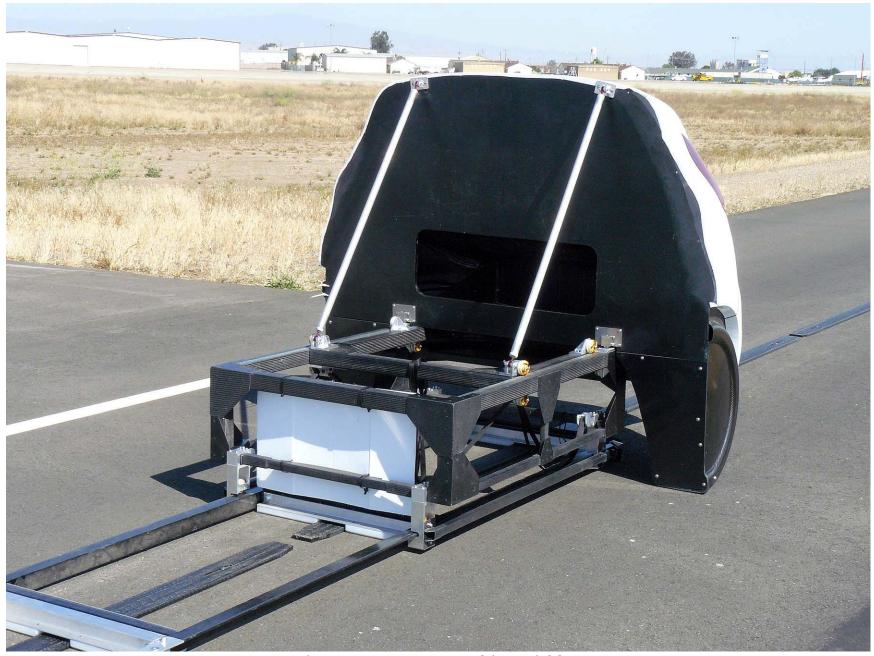
Figure A7. Load Frame/Slider of SSV

from the SV. The forward end of the rail has a cushioned stop to restrain forward motion of the shell/roller assembly. After impacting the SSV, the SV driver uses the steering wheel to maintain SV position in the center of the travel lane, thereby straddling the two-rail track. The SV driver must manually apply the SV brakes after impact. The SSV system is shown in Figures A6 through A8 and a detailed description can be found in the NHTSA report: NHTSA'S STRIKEABLE SURROGATE VEHICLE PRELIMINARY DESIGN + OVERVIEW, May 2013.

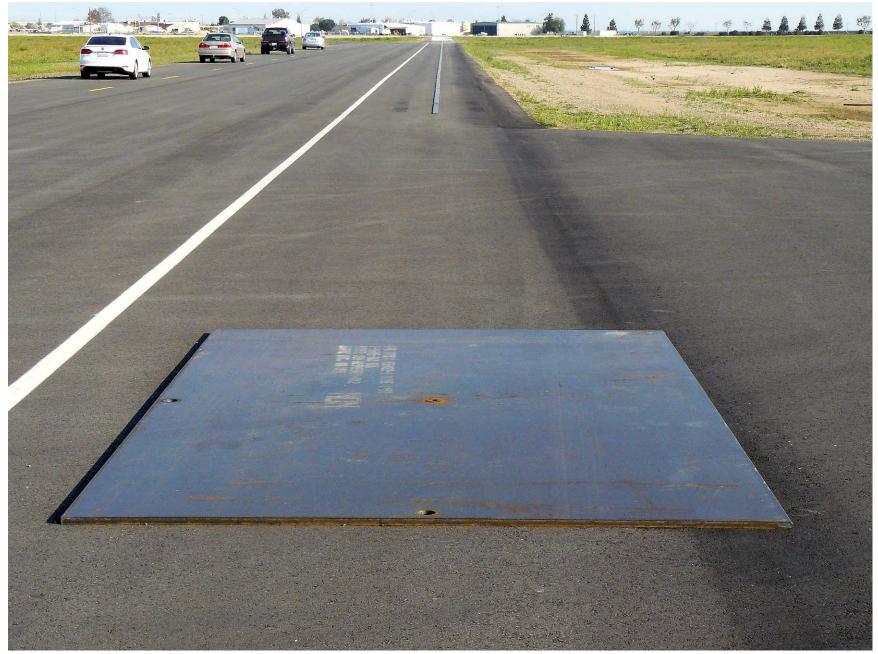
Figure A9. Steel Trench Plate

The false positive suppression test series evaluates the ability of a CIB system to differentiate a steel trench plate (STP) from an object presenting a genuine safety risk to the SV. Although the STP is large and metallic, it is designed to be driven over without risk of injury to the driver or damage to the SV. Therefore, in this scenario, the automatic braking available from CIB is not necessary and should be suppressed. The test condition is nearly equivalent to that previously defined for Test 1, the stopped POV condition, but with an STP in the SV forward path in lieu of a POV.

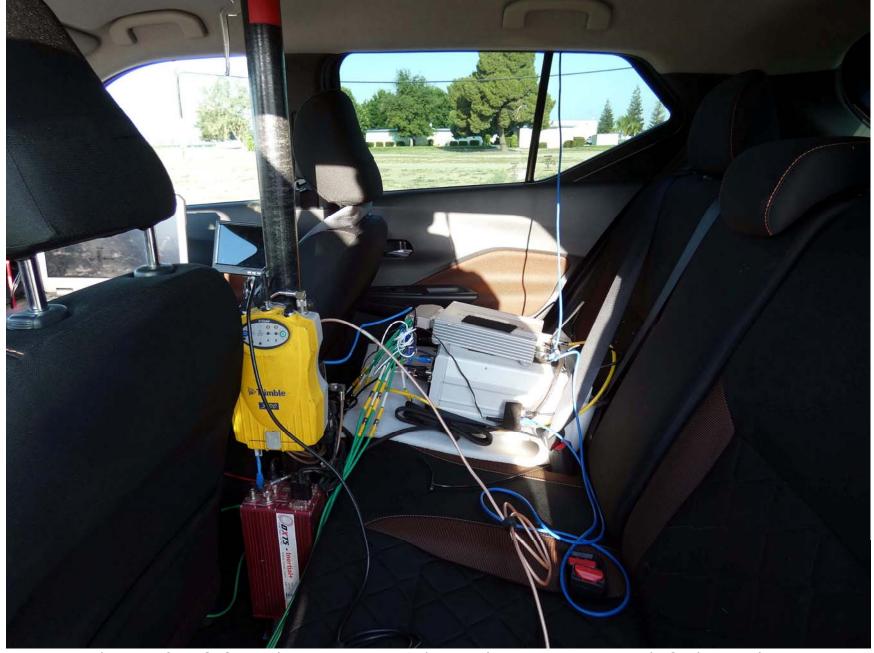
Figure A10. DGPS, Inertial Measurement Unit and MicroAutoBox Installed in Subject Vehicle

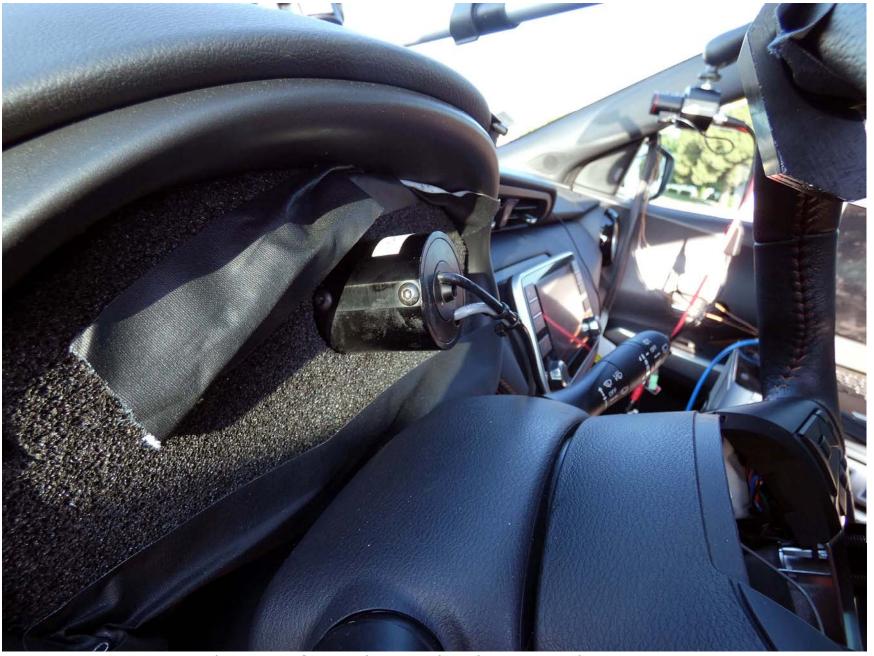
Figure A11. Sensors for Detecting Visual and Auditory Alerts

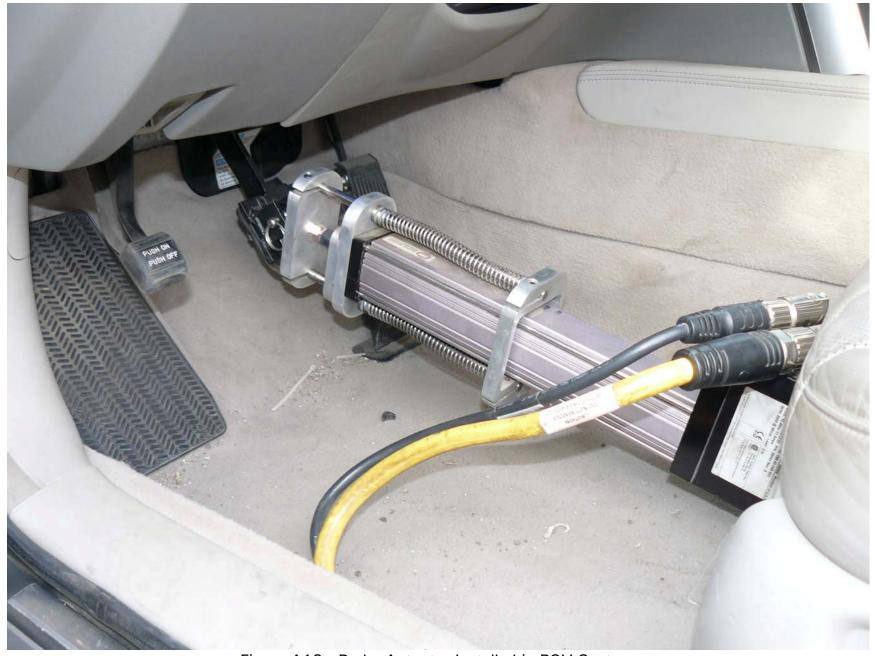
Figure A13. Brake Actuator Installed in POV System

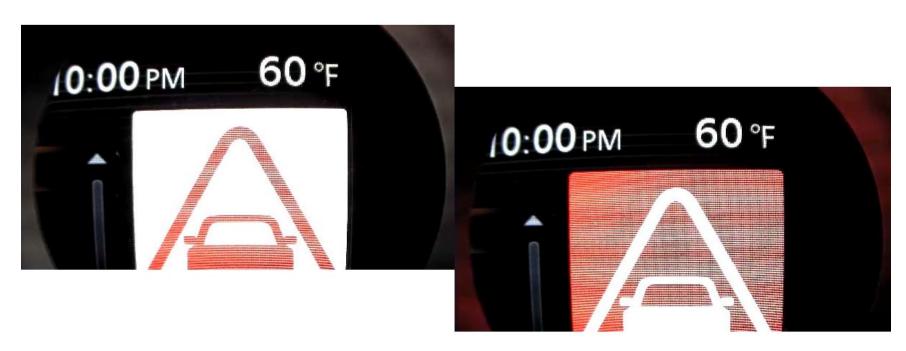
Figure A14. AEB Visual Alert

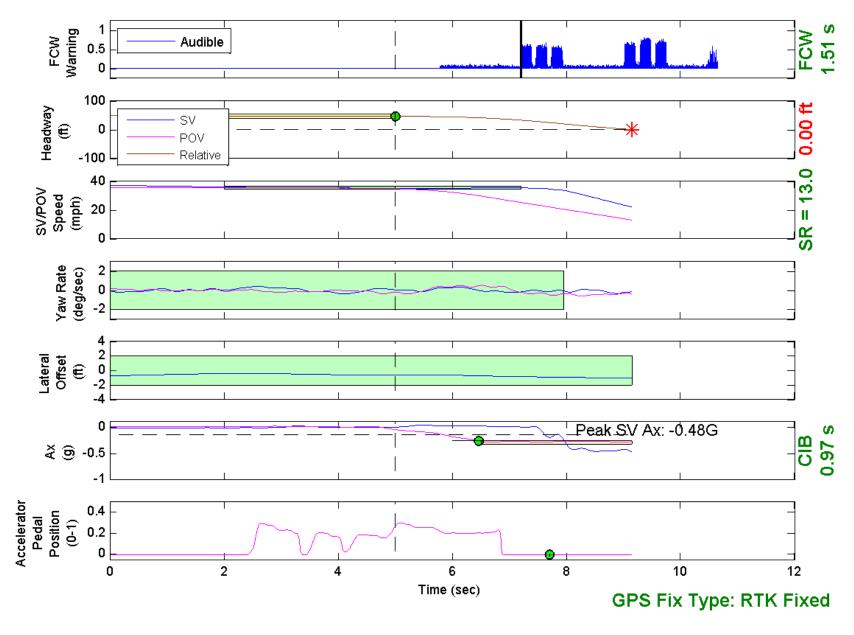
CIB Test: Braking POV 35 mph

Figure D4. Example Time History for Braking POV 35, Passing

Examples of time history plots for each test type (including passing, failing and invalid runs) are shown in Figure 1 through Figure 9. Figures 1 through 6 show passing runs for each of the 6 test types. Figures 7 and 8 show examples of invalid runs. Figure 9 shows an example of a valid test that failed the CIB requirements.
