REPORT NUMBER: NCAP-KAR-18-009

**NEW CAR ASSESSMENT PROGRAM (NCAP)
FRONTAL BARRIER IMPACT TEST**

**DAIMLER AG STUTT GART
2018 MERCEDES-BENZ GLC300 4MATIC 5-DOOR MPV**

FINAL REPORT

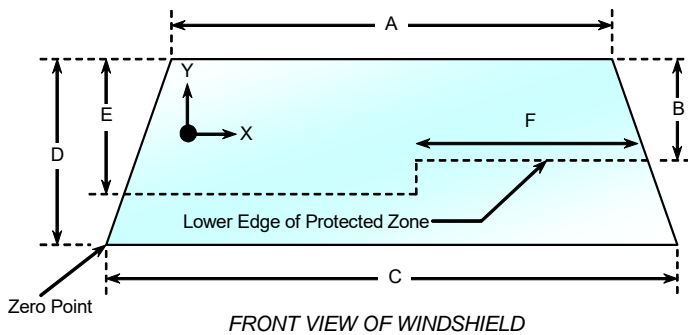
WINDSHIELD PERIPHERY MEASUREMENTS

Measurement	Pre-Test (mm)	Post-Test (mm)	% Retention
Left Side	2065	2065	100.0%
Right Side	2065	2065	100.0%
Total	4130	4130	100.0%

Item	Units	Value
A	mm	1150
B	mm	325
C	mm	1400
D	mm	790
E	mm	446
F	mm	512

There was 100% windshield retention and no intrusion into the protected zone of the windshield during the event.

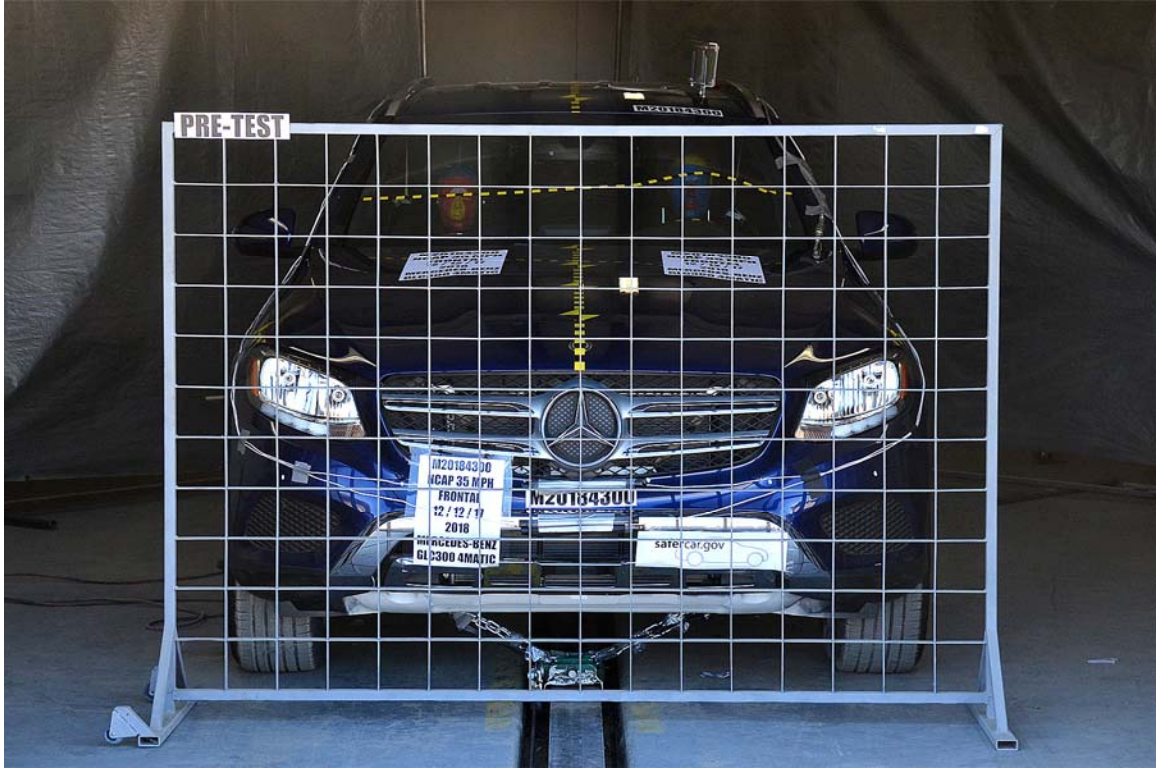
FIGURE 1. Load Cell Location

A load cell barrier consisting of 176 load cells was impacted by a 2018 Mercedes-Benz GLC300 4MATIC 5-door MPV at a velocity of 55.78 km/h. The test was performed at KARCO Engineering, LLC. on December 12, 2017. Pre- and post-test photographs of the vehicle and dummies can be found in Appendix A of this report.

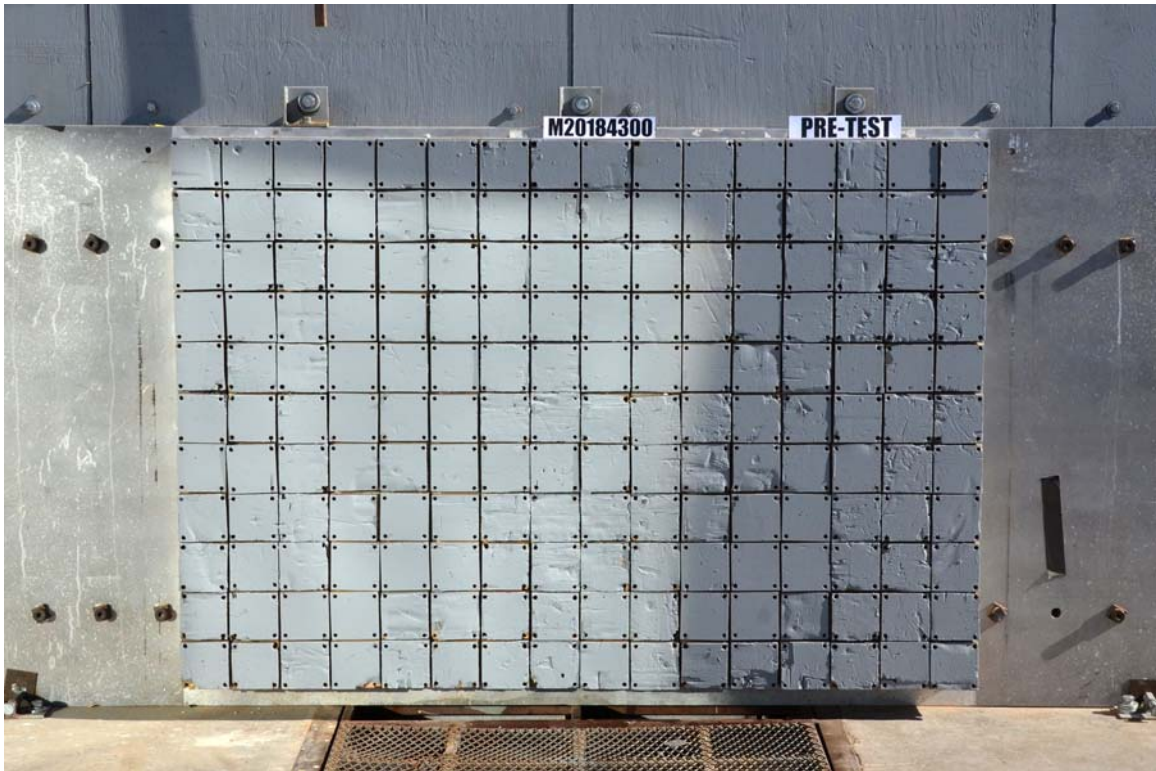
FIGURE 2. Pre-Test Load Cell Wall

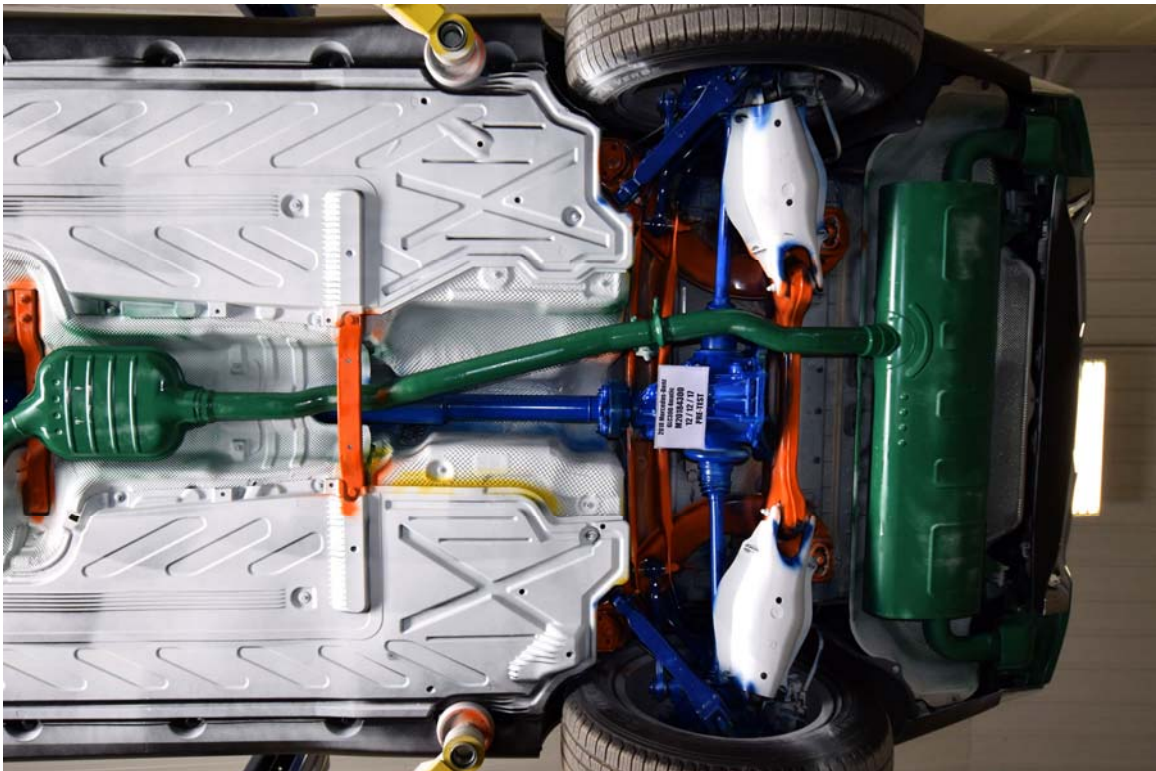
FIGURE 26. Pre-Test Rear Underbody View

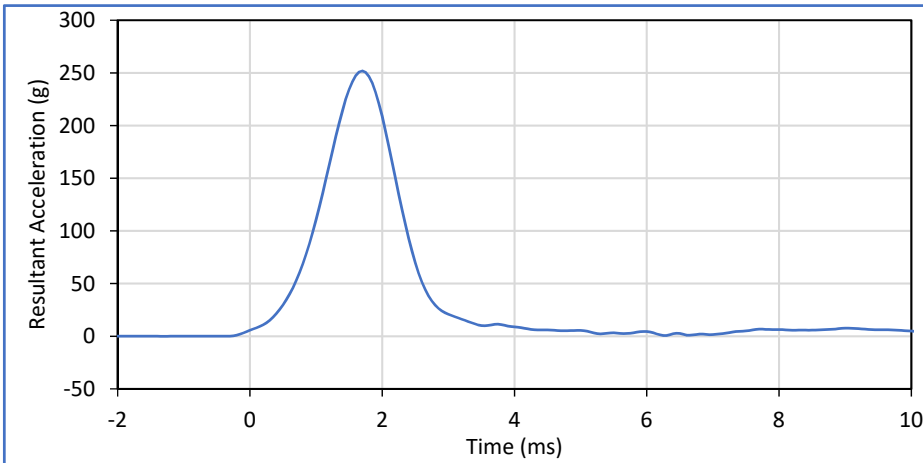
Head Acceleration Resultant
 Max:251.9@1.7 / Min:0.7@6.3
 SAE Class 1000

Tested Parameter	Units	Spec. Low	Spec. High	Result	Pass/Fail
Laboratory Temperature	°C	18.9	25.6	20.7	Pass
Laboratory Humidity	%	10	70	26	Pass
Peak Resultant Acceleration	g	225.0	275.0	251.9	Pass
Peak Lateral Acceleration	g	-15.0	15.0	10.3	Pass
Oscillations After Main Pulse	%	0.0	10.0	3.0	Pass
Is Acceleration Unimodal?	Yes/No	Yes		Yes	Pass
Overall Test Results					Pass

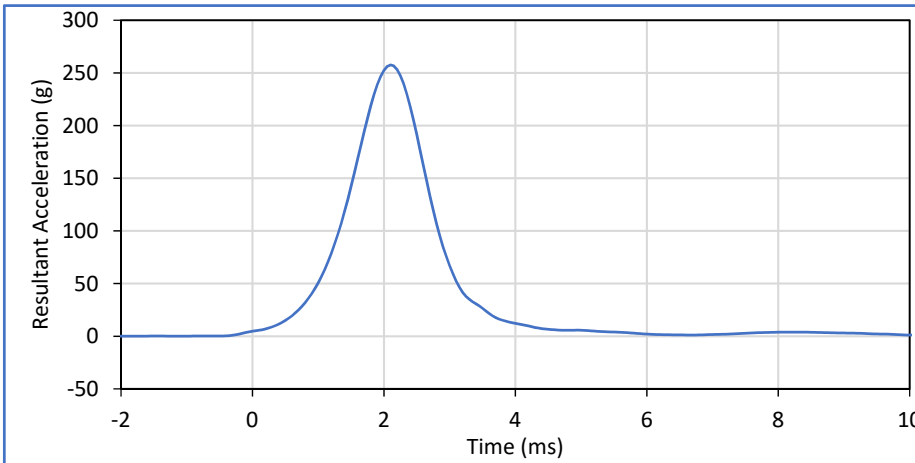
Head Acceleration Resultant
 Max:257.6@2.1 / Min:1.2@10.0
 SAE Class 1000

Tested Parameter	Units	Spec. Low	Spec. High	Result	Pass/Fail
Laboratory Temperature	°C	18.9	25.6	20.6	Pass
Laboratory Humidity	%	10	70	17	Pass
Peak Resultant Acceleration	g	250.0	300.0	257.6	Pass
Peak Lateral Acceleration	g	-15.0	15.0	8.7	Pass
Oscillations After Main Pulse	%	0.0	10.0	1.5	Pass
Is Acceleration Unimodal?	Yes/No	Yes		Yes	Pass
Overall Test Results					Pass

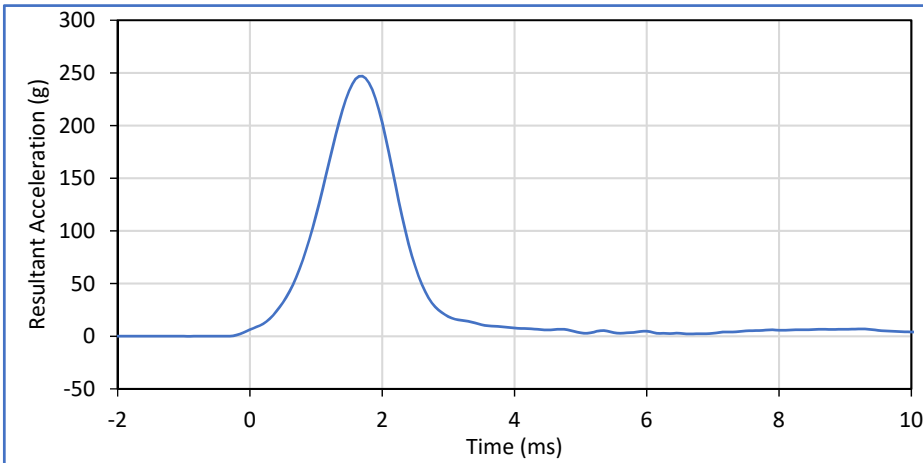
Head Acceleration Resultant
 Max:247.0@1.7 / Min:2.2@6.7
 SAE Class 1000

Tested Parameter	Units	Spec. Low	Spec. High	Result	Pass/Fail
Laboratory Temperature	°C	18.9	25.6	20.7	Pass
Laboratory Humidity	%	10	70	26	Pass
Peak Resultant Acceleration	g	225.0	275.0	247.0	Pass
Peak Lateral Acceleration	g	-15.0	15.0	-7.2	Pass
Oscillations After Main Pulse	%	0.0	10.0	2.8	Pass
Is Acceleration Unimodal?	Yes/No	Yes		Yes	Pass
Overall Test Results					Pass

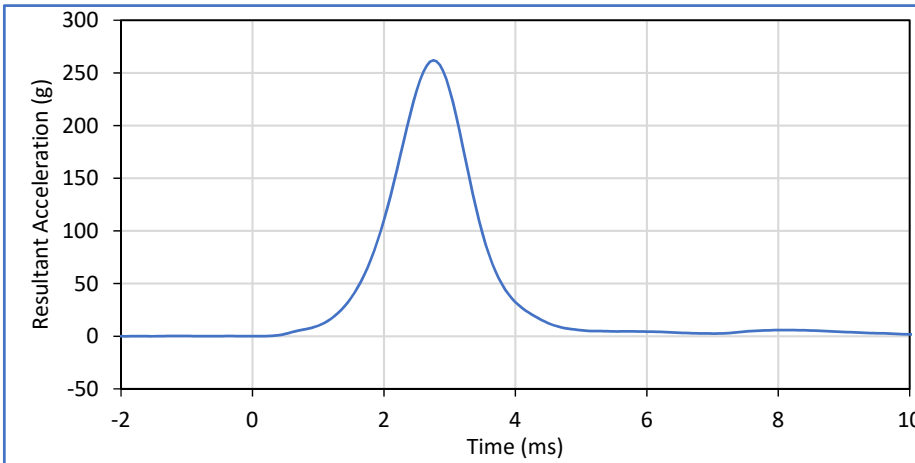
Head Acceleration Resultant
 Max:262.0@2.8 / Min:0.1@0.1
 SAE Class 1000

Tested Parameter	Units	Spec. Low	Spec. High	Result	Pass/Fail
Laboratory Temperature	°C	18.9	25.6	21.1	Pass
Laboratory Humidity	%	10	70	23	Pass
Peak Resultant Acceleration	g	250.0	300.0	262.0	Pass
Peak Lateral Acceleration	g	-15.0	15.0	10.1	Pass
Oscillations After Main Pulse	%	0.0	10.0	2.3	Pass
Is Acceleration Unimodal?	Yes/No	Yes		Yes	Pass
Overall Test Results					Pass
