REPORT NUMBER: SINCAP-KAR-18-010

**NEW CAR ASSESSMENT PROGRAM (NCAP)
MOVING DEFORMABLE BARRIER SIDE IMPACT TEST**

**DAIMLER AG STUTTGART
2018 MERCEDES-BENZ GLC300 5-DOOR MPV**

NHTSA No: M20184302

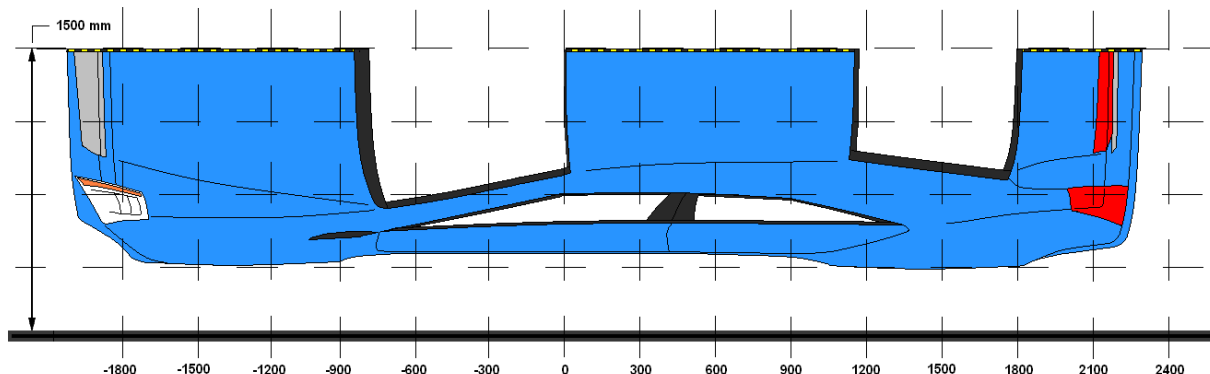
VEHICLE AND MDB DAMAGE PROFILE DISTANCES

DPD	Distance From Impact Point (mm)	Level	Pre-Test (mm)	Post-Test (mm)	Crush (mm)
1	2850	4	670	678	8
2	2250	5	916	936	20
3	1650	3	581	710	129
4	1050	3	577	700	123
5	450	3	577	684	107
6	-150	2	557	571	14
