REPORT NUMBER: SPNCAP-MGA-2018-025

**NEW CAR ASSESSMENT PROGRAM (NCAP)
Side Impact Pole Test**

**HONDA OF AMERICA MFG., INC.
2018 Honda Accord 1.5T LX 4-Door SUV
NHTSA No.: M20185301**

**MGA RESEARCH CORPORATION
5000 Warren Road
Burlington, WI 53105**

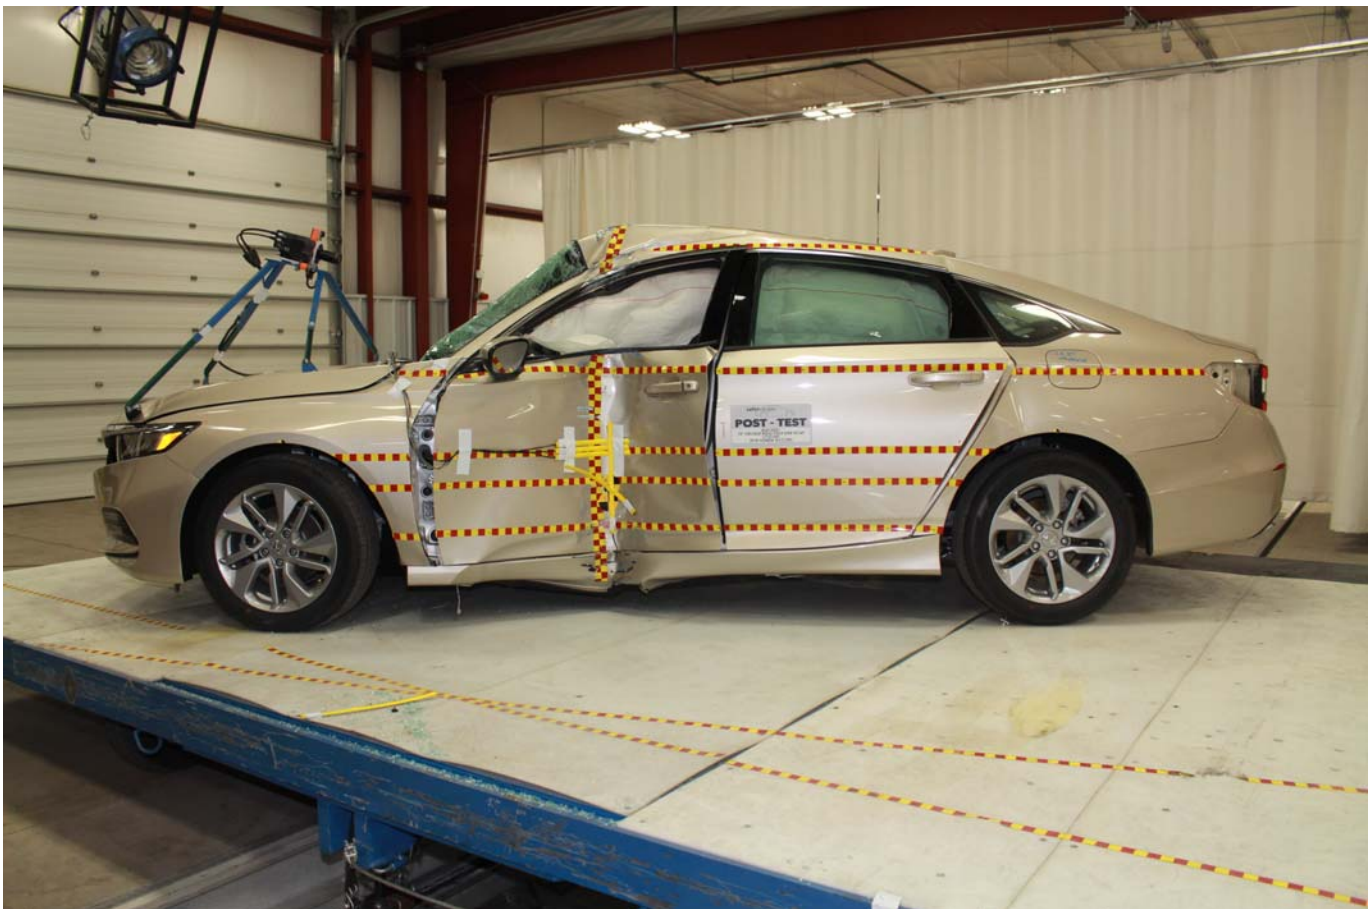
Photo No. 008 - Post-Test Left Side View of Test Vehicle

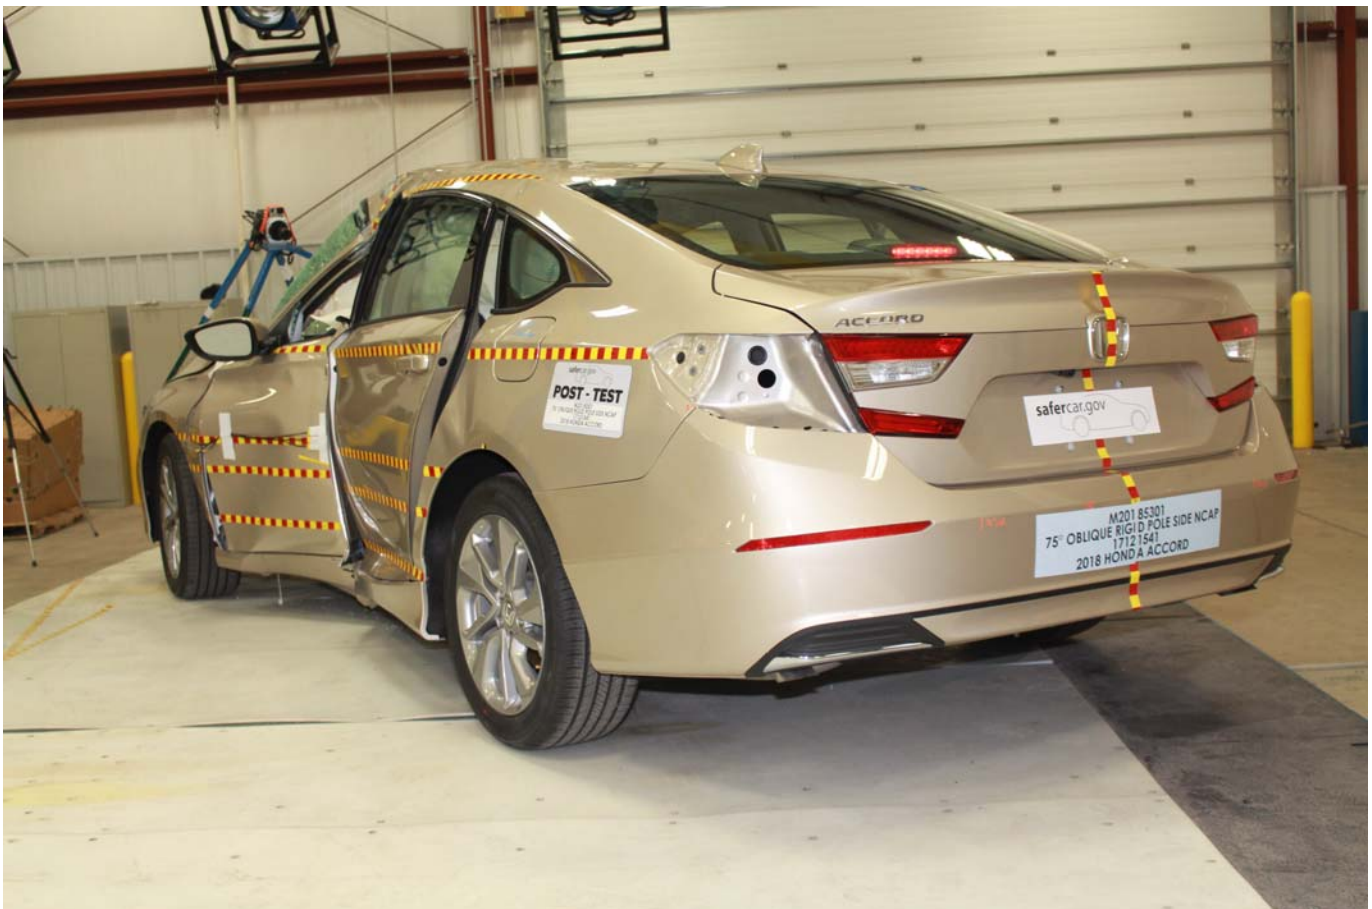
Photo No. 010 - Post-Test Left Rear Three-Quarter View of Test Vehicle

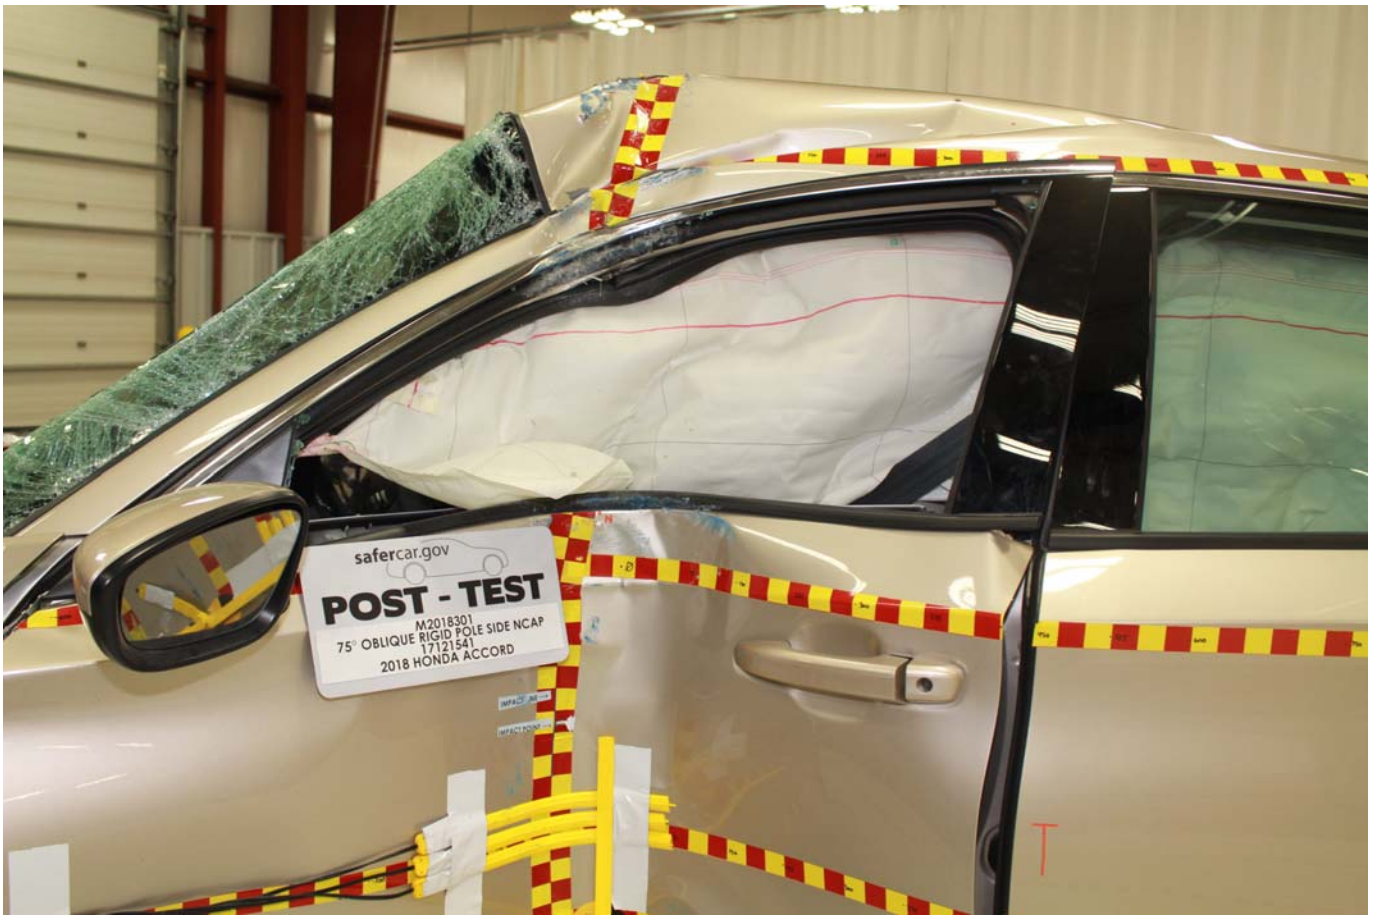
Photo No. 025 - Post-Test Left Side View of Dummy Shoulder and Door Top View

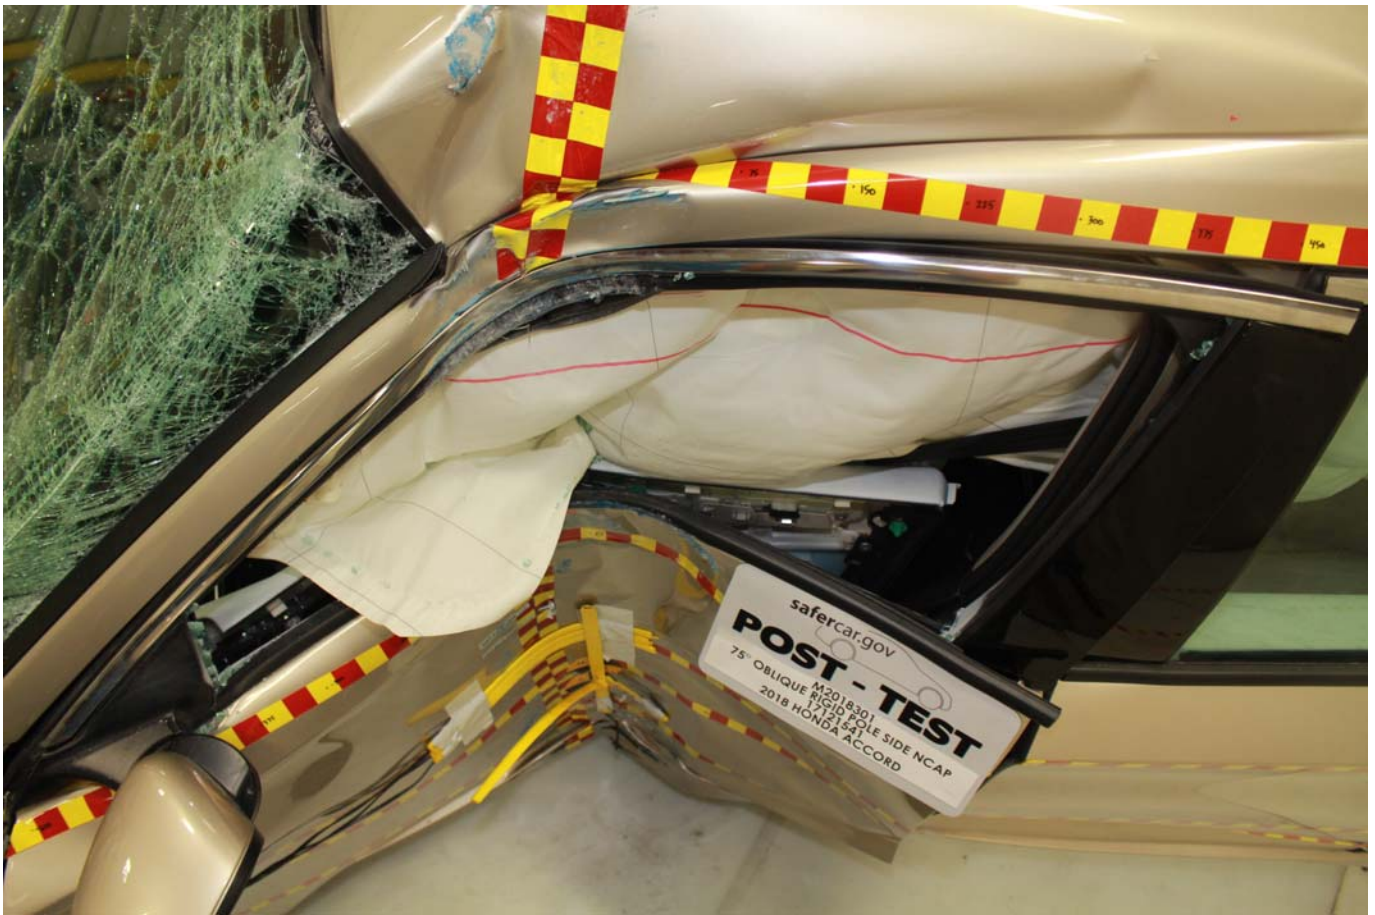
Photo No. 041 - Post-Test Dummy and Door Clearance View

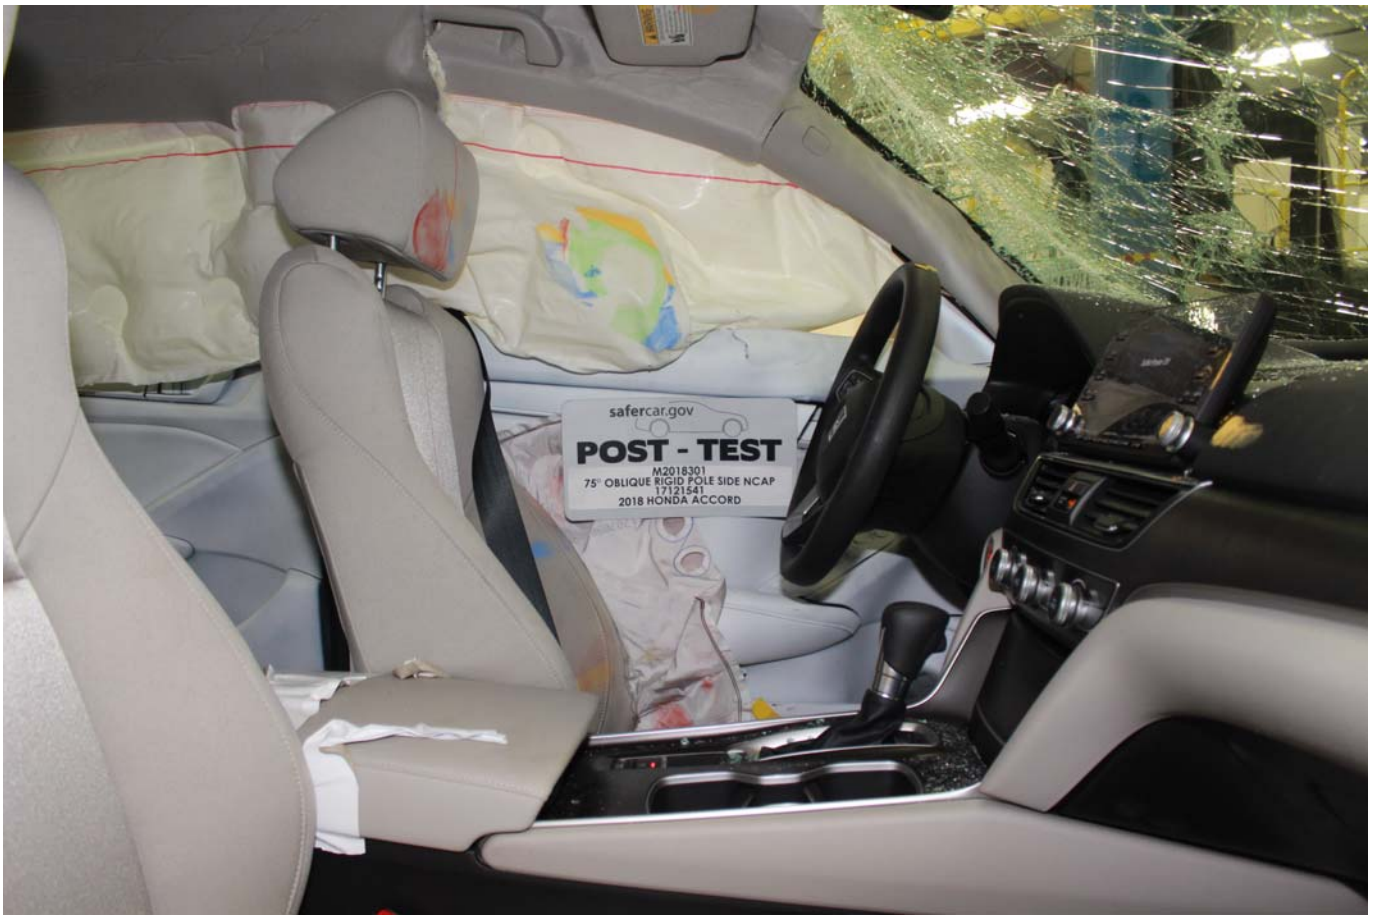
Photo No. 045 - Post-Test Inner Door Panel View Showing Dummy Contact Location

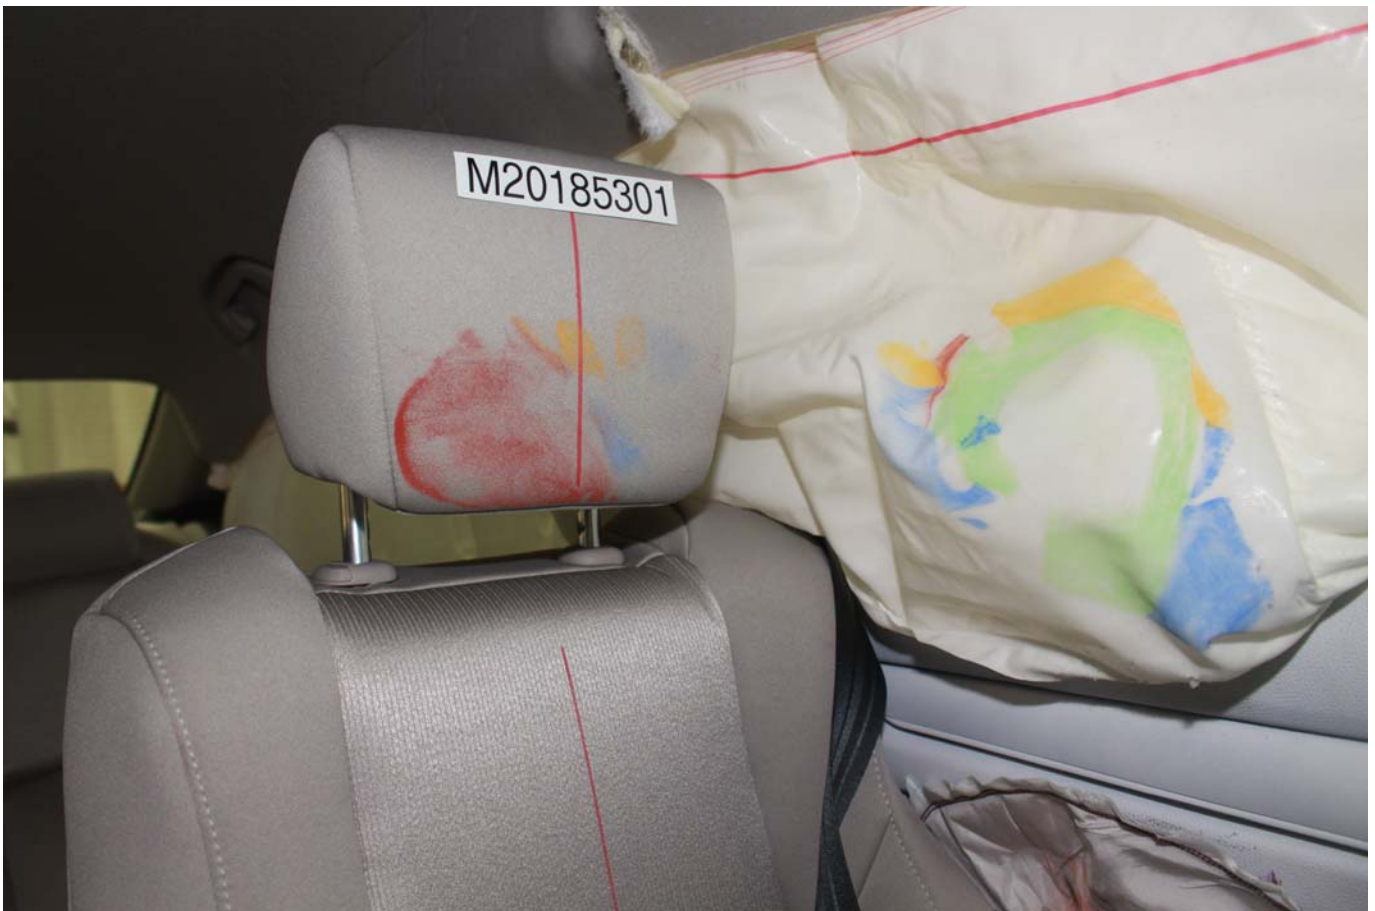
Photo No. 046 - Post-Test Dummy Close-Up Head Contact with Vehicle Interior View

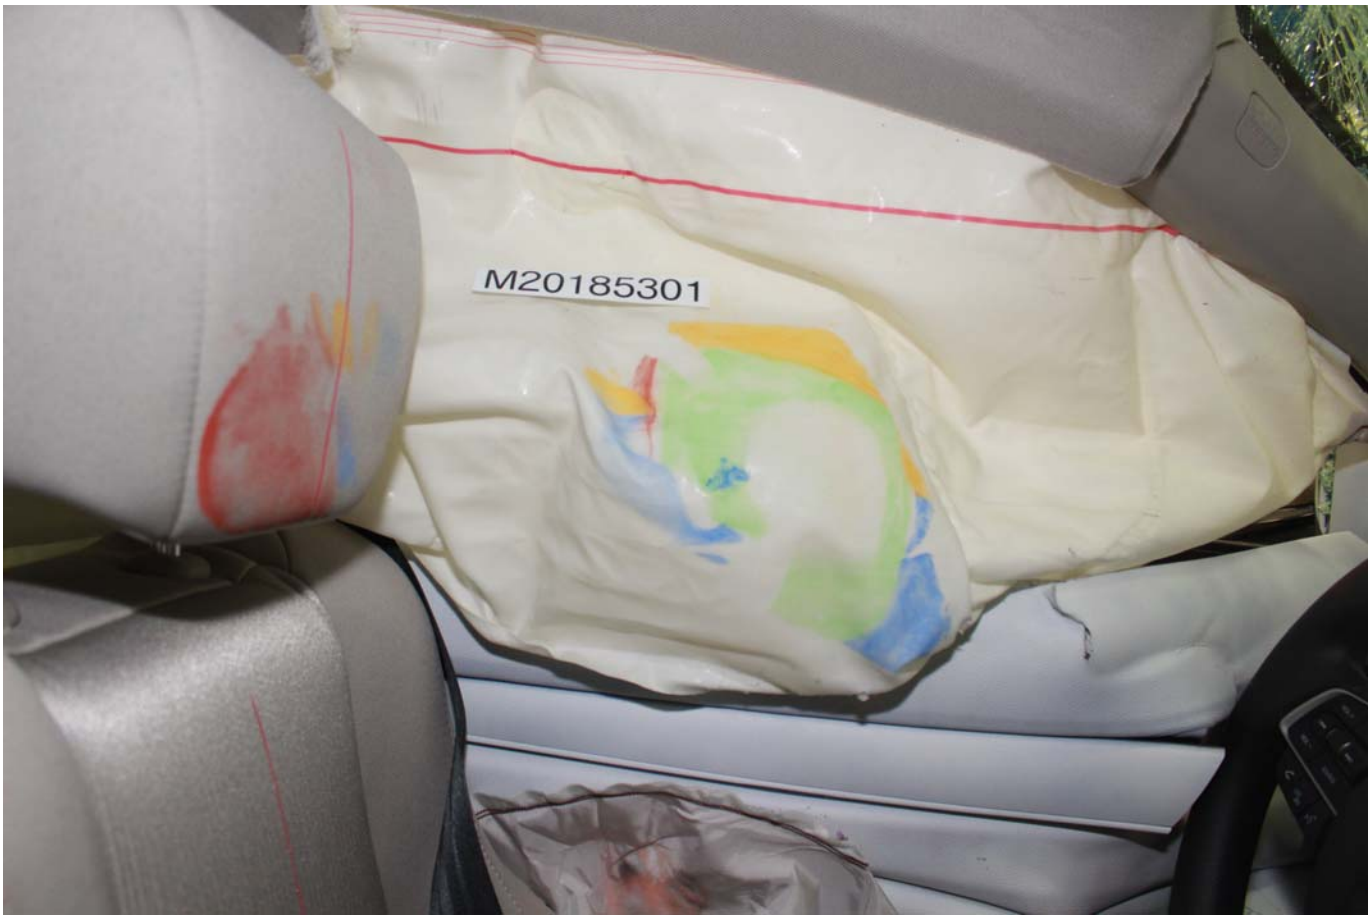
Photo No. 047 - Post-Test Dummy Close-Up Head Contact with Side Air Bag View

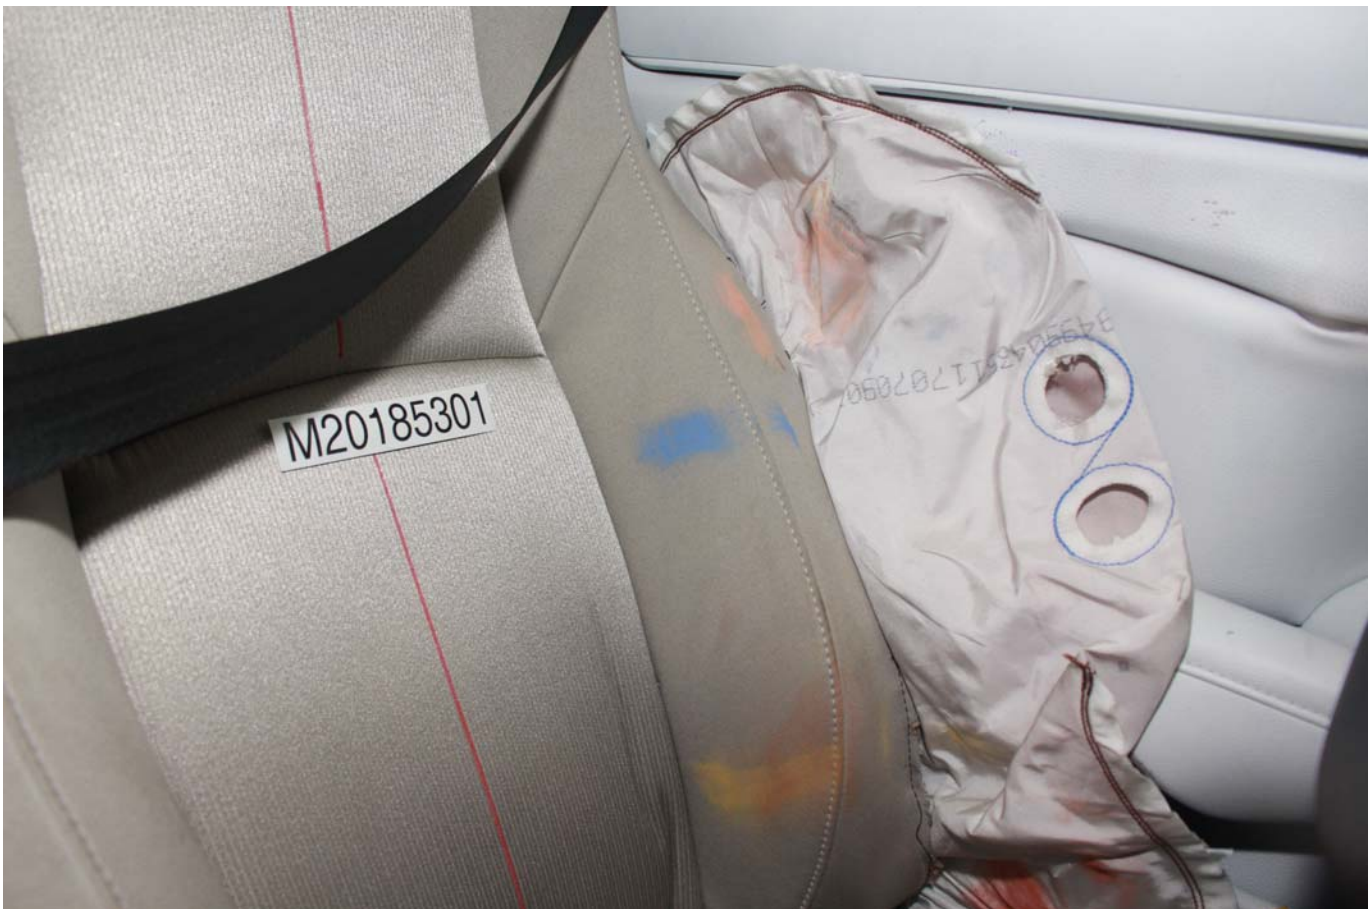
Photo No. 048 - Post-Test Dummy Close-Up Torso Contact with Vehicle Interior View

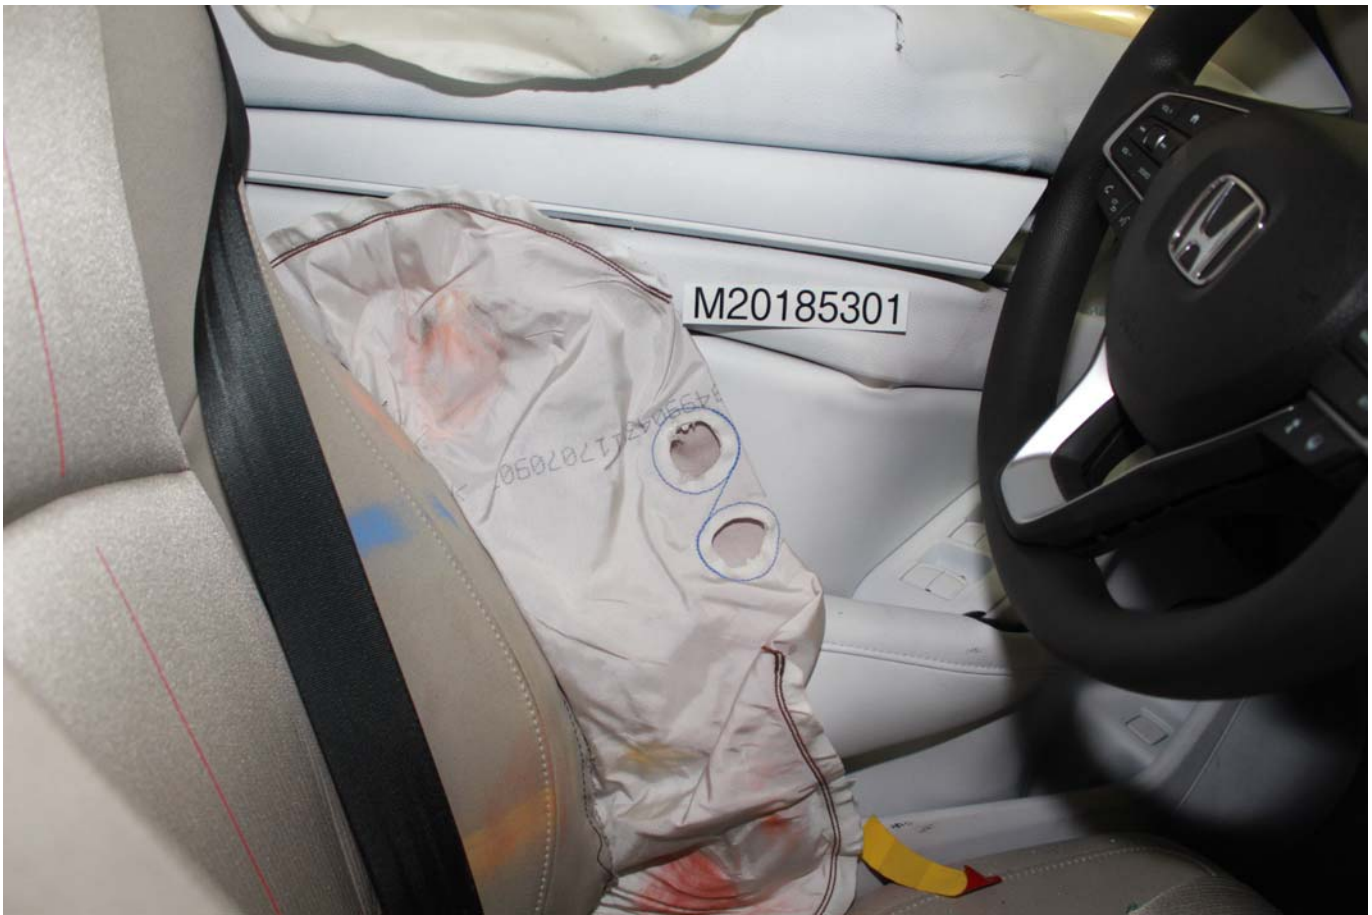
Photo No. 049 - Post-Test Dummy Close-Up Torso Contact with Side Air Bag View

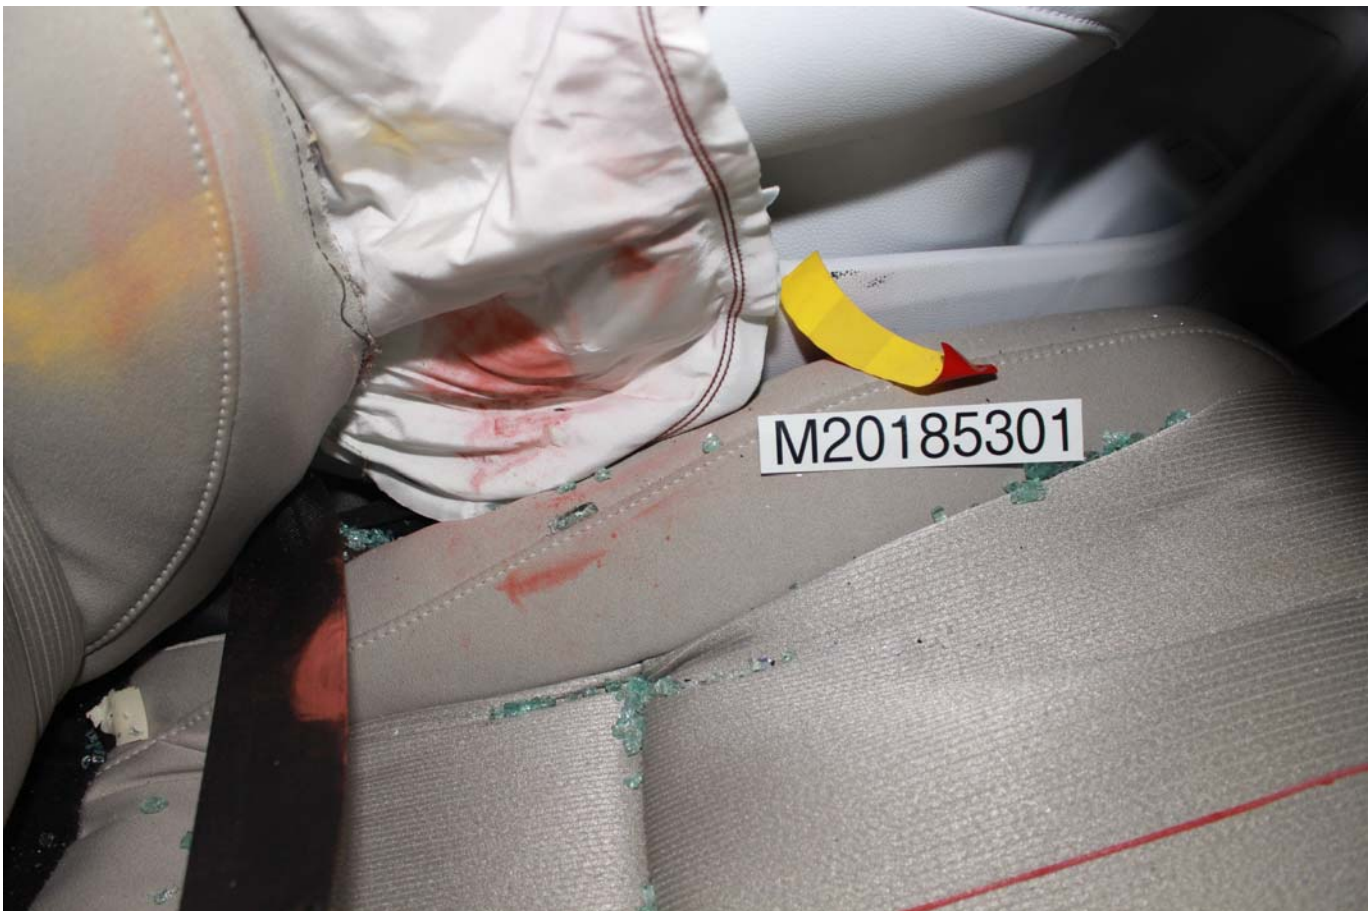
Photo No. 050 - Post-Test Dummy Close-Up Pelvis Contact with Vehicle Interior View

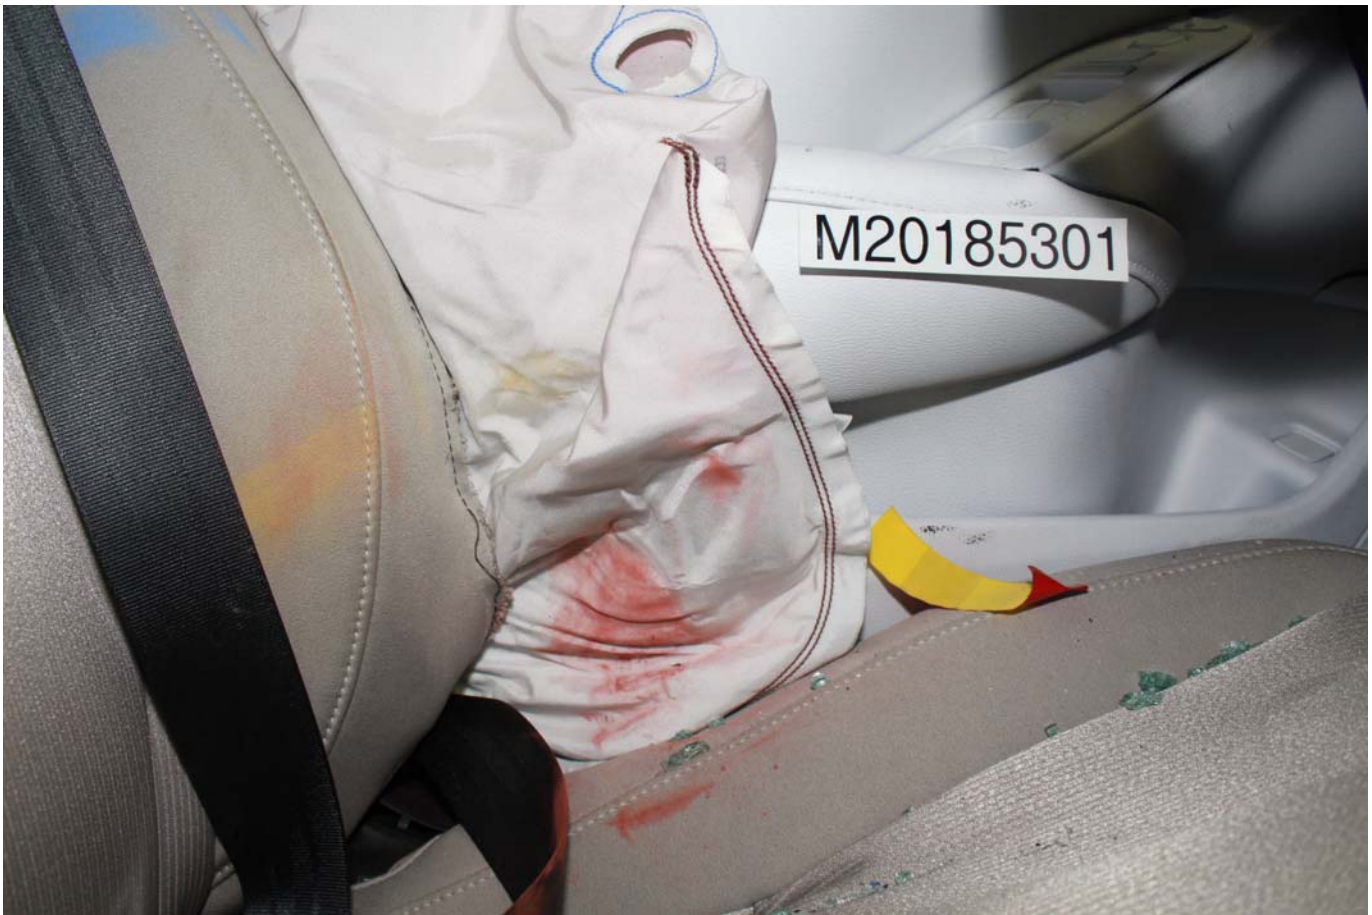
Photo No. 051 - Post-Test Dummy Close-Up Pelvis Contact with Side Air Bag View

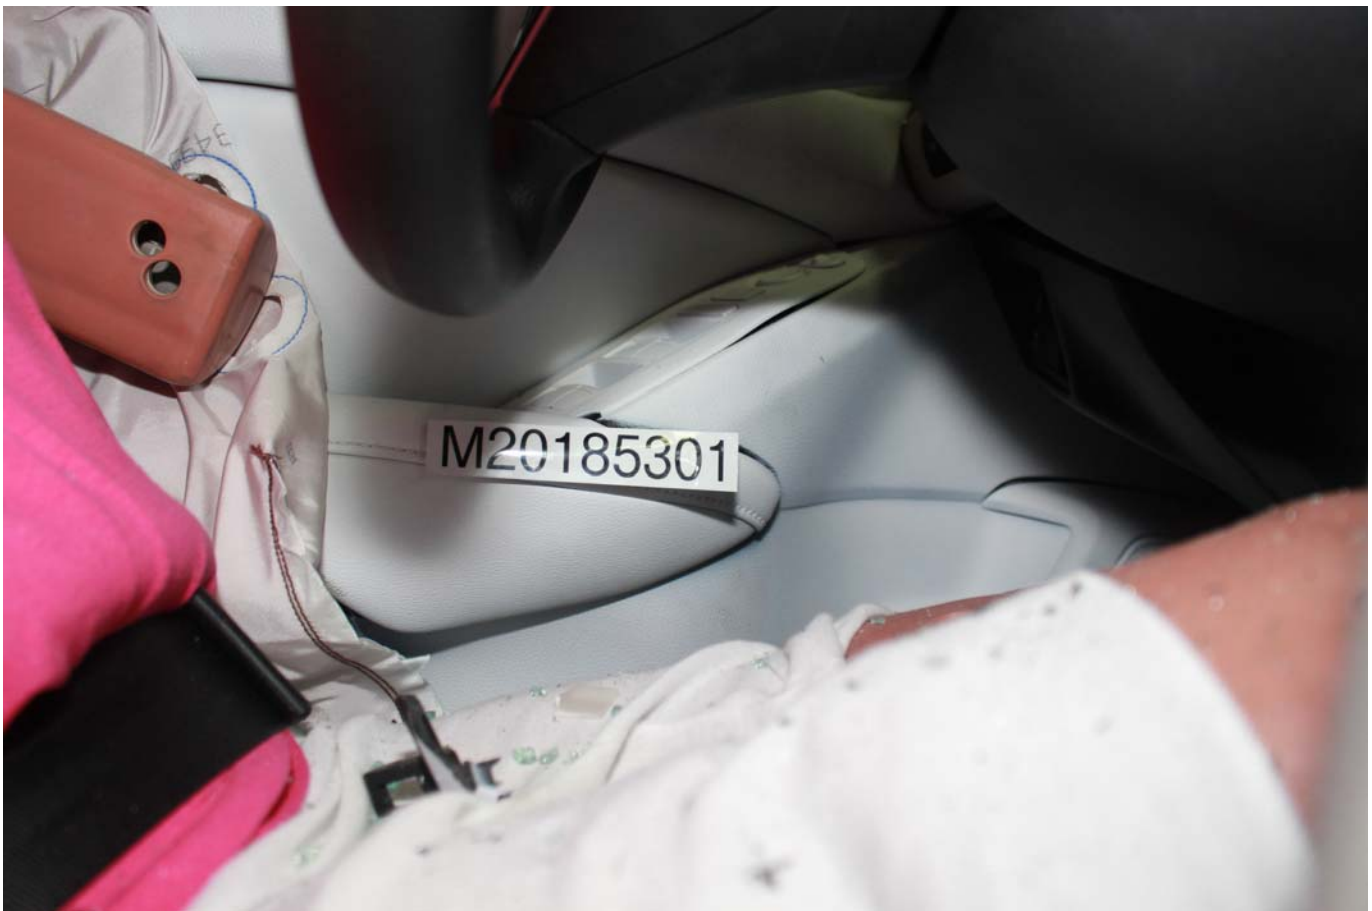
Photo No. 052 - Post-Test Dummy Close-Up Knee Contact with Vehicle Interior View

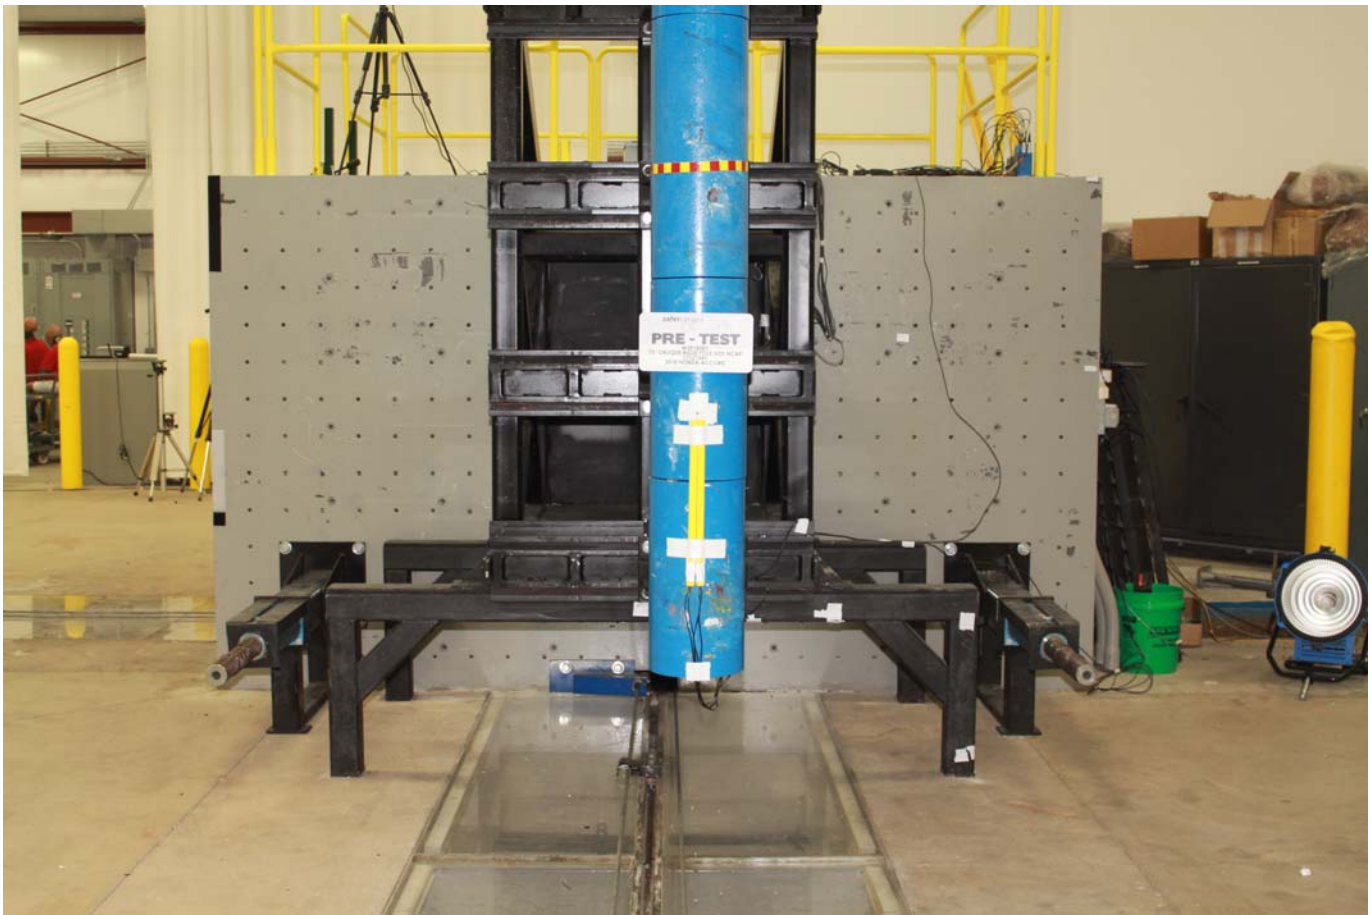
Photo No. 058 - Post-Test Pole Barrier Front View

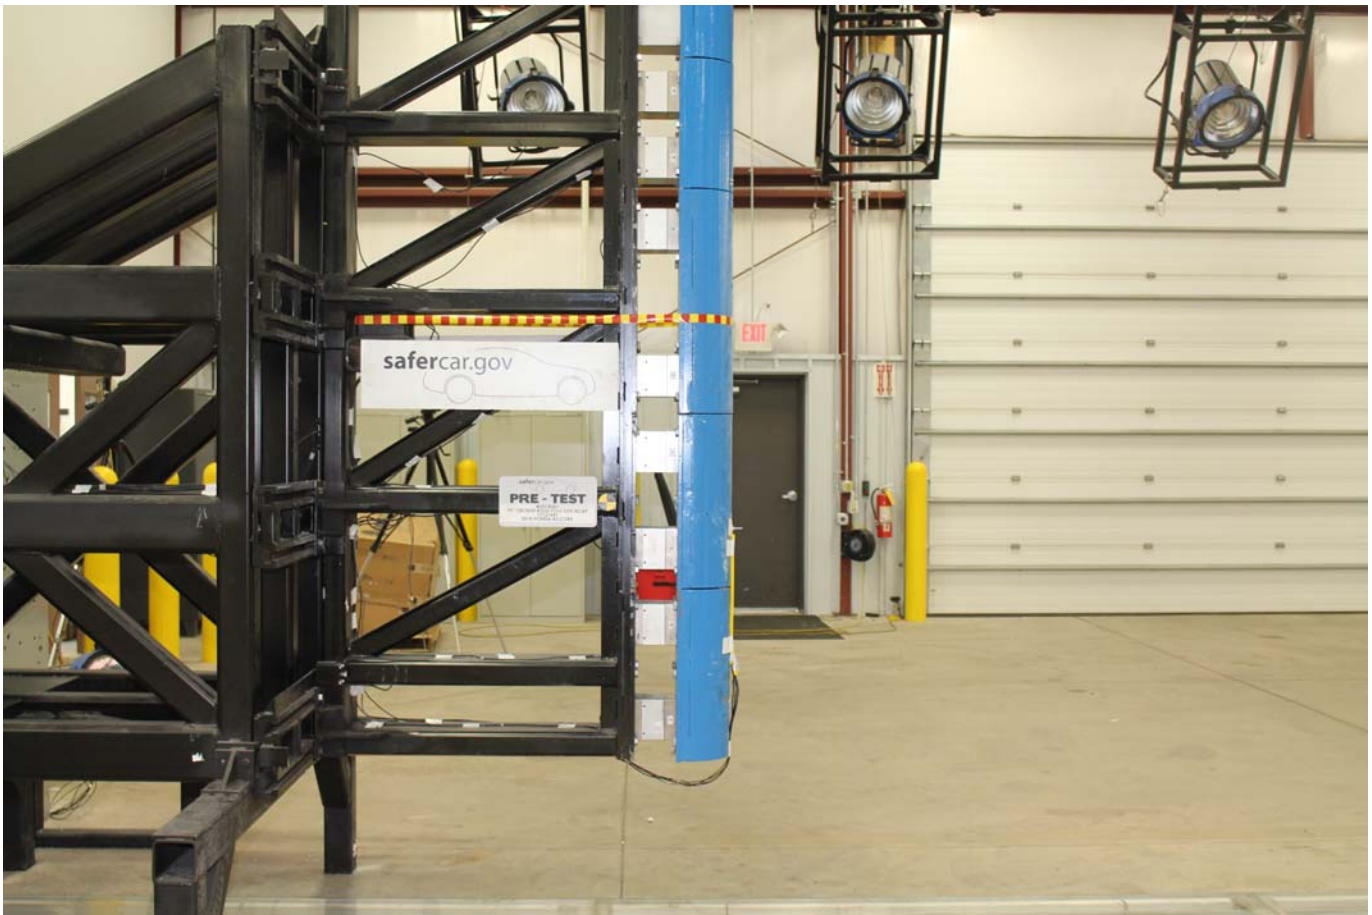
Photo No. 060 - Post-Test Pole Barrier Side View
