**REPORT NUMBER: NCAP-MGA-2018-022**

**NEW CAR ASSESSMENT PROGRAM (NCAP)  
Frontal Barrier Impact Test**

**AUDI AG  
2018 Audi Q5 2.0T AWD 5-Door SUV  
NHTSA No.: O20185806**

**MGA RESEARCH CORPORATION  
5000 Warren Road  
Burlington, WI 53105**

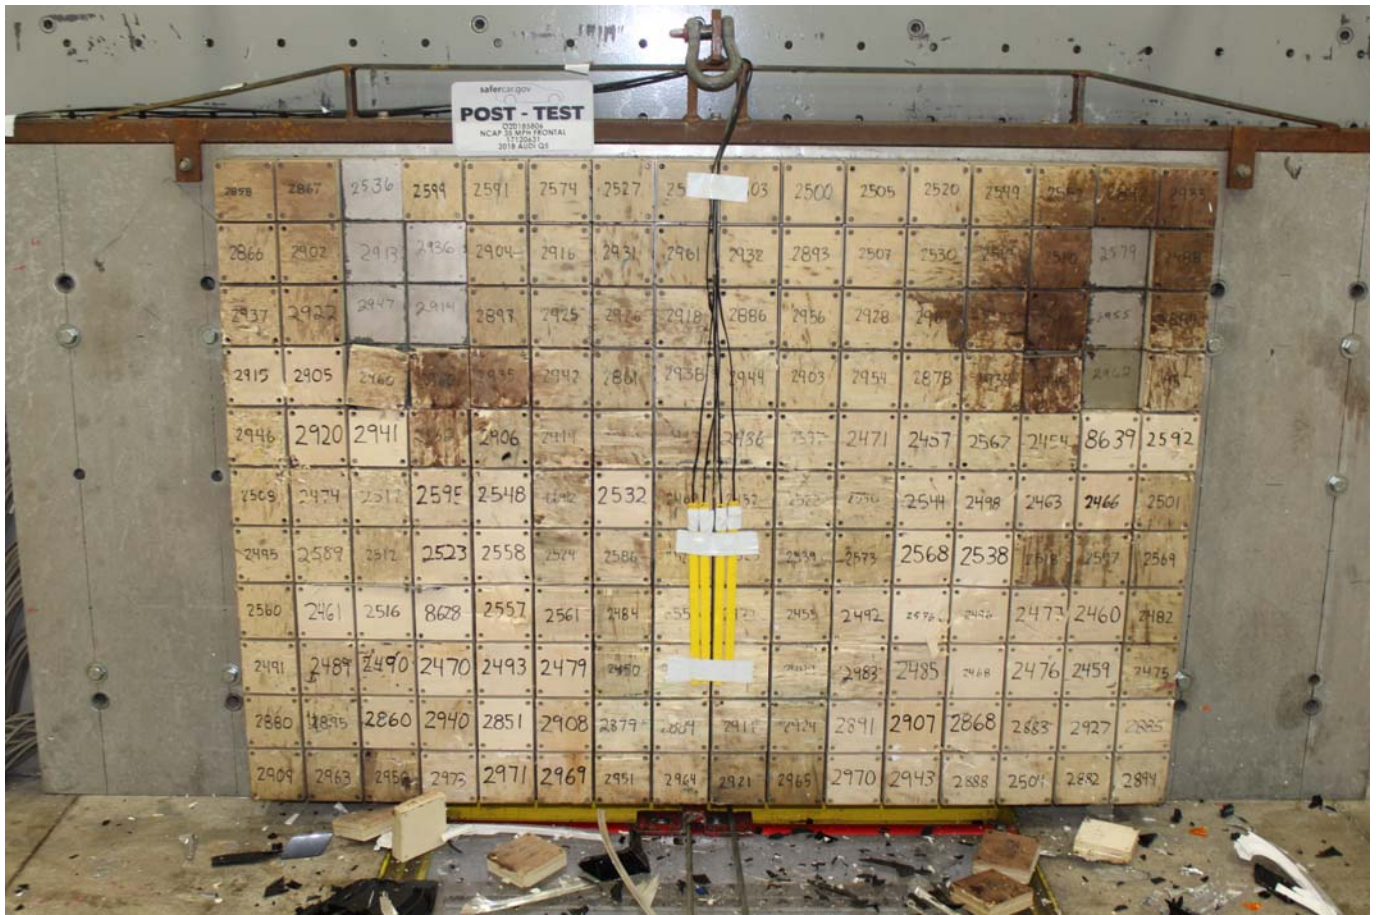
Photo No. 003 - Post-Test Load Cell Wall

A load cell barrier consisting of 176 load cells was impacted by a 2018 Audi Q5 2.0T AWD 5-Door SUV at a velocity of 56.14 km/h. The test was performed at MGA Research Corporation on December 6, 2017. Pre-test and post-test photographs of the vehicle and dummies can be found in Appendix A.

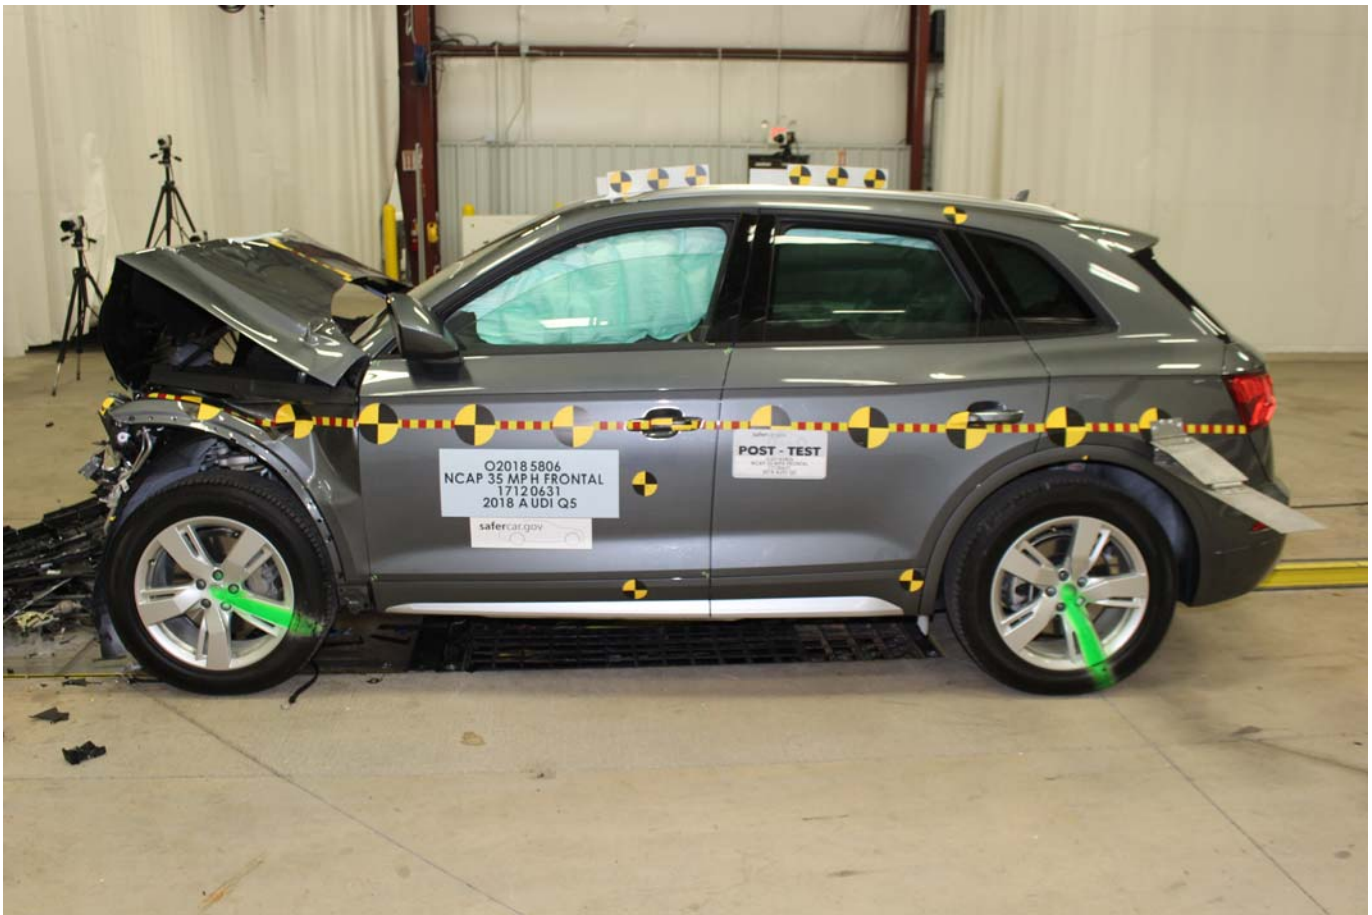
Photo No. 011 - Post-Test Left View of Test Vehicle

The maximum static crush of the vehicle was 545mm to the left of the vehicle centerline and both the driver and passenger side doors remained closed during the impact event and were operable after the impact.

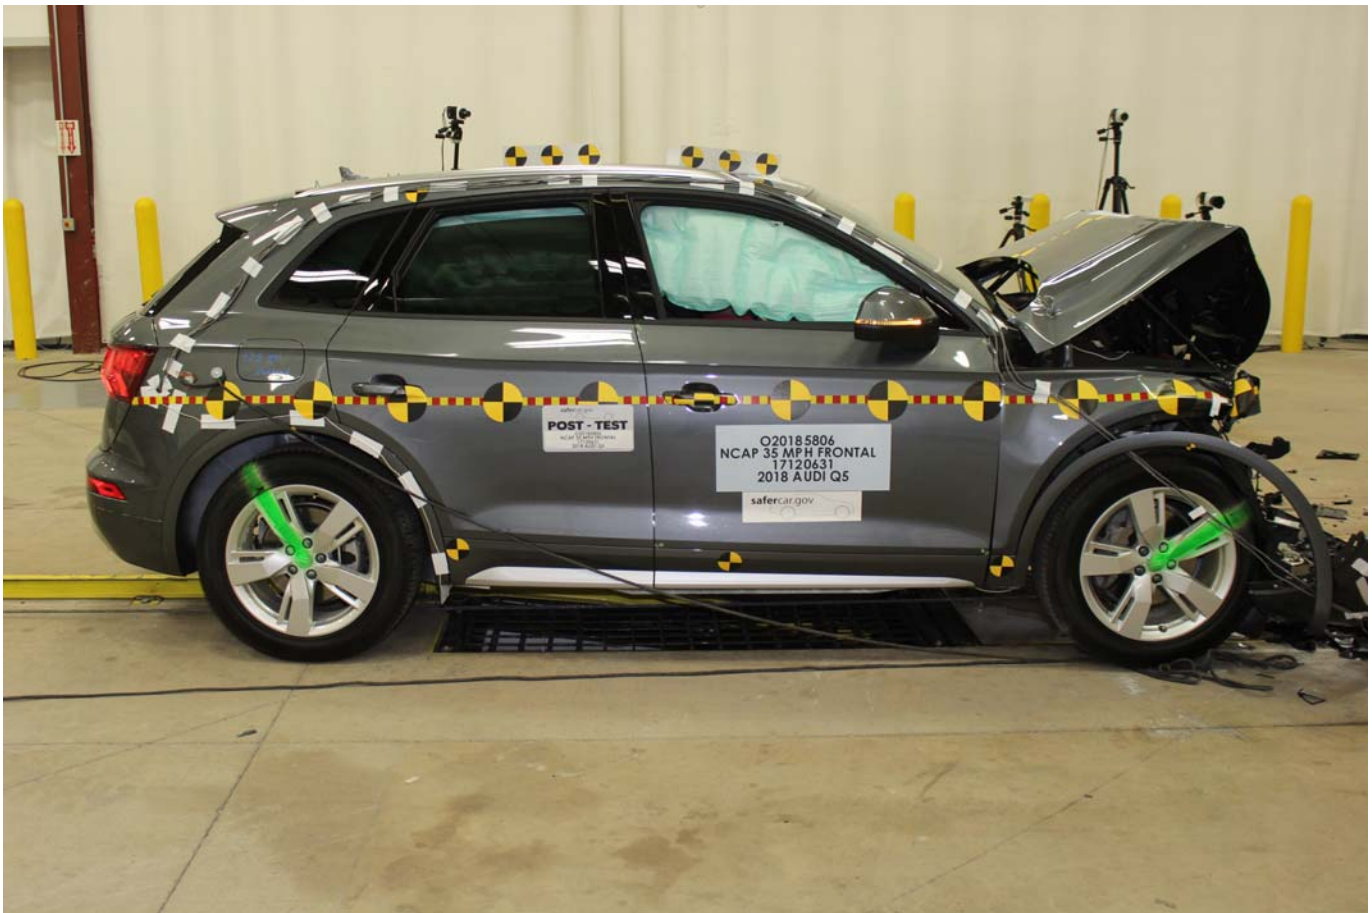
Photo No. 013 - Post-Test Right View of Test Vehicle

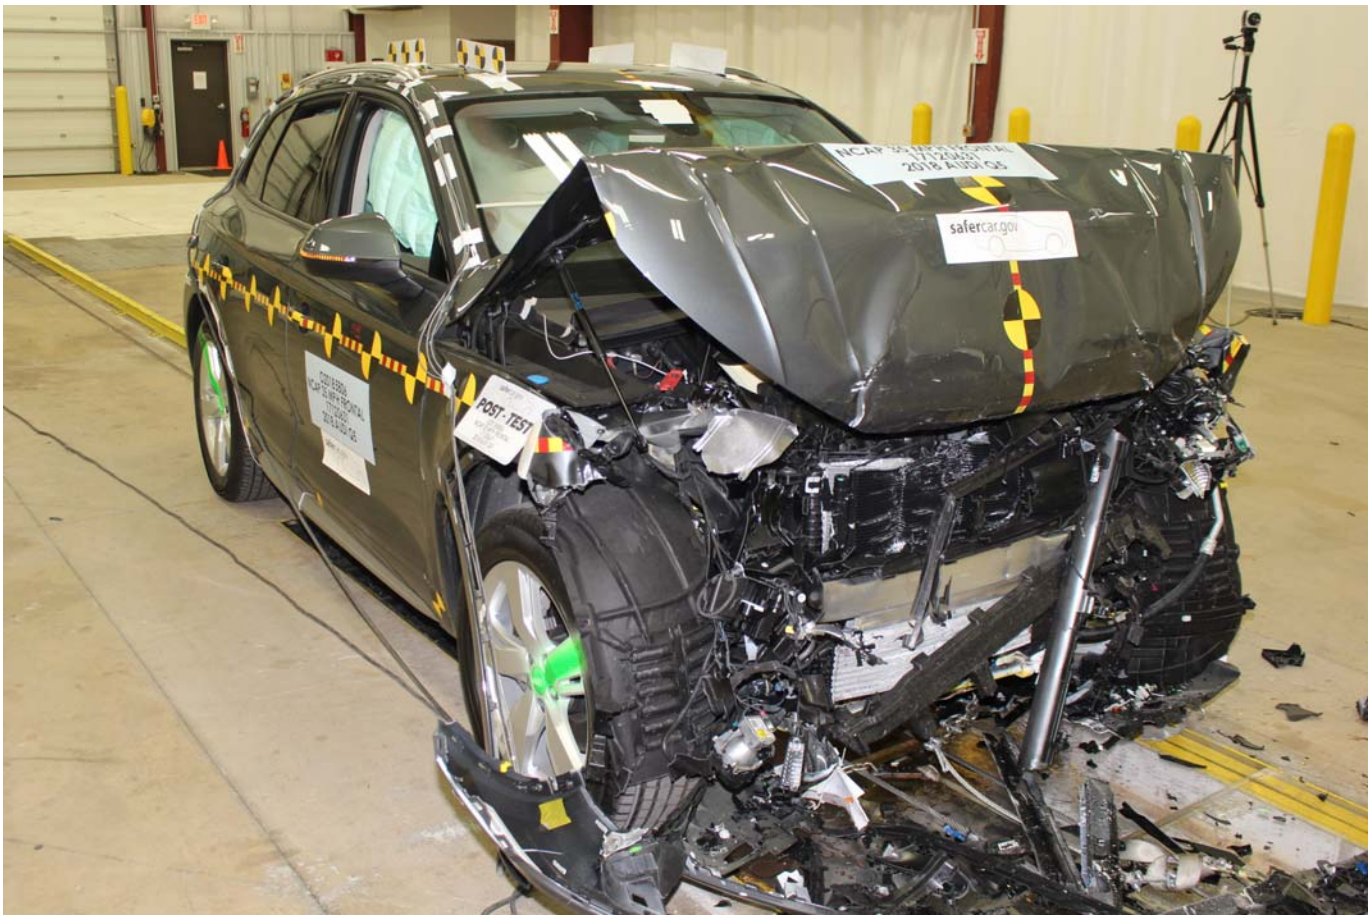
Photo No. 015 - Post-Test Right Front 3-4 View

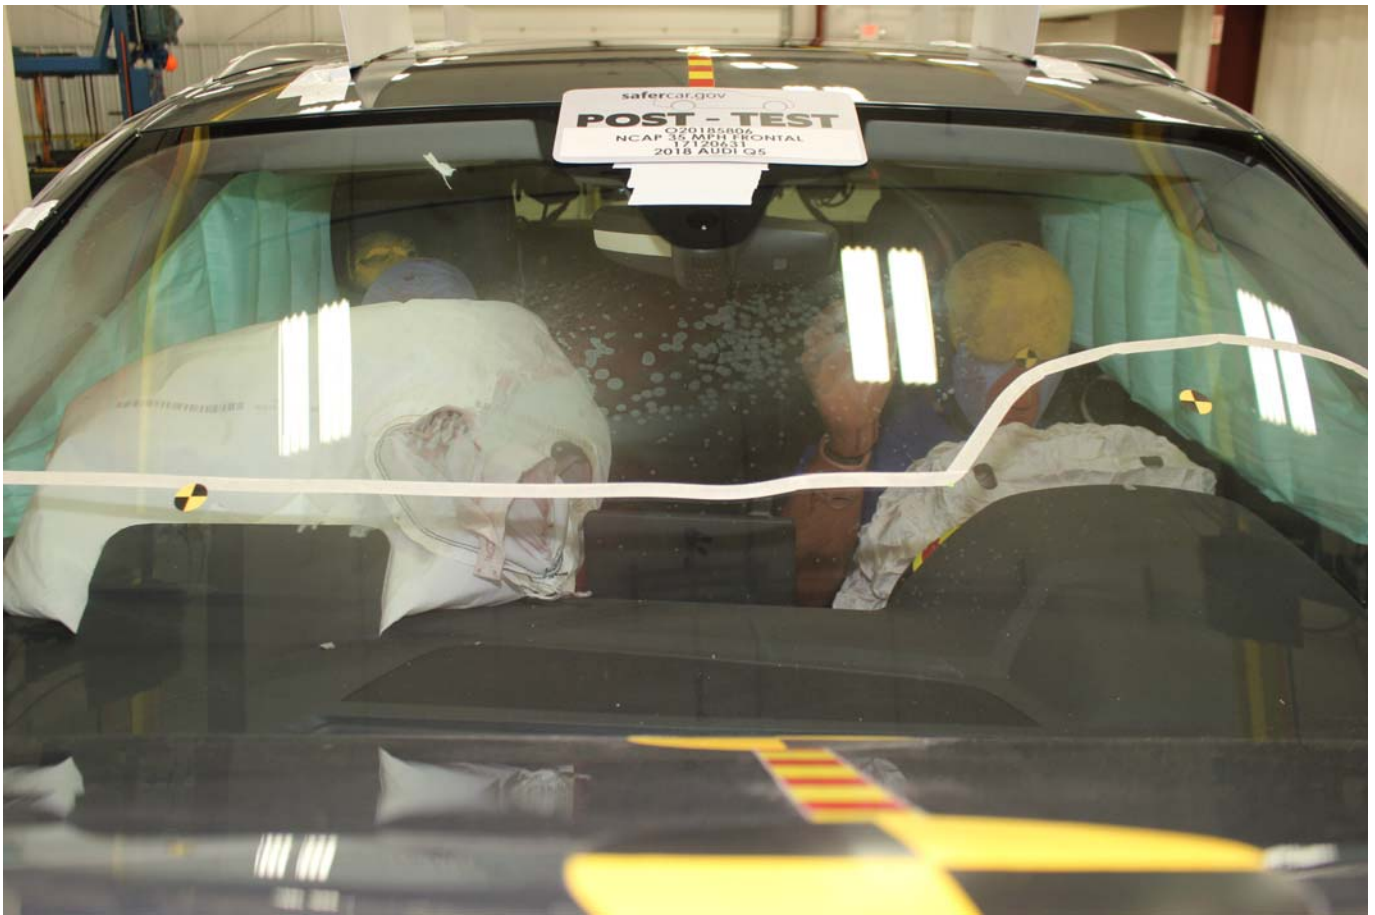
Photo No. 019 - Post-Test Windshield View

There was 100 percent windshield retention and no intrusion into the protected zone of the windshield during the event. There was no Stoddard Solvent leakage after the event or during any phase of the static rollover.

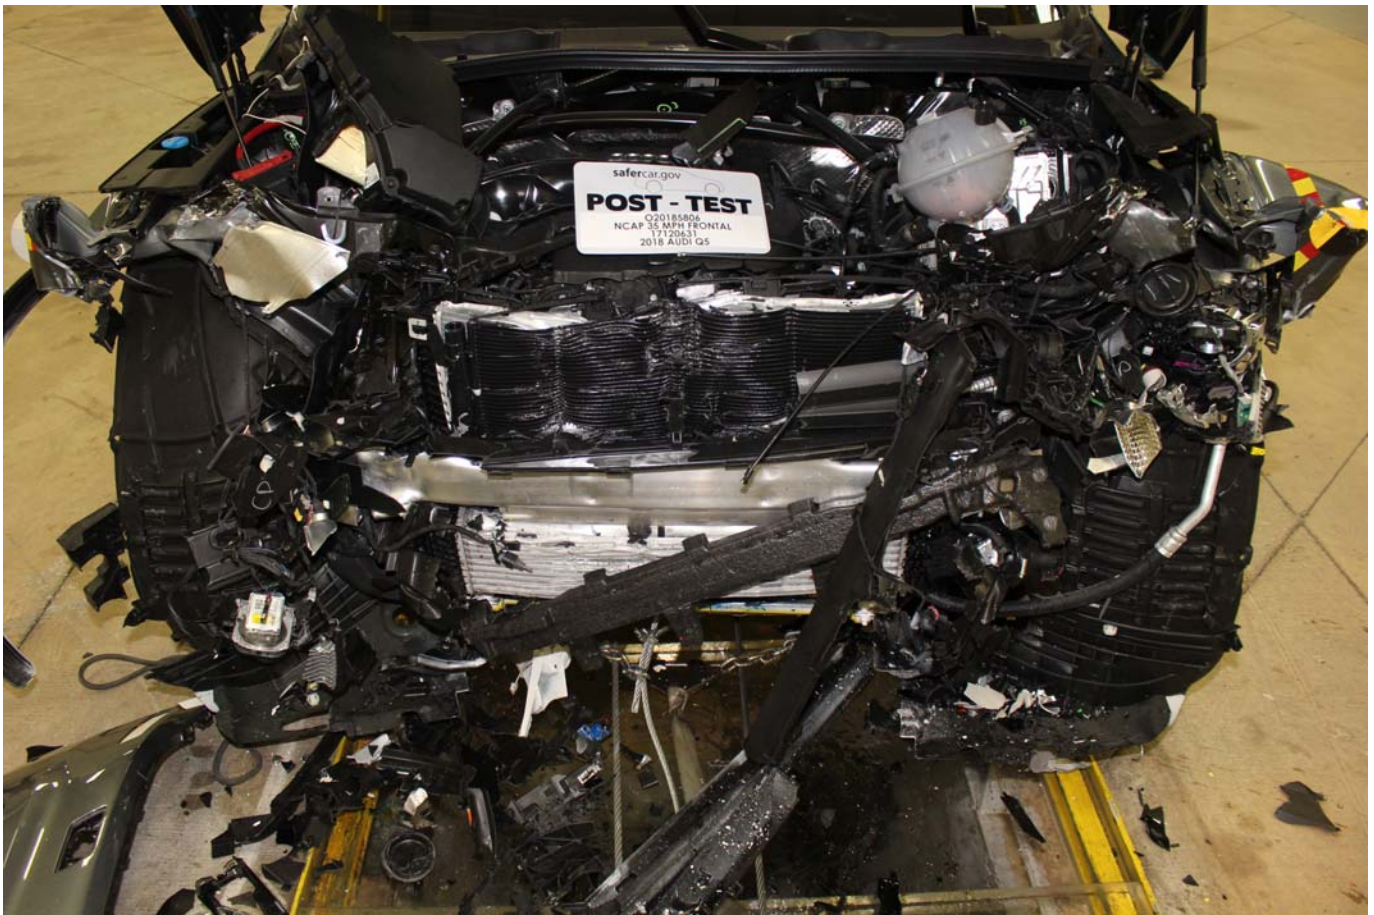
Photo No. 021 - Post-Test Engine Compartment View

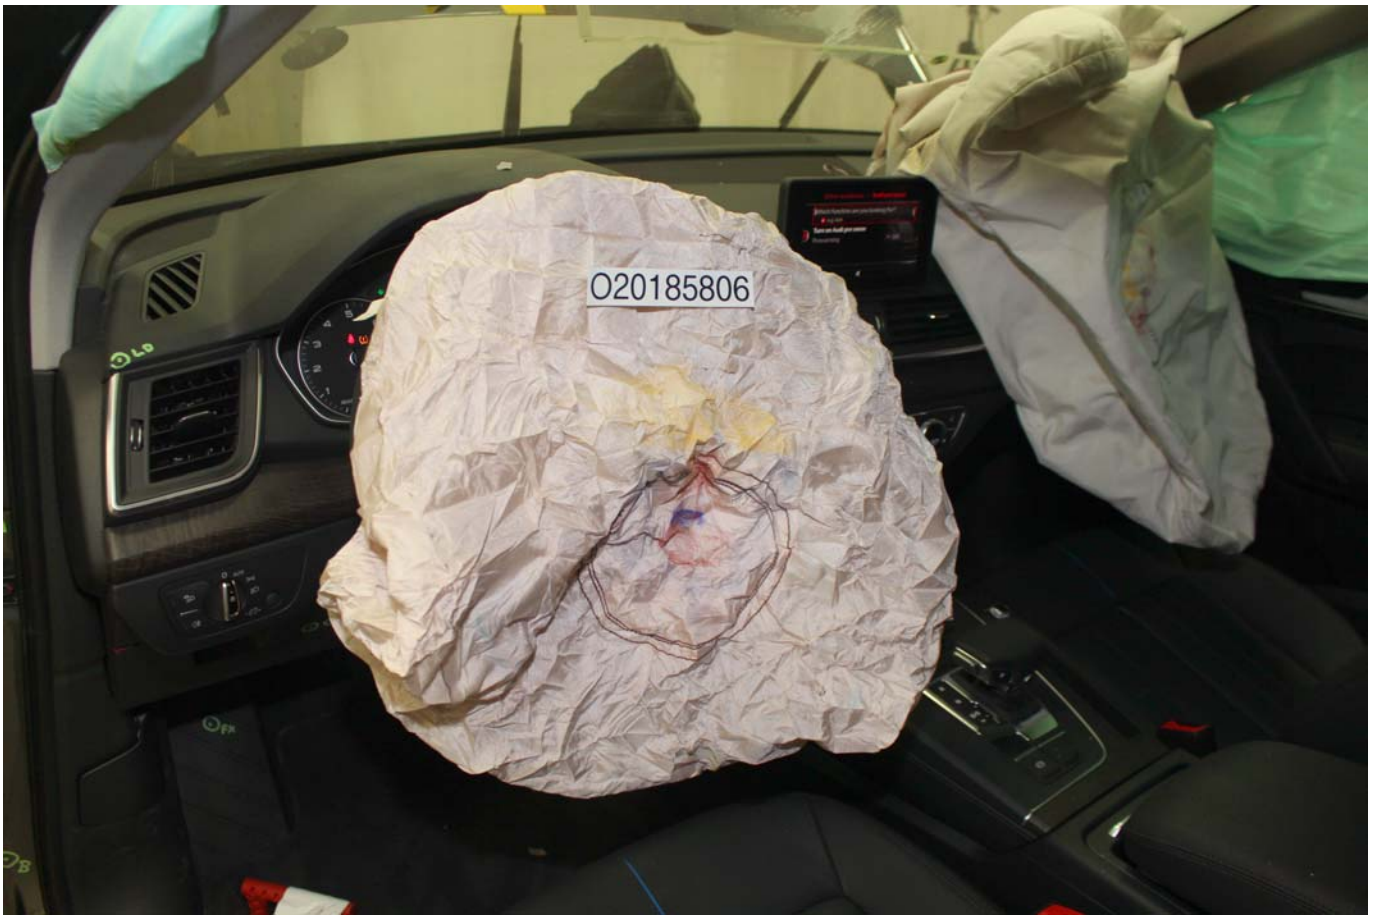
Photo No. 047 - Post-Test Driver Dummy Contact with Airbag

The driver's visible contact points were as follows: The driver's head contacted the airbag. The driver's head also contacted the headrest. The driver's knees contacted the knee bolster. The passenger's visible contact points were as follows: The passenger's head contacted the airbag. The passenger's head also contacted the headrest.

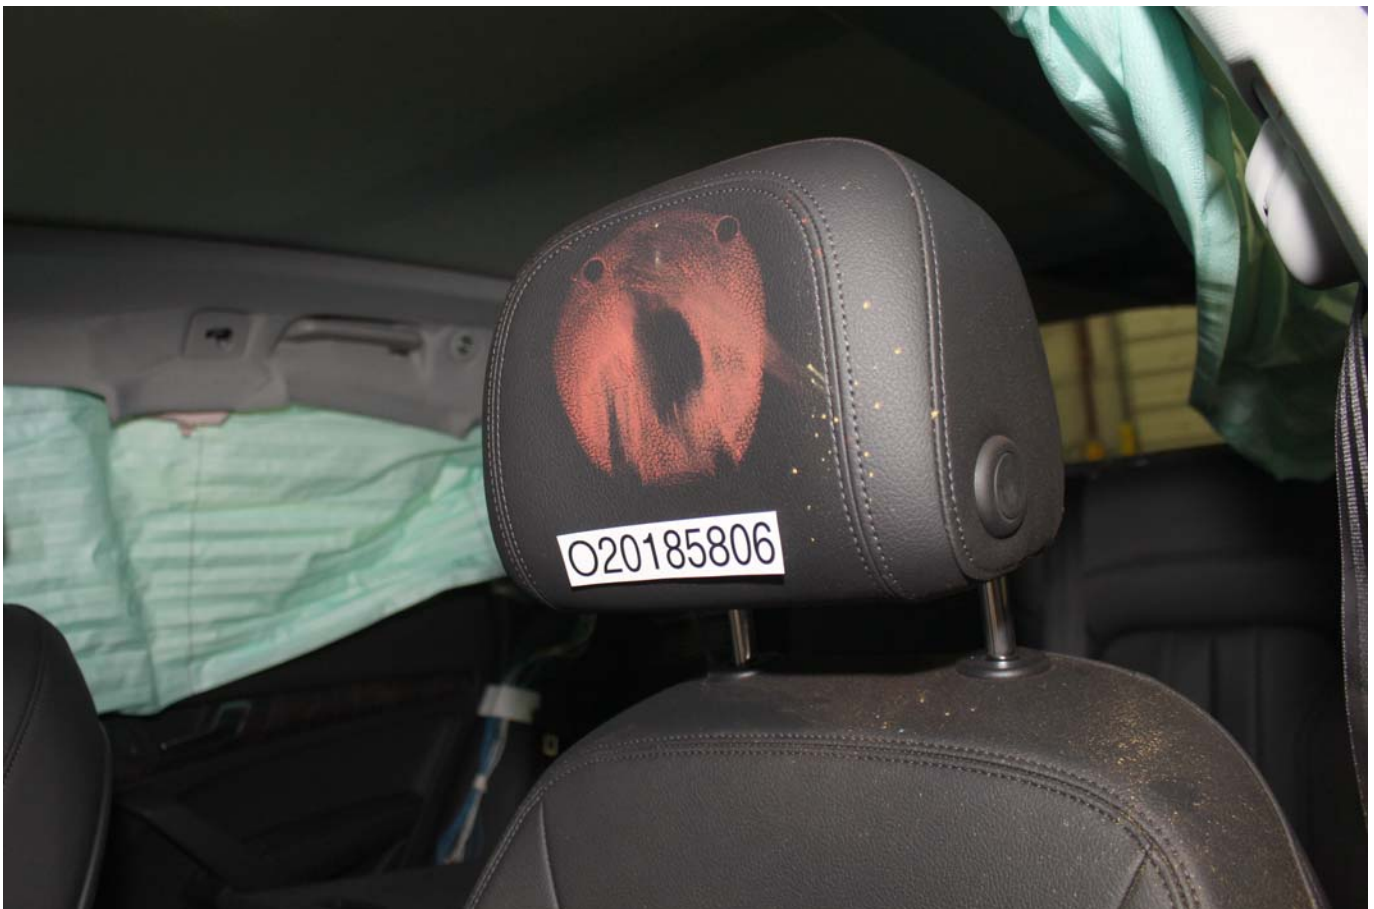
Photo No. 048 - Post-Test Driver Dummy Contact with Headrest

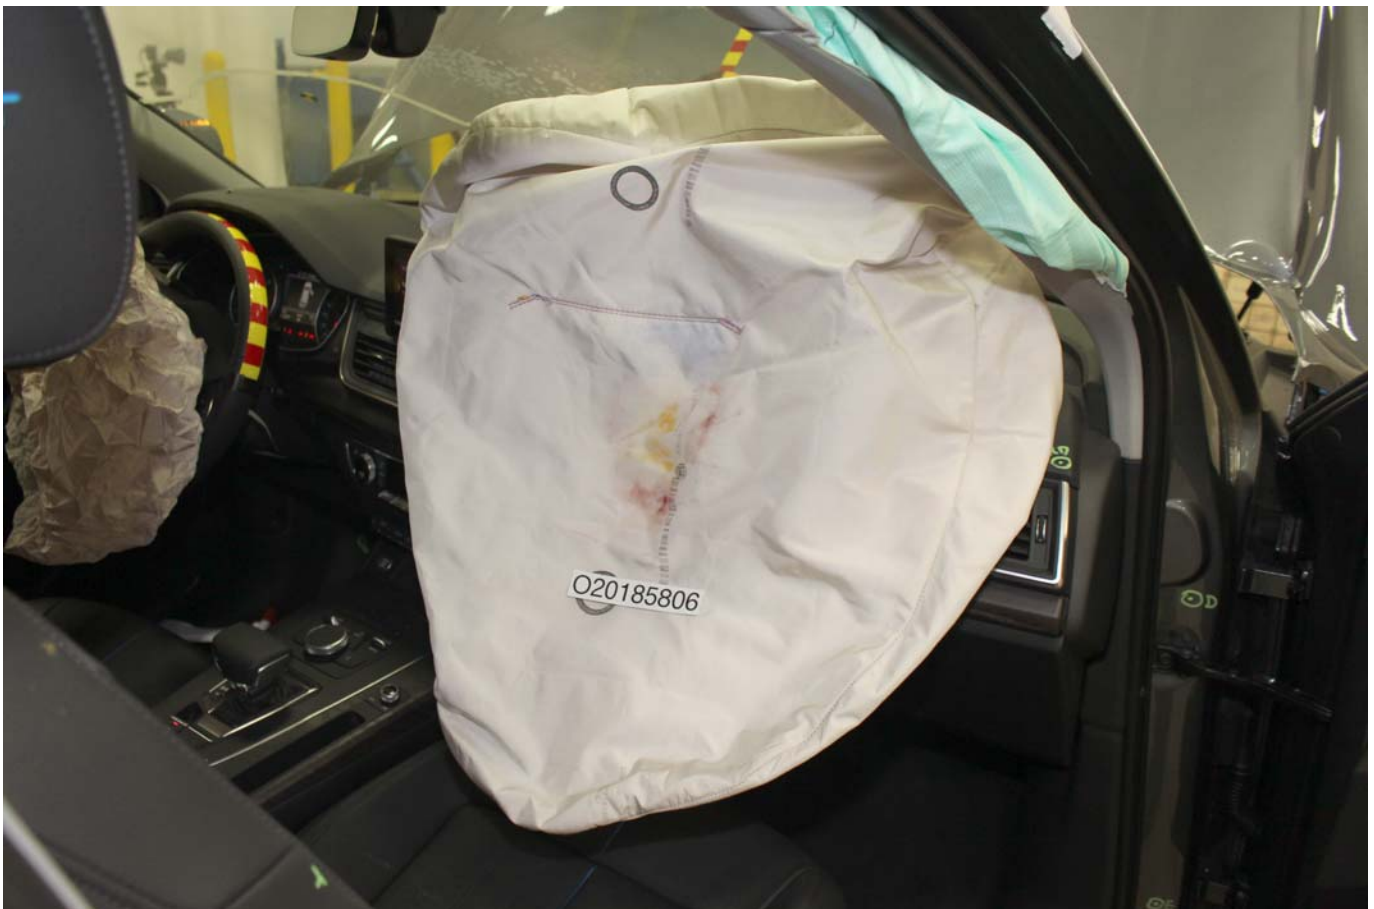
Photo No. 068 - Post-Test Passenger Dummy Contact with Airbag

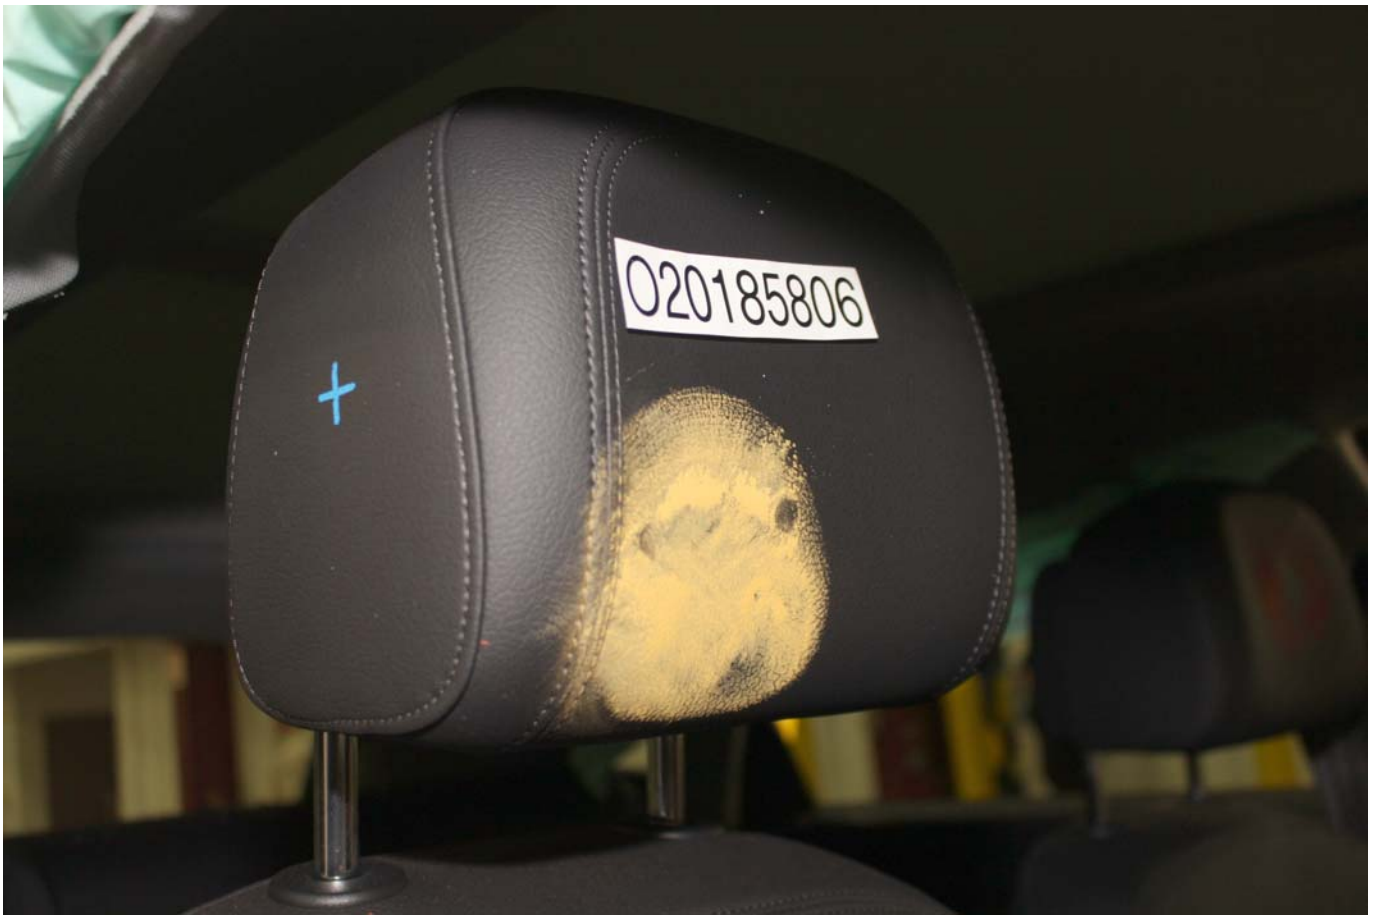
Photo No. 069 - Post-Test Passenger Dummy Contact with Headrest

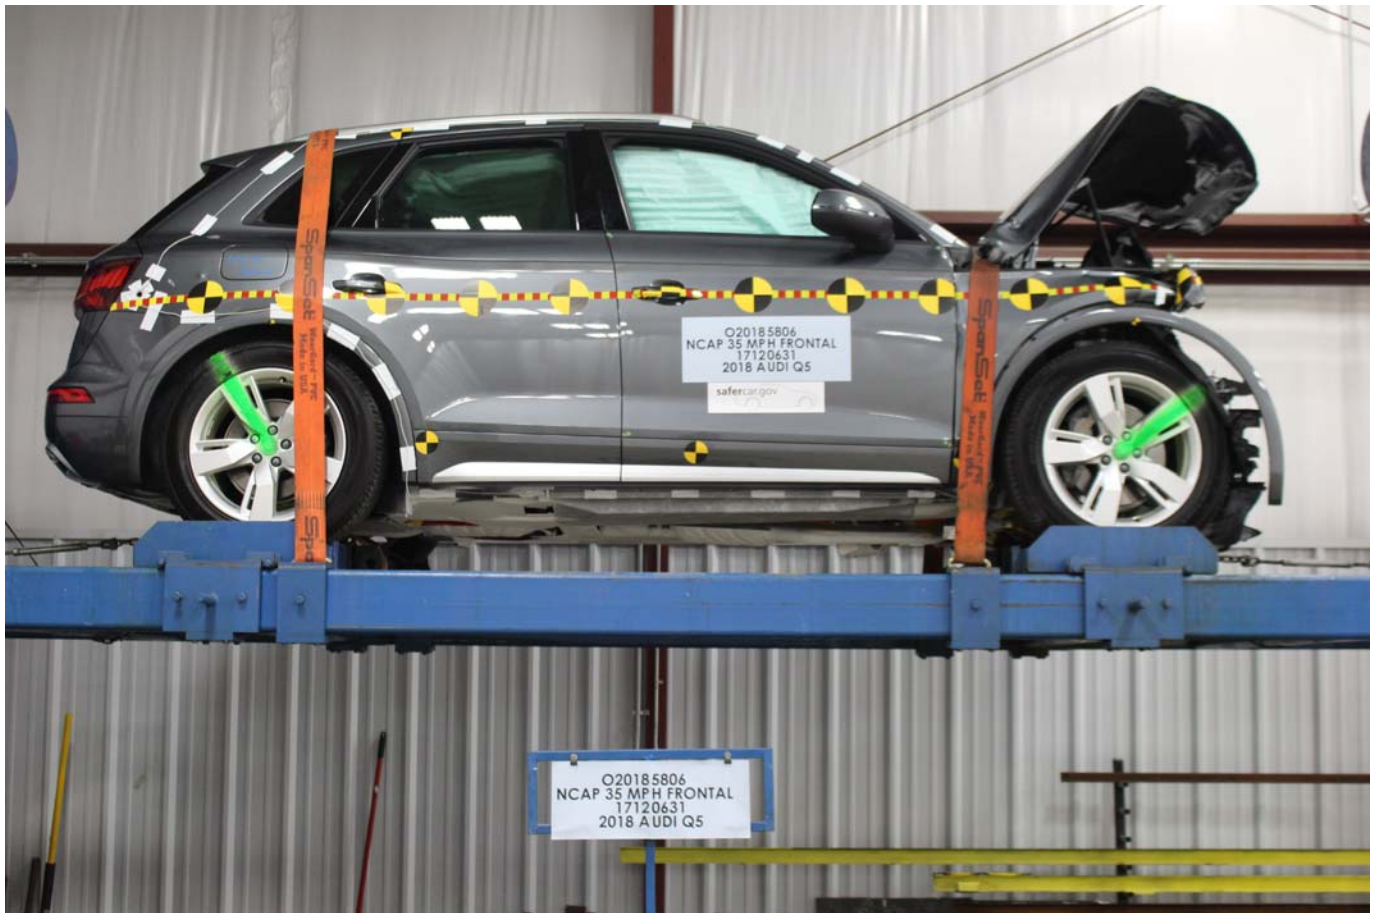
Photo No. 073 - Vehicle at 0 Degree on Static Rollover Device

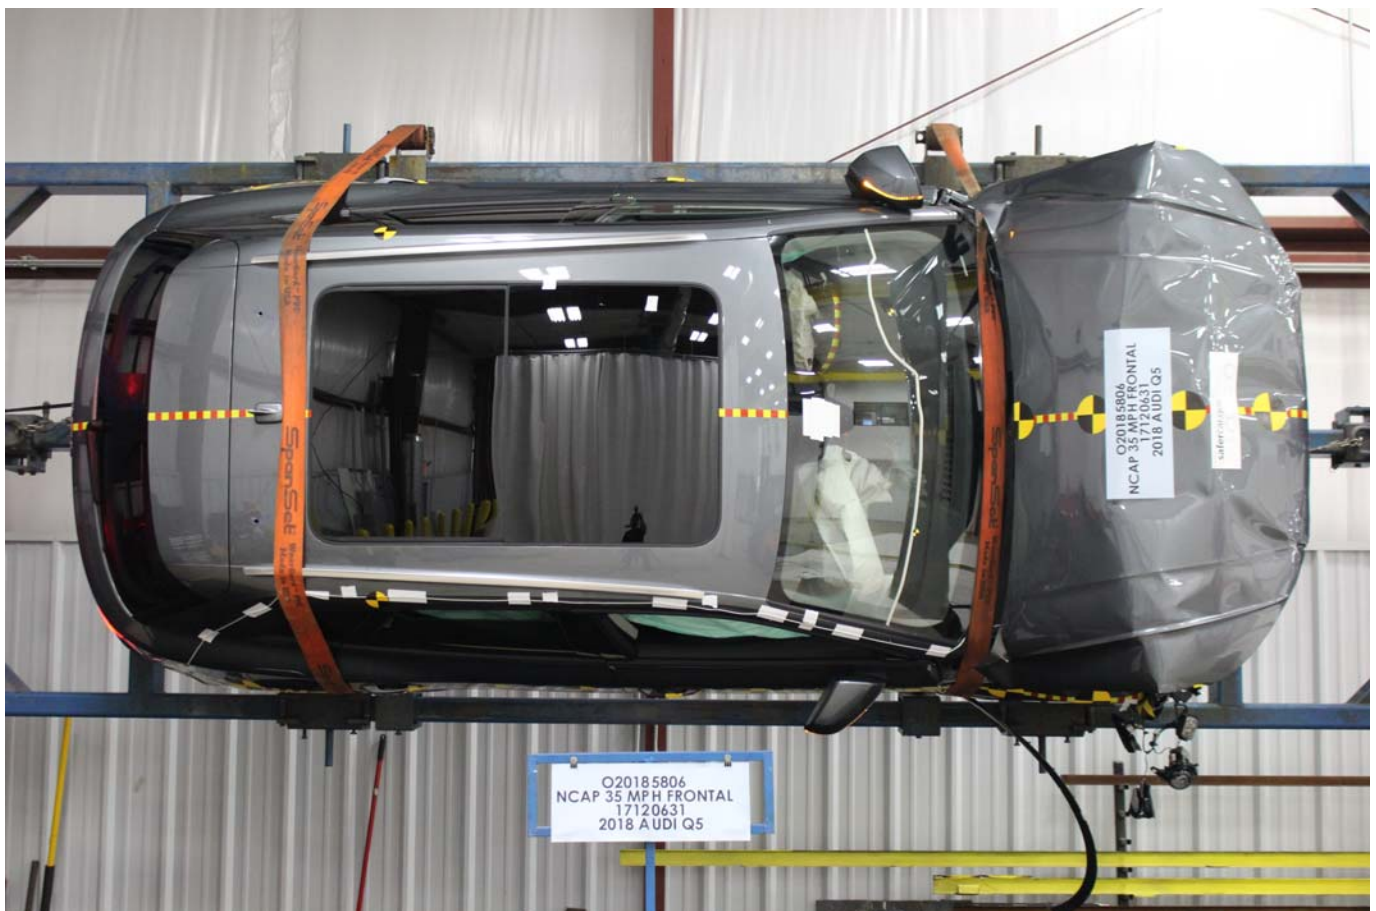
Photo No. 074 - Vehicle at 90 Degrees on Static Rollover Device

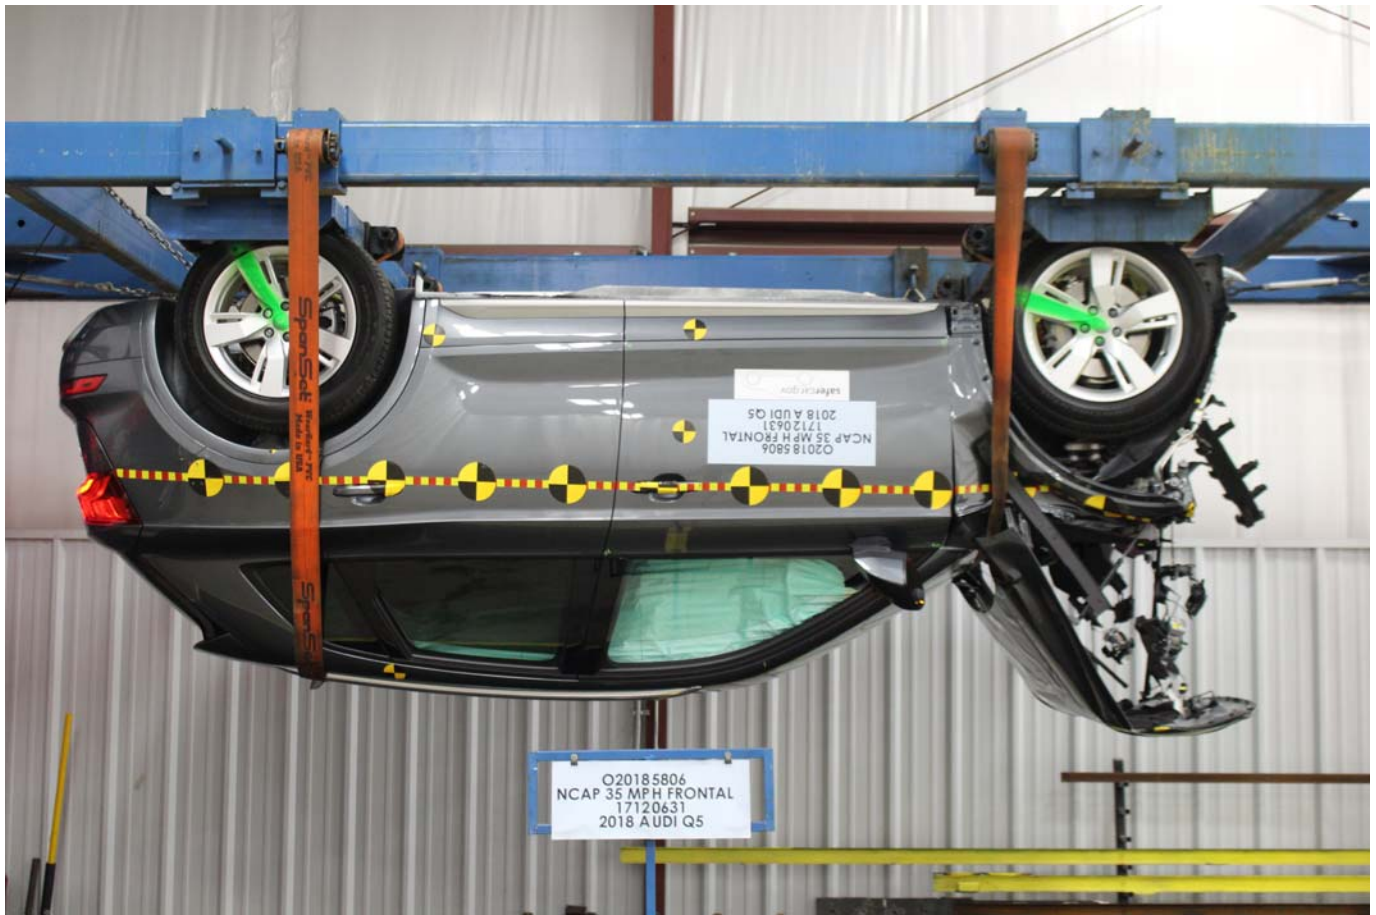
Photo No. 075 - Vehicle at 180 Degrees on Static Rollover Device

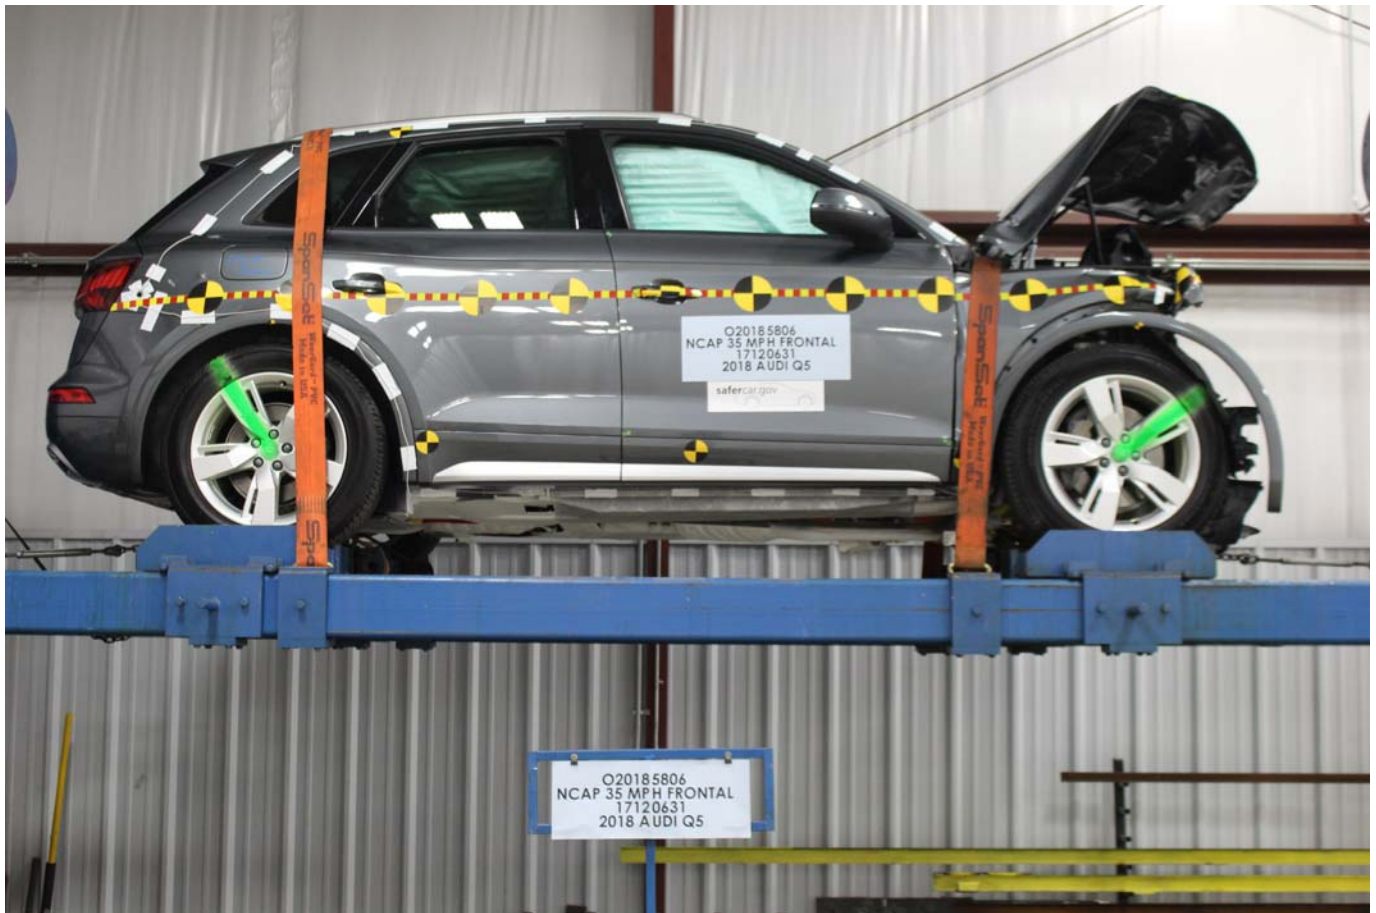
Photo No. 077 - Vehicle at 360 Degrees on Static Rollover Device
