REPORT NUMBER: NCAP-MGA-2018-013

**NEW CAR ASSESSMENT PROGRAM (NCAP)
Frontal Barrier Impact Test**

**AUDI AG
2018 Audi Q7 2.0T AWD 5-Door SUV
NHTSA No.: O20185809**

**MGA RESEARCH CORPORATION
5000 Warren Road
Burlington, WI 53105**

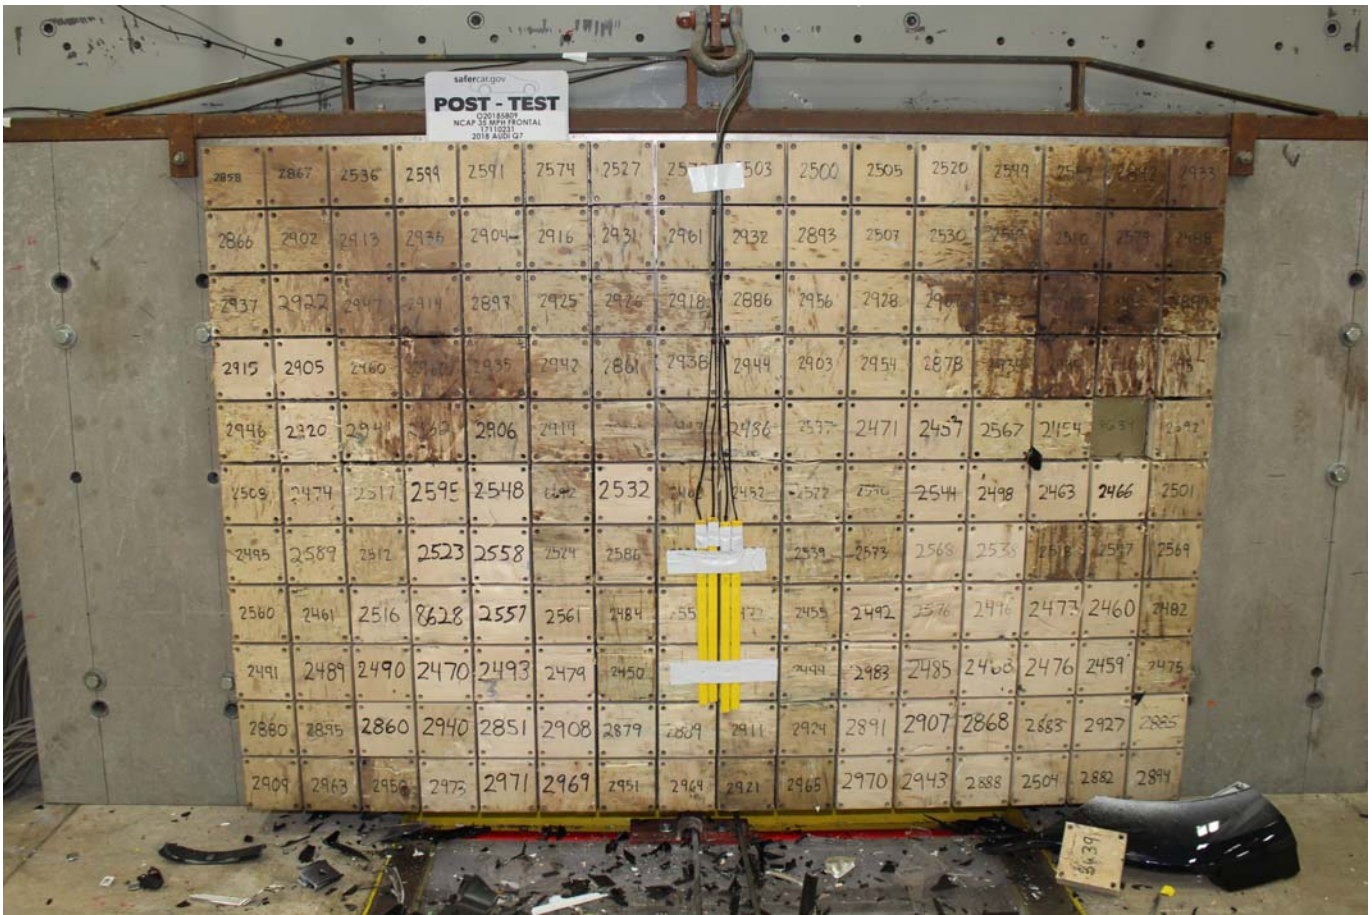
Photo No. 003 - Post-Test Load Cell Wall

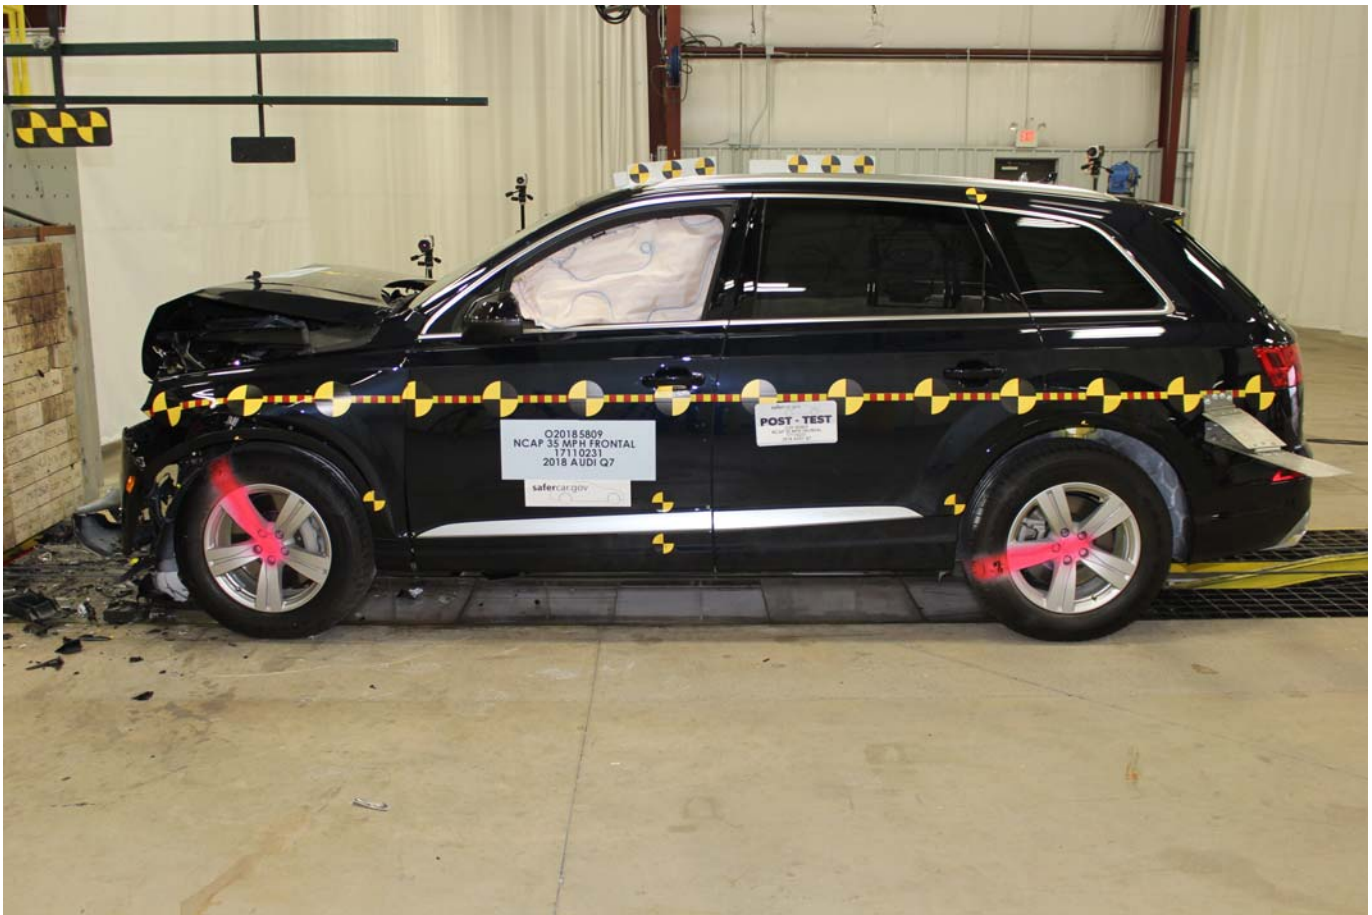
Photo No. 011 - Post-Test Left View of Test Vehicle

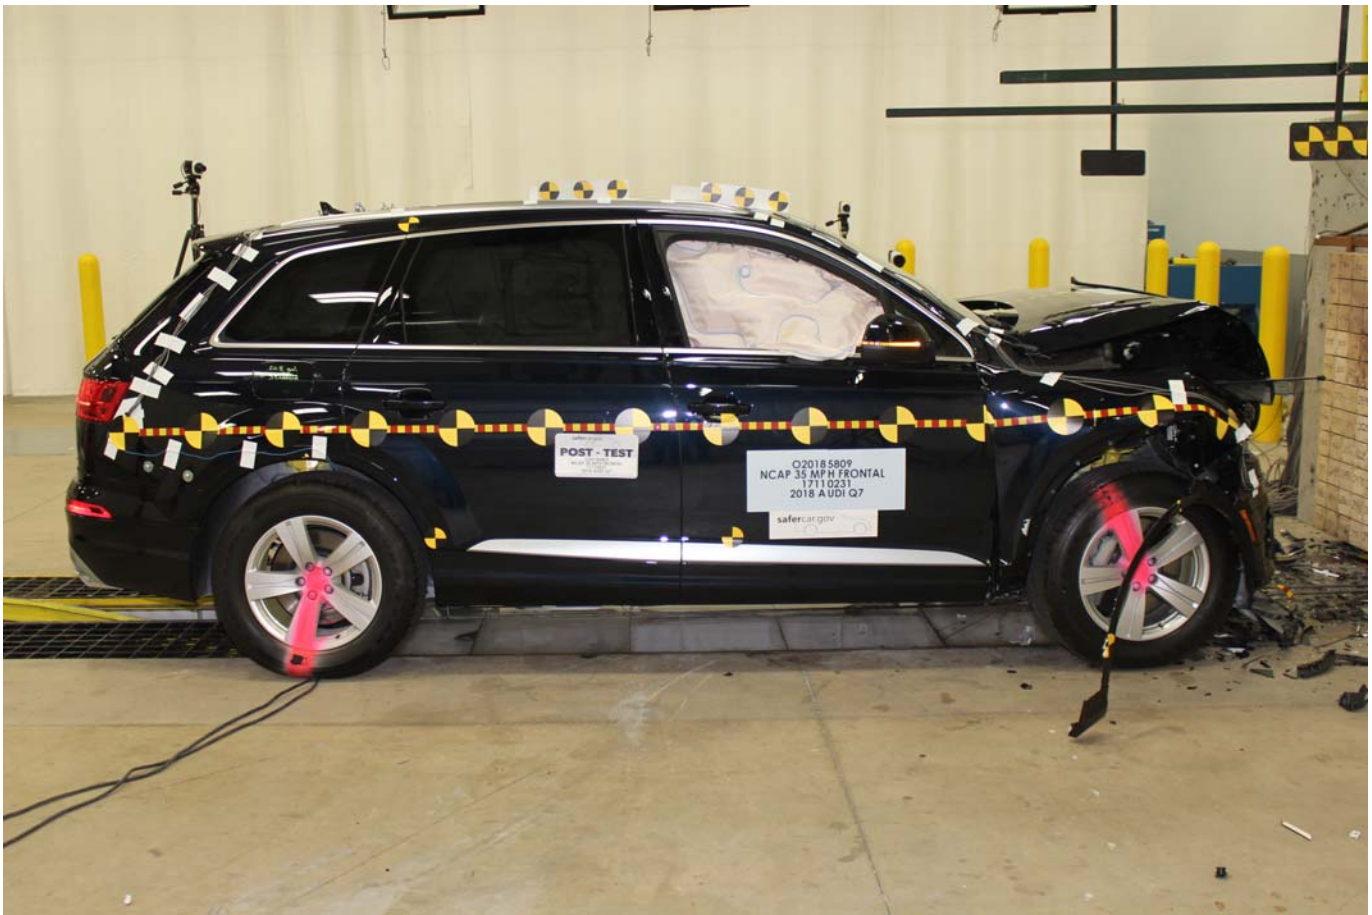
Photo No. 013 - Post-Test Right View of Test Vehicle

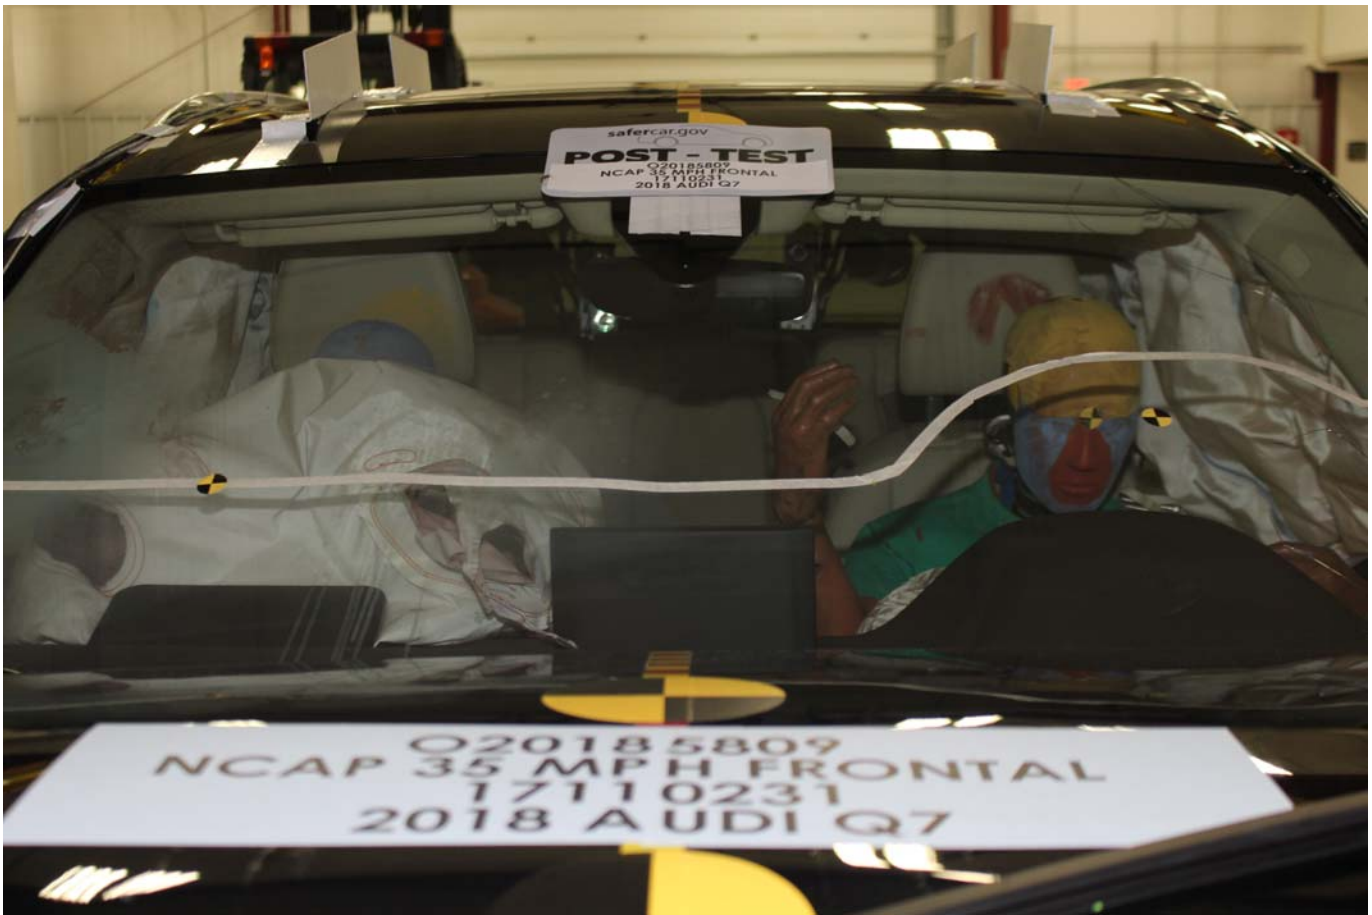
Photo No. 019 - Post-Test Windshield View

There was 100 percent windshield retention and no intrusion into the protected zone of the windshield during the event. There was no Stoddard Solvent leakage after the event or during any phase of the static rollover.

Critical Areas of Performance	Observations and Conclusions
Windshield Damage	Cracked
Window Damage	None
Other Notable Effects	None

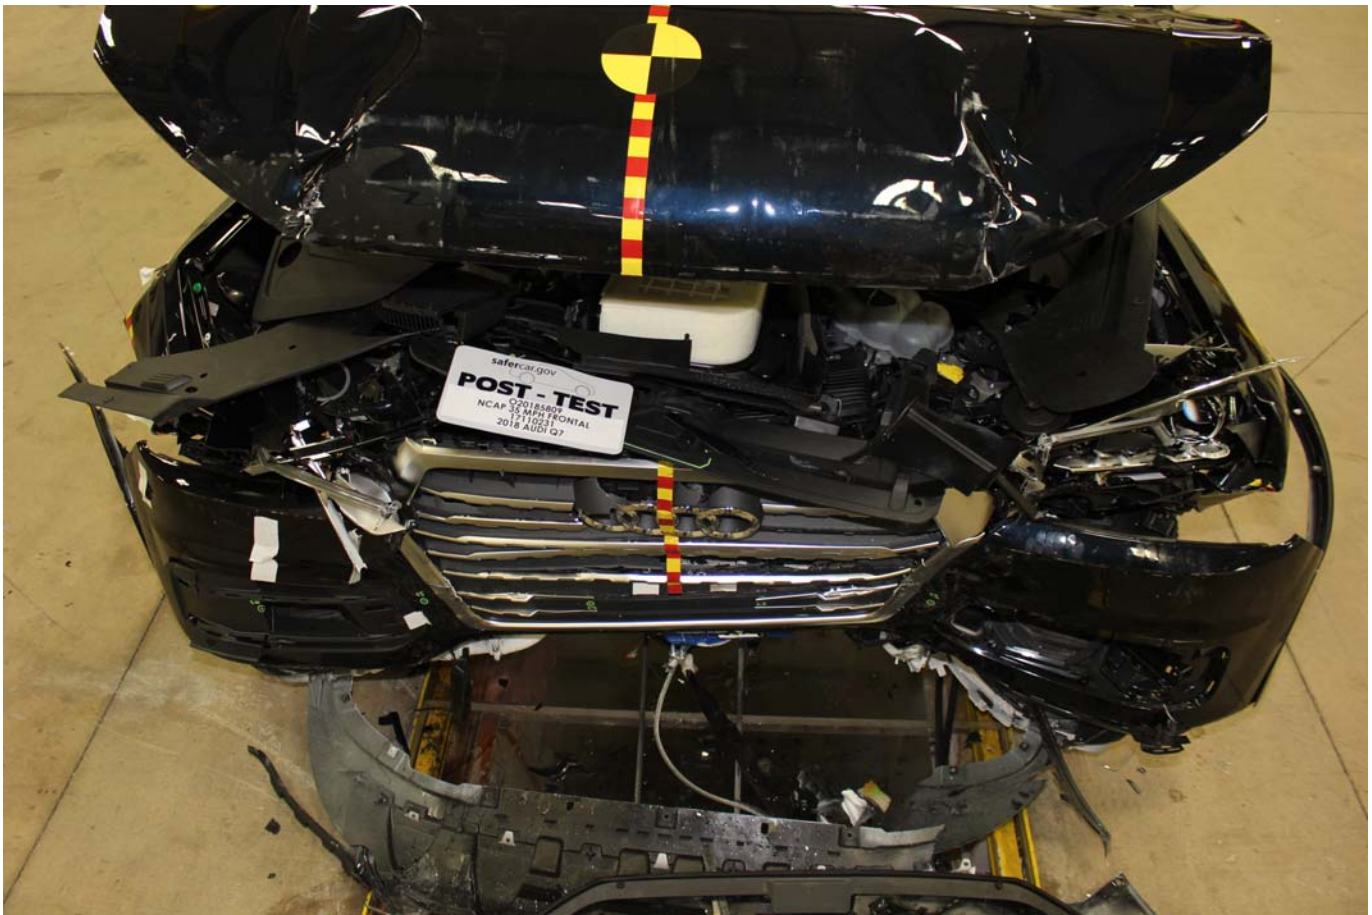
Photo No. 021 - Post-Test Engine Compartment View

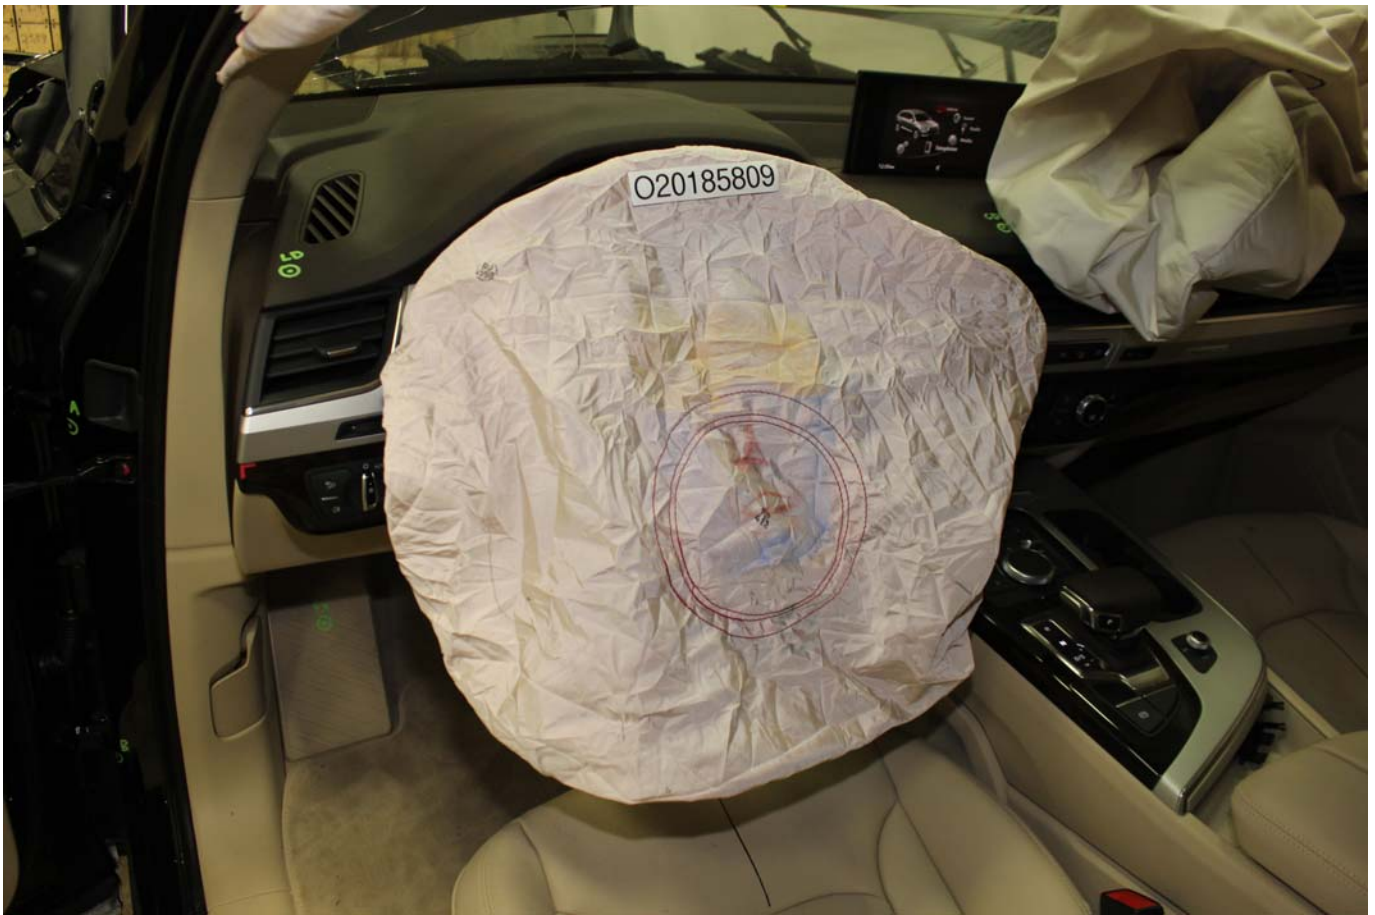
Photo No. 047 - Post-Test Driver Dummy Contact with Airbag

The driver's visible contact points were as follows: The driver's head contacted the airbag. The driver's head also contacted the headrest. The passenger's visible contact points were as follows: The passenger's head contacted the airbag. The passenger's head also contacted the headrest. The passenger's knees contacted the glove box.

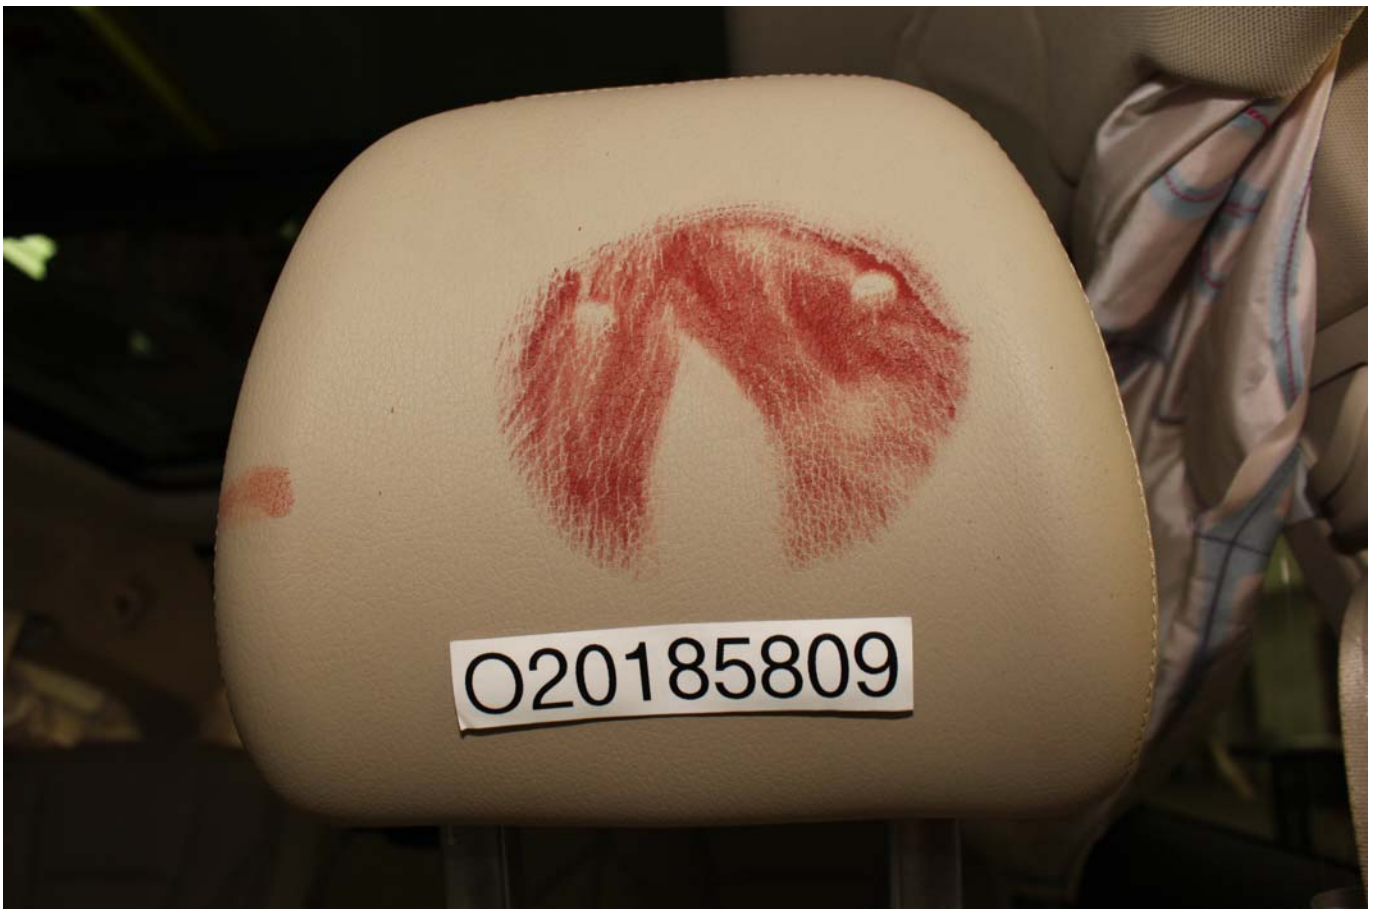
Photo No. 048 - Post-Test Driver Dummy Contact with Headrest

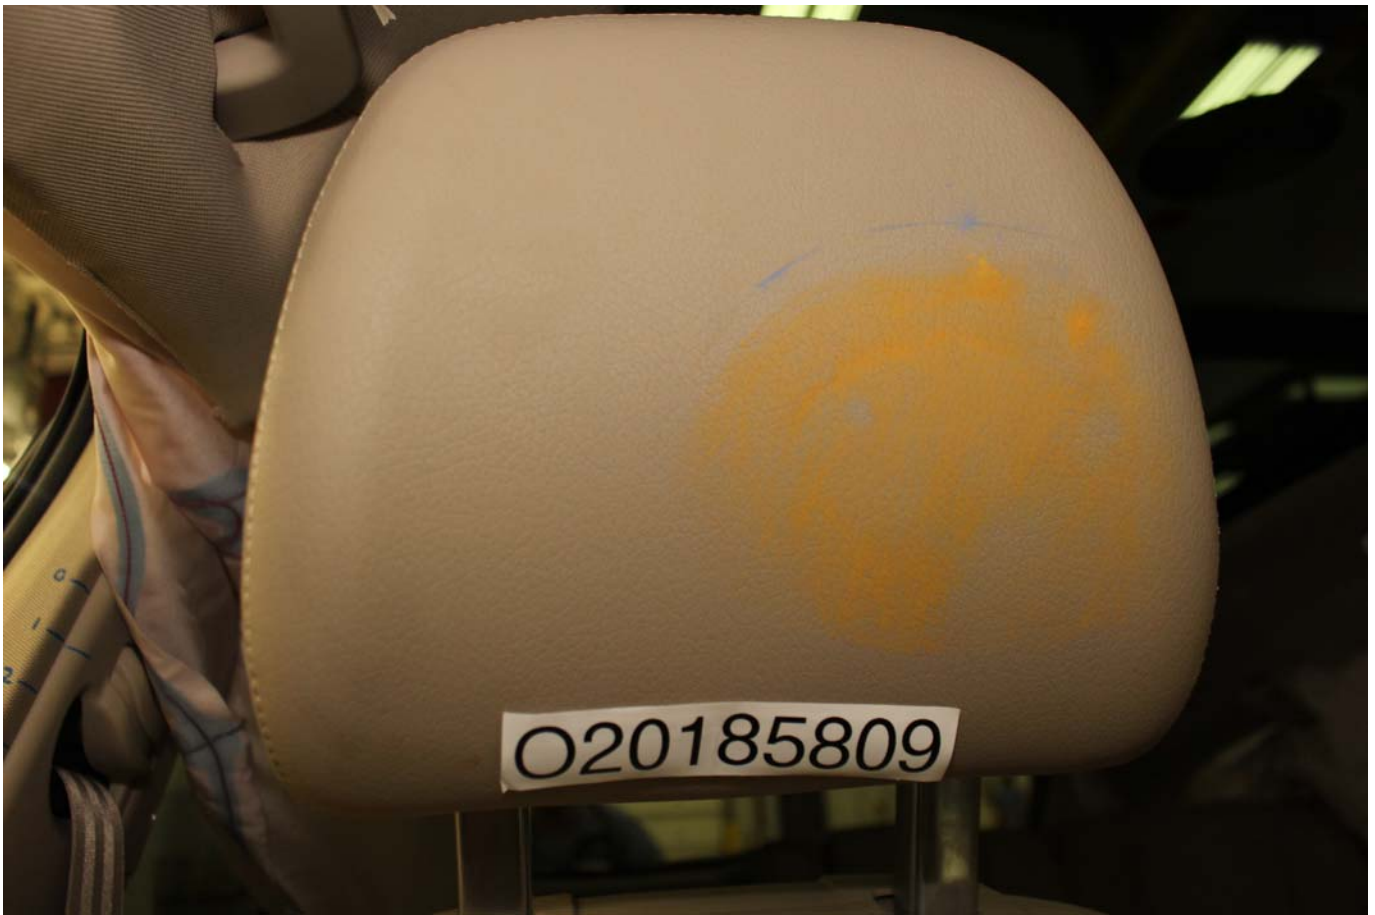
Photo No. 069 - Post-Test Passenger Dummy Contact with Headrest

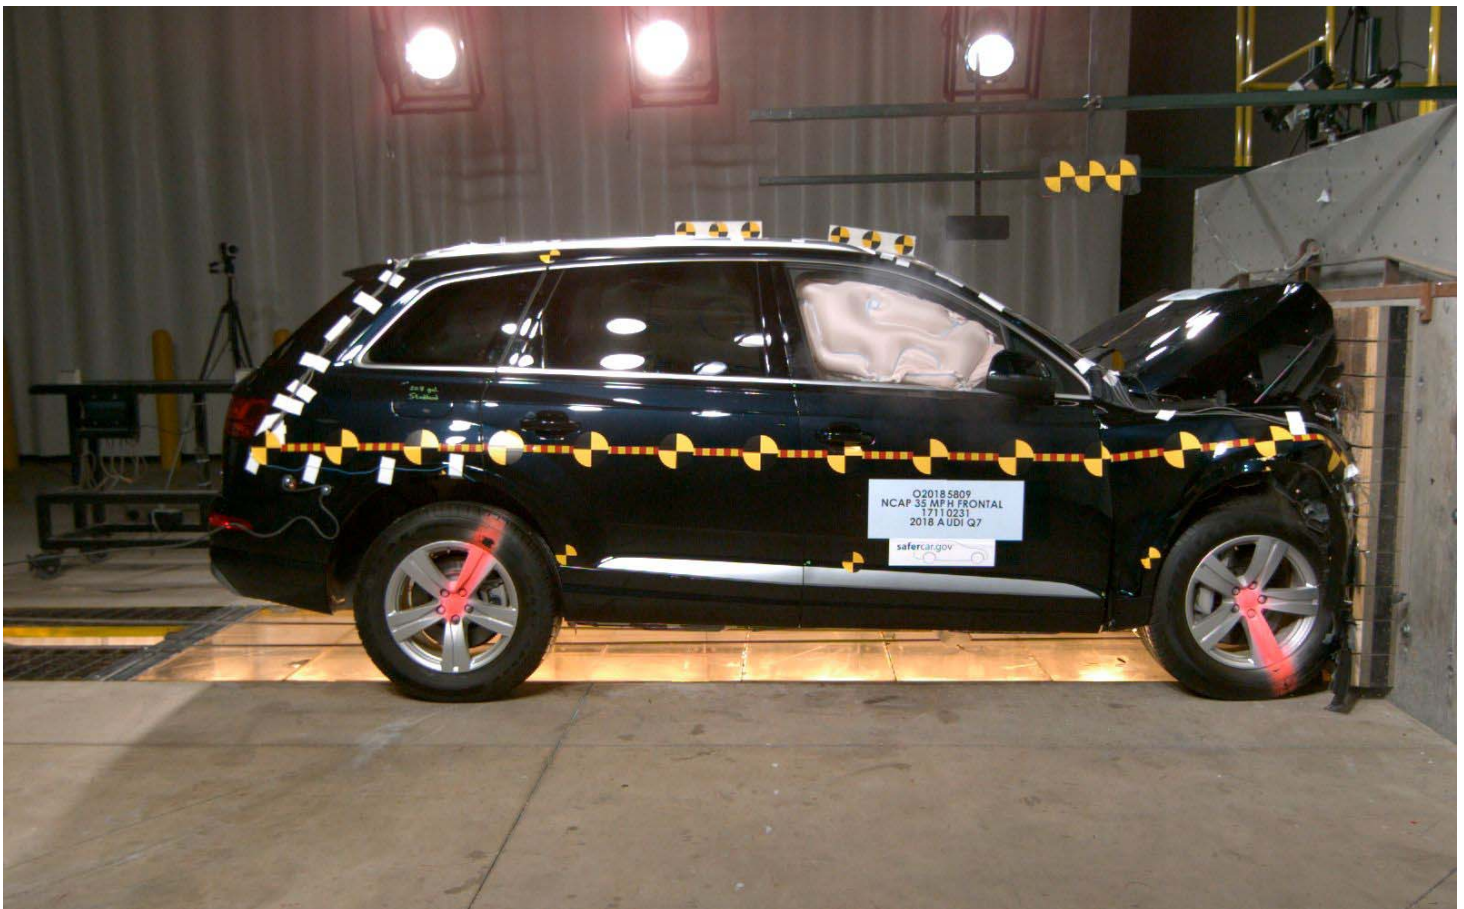
Photo No. 078 - 2018 Audi Q7 2.0T AWD 5-Door SUV Frontal Impact Event

A load cell barrier consisting of 176 load cells was impacted by a 2018 Audi Q7 2.0T AWD 5-Door SUV at a velocity of 56.21 km/h. The test was performed at MGA Research Corporation on November 2, 2017. Pre-test and post-test photographs of the vehicle and dummies can be found in Appendix A.
