REPORT NUMBER: NCAP-CAL-19-010

**NEW CAR ASSESSMENT PROGRAM (NCAP)
FRONTAL BARRIER IMPACT TEST**

**General Motors LLC
2019 Chevrolet Silverado LD 1500 Quad Cab
Truck**

NHTSA No: M20190120

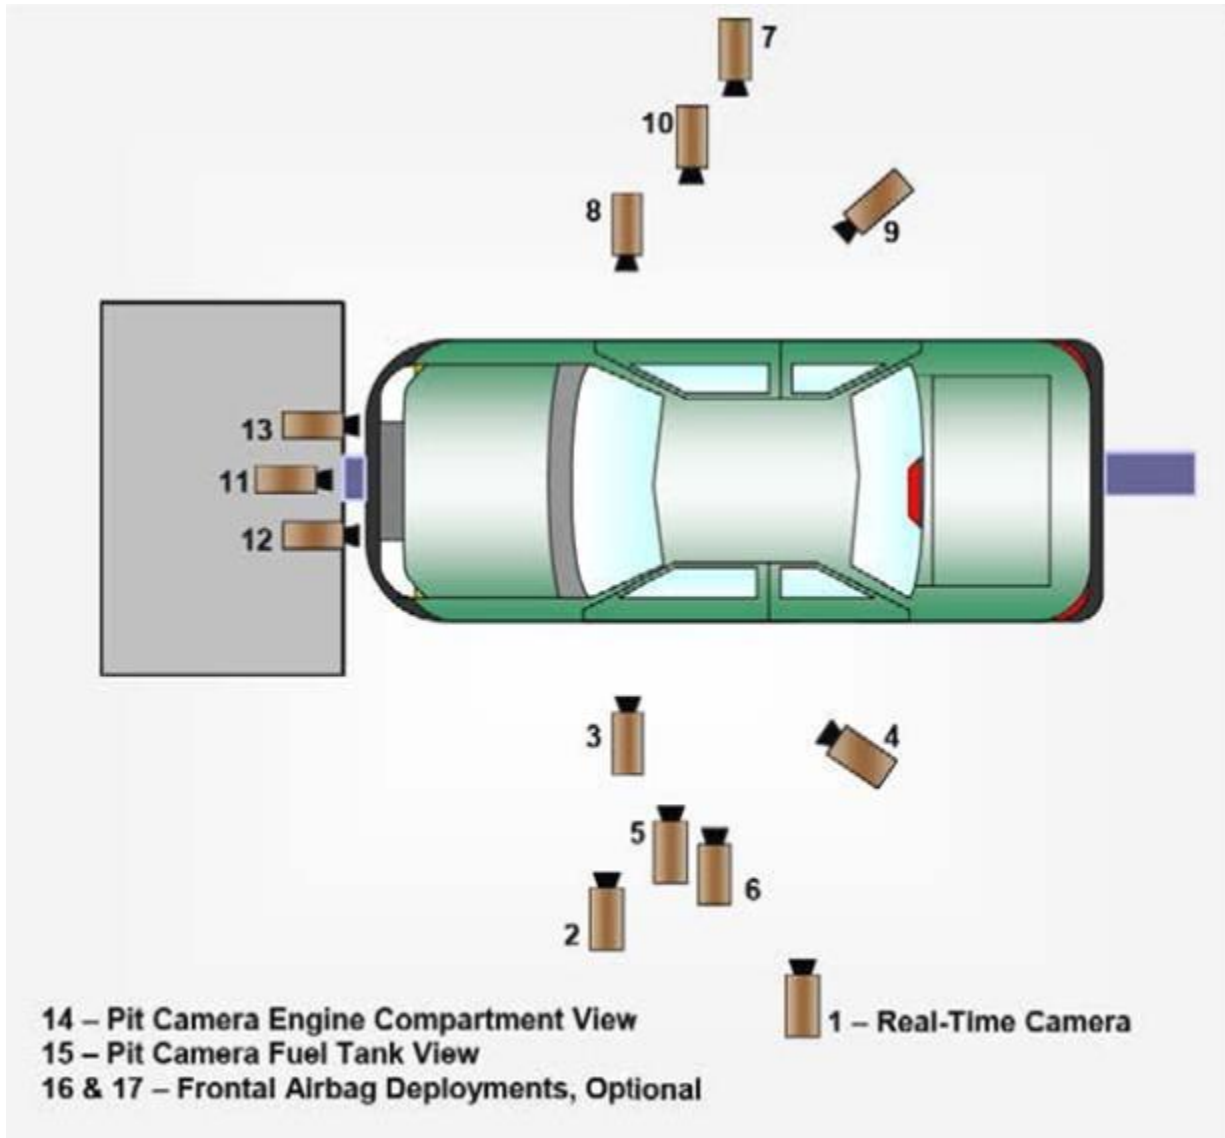
CAMERA POSITIONS FOR FRONTAL IMPACTS

Top View

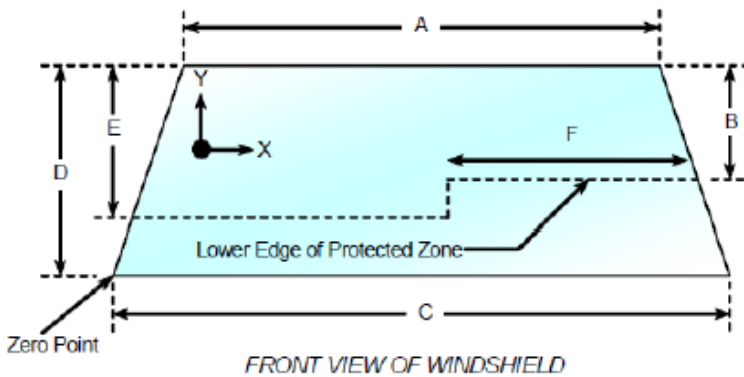
WINDSHIELD PERIPHERY MEASUREMENTS

Measurement	Pre-Test (mm)	Post-Test (mm)	% Retention
Left Side	2296	2296	100
Right Side	2296	2296	100
Total	4592	4592	100

Item	Units	Value
A	mm	1373
B	mm	423
C	mm	1633
D	mm	794
E	mm	435
F	mm	532

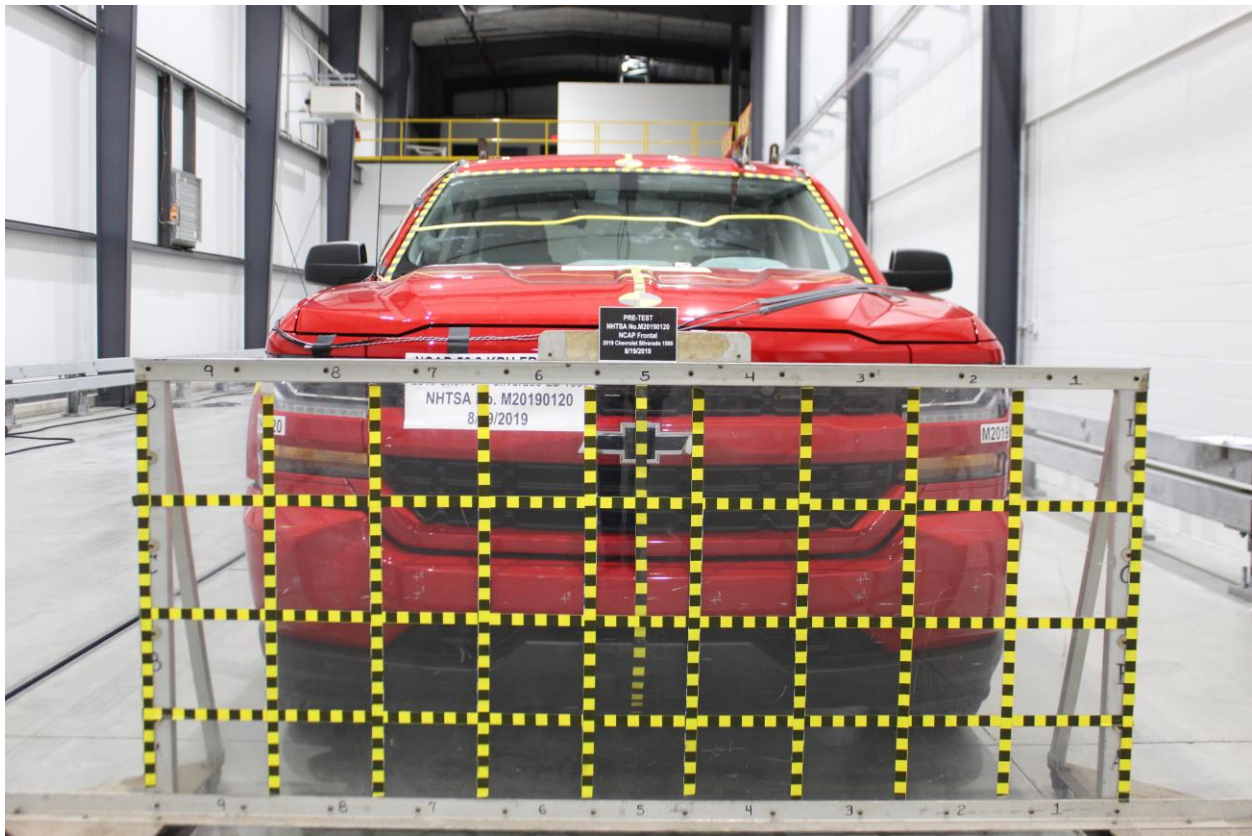
Figure A-1: Load Cell Location

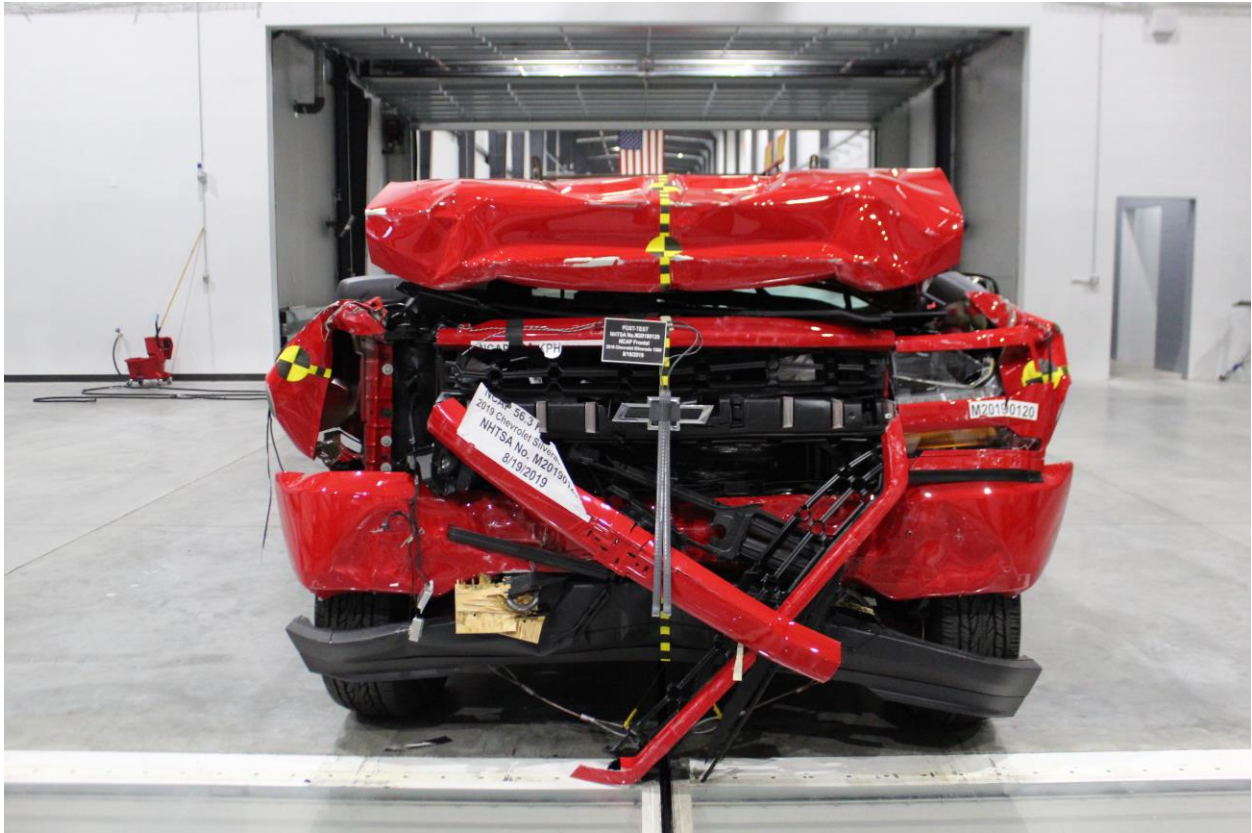
Figure A-9: Post-Test Front View of Test Vehicle

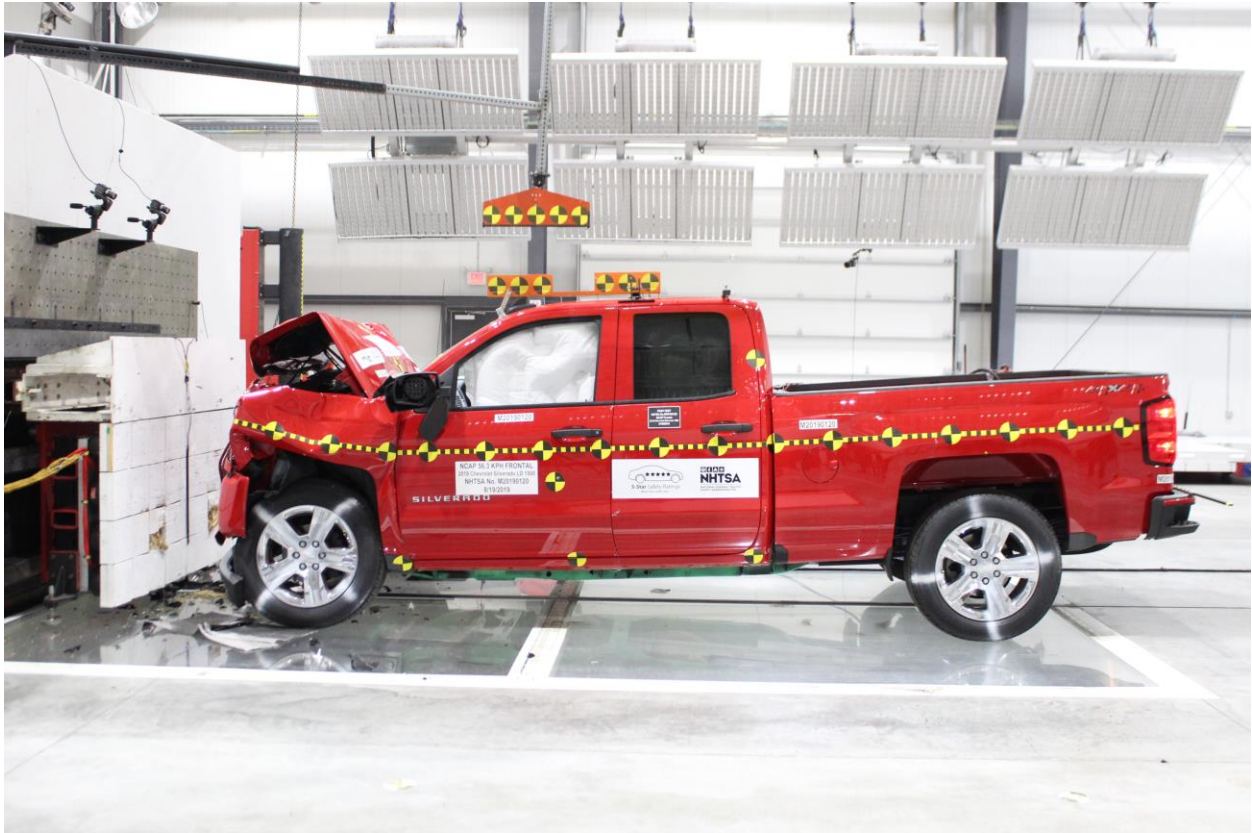
Figure A-11: Post-Test Left View of Test Vehicle

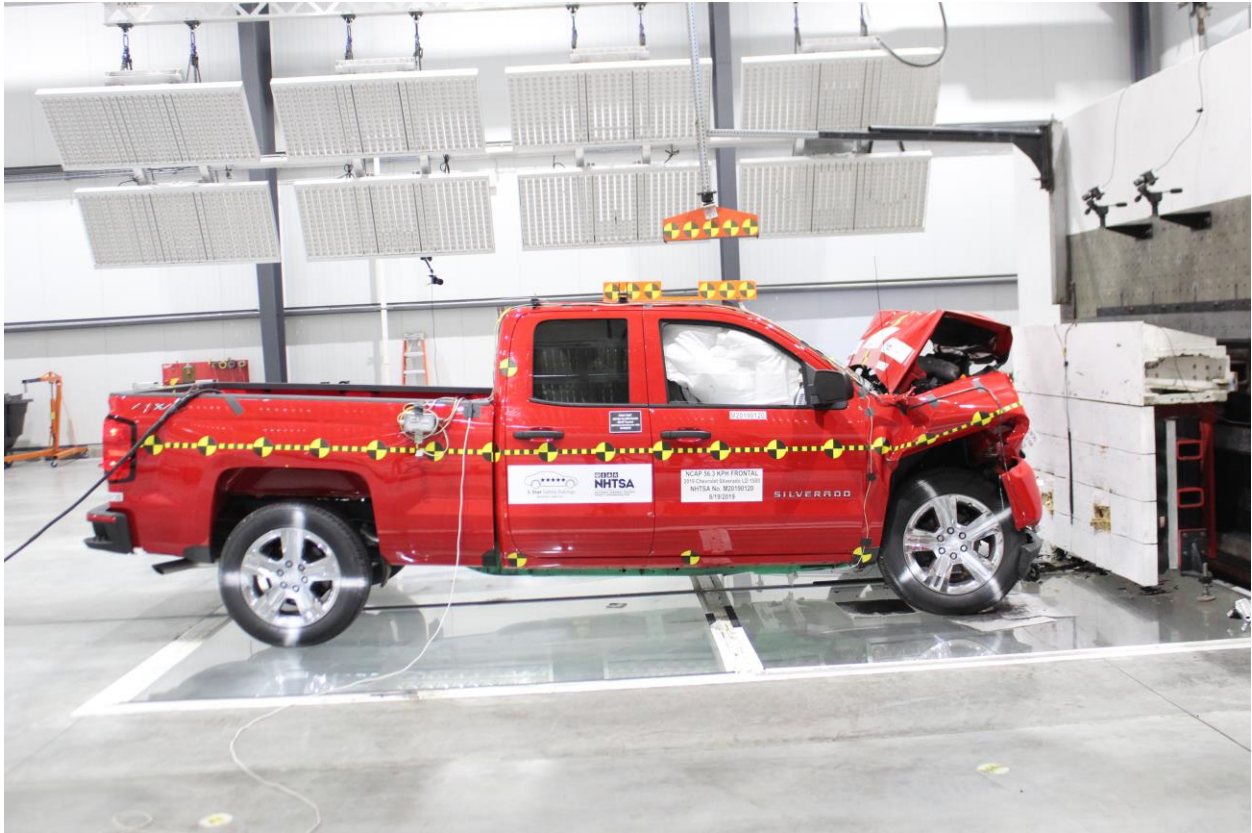
Figure A-13: Post-Test Right View of Test Vehicle

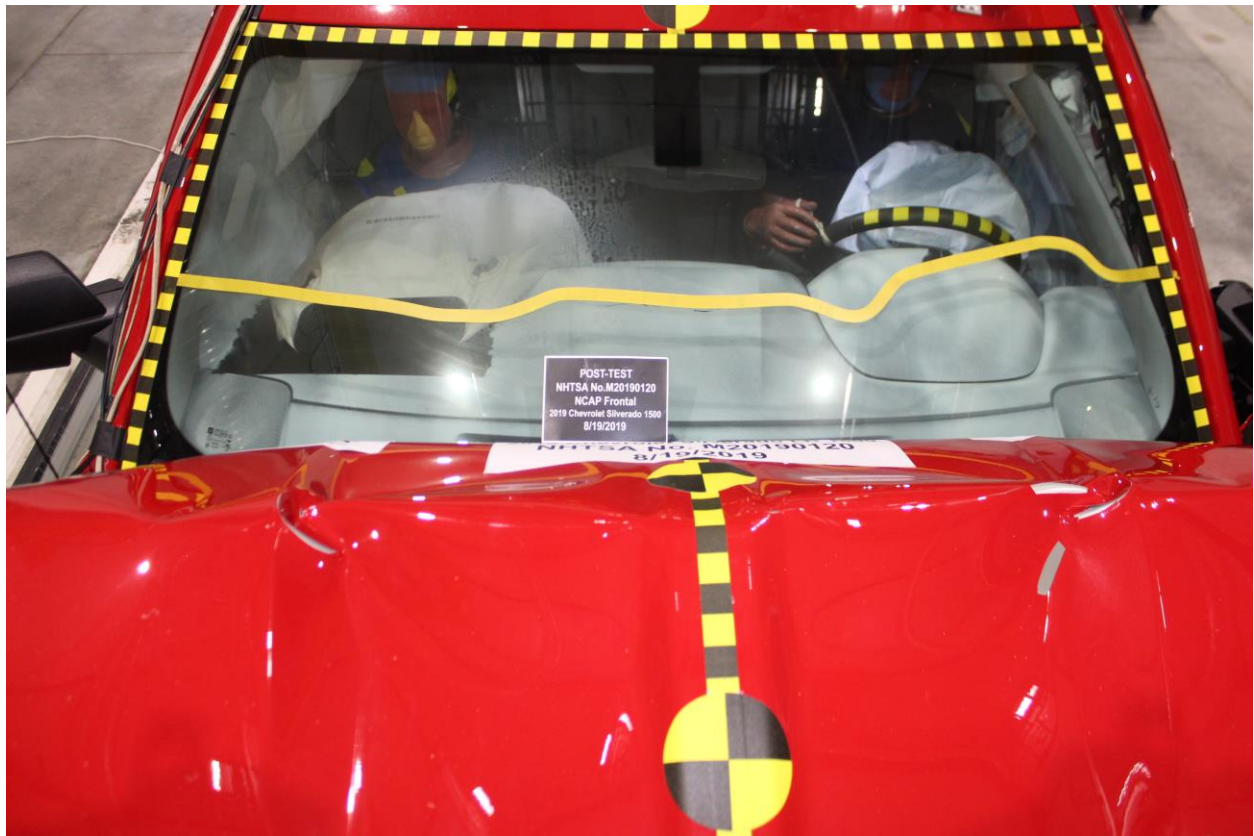
Figure A-19: Post-Test Windshield View

There was 100 percent windshield retention and no intrusion into the protected zone of the windshield during the event. There was a total of 0.0 grams of stoddard solvent leakage after the event and including all phases of the static rollover. The maximum static crush of the test vehicle was 692 mm at the vehicles centerline. During and after the impact event, the driver's and passenger's side doors were closed and operational.

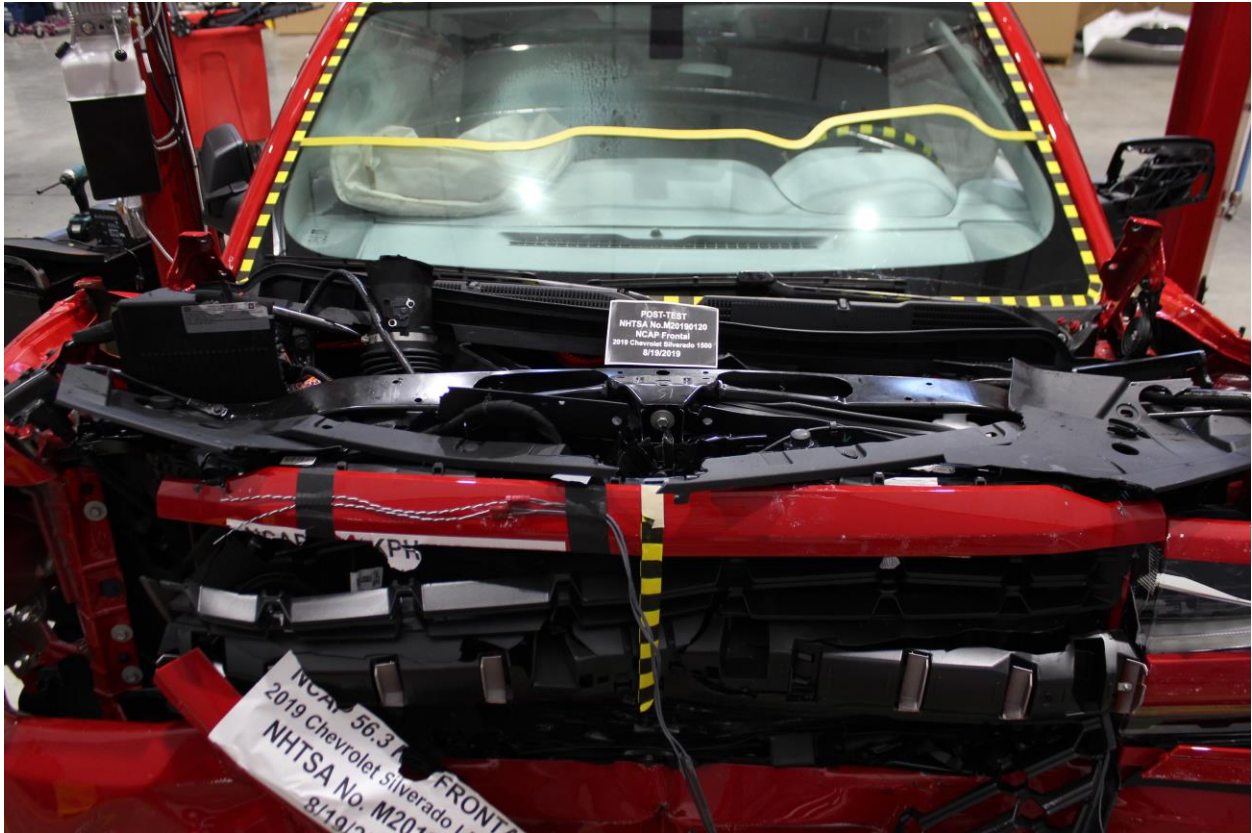
Figure A-21: Post-Test Engine Compartment View

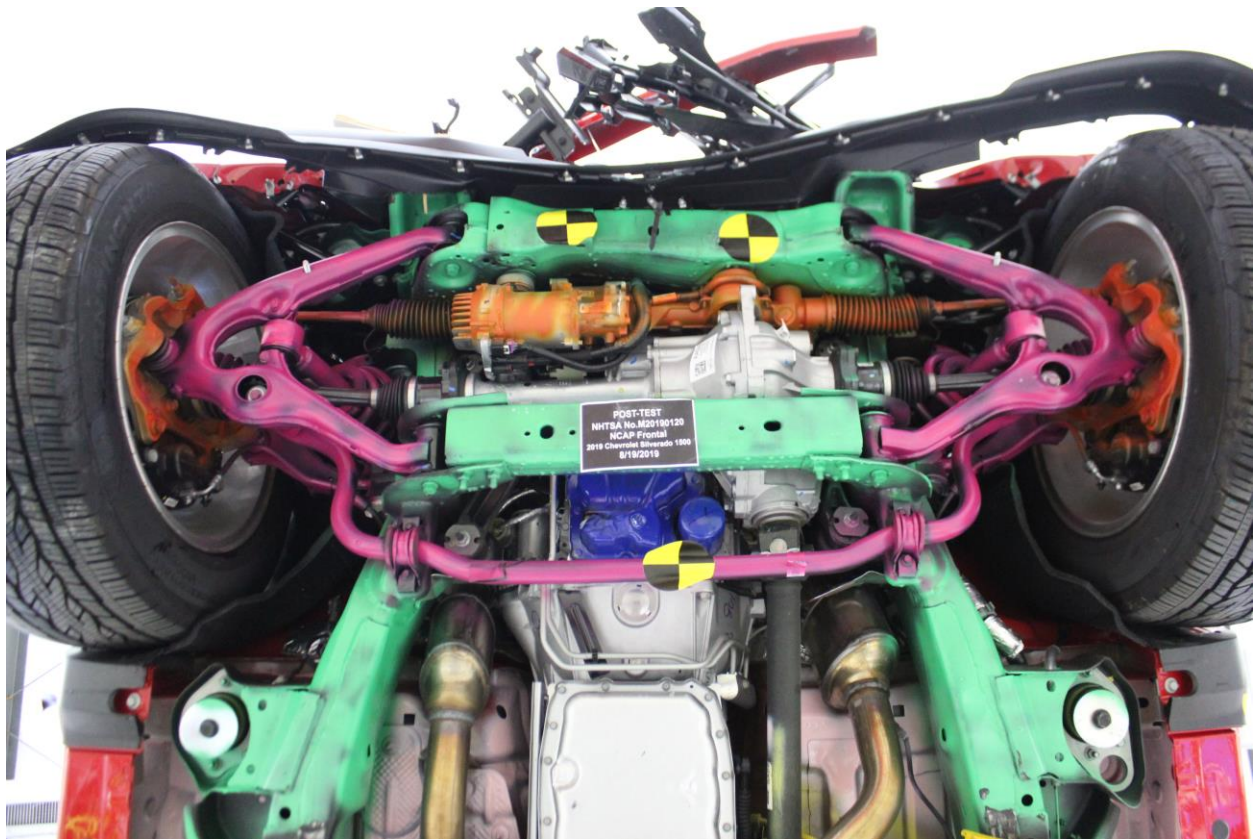
Figure A-25: Post-Test Front Underbody View

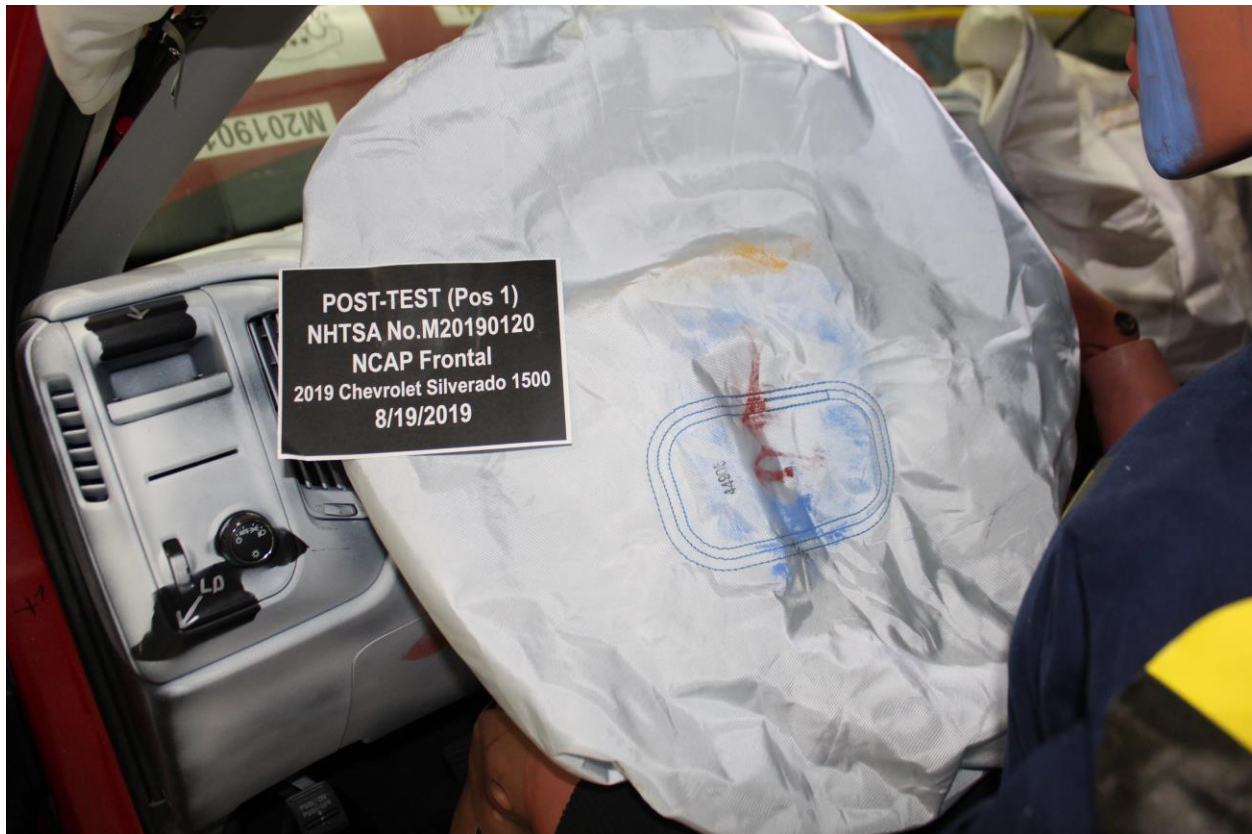
Figure A-47: Post-Test Driver Dummy Contact With Airbag

The driver's visible contact points were as follows: The driver's head contacted the frontal airbag and then the head restraint. The upper torso contacted the frontal airbag. Both knees contacted the knee bolster.

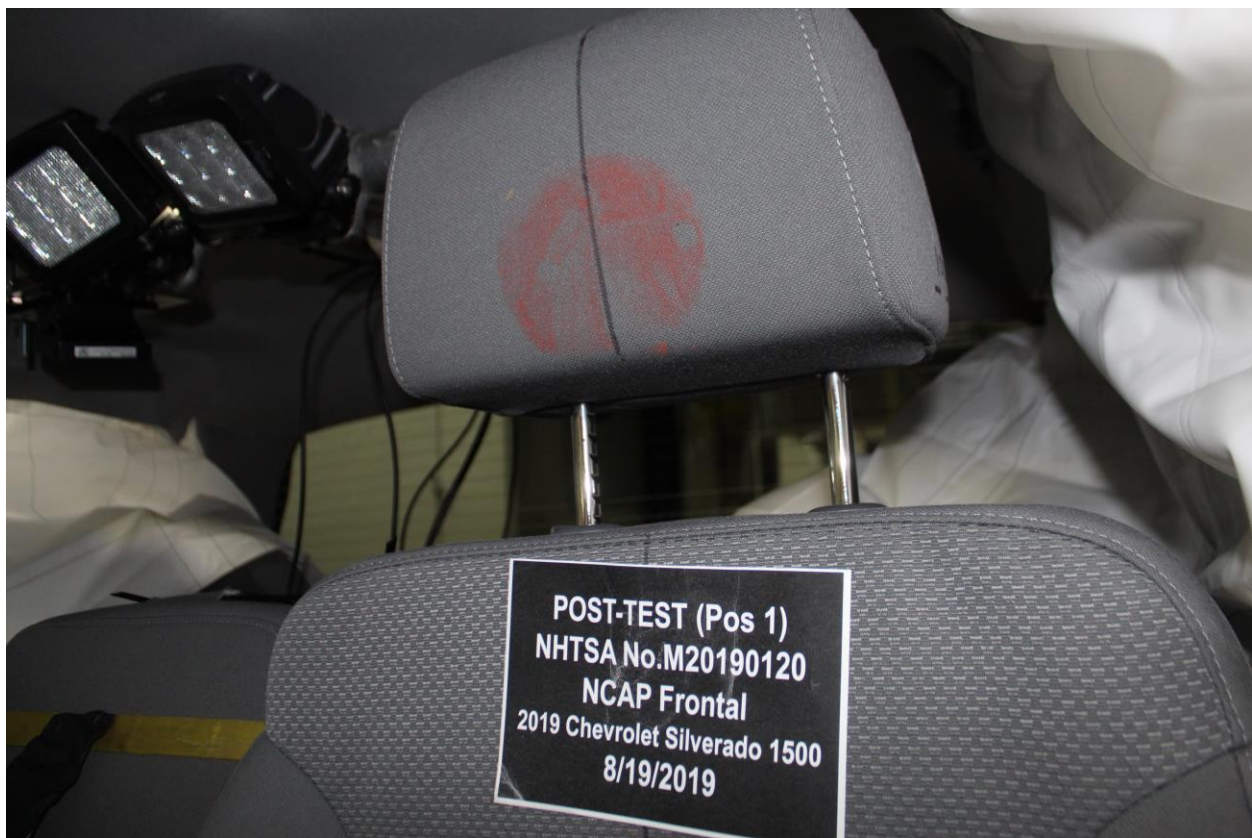
Figure A-48: Post-Test Driver Dummy Contact With Headrest

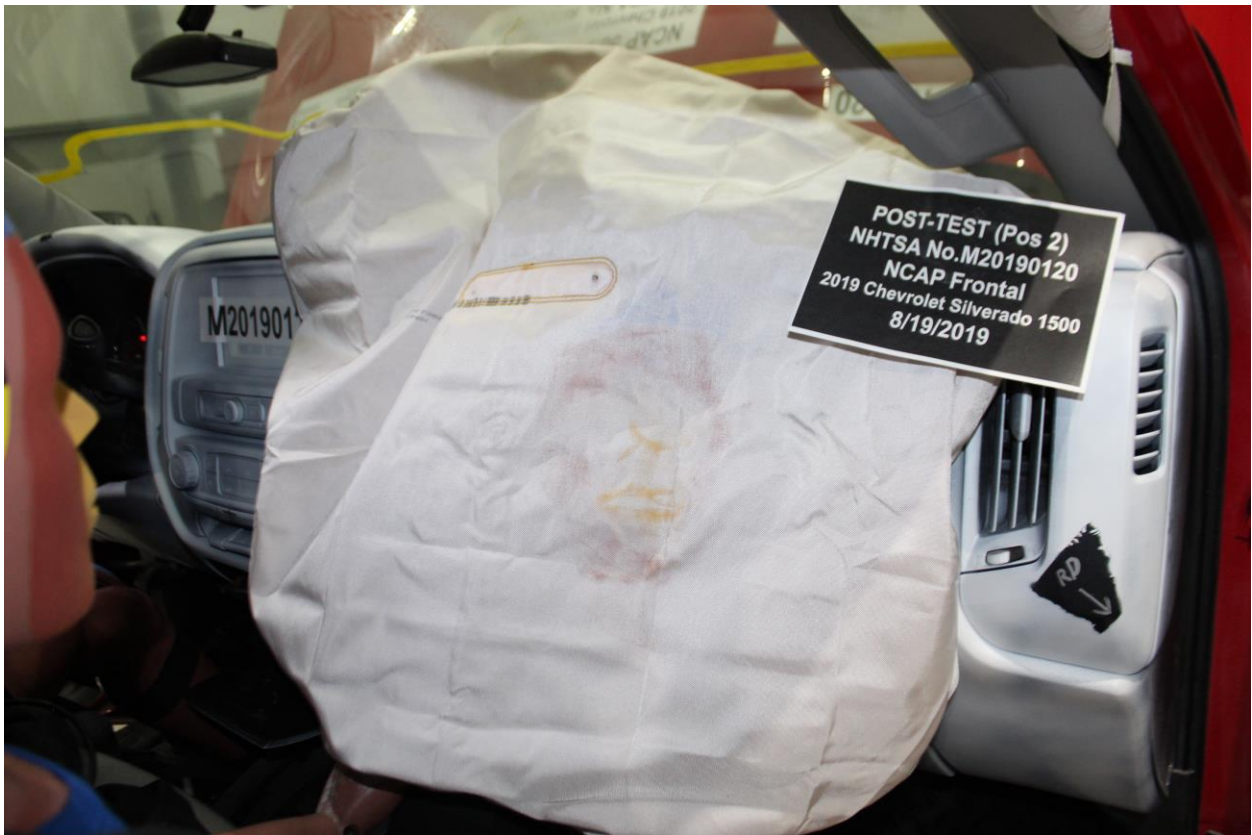
Figure A-68: Post-Test Passenger Dummy Contact With Airbag

The passenger's visible contact points were as follows: The passenger's head contacted the frontal airbag and then the head restraint. The upper torso contacted the frontal airbag. Both knees contacted the glove box.

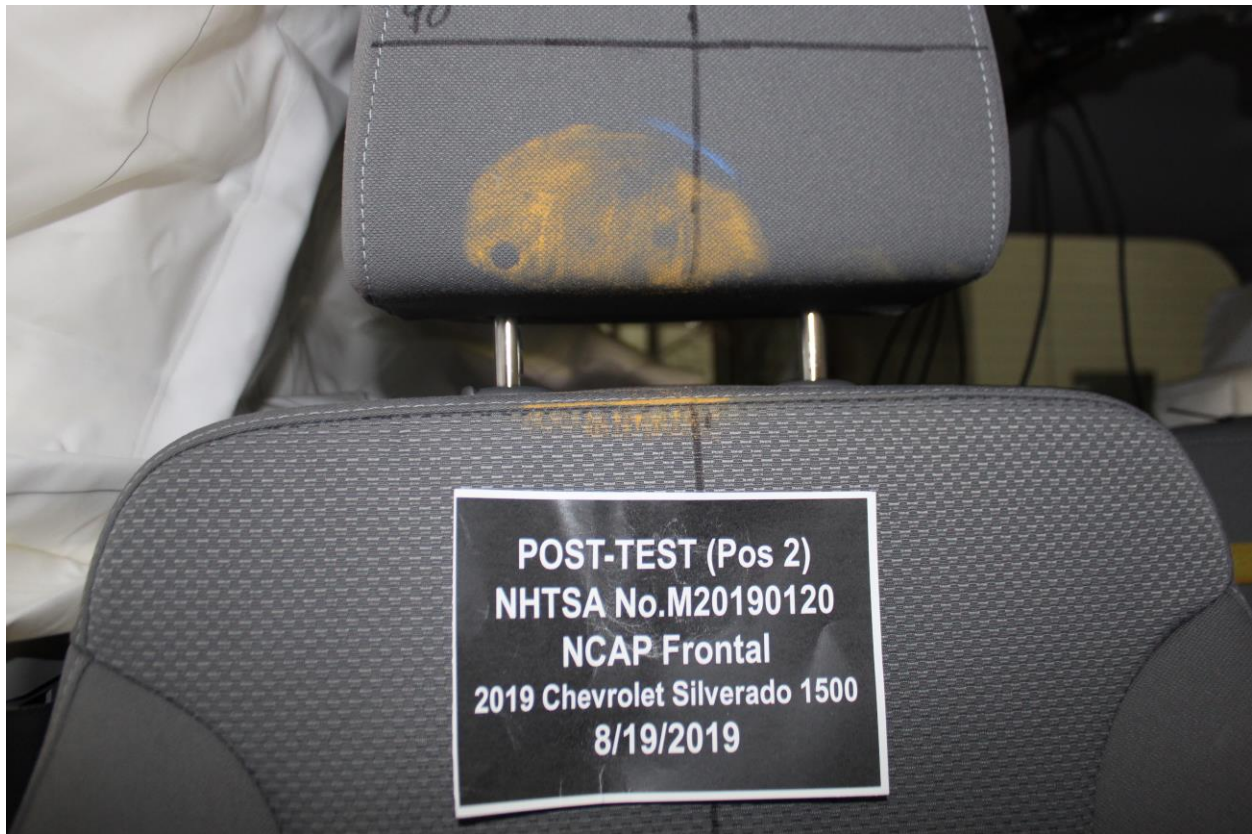
Figure A-69: Post-Test Passenger Dummy Contact With Headrest
