**REPORT NUMBER: SINCAP-MGA-19-049**

**NEW CAR ASSESSMENT PROGRAM (NCAP)  
Moving Deformable Barrier Side Impact Test**

**FORD MOTOR CO.  
2019 Ford F-250 SuperCab XL Truck  
NHTSA No.: M20190210**

**MGA RESEARCH CORPORATION  
5000 Warren Road  
Burlington, WI 53105**

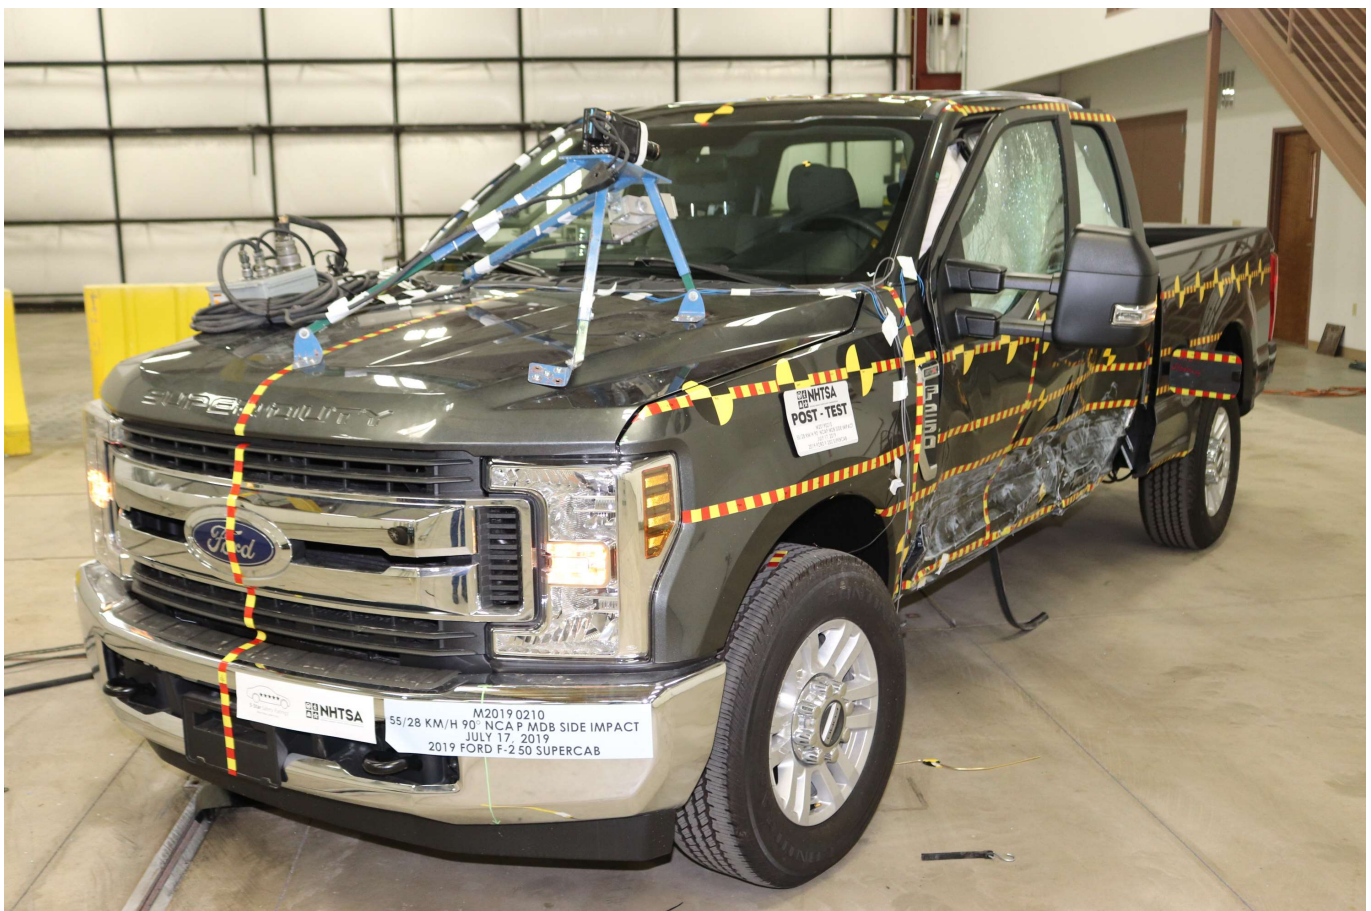
Photo No. 006 - Post-Test Left Front Three-Quarter View of Test Vehicle

Critical Areas of Performance	Observations and Conclusions
Pillar Performance	No Separation
Sill Separation	None
Windshield Damage	None
Side Window Damage	LF window cracked
Other Notable Effects	None

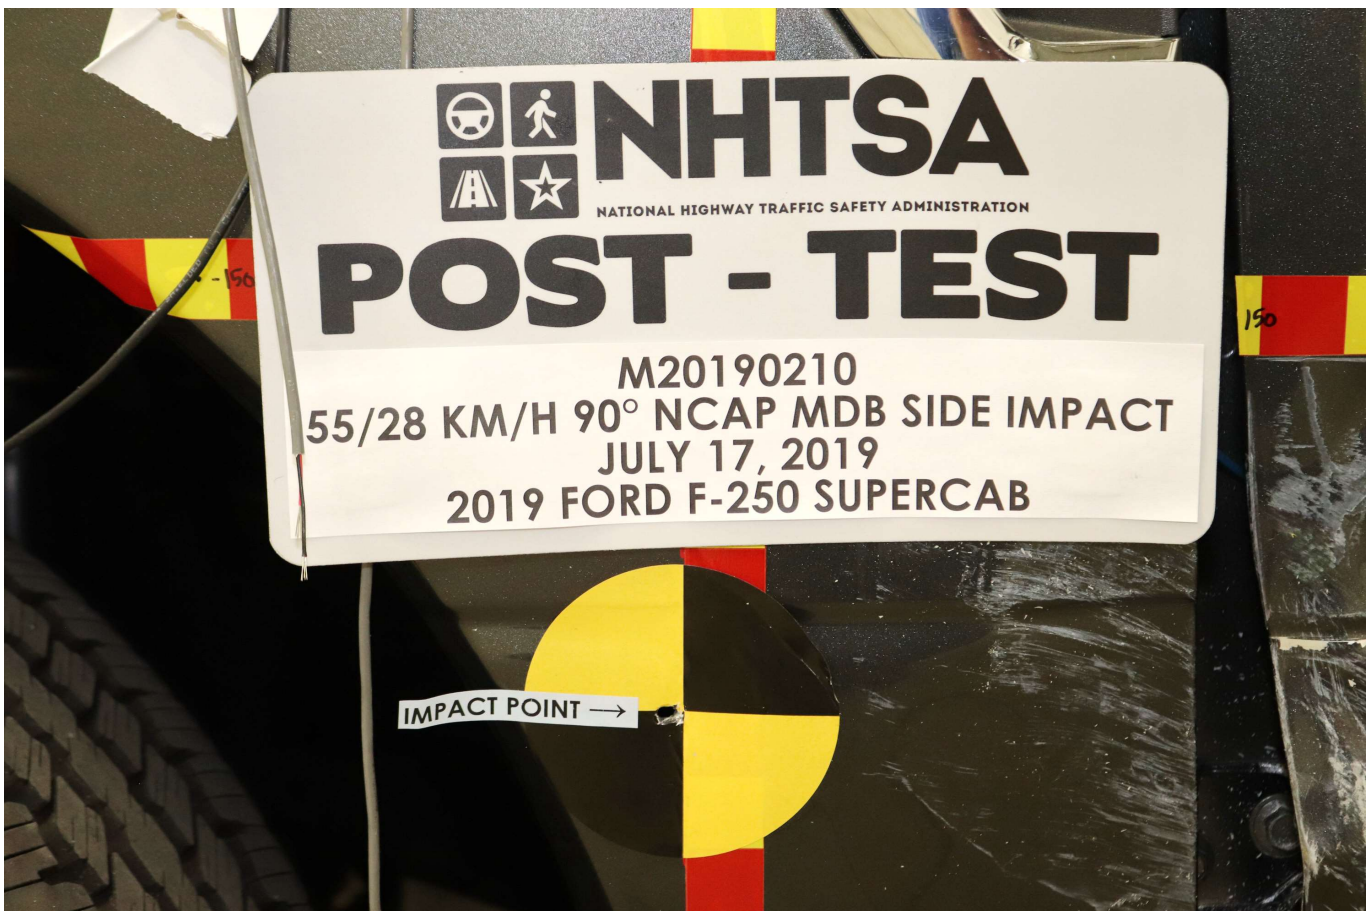
Photo No. 020 - Post-Test Close-Up View of Impact Point Target

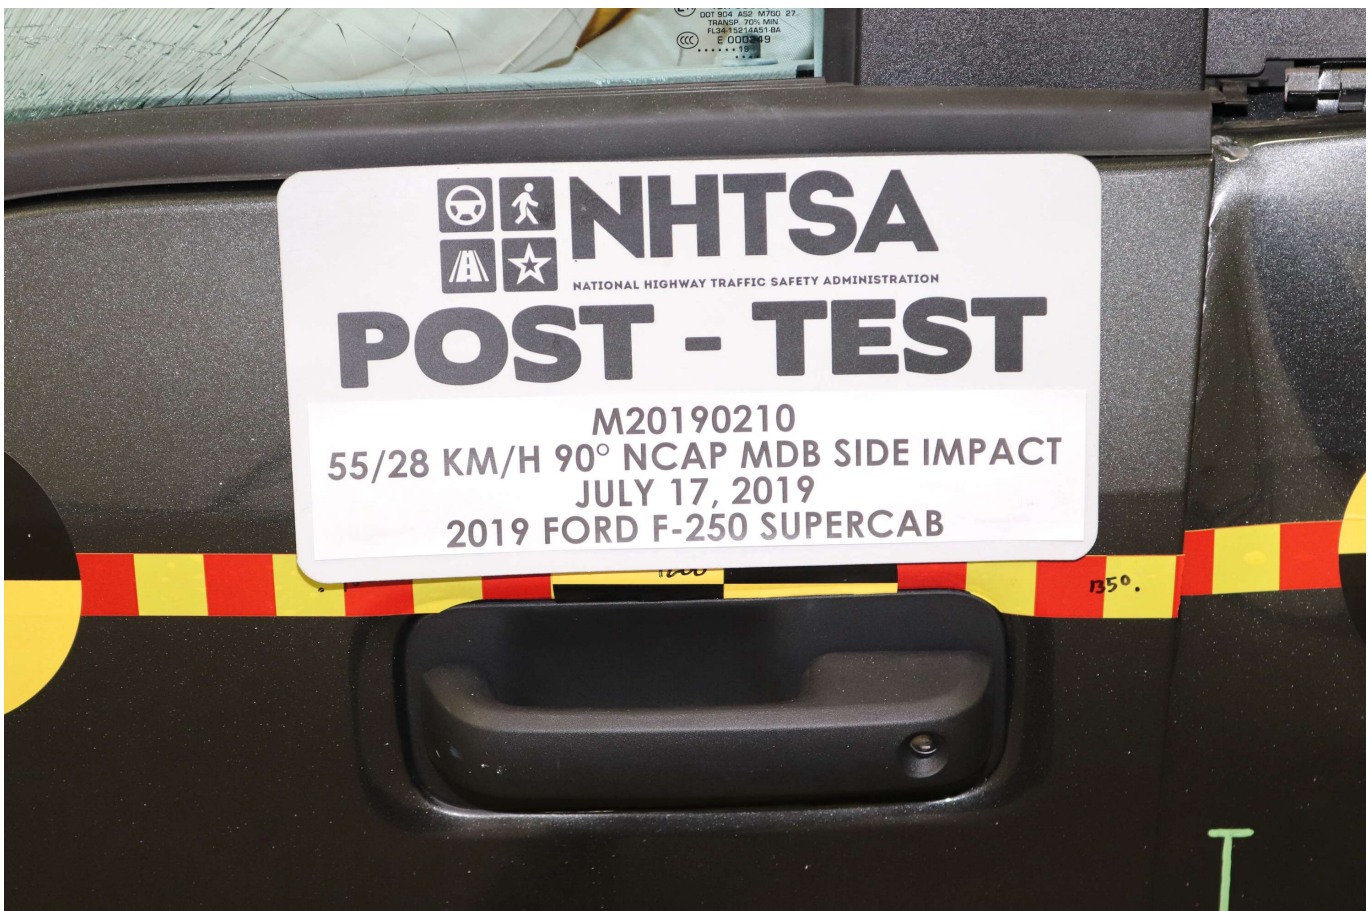
Photo No. 022 - Post-Test Left Front Door Latch Close-Up

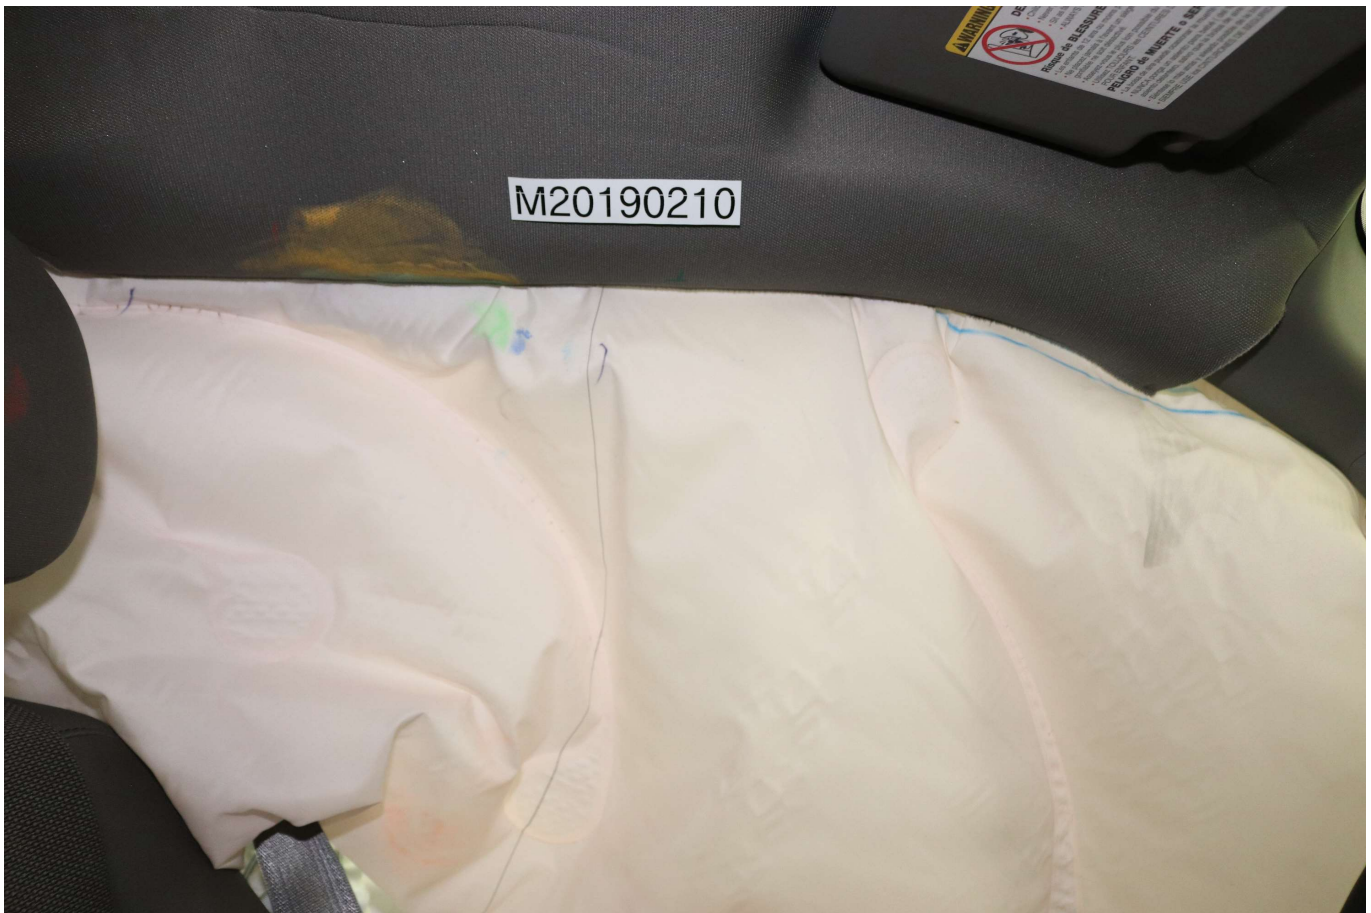
Photo No. 049 - Post-Test Driver Dummy Close-up Head Contact with Side Airbag View

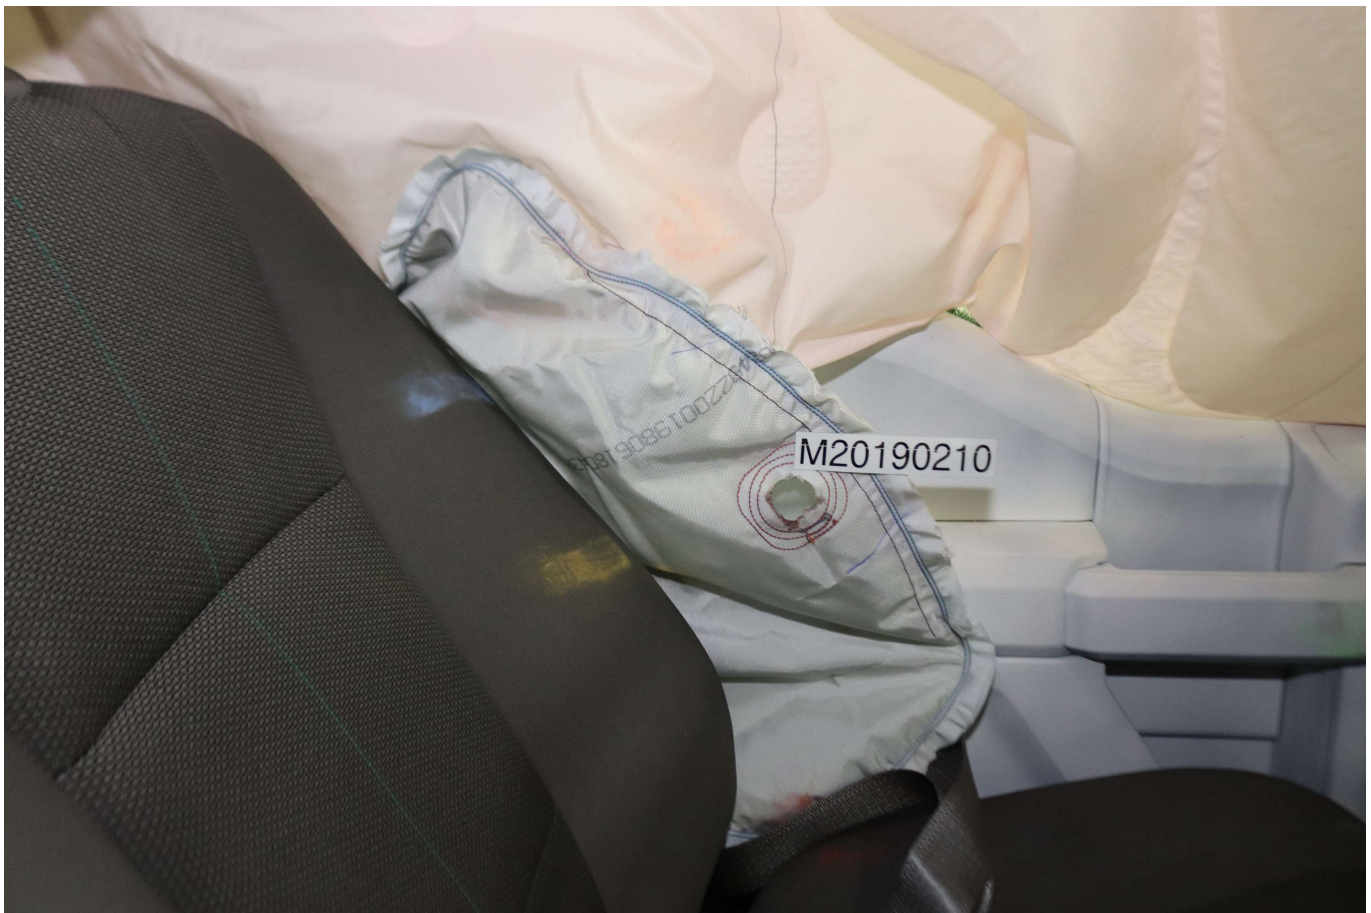
Photo No. 051 - Post-Test Driver Dummy Close-up Torso Contact with Side Airbag View

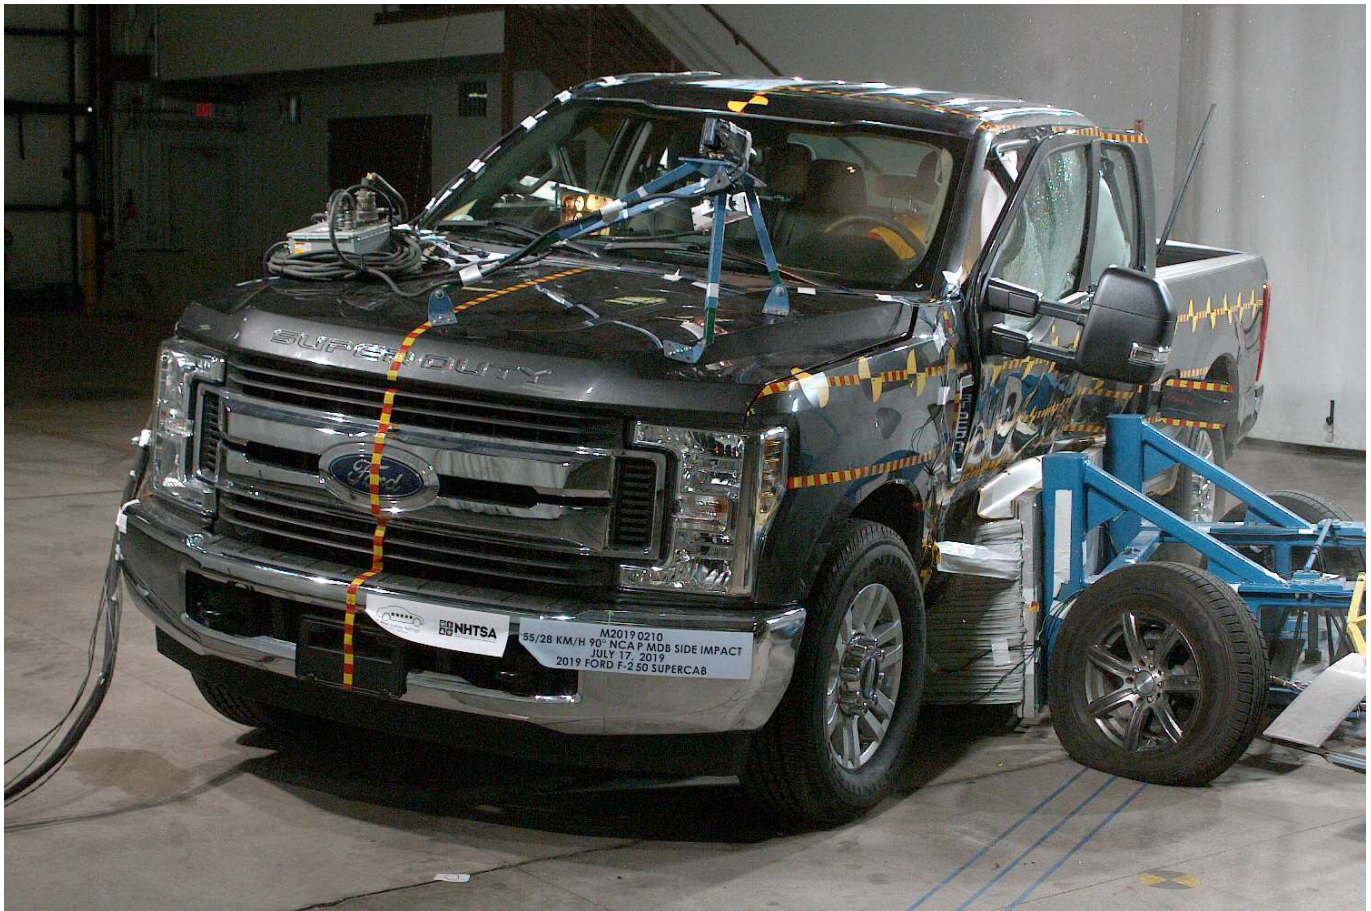
Photo No. 101 - Impact Event
