**REPORT NUMBER: SPNCAP-KAR-19-025
NEW CAR ASSESSMENT PROGRAM (NCAP)
SIDE IMPACT POLE TEST**

**KIA MOTORS CORPORATION
2019 KIA NIRO HYBRID LX 5-DOOR MPV**

NHTSA No: M20194210

FINAL REPORT

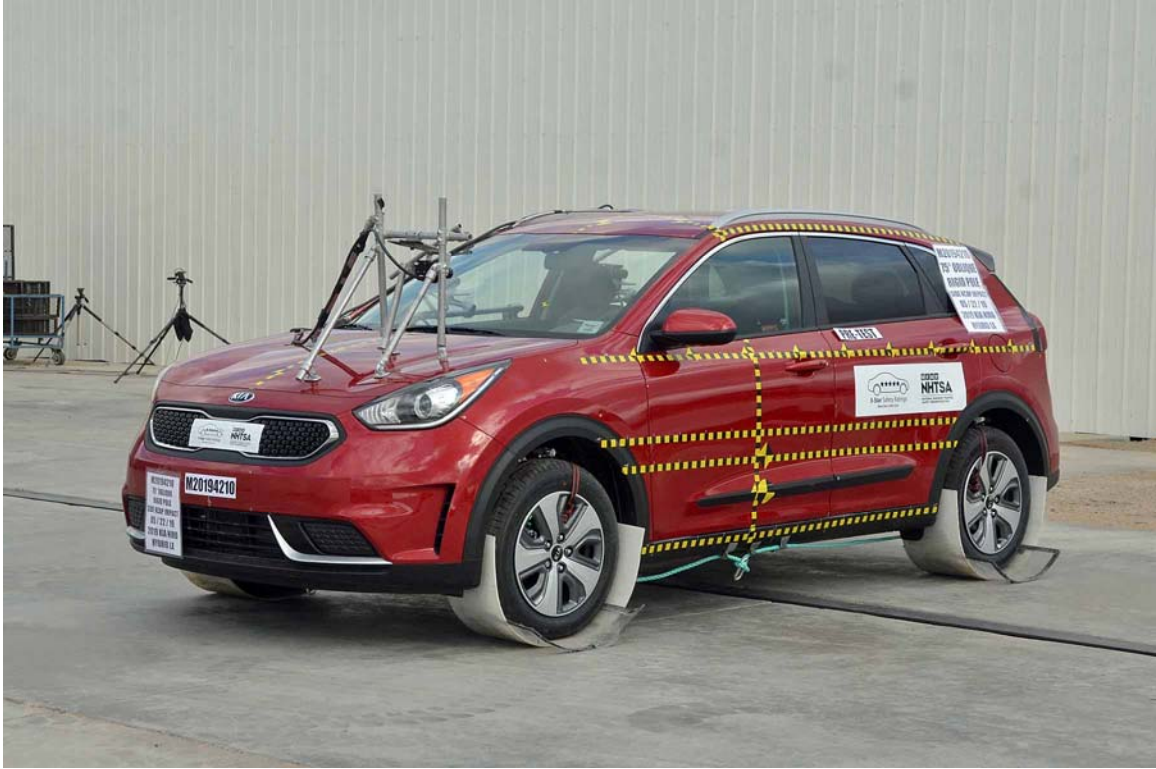
FIGURE 5. Pre-Test Left Front $\frac{3}{4}$ View of Test Vehicle

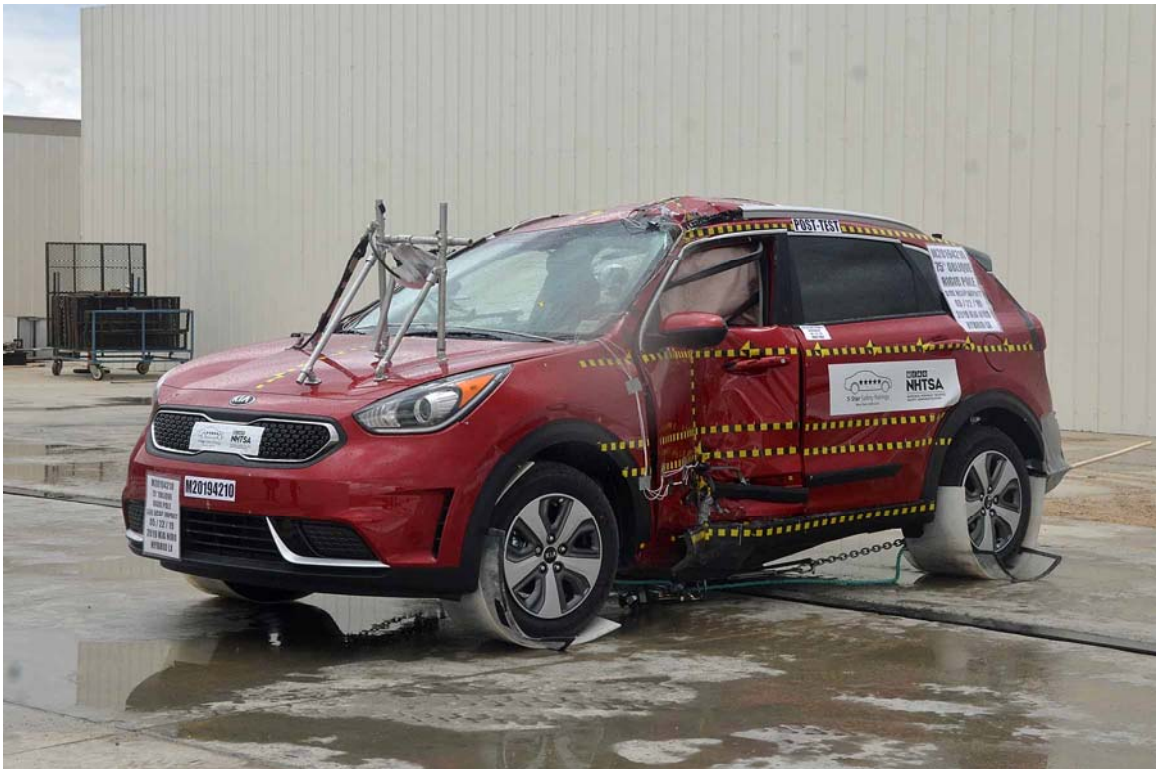
FIGURE 6. Post-Test Left Front $\frac{3}{4}$ View of Test Vehicle

The struck side doors of the vehicle were jammed shut. There was no separation at the hinges or latches. The remaining doors remained closed and latched. There were no ATD values that exceeded limits. The Left Floor Sill Y channel failed at 30.0 ms and the Driver Seat Track Y channel failed at 35.1 ms. The Right Sill Y, Floorpan at Rear Axle X, and Load Cell Pole #3 Force Y channels failed and no data was collected.

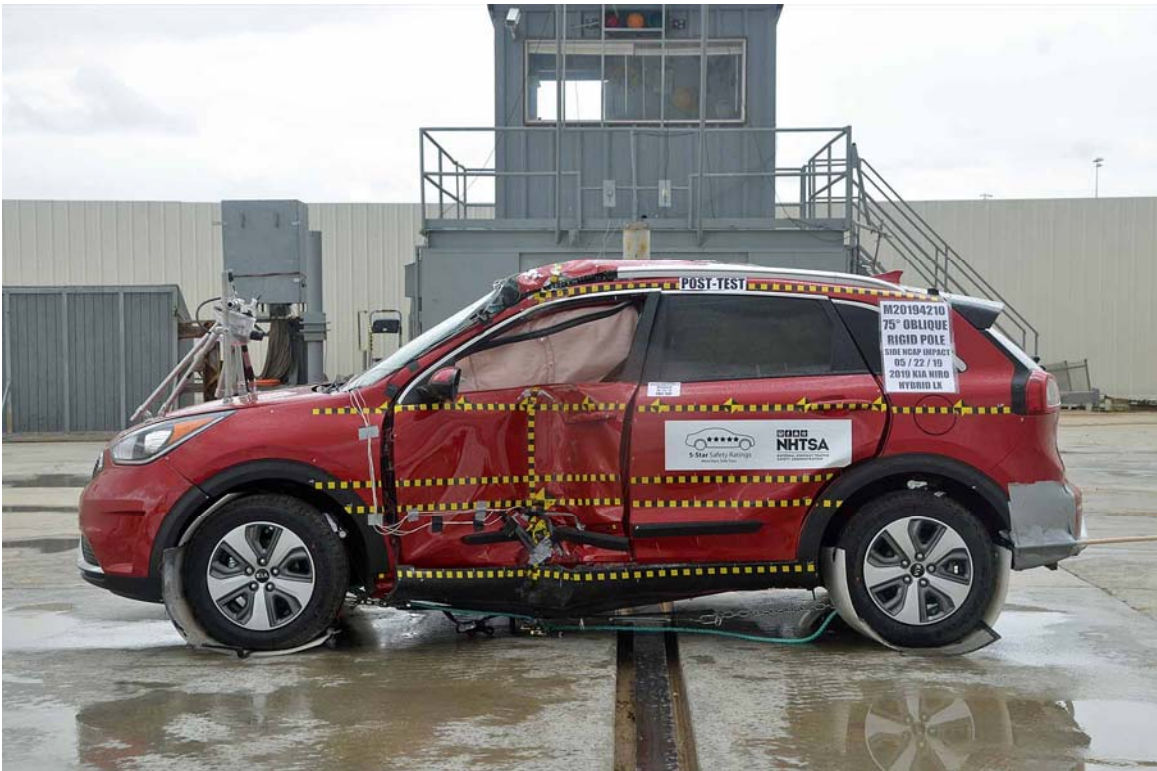
FIGURE 8. Post-Test Left Side View of Test Vehicle

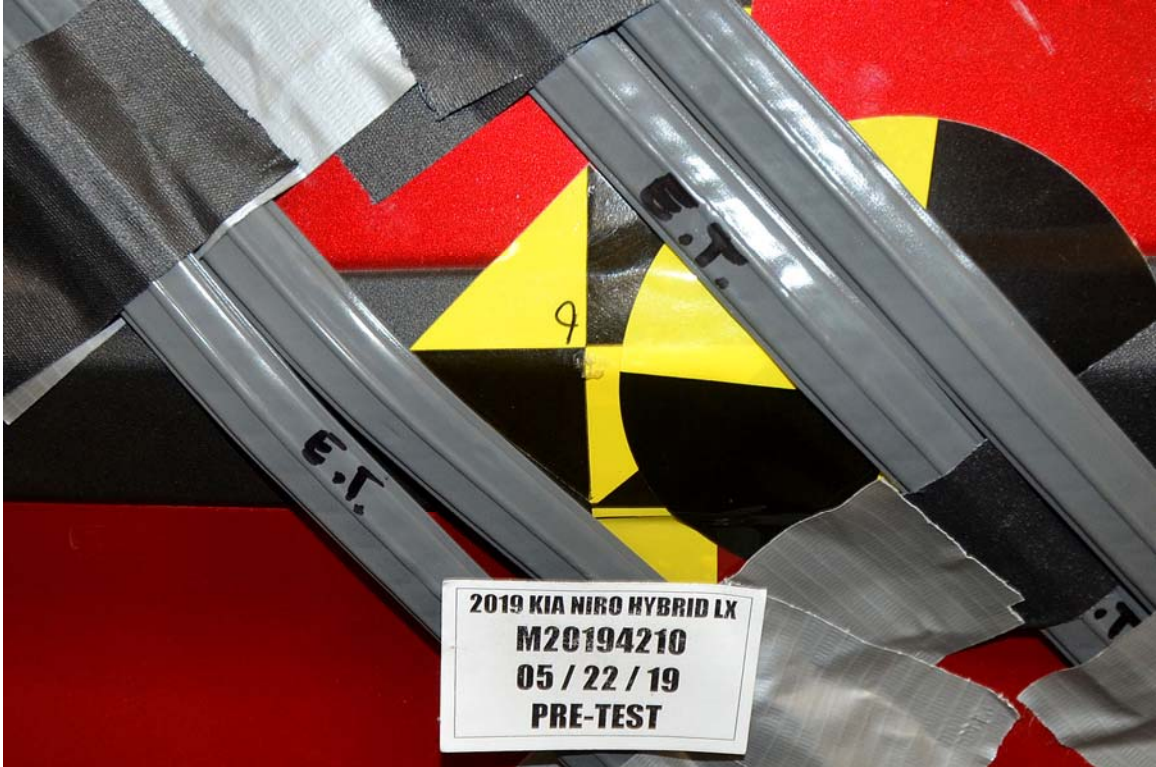
FIGURE 19. Pre-Test Close-Up View of Impact Point Target

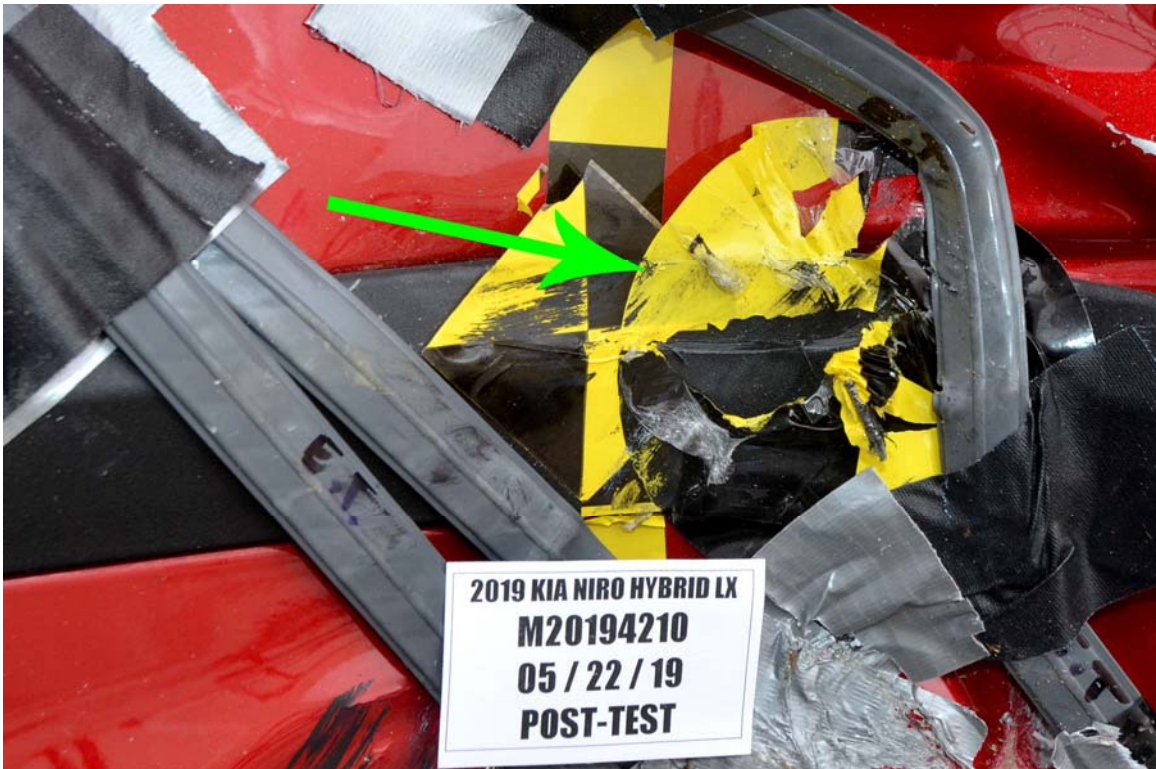
FIGURE 20. Post-Test Close-Up View of Impact Point Target Showing Impact Location

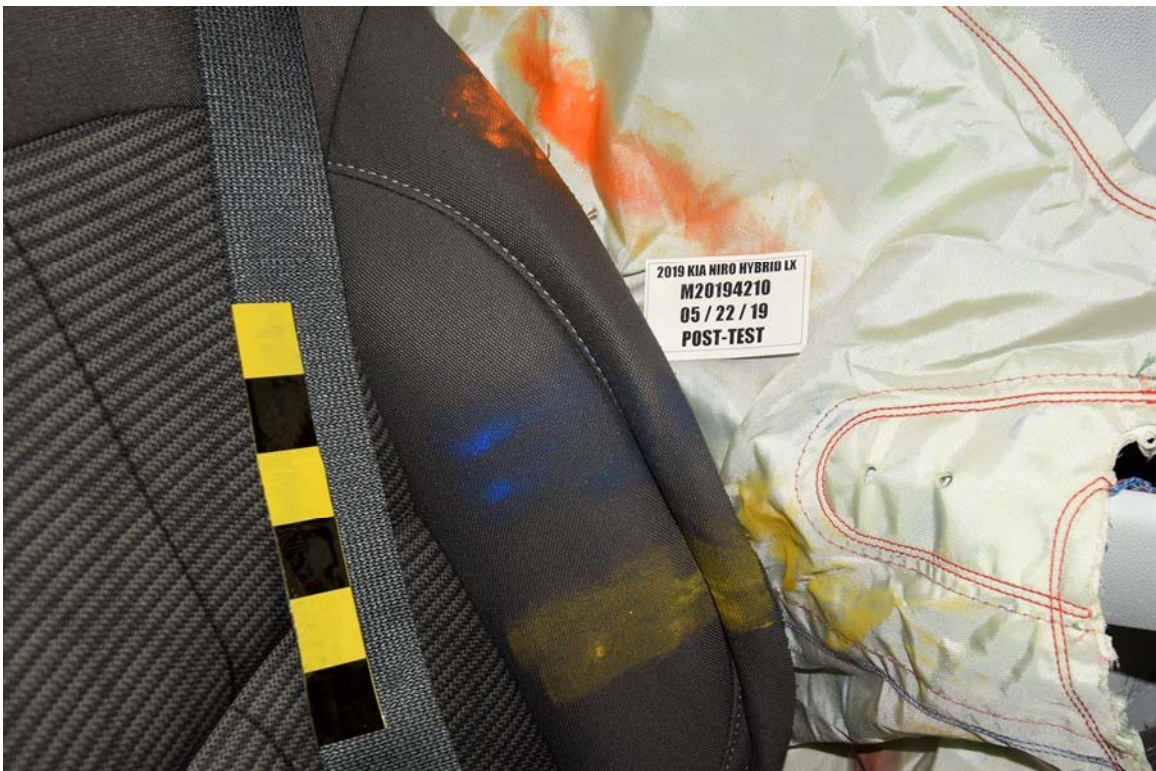
FIGURE 48. Post-Test Dummy Close-Up Torso Contact With Vehicle Interior View

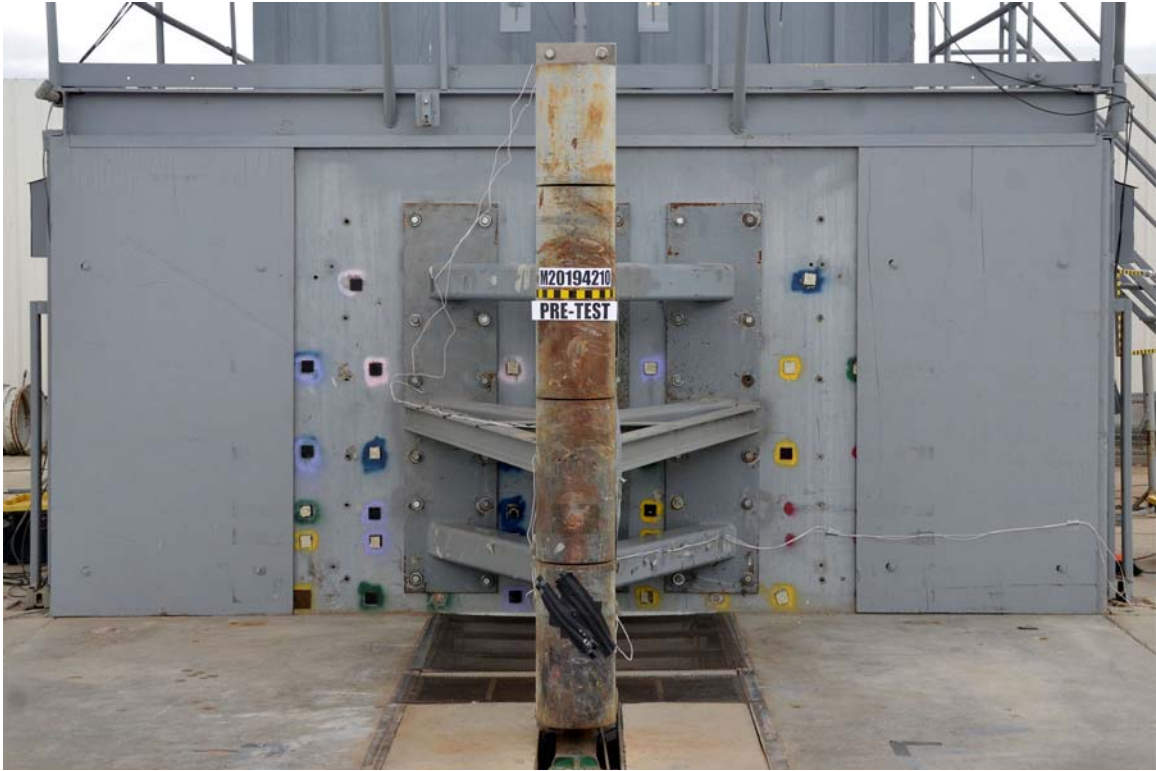
FIGURE 57. Pre-Test Pole Barrier Front View

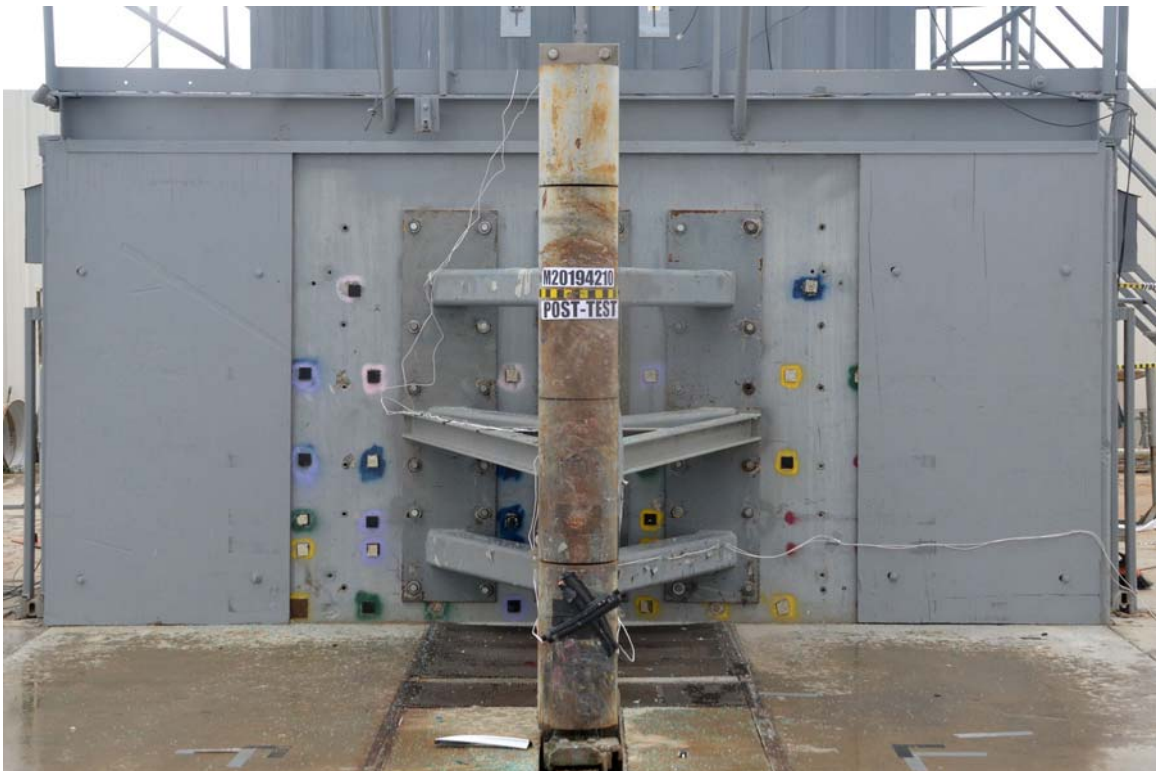
FIGURE 58. Post-Test Pole Barrier Front View

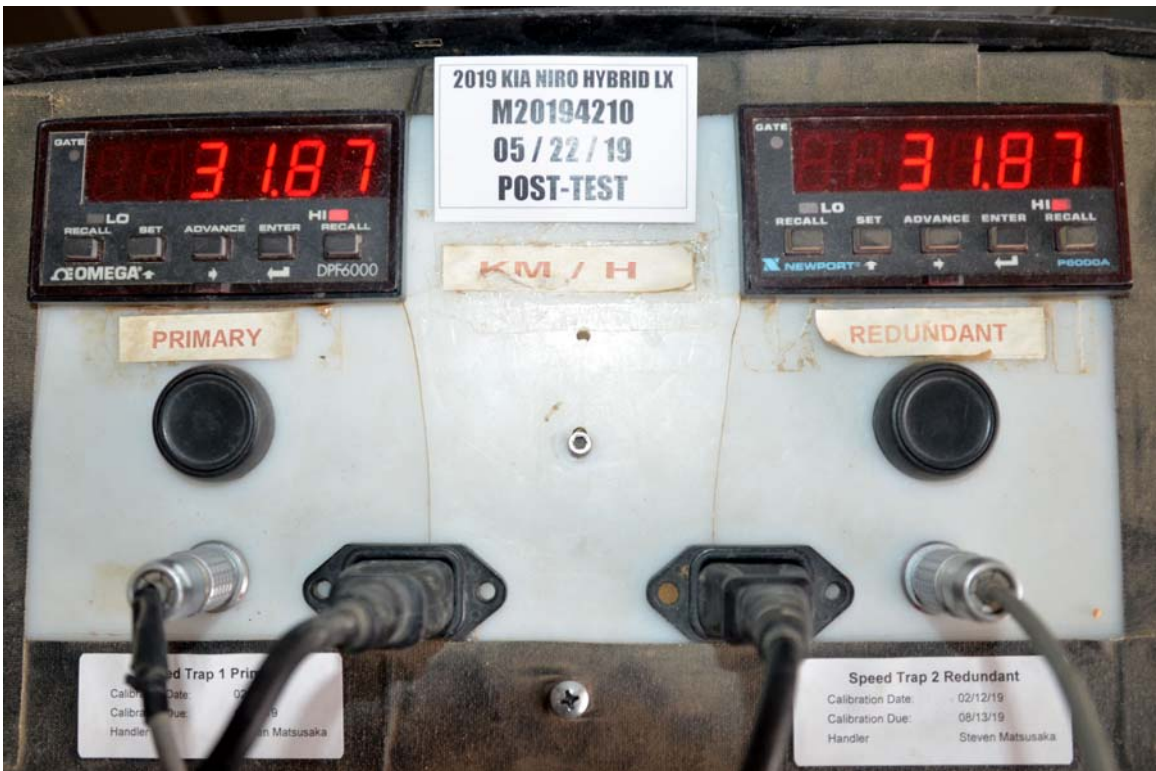
FIGURE 62. Post-Test Primary and Redundant Speed Trap Read-Out

A rigid pole side impact test was conducted on a 2019 Kia Niro Hybrid LX 5-door MPV. The subject vehicle was towed into the rigid pole at an angle of 75.9° and a velocity of 31.87 km/h. The test was conducted by Applus IDIADA KARCO Engineering, LLC. in Adelanto, California on May 22, 2019. Pre- and post-test photographs of the test vehicle and side impact dummy (SID-IIs) are included in Appendix A of this report.

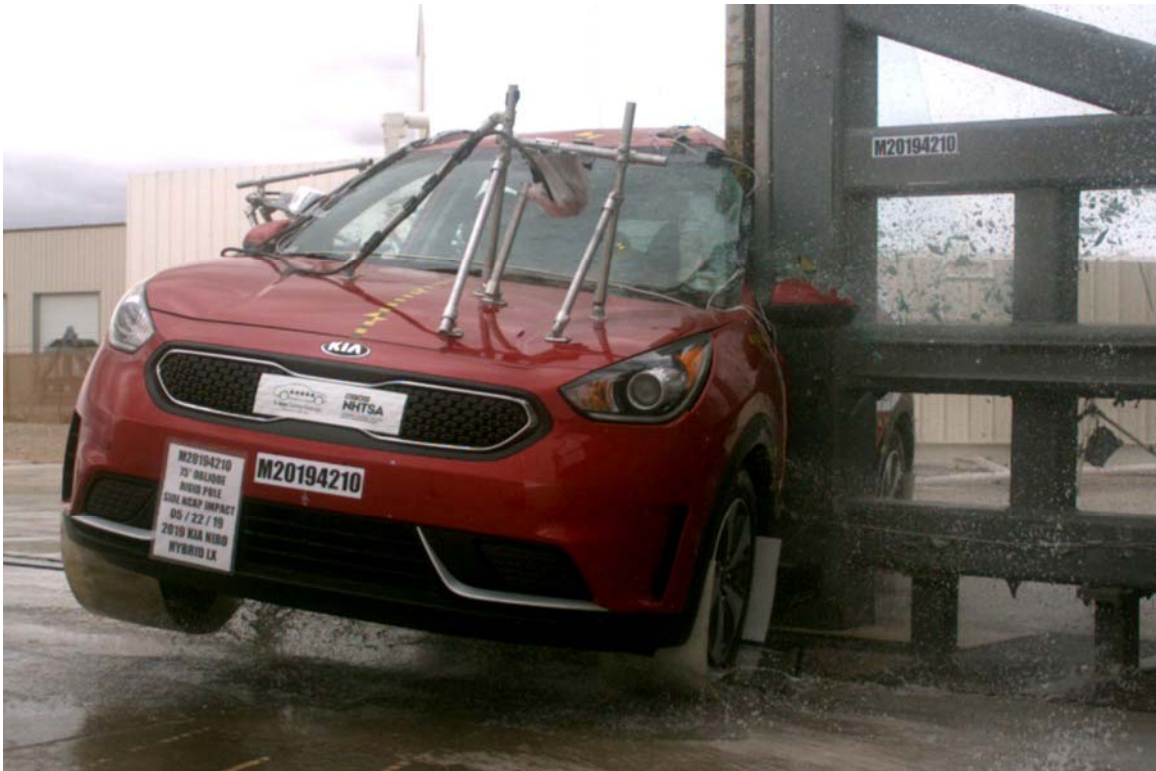
FIGURE 68. Impact Event
