**REPORT NUMBER: SPNCAP-KAR-19-031
NEW CAR ASSESSMENT PROGRAM (NCAP)
SIDE IMPACT POLE TEST**

**FCA US LLC
2019 JEEP GRAND CHEROKEE LAREDO 5-DOOR MPV**

**PREPARED BY:
APPLUS IDIADA KARCO ENGINEERING, LLC.
9270 HOLLY ROAD
ADELANTO, CA 92301**

FINAL REPORT

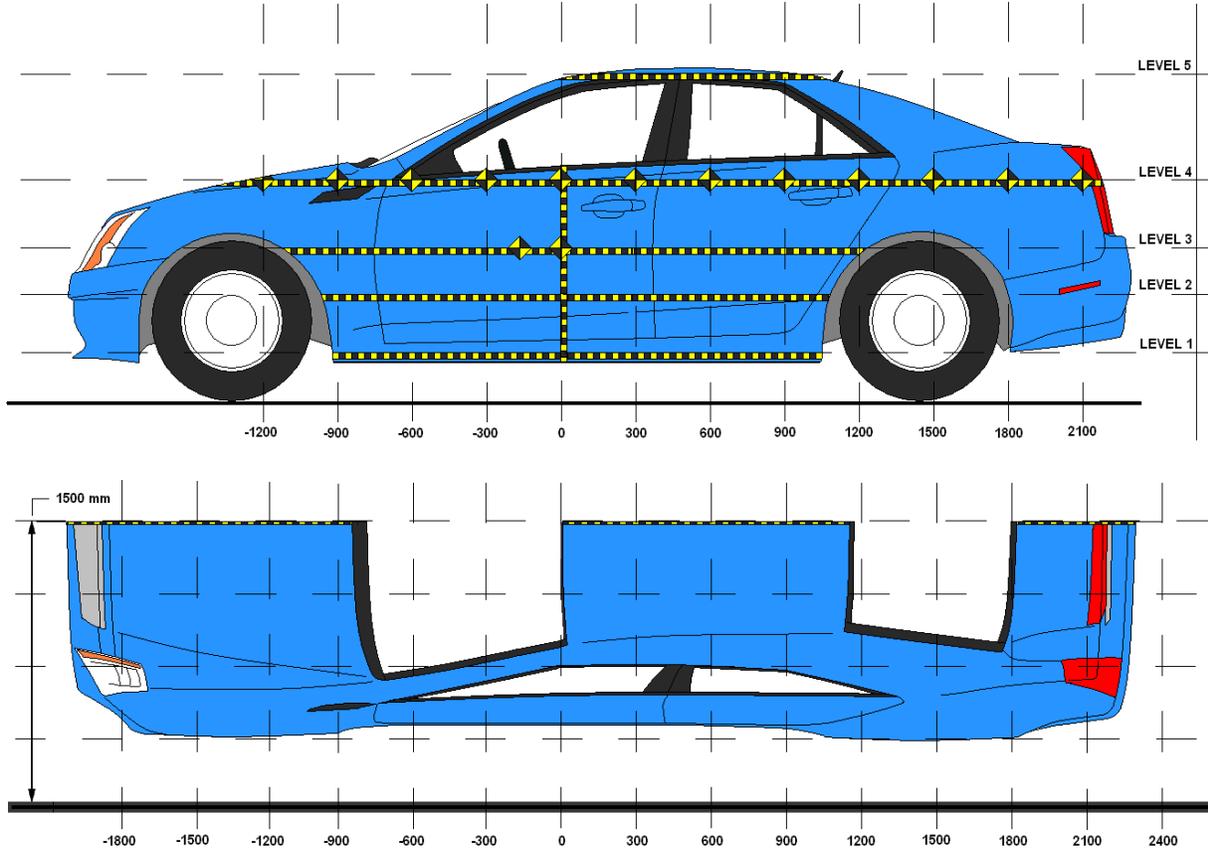
NOTE: All measurements in mm with tolerance of ± 3 mm

MAXIMUM EXTERIOR CRUSH MEASUREMENTS
