**OCAS-DRI-CIB-19-01
NEW CAR ASSESSMENT PROGRAM
CRASH IMMINENT BRAKE SYSTEM CONFIRMATION TEST**

2019 Ford Expedition

Final Report

1. Report No. OCAS-DRI-CIB-19-01	2. Government Accession No.	3. Recipient's Catalog No.	
4. Title and Subtitle Final Report of Crash Imminent Brake System Confirmation Testing of a 2019 Ford Expedition.		5. Report Date 31 October 2019

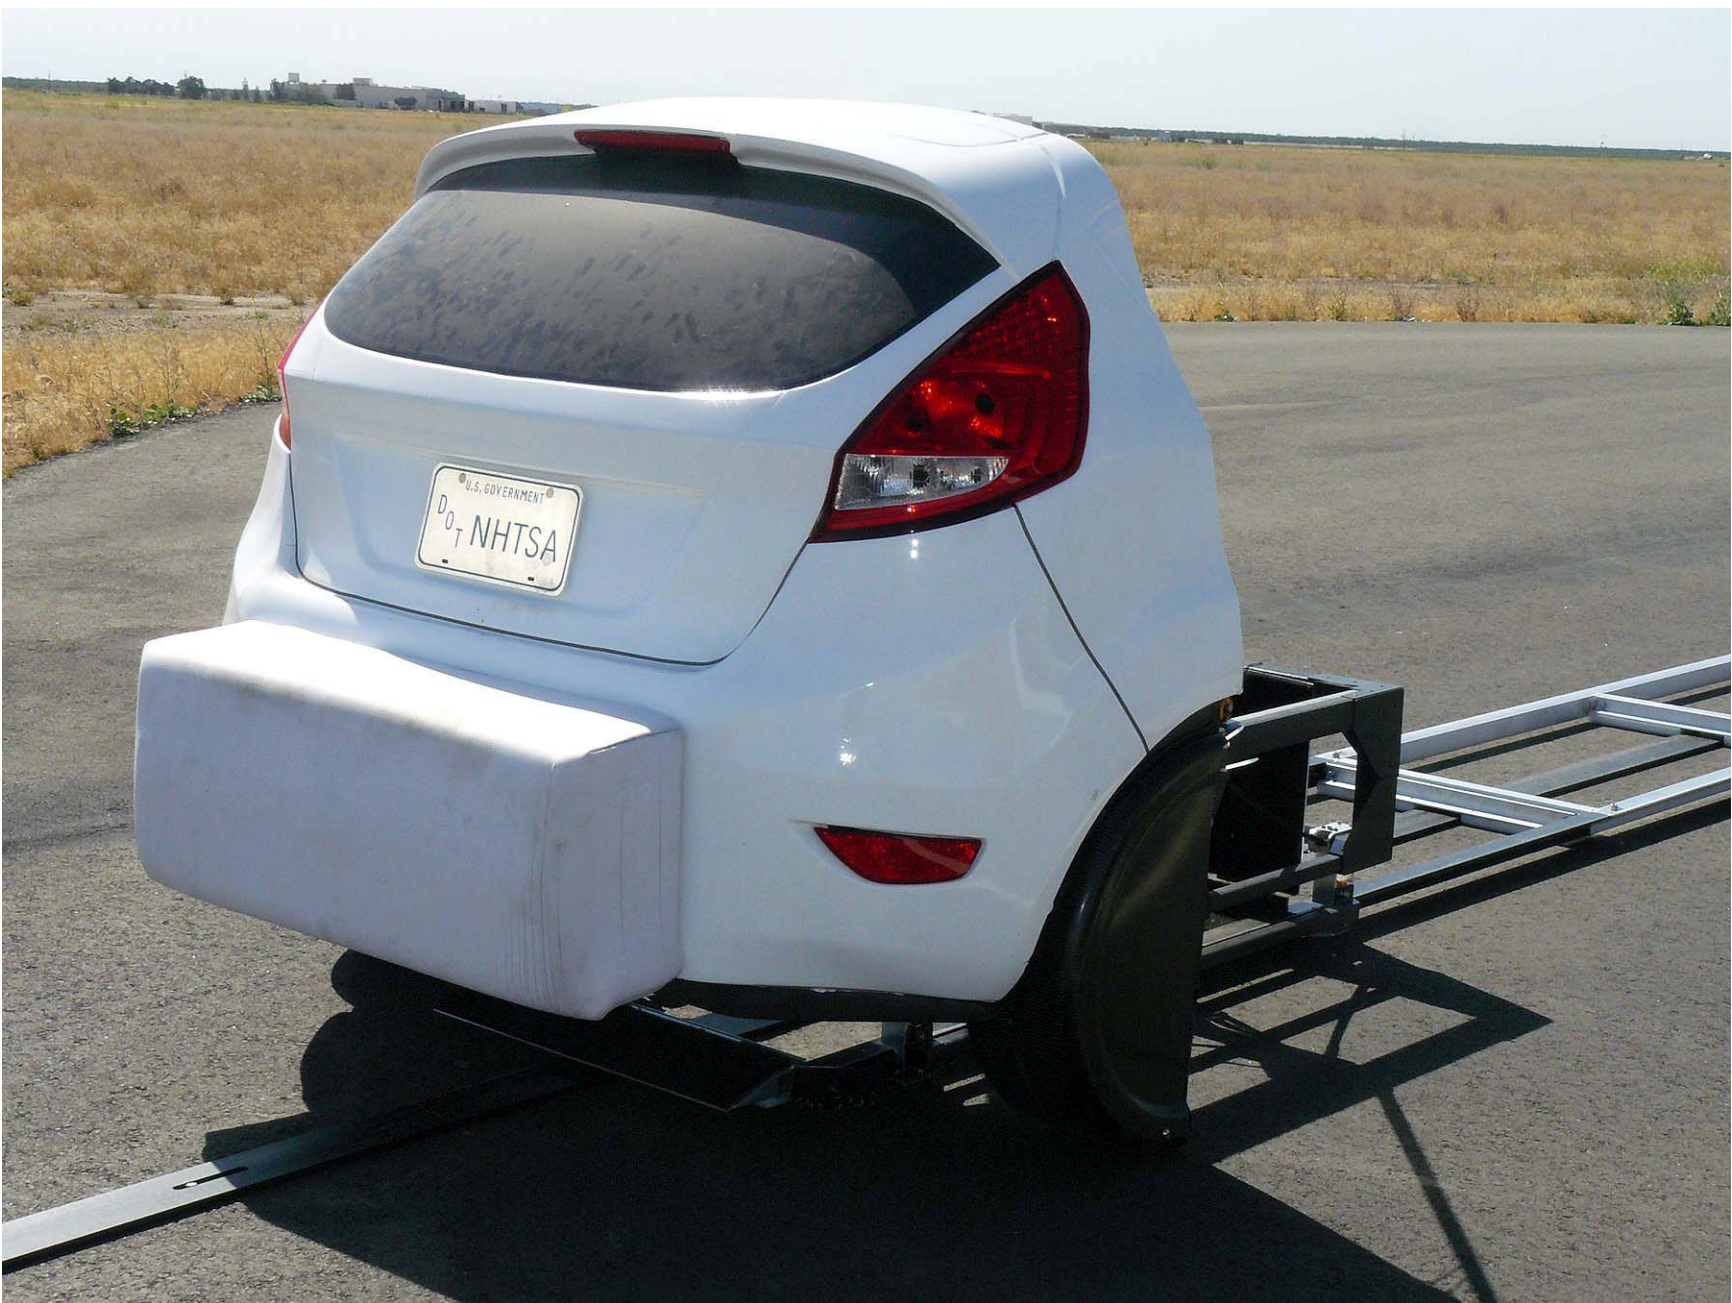
Figure A6. Rear View of Principal Other Vehicle (SSV)

CIB testing requires a POV that realistically represents typical vehicles, does not suffer damage or cause damage to a test vehicle in the event of collision, and can be accurately positioned and moved during the tests. The tests reported herein made use of the NHTSA developed Strikeable Surrogate Vehicle (SSV).

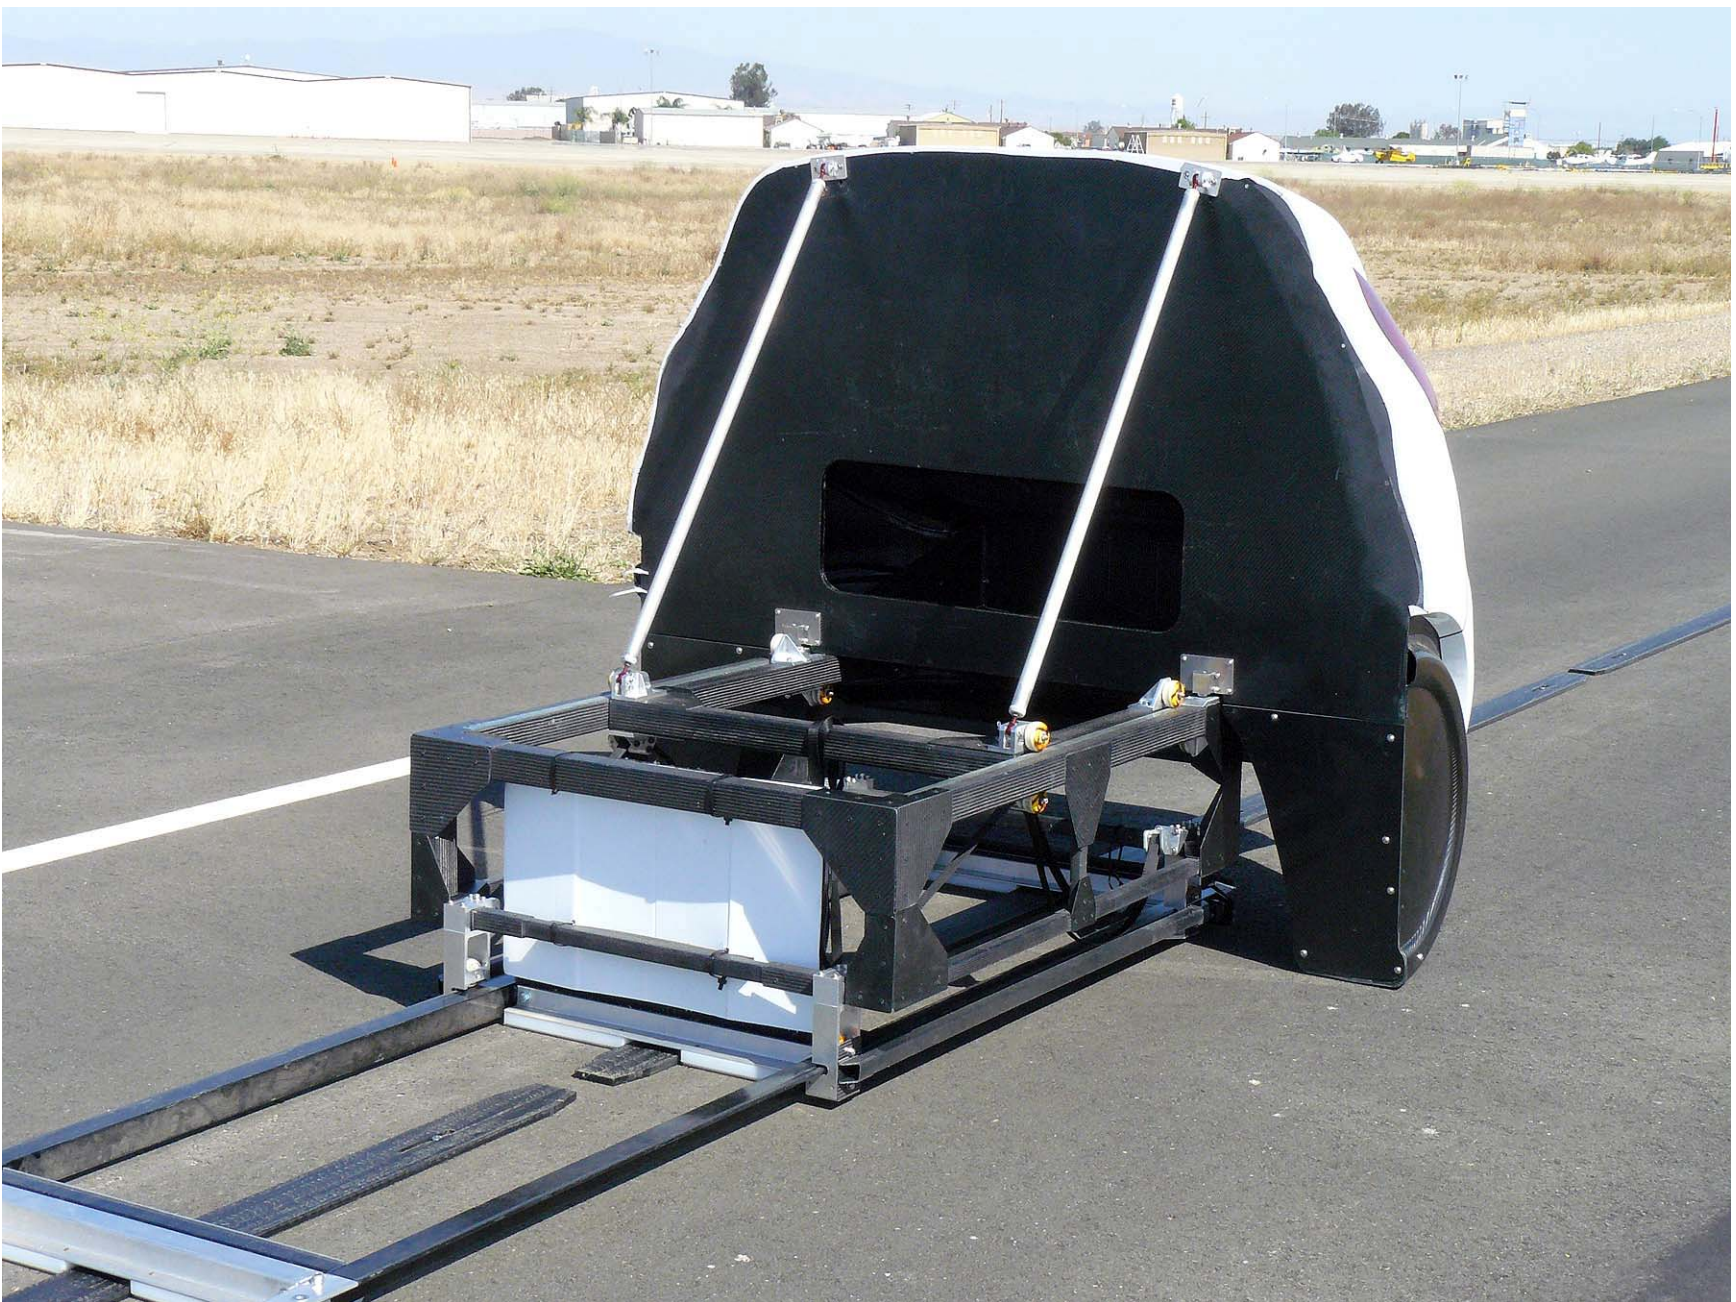
Figure A7. Load Frame/Slider of SSV

from the SV. The forward end of the rail has a cushioned stop to restrain forward motion of the shell/roller assembly. After impacting the SSV, the SV driver uses the steering wheel to maintain SV position in the center of the travel lane, thereby straddling the two-rail track. The SV driver must manually apply the SV brakes after impact. The SSV system is shown in Figures A6 through A8 and a detailed description can be found in the NHTSA report: NHTSA'S STRIKEABLE SURROGATE VEHICLE PRELIMINARY DESIGN + OVERVIEW, May 2013.

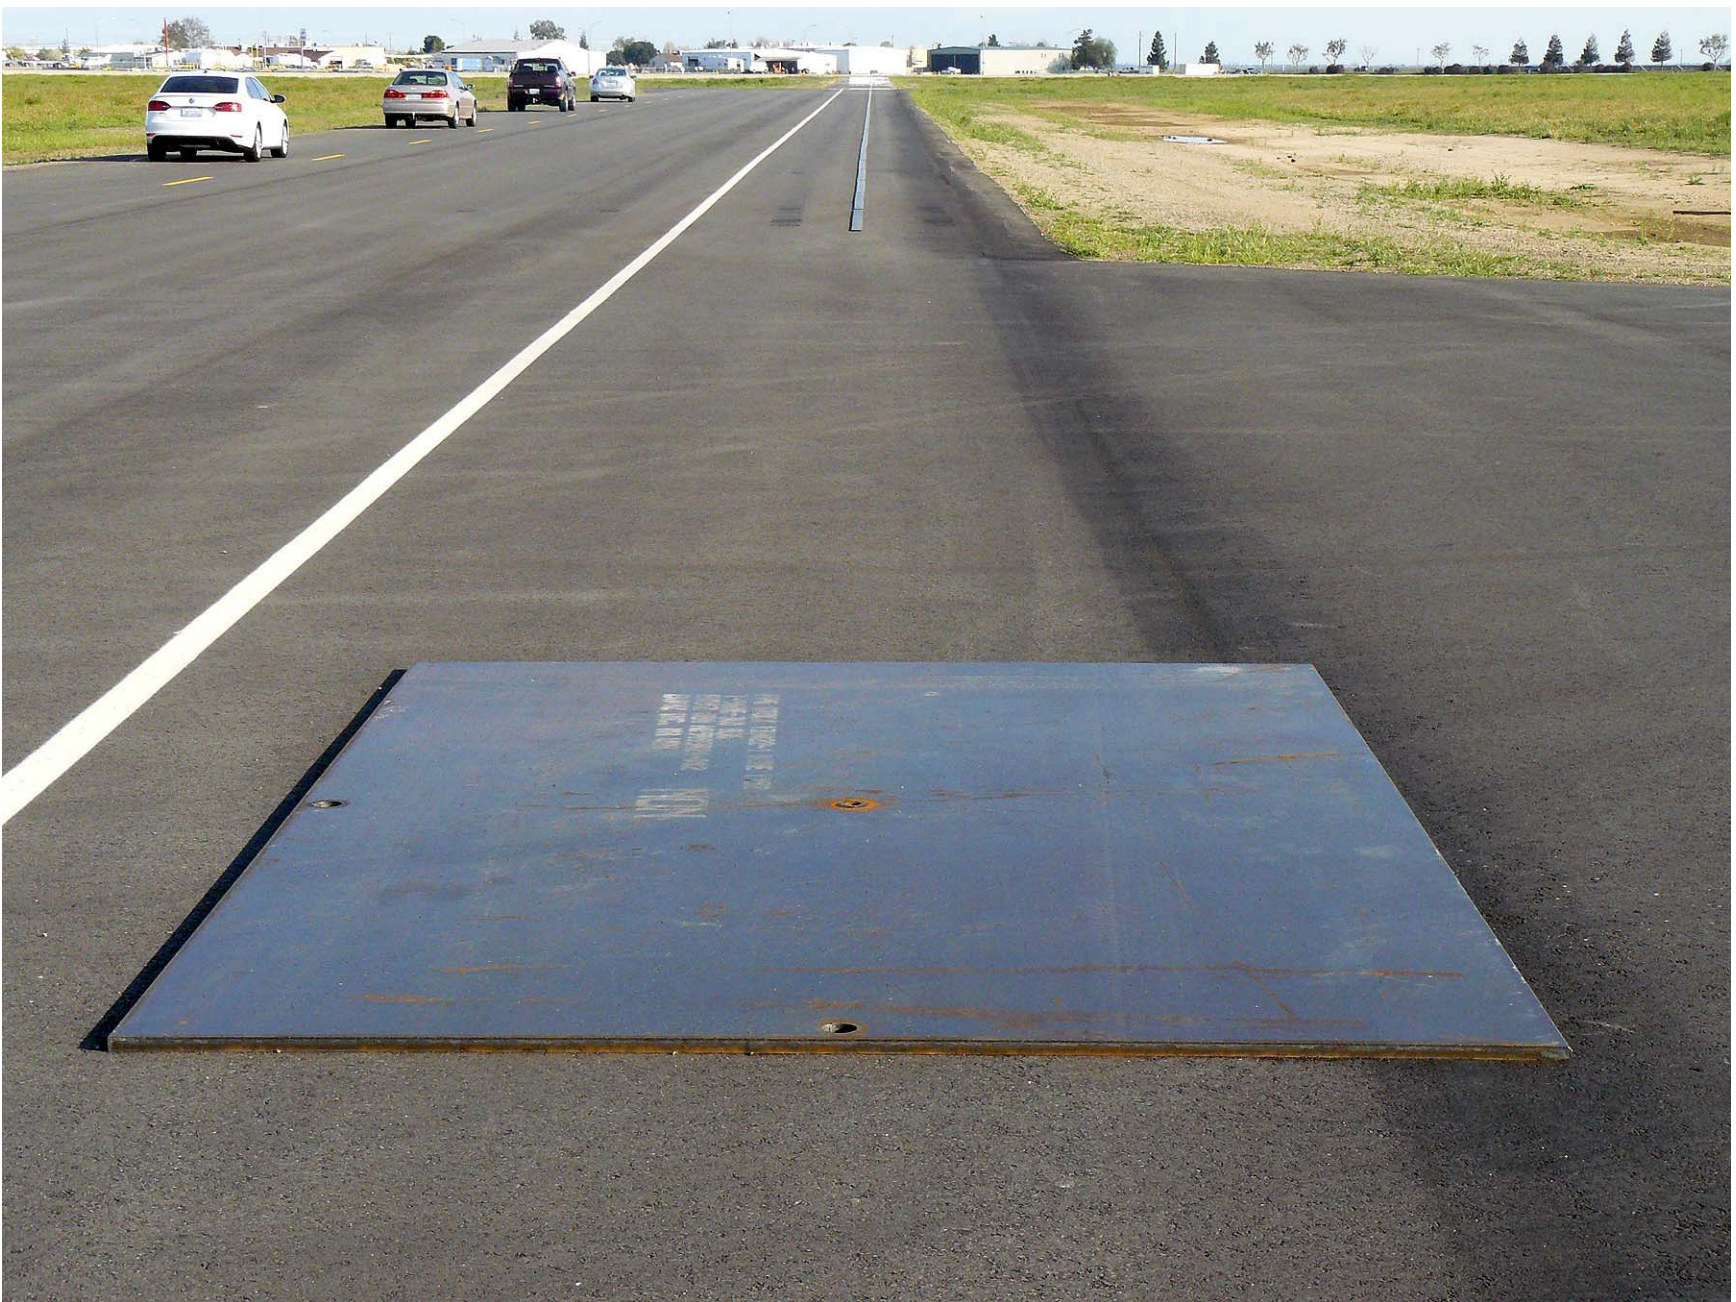
Figure A9. Steel Trench Plate

The false positive suppression test series evaluates the ability of a CIB system to differentiate a steel trench plate (STP) from an object presenting a genuine safety risk to the SV. Although the STP is large and metallic, it is designed to be driven over without risk of injury to the driver or damage to the SV. Therefore, in this scenario, the automatic braking available from CIB is not necessary and should be suppressed. The test condition is nearly equivalent to that previously defined for Test 1, the stopped POV condition, but with an STP in the SV forward path in lieu of a POV.

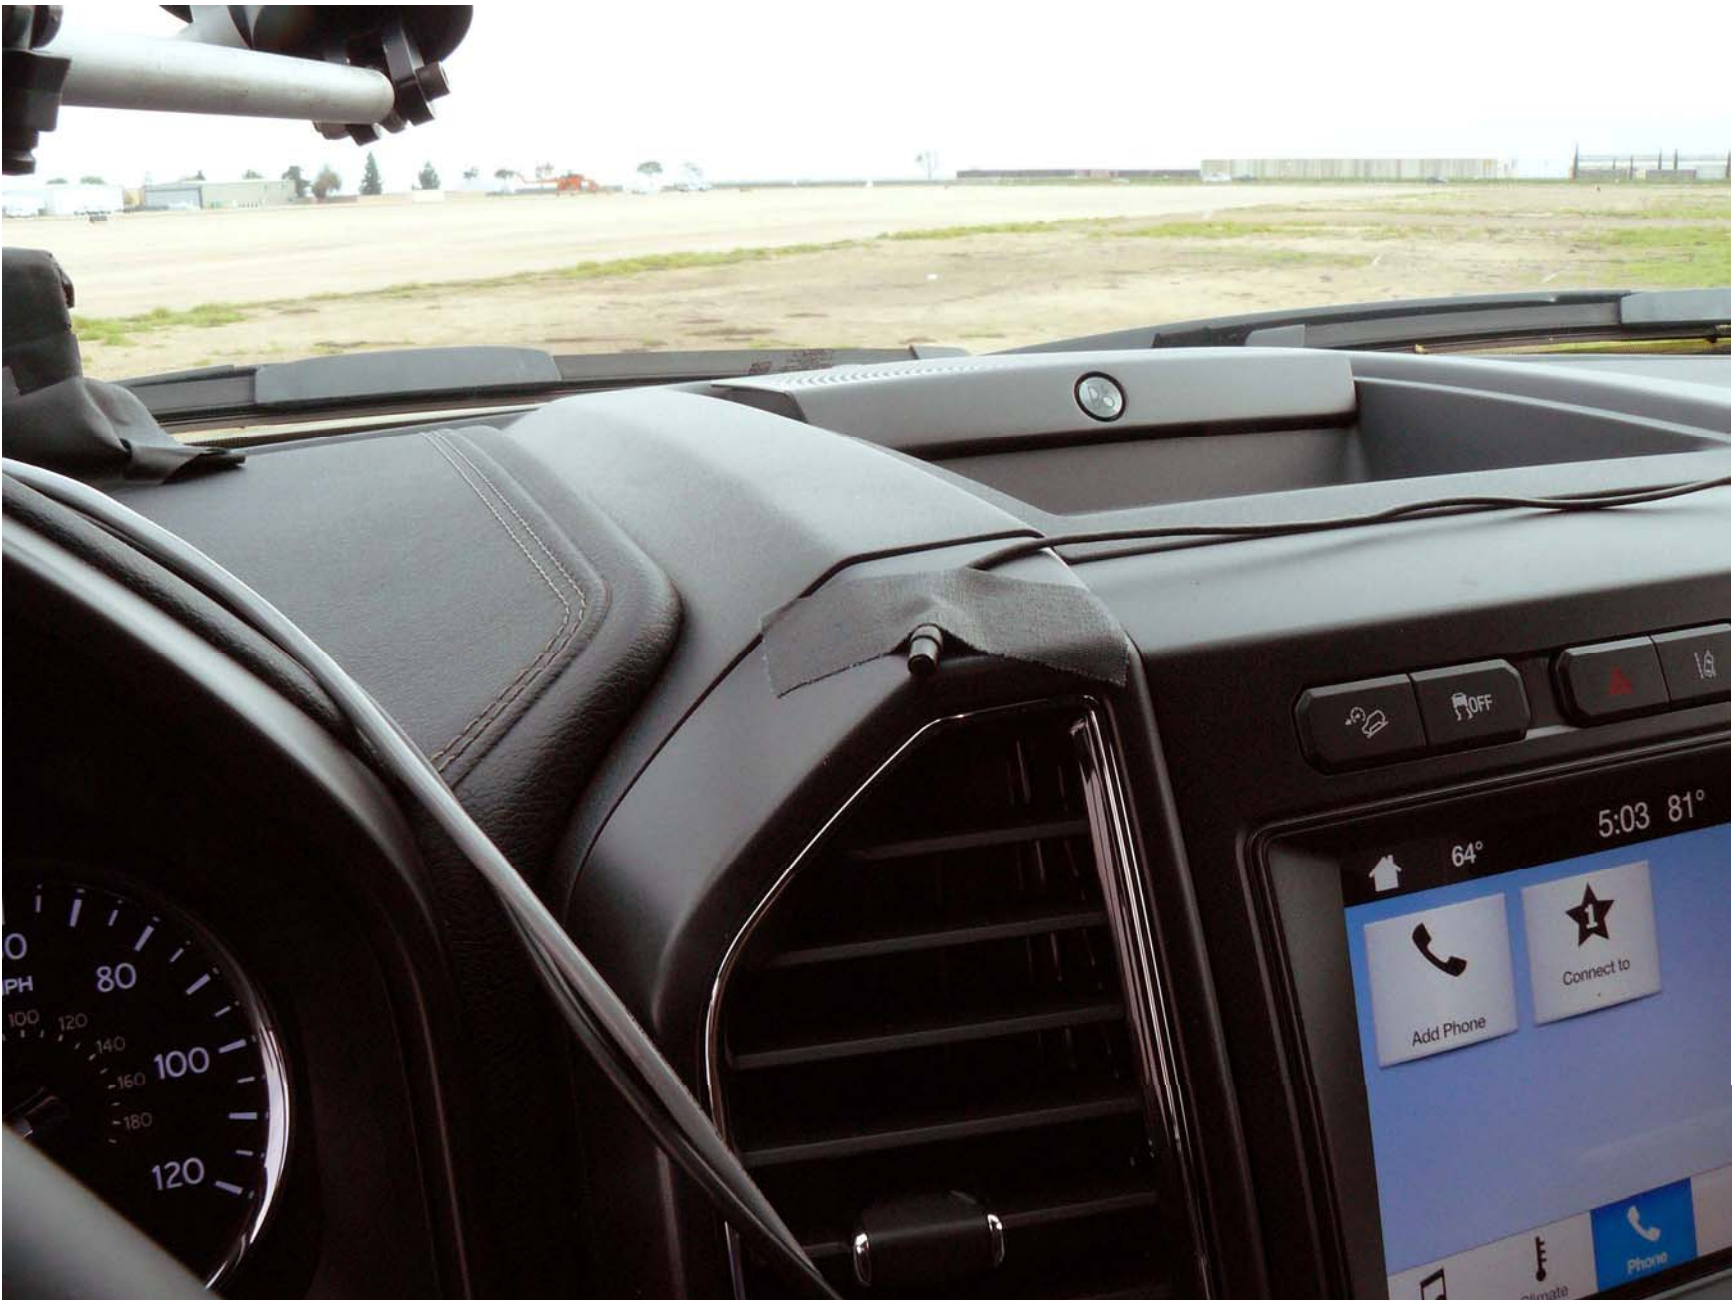
Figure A11. Sensor for Detecting Auditory Alerts

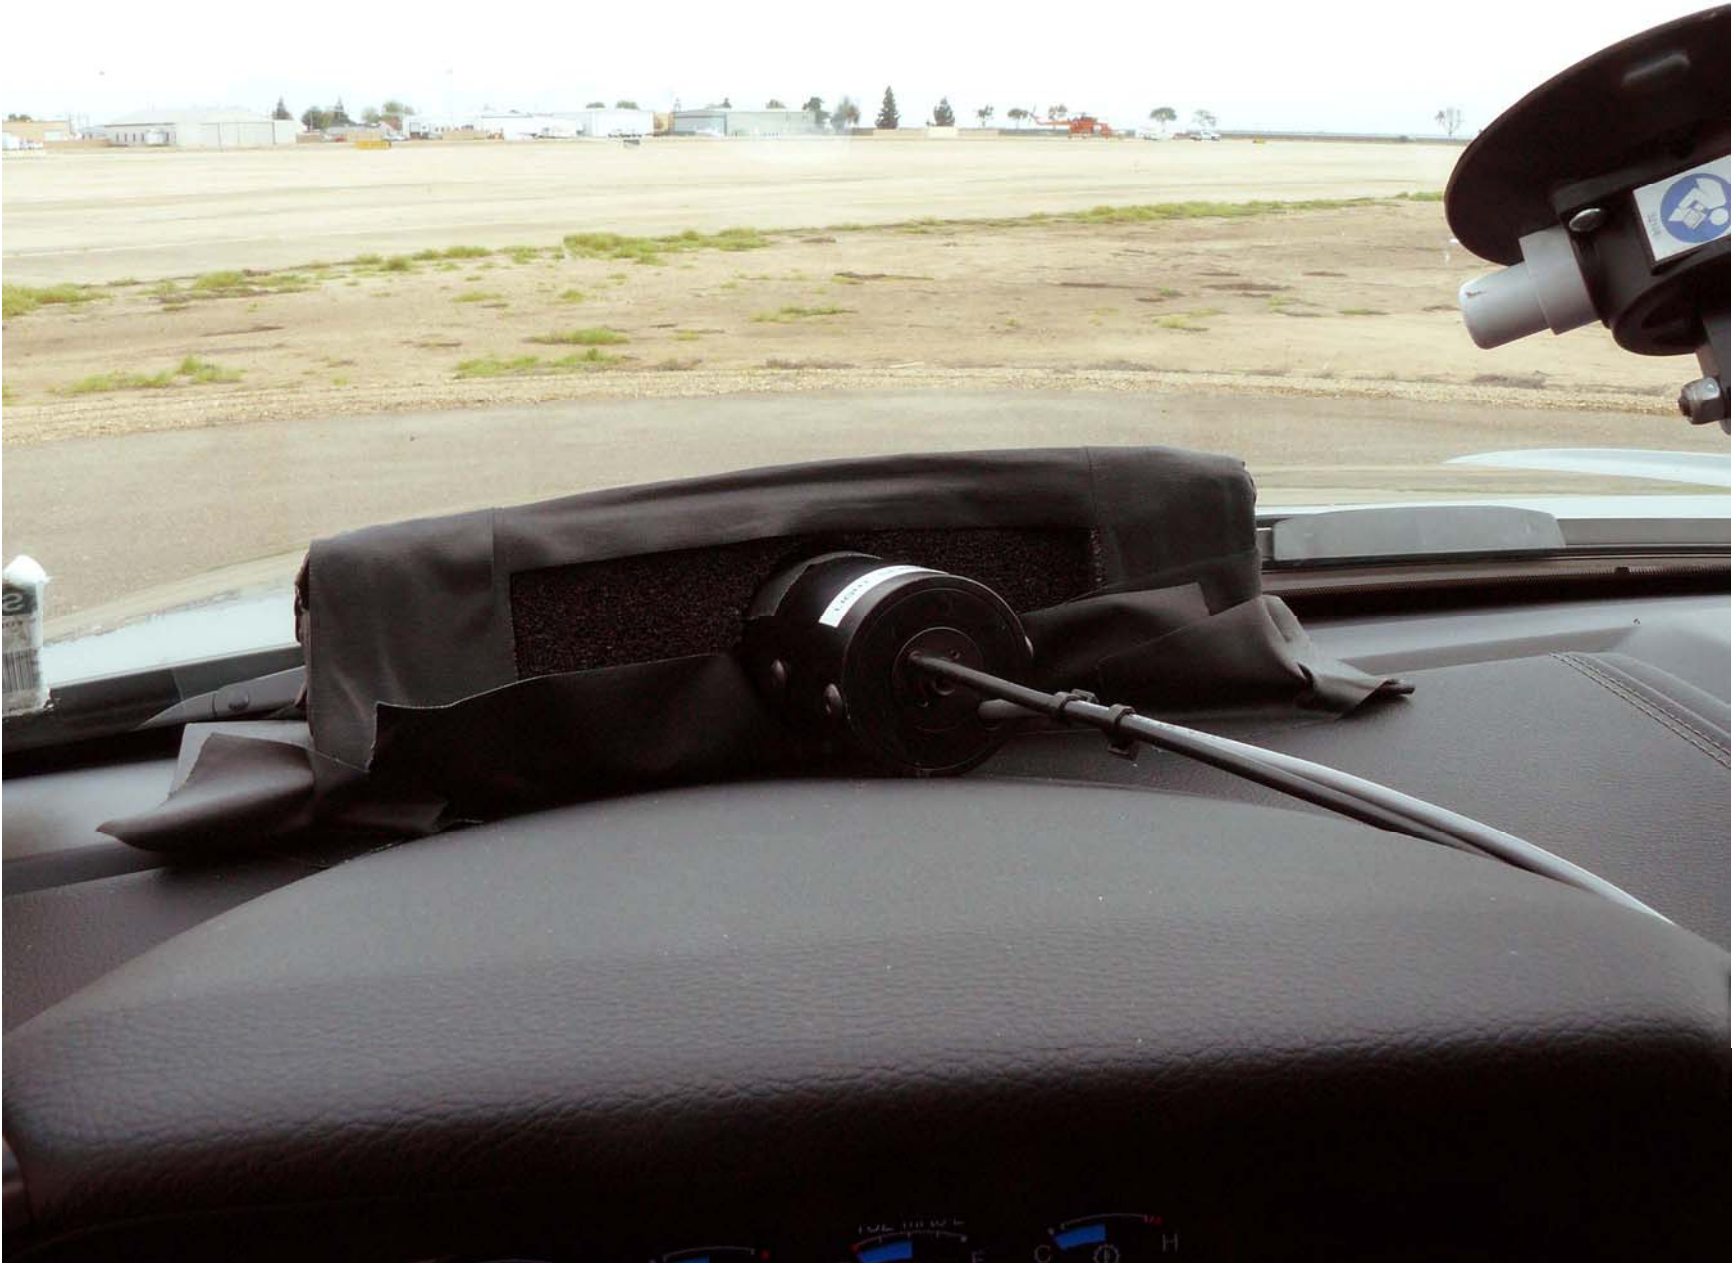
Figure A12. Sensor for Detecting Visual Alert

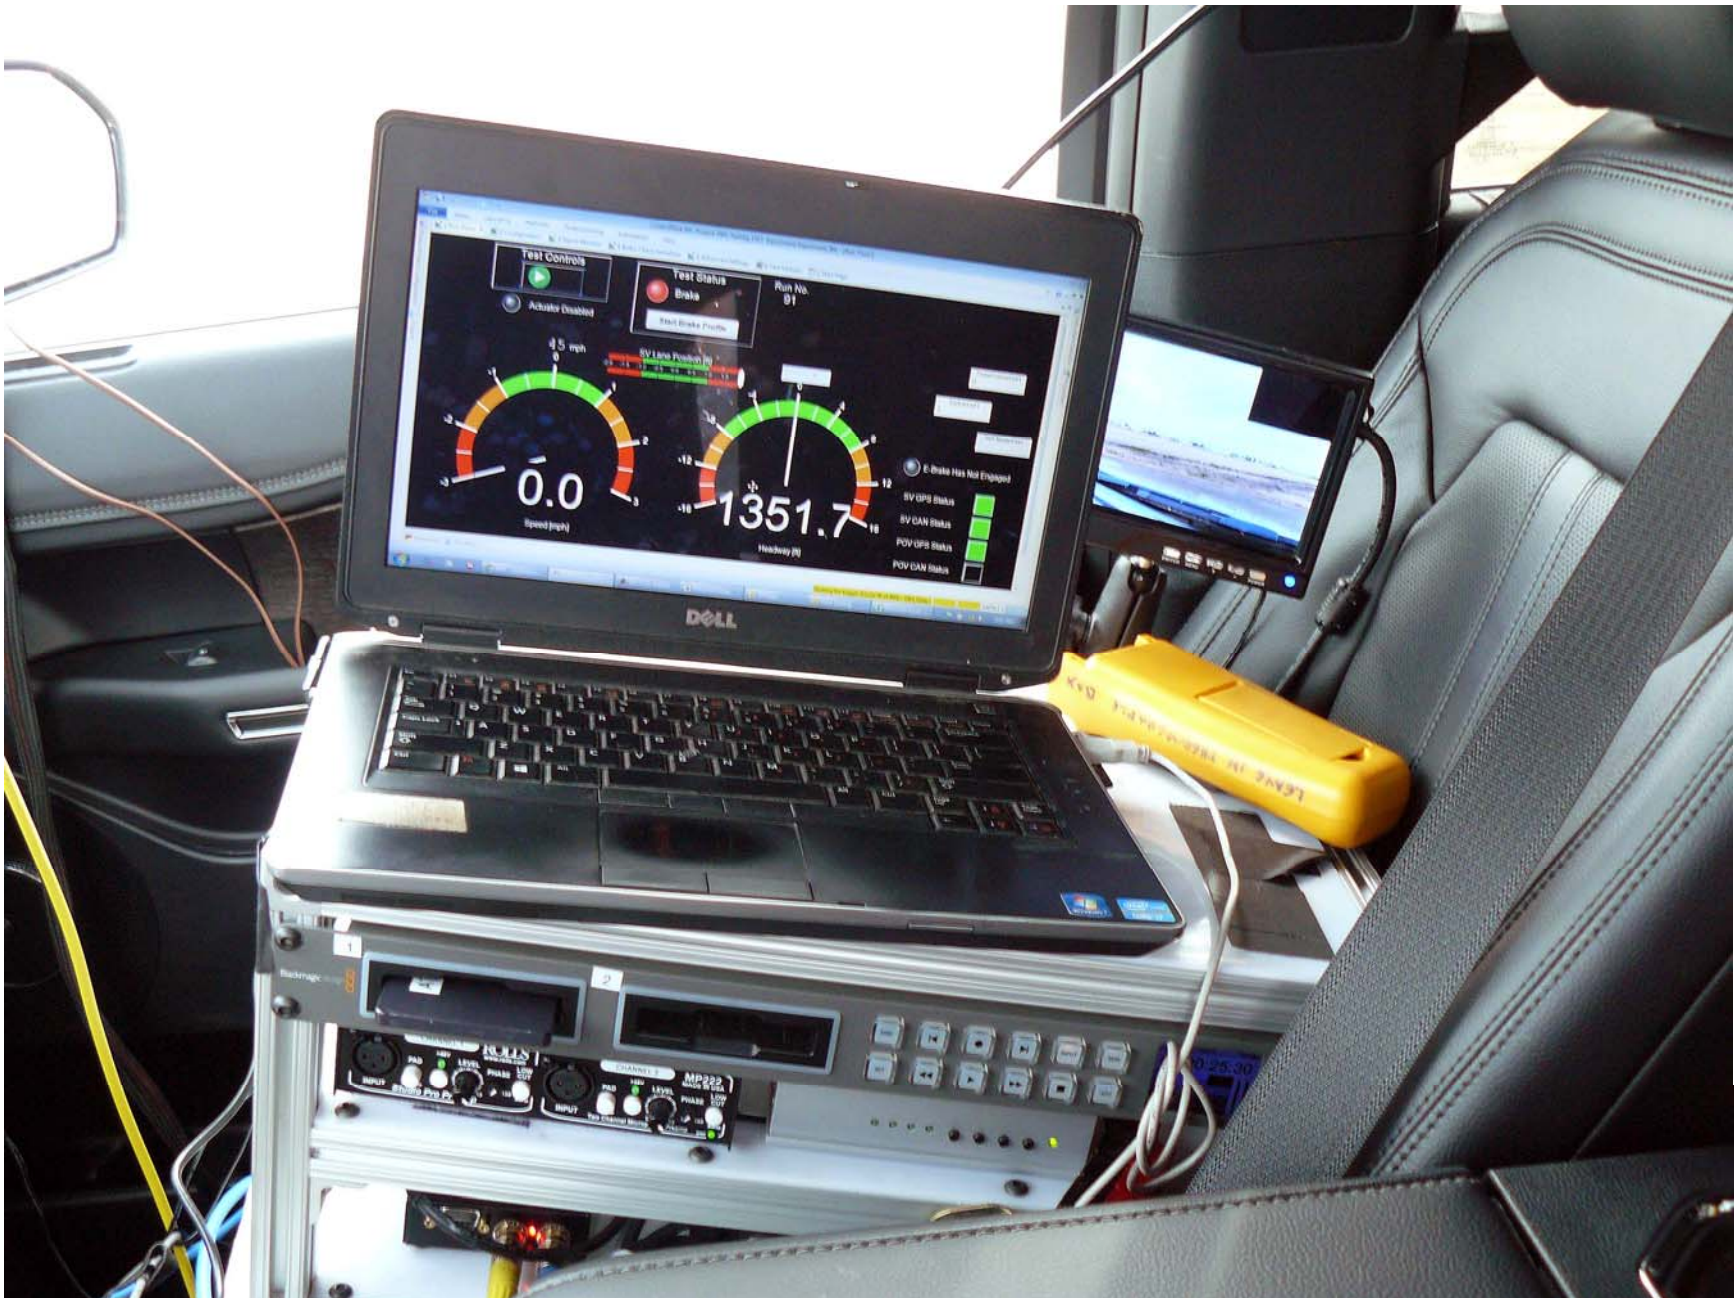
Figure A13. Computer Installed in Subject Vehicle

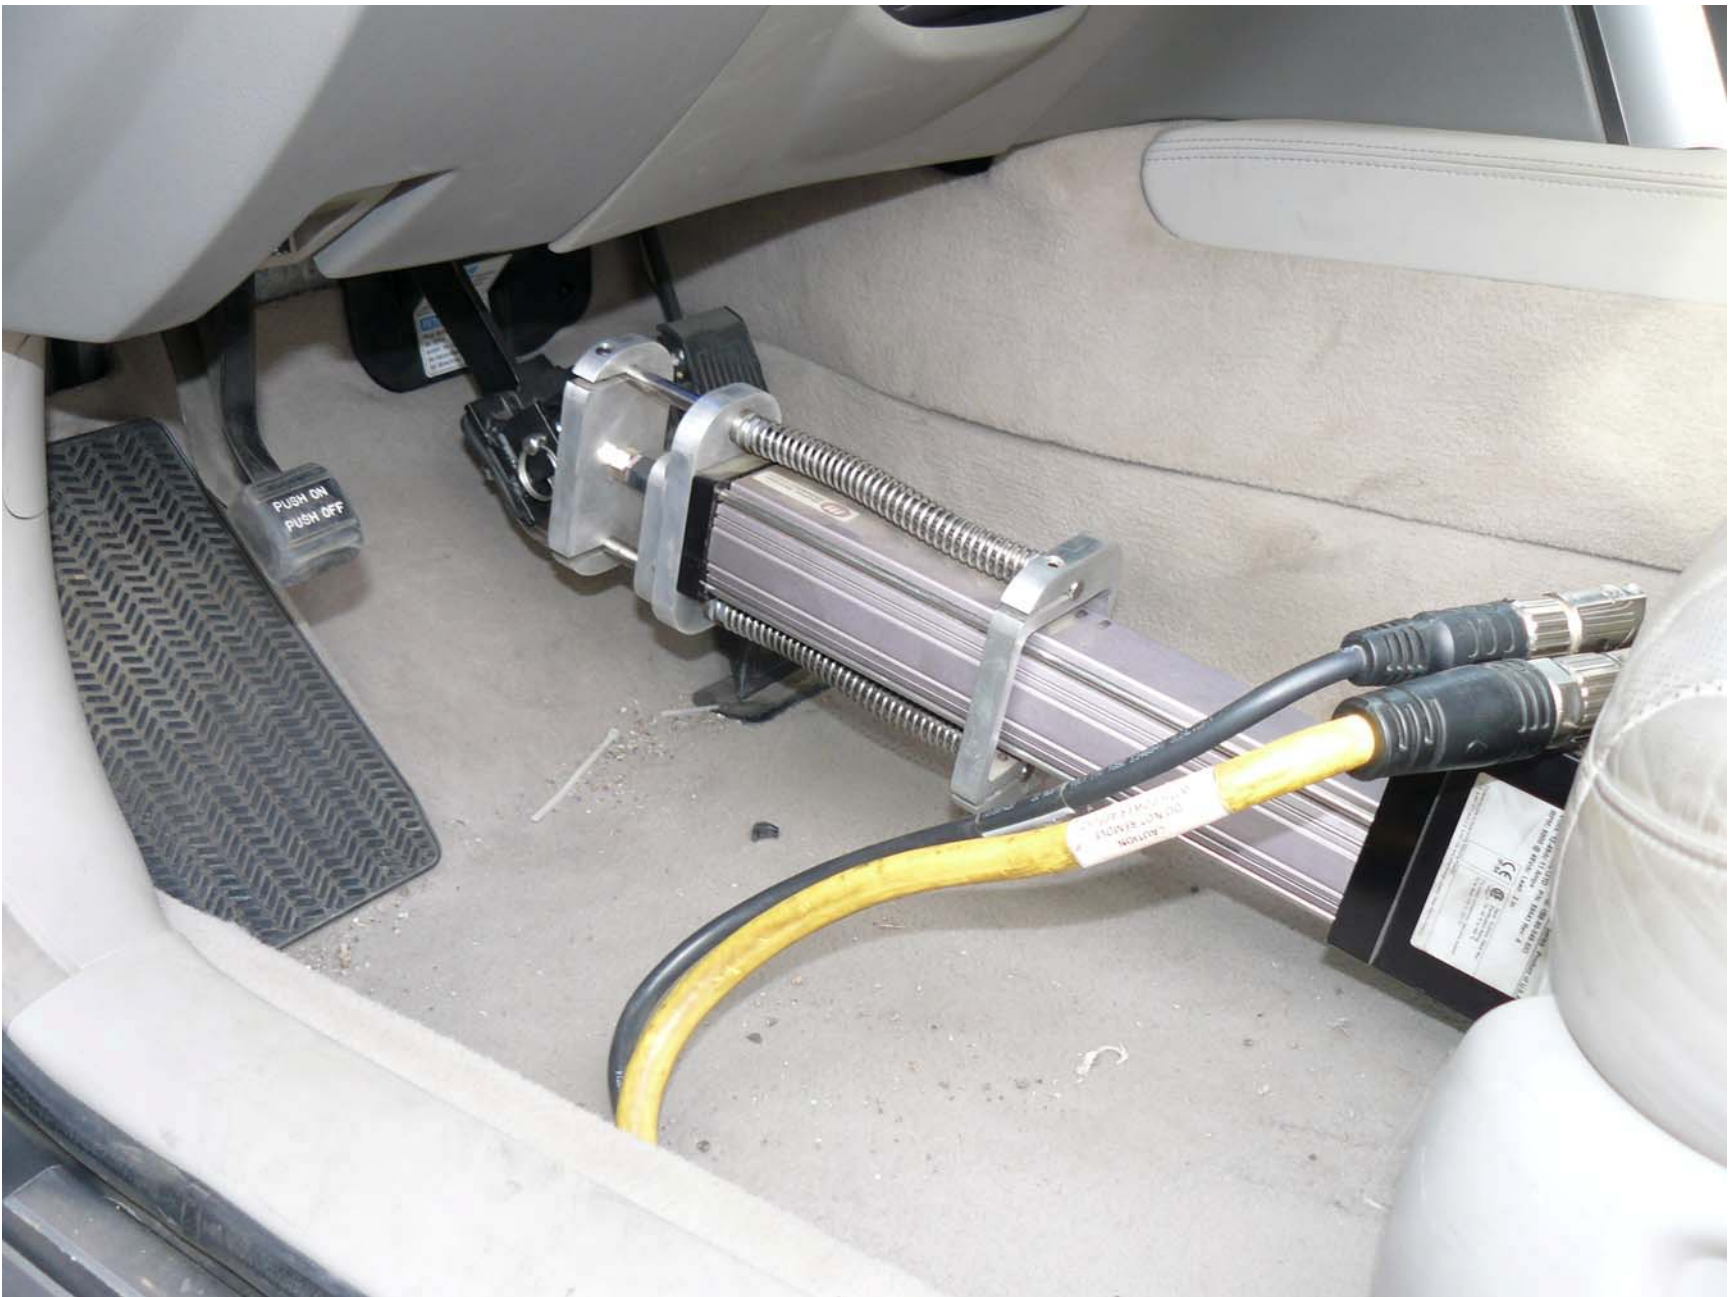
Figure A14. Brake Actuator Installed in POV System

In some cases, the subject vehicle is also equipped with an automatic braking system (E-brake) for the purpose of slowing the subject vehicle before impact with the SSV in cases where the subject vehicle is likely to fail a test. The system fires when TTC is below 0.7 sec. It is typically enabled when an SV has already impacted the SSV one or two times.

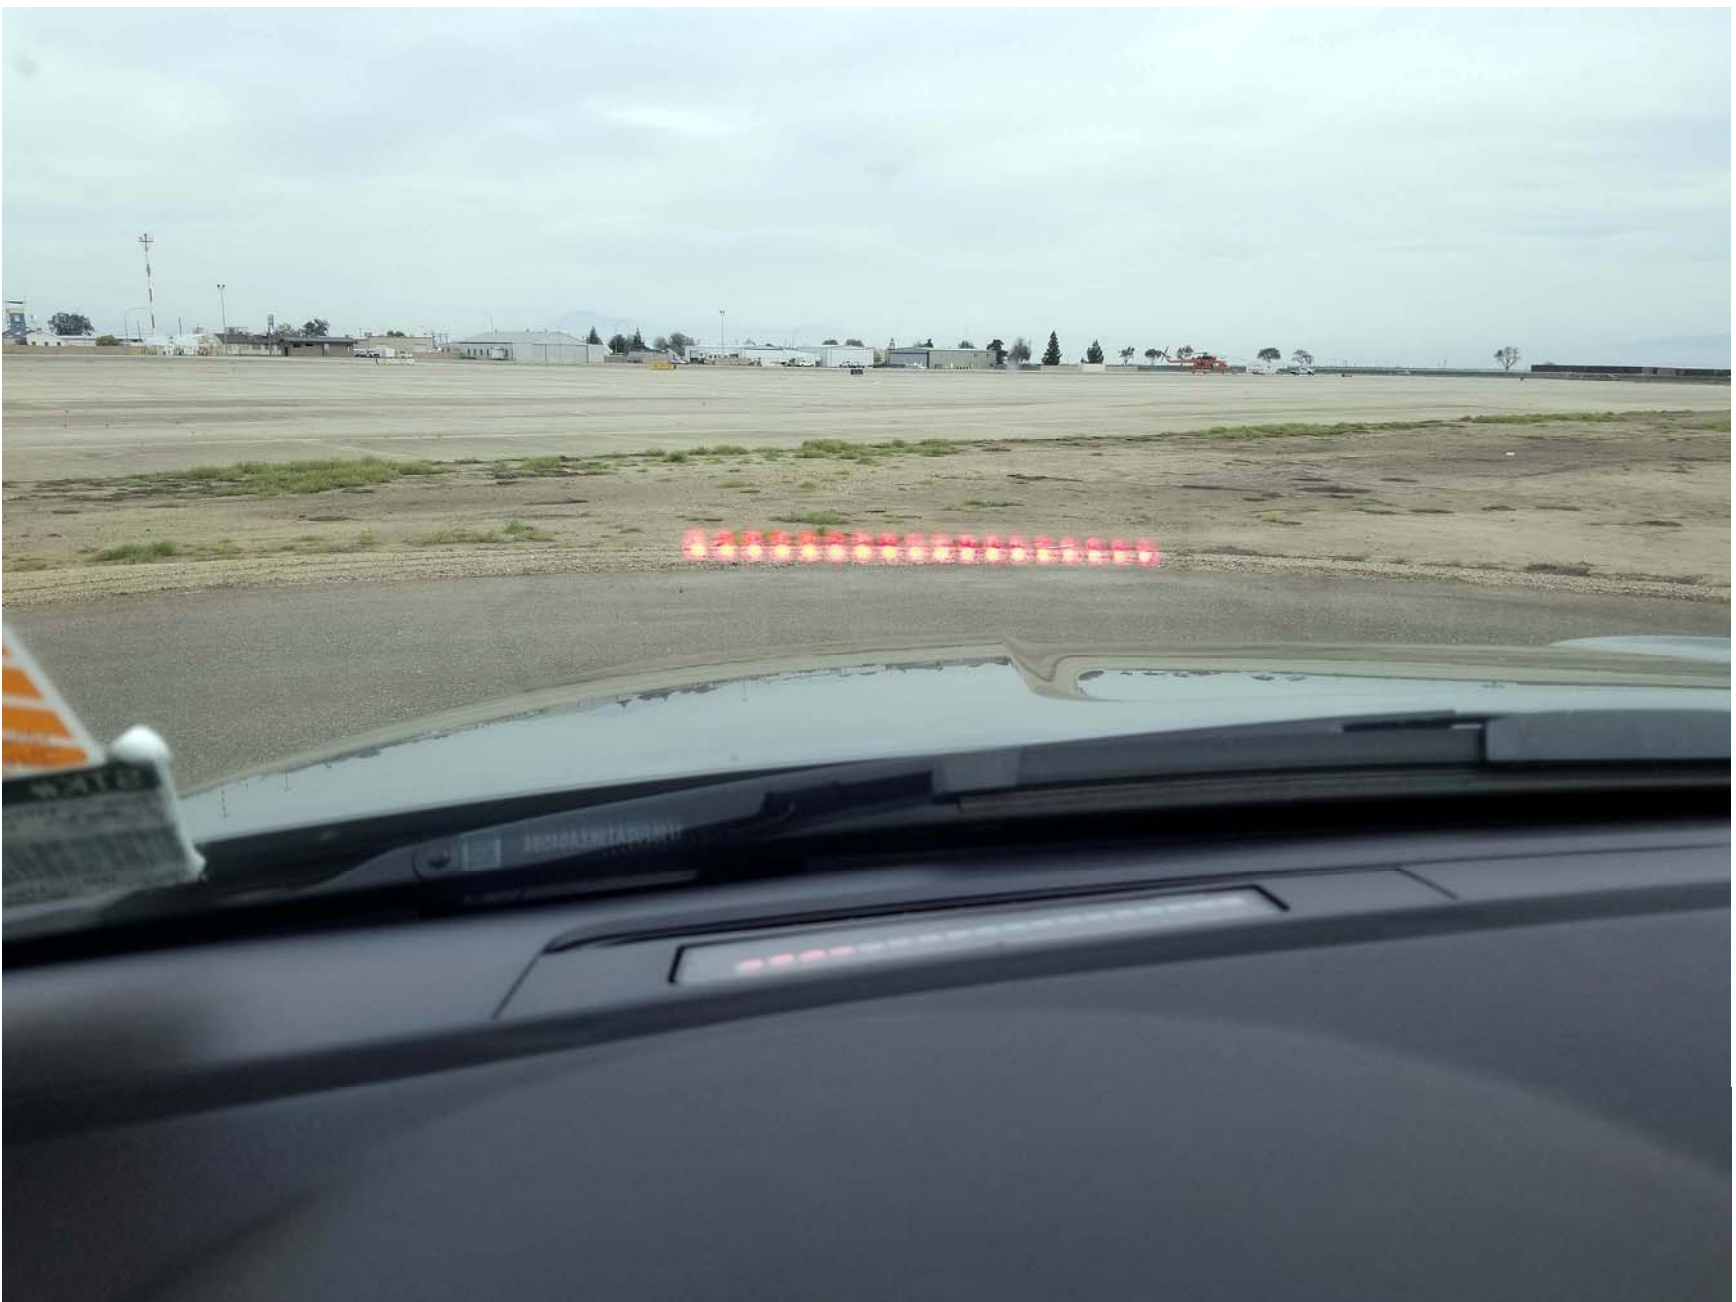
Figure A15. Heads Up AEB Visual Alert

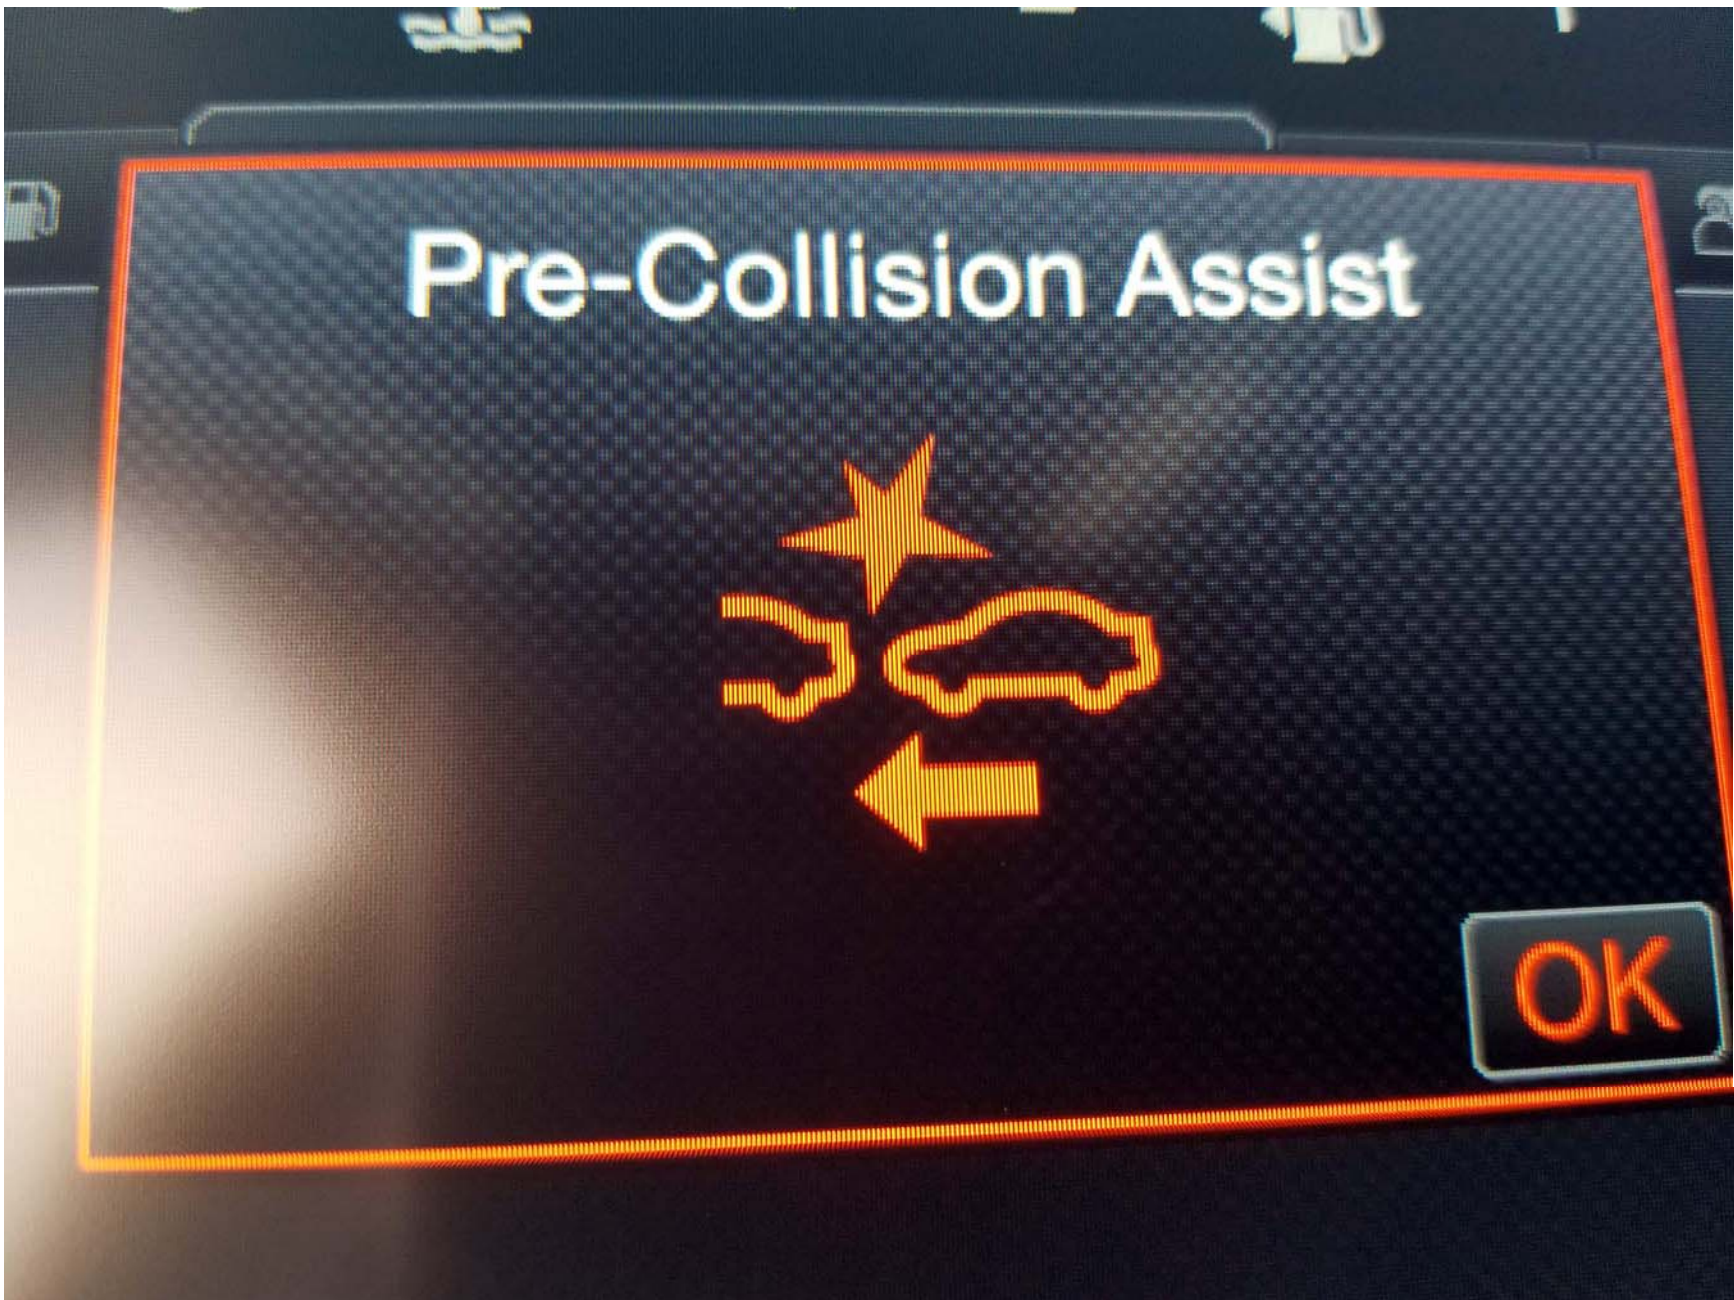
Figure A16. AEB Instrument Panel Visual Alert

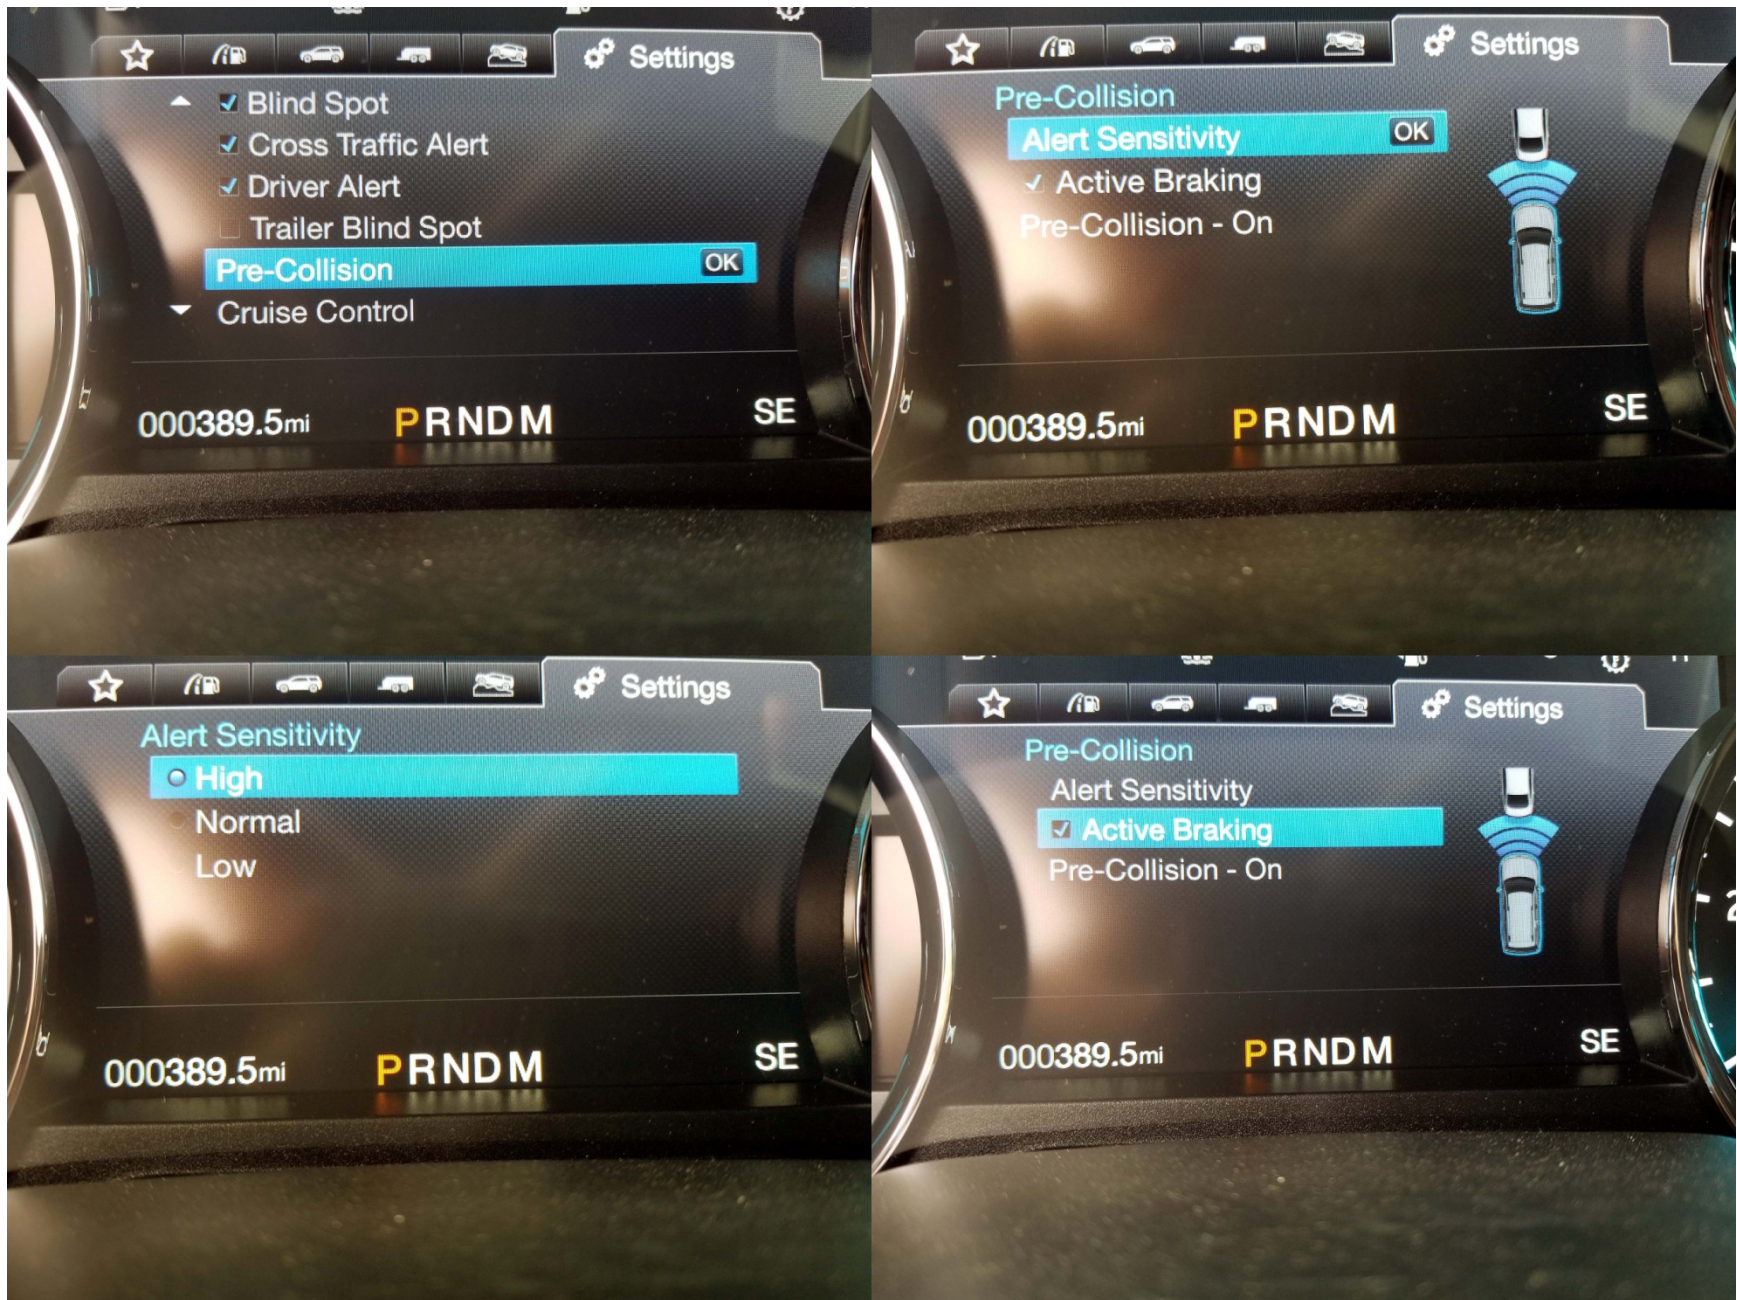
Figure A17. AEB Setup Menus
