**OCAS-DRI-CIB-19-01
NEW CAR ASSESSMENT PROGRAM
CRASH IMMINENT BRAKE SYSTEM CONFIRMATION TEST**

2019 Ford Expedition

Final Report

1. Report No. OCAS-DRI-CIB-19-01	2. Government Accession No.	3. Recipient's Catalog No.	
4. Title and Subtitle Final Report of Crash Imminent Brake System Confirmation Testing of a 2019 Ford Expedition.		5. Report Date 31 October 2019

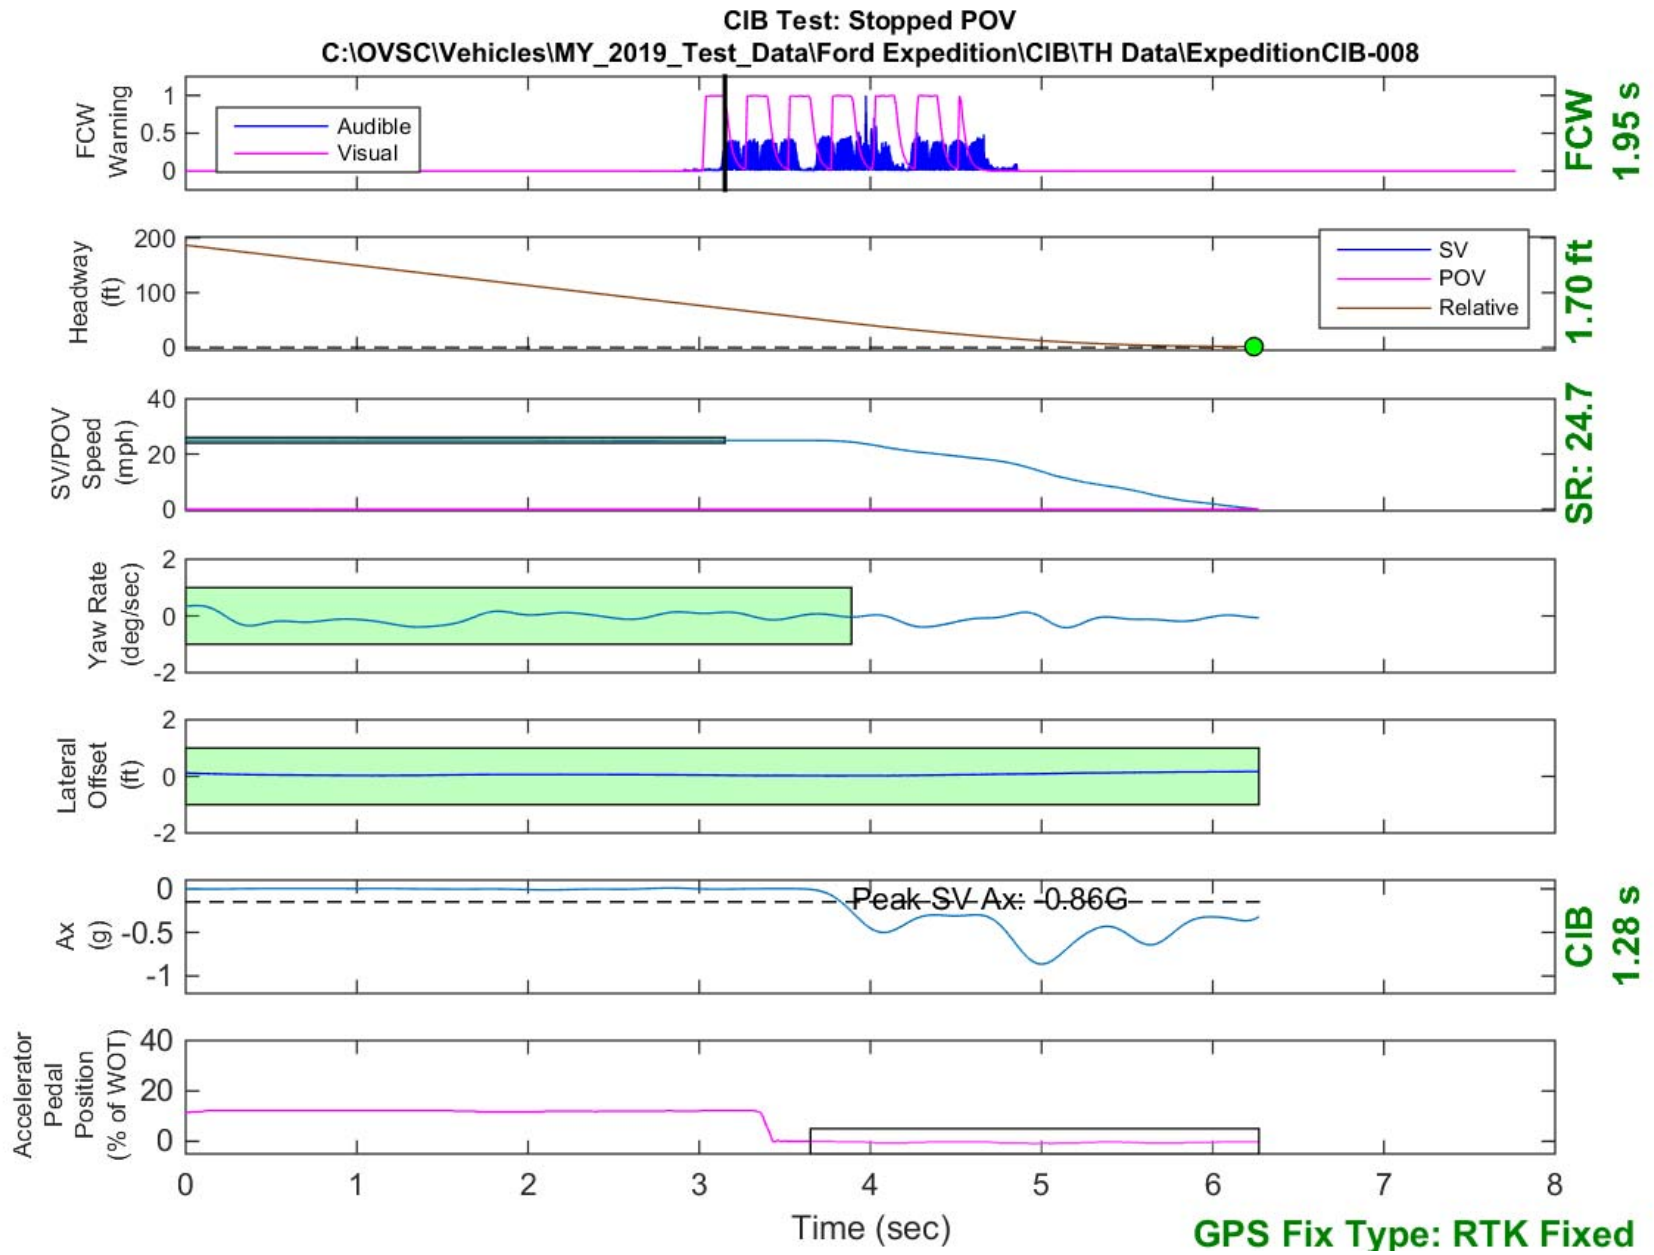
Figure D10. Time History for CIB Run 2, SV Encounters Stopped POV

Figure D11. Time History for CIB Run 3, SV Encounters Stopped POV

Figure D12. Time History for CIB Run 4, SV Encounters Stopped POV

Figure D13. Time History for CIB Run 5, SV Encounters Stopped POV

Figure D14. Time History for CIB Run 6, SV Encounters Stopped POV

Figure D15. Time History for CIB Run 7, SV Encounters Stopped POV

Figure D16. Time History for CIB Run 8, SV Encounters Stopped POV

Run	Test Type	Valid Run?	FCW TTC (s)	Min. Distance (ft)	Speed Reduction (mph)	Peak Decel. (g)	CIB TTC (s)	Pass/Fail	Notes
1	Static Run								
2	Stopped POV	Y	1.87	1.88	25.2	0.86	1.34	Pass	
3		Y	1.91	2.06	25.3	0.90	1.29	Pass	
4		Y	1.95	2.06	25.5	0.91	1.31	Pass	
5		Y	1.86	2.04	25.1	1.00	1.27	Pass	
6		Y	1.94	1.88	24.9	0.94	1.25	Pass	
7		Y	1.93	0.00	20.8	0.99	1.19	Pass	
8		Y	1.95	1.70	24.7	0.86	1.28	Pass	
9	Static Run								
10	Slower POV, 25 vs 10	Y	1.82	5.49	15.2	0.83	0.89	Pass	
11		Y	1.83	5.45	15.0	0.86	0.86	Pass	
12		Y	1.89	5.12	15.3	0.83	0.89	Pass	
13		Y	1.75	5.24	15.1	0.82	0.88	Pass

Time history data plots for the tests of the vehicle under consideration herein are provided beginning with Figure 10.

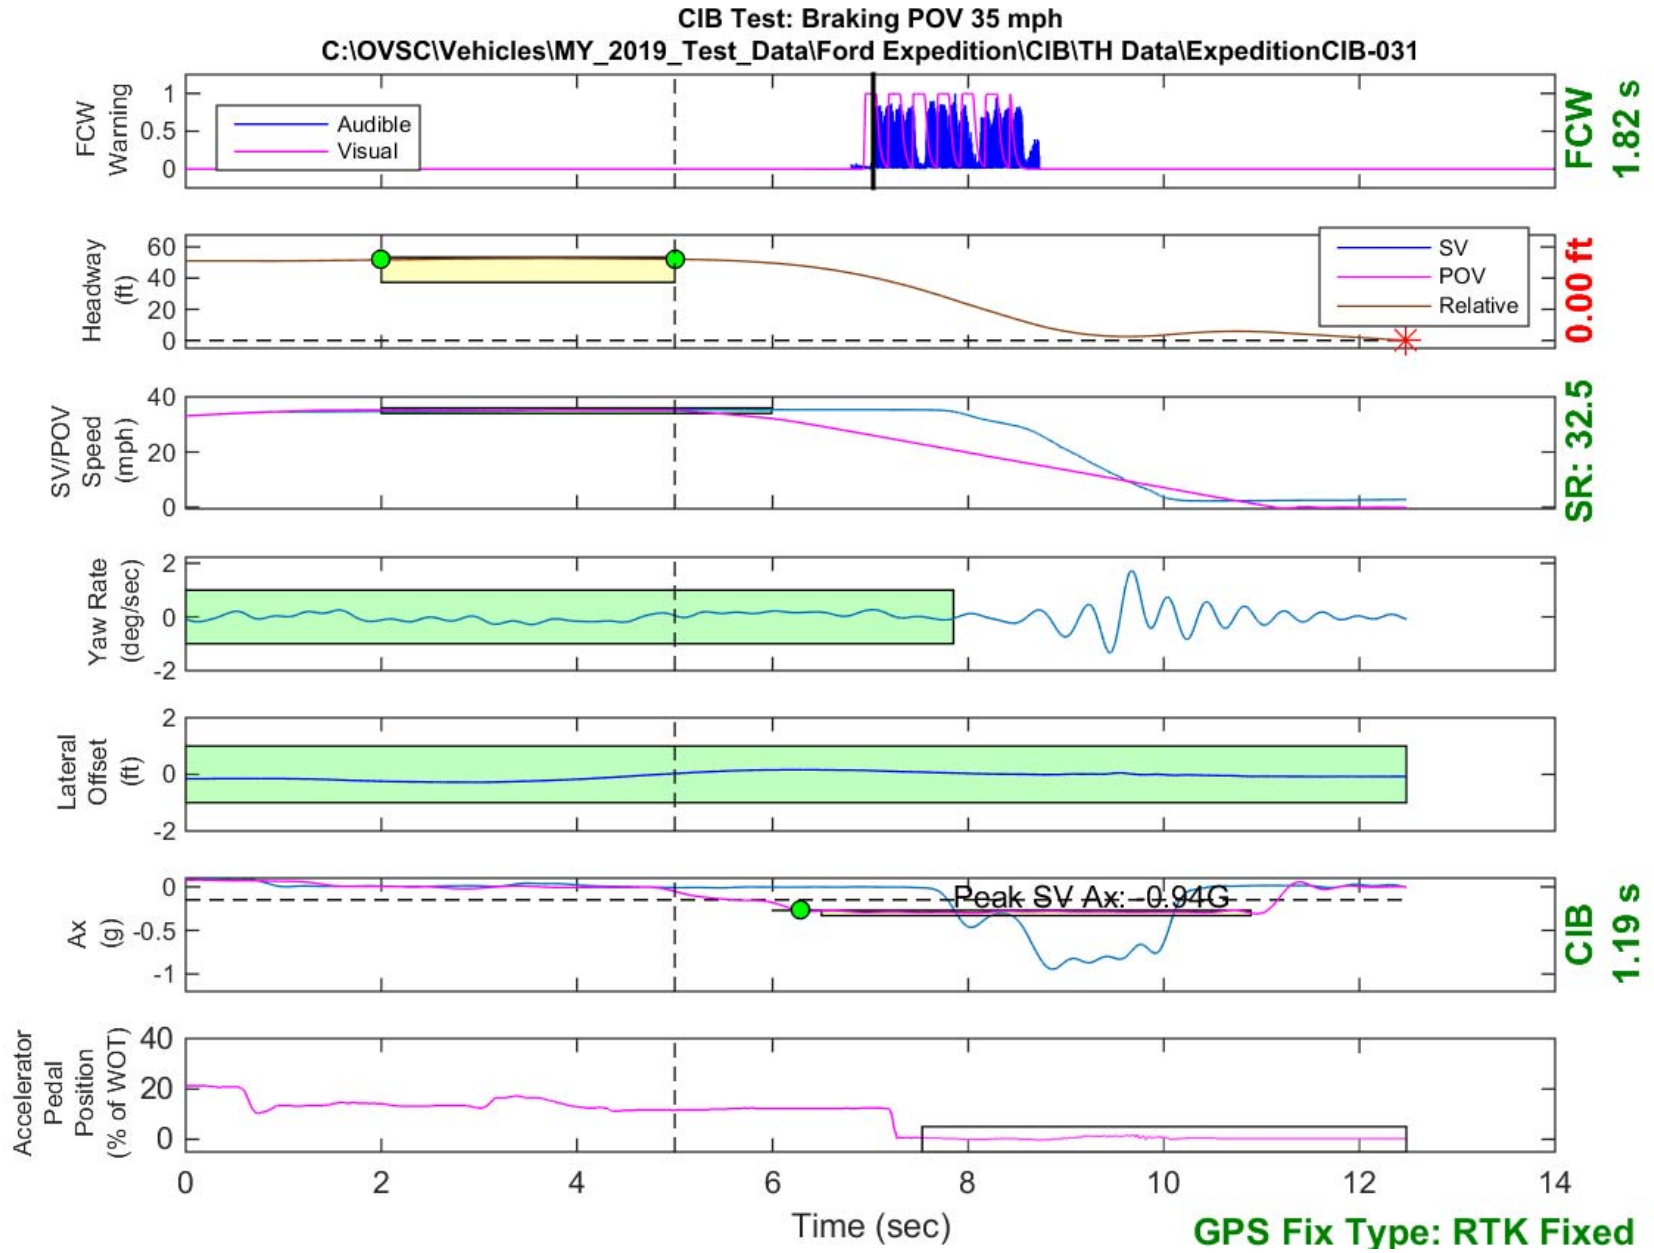
Figure D31. Time History for CIB Run 26, SV Encounters Decelerating POV, SV 35 mph, POV 35 mph

Figure D32. Time History for CIB Run 27, SV Encounters Decelerating POV, SV 35 mph, POV 35 mph

Figure D33. Time History for CIB Run 28, SV Encounters Decelerating POV, SV 35 mph, POV 35 mph

Figure D34. Time History for CIB Run 29, SV Encounters Decelerating POV, SV 35 mph, POV 35 mph

Figure D35. Time History for CIB Run 30, SV Encounters Decelerating POV, SV 35 mph, POV 35 mph

Figure D36. Time History for CIB Run 31, SV Encounters Decelerating POV, SV 35 mph, POV 35 mph

Figure D37. Time History for CIB Run 32, SV Encounters Decelerating POV, SV 35 mph, POV 35 mph

Run	Test Type	Valid Run?	FCW TTC (s)	Min. Distance (ft)	Speed Reduction (mph)	Peak Decel. (g)	CIB TTC (s)	Pass/Fail	Notes
31		Y	1.82	0.00	32.5	0.94	1.19	Pass	
32		Y	1.75	0.00	29.7	0.83	1.11	Pass	
33	Static Run								
34	STP - Static Run								
35	STP False Positive, 25	Y				0.00		Pass	
36		Y				0.01		Pass	
37		Y				0.00		Pass	
38		Y				0.00		Pass	
39		Y				0.01		Pass	
40		Y				0.02		Pass	
41		Y				0.01		Pass	
42	STP - Static Run								
43	STP False Positive, 45	Y				0.01		Pass	
44		Y				0.01		Pass

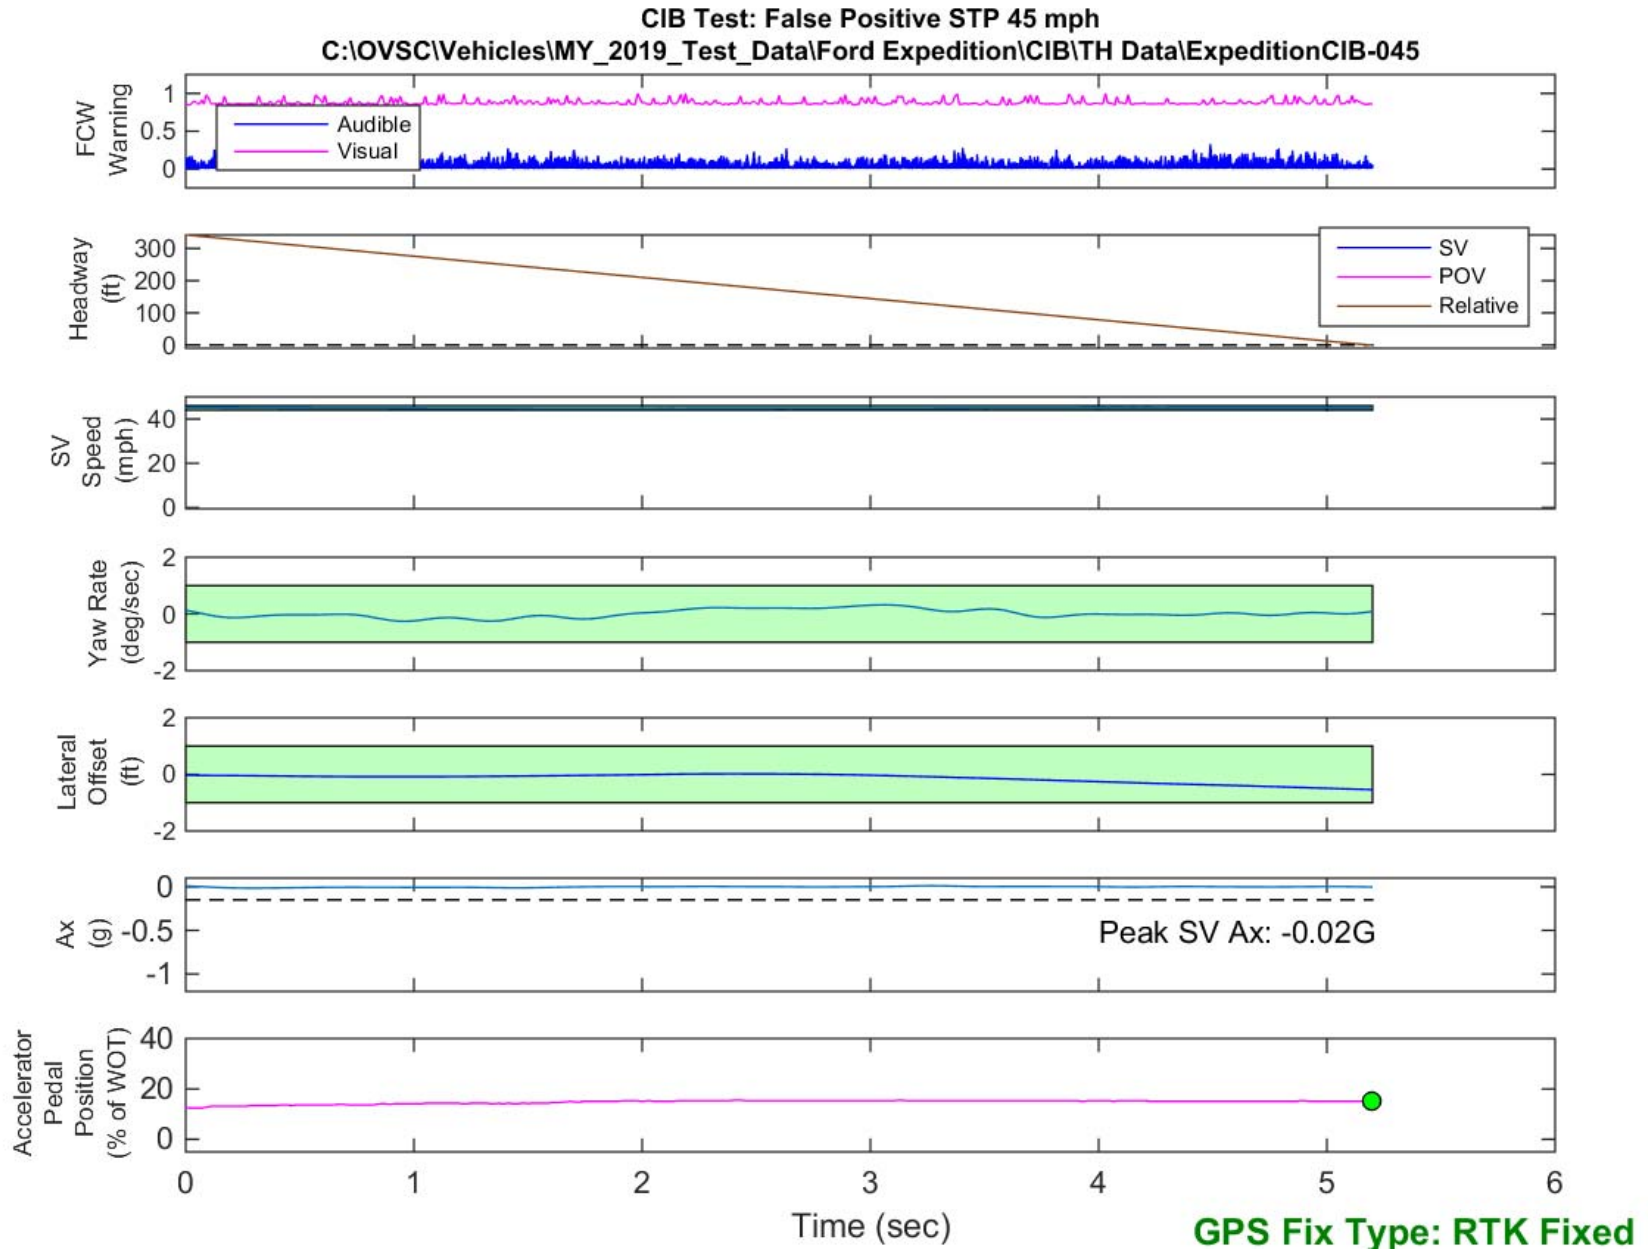
Figure D45. Time History for CIB Run 43, SV Encounters Steel Trench Plate, SV 45 mph

Figure D46. Time History for CIB Run 44, SV Encounters Steel Trench Plate, SV 45 mph

Figure D47. Time History for CIB Run 45, SV Encounters Steel Trench Plate, SV 45 mph

Figure D48. Time History for CIB Run 46, SV Encounters Steel Trench Plate, SV 45 mph

Figure D49. Time History for CIB Run 47, SV Encounters Steel Trench Plate, SV 45 mph

Figure D50. Time History for CIB Run 48, SV Encounters Steel Trench Plate, SV 45 mph

Figure D51. Time History for CIB Run 49, SV Encounters Steel Trench Plate, SV 45 mph

Run	Test Type	Valid Run?	FCW TTC (s)	Min. Distance (ft)	Speed Reduction (mph)	Peak Decel. (g)	CIB TTC (s)	Pass/Fail	Notes
45		Y				0.02		Pass	
46		Y				0.01		Pass	
47		Y				0.01		Pass	
48		Y				0.02		Pass	
49		Y				0.01		Pass	
50	STP - Static Run
