FINAL REPORT NUMBER: SINCAP-TRC-19-007

NEW CAR ASSESSMENT PROGRAM (NCAP) MOVING DEFORMABLE BARRIER SIDE IMPACT TEST

FORD MOTOR CO. 2019 Ford Ranger Supercrew NHTSA NUMBER: M20190213

PREPARED BY: Transportation Research Center Inc. 10820 State Route 347 P. O. Box B-67 East Liberty, OH 43319

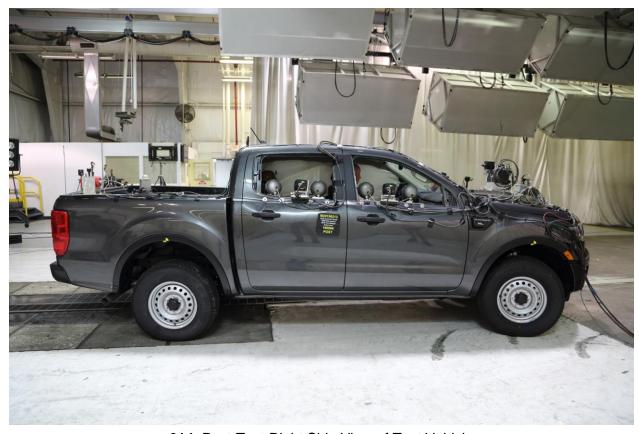
014 Post-Test Right Side View of Test Vehicle
