**FINAL REPORT NUMBER: SPNCAP-TRC-19-007**

**NEW CAR ASSESSMENT PROGRAM (NCAP)  
SIDE IMPACT POLE TEST**

**FORD MOTOR CO.  
2019 Ford Ranger Supercrew  
NHTSA NUMBER: M20190212**

**PREPARED BY:  
Transportation Research Center Inc.  
10820 State Route 347  
P. O. Box B-67  
East Liberty, OH 43319**

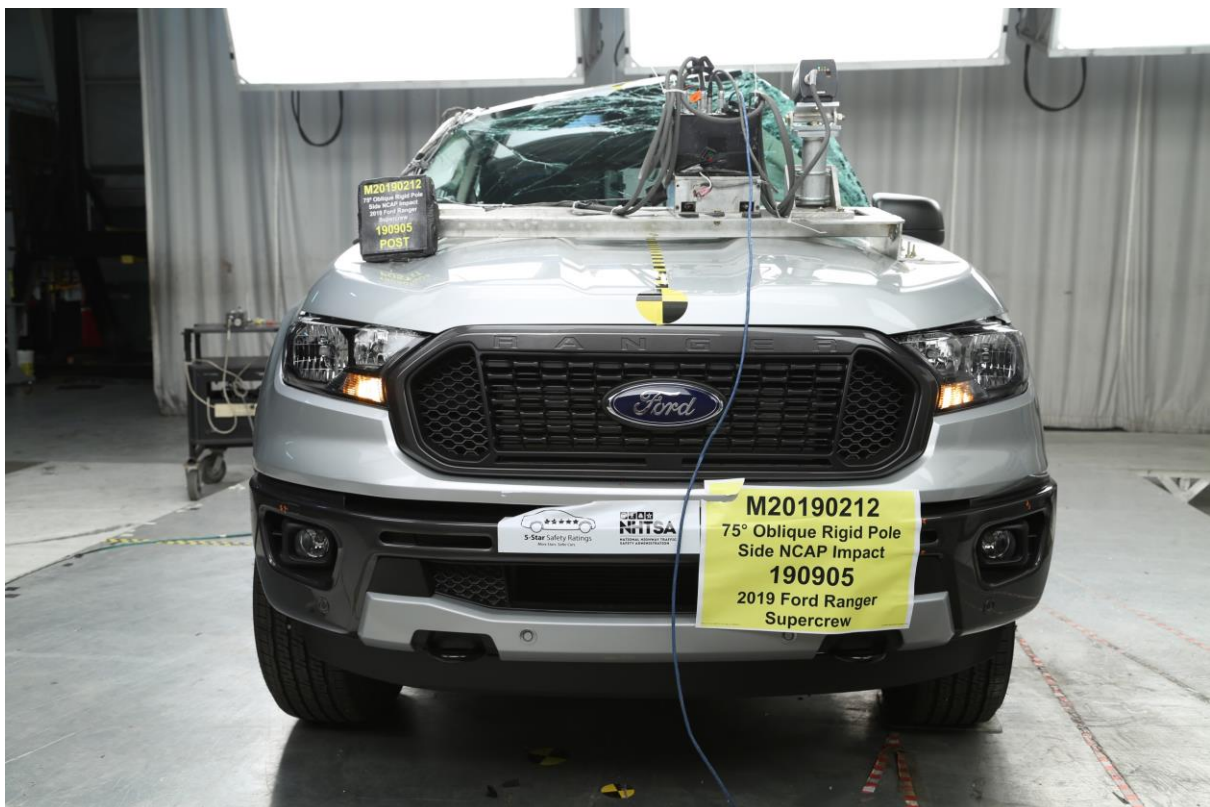
**No. 004 Post-Test Frontal View of Test Vehicle**

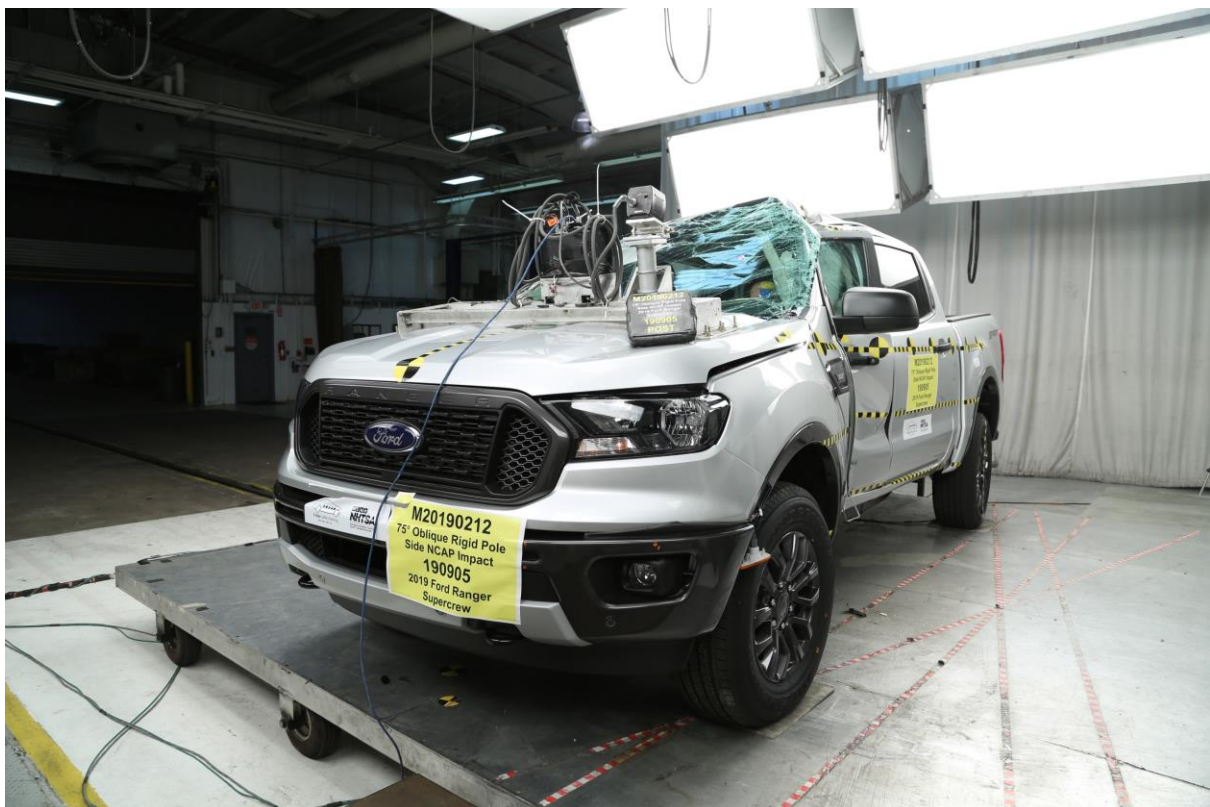
**No. 006 Post-Test Left Front  $\frac{3}{4}$  View of Test Vehicle**

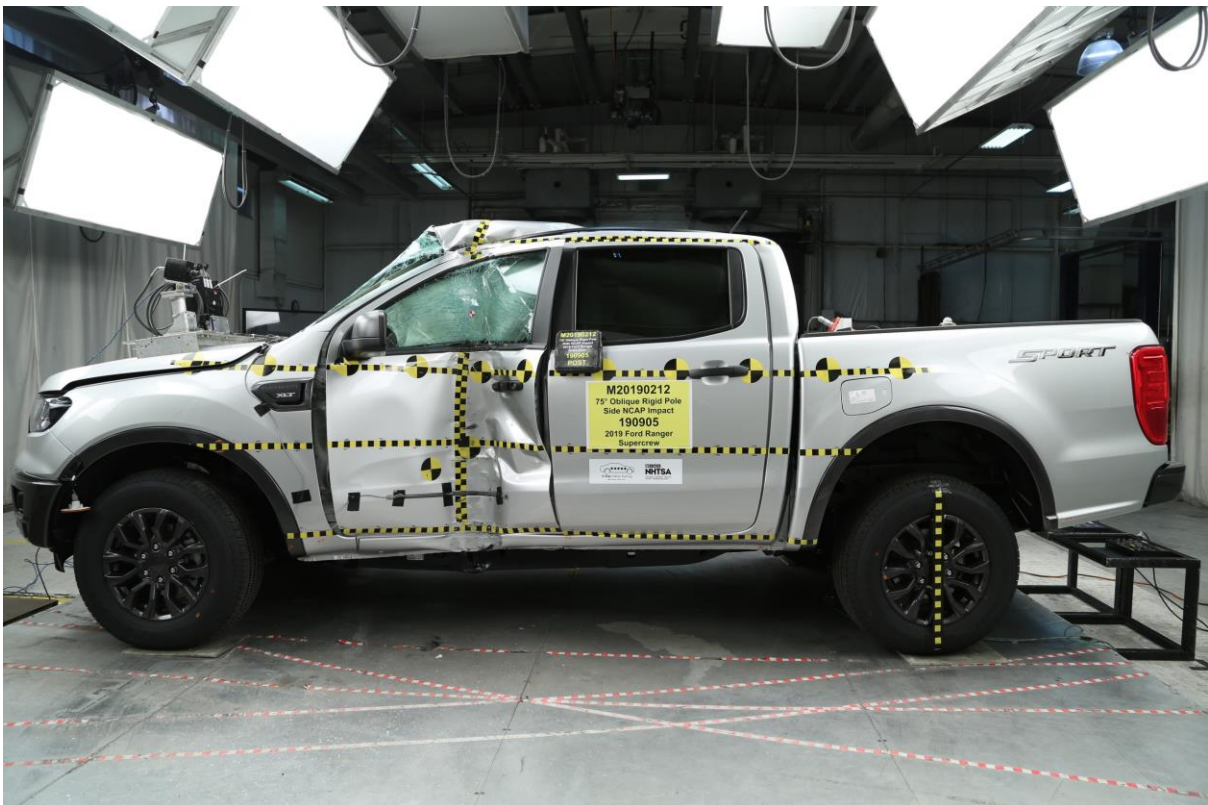
**No. 008 Post-Test Left Side View of Test Vehicle**

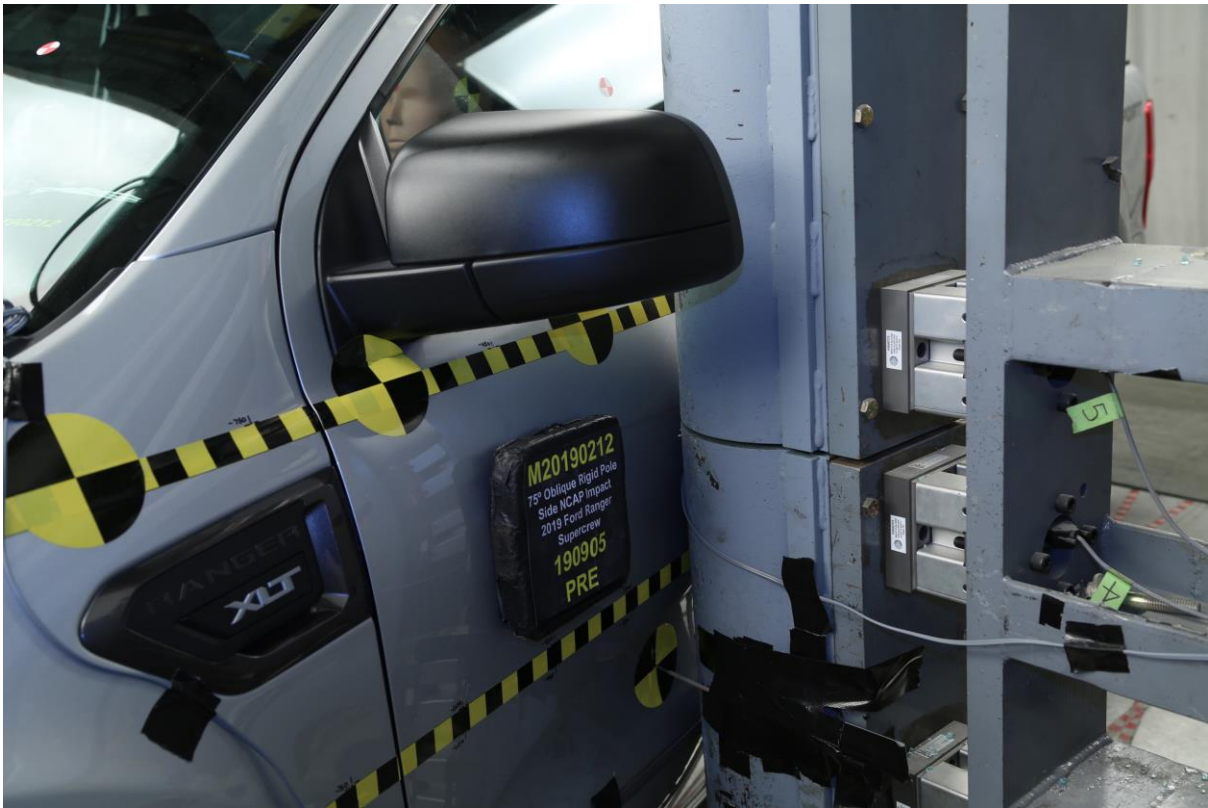
**No. 017 Pre-Test Left Side View of Pole Positioned Against Side of Vehicle**

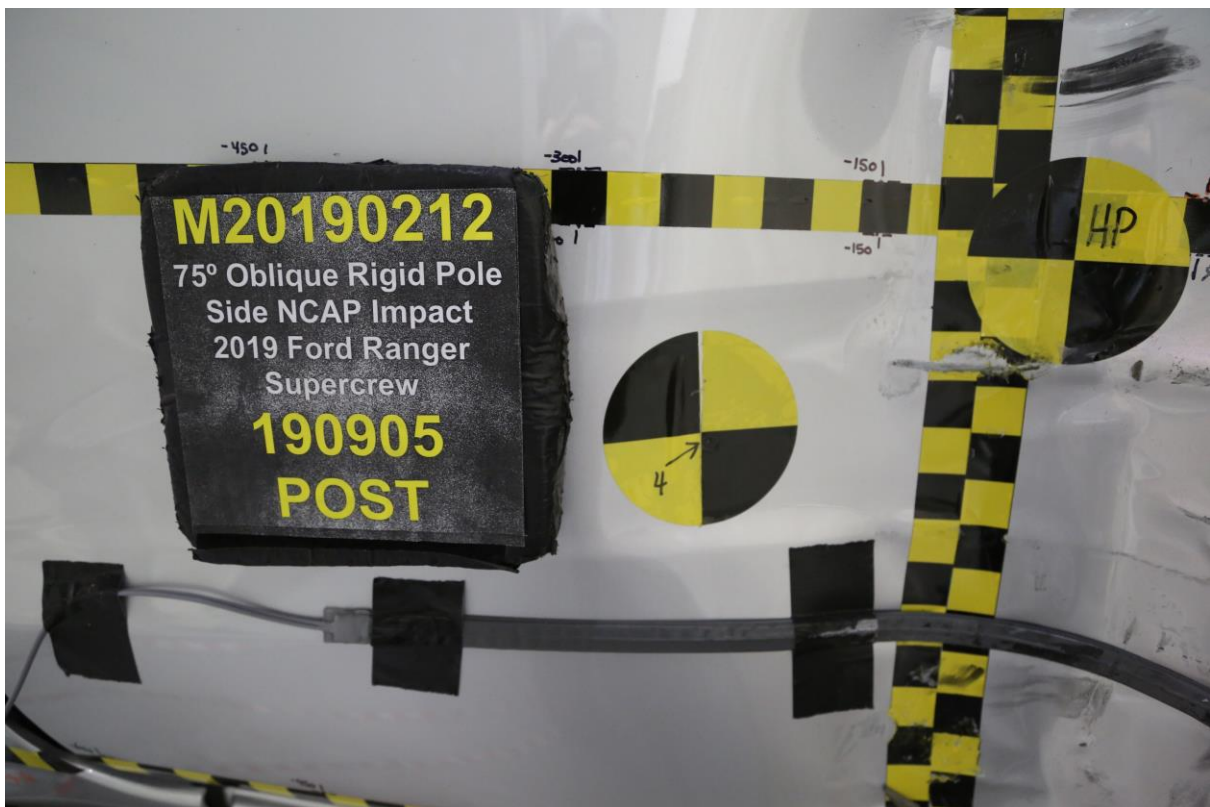
No. 020 Post-Test Close-Up View of Impact Point Target Showing Impact Location

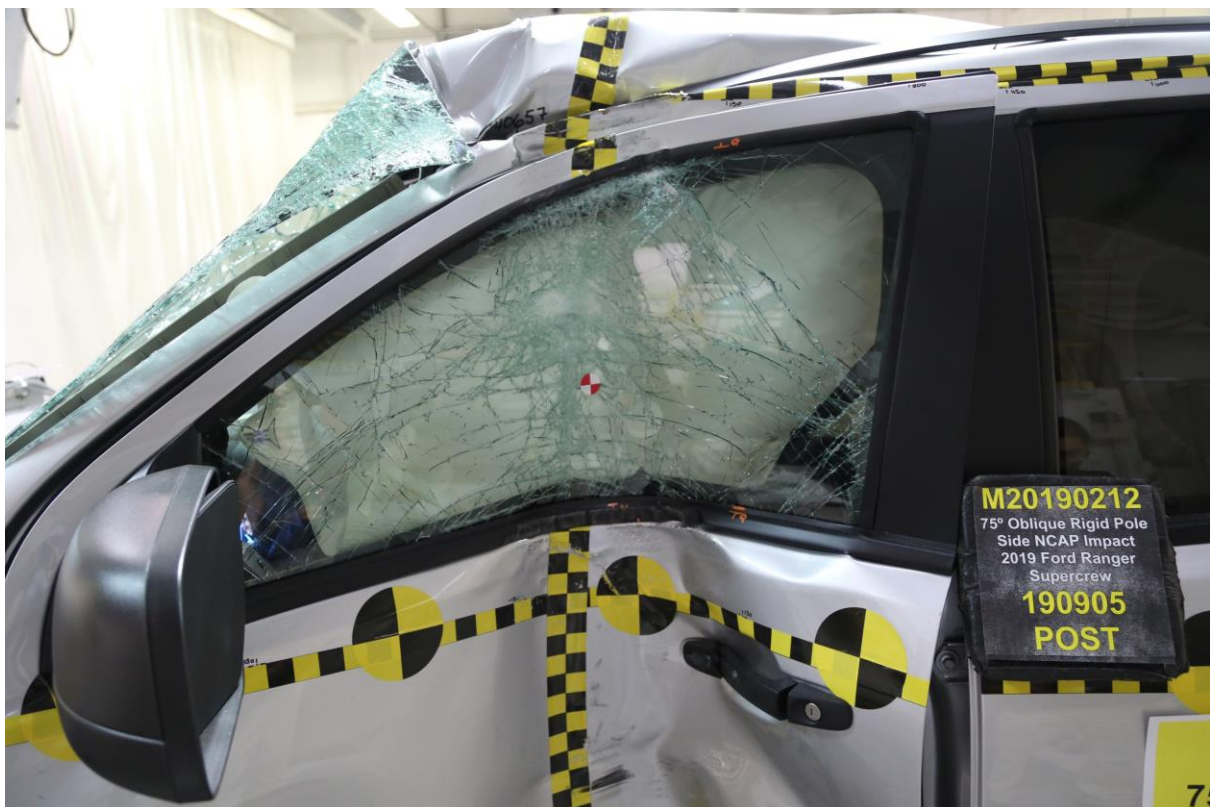
**No. 025 Post-Test Left Side View of Dummy Shoulder and Door Top View**

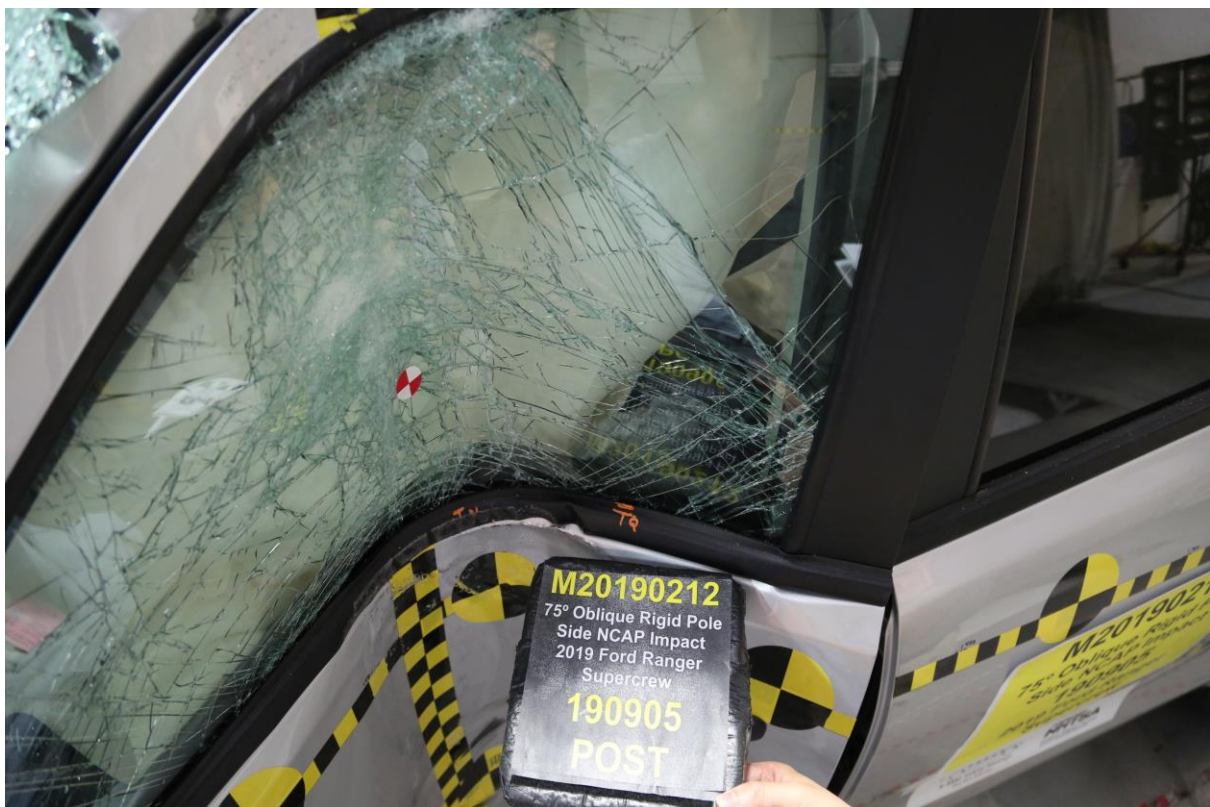
**No. 041 Post-Test Dummy and Door Clearance View**

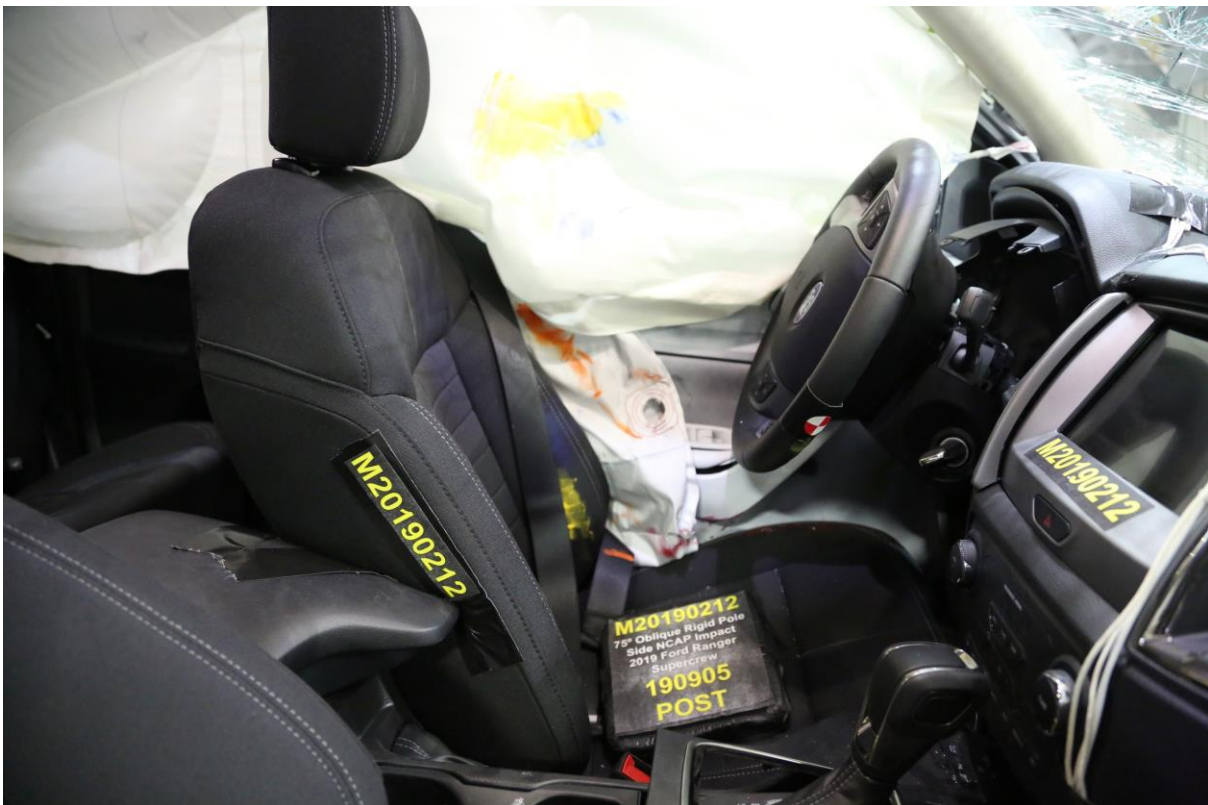
**No. 045 Post-Test Inner Door Panel View Showing Dummy Contact Location**

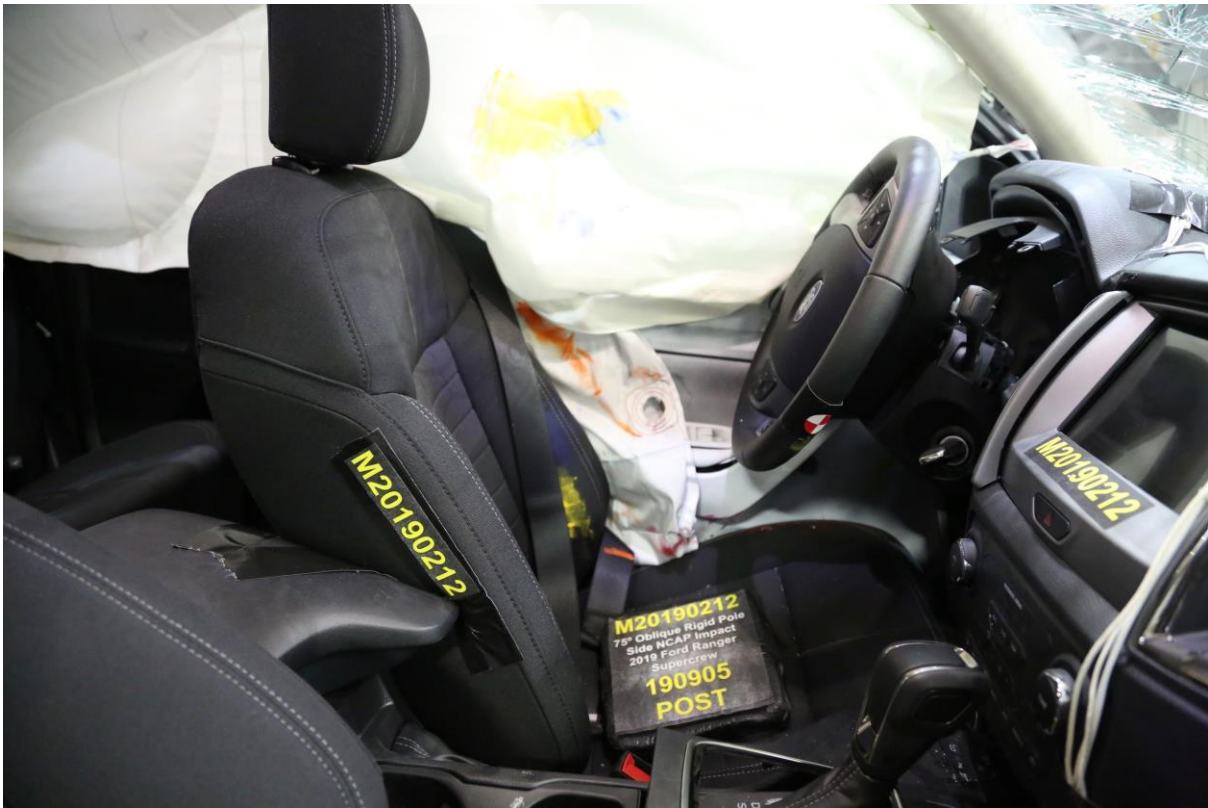
**No. 047 Post-Test Dummy Close-Up Head Contact with Side Airbag View**

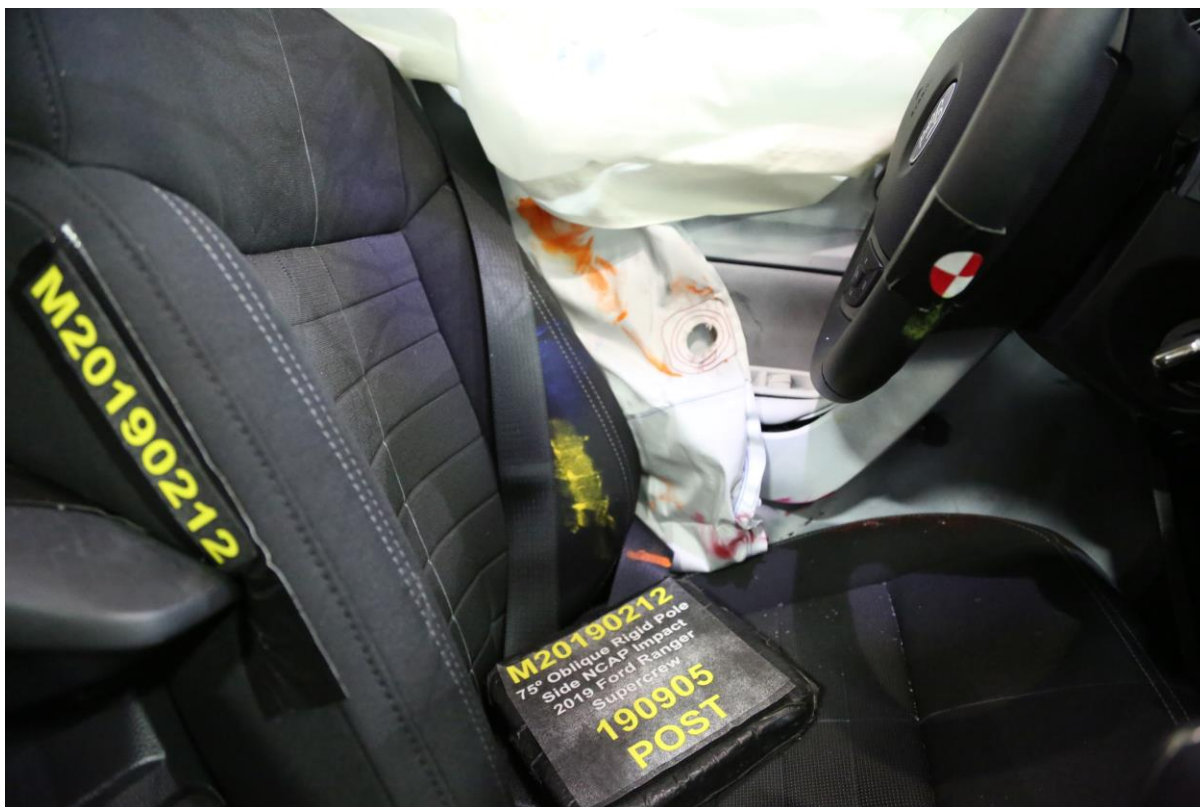
**No. 049 Post-Test Dummy Close-Up Torso Contact with Side Airbag View**

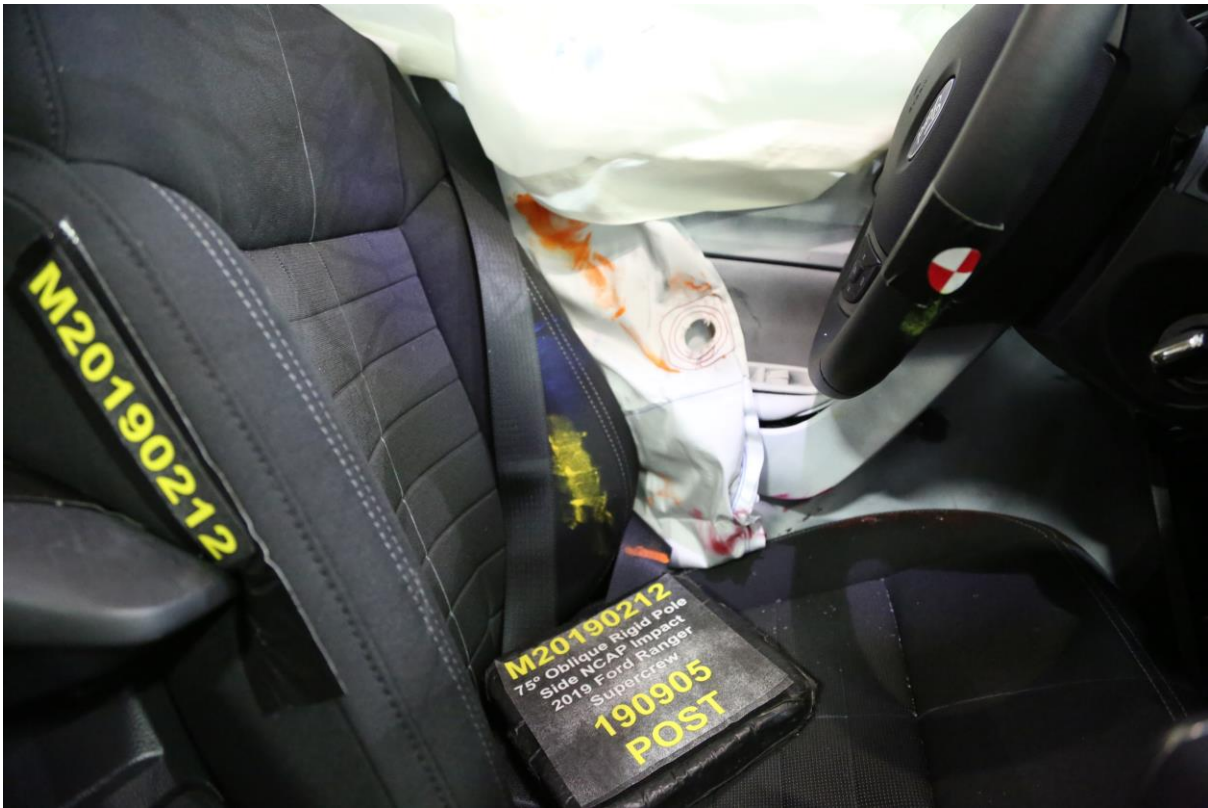
No. 051 Post-Test Dummy Close-Up Pelvis Contact with Side Airbag View

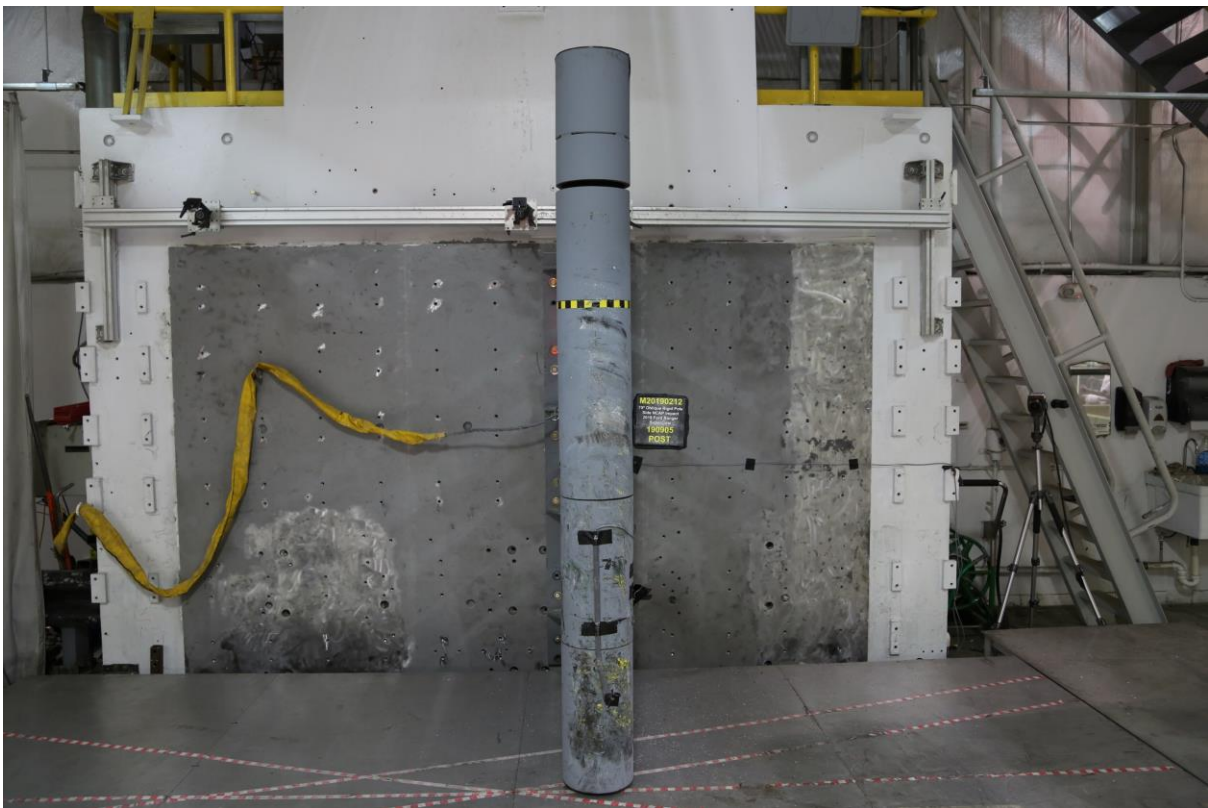
**No. 058 Post-Test Pole Barrier Front View**

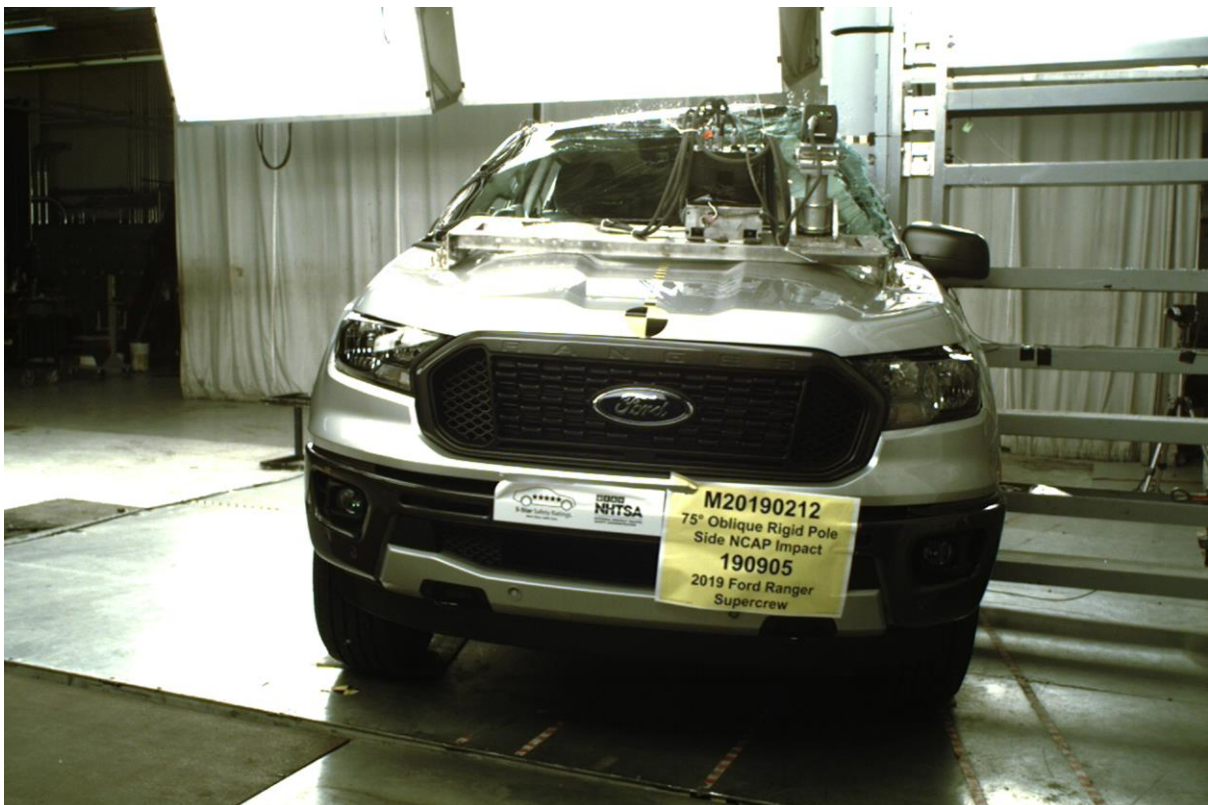
**No. 068 Impact Event**
