**FINAL REPORT NUMBER: SPNCAP-TRC-19-008**

**NEW CAR ASSESSMENT PROGRAM (NCAP)  
SIDE IMPACT POLE TEST**

**GENERAL MOTORS LLC  
2019 Chevrolet Malibu 4-DR Sedan  
NHTSA NUMBER: M20190121**

**PREPARED BY:  
Transportation Research Center Inc.  
10820 State Route 347  
P. O. Box B-67  
East Liberty, OH 43319**

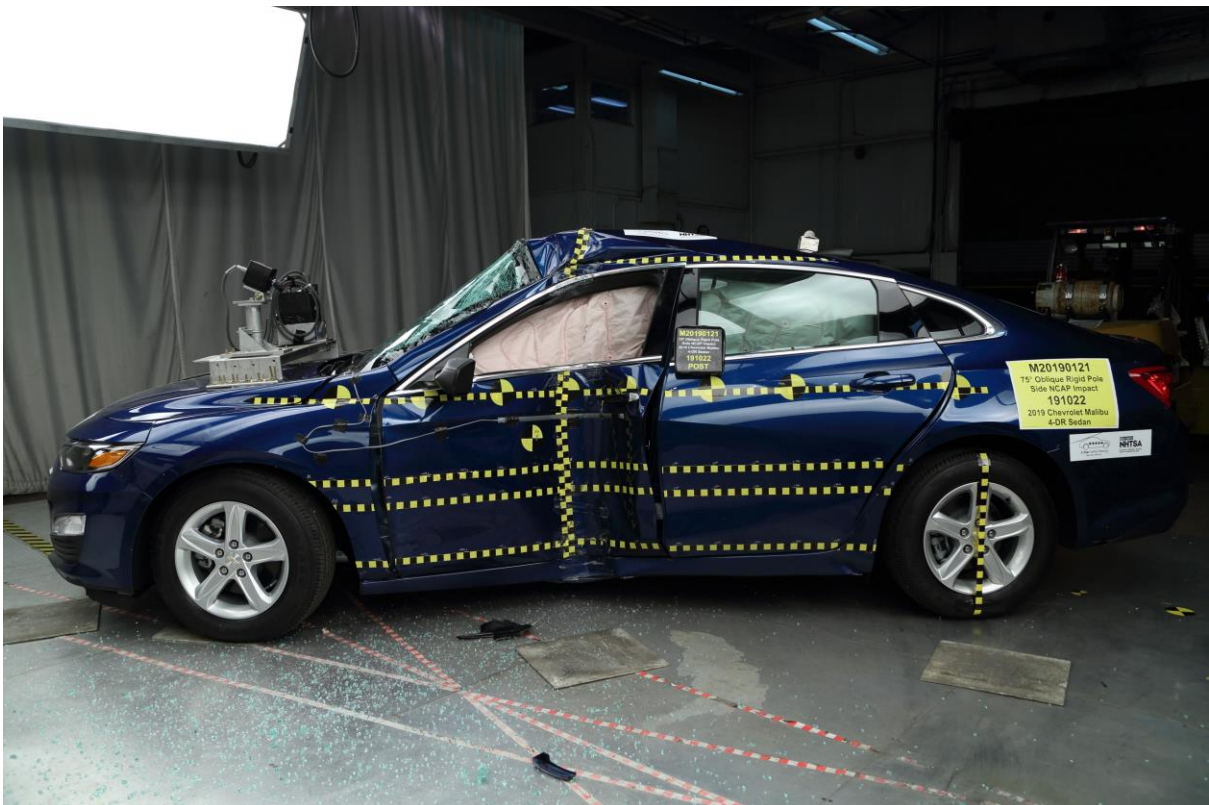
**No. 008 Post-Test Left Side View of Test Vehicle**

Critical Areas of Performance	Observations and Conclusions
Pillar Performance	Good
Sill Separation	None
Windshield Damage	Shattered across top & along left A pillar
Side Window Damage	Driver side window broken out
Other Notable Effects	None

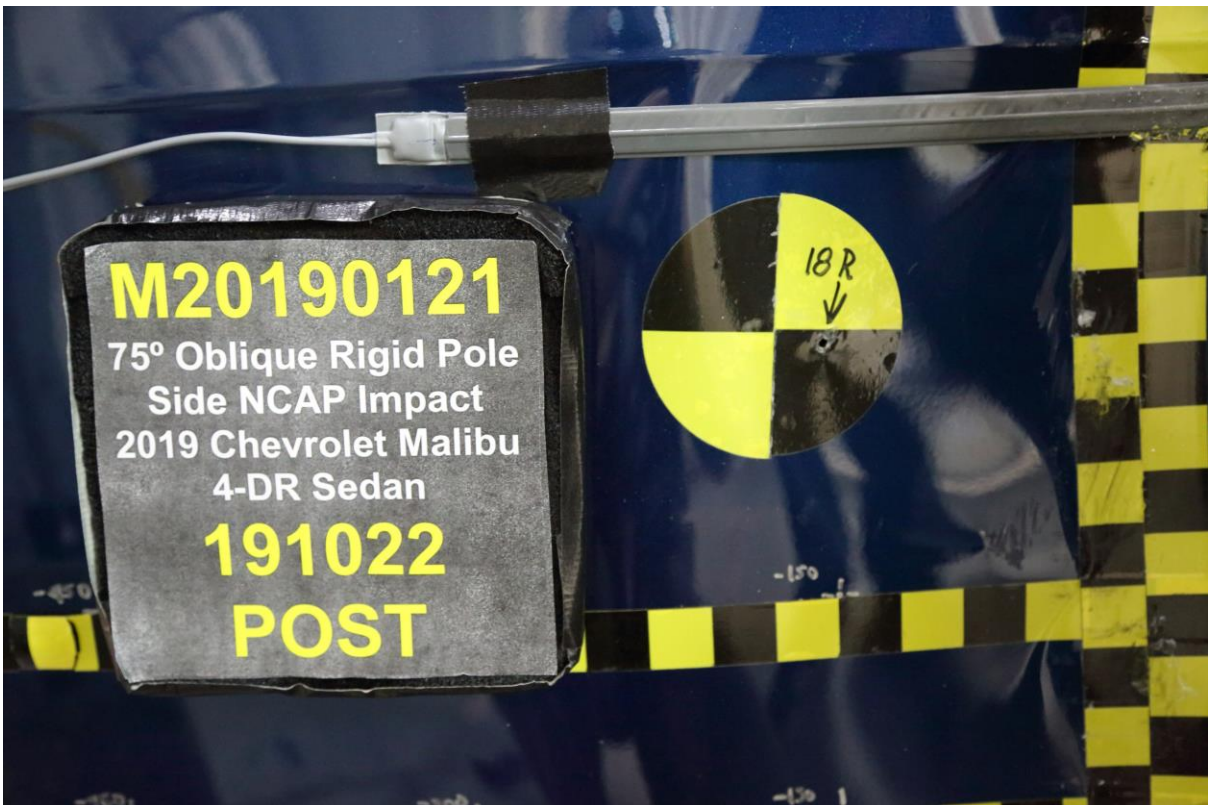
No. 020 Post-Test Close-Up View of Impact Point Target Showing Impact Location
