**REPORT NUMBER: SPNCAP-MGA-19-057**

**NEW CAR ASSESSMENT PROGRAM (NCAP)  
Side Impact Pole Test**

**AUDI AG  
2019 Audi e-tron quattro 5-Door SUV  
NHTSA No.: O20195804**

**FINAL REPORT**

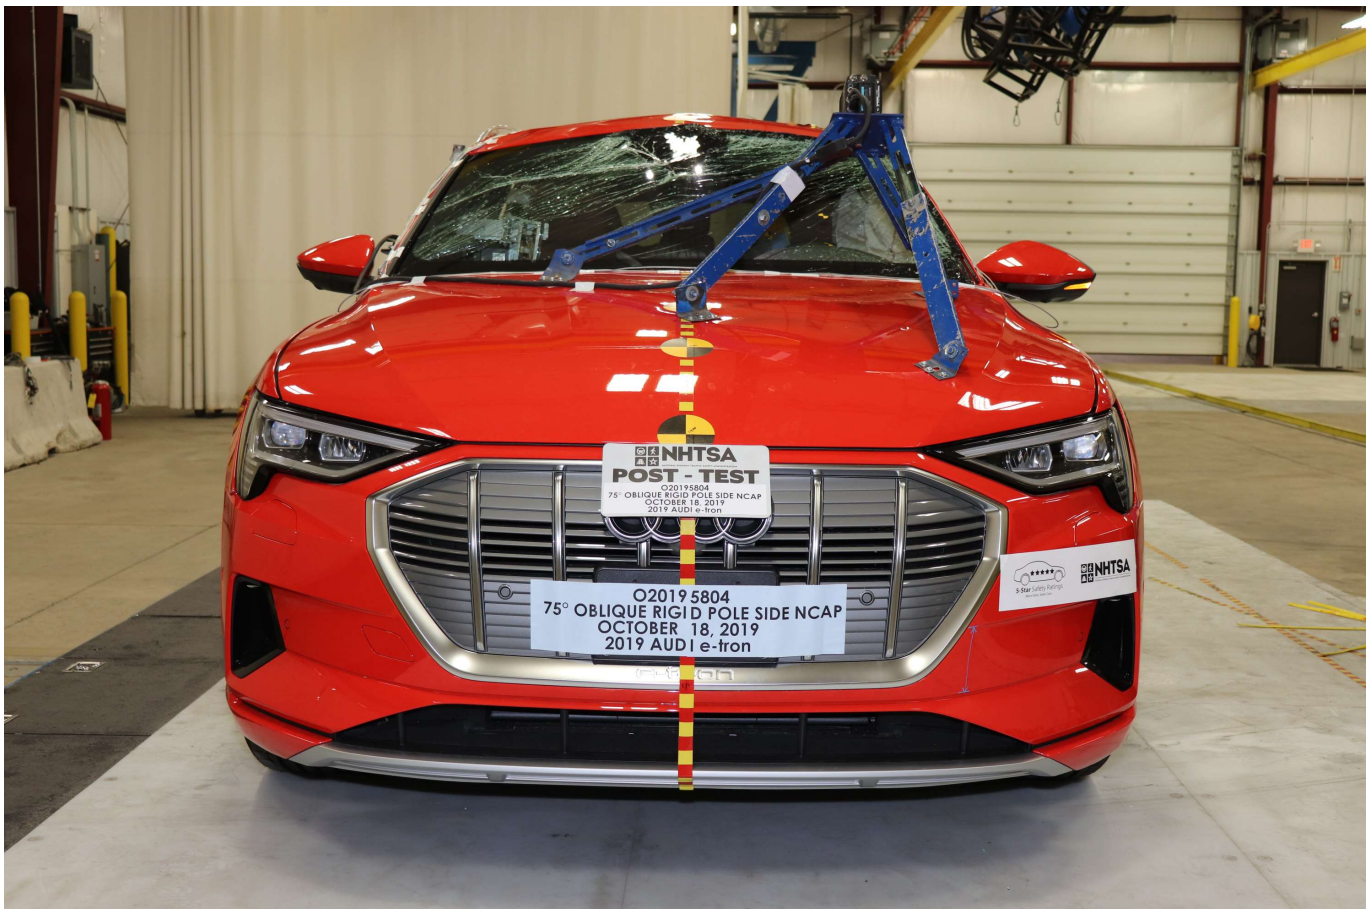
Photo No. 004 - Post-Test Frontal View of Test Vehicle

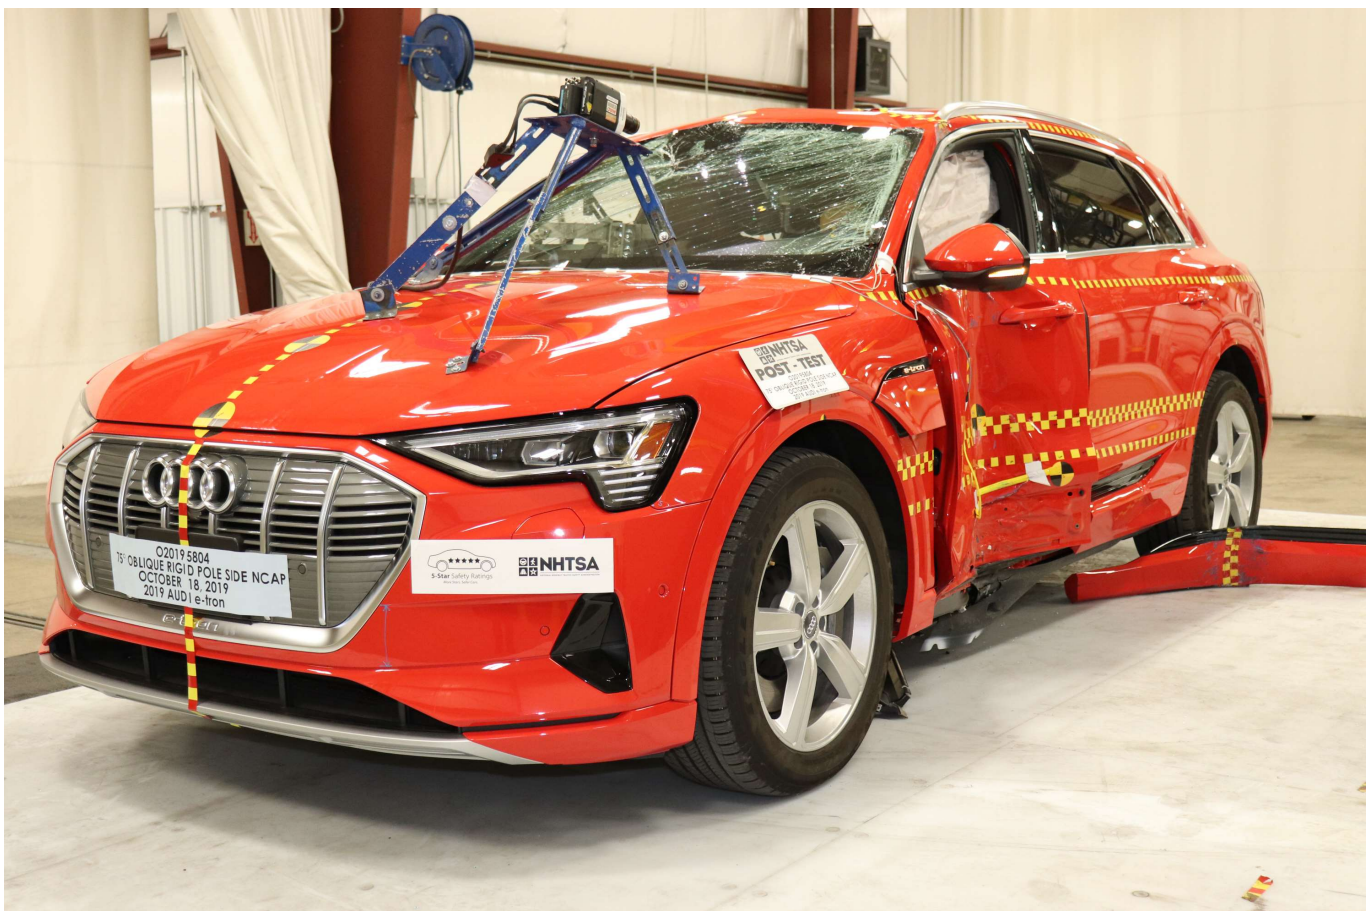
Photo No. 006 - Post-Test Left Front Three-Quarter View of Test Vehicle

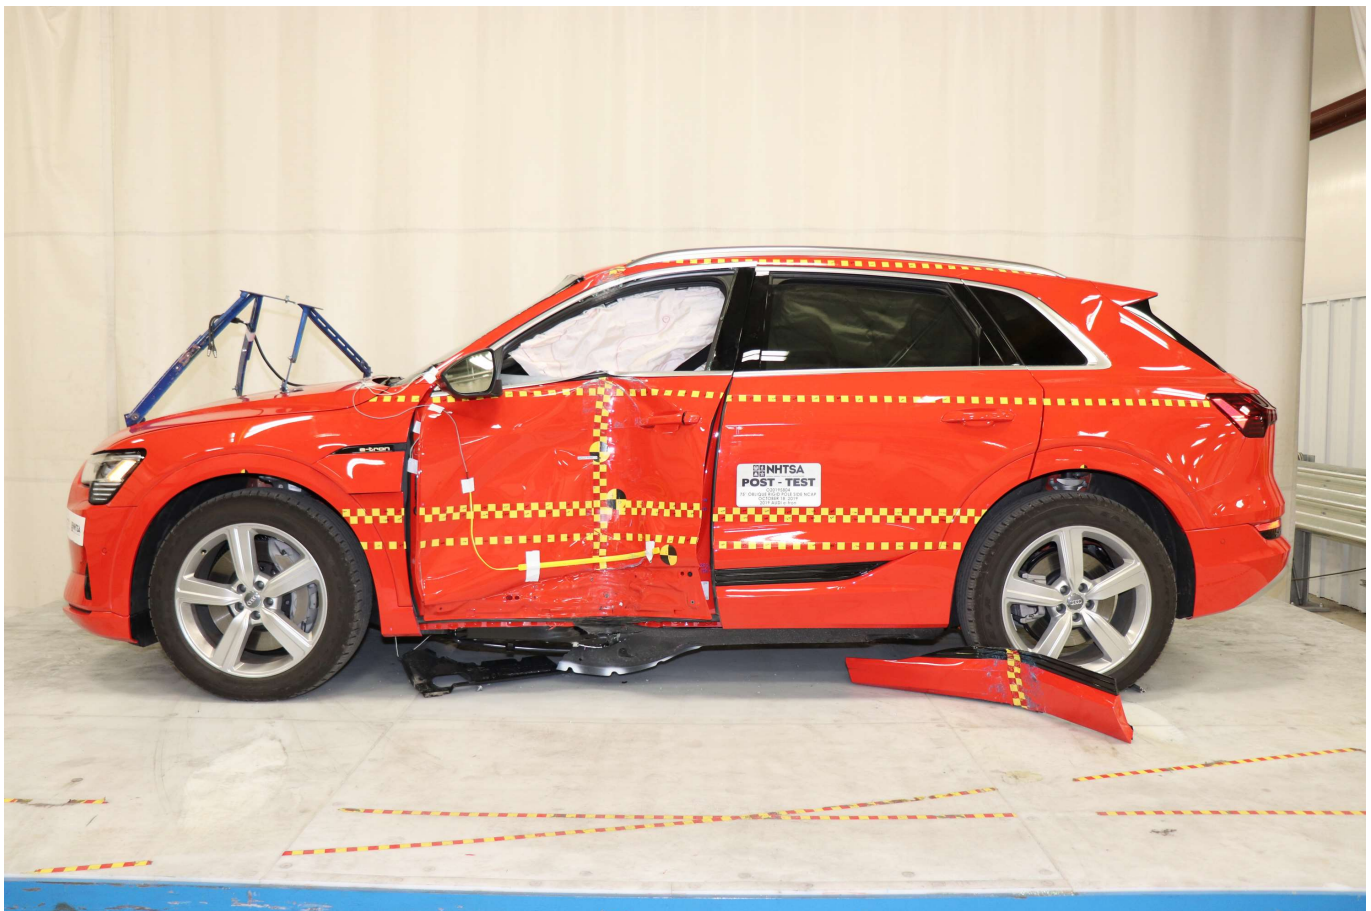
Photo No. 008 - Post-Test Left Side View of Test Vehicle

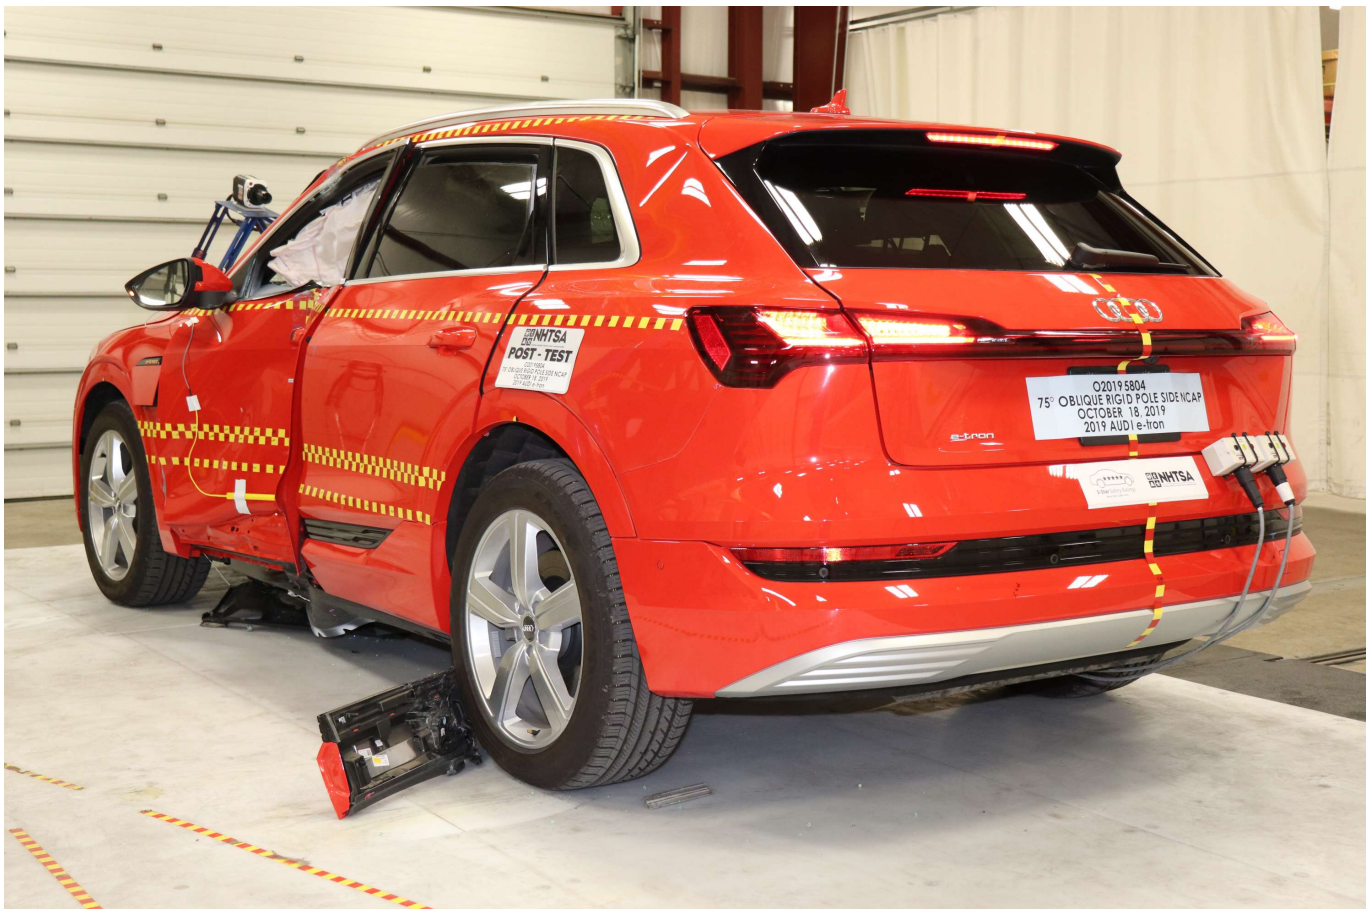
Photo No. 010 - Post-Test Left Rear Three-Quarter View of Test Vehicle

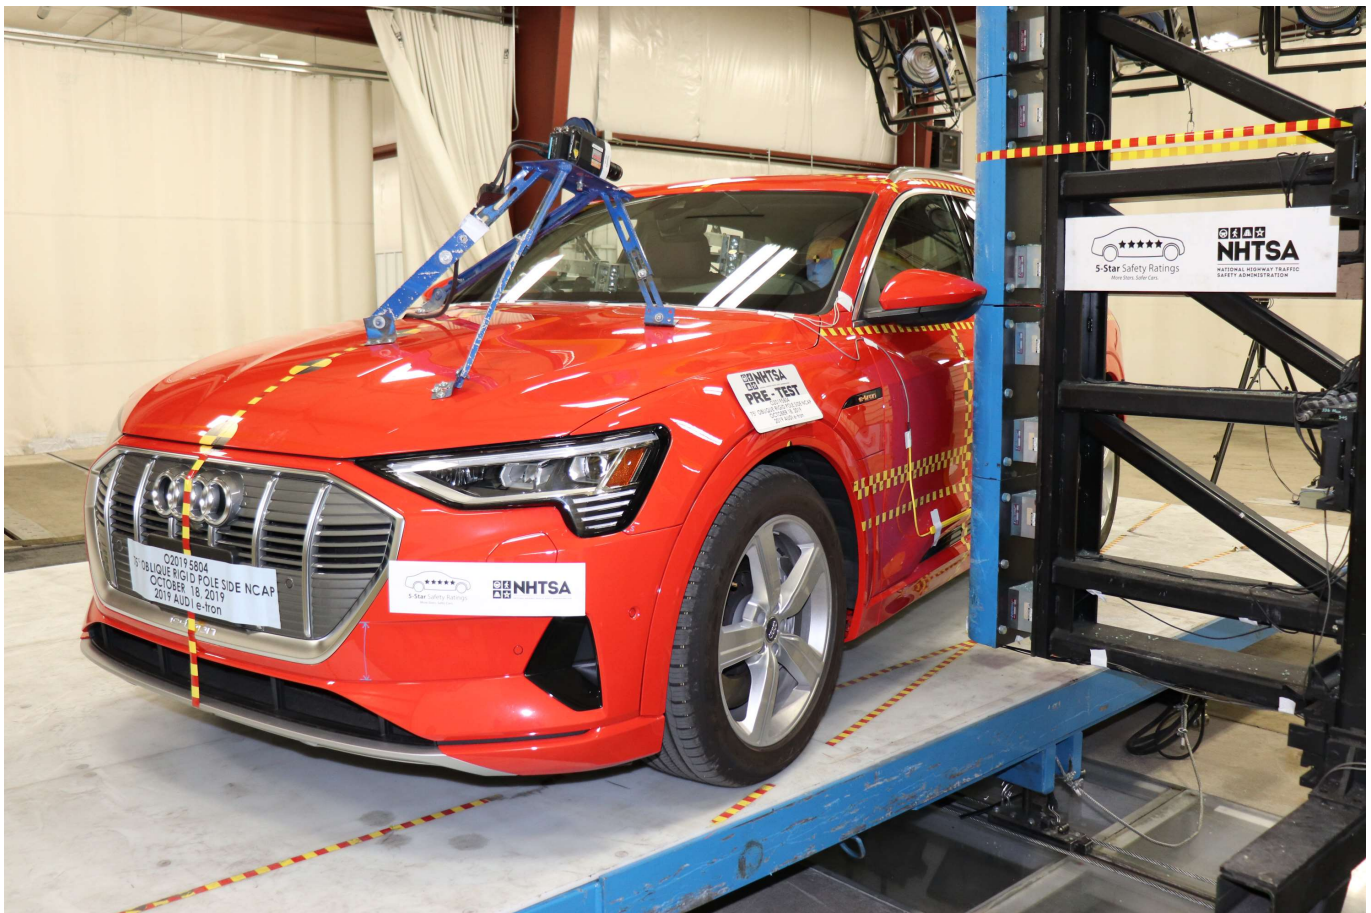
Photo No. 017 - Pre-Test Left Side View of Pole Positioned Against Side of Vehicle

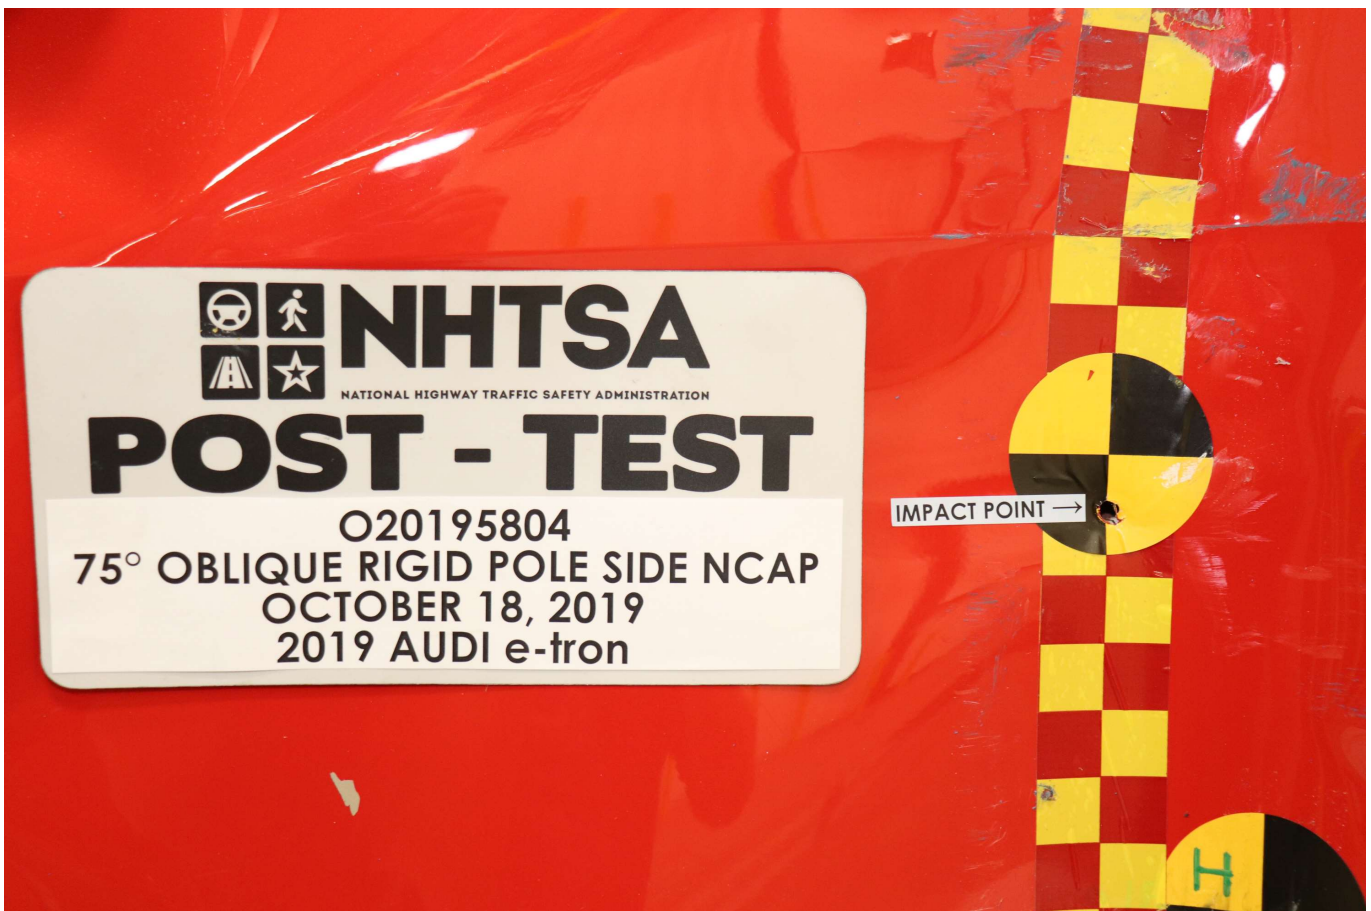
Photo No. 020 - Post-Test Close-Up View of Impact Point Target Showing Impact Location

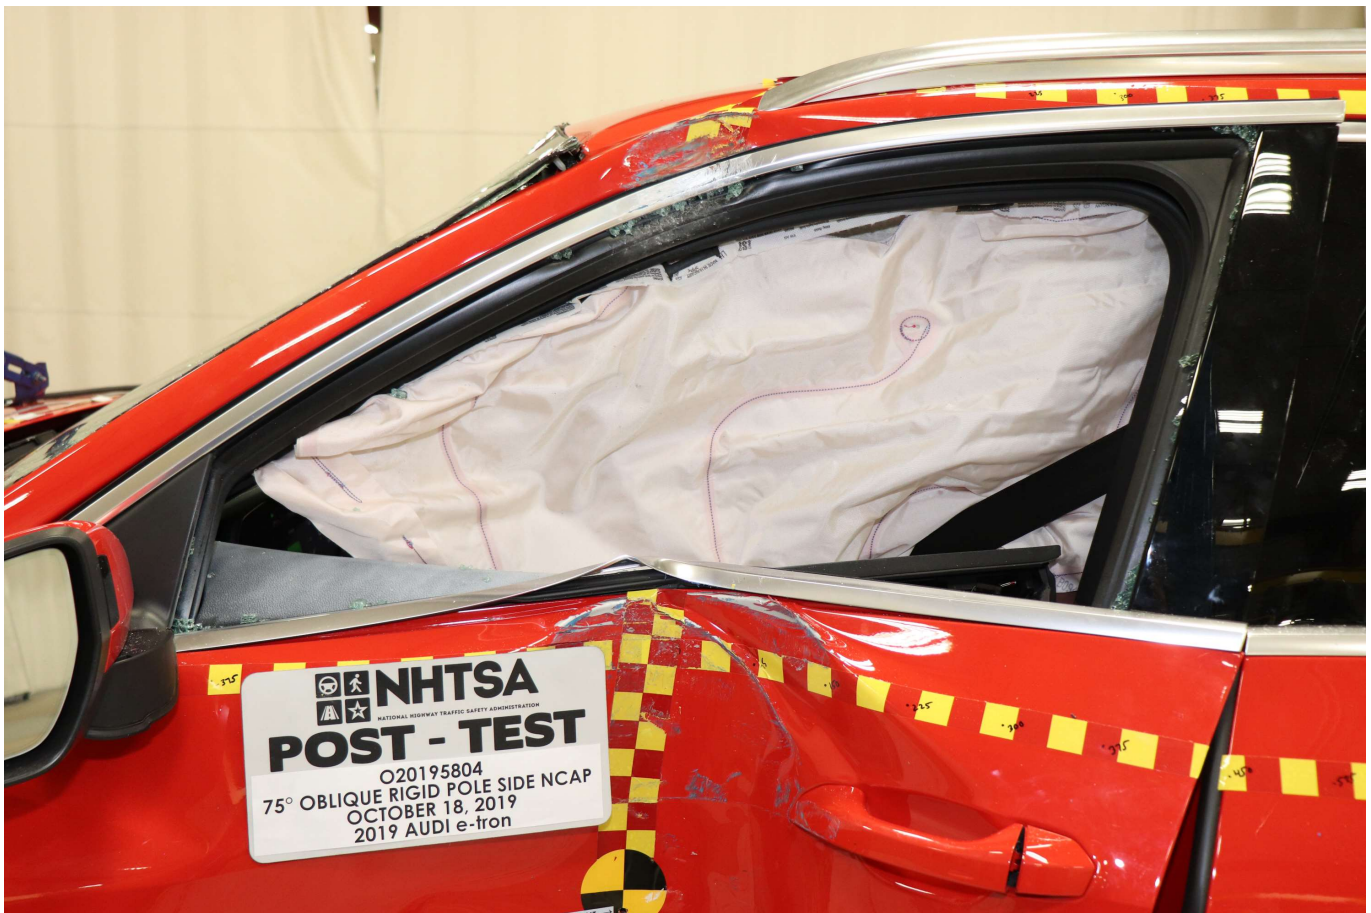
Photo No. 025 - Post-Test Left Side View of Dummy Shoulder and Door Top View

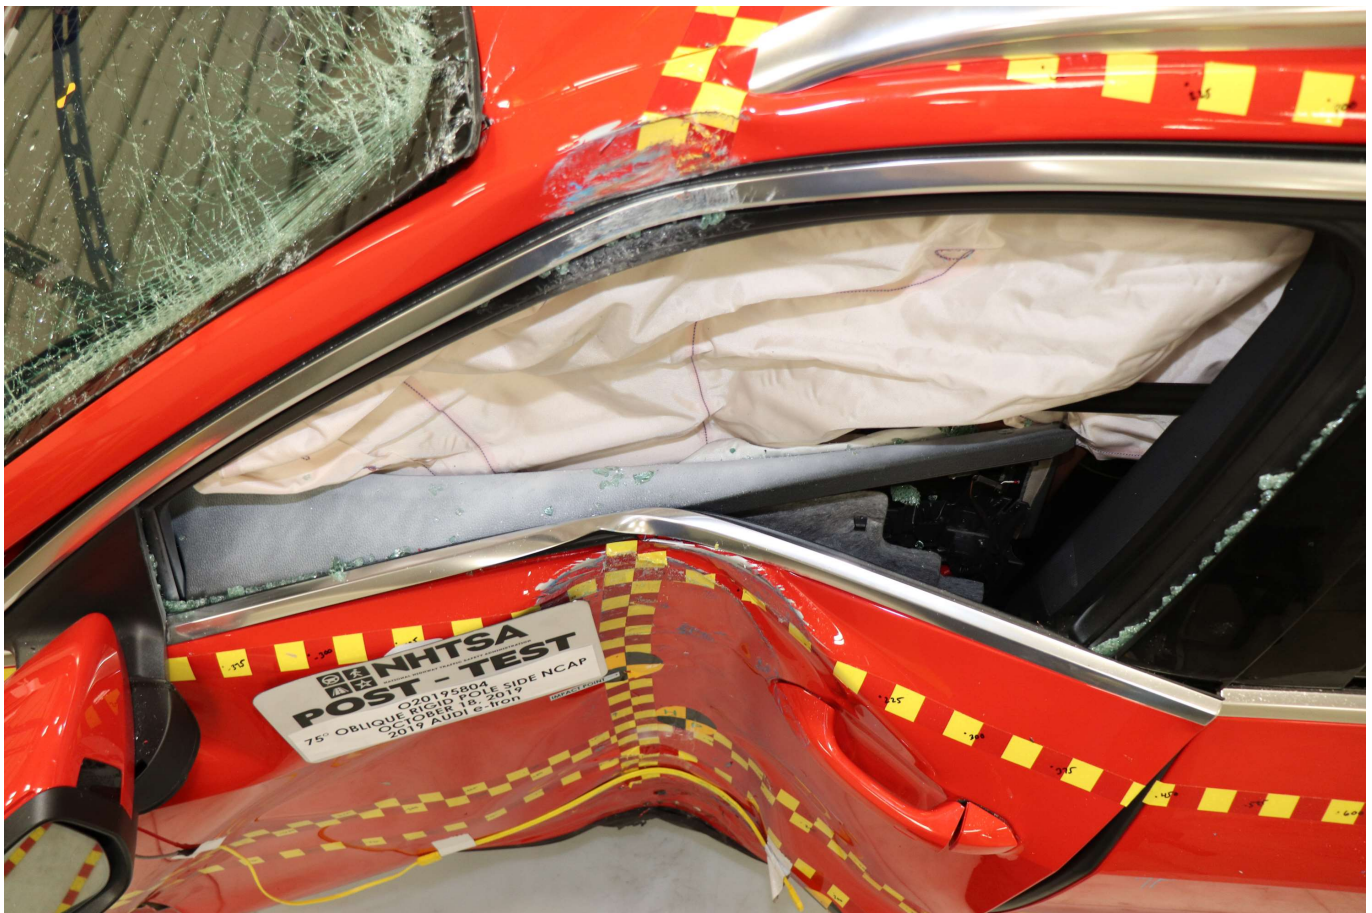
Photo No. 041 - Post-Test Dummy and Door Clearance View

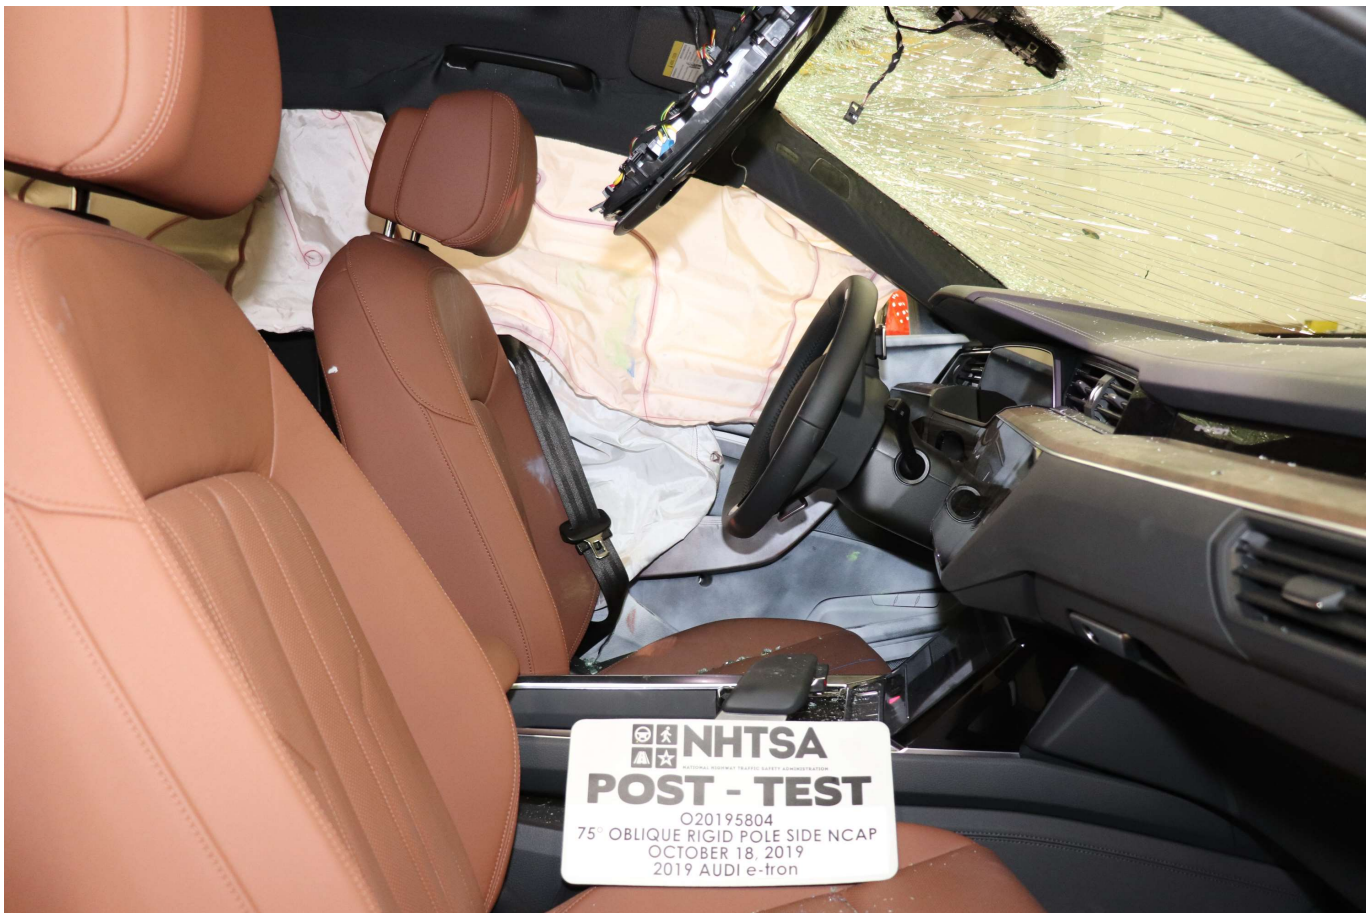
Photo No. 045 - Post-Test Inner Door Panel View Showing Dummy Contact Location

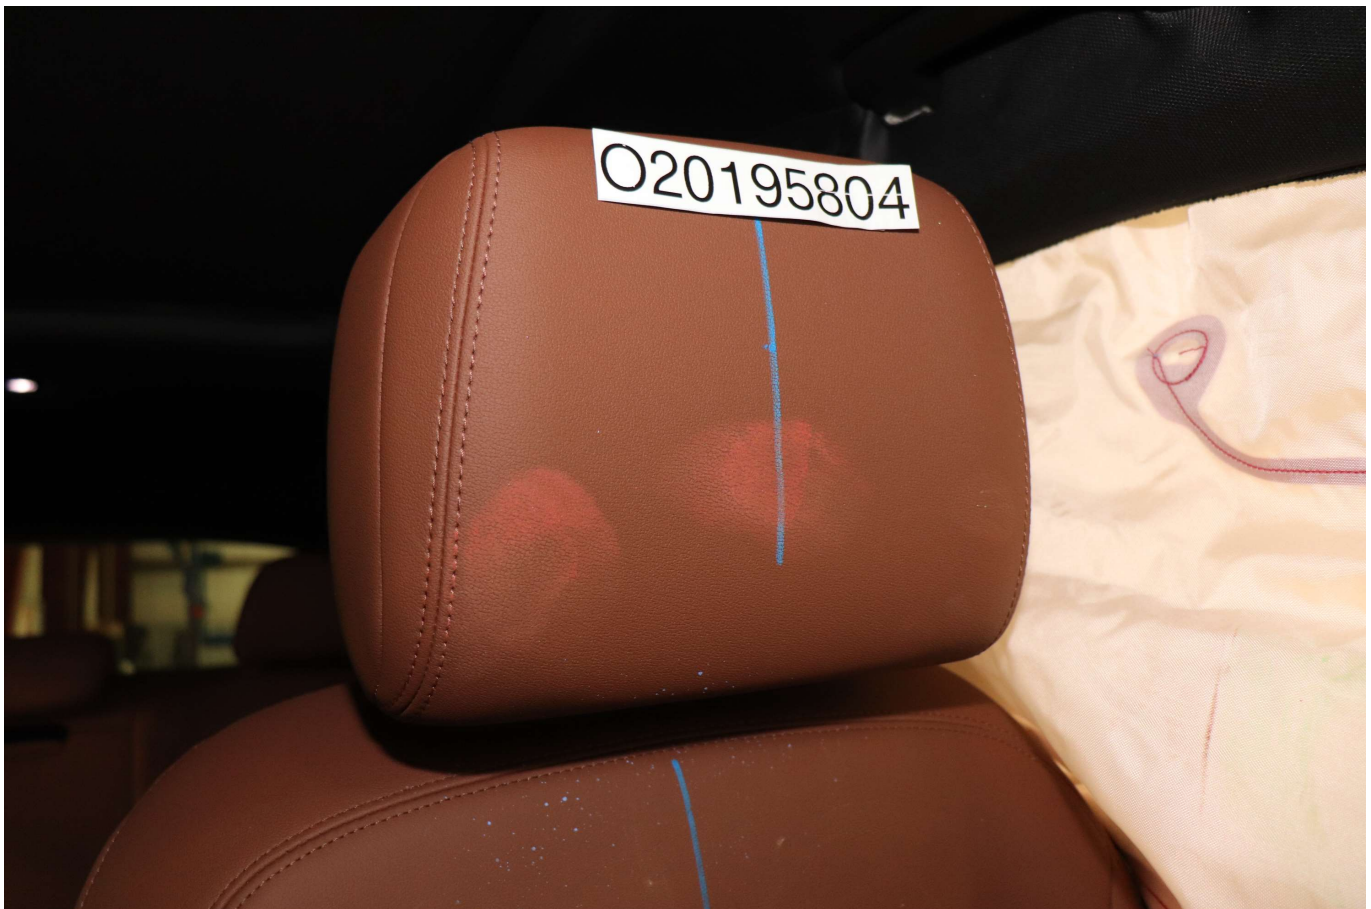
Photo No. 046 - Post-Test Dummy Close-Up Head Contact with Vehicle Interior View

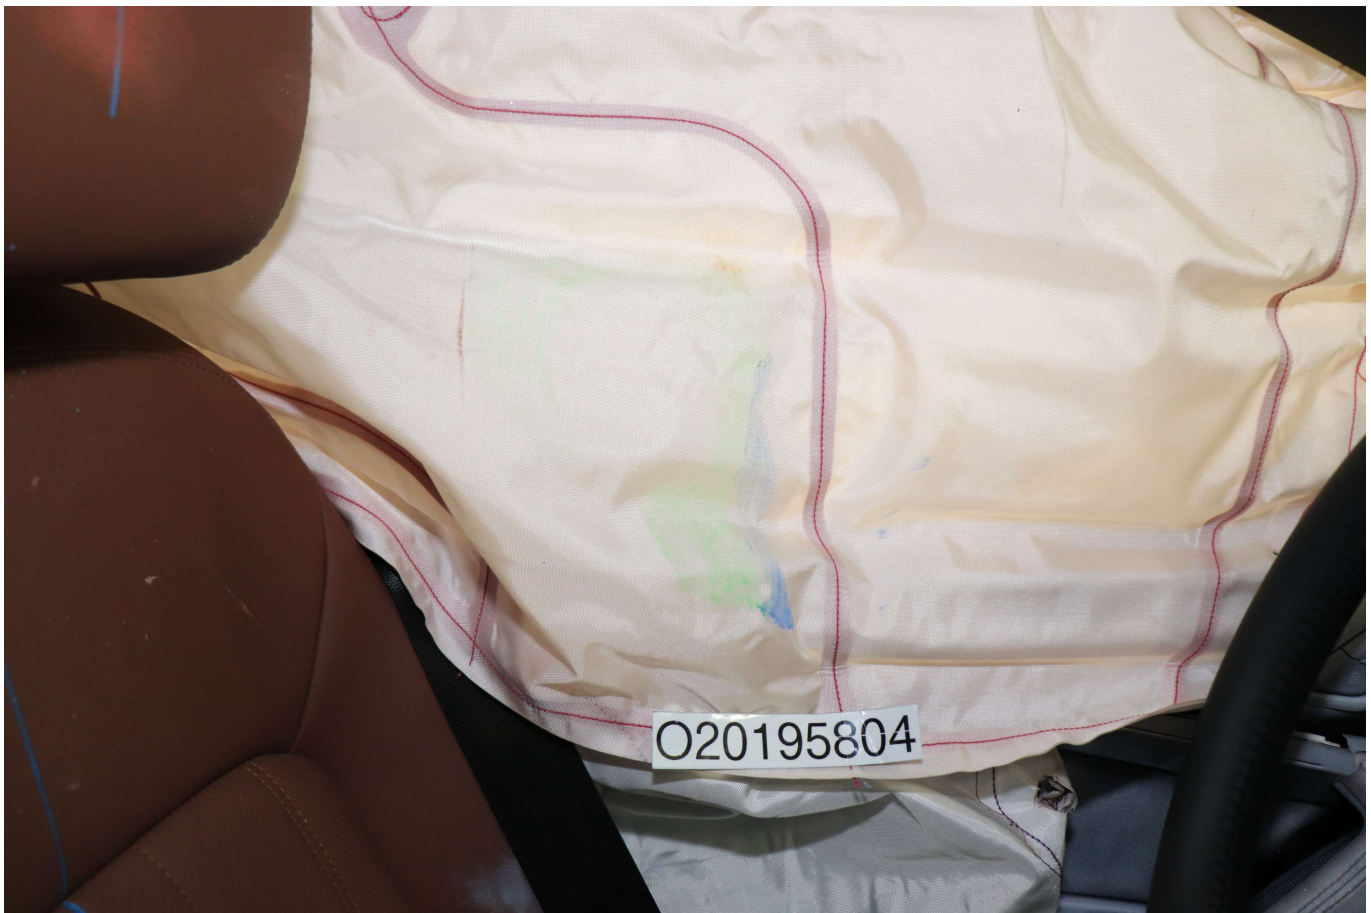
Photo No. 047 - Post-Test Dummy Close-Up Head Contact with Side Air Bag View

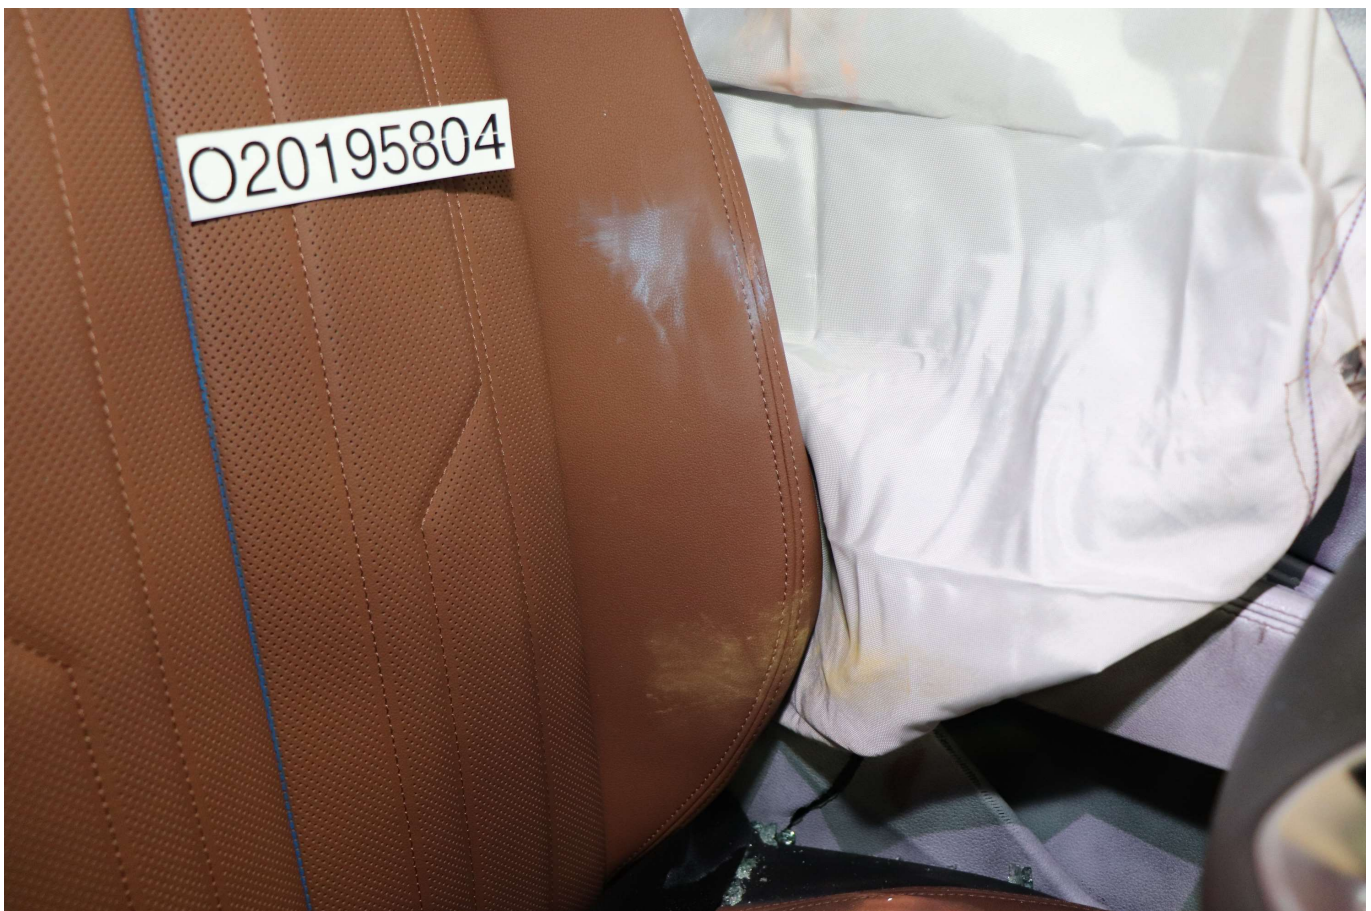
Photo No. 048 - Post-Test Dummy Close-Up Torso Contact with Vehicle Interior View

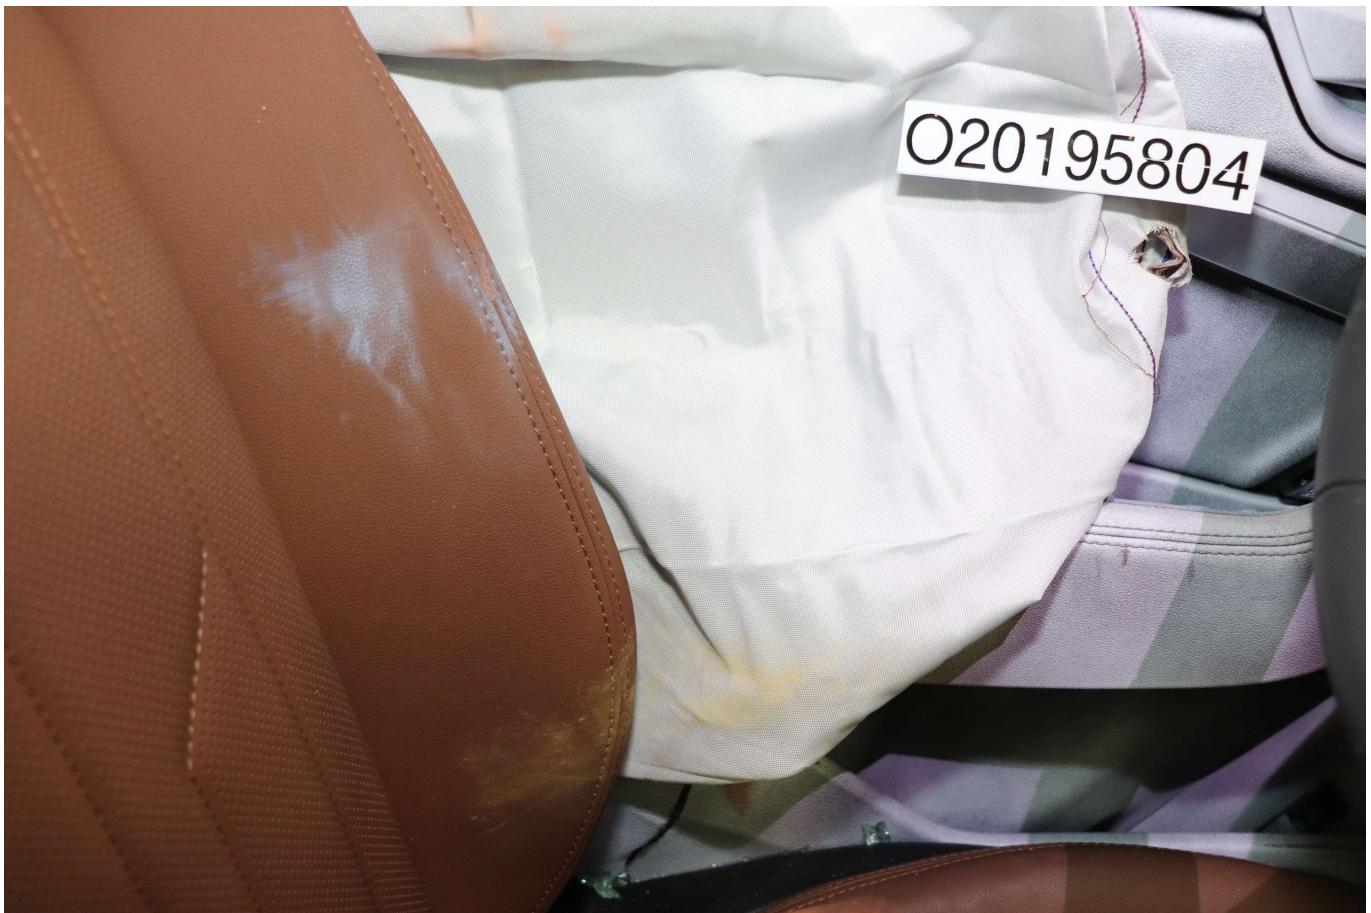
Photo No. 049 - Post-Test Dummy Close-Up Torso Contact with Side Air Bag View

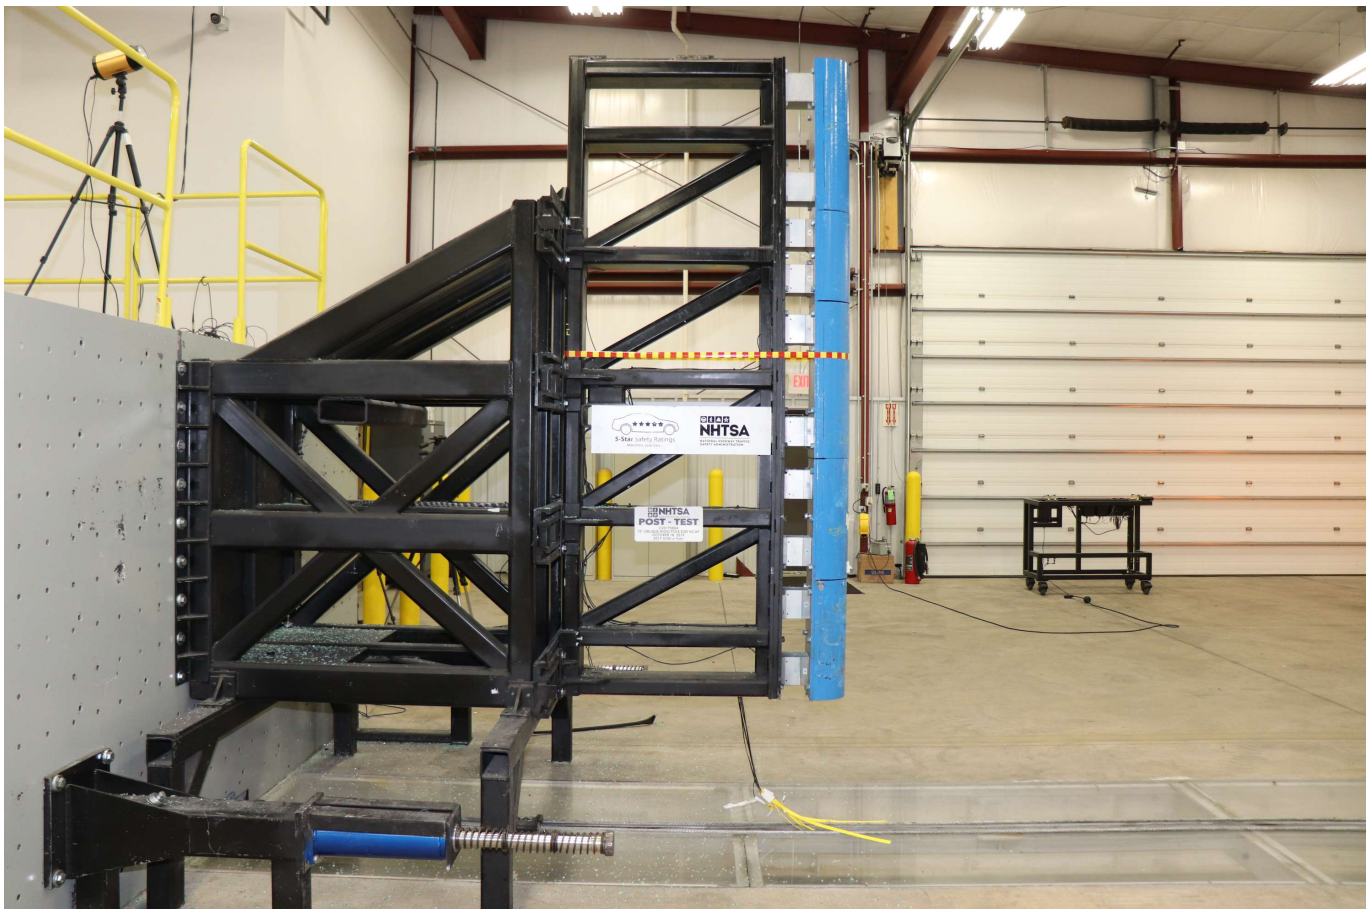
Photo No. 060 - Post-Test Pole Barrier Side View

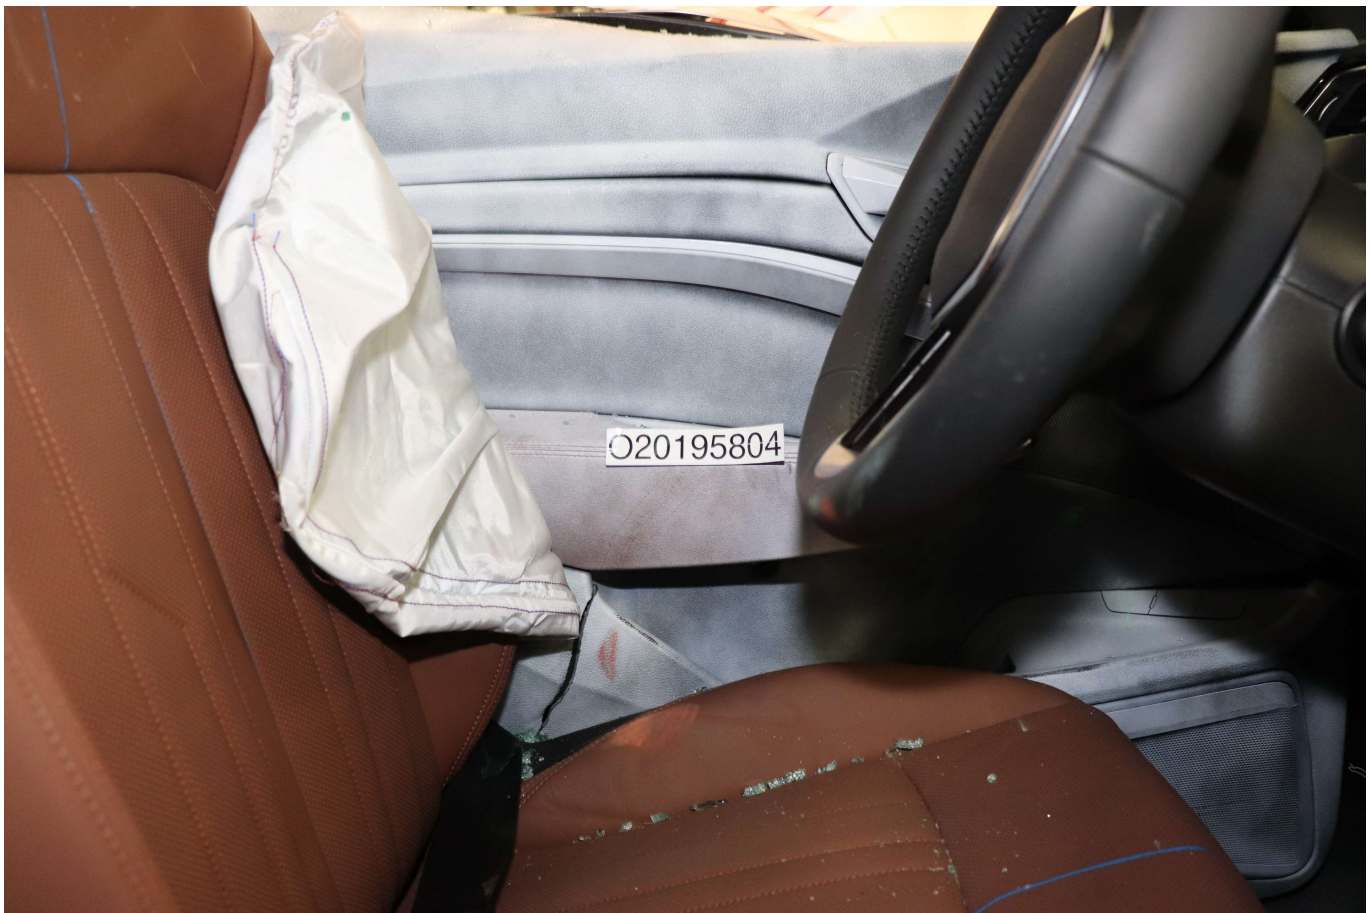
Photo No. 071 - Post-Test View of Shattered Vehicle Inner Door Panel
