**REPORT NUMBER: SINCAP-MGA-19-056**

**NEW CAR ASSESSMENT PROGRAM (NCAP)  
Moving Deformable Barrier Side Impact Test**

**AUDI AG  
2019 Audi e-tron quattro 5-Door SUV  
NHTSA No.: O20195805**

**MGA RESEARCH CORPORATION  
5000 Warren Road  
Burlington, WI 53105**

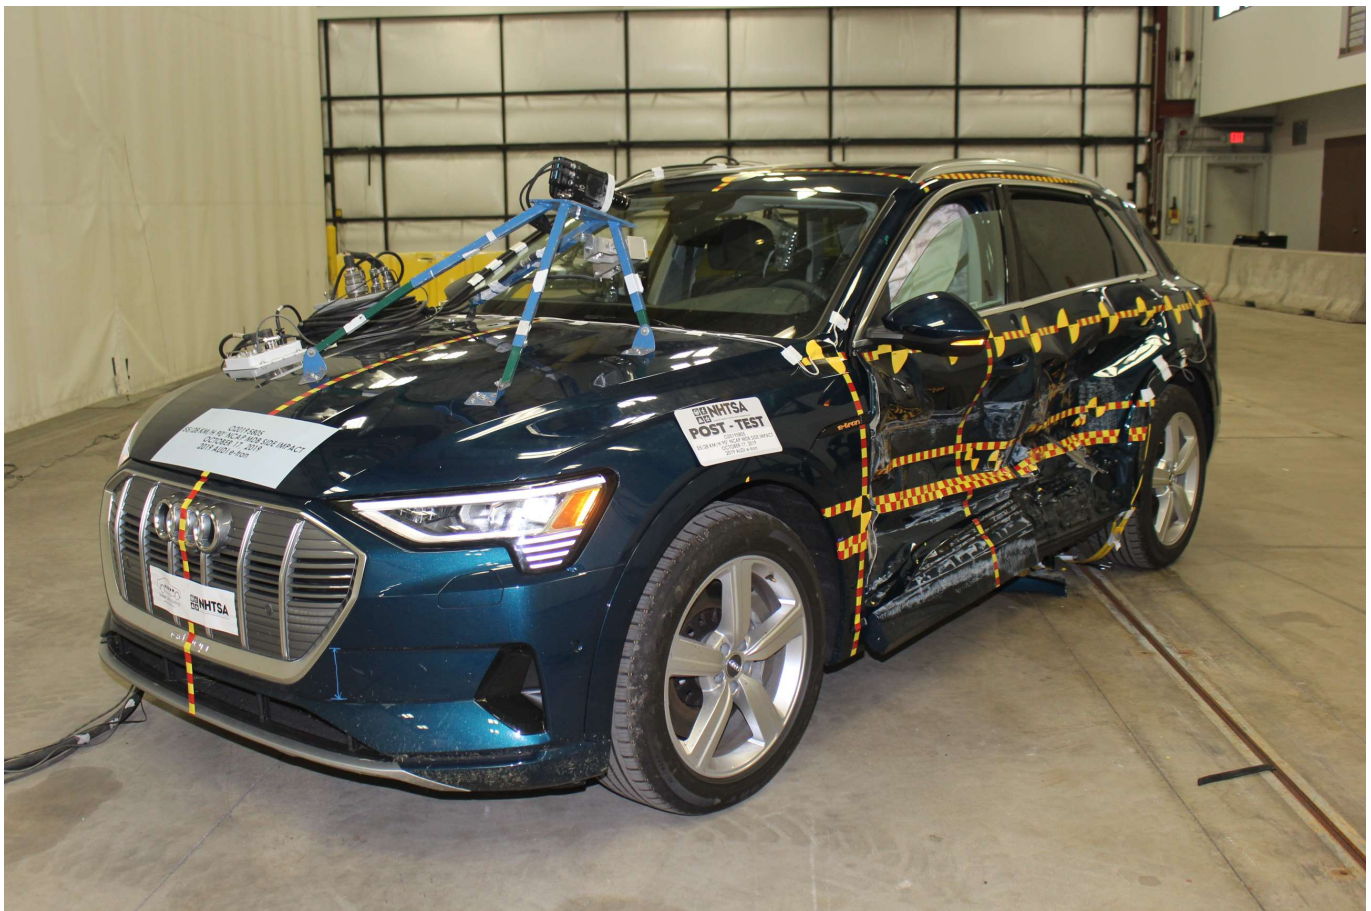
Photo No. 006 - Post-Test Left Front Three-Quarter View of Test Vehicle

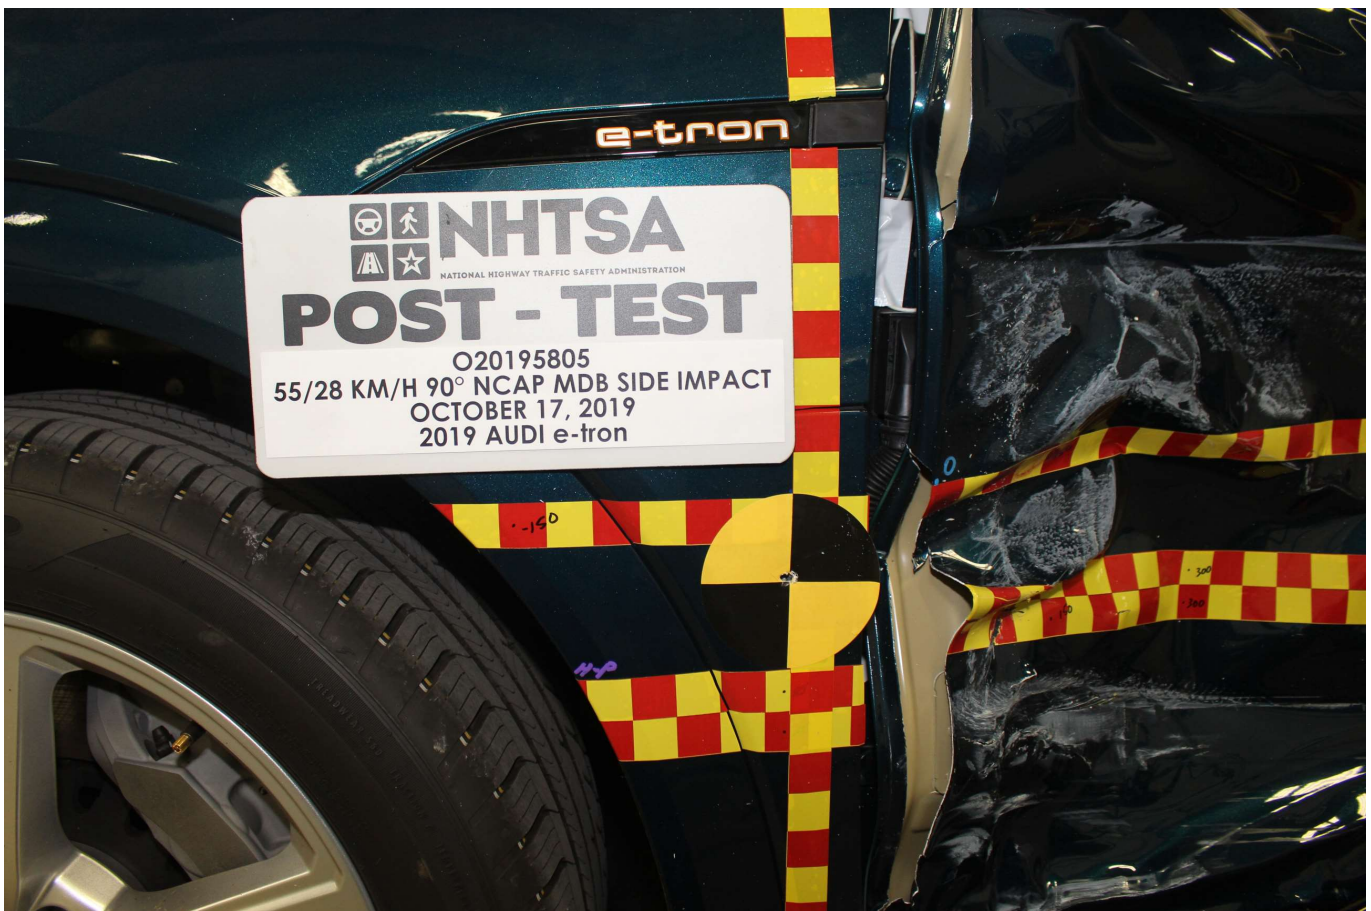
Photo No. 020 - Post-Test Close-Up View of Impact Point Target

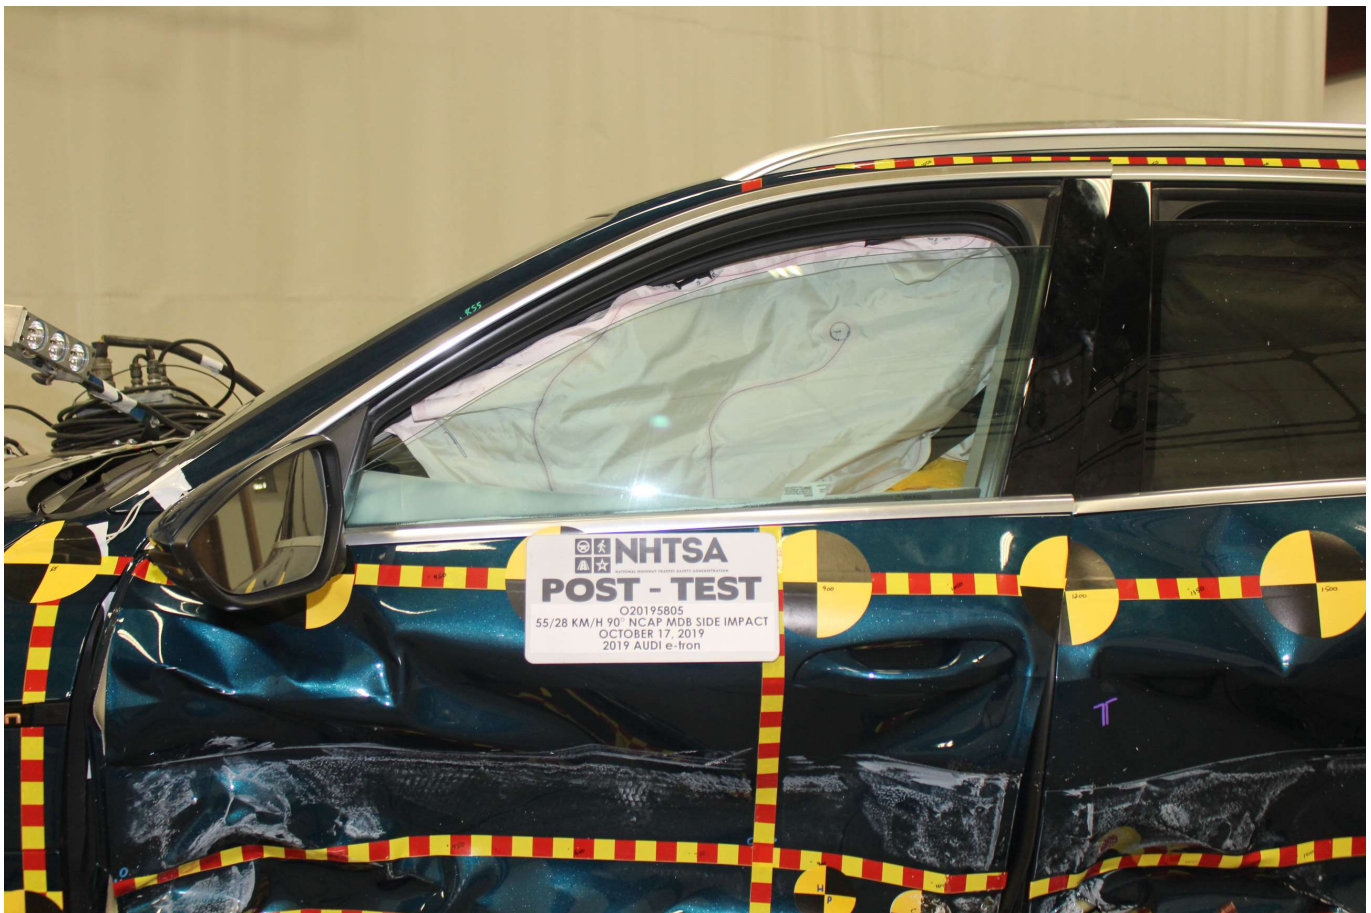
Photo No. 029 - Post-Test Left Side View of Driver Dummy Shoulder and Door Top View

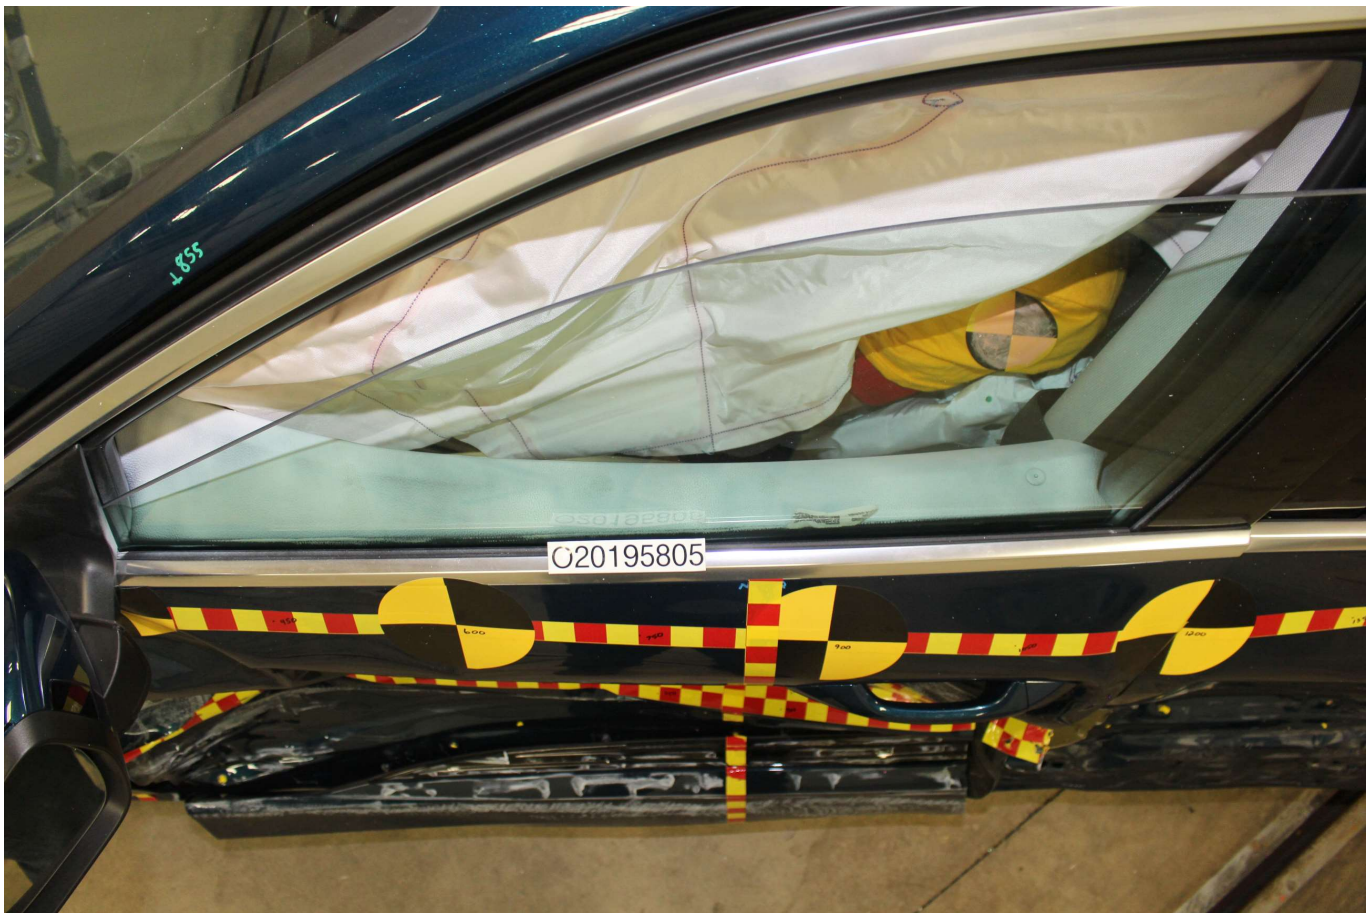
Photo No. 043 - Post-Test Driver Dummy and Door Clearance View

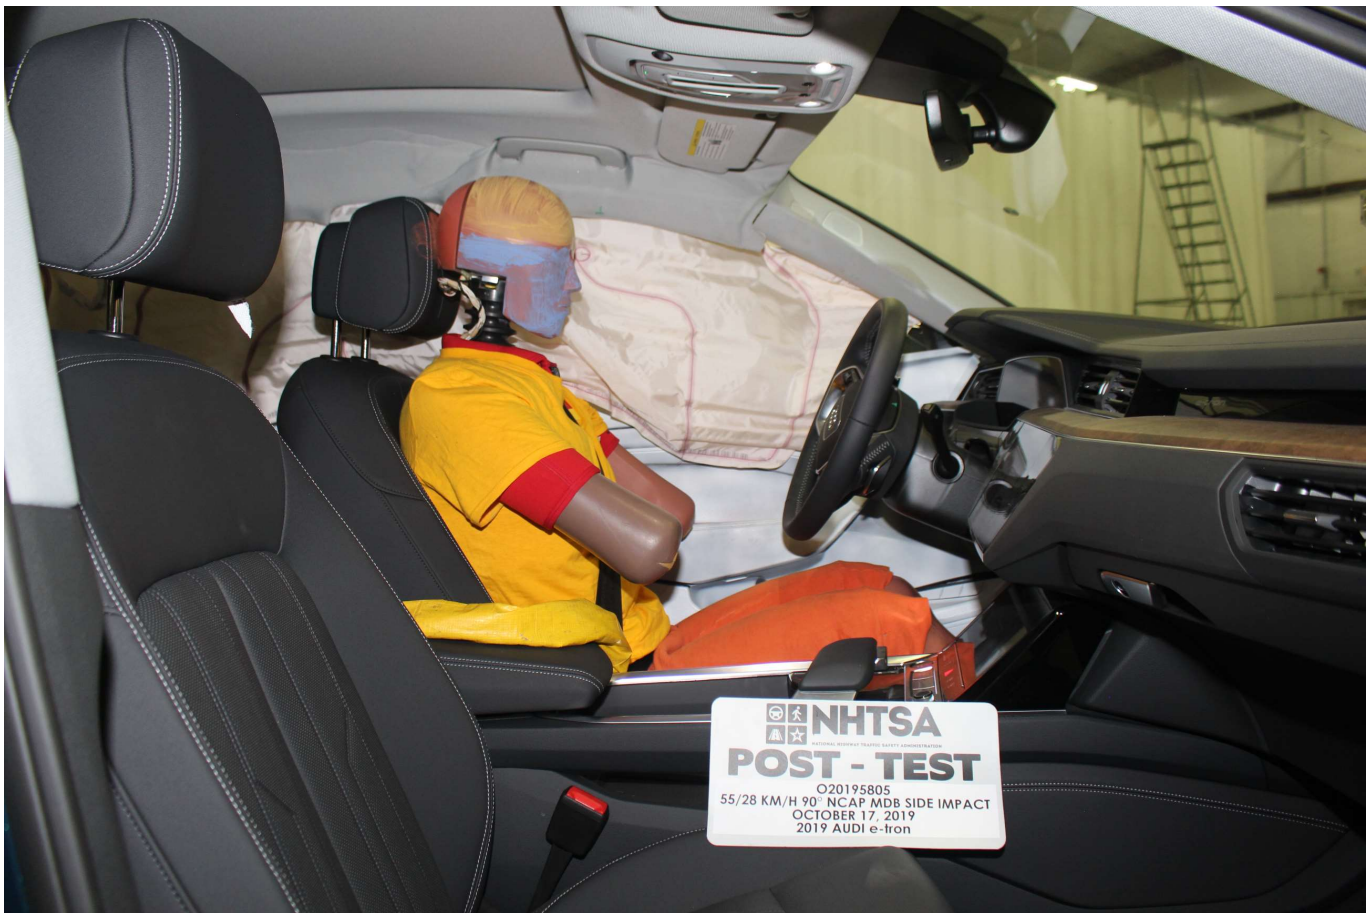
Photo No. 045 - Post-Test Right Side View of Driver Dummy and Front Seat of Occupant Compartment

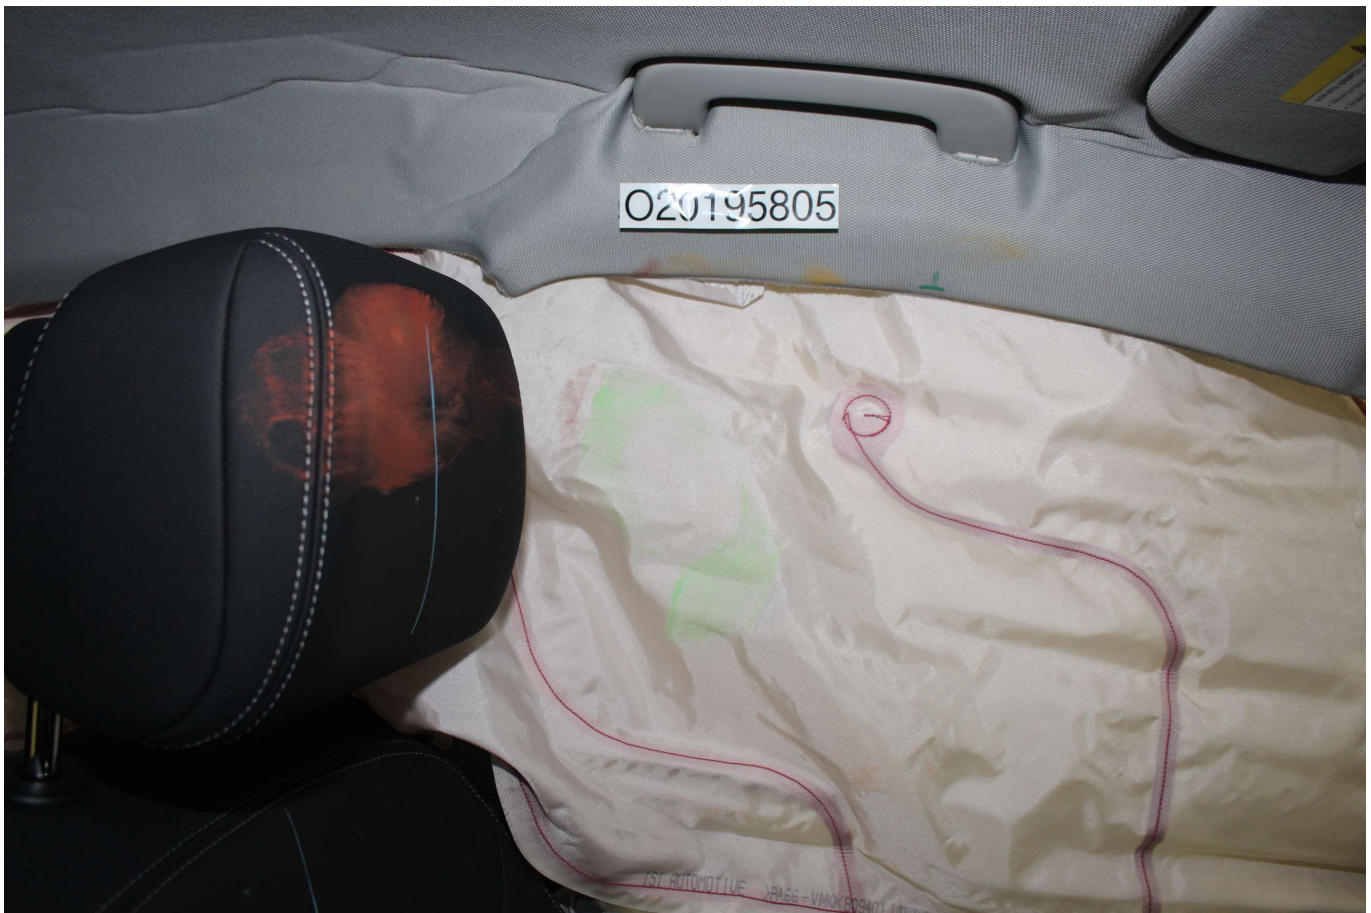
Photo No. 049 - Post-Test Driver Dummy Close-up Head Contact with Side Airbag View

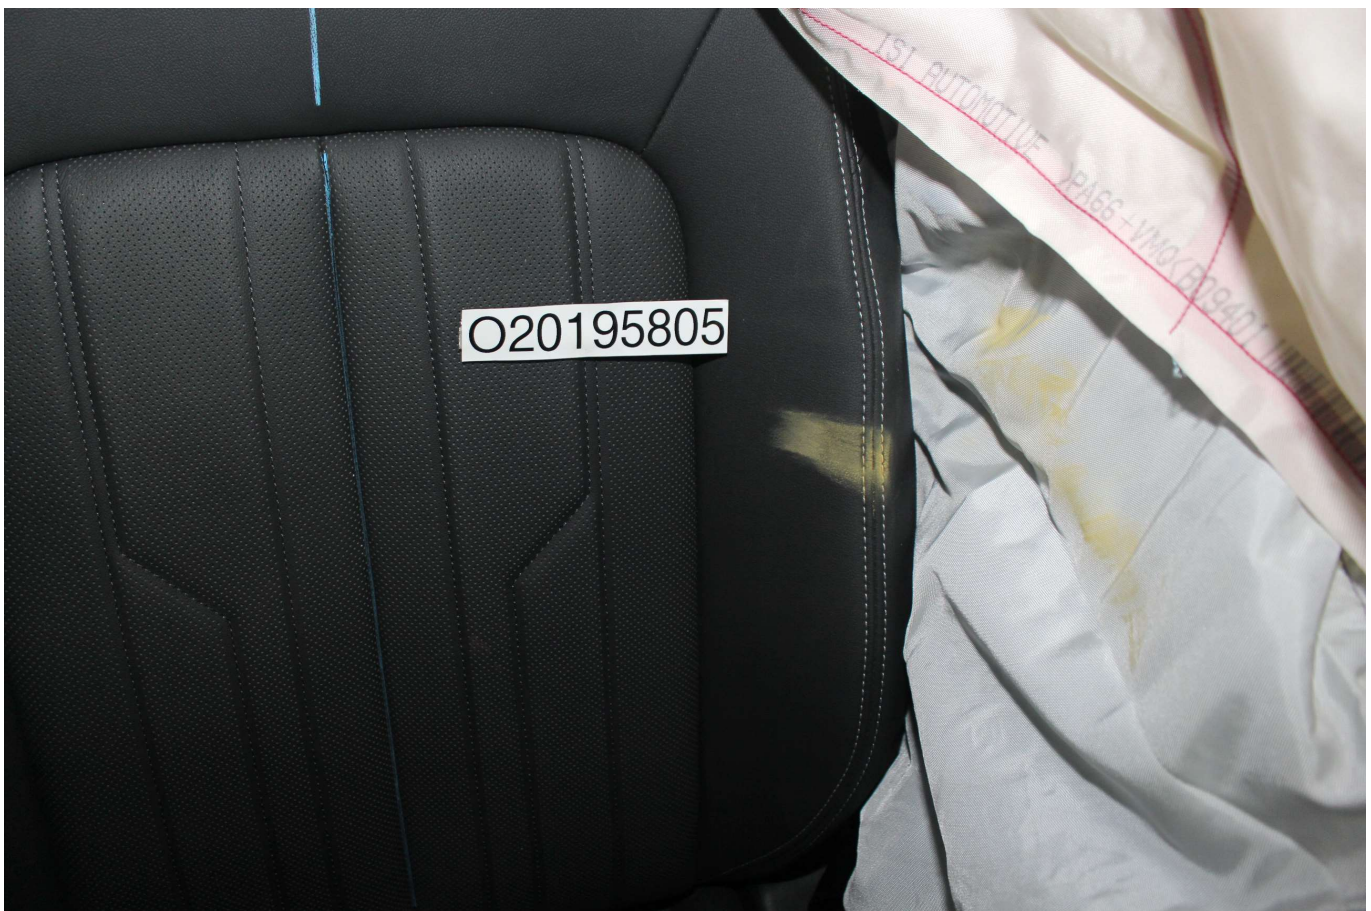
Photo No. 050 - Post-Test Driver Dummy Close-up Torso Contact with Vehicle Interior View

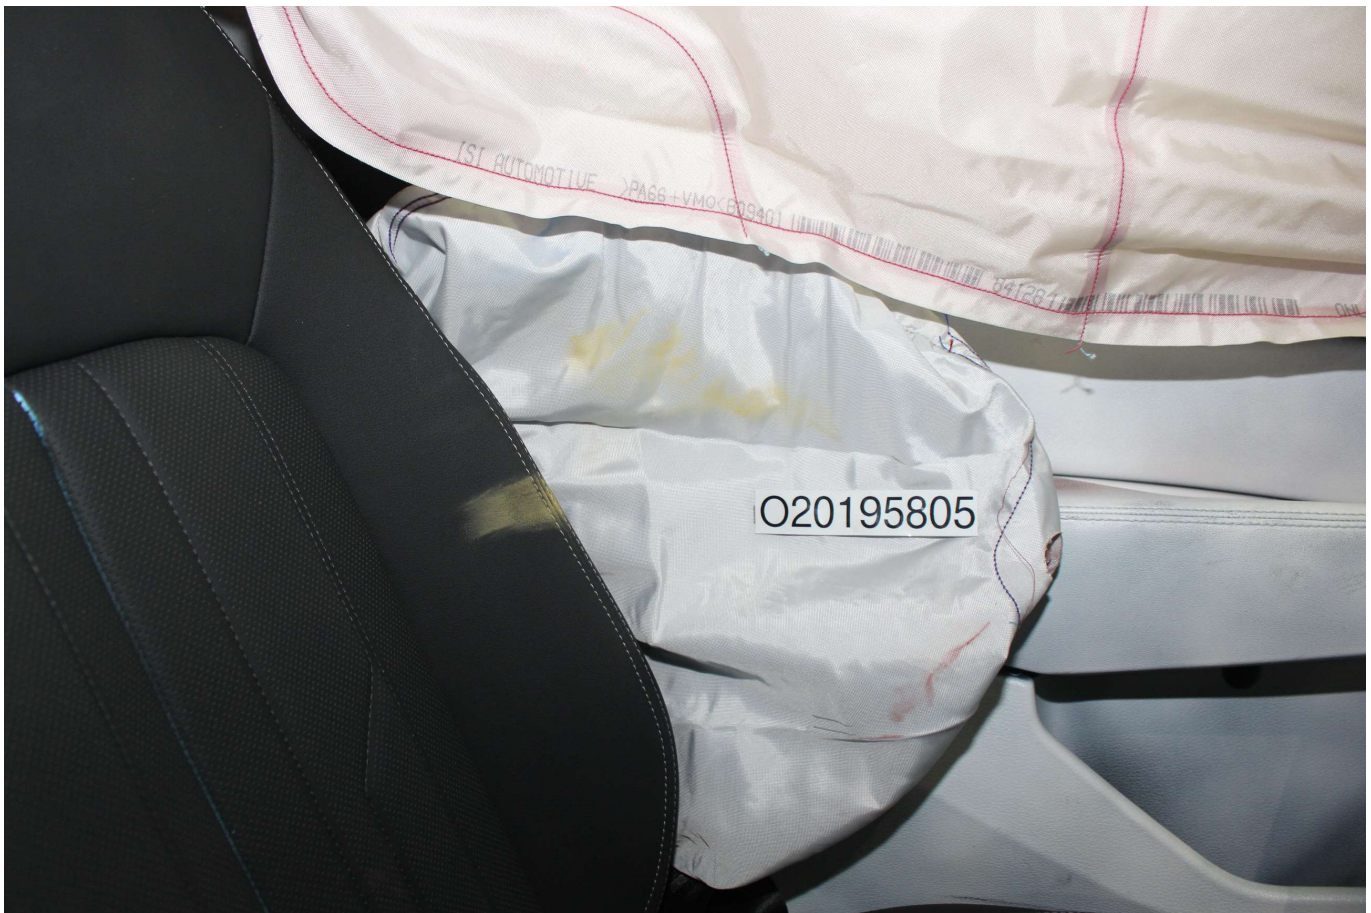
Photo No. 051 - Post-Test Driver Dummy Close-up Torso Contact with Side Airbag View

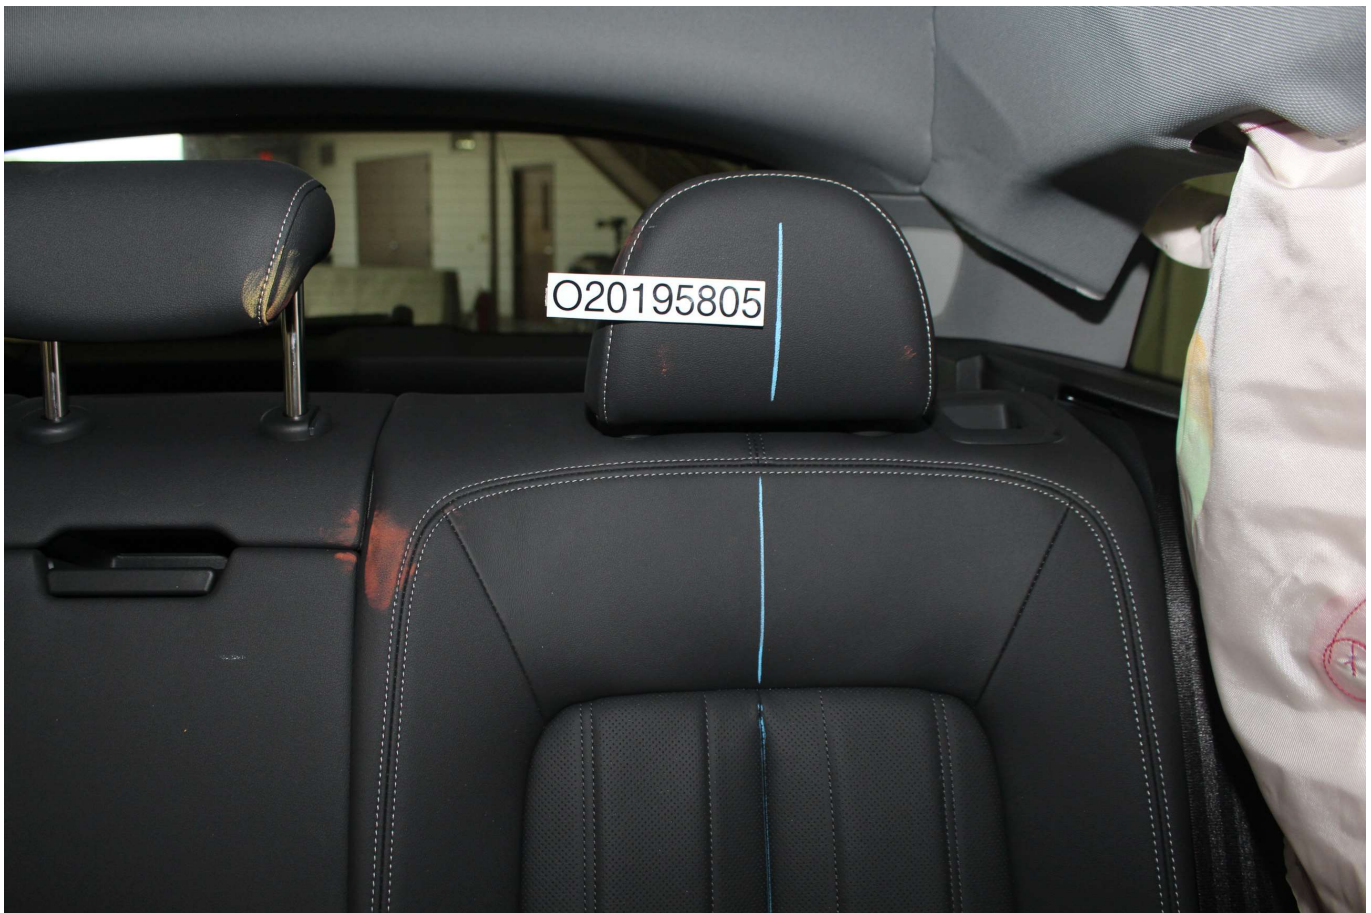
Photo No. 075 - Post-Test Rear Passenger Dummy Close-up Head Contact with Vehicle Interior View

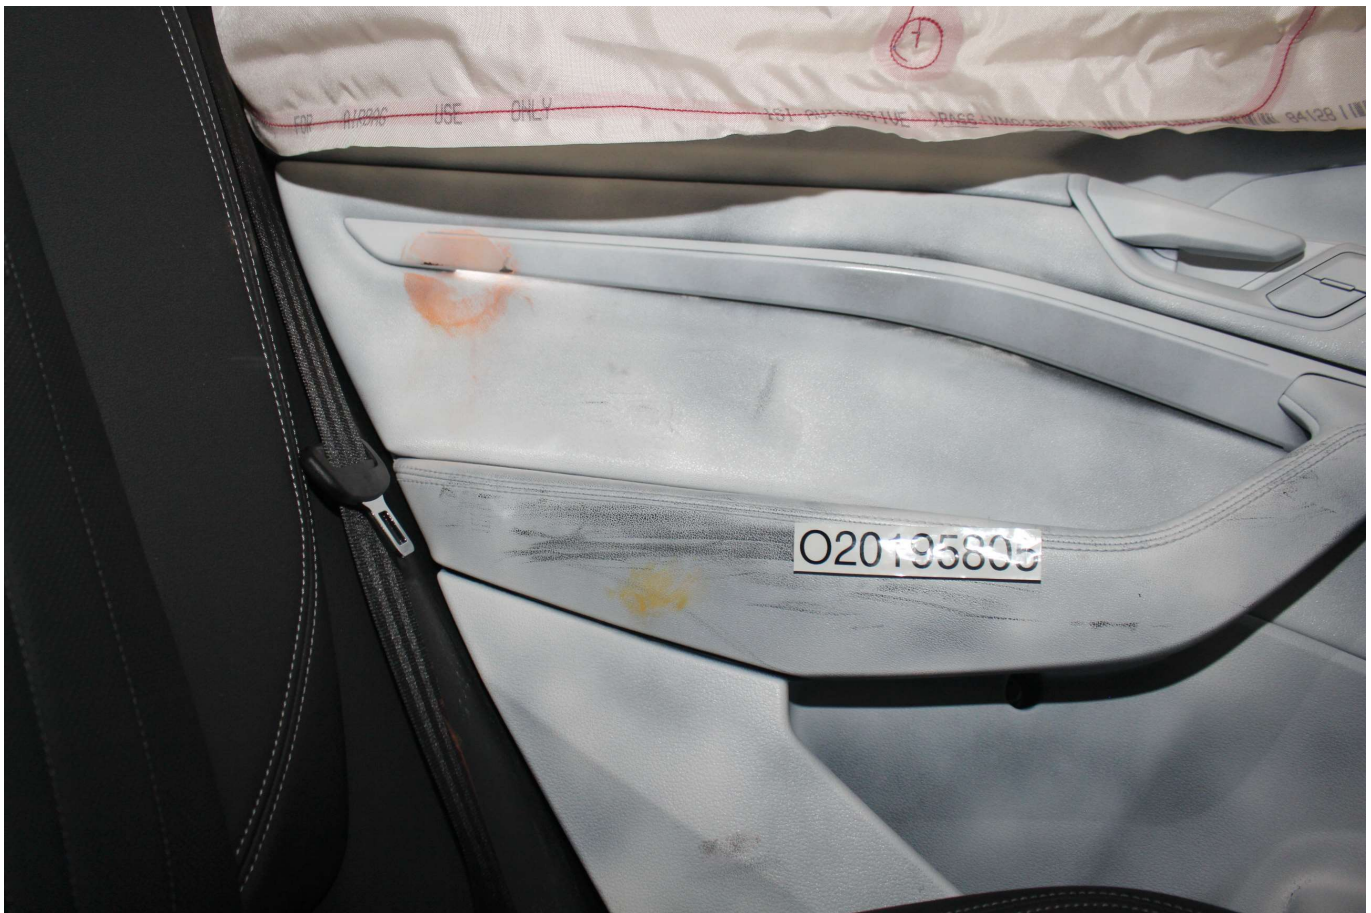
Photo No. 077 - Post-Test Rear Passenger Dummy Close-up Torso Contact with Vehicle Interior View

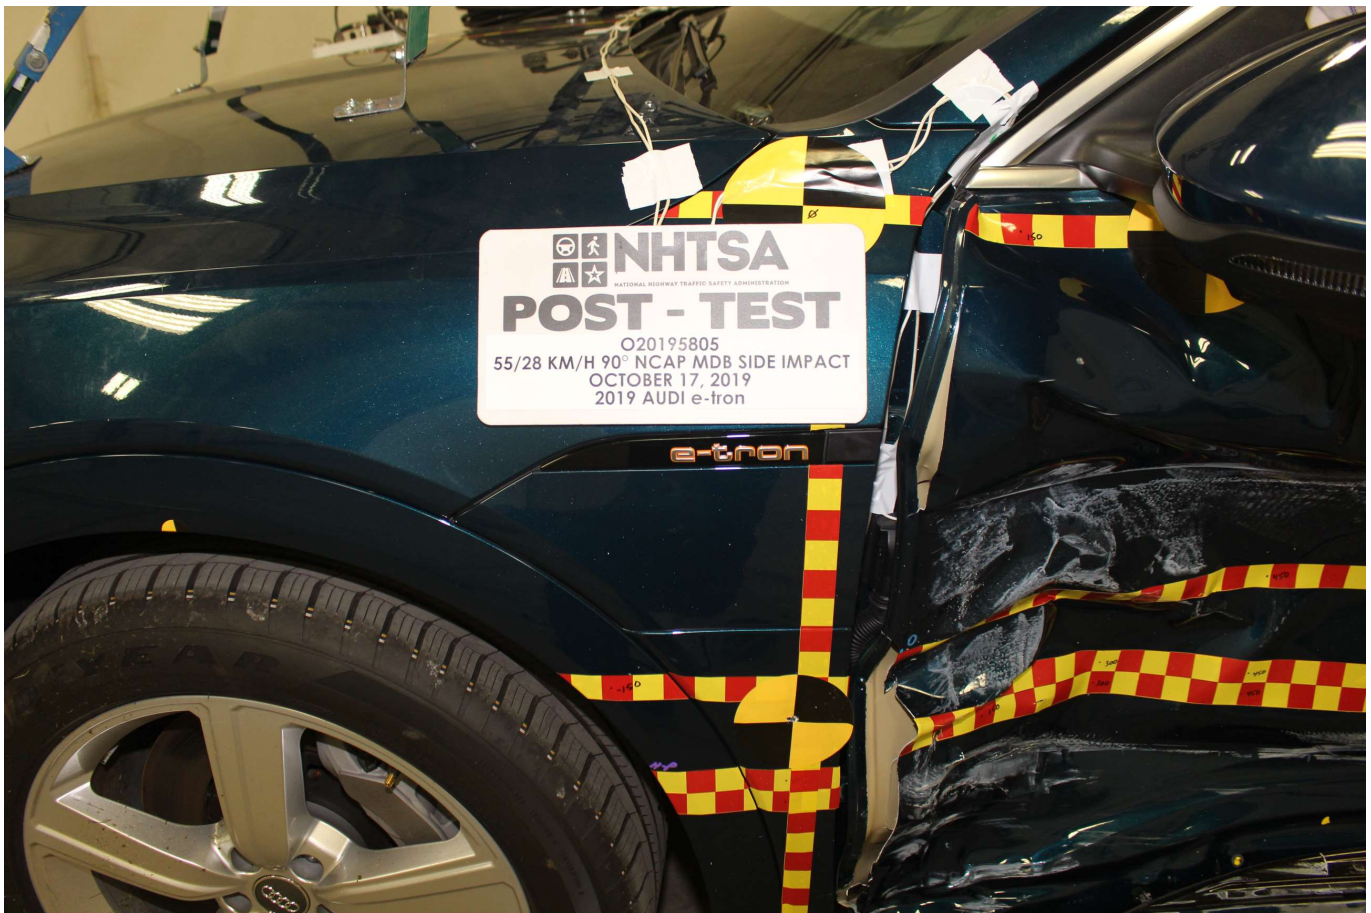
Photo No. 083 - Post-Test View of Fuel Filler Cap or Fuel Filler Neck

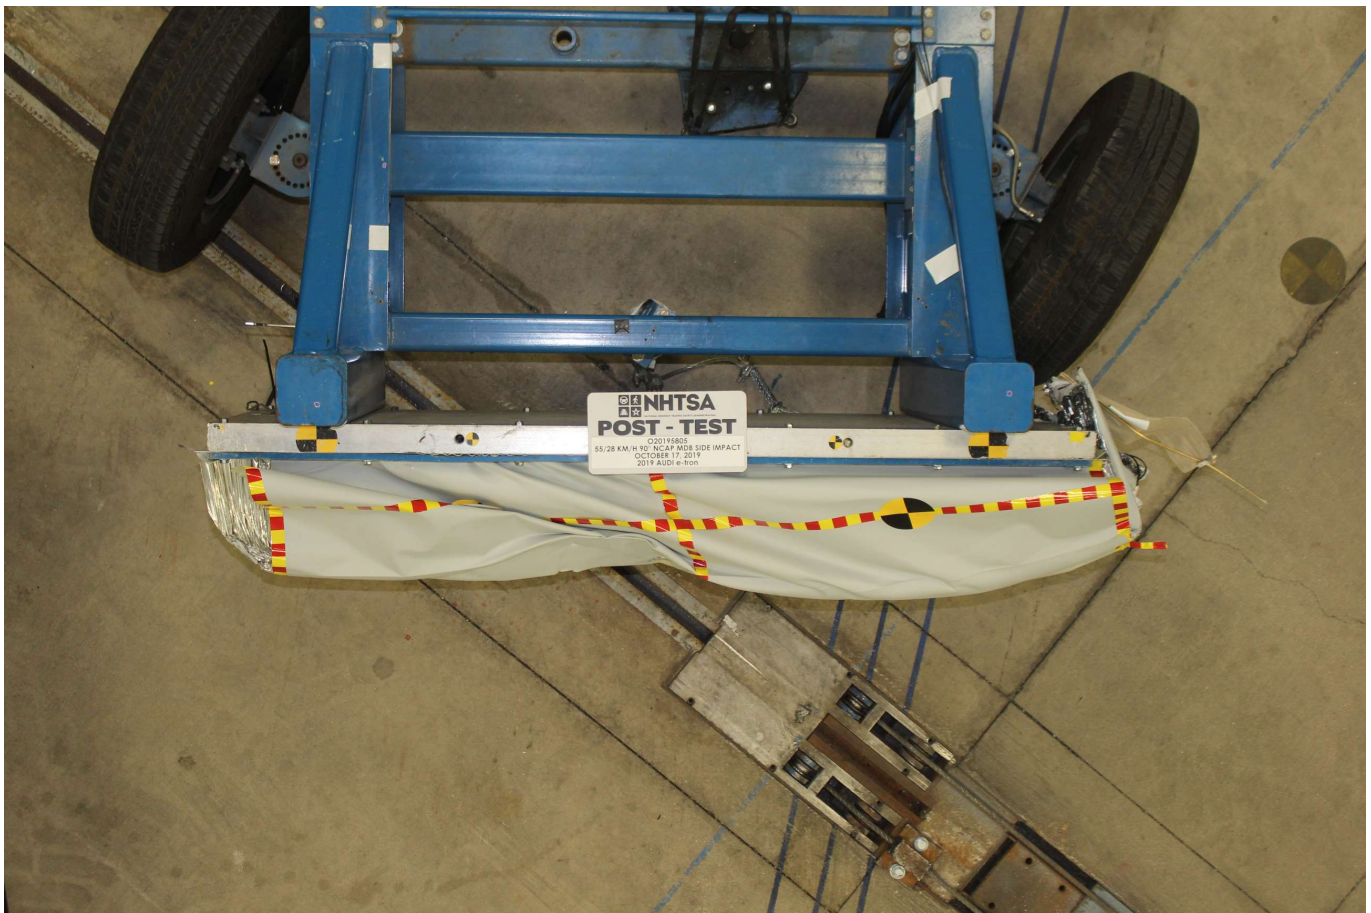
Photo No. 087 - Post-Test Top View of MDB Impactor Face

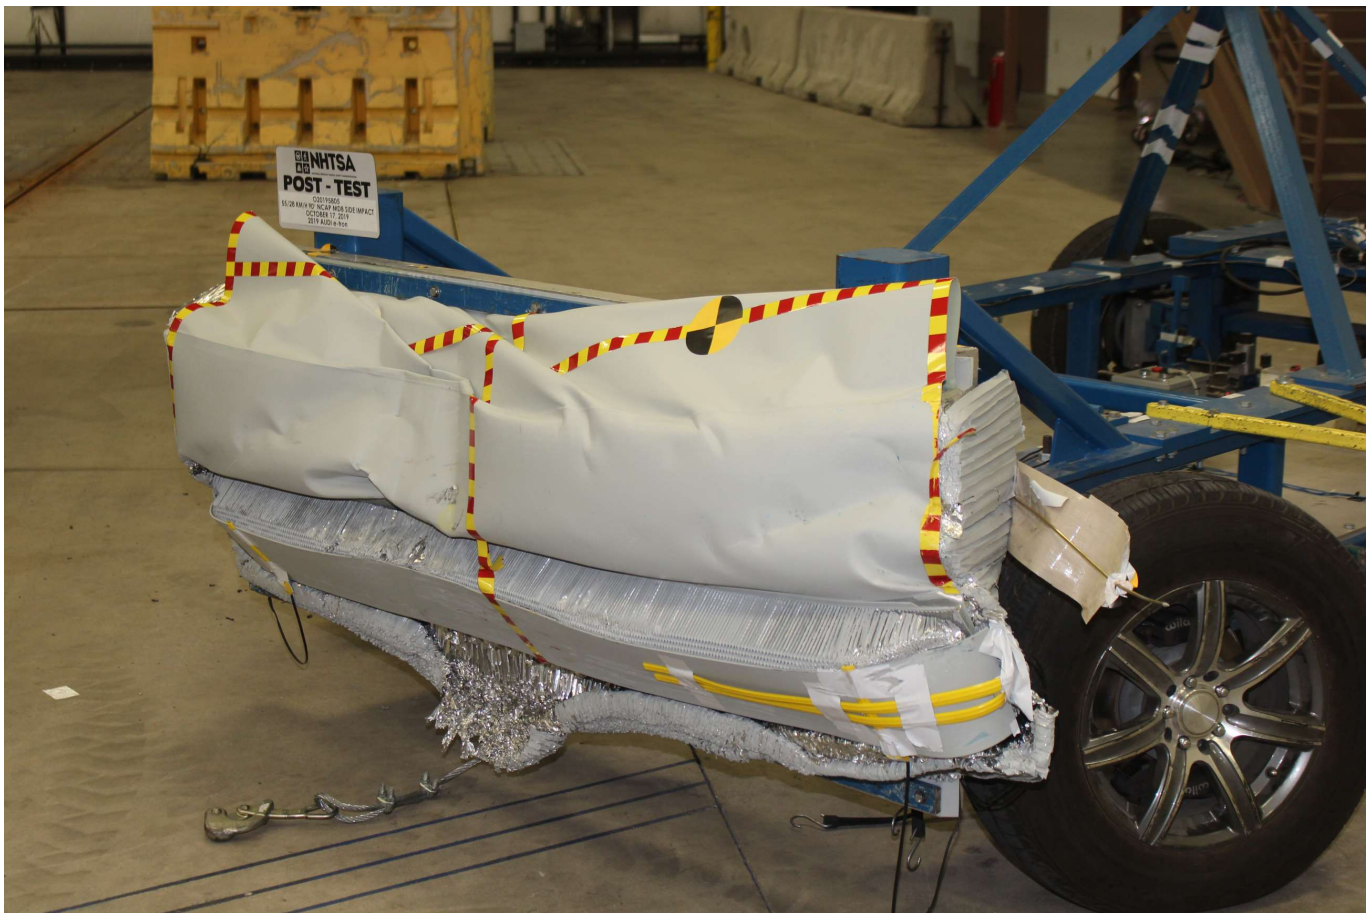
Photo No. 089 - Post-Test Left Side View of MDB Impactor Face

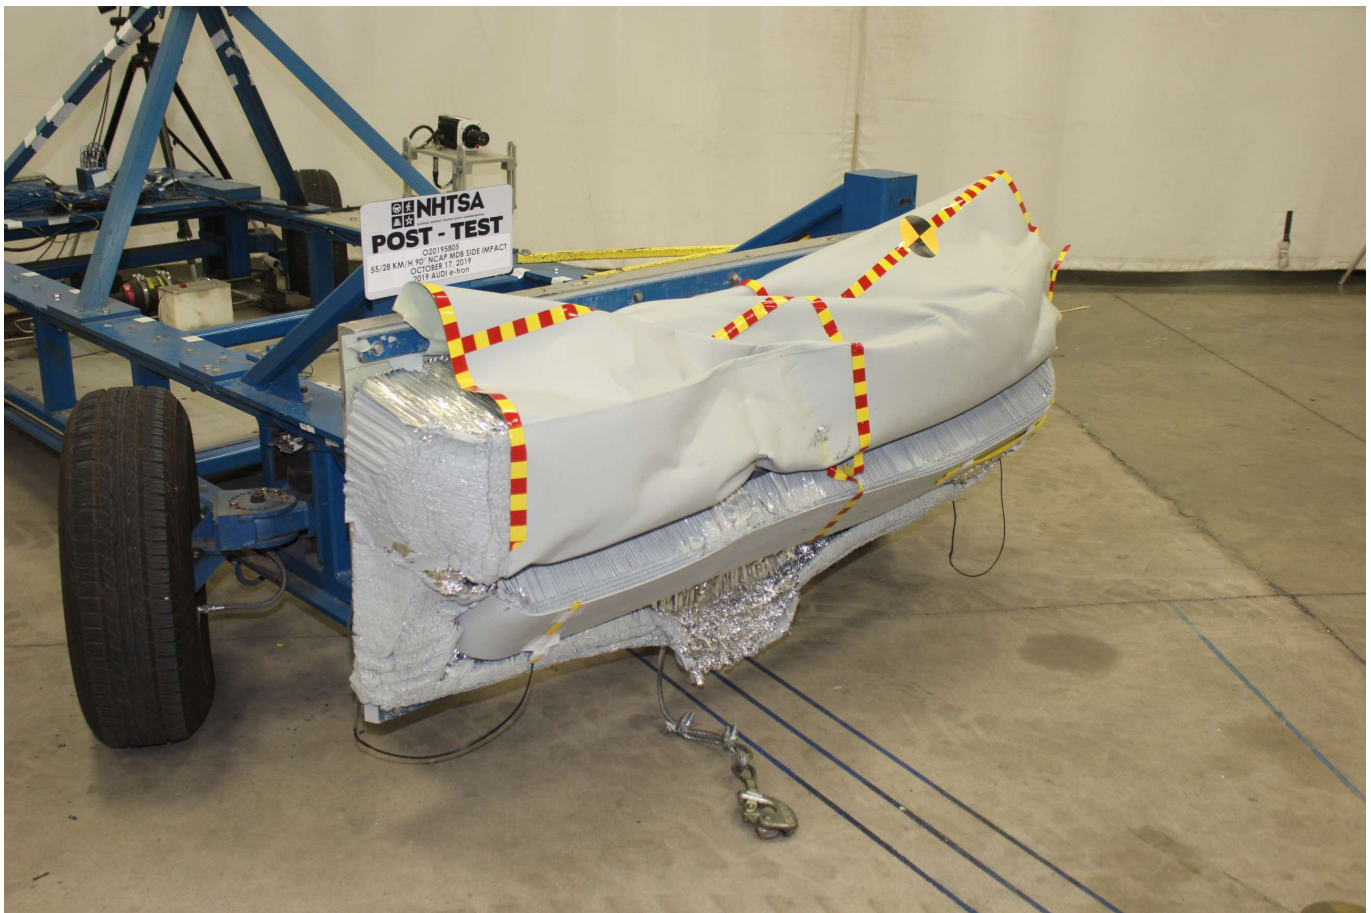
Photo No. 091 - Post-Test Right Side View of MDB Impactor Face
