REPORT NUMBER: NCAP-CAL-20-001

NEW CAR ASSESSMENT PROGRAM (NCAP) FRONTAL BARRIER IMPACT TEST

FCA US LLC 2020 Jeep Gladiator Four Door Truck

NHTSA No: M20200307

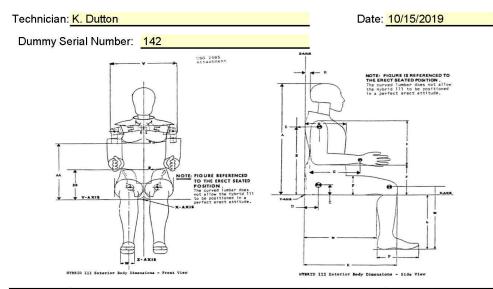
External Measurements - Hybrid 3 - 50th Male

Symbol	Description	the second secon	ication n)	Result (in)	Pass/Fail
А	Sitting Height	34.6	35.0	34.8	Pass
В	Shoulder Pivot Height	19.9	20.5	20.2	Pass
С	H-Point Height	3.3	3.5	3.4	Pass
D	H-Point from Backline	5.3	5.5	5.4	Pass
Ξ	Shoulder Pivot from Backline	3.3	3.7	3.5	Pass
F	Thigh Clearance	5.5	6.1	5.6	Pass
G	Back of Elbow to Wrist Pivot	11.4	12.0	11.7	Pass
Н	Head Back to Backline	1.6	1.8	1.7	Pass
	Shoulder to Elbow Length	13.0	13.6	13.5	Pass
J	Elbow Rest Height	7.5	8.3	8.2	Pass
K	Buttock to Knee Length	22.8	23.8	23.4	Pass
L	Popliteal Height	16.9	17.9	17.4	Pass
М	Knee Pivot Height	19.1	19.7	19.4	Pass
Ν	Buttock Popliteal Length	17.8	18.8	18.5	Pass
0	Chest Depth without Jacket	8.4	9.0	8.6	Pass
Р	Foot Length (right)	9.9	10.5	10.3	Pass
V	Shoulder Breadth	16.3	17.2	16.8	Pass
W	Foot Breadth	3.6	4.2	3.9	Pass
Y	Chest Circumference with Jacket	38.2	39.4	38.9	Pass
Z	Waist Circumference	32.9	34.1	33.7	Pass
AA	Reference Location (Chest Circumference)	16.9	17.1	17.0	Pass

BB	Reference Location (Waist Circumference)	8.9	9.1	9.0	Pass

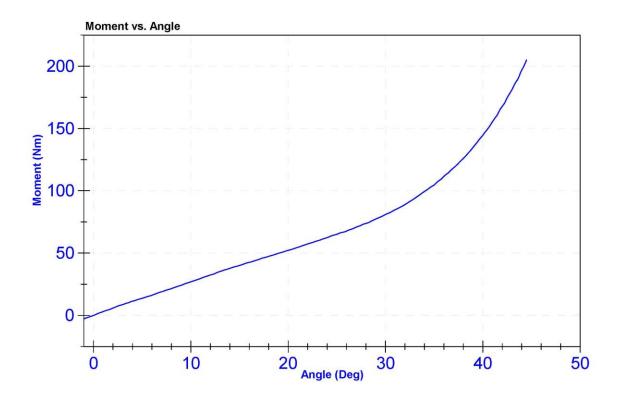
Certification Report Hybrid 3 - 50th Male Hip ROM Left - CFR 572

Results **Test Parameter** Minimum Maximum Unit Result Pass/Fail Specification Specification Temperature °C 18.9 25.6 21.8 Pass Humidity 10 70 % 53.0 Pass Average Velocity 5 7.3 Pass 10 deg/s Angle at 203Nm 40 50 44.4 Pass deg Moment at 30 degrees 0 94.9 Nm 81.1 Pass

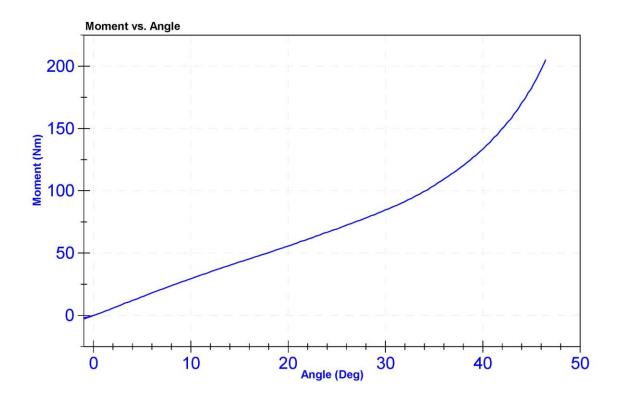
Certification Report Hybrid 3 - 50th Male Hip ROM Right - CFR 572

Results **Test Parameter** Minimum Maximum Unit Result Pass/Fail Specification Specification Temperature °C 18.9 25.6 20.9 Pass Humidity 10 70 % 56.0 Pass Average Velocity 5 7.4 Pass 10 deg/s Angle at 203Nm 40 50 46.3 Pass deg Moment at 30 degrees 0 94.9 Nm 84.7 Pass

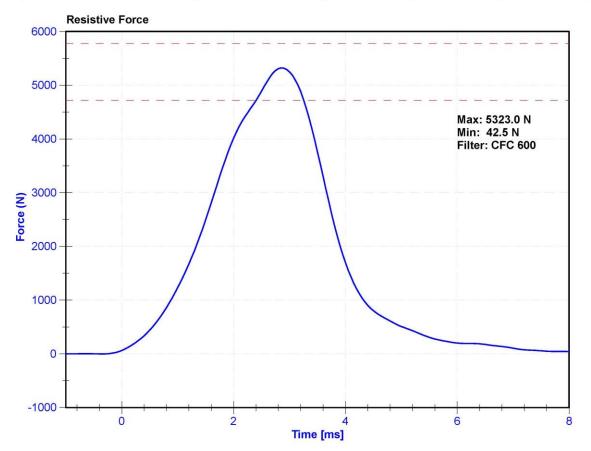
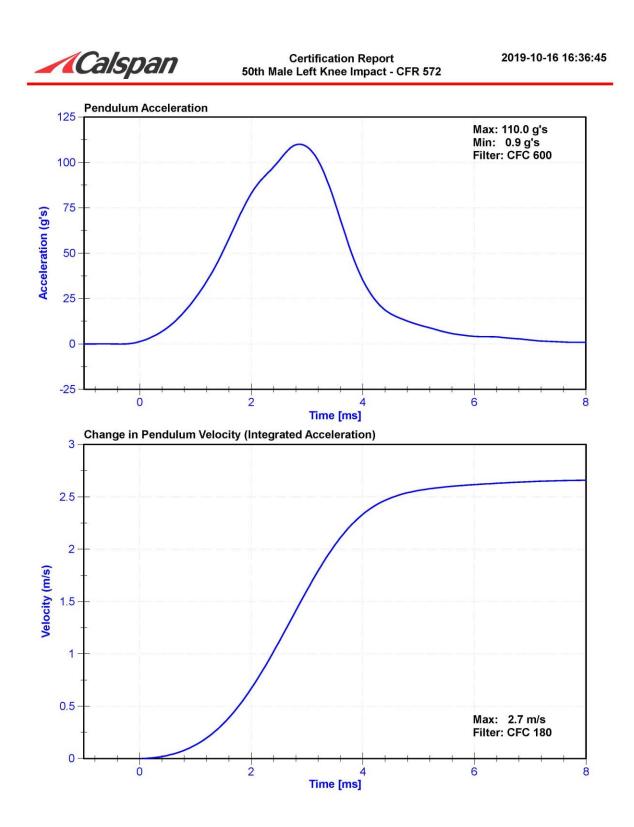
Certification Report 50th Male Left Knee Impact - CFR 572

Test Parameter	Minimum Specification	Maximum Specification	Unit	Result	Pass/Fail	
Temperature	18.9	25.6	°C	21.5	Pass	
Humidity	10	70	%	40	Pass	
Velocity	2.07	2.13	m/s	2.114	Pass	
Maximum Resistive Force	4720	5780	N	5323.0	Pass

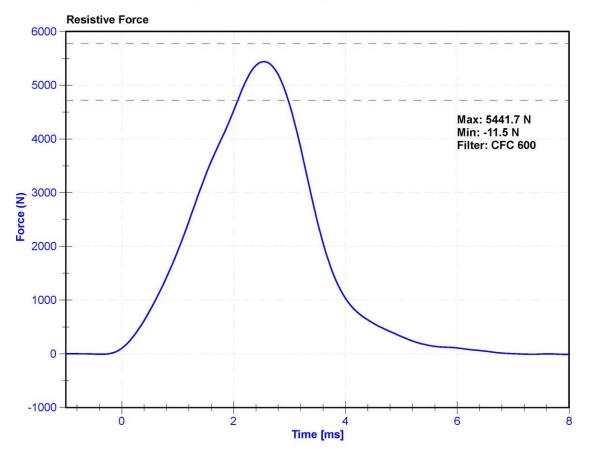
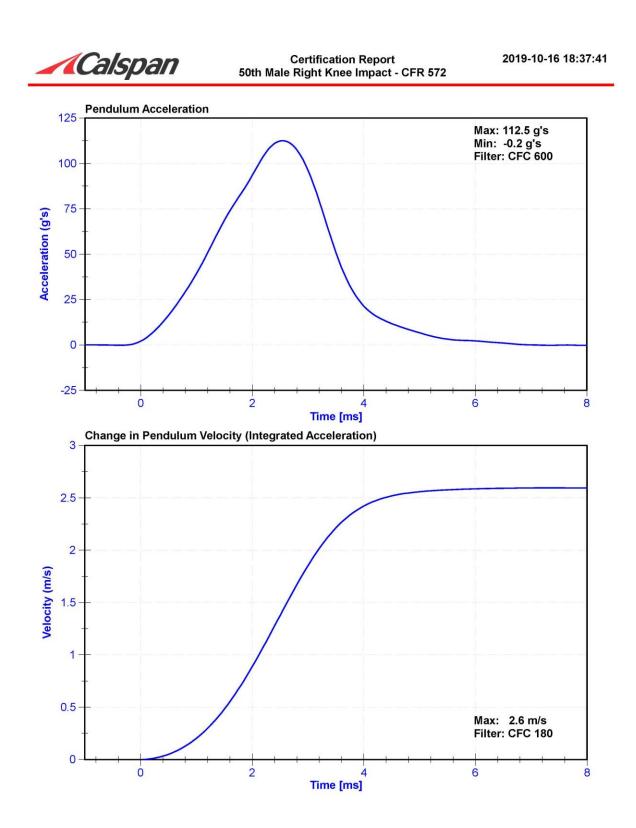
Certification Report 50th Male Right Knee Impact - CFR 572

Test Parameter	Minimum Specification	Maximum Specification	Unit	Result	Pass/Fail
Temperature	18.9	25.6	°C	21.5	Pass
Humidity	10	70	%	40	Pass
Velocity	2.07	2.13	m/s	2.115	Pass
Maximum Resistive Force	4720	5780	N	5441.7	Pass

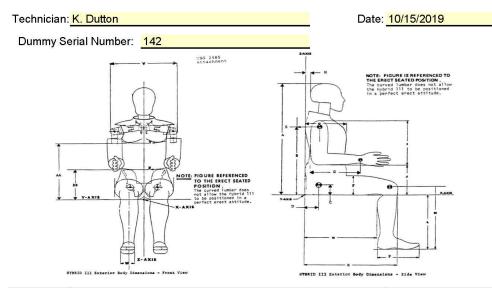
External Measurements - Hybrid 3 - 50th Male

Symbol	Description	100 M 100 M 100 M 100 M 100 M	ication n)	Result (in)	Pass/Fail
А	Sitting Height	34.6	35.0	34.8	Pass
В	Shoulder Pivot Height	19.9	20.5	20.2	Pass
С	H-Point Height	3.3	3.5	3.4	Pass
D	H-Point from Backline	5.3	5.5	5.4	Pass
E	Shoulder Pivot from Backline	3.3	3.7	3.5	Pass
F	Thigh Clearance	5.5	6.1	5.6	Pass
G	Back of Elbow to Wrist Pivot	11.4	12.0	11.7	Pass
Н	Head Back to Backline	1.6	1.8	1.7	Pass
	Shoulder to Elbow Length	13.0	13.6	13.5	Pass
J	Elbow Rest Height	7.5	8.3	8.2	Pass
K	Buttock to Knee Length	22.8	23.8	23.4	Pass
L	Popliteal Height	16.9	17.9	17.4	Pass
М	Knee Pivot Height	19.1	19.7	19.4	Pass
N	Buttock Popliteal Length	17.8	18.8	18.5	Pass
0	Chest Depth without Jacket	8.4	9.0	8.6	Pass
Р	Foot Length (right)	9.9	10.5	10.3	Pass
V	Shoulder Breadth	16.3	17.2	16.8	Pass
W	Foot Breadth	3.6	4.2	3.9	Pass
Y	Chest Circumference with Jacket	38.2	39.4	38.9	Pass
Z	Waist Circumference	32.9	34.1	33.7	Pass
AA	Reference Location (Chest Circumference)	16.9	17.1	17.0	Pass

BB	Reference Location (Waist Circumference)	8.9	9.1	9.0	Pass

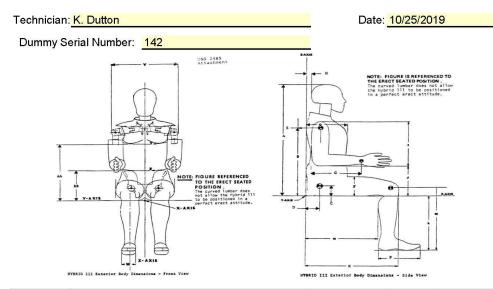
External Measurements - Hybrid 3 - 50th Male

Symbol	Description	the second secon	ication n)	Result (in)	Pass/Fail
А	Sitting Height	34.6	35.0	34.8	Pass
В	Shoulder Pivot Height	19.9	20.5	20.2	Pass
С	H-Point Height	3.3	3.5	3.4	Pass
D	H-Point from Backline	5.3	5.5	5.4	Pass
Е	Shoulder Pivot from Backline	3.3	3.7	3.5	Pass
F	Thigh Clearance	5.5	6.1	5.6	Pass
G	Back of Elbow to Wrist Pivot	11.4	12.0	11.7	Pass
Н	Head Back to Backline	1.6	1.8	1.7	Pass
	Shoulder to Elbow Length	13.0	13.6	13.5	Pass
J	Elbow Rest Height	7.5	8.3	8.2	Pass
K	Buttock to Knee Length	22.8	23.8	23.3	Pass
L	Popliteal Height	16.9	17.9	17.4	Pass
М	Knee Pivot Height	19.1	19.7	19.4	Pass
N	Buttock Popliteal Length	17.8	18.8	18.4	Pass
0	Chest Depth without Jacket	8.4	9.0	8.6	Pass
Р	Foot Length (right)	9.9	10.5	10.3	Pass
V	Shoulder Breadth	16.3	17.2	16.8	Pass
W	Foot Breadth	3.6	4.2	3.9	Pass
Y	Chest Circumference with Jacket	38.2	39.4	38.9	Pass
Z	Waist Circumference	32.9	34.1	33.7	Pass
AA	Reference Location (Chest Circumference)	16.9	17.1	17.0	Pass

BB	Reference Location (Waist Circumference)	8.9	9.1	9.0	Pass

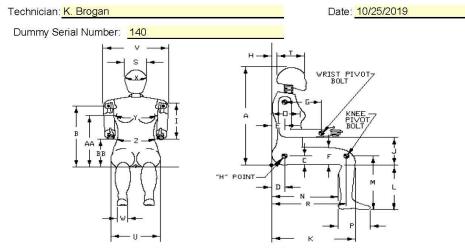
External Measurements - Hybrid 3 - 5th Female

Symbol	Description	24	ication im)	Result (mm)	Pass/Fail
A	Sitting Height	775	800	791	Pass
В	Shoulder Pivot Height	432	457	442	Pass
С	H-Point Height	81	86	84	Pass
D	H-Point from Backline	145	150	147	Pass
E	Shoulder Pivot from Backline	69	84	73	Pass
F	Thigh Clearance	119	135	126	Pass
G	Back of Elbow to Wrist Pivot	244	259	251	Pass
Н	Head Back to Backline	43	48	45	Pass
I	Shoulder to Elbow Length	277	297	290	Pass
J	Elbow Rest Height	183	203	191	Pass
ĸ	Buttock to Knee Length	521	546	535	Pass
L	Popliteal Height	356	376	366	Pass
M	Knee Pivot Height	394	419	405	Pass
N	Buttock Popliteal Length	414	439	428	Pass
0	Chest Depth without Jacket	175	191	182	Pass
Р	Foot Length (right)	219	234	228	Pass
R	Buttock To Knee Pivot Length	457	483	467	Pass
S	Head Breadth	137	147	142	Pass
Т	Head Depth	178	188	180	Pass
U	Hip Breadth	300	315	313	Pass
V	Shoulder Breadth	351	366	361	Pass
W	Foot Breadth	79	94	83	Pass
Х	Head Circumference	528	549	540	Pass

Y	Chest Circumference with Jacket	851	881	874	Pass
Z	Waist Circumference	460	790	624	Pass
AA	Reference Location (Chest Circumference)	333	358	345	Pass
BB	Reference Location (Waist Circumference)	160	170	165	Pass

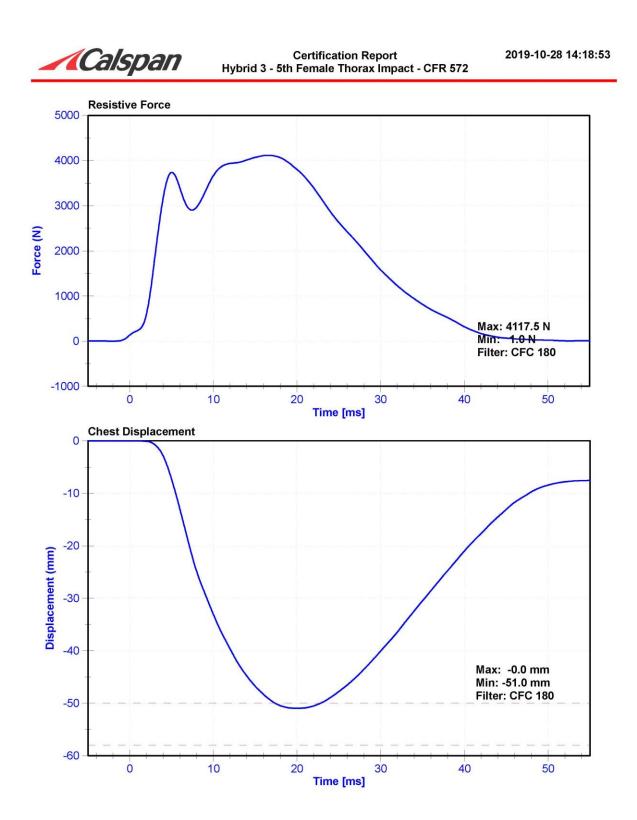
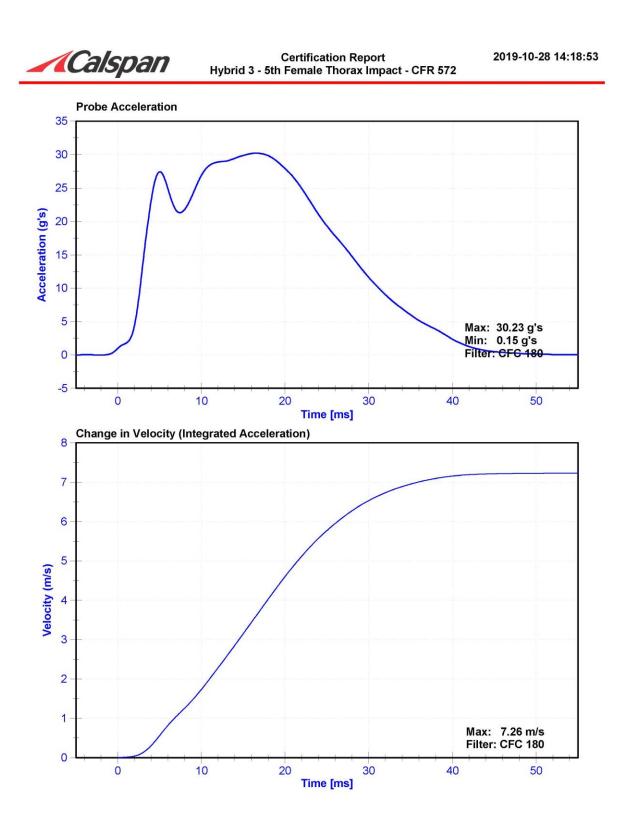
Force vs. Displacement

Test Parameter	Minimum Specification	Maximum Specification	Unit	Result	Pass/Fail
Temperature	20.6	22.2	°C	21.3	Pass
Humidity	10	70	%	47.2	Pass
Velocity	6.59	6.83	m/s	6.655	Pass
Chest Deflection	-58	-50	mm	-51.0	Pass
Maximum Resistive Force (50 to 58mm)	3900	4400	Ν	4100.1	Pass
Maximum Resistive Force (18 to 50mm)	0	4600	Ν	4117.5	Pass
Hysteresis	69	85	%	75.2	Pass

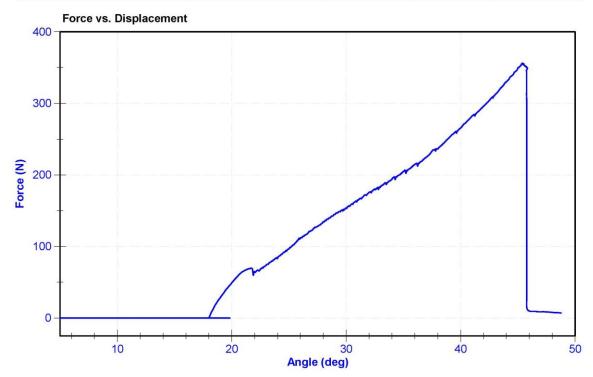
Certification Report Hybrid 3 - 5th Female Torso Flexion - CFR 572

To the Development of the			11	D	D
Test Parameter	Minimum Specification	Maximum Specification	Unit	Result	Pass/Fail
Temperature	18.6	25.6	°C	21.2	Pass
Humidity	10	70	%	48	Pass
Initial Angle	0	20	deg	17.9	Pass
Force at 45 Degrees	320	390	N	356.1	Pass
Return Angle Relative to Initial	0	8	deg	1.2	Pass

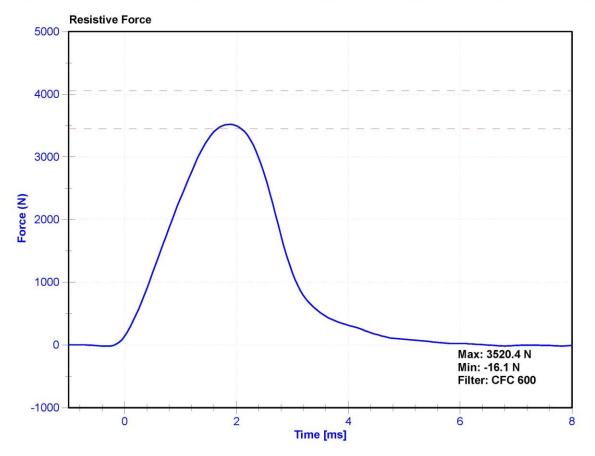
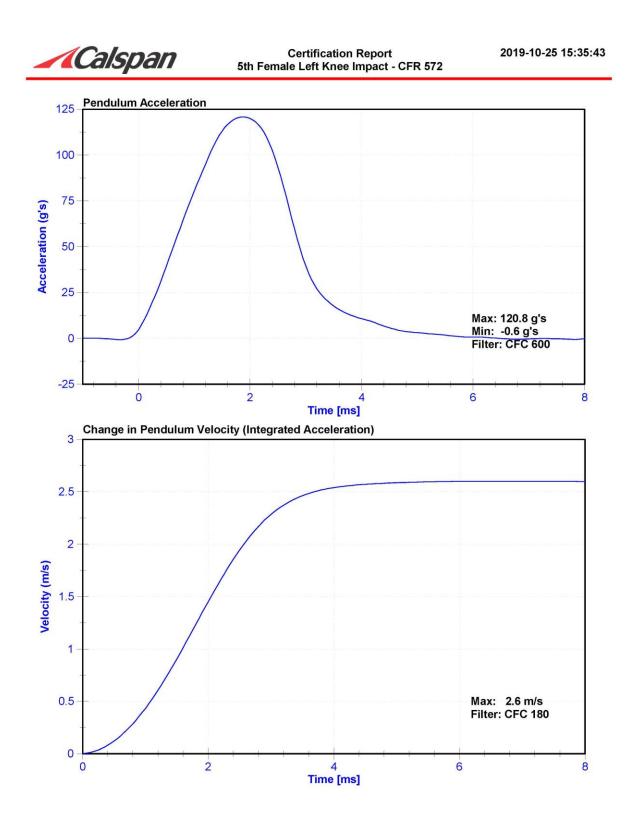
Certification Report 5th Female Left Knee Impact - CFR 572

Test Parameter	Minimum Specification	Maximum Specification	Unit	Result	Pass/Fail
Temperature	18.9	25.6	°C	21.5	Pass
Humidity	10	70	%	40.1	Pass
Velocity	2.07	2.13	m/s	2.130	Pass
Resistive Force	3450	4060	N	3520.4	Pass

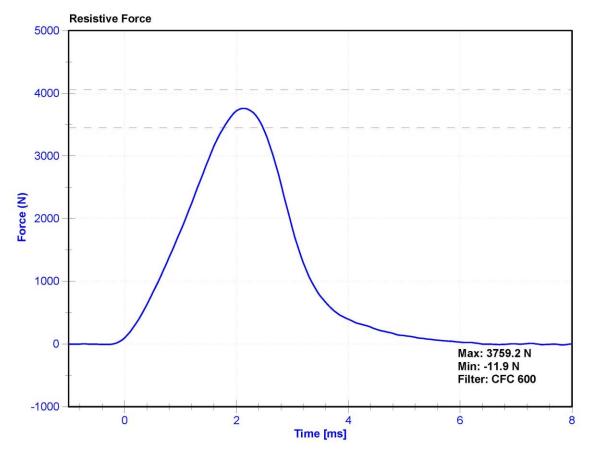
Certification Report 5th Female Right Knee Impact - CFR 572

Test Parameter	Minimum Specification	Maximum Specification	Unit	Result 21.7 40.0 2.111	Pass/Fail	
Temperature	18.9	25.6 70 2.13	℃ %			
Humidity	10				Pass Pass	
Velocity	2.07		m/s			
Resistive Force	3450	4060	N	3759.2	Pass
