**REPORT NUMBER: SINCAP-CAL-20-001**

**NEW CAR ASSESSMENT PROGRAM (NCAP)  
MOVING DEFORMABLE BARRIER SIDE IMPACT TEST**

**Mitsubishi Motors Corporation  
2020 Mitsubishi Eclipse Cross  
Four Door SUV**

**NHTSA No: M20205602**

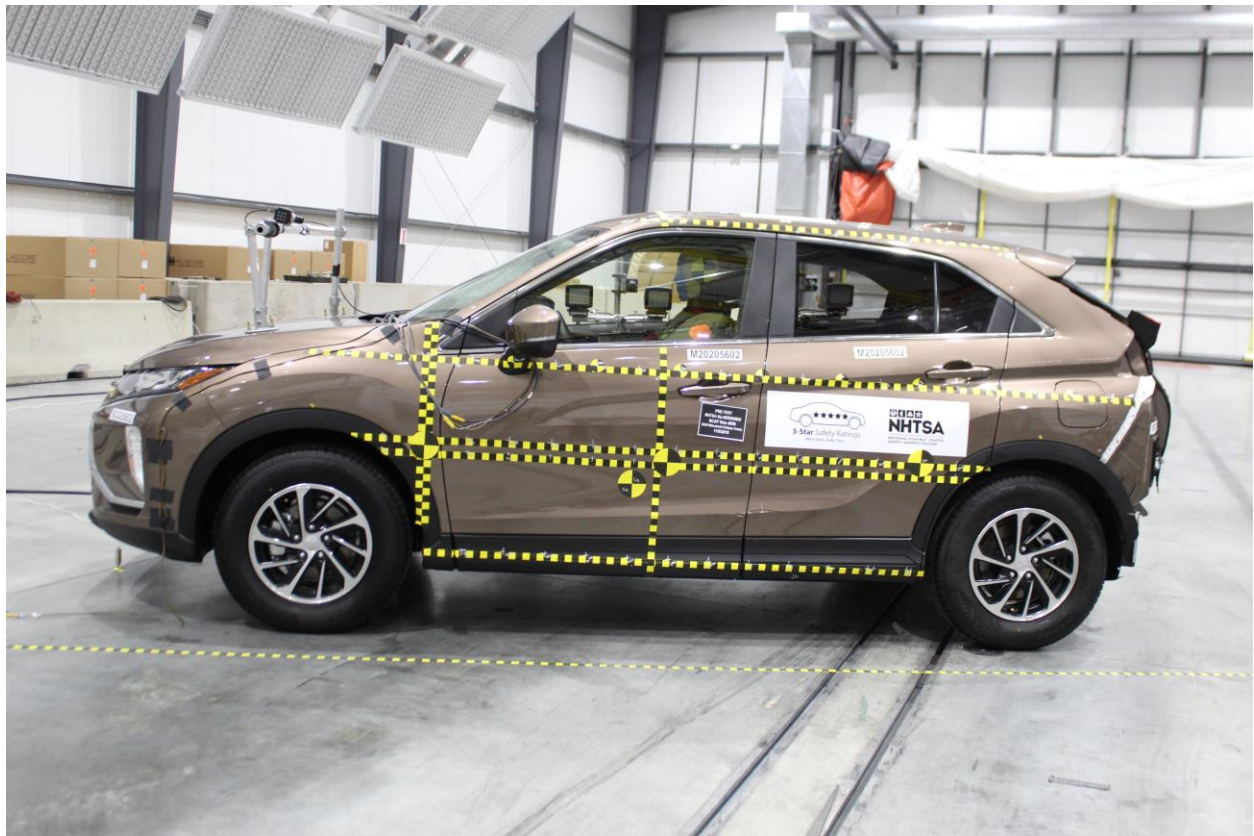
**Figure A-7: Pre-Test Left Side View of Test Vehicle**

Critical Areas of Performance	Observations and Conclusions
Pillar Performance	B-Pillar & C-Pillar buckled
Sill Separation	None
Windshield Damage	None
Side Window Damage	Driver Window Shattered
Other Notable Effects	None

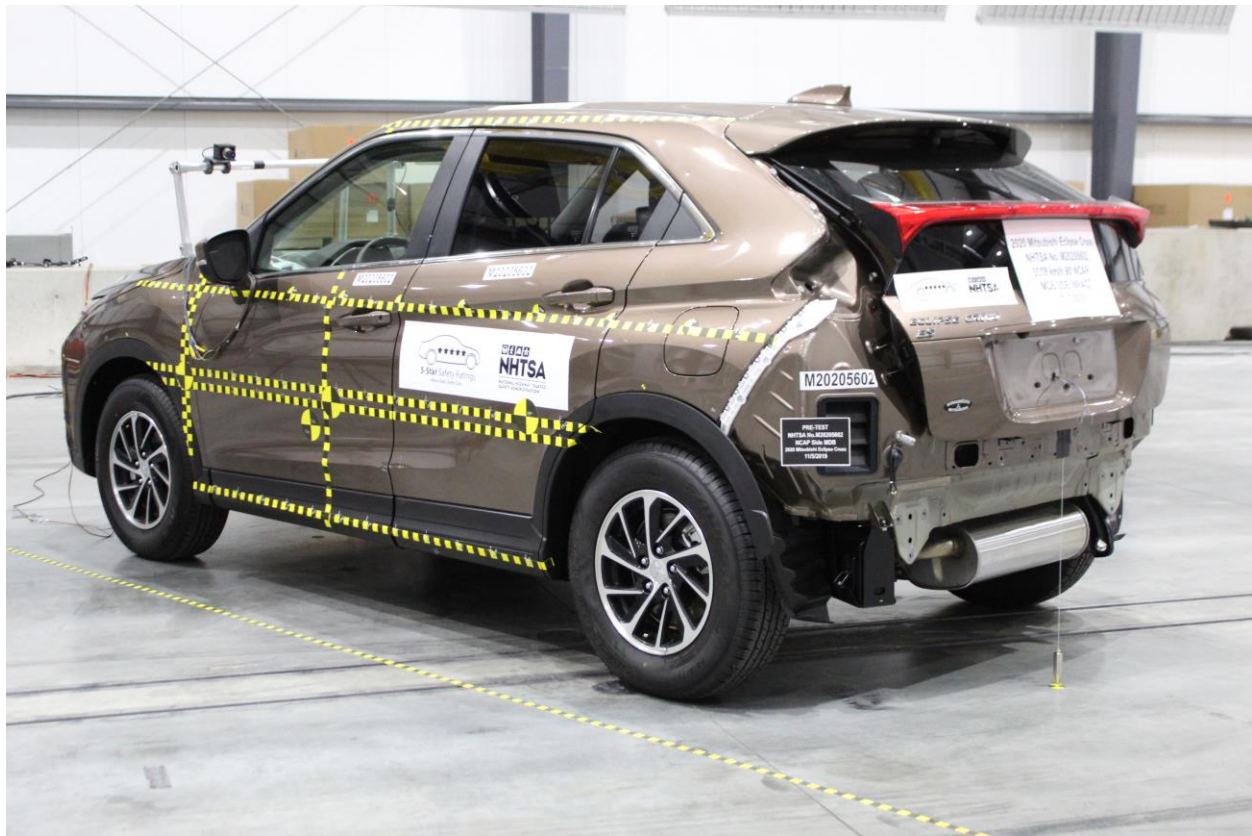
**Figure A-9: Pre-Test Left Rear  $\frac{3}{4}$  View of Test Vehicle**
