Re: Petition for Exemption from Notification and Remedy Requirements
Inconsequential Noncompliance with FMVSS 110 - Certain 2019-2020MY Toyota Vehicles

**Petition for Exemption from Notification and Remedy Requirements
Pursuant to 49 CFR Part 556**

**Inconsequential Noncompliance with FMVSS No. 110
In Certain 2019-2020 Model Year Toyota Vehicles**

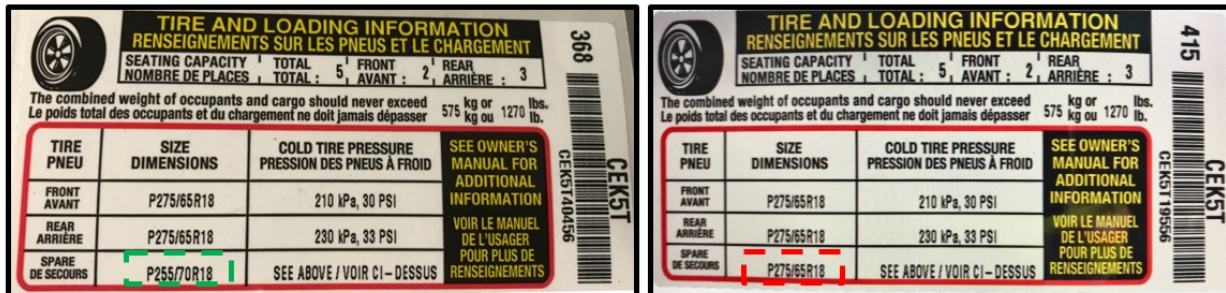
During a standard audit at the vehicle assembly plant, Toyota found that the spare tire size listed on the tire information label did not match the installed spare tire on a vehicle with a specific tire and wheel configuration. The issue was investigated, and it was found that a production change was implemented to change the spare tire size on vehicles equipped with a specific tire and wheel combination. At the time of the production change, the tire information label was not updated to reflect the new spare tire size. See Figure 1 below.

Correct Label

(Spare Tire Indicated P255/70R18)

Incorrect Label

(Spare Tire Indicated P275/65R18)

FMVSS No. 110, paragraph S4.3(d) requires that the tire information placard include certain information for originally-equipped tires, including spare tires. Because the spare tire size indicated on the placard does not match the actual spare tire size installed on the vehicle, the requirement is not met. No other portions of the label or the spare tire itself required to meet FMVSS No. 110 are affected, and there is no impact to performance, functionality, or occupant safety. Improvements have been made as of August 19, 2019 to assure new vehicles have the correct spare tire size indicated on the placard.
