DOT HS 812 766

July 2019

Rear Automatic Braking Feature Confirmation Test – Draft Test Procedure Assessment

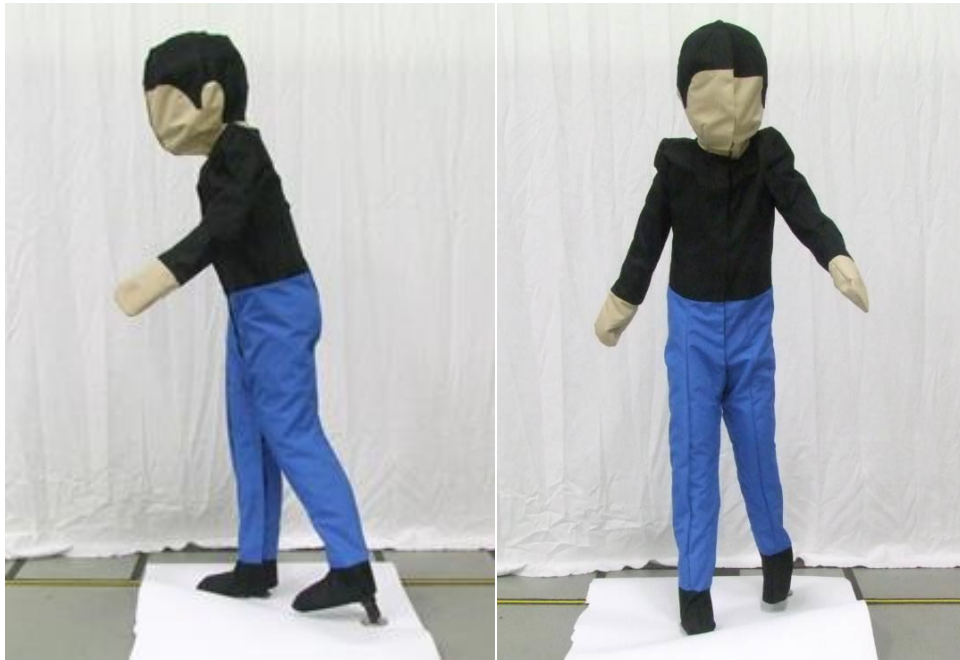
The test object used in this program was the 4active Systems EuroNCAP pedestrian child posable mannequin, a 46.5-inch tall radar-representative child surrogate simulating a 6-year-old child. The child mannequin test object is shown in Figure 1.

Figure 1. Child Mannequin Test Object, Side View and Front View

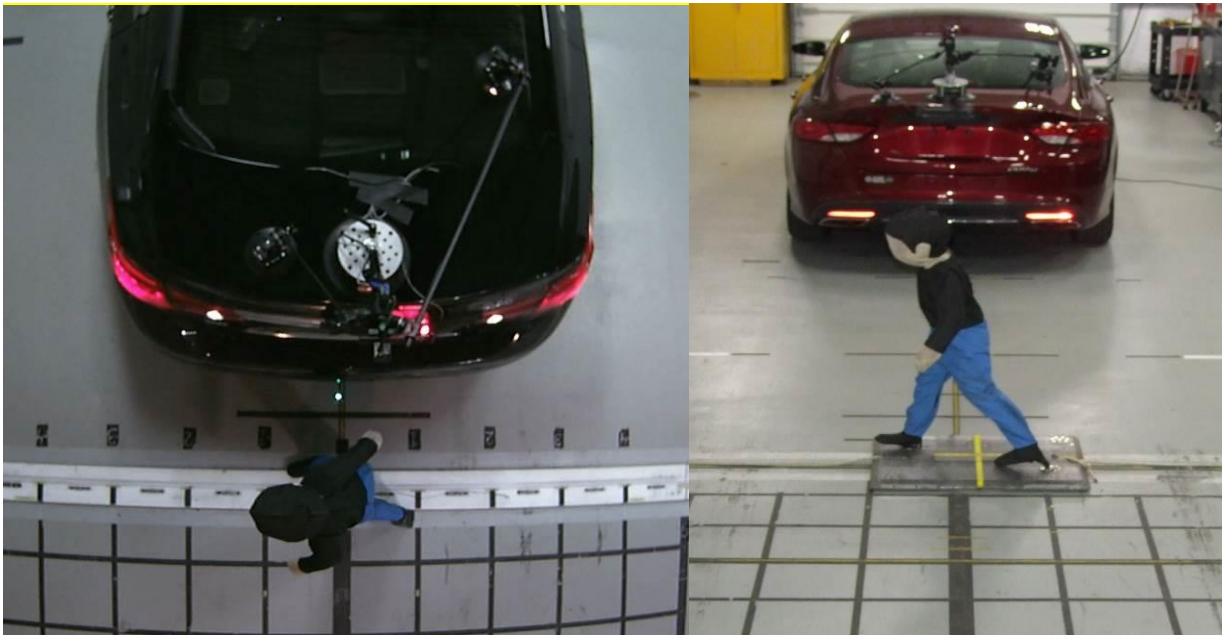
The systems were tested to measure their performance in detecting the test object in a scenario in which the vehicle was moving and the test object was stationary. The test surface was marked with a dimensioned floor grid of 1-foot squares. Prior to each test trial, the test object was placed at one of three grid locations in the travel path of the backing test vehicle. The three grid locations correlated to the number of feet laterally from the centerline of the vehicle's intended backing path, labeled as grid locations -2 ft, 0 ft, and 2 ft from left to right. The test object was oriented in an upright (vertical) position, facing perpendicular to the vehicle's centerline for all three grid locations and in an appropriate direction as if the object was crossing behind the vehicle from right to left (as shown in Figure 2, with the object positioned at grid location 0).

Figure 2. Child Mannequin Test Object at Grid Location 0 Behind Backing Test Vehicle

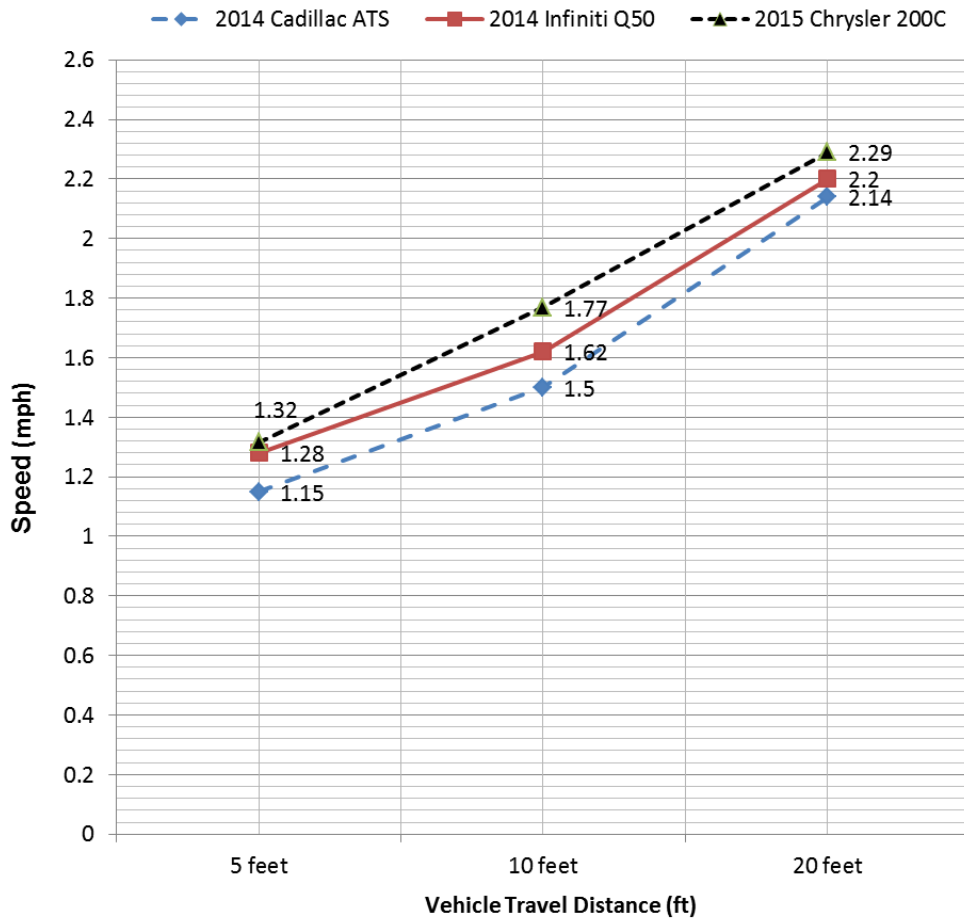
To determine whether the test vehicles’ backing speeds may have been variable enough to affect system performance and test outcomes, trials were run to measure each vehicle’s typical backing speed when rolling rearward on a level surface without accelerator pedal application. Trials were run that were identical to the specified test procedure except that no test object was present. Average backing speed across all speed trials was calculated for points representing 5, 10, and 20 feet of travel. Figure 4 presents average backing speed data. The data show that average backing speeds for the tested vehicles differed only slightly under the conditions of this test procedure. At 20 feet, the average backing speed was 2.14 mph (n=44, SD=0.13) for the Cadillac, 2.20 mph (n=68, SD=0.13) for the Infiniti, and 2.29 for the Chrysler 200C (n=23, SD=0.06). Given that the observed variability in backing speed for the vehicles involved in this testing was quite small, it is unlikely that backing speed differences would have been a contributing factor to any failing test outcome.

While the Chrysler had slightly less time (approximately 0.3 – 0.5 seconds less time) than did the other two vehicles to detect and avoid the test object based on its average backing speed, this small time difference was not likely to be the primary reason that the Chrysler was less successful in passing this test procedure.

Figure 4. Average Backing Speed Over 20-Foot Distance for Vehicles Tested

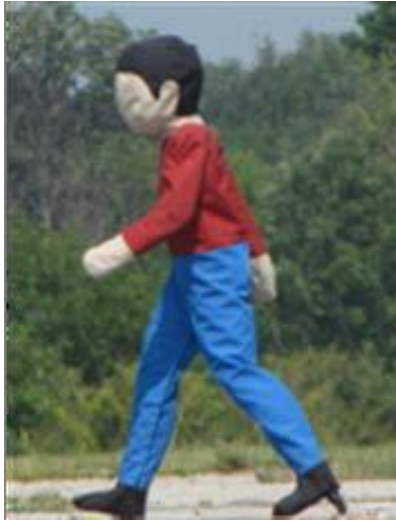
(a) The 4active Systems EuroNCAP pedestrian child posable mannequin (46.5 inch height, simulating a 6-year-old child) developed by 4a Engineering GmbH, Traboch, Austria.

This is a posable mannequin developed for testing vehicles equipped with advanced pedestrian avoidance technologies. The mannequin is tuned for RADAR, IR, and optical features.

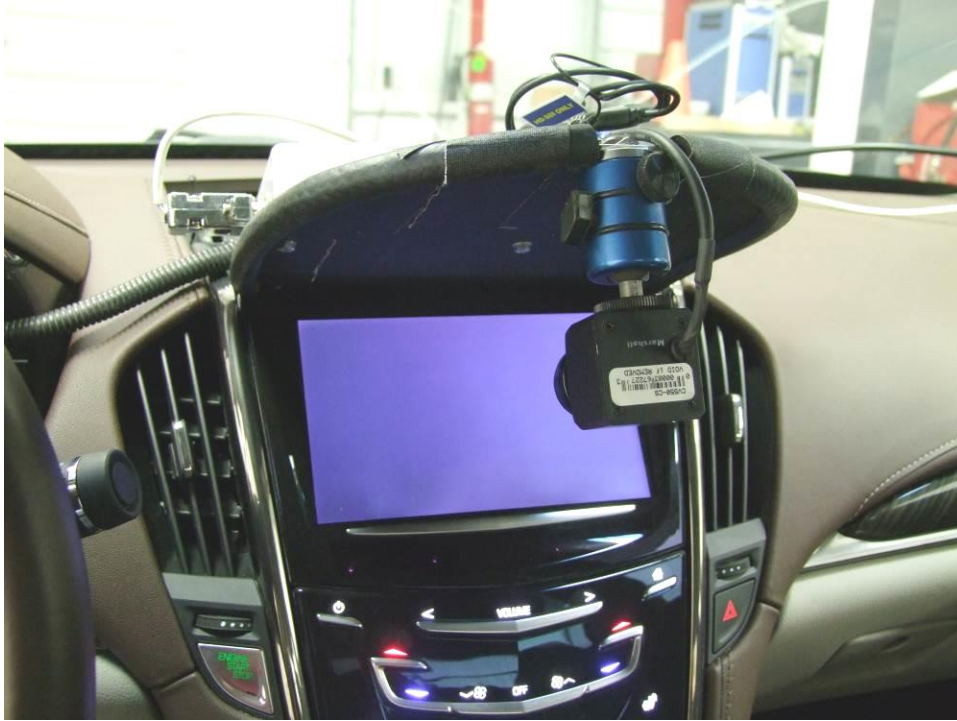
Figure 6. Image of Camera, Capturing Vehicle's Rearview Video Display

The draft test procedure specifies that three cameras shall be used to videograph the dynamic test scenario: one overhead view, one full-frame view of the vehicle's rearview image, and an image of any visual alerts presented separately from the rearview image. These video data documented the test object's position with respect to the vehicle as well as the system's response to the object's presence (if any). One video camera was mounted up above the test object to capture an overhead view of the vehicle approaching the test object. Two cameras and a microphone were located inside the vehicle to capture any visual and/or auditory warnings produced by the systems.

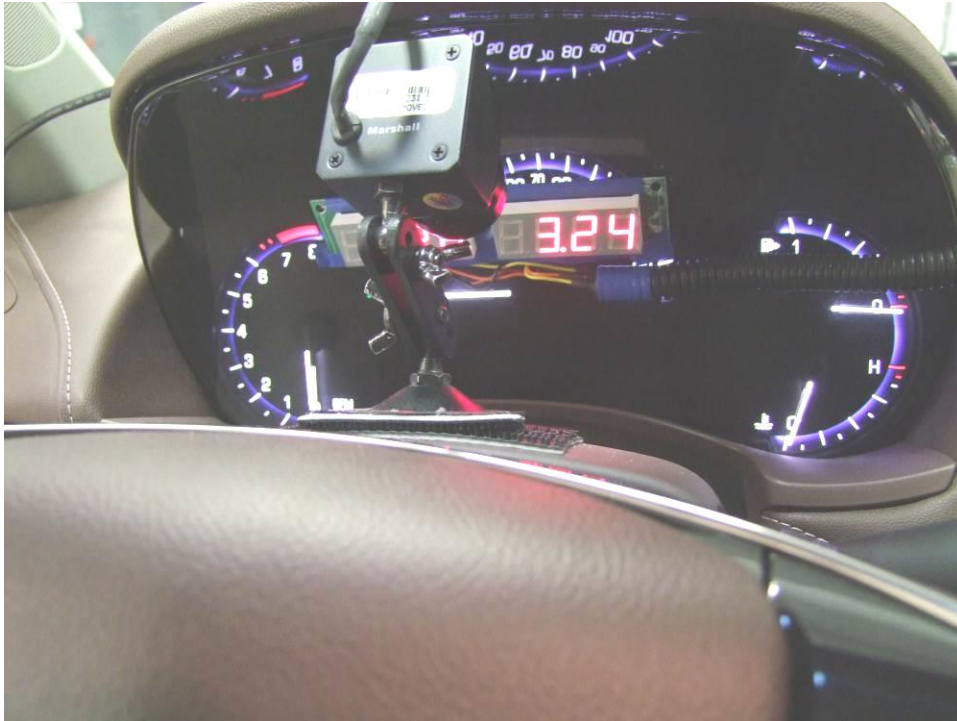
Figure 7. Image of Camera and Equipment, Capturing Instrument Panel Warnings and Vehicle Speed

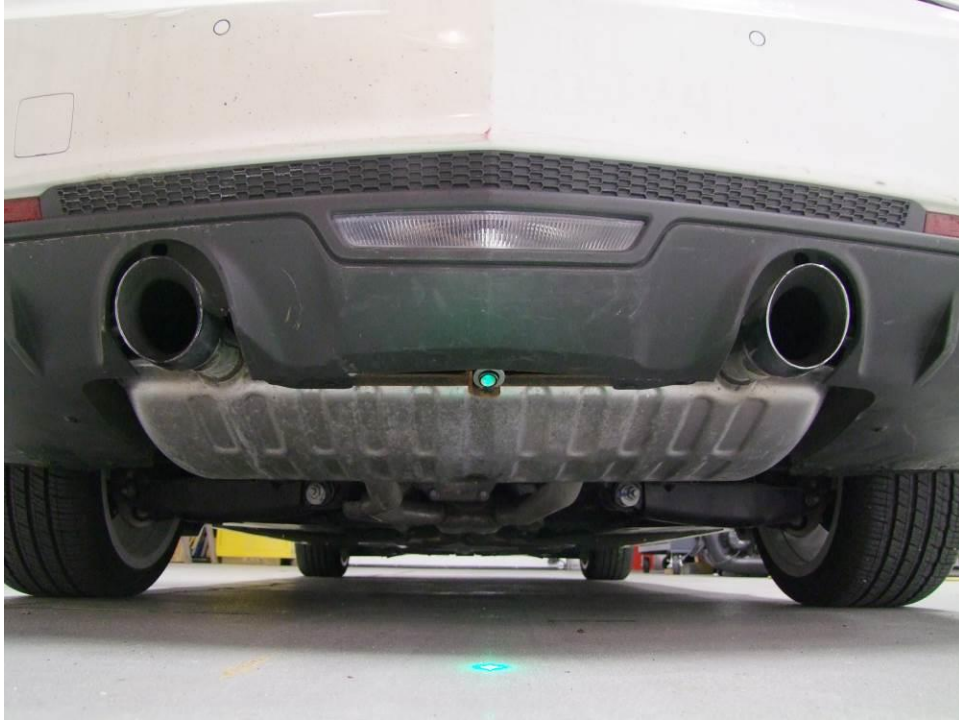
Figure 8. Image of Green Laser Installed on Vehicle Bumper for Alignment Purposes

Two pen lasers were mounted on the vehicle to help with vehicle alignment prior to beginning each dynamic test trial, as well as to aid the driver in guiding the vehicle rearward in a straight line during the trial. One laser was mounted on the vehicle's hood along its longitudinal centerline and was pointed at a vertical post forward of the vehicle and at the test grid's centerline. A second laser was mounted below the test vehicle's rear bumper and pointed downward to highlight the vehicle's lateral position with respect to the grid's centerline. To ensure a consistent, straight backing path across tests, trials were repeated if the laser on the rear bumper showed the vehicle's lateral position straying by more than 1 inch from the grid centerline at any time during the 20-foot backing path.

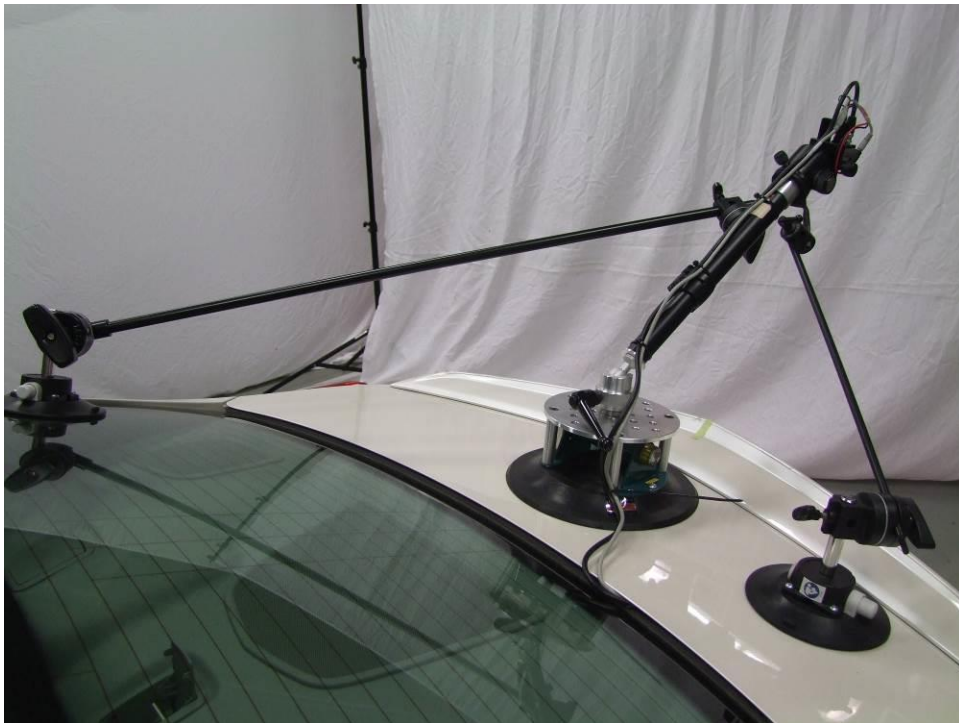
Figure 9. Image of Camera Mounted to Rear Trunk Lid of Vehicle

One additional camera was used in this test effort but not specified in the test procedure. The camera was mounted on the vehicle's trunk lid and pointed downward to capture a view of the floor grid as well as the rear-mounted laser beam used to guide the vehicle along a straight rearward path.
