ASSESSMENT OF AN ADVANCED PEDESTRIAN DUMMY
FOR USE IN FULL-SCALE CASE RECONSTRUCTIONS

NHTSA TECHNICAL REPORT
DOT HS 809 391

Vehicle Research & Test Center
National Highway Traffic Safety Administration
July 9, 2001

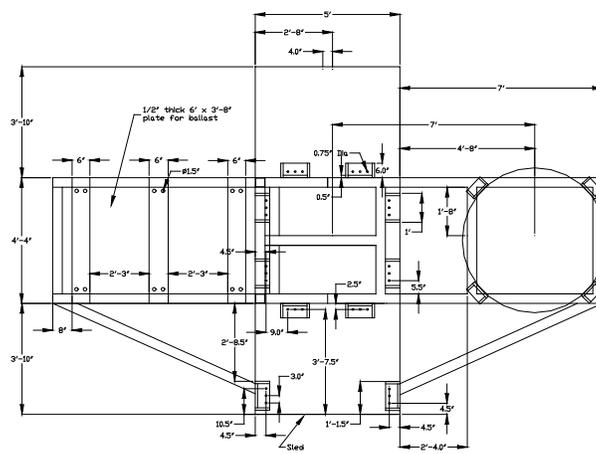
Figure 2.1. Top view of buck as it attaches to the HYGE sled

In order to perform full-scale sled tests, a pedestrian sled buck was designed and fabricated. Several configurations were suggested, but only one design fully incorporated a majority of the conditions present in the case. This design has the buck extending seven feet laterally from each side of the sled (total of 19' in width), with the test vehicle balanced by the appropriate ballast weight on the opposite side (Figure 2.1). Diagonal braces that attach the two ends of the buck to the sled prevented rotation of the buck. The frame was constructed from 4" x 6" x 3/16" steel rectangular tubing, and the sled attachment plates (1/2" cold-drawn steel) were welded directly to it. Thirty thru holes (3/4" diameter) were located on the ten plates to facilitate 5/8" diameter bolts for sled attachment.

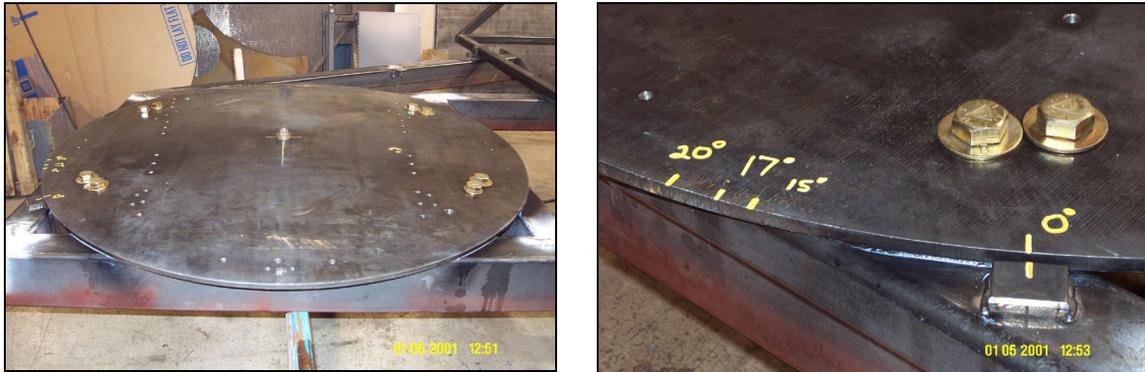
Figure 2.2. Vehicle interface plate with rotation capability

Since pedestrian accidents involve a wide range of vehicles, the buck was designed accordingly. A circular ½” thick, 5’ diameter steel plate was used as the interface between the buck and vehicle. This shape was chosen to allow vehicle rotation, as is occasionally necessary when attempting to reconstruct an accident. Holes could be drilled to match the bottom frame of most vehicles, and the disc could then be rotated to the specified angle and bolted in place (Figure 2.2). For this study, the bottom frames of the Civic and Silverado were fabricated so that the center of gravity of the vehicle was near the center of the disc to prevent any unbalance in the vertical direction (Figure 2.3).

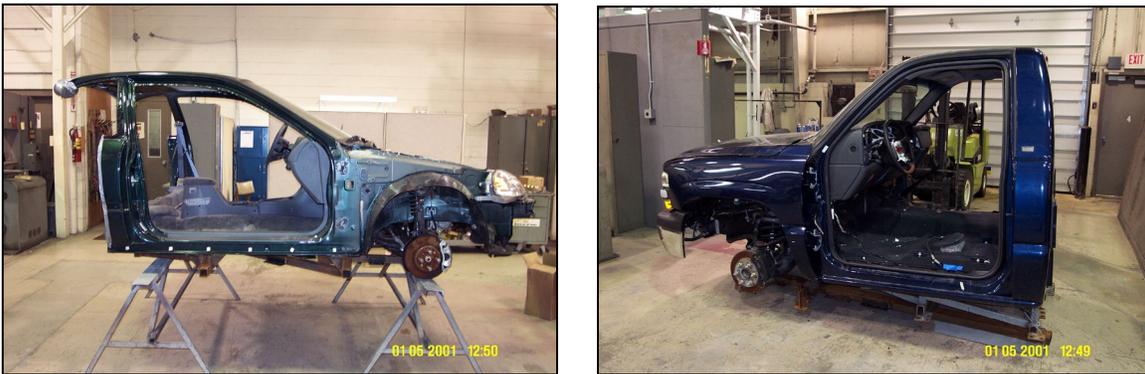
Figure 2.3. Civic (left) and Silverado (right) with frame for buck attachment

Half-inch diameter bolts were used to attach the vehicles to the disc, and the minimum number bolts were calculated to be 15 for the Silverado and 10 for the Civic, based on a 10 g sled acceleration pulse. With a factor of safety incorporated into the design, 26 bolts were used for the Silverado and 14 bolts were used for the Civic (Table 2.1).

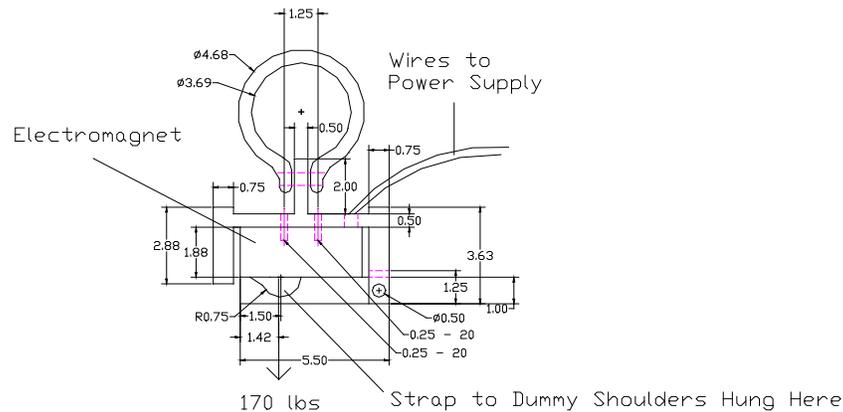
Figure 2.4. Magnetic release mechanism in the closed (pre-impact) position

The Polar dummy was unable to stand without support. A magnetic release mechanism was built to allow electrically controlled release of the dummy prior to impact by the vehicle. An electromagnet was purchased (Storch Magnetics, Inc.) based on its static holding capacity. This capacity had to be greater than the weight of the dummy (70 kg). A latch mechanism was fabricated based on the design parameters of the magnet (Figure 2.4). Deactivation of the magnet triggers the release of the dummy via a rotating member, which is pulled downward almost instantaneously by the weight of the standing dummy.

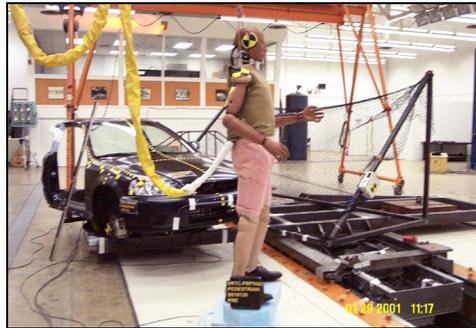
Figure 2.5. Civic Test Setup

expected that at most one test would be done per day due to the time needed for 24-hour windshield curing, vehicle part replacement, dummy repair, and vehicle rotation. Five tests were allowed for replication of vehicle damage patterns with the actual case.

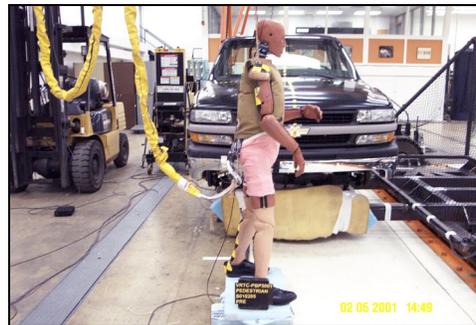
Figure 2.6. Silverado Test Setup

A 1999 Chevrolet Silverado was used for the high profile vehicle test series. In this set, the dummy was impacted on its left side by the front right side of the vehicle (Figure 2.6). As mentioned previously, exact replication of the PCDS case was not the main objective of this series; instead, the kinematics of the dummy in response to a high profile impact and the effect of velocity change on head/neck motion were the main objectives. Three tests were done at 20 km/hr (12.4 mph), and two were done at 25 km/hr (15.5 mph). The low speeds were applied because these were the first tests performed with a high profile vehicle, and the durability of the dummy was uncertain. The case that these tests were modeled after involved a vehicle impact speed of around 50 km/hr. Computer simulations done by Honda predicted moderate to heavy dummy damage at 30 km/hr, so care was taken to stay below this velocity.

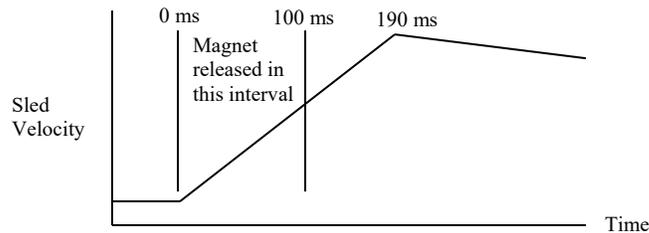
Figure 2.7. Example of the release timing

For example, if the sled got to 30 mph in 190 milliseconds after launch, and it took 90 milliseconds for the latch to release after voltage shutoff, the magnet deactivation would be set to occur prior to 100 ms after launch for the dummy to be released right at impact (Figure 2.7). The length of a breakaway switch similar to the sled backup actuation switch could vary this shutoff time. The dummy was found to remain standing for roughly a half second after release, so it was better to deactivate the magnet prior to impact, near the initial launch time.

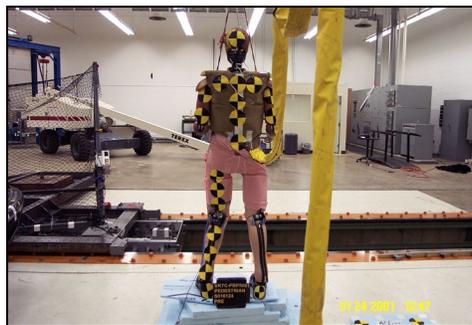
Figure 2.8. Target Locations

Four-inch camera targets were placed on important body landmarks to allow image analysis of trajectories (Image Express, version 4.3, SAI), and chalk paint was applied to the left side of the dummy to distinguish between different body regions that contact the vehicle front (Figure 2.8).

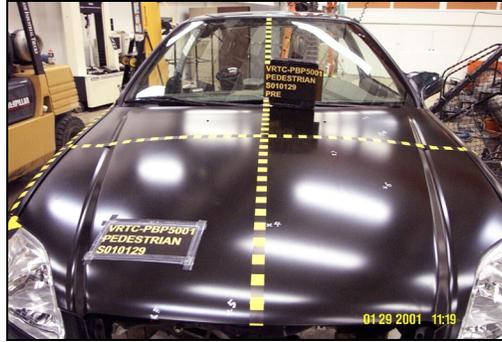
Figure 2.9. Contact point designation

After installation of a new windshield, hood, and bumper for each test, vehicle/pedestrian contact points were marked off based on case information. Points were sequenced from the initial bumper impact point to the final scuff or dent caused by the pedestrian (Figure 2.9).

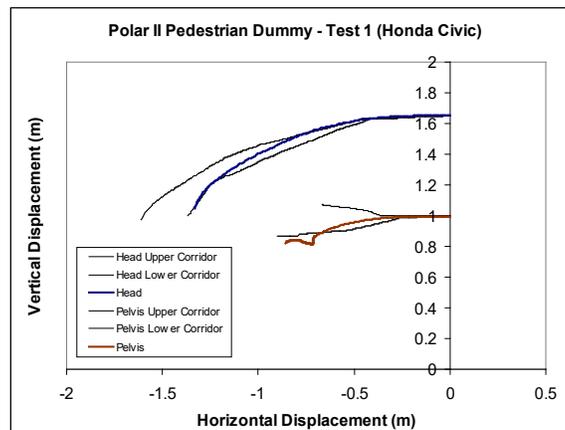
Figure 3.1. Dummy trajectories (target motion analysis) versus PHMS corridors for similar vehicle profile

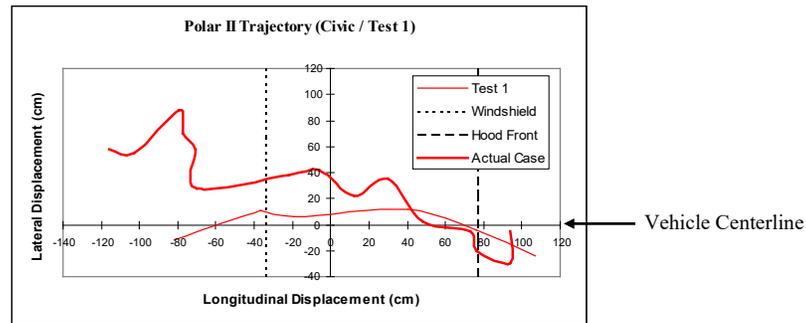
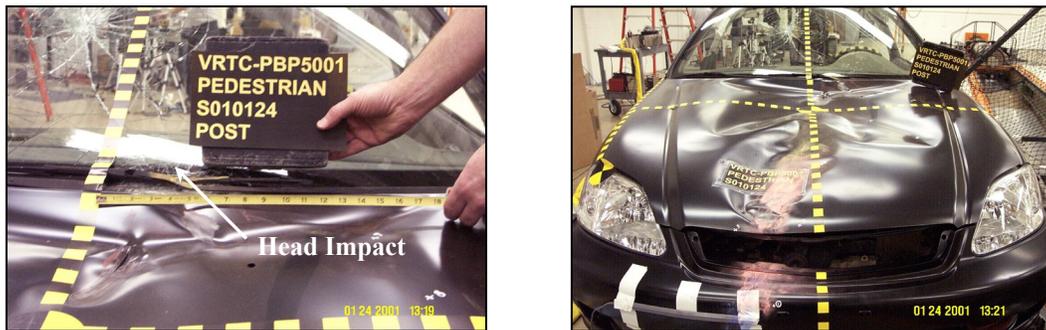
Figure 3.2. Damage patterns and comparison with marked contact points documented from actual case

The head impacted the rigid structure between the bottom of the windshield and top of hood (windshield frame), which was well below the target contact point on the upper right corner of the windshield. The wrap-around distance (WAD) was 182 cm, which was 66 cm less than in the case (248 cm). This caused a high head resultant acceleration of 373.6 g and calculated HIC_{36 ms} value of 3088.

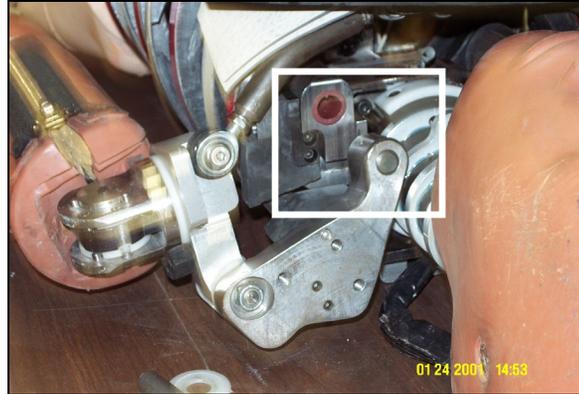
The left shoulder rotating shaft assembly was fractured in shear at contact with the hood surface, probably due to fatigue (Figure 3.3). The peak chest and pelvis resultant accelerations were 60.7 g and 55.0 g, respectively.

Figure 3.3. Sheared shoulder shaft

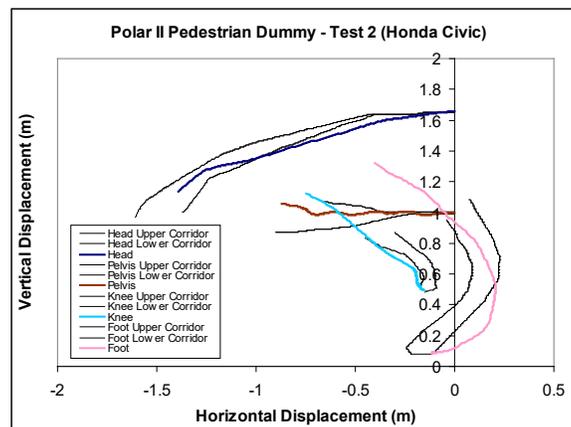
Figure 3.4. Dummy trajectories (target motion analysis) versus PHMS corridors for similar vehicle profile

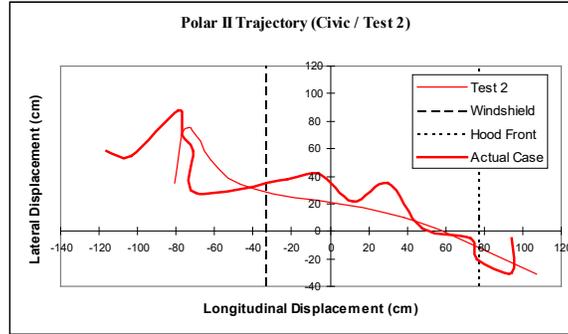
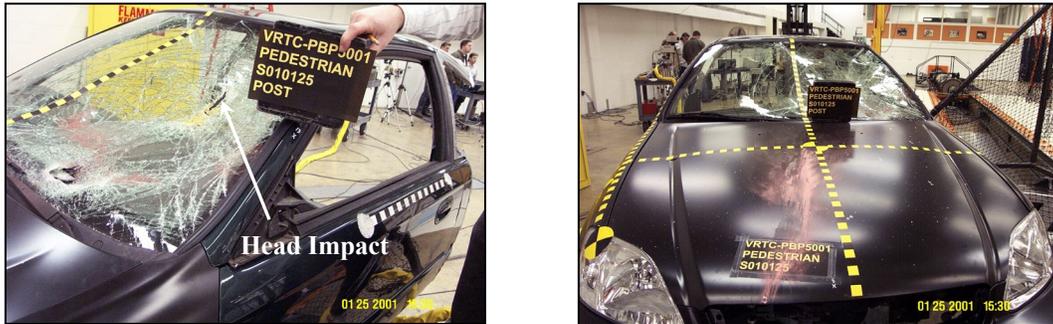
Figure 3.5. Damage patterns and comparison with marked contact points documented from actual case

The head impacted the windshield this time, although still too low (WAD = 222 cm). This caused a much lower head resultant acceleration of 168.7 g and calculated $HIC_{36\text{ ms}}$ value of 1464.

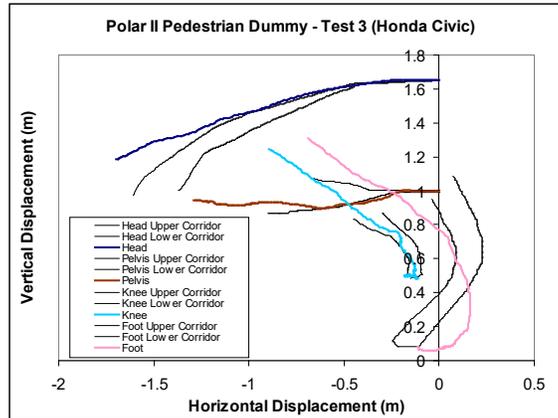
Figure 3.6. Dummy trajectories (target motion analysis) versus PHMS corridors for similar vehicle profile

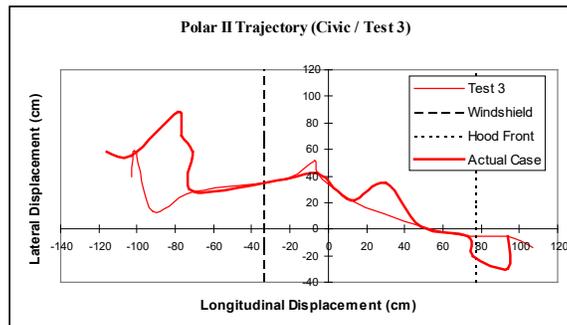
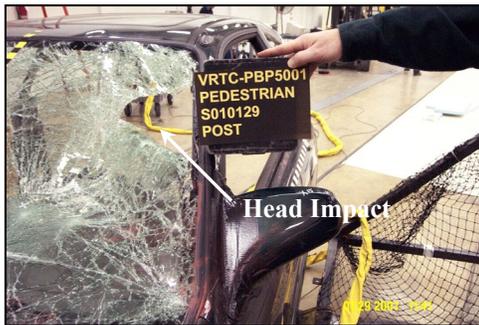
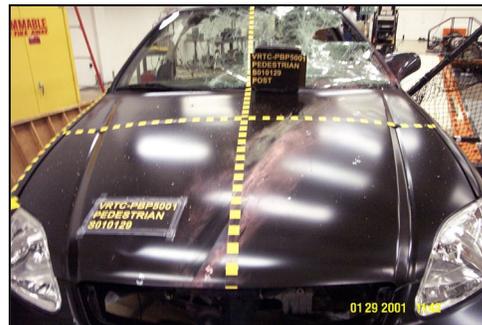
Figure 3.7. Damage patterns and comparison with marked contact points documented from actual case

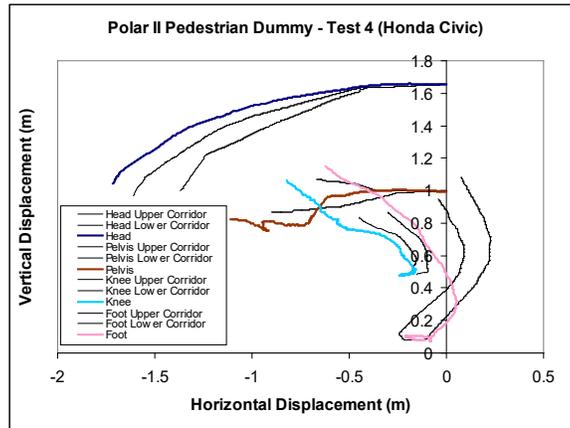
Figure 3.9. Dummy trajectories (target motion analysis) versus PHMS corridors for similar vehicle profile

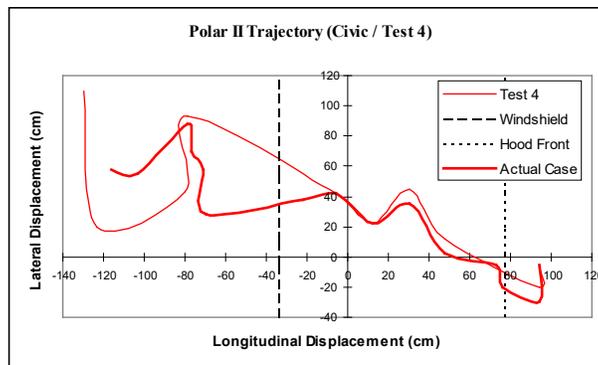
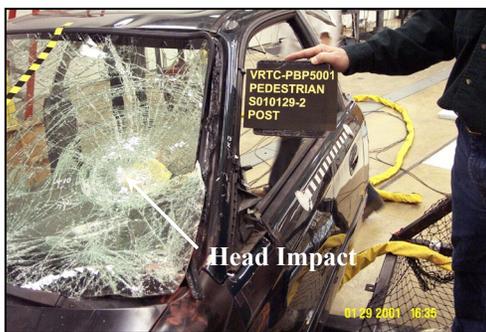
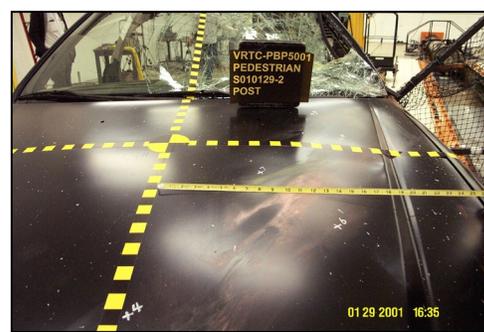
Figure 3.10. Damage patterns and comparison with marked contact points documented from actual case

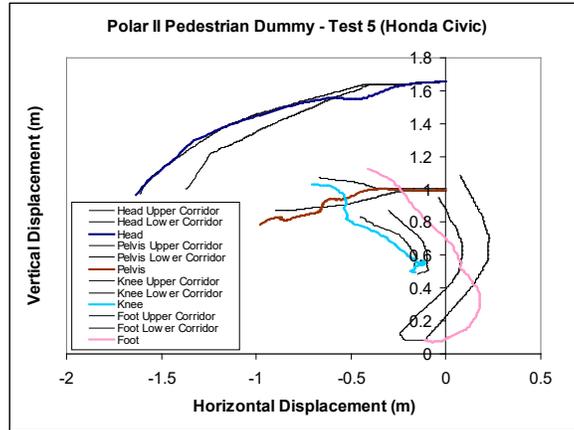
Figure 3.11. Dummy trajectories (target motion analysis) vs. PHMS corridors for similar vehicle profile

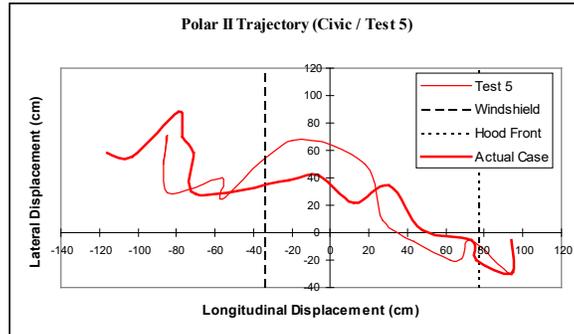
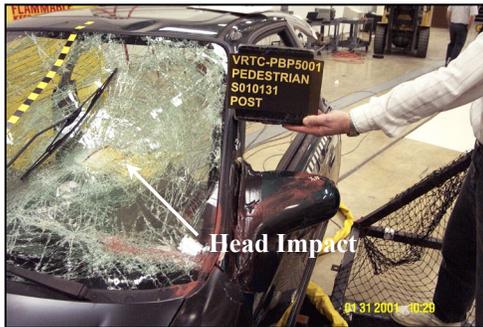
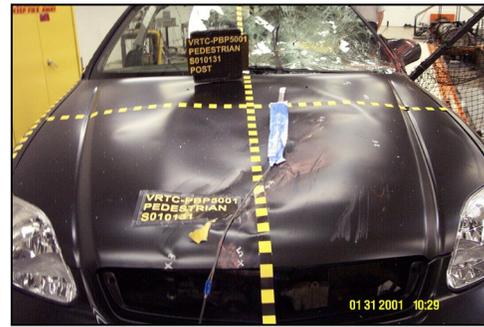
Figure 3.12. Damage patterns and comparison with marked contact points documented from actual case

Once again, the head impacted the windshield far short of the case head contact area (WAD = 216 cm). This time, the windshield sealant did not fail. The head resultant acceleration was 495.5 g, and the calculated HIC_{36 ms} value was 3779. This was the most violent test, with the head going all the way through the windshield and impacting the steering wheel.

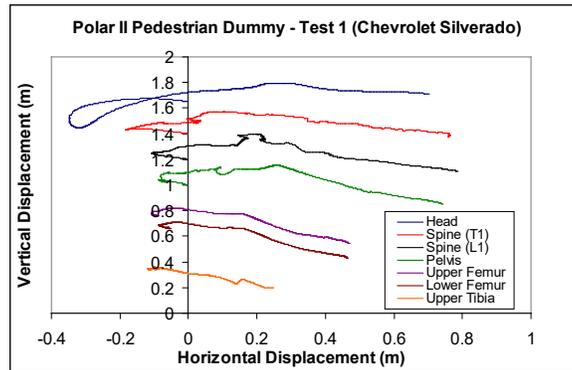
Figure 4.1. Dummy trajectories (target motion analysis) vs. PHMS corridors for similar vehicle profile

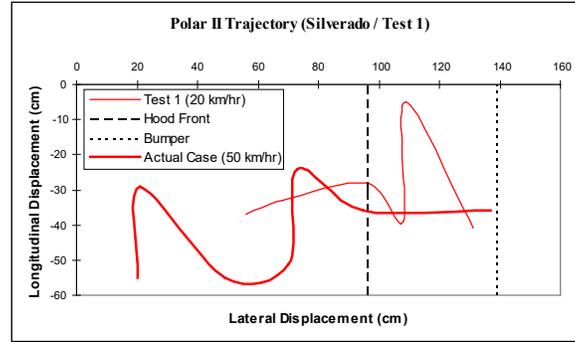
Figure 4.2. Damage patterns and comparison with marked contact points documented from actual case

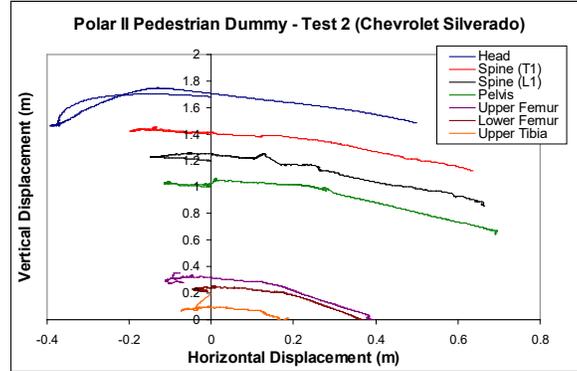
Figure 4.3. Dummy trajectories (target motion analysis) vs. PHMS corridors for similar vehicle profile

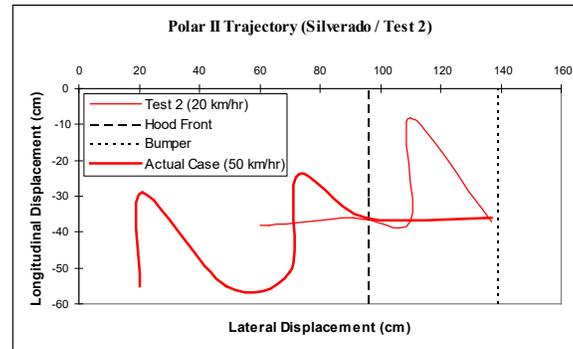
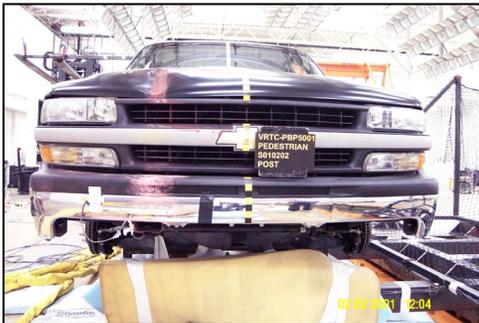
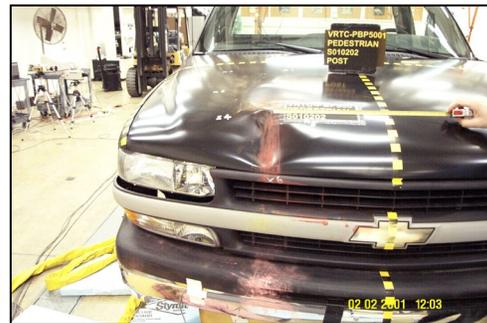
Figure 4.4. Damage patterns and comparison with marked contact points documented from actual case

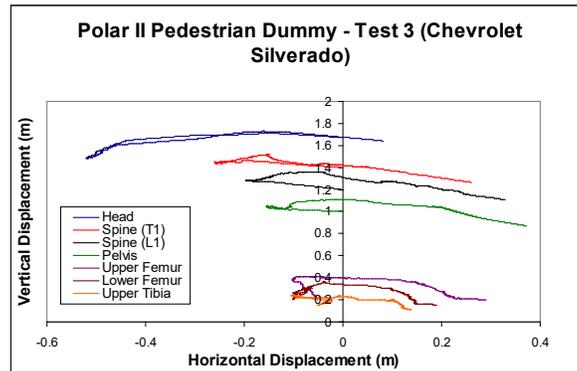
Figure 4.5. Dummy trajectories (target motion analysis) vs. PHMS corridors for similar vehicle profile

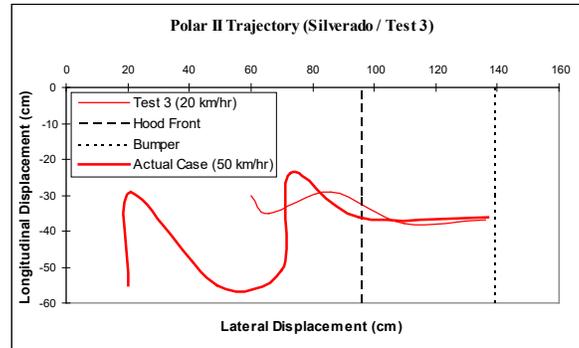
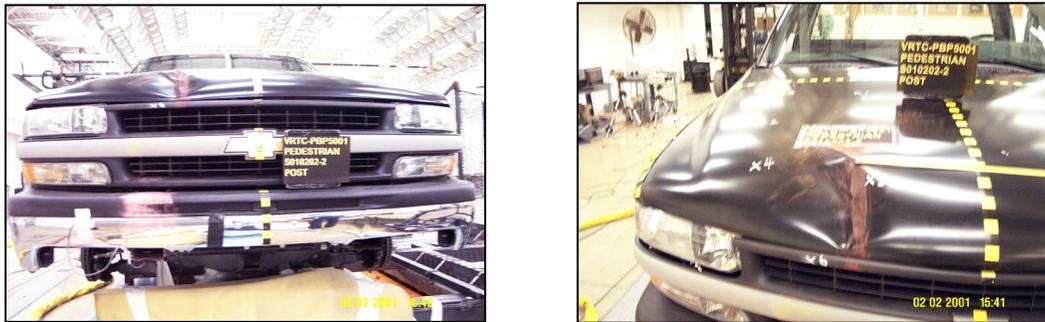
Figure 4.6. Damage patterns and comparison with marked contact points documented from actual case

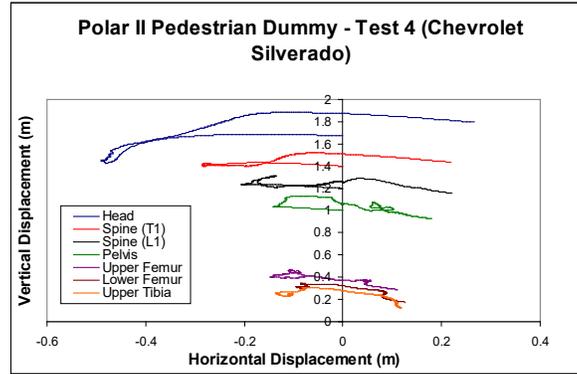
Figure 4.7. Dummy trajectories (target motion analysis) vs. PHMS corridors for similar vehicle profile

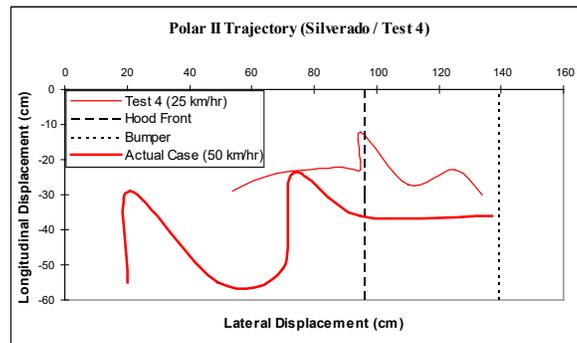
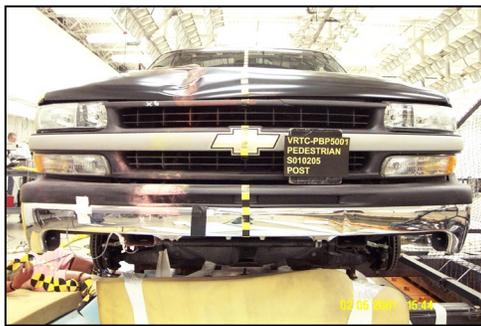
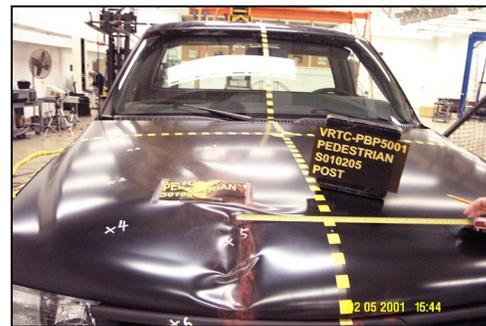
Figure 4.8. Damage patterns and comparison with marked contact points documented from actual case

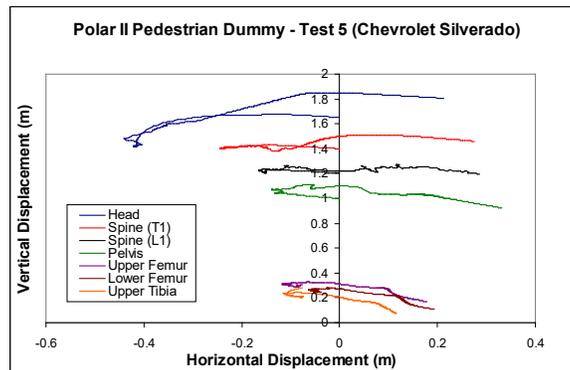
Figure 4.9. Dummy trajectories (target motion analysis) vs. PHMS corridors for similar vehicle profile

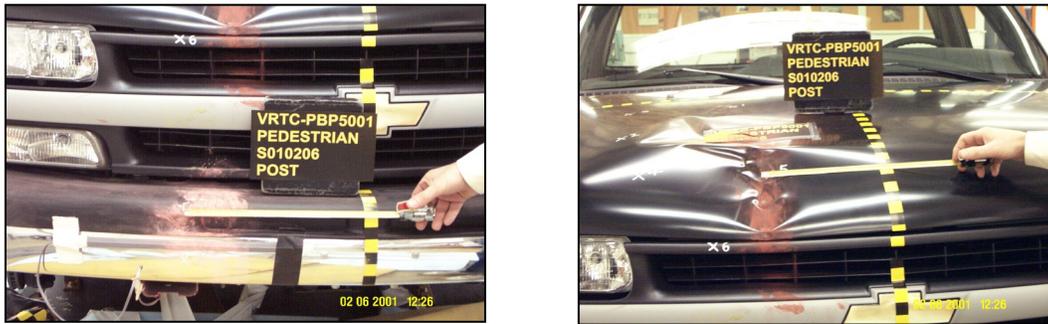
Figure 4.10. Damage patterns and comparison with marked contact points documented from actual case

The WAD for this test was slightly lower than Test 4 (147 cm), which was the same trend noted between Tests 2 and 3 (arms at sides versus arms crossed). The head resultant acceleration was slightly lower at 141.6 g, and the calculated HIC_{36 ms} value was 1105.

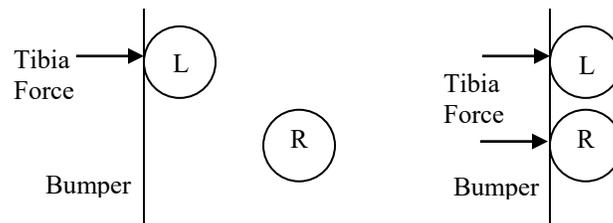
Dynamically, the energy transferred from the bumper to the left leg would be near the force transmitted to the right leg at contact because nothing is between both legs and the bumper. Therefore, the contact forces on the left leg and right leg were assumed to be nearly equal (Figure 5.1). Under this assumption, the upper tibia force on the left leg was compared with the injury tolerance in the literature, and this was used as the basis for determining the similarity of a test with the case.

Figure 5.1. Stance does not affect force transferred to right leg

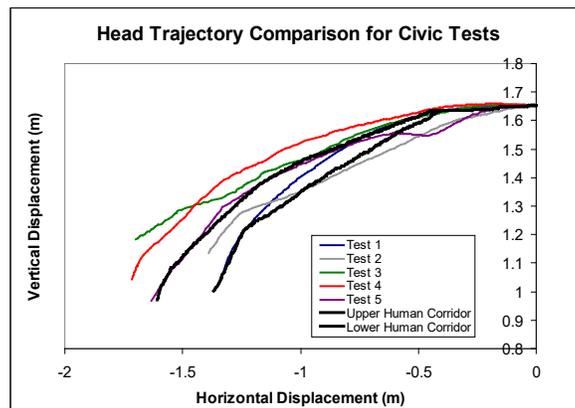
Tests 4 and 5 incorporated slight differences in arm and leg positions, but nothing significant enough to change the head trajectory. The head paths in Test 4 and 5 followed roughly the same pattern, except for a noticeable “dip” in the initial stage of head movement in Test 5. This motion was most likely due to the inertia of the head moving downward prior to impact because the dummy wasn’t fully balanced prior to release of the magnet. If this did not occur, the two paths would have been close to identical.

Figure 5.2. Head trajectories for all tests

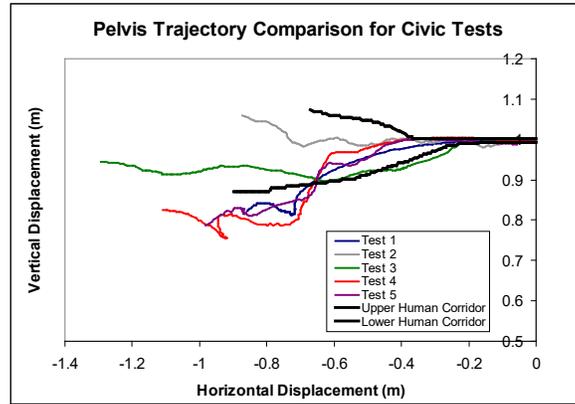
The pelvis trajectories of all tests fell within the biofidelic corridors prior to 60 cm travel into the vehicle. As expected, the increase in dummy elevation increased the pelvis vertical displacement as seen in the

difference between Test 1 and Test 2 (Figure 5.3). Once again, the loss of the right leg in Test 3 caused it to have the largest horizontal displacement. A comparison of Tests 2 and 4/5 shows the effect of pedestrian orientation with the vehicle. The trajectory in Test 2 stays at roughly the same vertical position then goes up at 0.7 meters. In Tests 4 and 5, the pelvis moves in the opposite direction. An interesting extension of this study would be to look at the effect of pedestrian rotation on its kinematics.

Figure 5.3. Pelvis trajectories for all tests

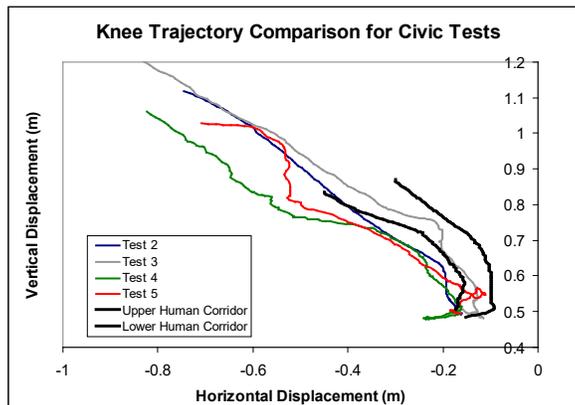
Unfortunately for Test 1, the knee and foot trajectory was not in view by the cameras. The views were adjusted for the next four tests, however. Test 2 had a more linear knee path when compared with the others, but for the most part, all tests showed similar trajectories (Figure 5.4). The initial knee position varied slightly, which resulted in differences in horizontal displacement. If all trajectories began at the same position, the shapes of all tests would have fallen within the corridors.

Figure 5.4. Knee trajectories for Civic tests

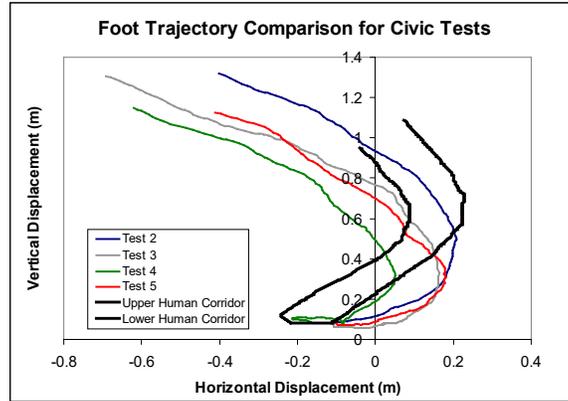
In terms of foot kinematics, Tests 2, 3, and 5 were similar for the initial 0.3 meters of horizontal displacement. Tests 3 and 5 remained similar, but Test 2 seemed to lag behind (lower horizontal position for the same vertical position) the rest of the way. It's possible that this is again due to pedestrian orientation. In Test 4, the foot began closer to the vehicle than Tests 3 and 5, which accounts for the difference in position from 3 and 5. The shapes are similar. The paths seem to turn from positive to negative horizontal displacement more abruptly than is described by the corridor. It is not clear why this is, but a reason could be that the ankle joint is too flexible.

Figure 5.5. Foot trajectories for Civic tests

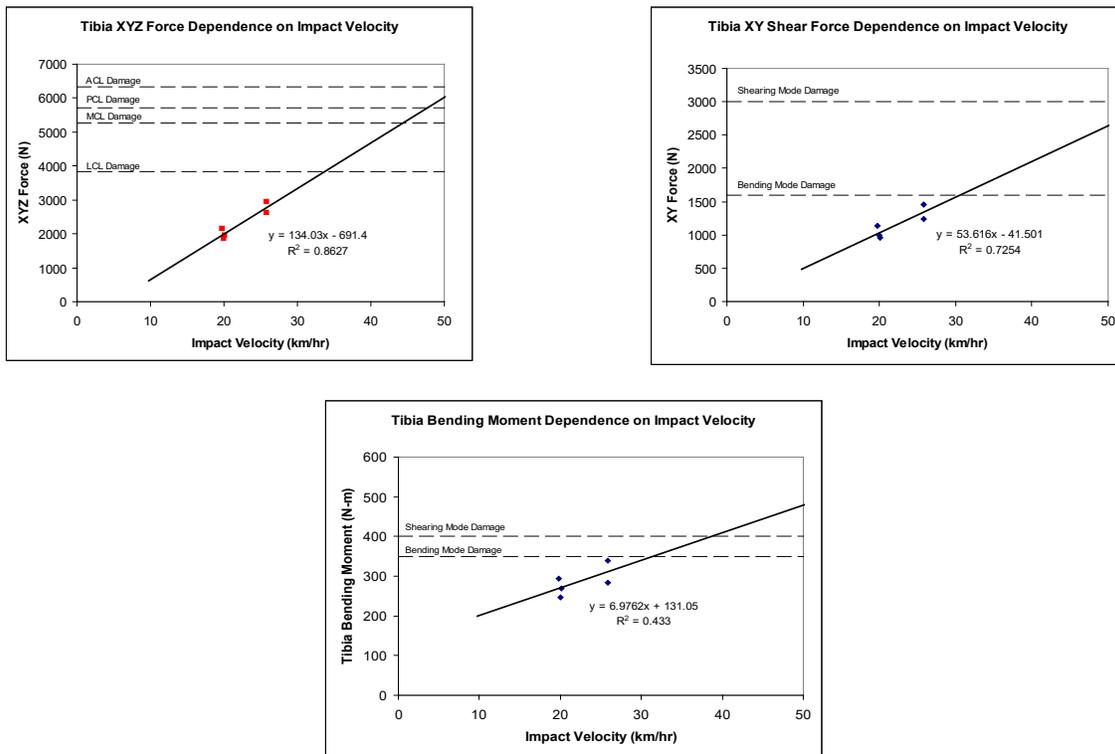
Based on these estimations, there is a good probability that force and moment magnitudes associated with upper tibia injury (both fracture and skin contusion) would have occurred if testing were performed near 50 km/hr.

Figure 5.6. Extrapolation of test results to 50-km/hr velocity

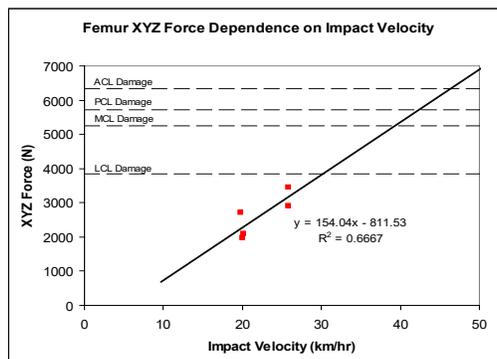
Based on the velocity dependence of the femur force, the pedestrian in the case was fortunate to escape with only a skin contusion on the thigh. The resultant femur force extrapolated at 50 km/hr indicates severe damage to the knee (Figure 5.7). This gives support to a nonlinear relationship between femur force and impact velocity. The trajectory of the upper body may supply more information as to why the forces were so high for low speeds. For example, the left arm may have absorbed a lot of energy prior to leg contact in the case, whereas in the tests, the leg was the first contact location. The shear force (x and y resultant) gave a trend with a very low R-squared value; therefore, it was not shown here.

Figure 5.7. Knee force dependence on impact velocity

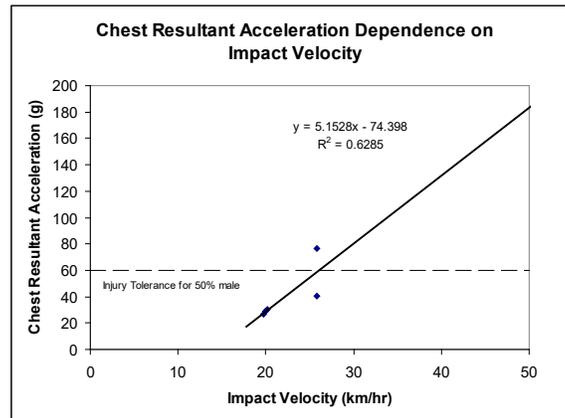
The pedestrian involved in the case was severely injured in the chest area, with AIS 3 (bruised lung) and AIS 4 (five fractured ribs) injuries. It was not surprising that the resultant acceleration was near the injury criteria of 67 g [14] at the low speeds of 20 and 25 km/hr. When this is extrapolated to 50 km/hr, this value was roughly three times (180 g) the injury threshold for a 50% percentile male (Figure 5.8).

Figure 5.8. Chest acceleration extrapolated to 50 km/hr, the velocity of the case

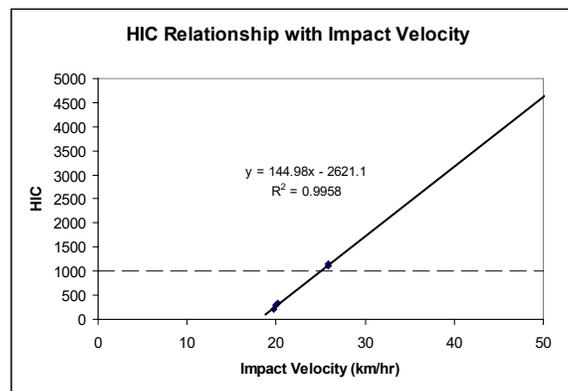
The pedestrian received an AIS 2 contusion on the back of the head. This is consistent with a HIC of below 800. For the Silverado tests at 20 km/hr, this was the case. The average HIC at this speed was 275 (n=3). As expected, there is a definite relationship between HIC and velocity, with the average HIC at 25 km/hr at 1127 (n=2). This indicates that the dummy was in the serious head injury range already at 25 km/hr. Based on an assumed linear relationship between HIC and velocity, the pedestrian would have been fatally injured at 50 km/hr (Figure 5.9).

Figure 5.9. Head injury criterion

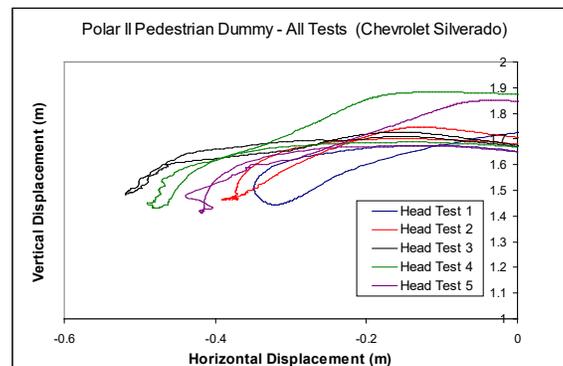
The arm and leg positions were varied for these tests, causing more changes in kinematics. For Test 1, the legs were in line and the arms were bent at the elbows with the hands free. In Test 2, the right leg was in front of the left and the arms were in the same position as Test 1. This change in leg position resulted in a higher trajectory of the head and subsequent increase of 4 cm in horizontal translation. In Test 4, the same stance as Test 2 was applied, this time at a higher speed. In Test 5, the same leg position was applied as in Test 4, but the hands were tied together. This resulted in a lower translation (5 cm) than in Test 4, most likely because the arms were closer to the body and therefore the head did not have as far to travel for impact with the hood.

Figure 5.10. Motion of the head in the Silverado tests

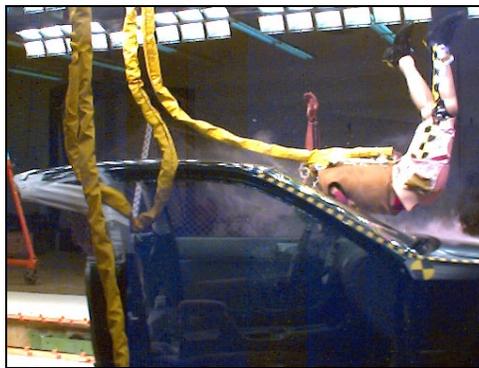
In Test 2, several components were damaged. The rear neck cable snapped from excessive tension, leading to less restriction of neck motion and cracking of the segments. The high force associated with cable failure was after the head had penetrated the windshield (Figure 5.12).

Figure 5.12. Circumstances leading to rupture of the rear neck cable

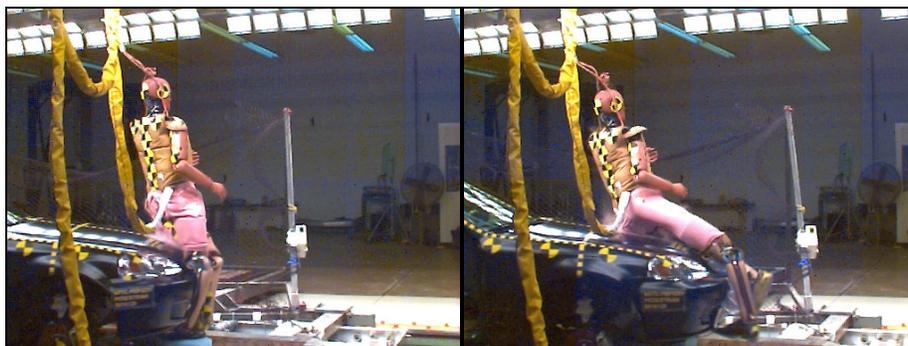
The pelvis resultant acceleration was not extremely high in Test 2, but there was damage to the lumbar flex joint. It was thus concluded that the damage was due to fatigue for the most part. Some of the internal sensor cables were tied loosely to the flex joint, which may have caused more stress. In Test 3, the right proximal femur was fractured and the entire right leg was detached (Figure 5.13).

Figure 5.13. Fracture of the right hip joint

Figure 3.8. Broken right hip sustained in Test 3
