# A Demographic Analysis and Reconstruction of Selected Cases from the Pedestrian Crash Data Study

## ABSTRACT

The second area presented is full-scale attempts at reconstruction of two selected PCDS cases using the Polar II pedestrian dummy to determine if the pre-crash motion of the pedestrian and vehicle could somehow be linked to the injuries and vehicle damage documented in the case.

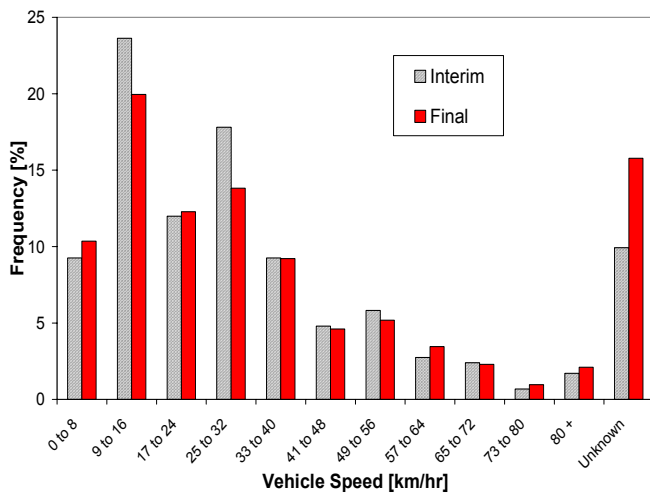
Figure 2: Vehicle Speed Distribution

There were significant decreases in the vehicle speed categories of 9-16 km/hr and 25-32 km/hr from the interim PCDS data ( $p<0.05$ ) (Figure 2), but the percentage of unknown vehicle speeds has increased, perhaps hiding instances in these speed categories.

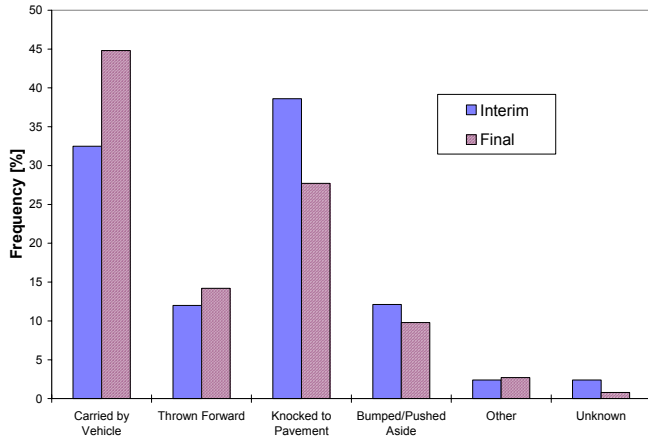
Figure 4: Post-Impact Pedestrian Motion [3,4]

Figure 4 indicates a large increase in the percentage of pedestrians carried by the vehicle. This number increased significantly from 32.5% to 44.8% ( $p<0.05$ ) [3]. This change is reflected in the noticeable decrease in pedestrians knocked to the pavement (38.6% to 27.7%).

There were noticeable changes in the frequency of AIS 2 or greater injuries caused by the bumper and hood areas from the interim PCDS. The frequency of injuries caused by contact with the bumper decreased from 25.5% to 21.5% ( $p<0.05$ ), while injury frequency due to hood surface contact increased by 4.5% ( $p<0.05$ ). In the category of “environment” (road surface), the percentage was 20% of all AIS injuries but only 7% of cases with AIS 2 or greater [3]. This trend may have been caused by the lower ride height, cab-forward design, and the lower lead angle of more recent model vehicles resulting in less energy absorption by the leg and pedestrians being carried by the vehicle more frequently, as shown in Figure 4.

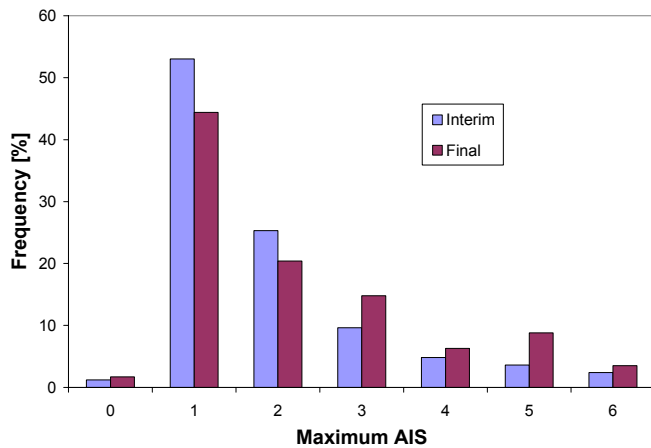
Figure 5: Maximum AIS Injury Suffered by Pedestrian

The maximum AIS injuries suffered are shown in Figure 5. In the interim PCDS analysis with 292 cases, over 50% were AIS 1 and 11% were AIS 4 or higher [1]. While the frequency of MAIS 1-2 injuries has decreased by 14% ( $p>0.05$ ), there has been an 8% increase in MAIS 4 and higher level of injuries ( $p>0.05$ ). The reason for this increase in injury severity is unclear, but it may have to do with the popularity of sport utility vehicles (SUVs) in the last few years, which are more likely to cause broken ribs and fractured upper legs and hips because of their geometry. These injuries are AIS 3 and higher in many cases. The frequency of upper and lower extremity injuries has in fact increased, especially in the AIS 2 and higher severity ranges [1,3,4].

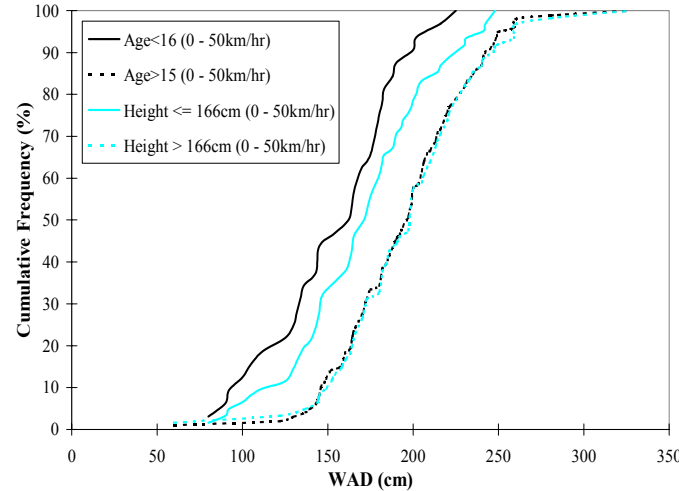
Figure 6: Child and Adult WAD by Age and Stature [7]

The average 15 year old in the U.S. is 166 cm tall according to CDC growth charts, regardless of gender [6]. The wrap around distance (WAD) is influenced by vehicle impact speed, age, and stature [3]. In Figure 6, the average WAD for adults regardless of using age ( $>15$  years) or stature ( $>166$  cm) as the independent variable is 197 cm. The average WAD for children when using stature as the independent variable is 171 cm, which is larger than when using age (162 cm). This

difference in WAD for adults and children reflects the need for concentrating on different areas of the vehicle, depending on whether a child or adult-sized test device is being used. For example, the windshield and A-pillars are important vehicle structures for adults, but not necessarily for children. The bumper and front end of hood are more prevalent injury-causing structures for ages 0-15.

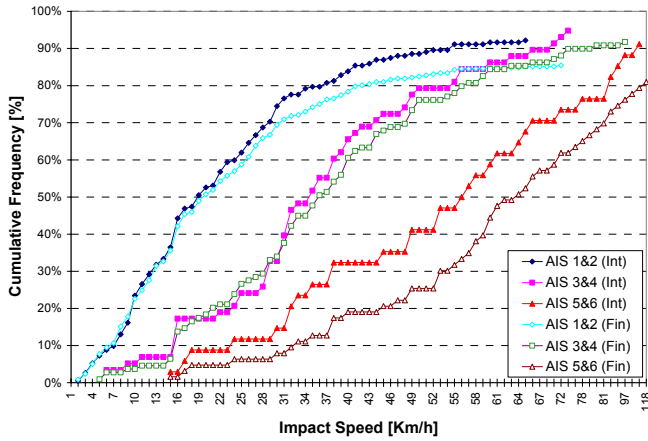
Figure 7: PCDS Impact Speed versus Injury AIS

The impact velocity curve of AIS 5-6 injuries for the final PCDS data showed lower percentages of these injuries for the same velocity than in the interim PCDS (Figure 7). As the average vehicle year had not changed significantly from the interim study, it seems that this change is mostly due to sparseness of data for high severity injuries. In fact, there were only 122 AIS 5-6 injuries out of 4,184 total injuries (3%) [3,4].

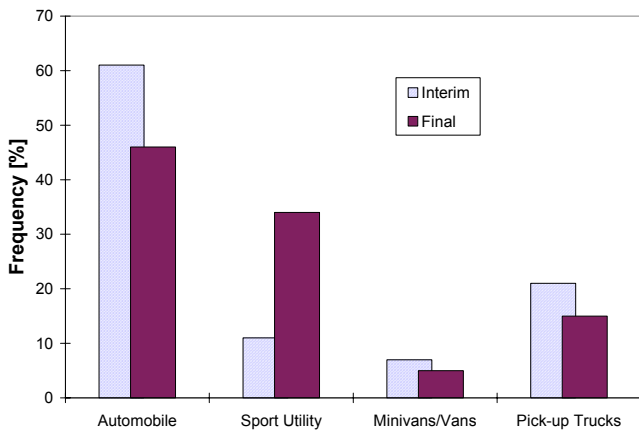
Figure 8: Vehicle Body Type Involvement (Fatalities)

The percentage of SUVs involved in fatal cases increased significantly from 11% of the interim cases to 35% of the finalized 521 cases [3], while the percentages of automobiles (sedan and coupe), minivans, and pick-up trucks decreased significantly from the interim PCDS analysis ( $p < 0.05$ ) (Figure 8). Even though this change can perhaps be explained again by paucity of data (only 63 fatalities in the final PCDS), this significant increase illustrates the popularity of SUVs in recent years, as well as emphasizing the need to address pedestrian safety concerns with these types of vehicles.

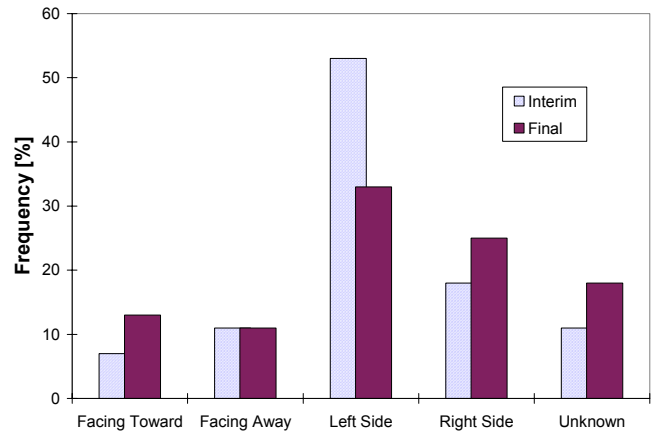
Figure 9: Fatally-Injured Pedestrian Body Orientation Relative to the Vehicle

There was a 38% decrease in the percentage of left-side pedestrian impacts in fatal cases (15 out of 28 fatal cases in the interim database but only 21 out of 63 fatal cases in the final database) [3,4], while the increases in the percentage of right side (28%), facing toward the vehicle (46%), and unknown orientations (39%) were also significant ( $p < 0.05$ ) (Figure 9). It is difficult to

assess whether there really was a substantial decrease in left side impacts because of the eight additional unknown cases. Even with these cases added, there is a significant decrease in fatalities resulting from left side impacts. It is unclear why this trend has changed so much in the past few years.

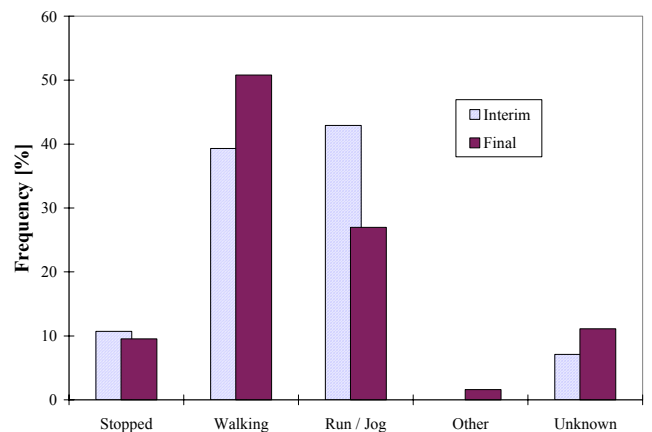
Figure 10: Pedestrian Motion (Fatalities Only)

The percentage of pedestrians walking increased from 39% to 51%, and there was a decrease in those running or jogging prior to being fatally injured ( $p < 0.05$ ) (Figure 10) [3,4]. It is unclear why this has changed so much since the interim PCDS, but it seems that the faster the pedestrian is moving laterally across the vehicle front, the less chance there is of receiving a direct fatal injury from one of the vehicle components. As discussed in Part II of this study, an increase in the height of the pedestrian center of gravity and lateral rate of motion relative to the vehicle front is more conducive to the pedestrian sliding across instead of impacting rigid front-end vehicle components.

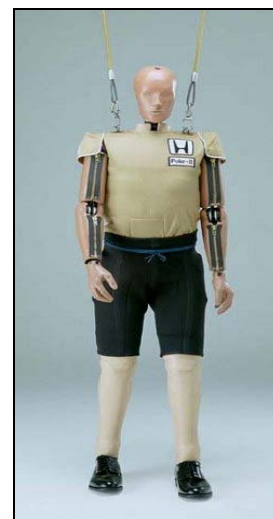
Figure 11: Polar II Pedestrian Dummy [8]

The Polar II dummy is a second-generation 50<sup>th</sup> percentile adult male pedestrian dummy (Figure 11). Table 3 shows the size of the dummy, which is identical to the size of a 50<sup>th</sup> percentile American male [8].

The dummy was designed using THOR, the NHTSA Advanced Frontal Dummy, as a base model for its initial design [8]. The dummy was specified to be durable enough to handle up to a 50-km/hr impact [8], and it possessed the following instrumentation scheme:

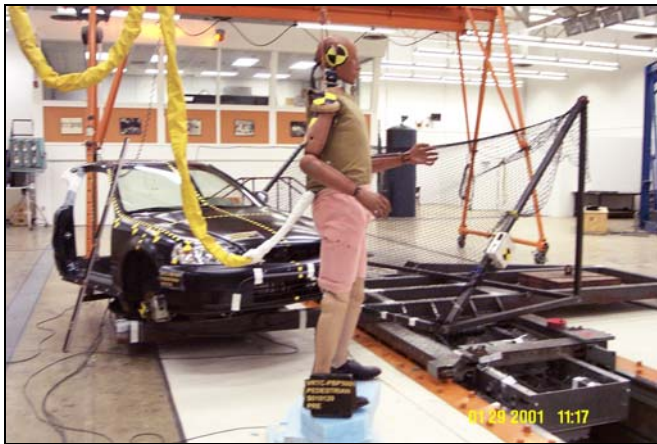
Figure 19: Pedestrian Case Reconstruction Test Setup

In preparation for the sled attachment, both of the test vehicles were cut behind the B-pillar and the interior compartment was emptied to reduce the weight of the vehicle (the under hood components were kept intact). The vehicle was rigidly attached to a buck via a circular steel interface plate. Because the vehicle was offset from the track, as shown in Figure 19 [9], a ballast equal to the vehicle weight was attached on the opposite side of the track to balance the buck-vehicle assembly and reduce torsion effects. A net was attached to the buck over the sled to prevent the dummy from getting caught in the sled.

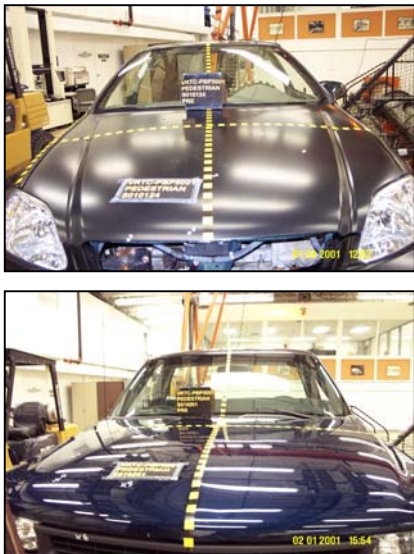
Figure 20: Measurement Reference Lines for Civic (above) and Silverado (below) [9]

The damage locations from the actual cases were marked on the test vehicles prior to the tests in order to facilitate comparison of the damage patterns.

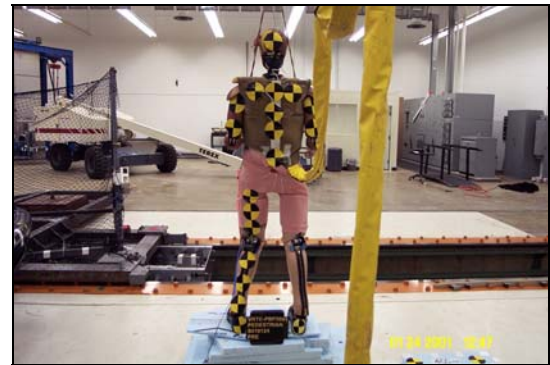
Figure 21: Target and Dummy Stance [9]

were the same for each test, except for changes made between tests to get a more accurate reconstruction of the case. Different colors of chalk were applied to the left side of the dummy to distinguish which area of the dummy contacted which portion of the vehicle in post-test analysis. These body areas included the head, arm, lumbar/pelvis, upper leg, and lower leg. Photographic targets were placed on important body landmarks for trajectory analysis (Figure 21).

The dummy was held in a standing position by a magnetic holding device that was triggered to release just prior to impact of the dummy by the vehicle so that the entire weight of the dummy was on the ground and downward acceleration of the dummy was minimal [9].

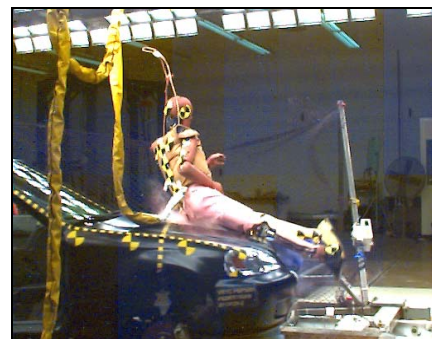
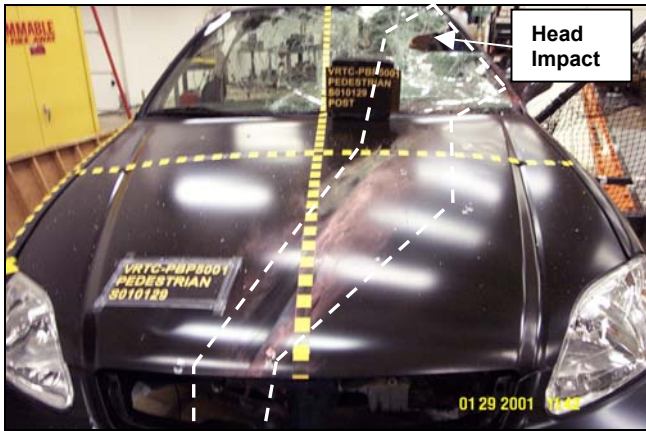
Figure 22b: Pedestrian Path of Civic Case vs. Test 3 [9]

In the Honda Civic tests, the third test out of five was most similar to the actual collision in terms of injury measurement levels, vehicle damage patterns, and the trajectory of the dummy. In Figure 22, the dotted white line indicates the region of vehicle damage, while the chalk on the hood and cracks on the windshield show that the test damage falls within this region. The head injury criteria (HIC) value was representative of an AIS 1 injury (688), which was the level suffered by the pedestrian in the case, and the WAD was 239 cm (9 cm short of the case WAD of 248 cm) [9].

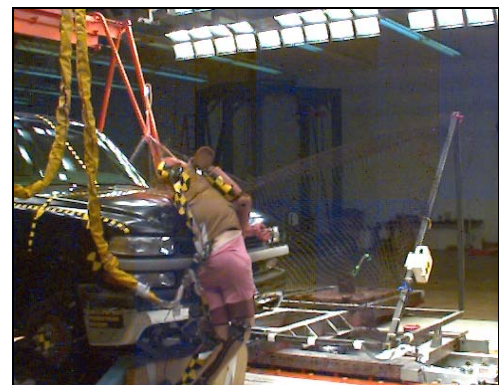
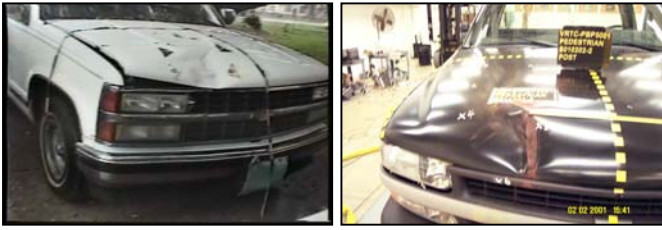
Figure 24b: Damage of Silverado Case vs. Test 3 [9]

The documented impact velocity in this case was about 50 km/hr, but the dummy manufacturer had concerns about the durability of the dummy in high speed, high vehicle profile impacts [9]. Because this prototype dummy was needed for other testing immediately following this test series, lower impact speeds of 20 and 25 km/hr were applied in this test series. Using estimated linear relationships of trajectories and injuries with impact velocity, results were extrapolated to 50 km/hr to get a comparison with the case. Because of this indirect comparison, more emphasis was put on how changes in stance and velocity affected the kinematics of the dummy [9] than injury replication. The third test was closest to the case both in terms of damage patterns on the vehicle and the path of the dummy (Figure 24).

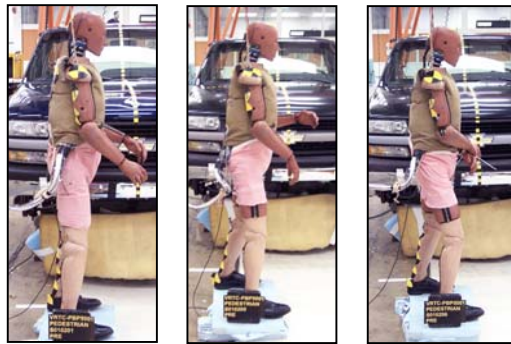
Figure 25: Silverado Test Dummy Stances for Tests 1 (Left), 2 and 4 (Middle), and 3 and 5 (Right)

For these tests, three dummy stances were used (Figure 25), incorporating combinations of two different leg positions (legs even, right leg in front of right) and two arm positions (bent in front at elbow, wrists tied in front). The “right leg in front” configuration modeled a walking pedestrian. The reason for tying the wrists together in one arm configuration is to negate the effect the arms would have on the kinematics. The effect of these stances and changing velocity on WAD and estimated injury levels (Tables 11 and 12) was evaluated. The elevation of the dummy was consistent from test to test because the tests were done at lower velocities than the case warranted.

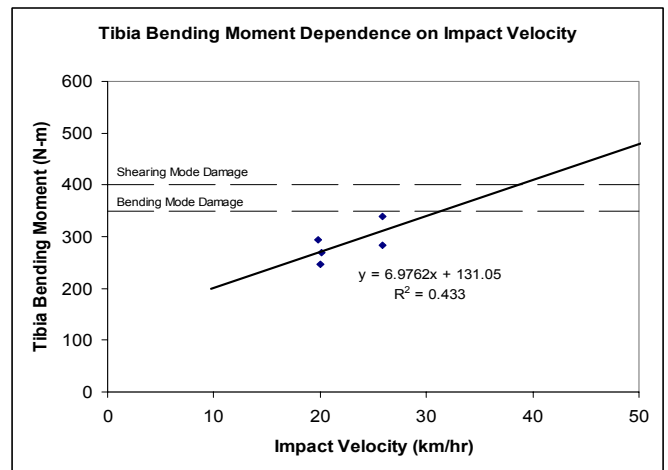
Figure 26: Extrapolation of test results to 50-km/hr

There was good agreement between the case and estimated test injury levels for the tibia and chest, indicating that the dummy responded to the high profile impact in a human-like manner. A linear relationship between injury levels and impact velocity provided an estimation of these injuries. Regardless of whether a linear or non-linear approximation was used, the measurements at low velocity were close enough to published injury thresholds to assume injury at 50 km/hr. Figure 26 gives an example of how the tests at two velocities were used to estimate the measurements at the case impact velocity of roughly 50 km/hr.

The test results for the head were quite different from the actual case results. The pedestrian received an AIS 2 contusion while extrapolated dummy results indicated a HIC of 4500. While this discrepancy may be partially do to the assumption of linearity between velocity and HIC, the dummy’s upper body may be too stiff causing the dummy to rotate and the head to strike the hood of the Silverado before the shoulder and torso can absorb the majority of energy [9]. Another theory is that pre-impact braking of the vehicle could have increased the amount of time between initial contact with the body and head impact, allowing the upper body to decrease kinetic energy of the head.
