REPORT NUMBER: TWG-TRC-18-04

NEW CAR ASSESSMENT PROGRAM (NCAP)
Side Airbag Out-of-Position Test

FCA US LLC
2018 Dodge Journey

NHTSA NUMBER: M20180305TWG2
TRC TEST NUMBER: 180719-1

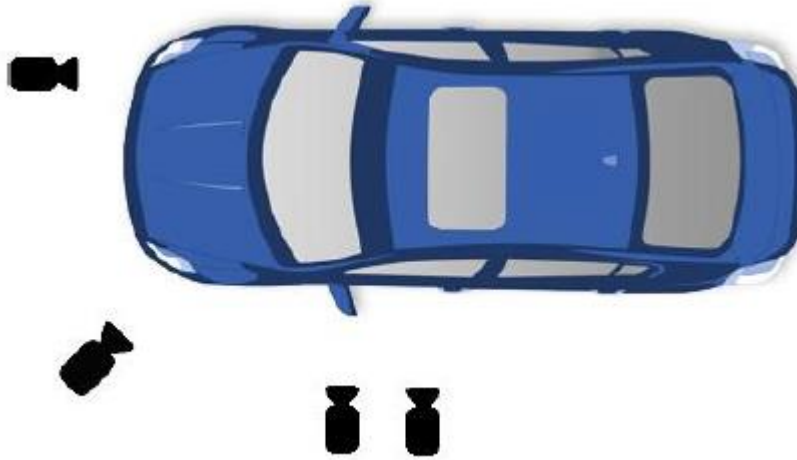
CAMERA SETUP DIAGRAM FOR SAB OOP TESTS

No.	Camera View	Location (mm) ¹			Lens (mm)	Speed (fps)
		X	Y	Z		
1	Left View	0	-2449	-1127	50	1000
2	Oblique View	2098	-1651	-1601	50	1000
3	Front View	2477	-221	-1658	50	1000
4	Real Time	-89	-2484	-1143	Zoom	30

¹ +X forward of vehicle, +Y right of vehicle, +Z into ground

One real-time camera and three high-speed cameras were used to record the air bag deployment event. High speed images were recorded at rates of 1,000 frames per second. Cameras were placed relative to the position 2 and were positioned to capture the deployment event from the side, the front, and the oblique views.

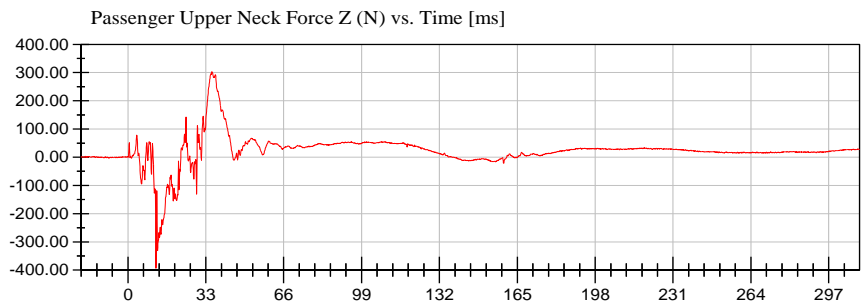
<Max>

302.86 N at 35.60 ms

<Min>

-393.67 N at 11.92 ms

Injury Criteria	Value	Time (ms)
Upper Neck NTF	0.05	22.64
Upper Neck NTE	0.22	35.36
Upper Neck NCF	0.13	12.80
Upper Neck NCE	0.07	29.04
Peak Tension	302.9	35.60
Peak Compression	-393.7	11.92

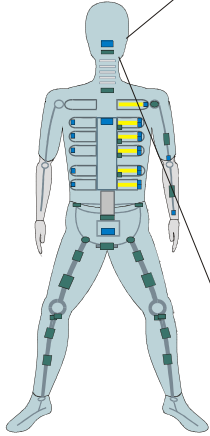
Neck Injury Predictor (NIJ)

Test Orientation = Side
Fz:(Tension) = 3880
Fz:(Compression) = 3880
Myc(Extension) = 61
Myc(Flexion) = 155

NIJ Source Code: (Fz/Fz)+(Myc/Myc)

Max [NTE] 0.2215 at 35.36 ms

Max [NTF] 0.0482 at 22.64 ms

Max [NCE] 0.0701 at 29.04 ms

Max [NCF] 0.1315 at 12.80 ms
