REPORT NUMBER: TWG-TRC-18-02

#### NEW CAR ASSESSMENT PROGRAM (NCAP) Side Airbag Out-of-Position Test

NISSAN MOTOR CO., LTD. 2018 Nissan Versa Sedan

FINAL REPORT

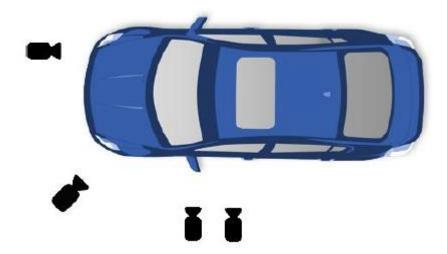
#### **CAMERA SETUP DIAGRAM FOR SAB OOP TESTS**

No. Camera Vie	Camora Viow	Location (mm) <sup>1</sup>		Lens (mm)	Speed (fps)	
	Camera view	X	Υ	Z	Lens (mm)	Speed (ips)
1	Left View	328	-2427	-1078	50	1000
2	Oblique View	2401	-1129	-1512	50	1000
3	Front View	2499	0	-1371	50	1000
4	Real Time (optional)	0	-2474	-1119	Zoom	30

<sup>1 +</sup>X forward of vehicle, +Y right of vehicle, +Z into ground

One real-time camera and three high-speed cameras were used to record the air bag deployment event. High speed images were recorded at rates of 1,000 frames per second. Cameras were placed relative to the position 2 and were positioned to capture the deployment event from the side, the front, and the oblique views.

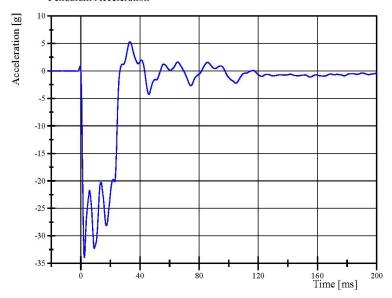
Filter Class: CFC\_180 Max: 5.3 g at 33.2 ms Min: -33.9 g at 2.4 ms

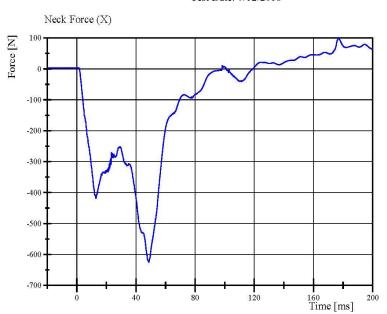
Filter Class: CFC\_1000 Max: 98.3 N at 177.0 ms Min: -625.1 N at 48.7 ms

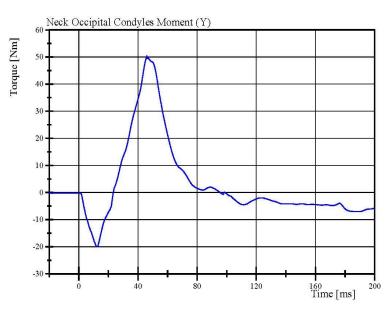
Filter Class: CFC\_600 Max: 50.4 Nm at 46.0 ms Min: -20.0 Nm at 12.2 ms

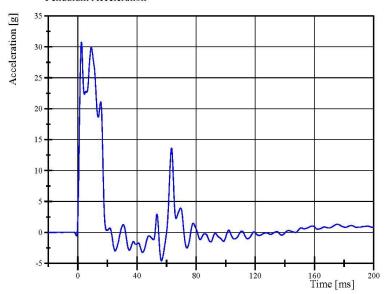
Filter Class: CFC\_180 Max: 30.8 g at 2.5 ms Min: -4.6 g at 56.6 ms

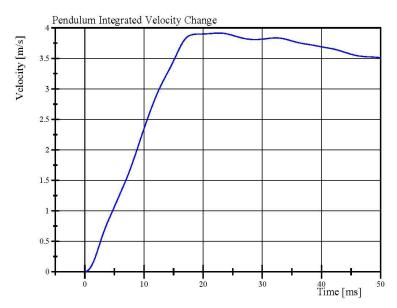
Filter Class: CFC\_180 Max: 3.9 m/s at 22.6 ms Min: 0.0 m/s at 0.0 ms

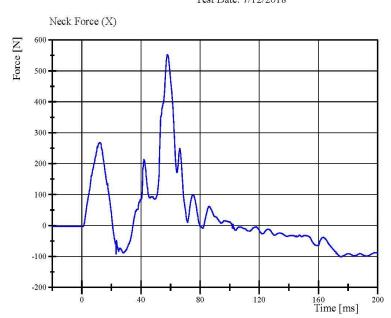
Filter Class: CFC\_1000 Max: 552.4 N at 57.8 ms Min: -101.0 N at 175.4 ms

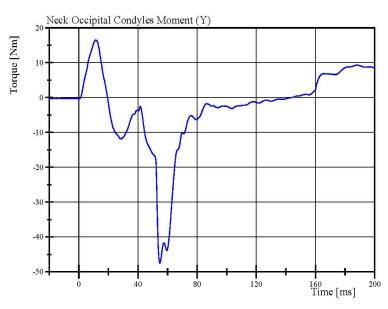
Filter Class: CFC\_600 Max: 16.5 Nm at 11.4 ms Min: -47.5 Nm at 54.7 ms

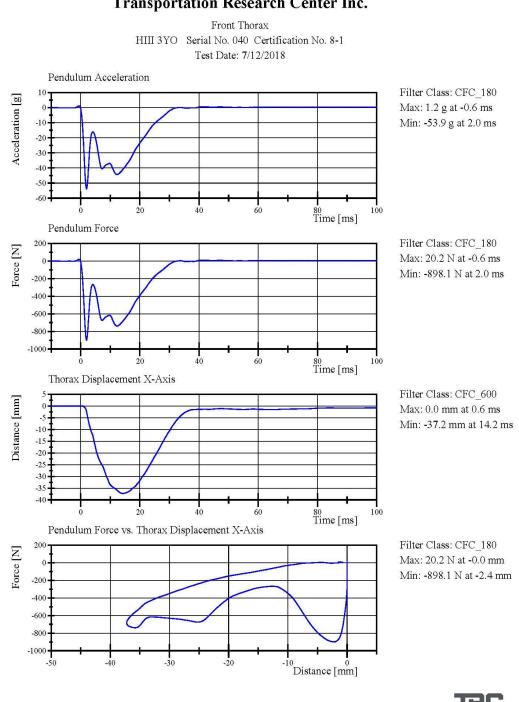
Front Thorax
HIII 3YO Serial No. 040 Certification No. 8-1
Test Date: 7/12/2018

<b>Test Parameter</b>	Specification	<b>Test Results</b>	Pass
Temperature	20.6 - 22.2 ℃	21.3 ℃	Yes
Relative Humidity	10 - 70 %	49 %	Yes
Probe Velocity Probe Force Peak Between 32.0 mm	5.9 - 6.1 m/s	5.97 m/s	Yes
and 38.0 mm Chest Deflection	(-680) - (-810) N	-738.0 N	Yes
Probe Force Peak Between 12.5 mm and 32.0 mm Chest Deflection	>= (-910) N	-674.2 N	Yes
Maximum Chest Compression	(-32) - (-38) mm	-37.2 mm	Yes
Internal Hysteresis	65 - 85 %	67.4 %	Yes

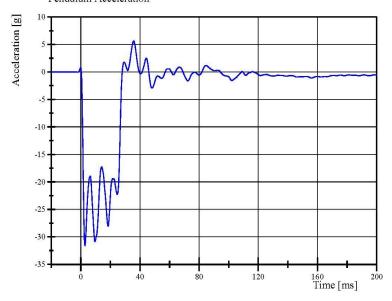
Pendulum Acceleration

Filter Class: CFC\_180 Max: 5.6 g at 35.8 ms Min: -31.6 g at 2.8 ms

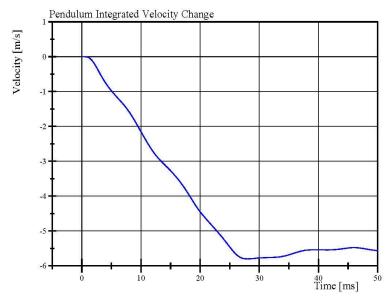
Filter Class: CFC\_180 Max: 0.0 m/s at 0.3 ms Min: -5.8 m/s at 28.0 ms

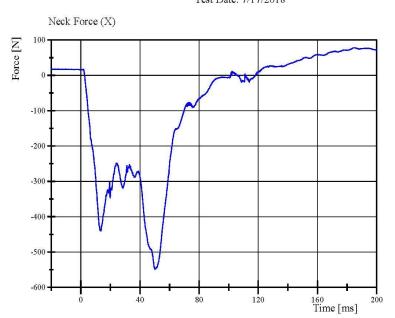
Filter Class: CFC\_1000 Max: 77.8 N at 184.8 ms Min: -548.6 N at 50.3 ms

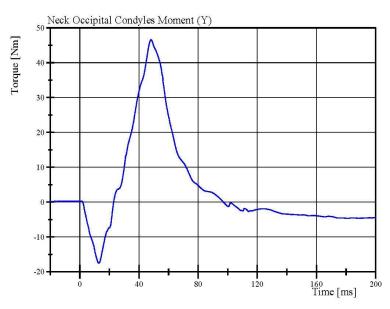
Filter Class: CFC\_600 Max: 46.6 Nm at 48.1 ms Min: -17.5 Nm at 12.8 ms

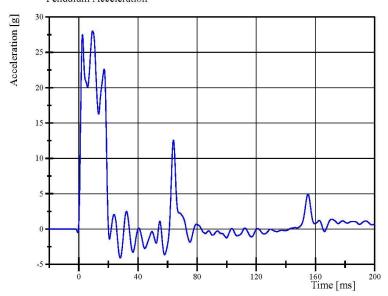
Filter Class: CFC\_180 Max: 28.0 g at 9.3 ms Min: -4.1 g at 28.1 ms

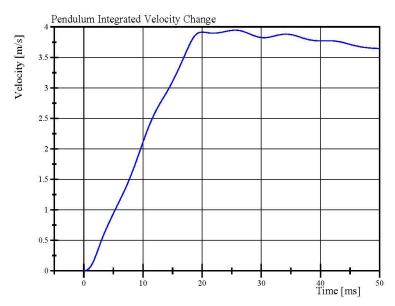
Filter Class: CFC\_180 Max: 3.9 m/s at 25.6 ms Min: 0.0 m/s at 0.0 ms

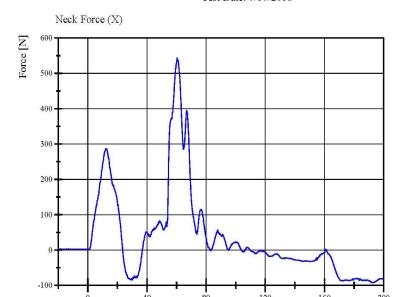
Filter Class: CFC\_1000 Max: 543.1 N at 60.5 ms Min: -92.4 N at 192.2 ms

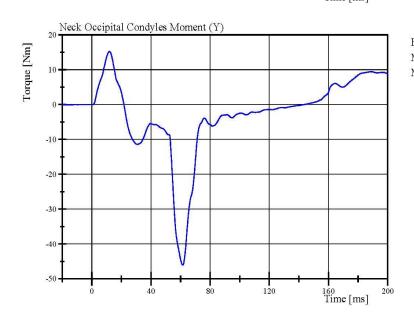
Filter Class: CFC\_600 Max: 15.3 Nm at 11.9 ms Min: -46.0 Nm at 61.6 ms
