REPORT NUMBER: TWG-CAL-18-02

**NEW CAR ASSESSMENT PROGRAM (NCAP)**  
SIDE AIRBAG OUT-OF-POSITION INJURY TESTING

**Toyota Motor Corporation**  
**2018 Toyota Prius C**

NHTSA NUMBER: M20185107TWG2  
CALSPAN TEST NUMBER: CT2018-02

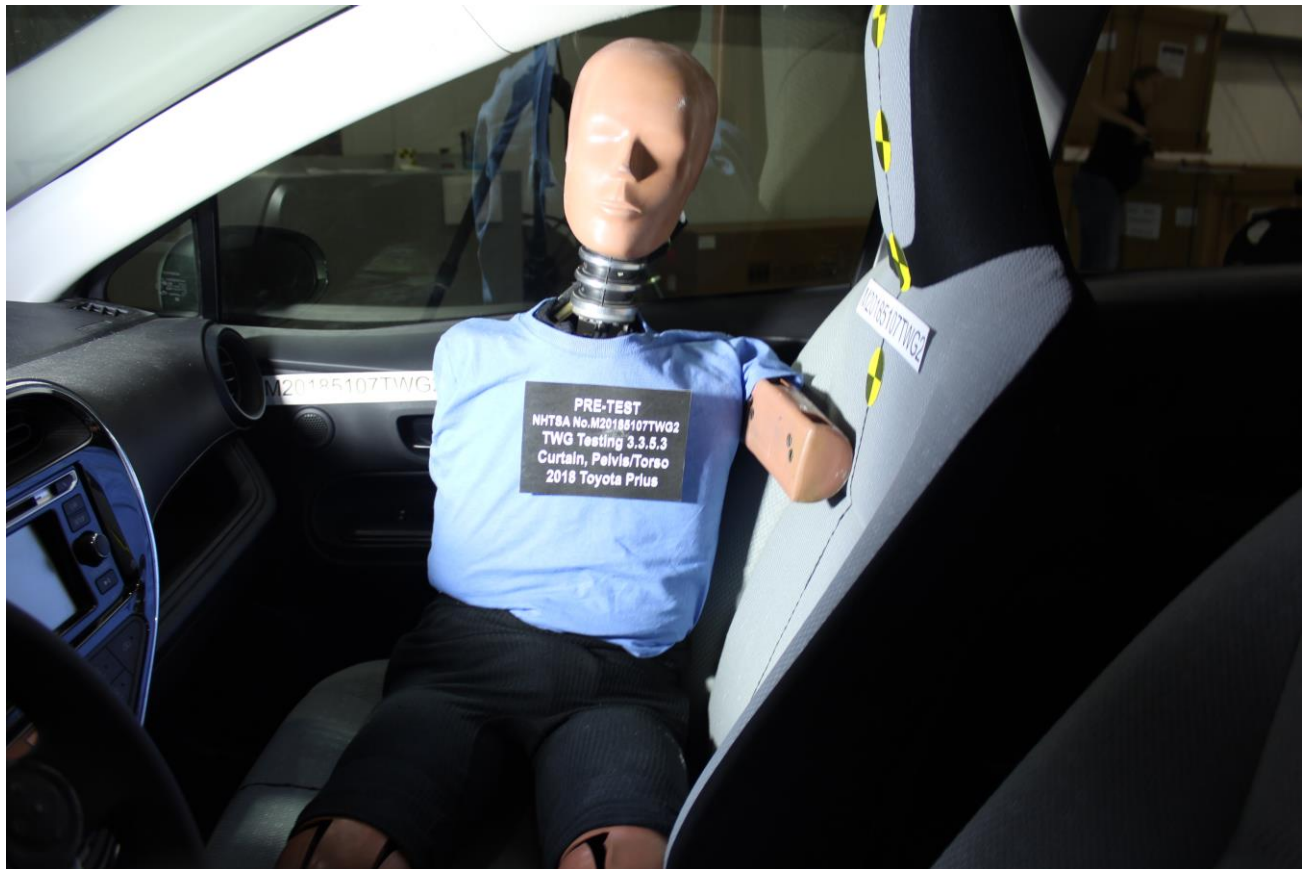
**Figure A-3: Pre-Test SID-IIs Left Side View**

The SID-IIs anthropomorphic test device (ATD) was placed in the right front (passenger) seat facing toward the center of the vehicle with its arm against the seatback according to the ATD placement instructions specified by Alpha Technology Associate, Inc. who referenced the Recommended Procedures for Evaluating Occupant Injury Risk from Deploying Side Airbags as prepared by the Side Airbag Out-of-Position Injury Technical Working Group (TWG). This orientation complies with section 3.3.5.3 of the TWG Recommended Procedures for Evaluating Occupant Injury Risk from Deploying Side Airbags as defined by Lund, et al and the Technical Working Group First Revision dated July, 2003.

<b>Head Contact:</b>	None
<b>Upper Torso Contact:</b>	Seatback, Passenger Door
<b>Lower Torso Contact:</b>	Seatback
<b>Knee Contact:</b>	Passenger Seatpan
<b>Foot Contact:</b>	Driver Seatpan

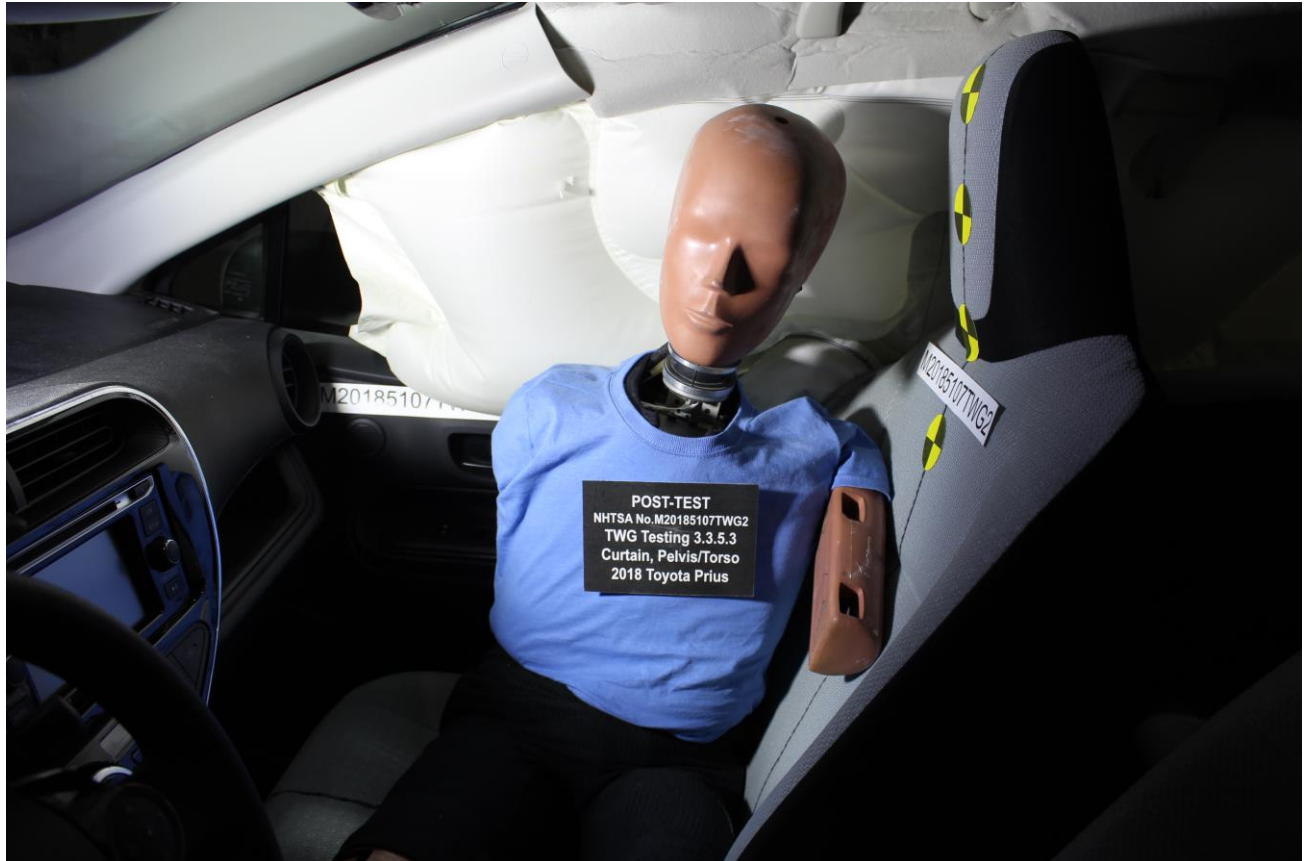
**Figure A-4: Post-Test SID-IIs Left Side View**

<b>Head Contact:</b>	Curtain Air Bag
<b>Upper Torso Contact:</b>	Torso Air Bag, Seatback
<b>Lower Torso Contact:</b>	Torso Air Bag, Seatback
<b>Knee Contact:</b>	Passenger Seatpan
<b>Foot Contact:</b>	Driver Seatpan

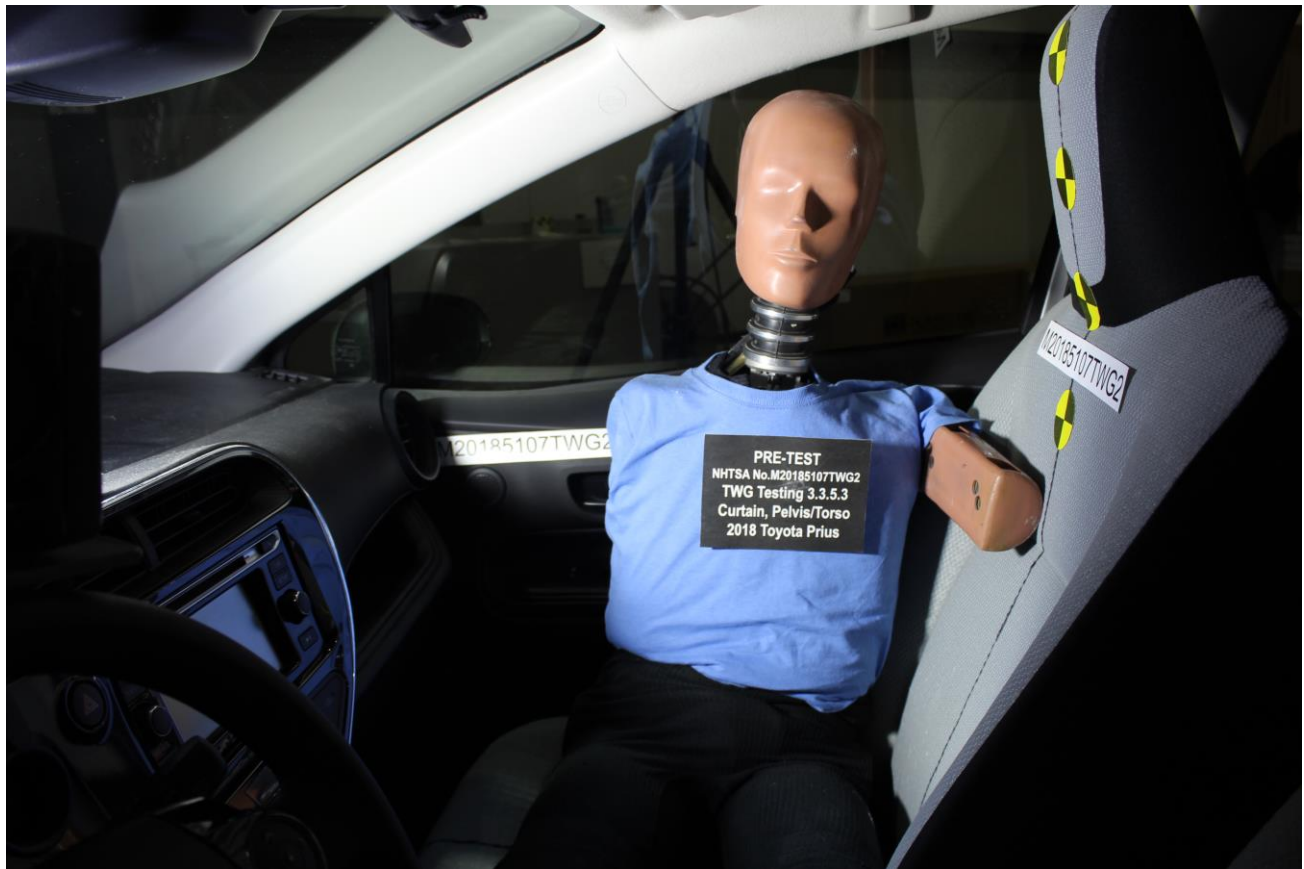
**Figure A-5: Pre-Test SID-IIs Left Side Close-up View**

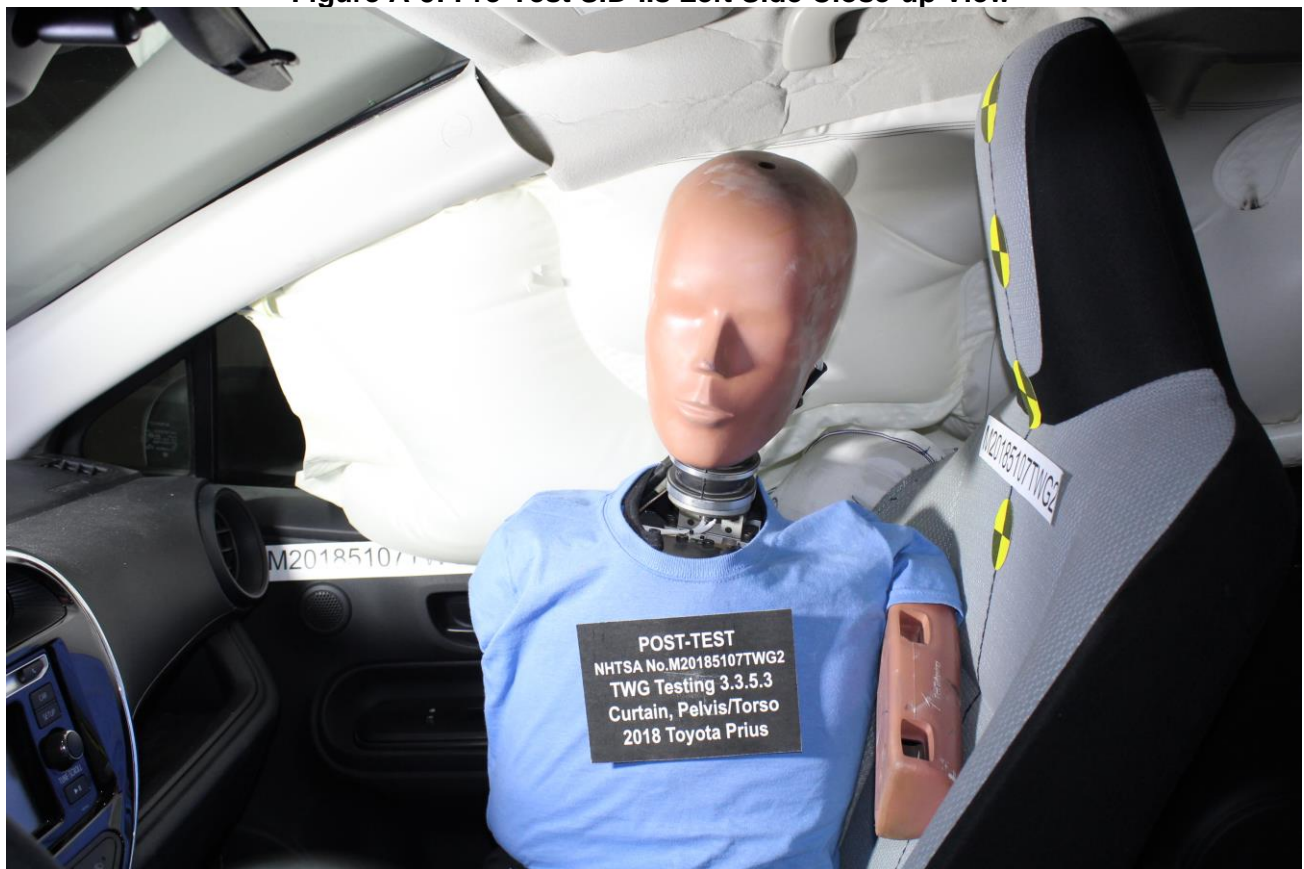
**Figure A-6: Post-Test SID-IIs Left Side Close-up View**

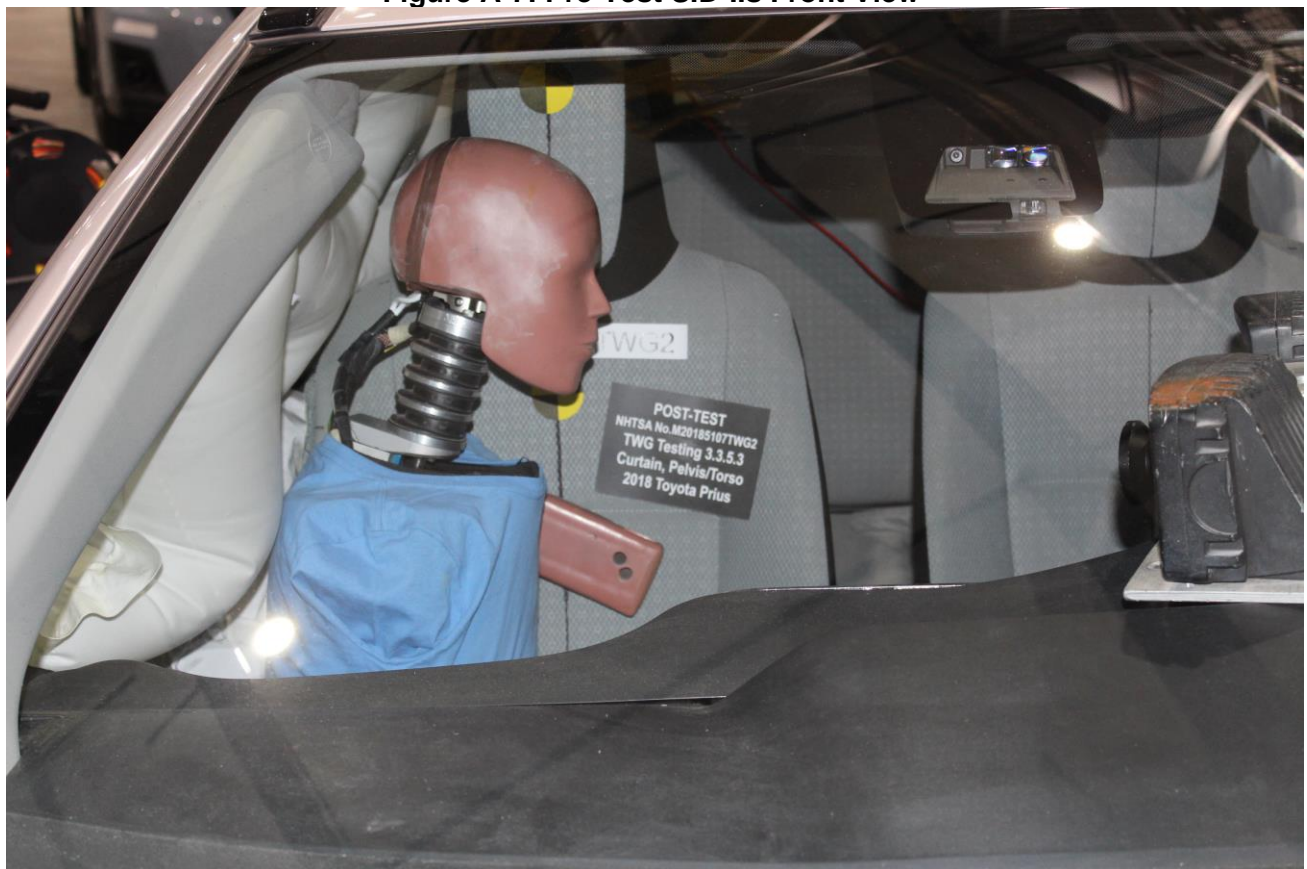
**Figure A-8: Post-Test SID-III Front View**

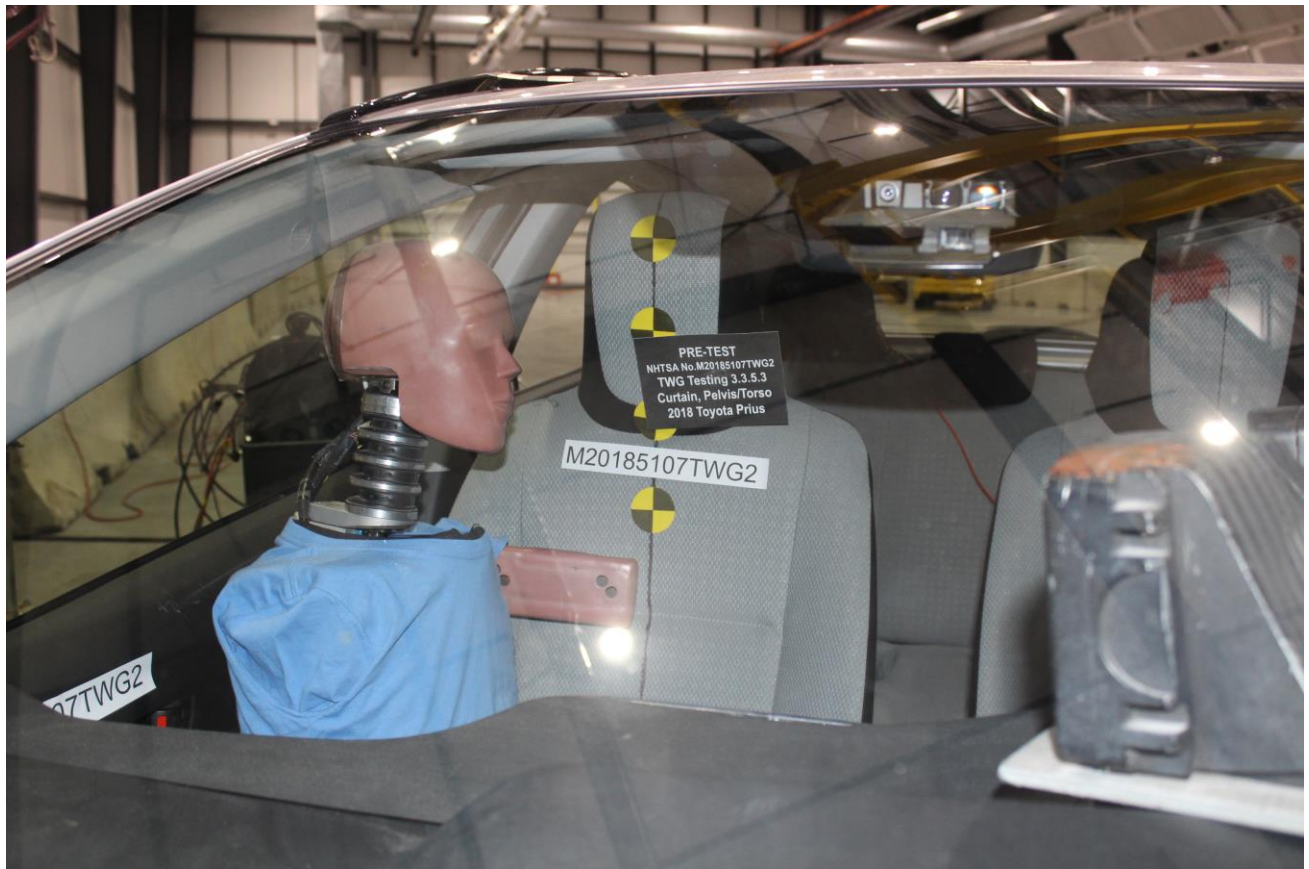
**Figure A-9: Pre-Test SID-IIs Left  $\frac{3}{4}$  Front View**

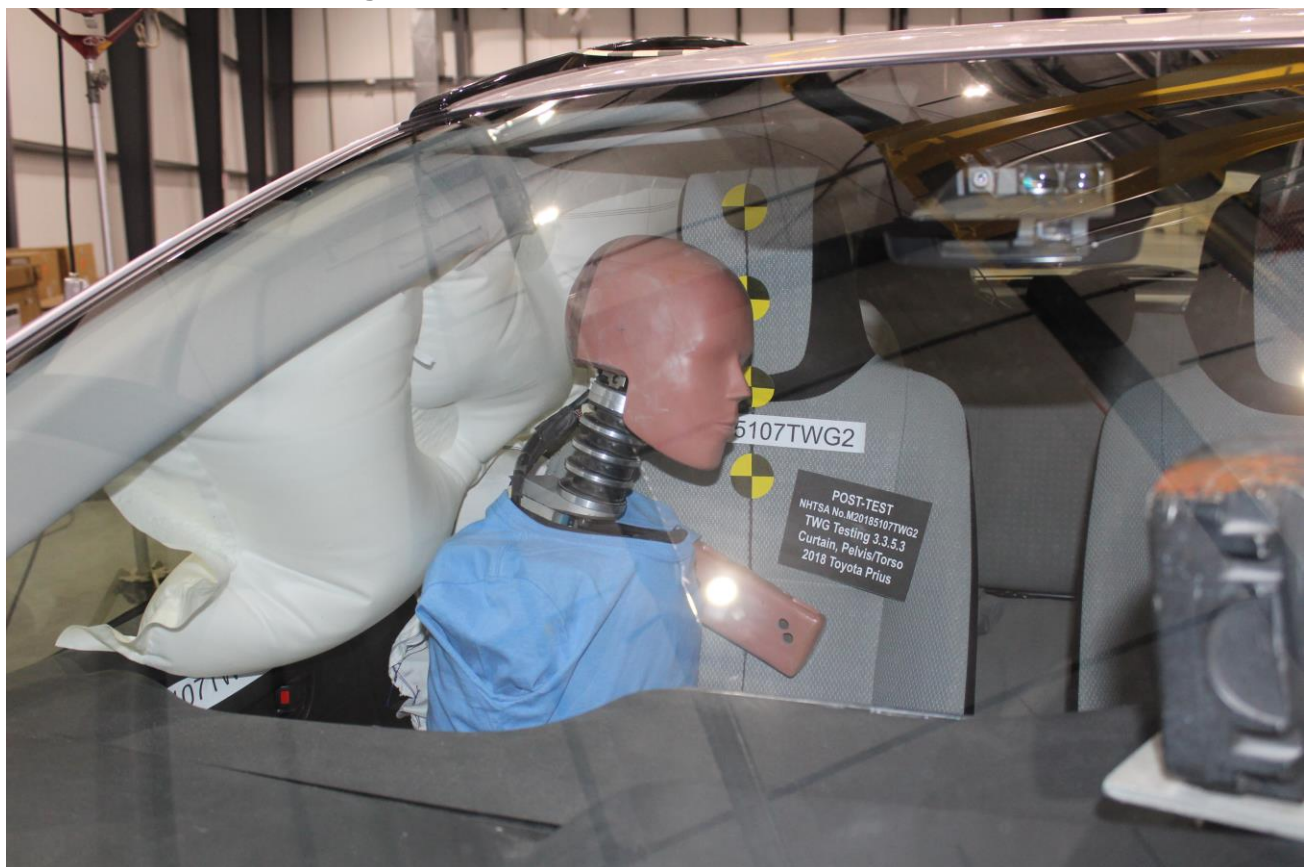
**Figure A-10: Post-Test SID-IIs Left  $\frac{3}{4}$  Front View**

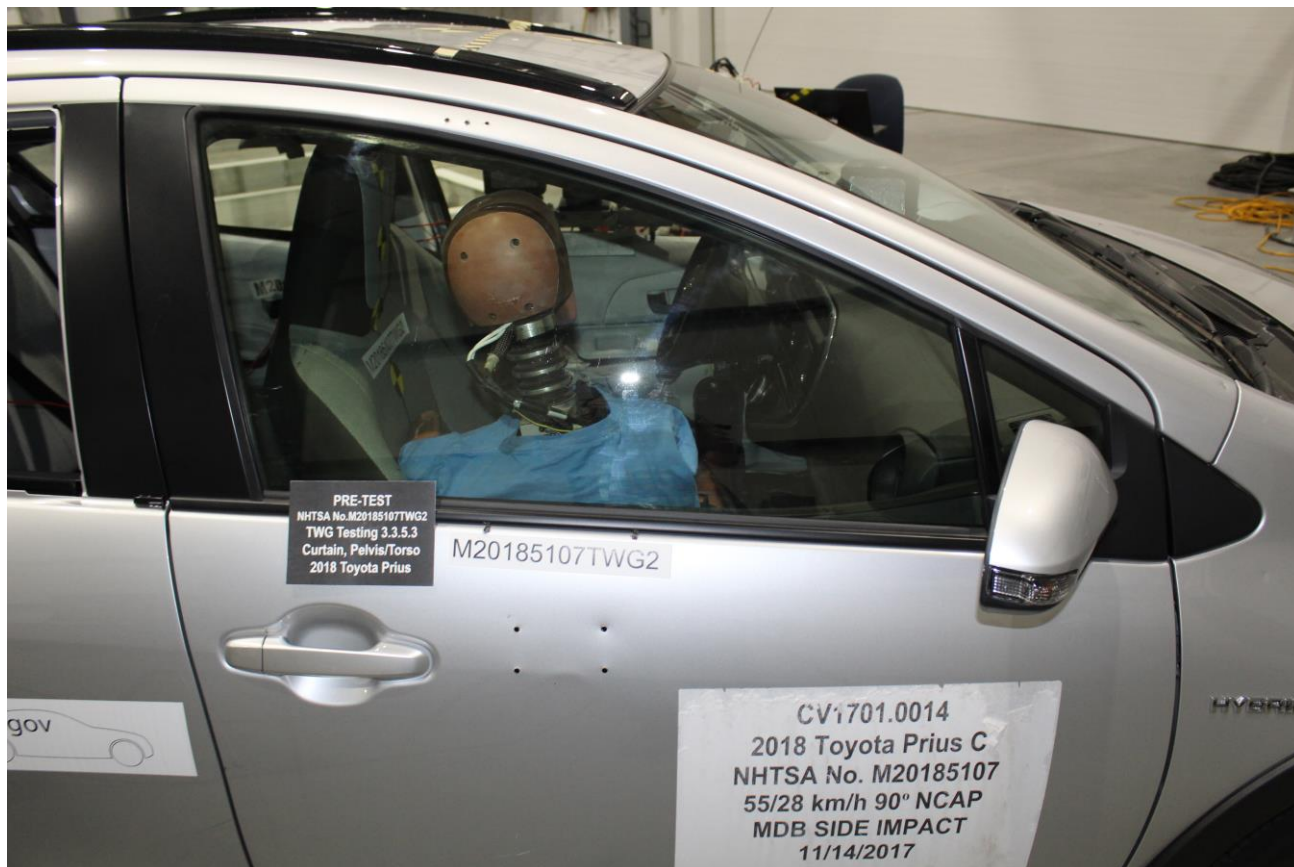
**Figure A-11: Pre-Test SID-IIs Right Side View**

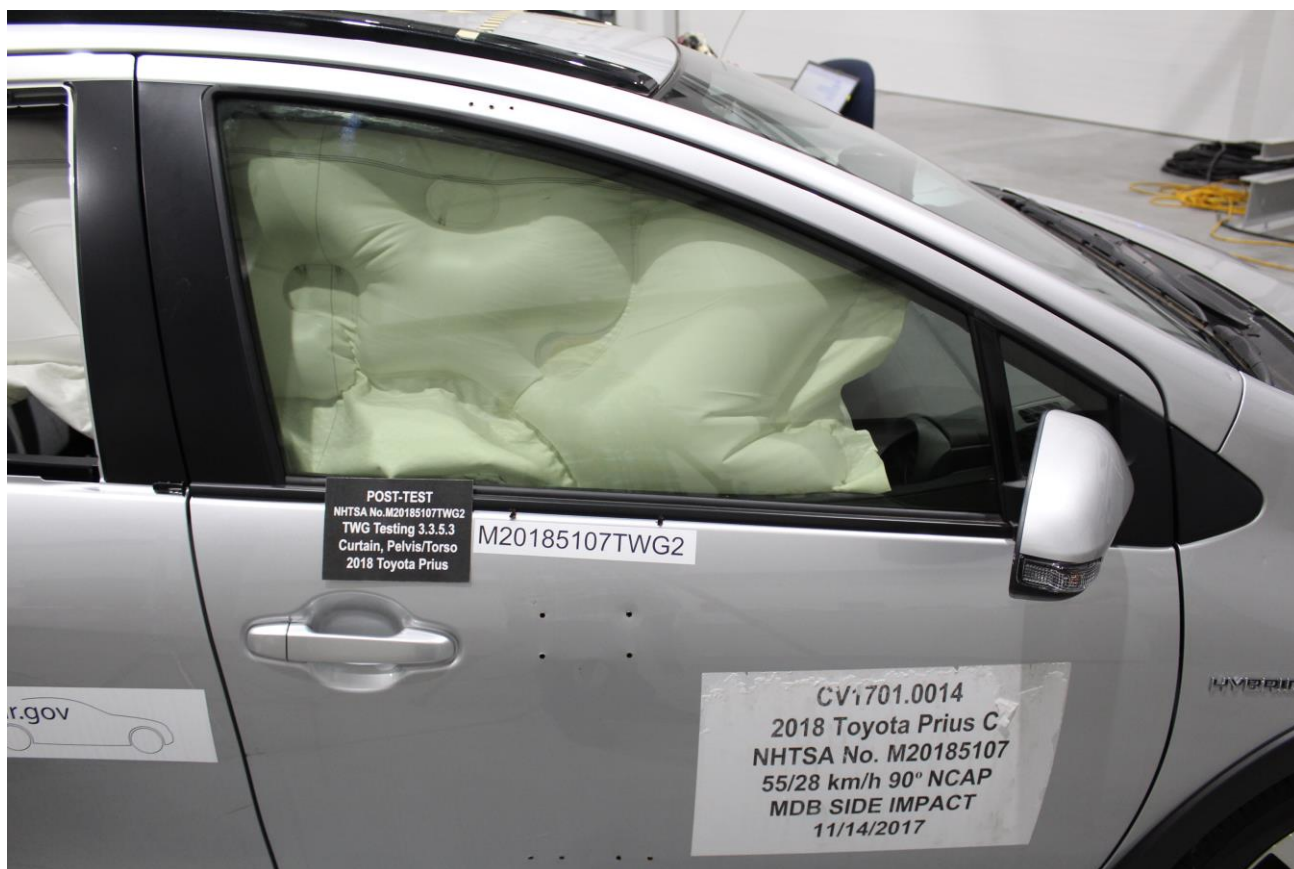
**Figure A-12: Post-Test SID-IIs Right Side View**

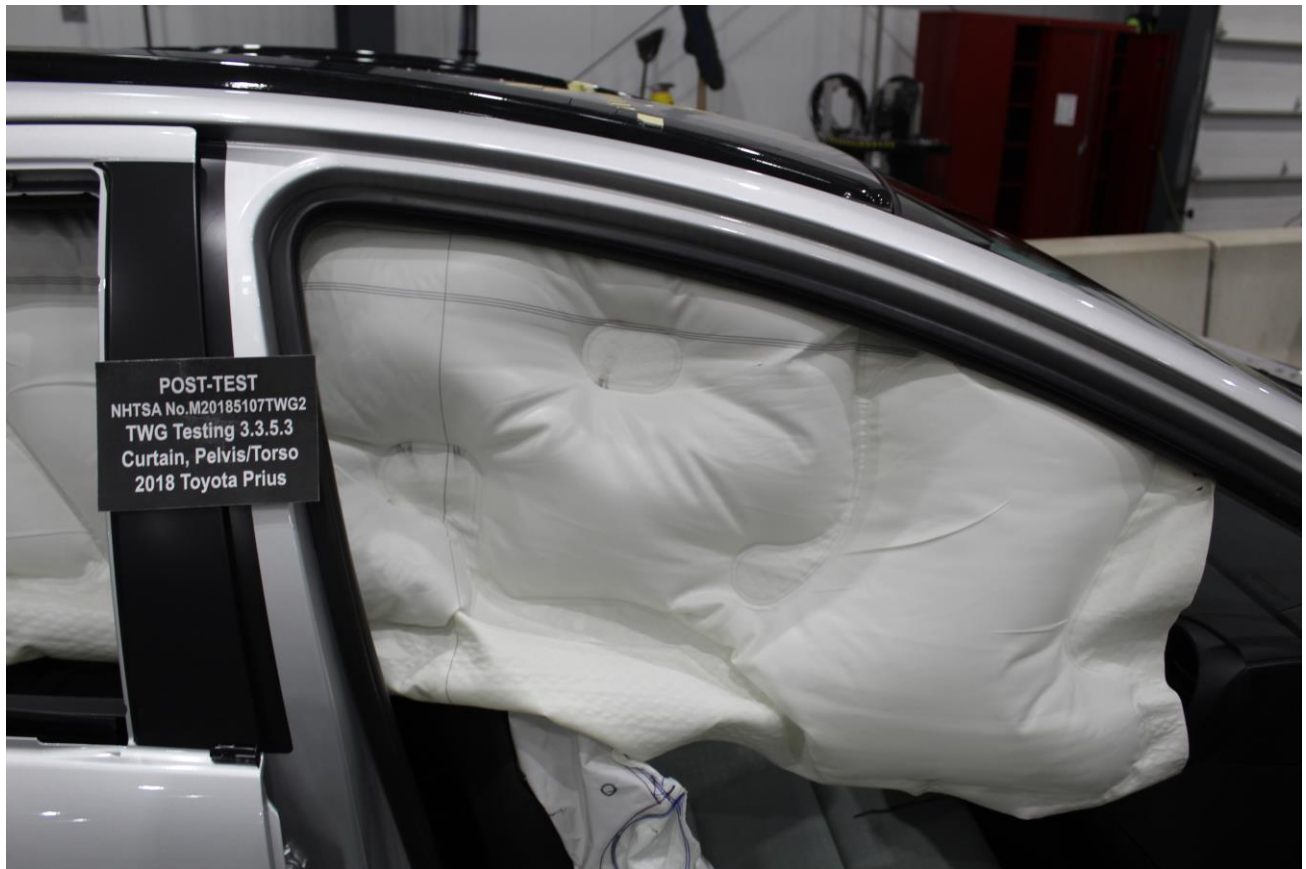
**Figure A-13: Post-Test Curtain Airbag View**

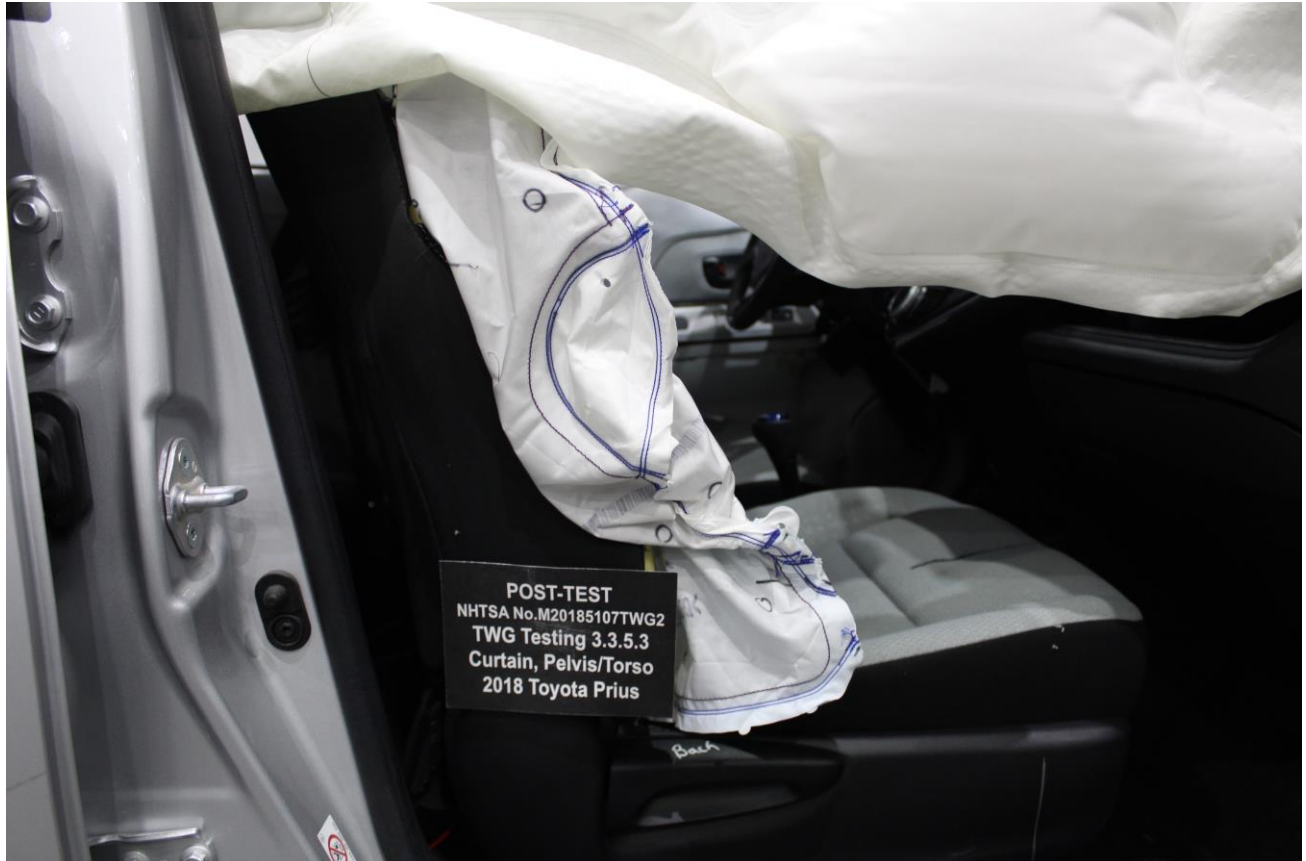
**Figure A-14: Post-Test Seat Airbag View**

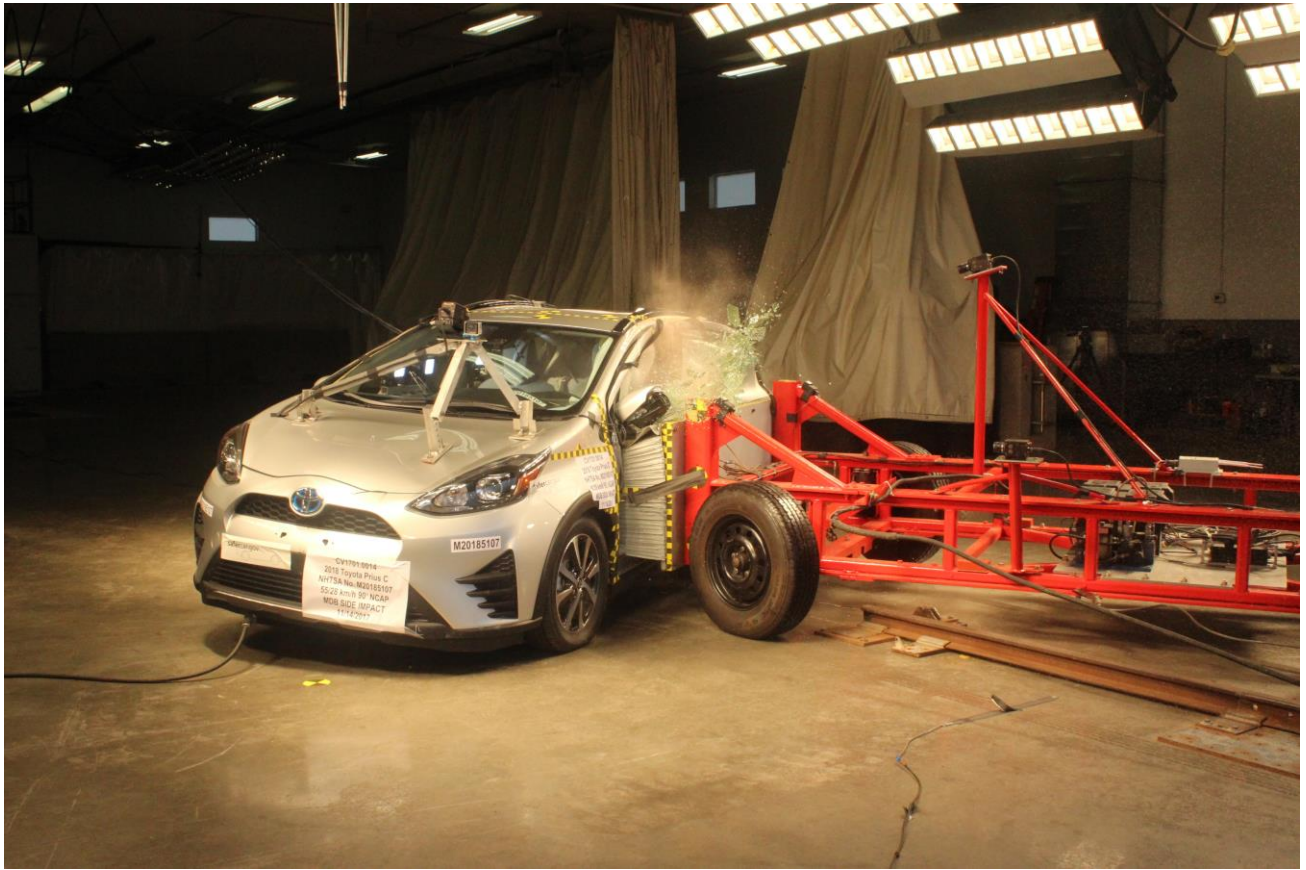
**Figure A-15: Impact Event**

Three high-speed digital cameras were used to document the side airbag deployment event. Images were recorded at rates of 1000 frames per second. The cameras were placed perpendicular to the right-front passenger seat centerline, Oblique, and through the passenger window to capture the deployment event from various positions.
