REPORT NUMBER: TWG-MGA-2018-005

**SIDE AIRBAG OUT-OF-POSITION INJURY
TECHNICAL WORKING GROUP**

**TOYOTA MOTOR CORPORATION
2018 Toyota Camry LE 4-Door Sedan
NHTSA No.: M20185102TWG2**

FINAL REPORT

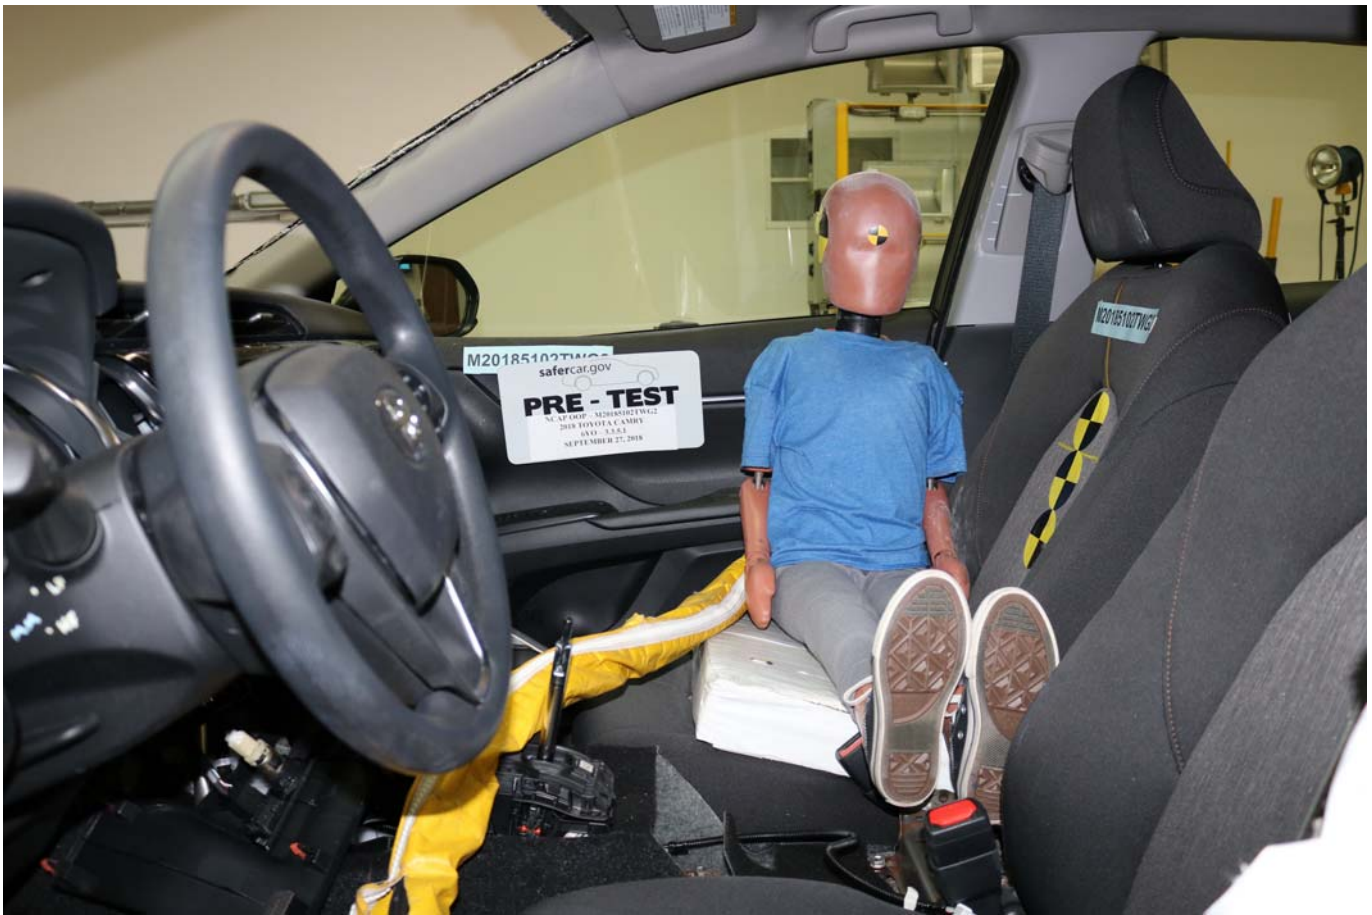
Photo No. 005 - Pre-Test 6-Year-Old Child Dummy Left Side View

The Hybrid III 6-Year-Old child dummy was placed in the right front passenger seat along the outboard edge of the foam block, facing inboard with its legs extended and arms hanging at its sides. The seat track was positioned forward to maximize the cushion to head interaction. The dummy's pelvis was slid outboard until the dummy's back contacted the door trim panel or armrest and the center of gravity of the head was centered in the deployment trajectory of the airbag. The head remained in its neutral orientation. A vertical plane through the centerline of the dummy's shoulder bolts was parallel to the vehicle centerline. The dummy's arms were bent at the elbow until the fingertips contacted the foam block.

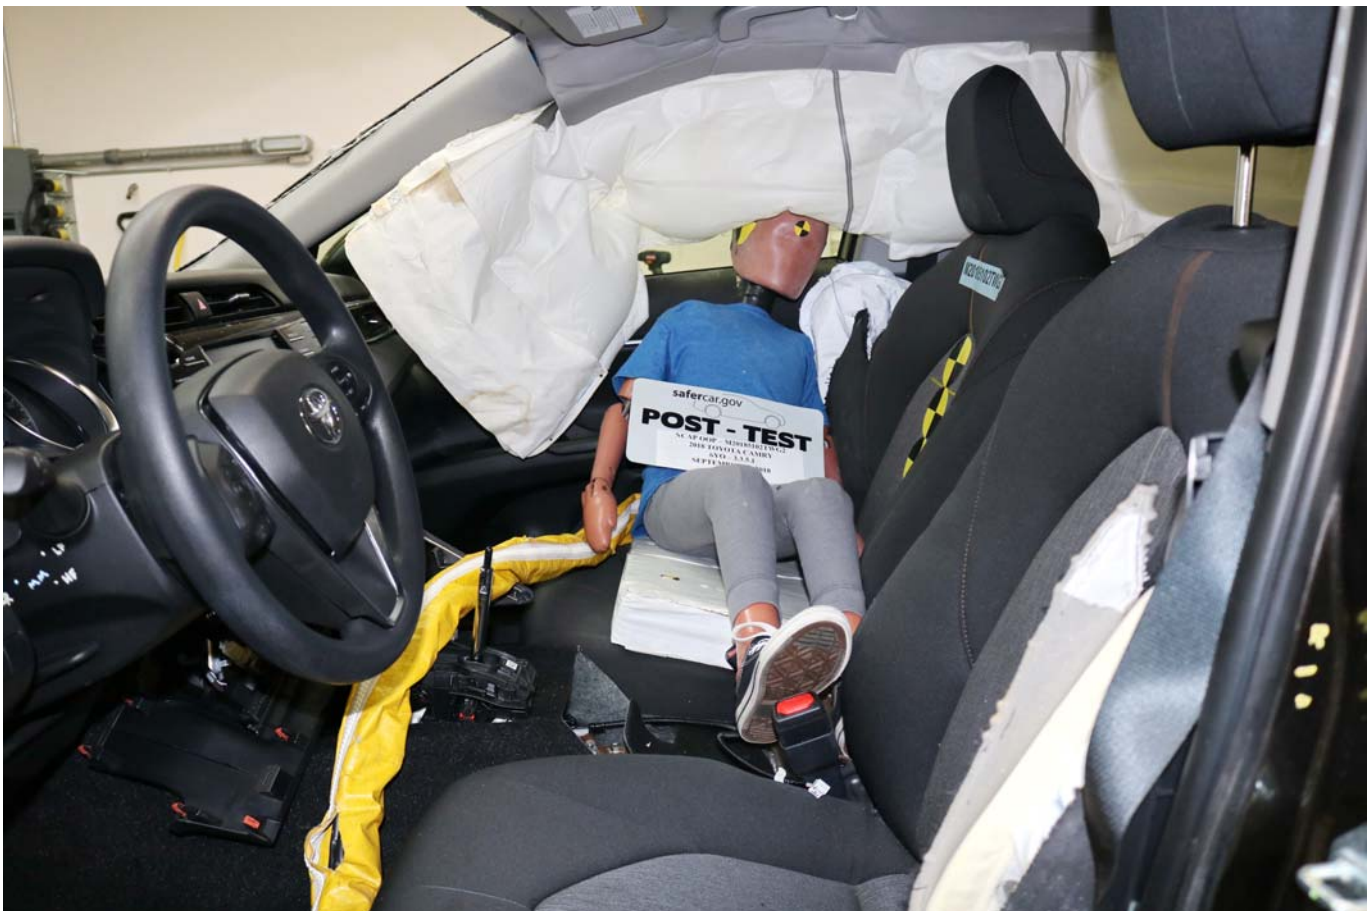
Photo No. 006 - Post-Test 6-Year-Old Child Dummy Left Side View

- Side curtain airbag to top of head
- Side torso/pelvis airbag to left side of torso and pelvis

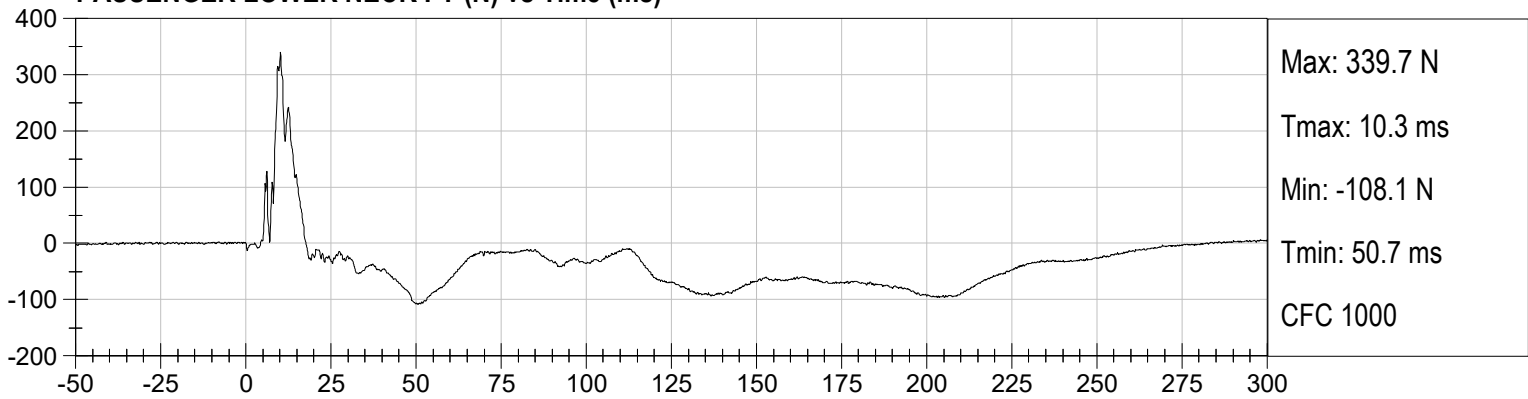
PASSENGER LOWER NECK FZ (N) vs Time (ms)
