REPORT NUMBER: TWG-CAL-18-04

**NEW CAR ASSESSMENT PROGRAM (NCAP)**  
SIDE AIRBAG OUT-OF-POSITION INJURY TESTING

**Ford Motor Co.**  
**2018 Ford EcoSport**

NHTSA NUMBER: M20180202TWG3  
CALSPAN TEST NUMBER: CT2018-04

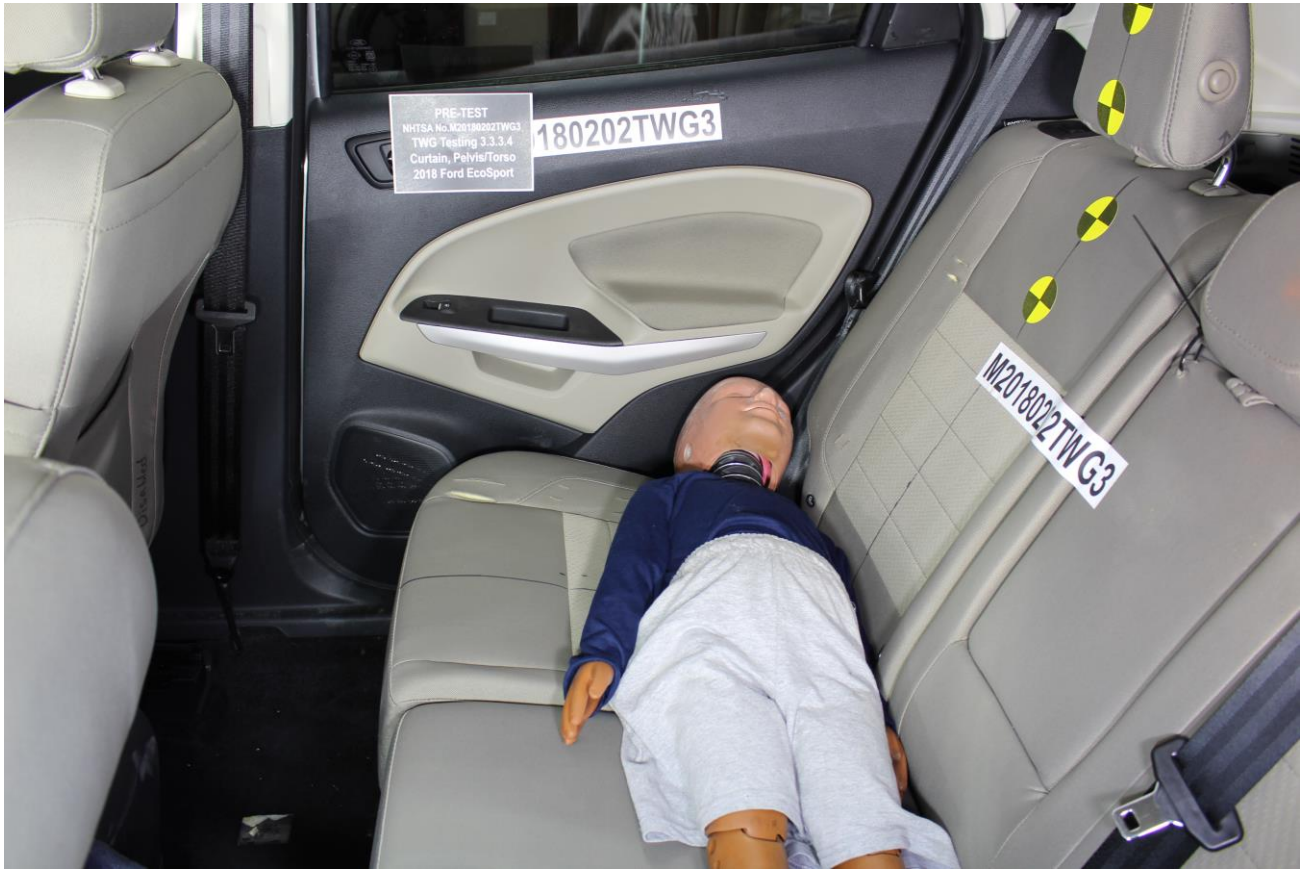
**Figure A-3: Pre-Test 3-Year-Old Left Side View**

The 3-Year-Old anthropomorphic test device (ATD) was placed in the right rear (passenger) seat laying with its back on the seatpan and its arm against the seatback according to the ATD placement instructions specified by Alpha Technology Associate, Inc. who referenced the Recommended Procedures for Evaluating Occupant Injury Risk from Deploying Side Airbags as prepared by the Side Airbag Out-of-Position Injury Technical Working Group (TWG). This orientation complies with section 3.3.3.4 of the TWG Recommended Procedures for Evaluating Occupant Injury Risk from Deploying Side Airbags as defined by Lund, et al and the Technical Working Group First Revision dated July, 2003.

<b>Head Contact:</b>	Seatpan
<b>Upper Torso Contact:</b>	Seatpan & Seatback
<b>Lower Torso Contact:</b>	Seatpan & Seatback
<b>Knee Contact:</b>	Seatpan
<b>Foot Contact:</b>	Seatpan

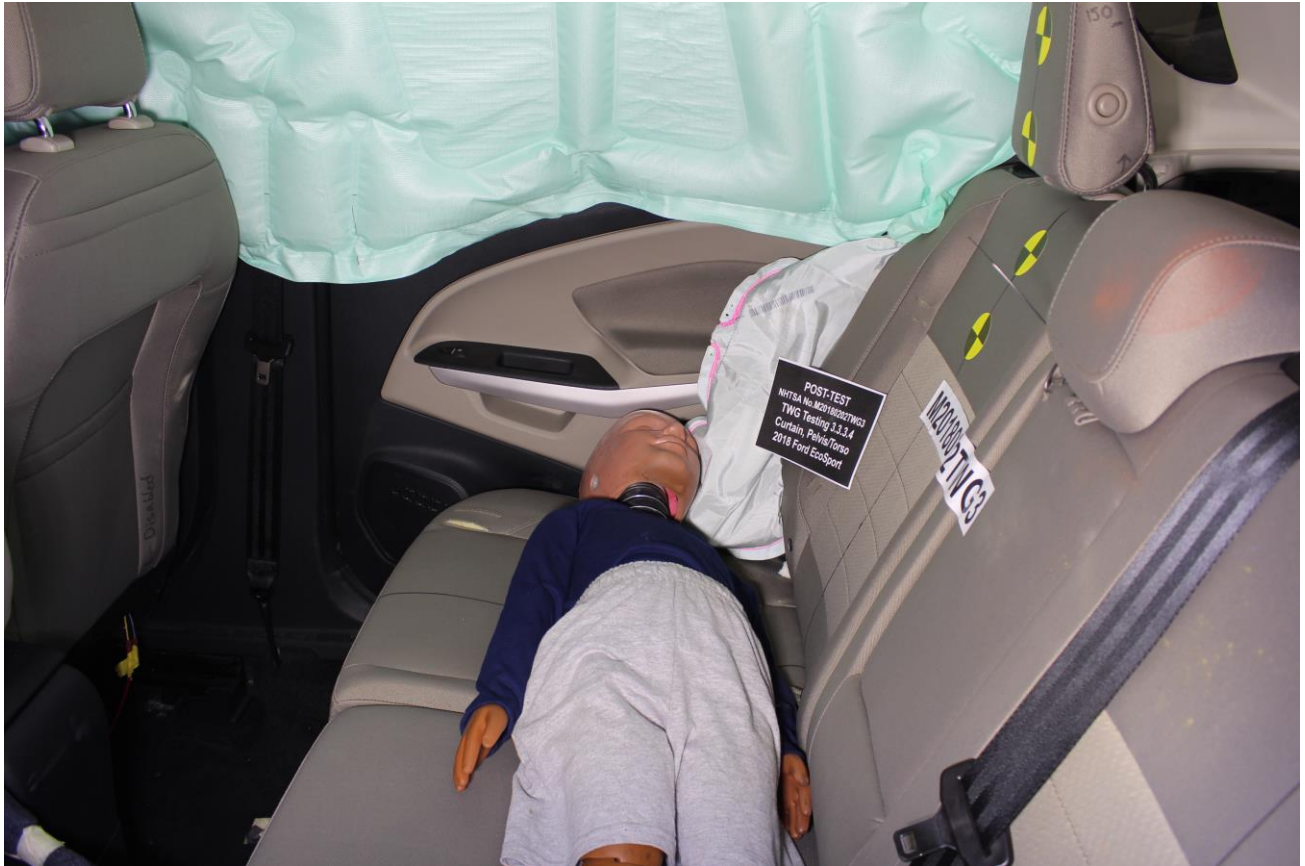
**Figure A-4: Post-Test 3-Year-Old Left Side View**

<b>Head Contact:</b>	Torso Airbag & Seatpan
<b>Upper Torso Contact:</b>	Seatpan
<b>Lower Torso Contact:</b>	Seatpan
<b>Knee Contact:</b>	Seatpan
<b>Foot Contact:</b>	Seatpan

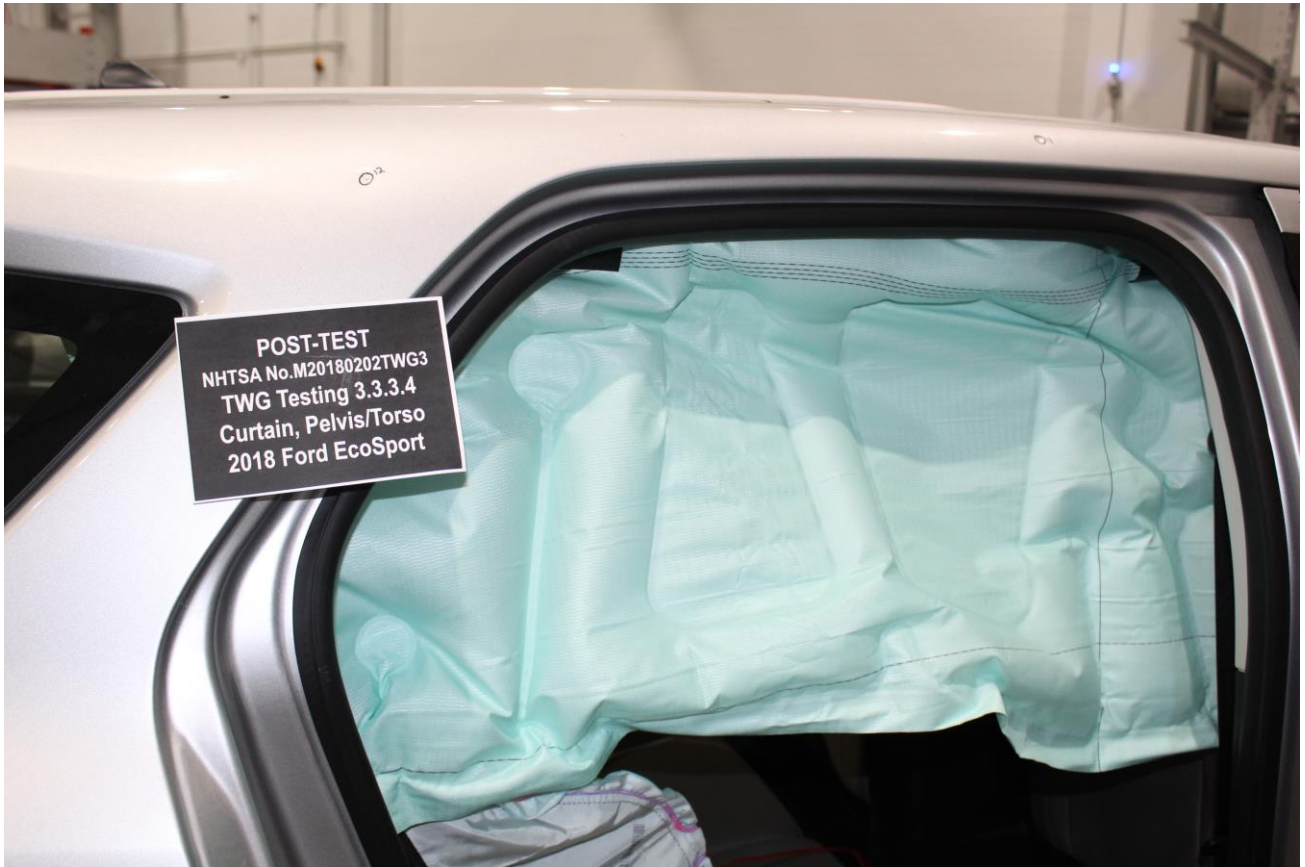
**Figure A-13: Post-Test Curtain Airbag View**

<b>Seating Position:</b>	P3	Right Rear Seating Position
<b>Test:</b>	3.3.3.4	Roof Rail Mounted – HIII 3YO Lying On Seat
<b>Airbag: 1</b>	Curtain	Roof Rail Mounted – Passenger Side
<b>Airbag: 2</b>	Seat/Torso	Rear Passenger Seat Mounted – Outside Seam
<b>Booster Block:</b>	N/A	N/A
<b>ATD Type/Serial No.:</b>	139	3-Year-Old
