**OCAS-DRI-LDW-19-06  
NEW CAR ASSESSMENT PROGRAM  
LANE DEPARTURE WARNING CONFIRMATION TEST**

**2018 Tesla Model 3**

**DYNAMIC RESEARCH, INC.**  
355 Van Ness Avenue, STE 200  
Torrance, California 90501

**Final Report**

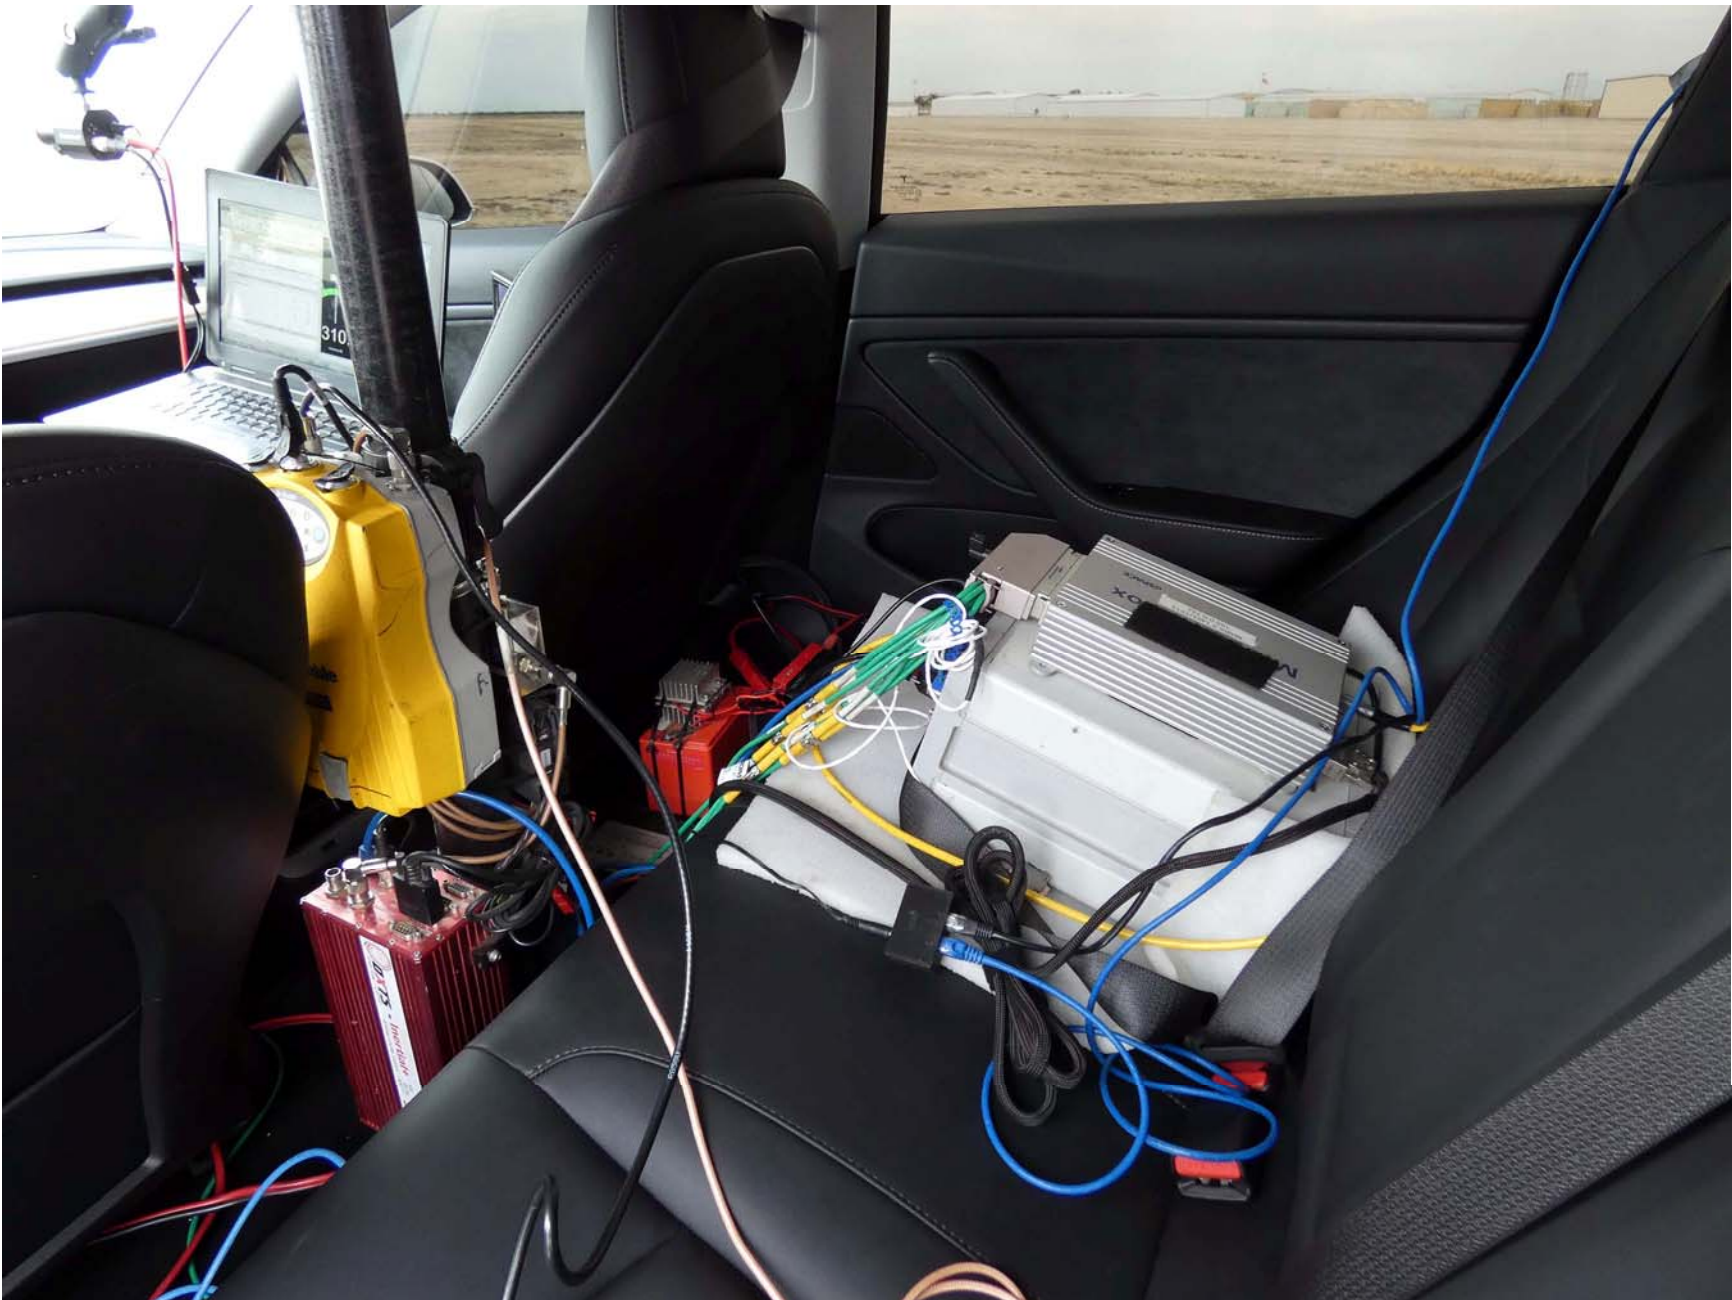
Figure A6. DGPS, Inertial Measurement Unit and MicroAutoBox Installed in Subject Vehicle

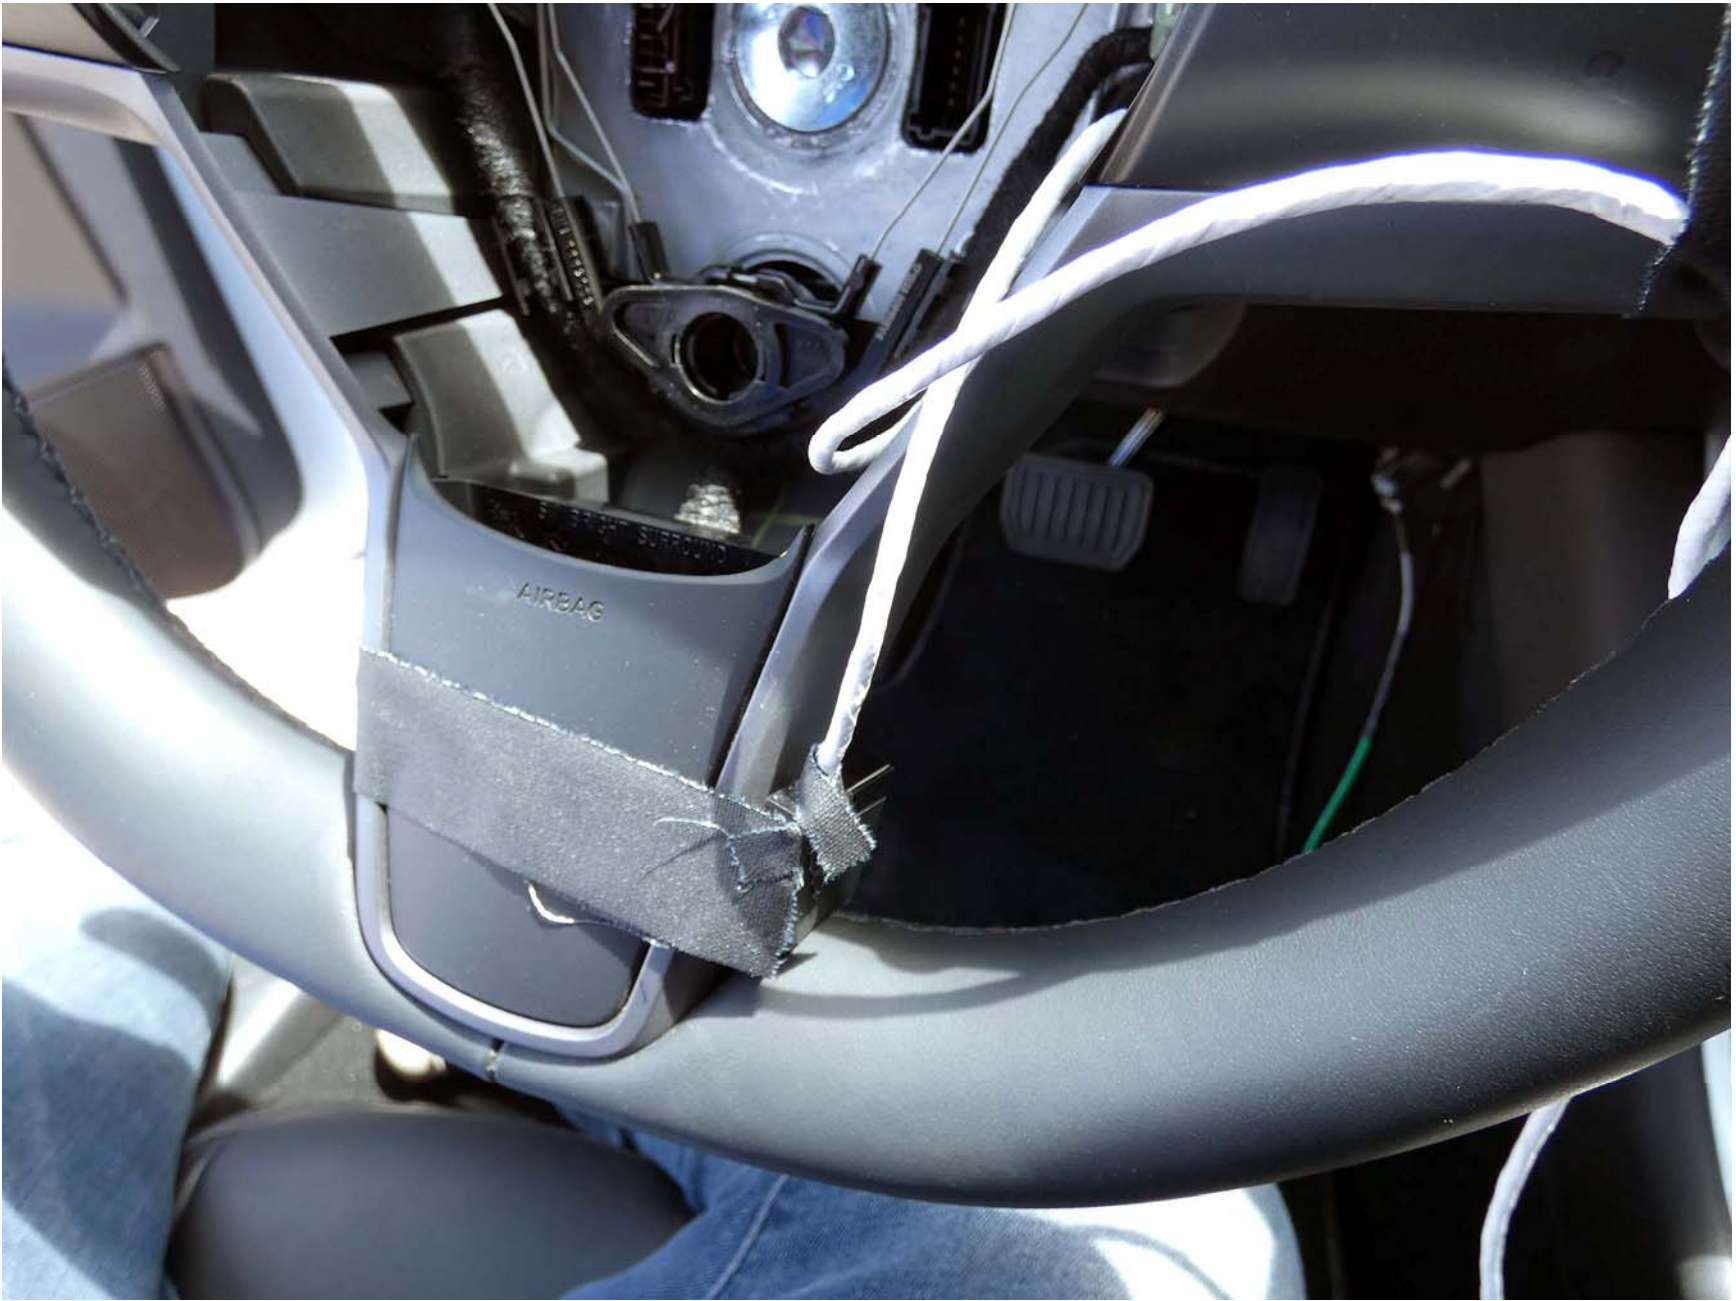
Figure A8. Sensor for Detecting Haptic Alerts

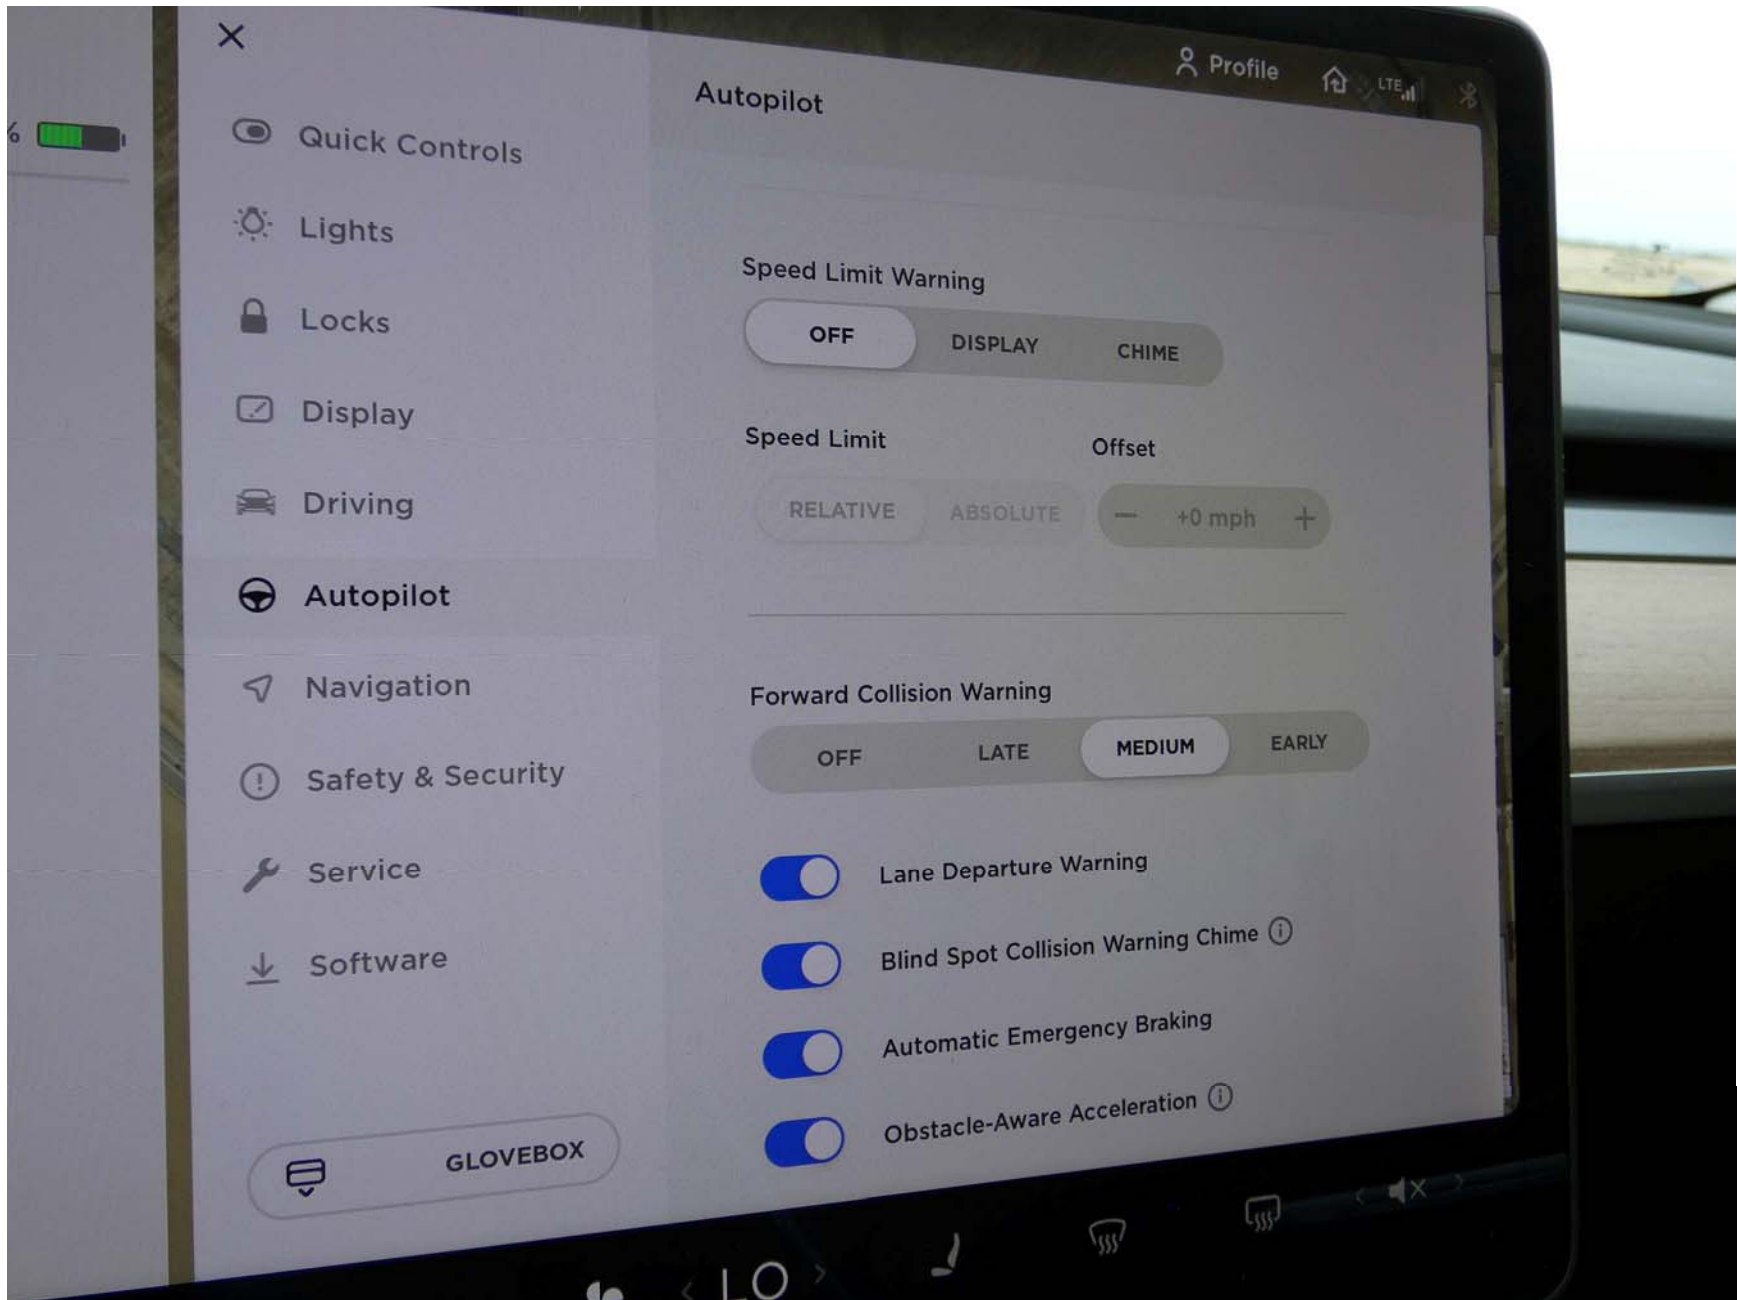
Figure A9. LDW On/Off Menu

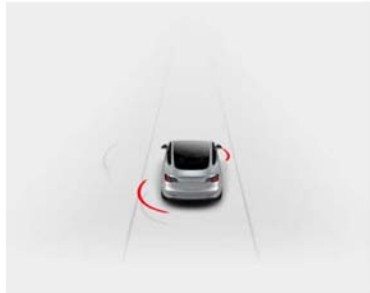
When an object is detected in your blind spot or close to the side of Model 3 (such as a vehicle, guard rail, etc.), colored lines radiate from the image of Model 3 on the touchscreen. The location of the lines correspond to the location of the detected object. The color of the lines (white, yellow, orange, or red) represents the object's proximity to Model 3, with white being the farthest and red being very close and requiring your immediate attention. These colored lines only display when driving between approximately 7 and 85 mph (12 and 140 km/h). When Autosteer is active, these colored lines also display if driving slower than 7 mph (12 km/h). However, the colored lines do not display if Model 3 is at a standstill (for example, in heavy traffic).

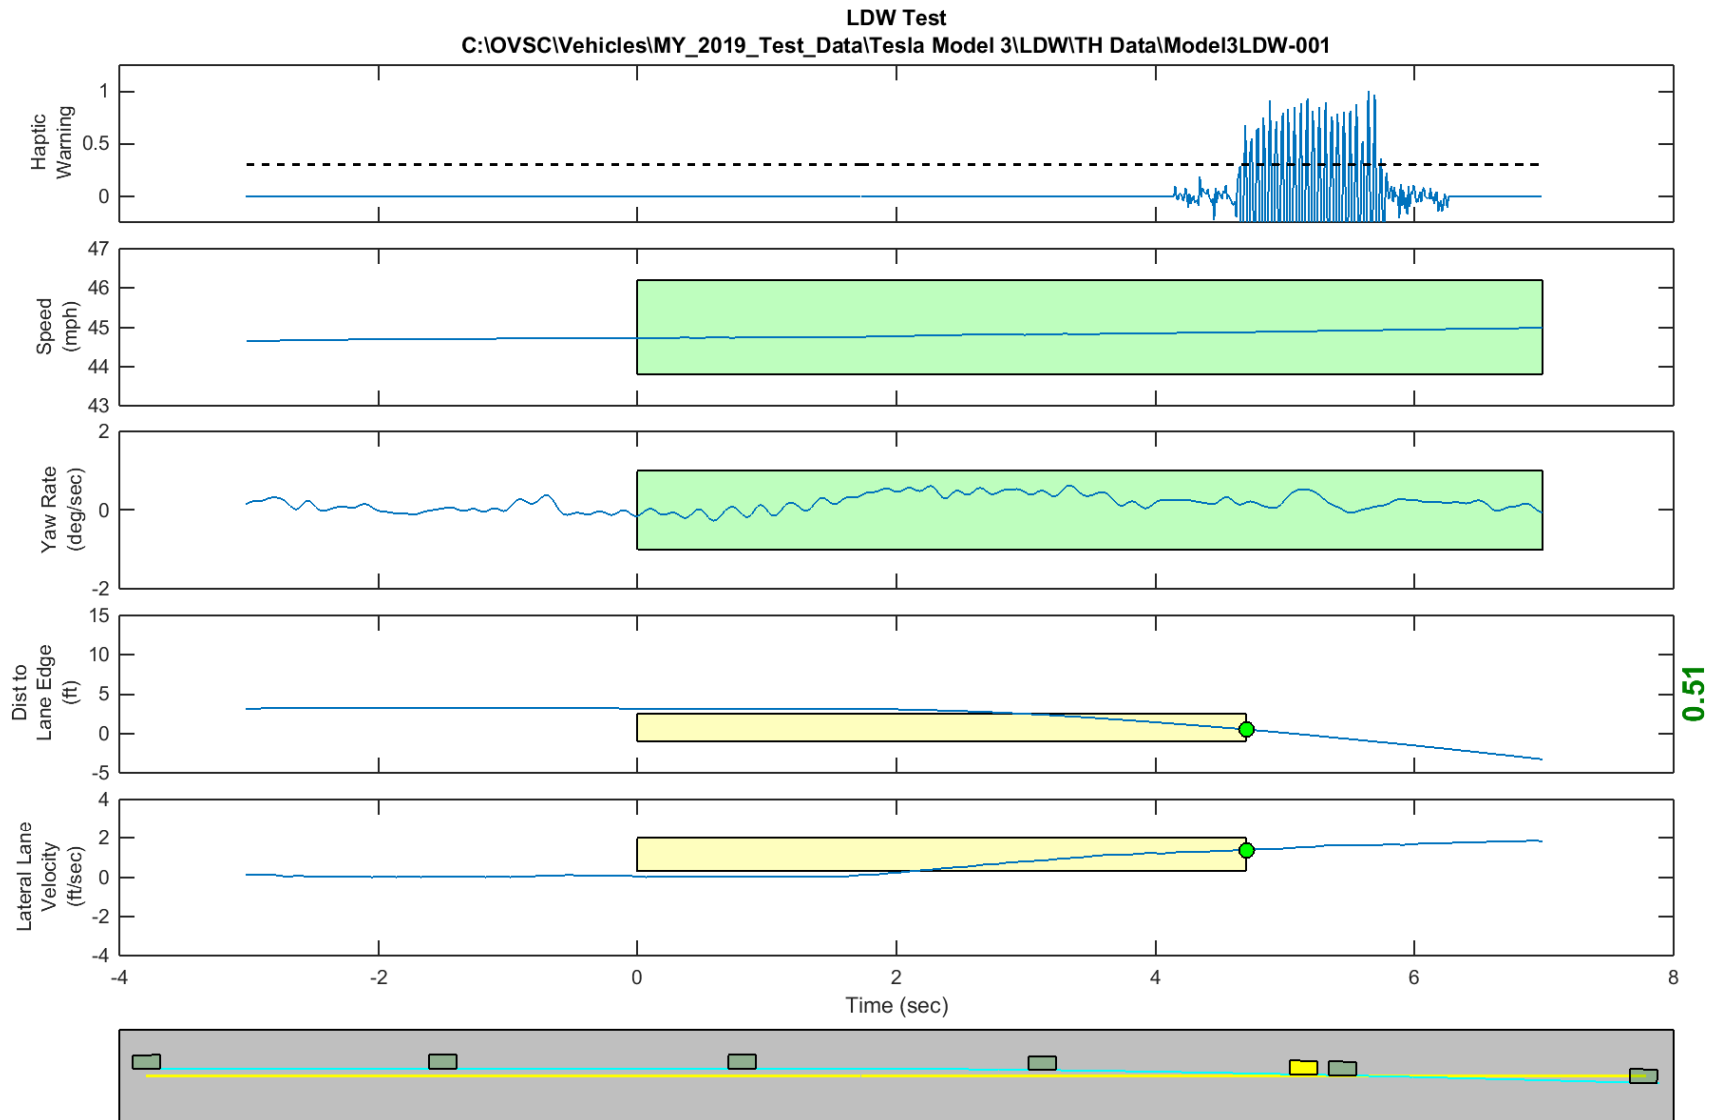
Figure D4. Time History for Run 1, Solid Line, Right Departure, Haptic Warning

Figure D5. Time History for Run 2, Solid Line, Right Departure, Haptic Warning

Figure D6. Time History for Run 3, Solid Line, Right Departure, Haptic Warning

Figure D7. Time History for Run 6, Solid Line, Right Departure, Haptic Warning

Figure D8. Time History for Run 7, Solid Line, Right Departure, Haptic Warning

Figure D9. Time History for Run 8, Solid Line, Right Departure, Haptic Warning

Figure D10. Time History for Run 9, Solid Line, Right Departure, Haptic Warning

Run	Lane Marking Type	Departure Direction	Valid Run?	Distance at Haptic Alert (ft)	Pass/Fail	Notes
1	Solid	Right	Y	0.51	Pass	
2			Y	0.55	Pass	
3			Y	0.60	Pass	
4			N			Speed, yaw rate
5			N			Yaw rate
6			Y	0.48	Pass	
7			Y	0.64	Pass	
8			Y	0.55	Pass	
9			Y	0.46	Pass	
10	Solid	Left	Y	-0.51	Pass	
11			N			Yaw rate
12			Y	-0.37	Pass	
13			Y	-0.41	Pass	
14			Y	-0.41	Pass	
15			Y	-0.46	Pass	
16			Y	-0.39	Pass	
17			Y	-0.34	Pass

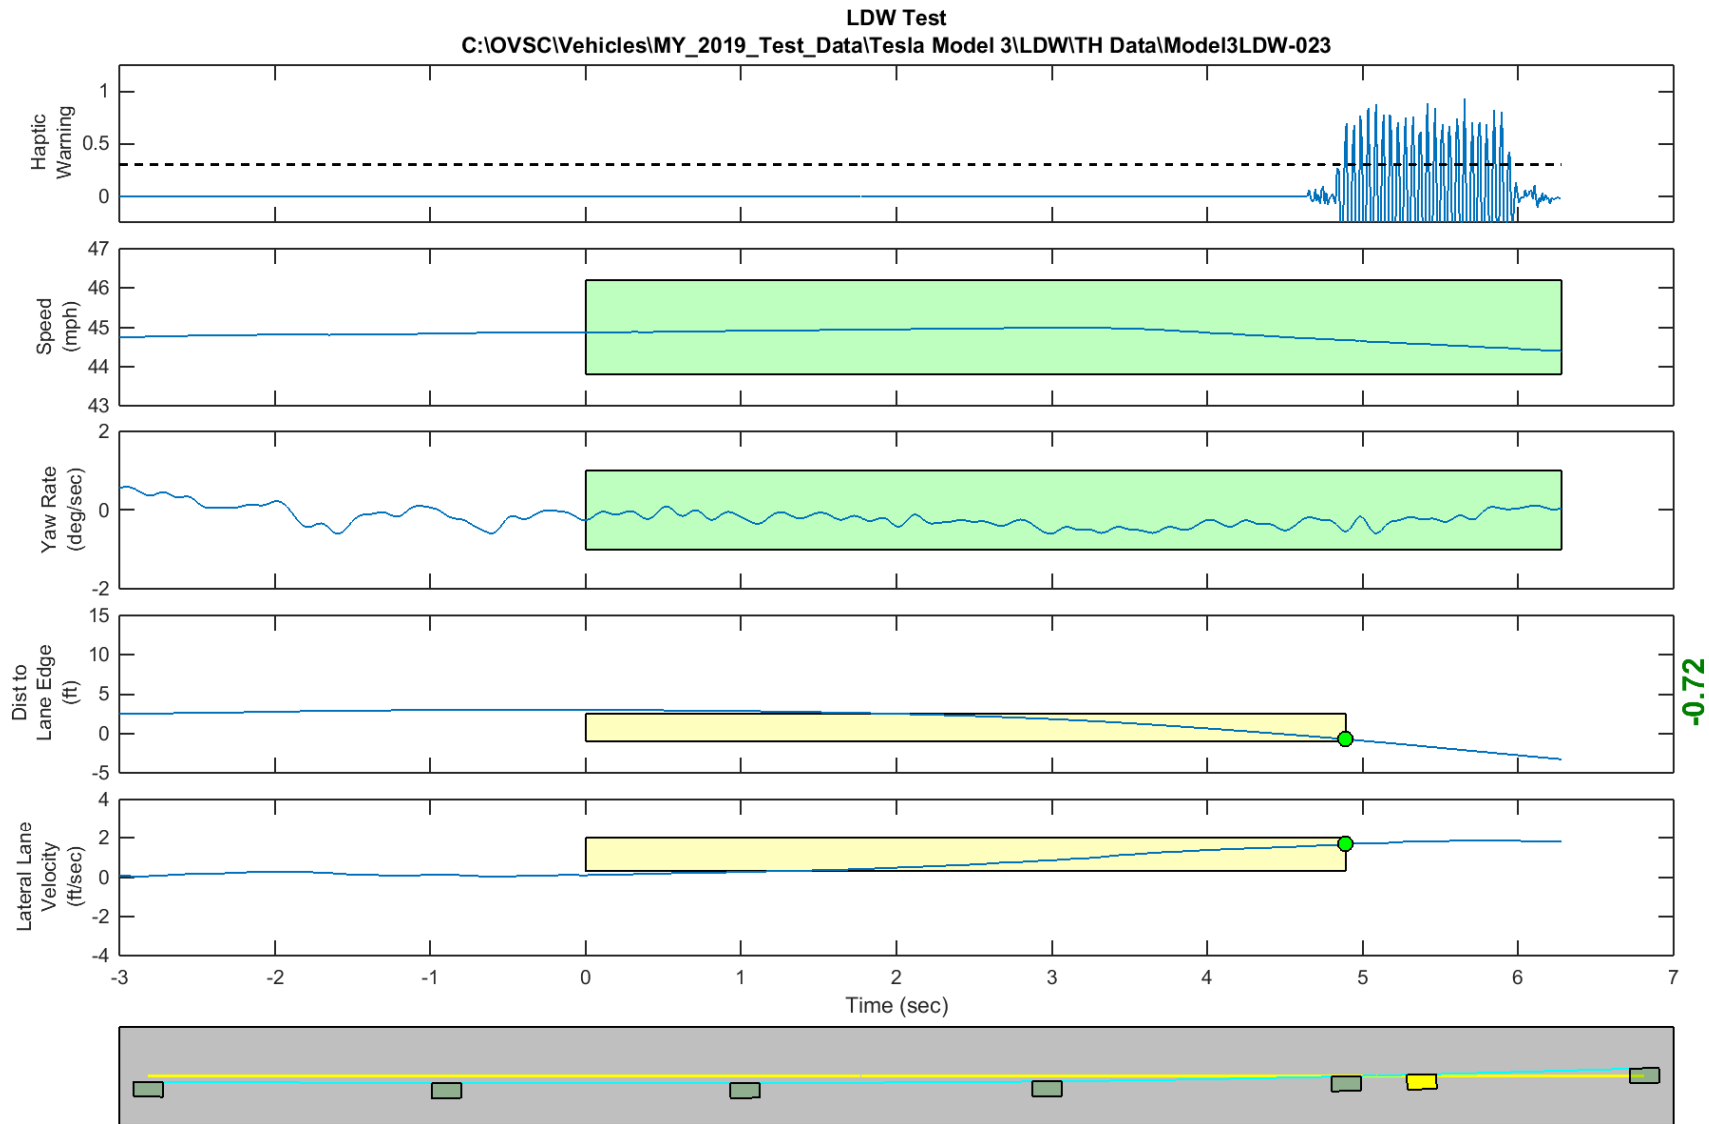
Figure D18. Time History for Run 18, Dashed Line, Left Departure, Haptic Warning

Figure D19. Time History for Run 19, Dashed Line, Left Departure, Haptic Warning

Figure D20. Time History for Run 20, Dashed Line, Left Departure, Haptic Warning

Figure D21. Time History for Run 21, Dashed Line, Left Departure, Haptic Warning

Figure D22. Time History for Run 22, Dashed Line, Left Departure, Haptic Warning

Figure D23. Time History for Run 23, Dashed Line, Left Departure, Haptic Warning

Figure D24. Time History for Run 24, Dashed Line, Left Departure, Haptic Warning

Run	Lane Marking Type	Departure Direction	Valid Run?	Distance at Haptic Alert (ft)	Pass/Fail	Notes
18	Dashed	Left	Y	-0.85	Pass	
19			Y	-0.64	Pass	
20			Y	-0.71	Pass	
21			Y	-0.74	Pass	
22			Y	-0.87	Pass	
23			Y	-0.72	Pass	
24			Y	-0.91	Pass	
25	Dashed	Right	Y	0.13	Pass	
26			Y	0.11	Pass	
27			Y	0.17	Pass	
28			Y	0.15	Pass	
29			Y	0.25	Pass	
30			Y	0.13	Pass	
31			Y	0.13	Pass	
32	Botts	Right	Y	0.02	Pass	
33			Y	0.09	Pass	
34			N			Speed
35			Y	0.14	Pass	
36			Y	0.16	Pass	
37			Y	0.07	Pass
