**OCAS-DRI-CIB-19-12
NEW CAR ASSESSMENT PROGRAM
CRASH IMMINENT BRAKE SYSTEM CONFIRMATION TEST**

2019 Genesis G70

14 November 2019

Final Report

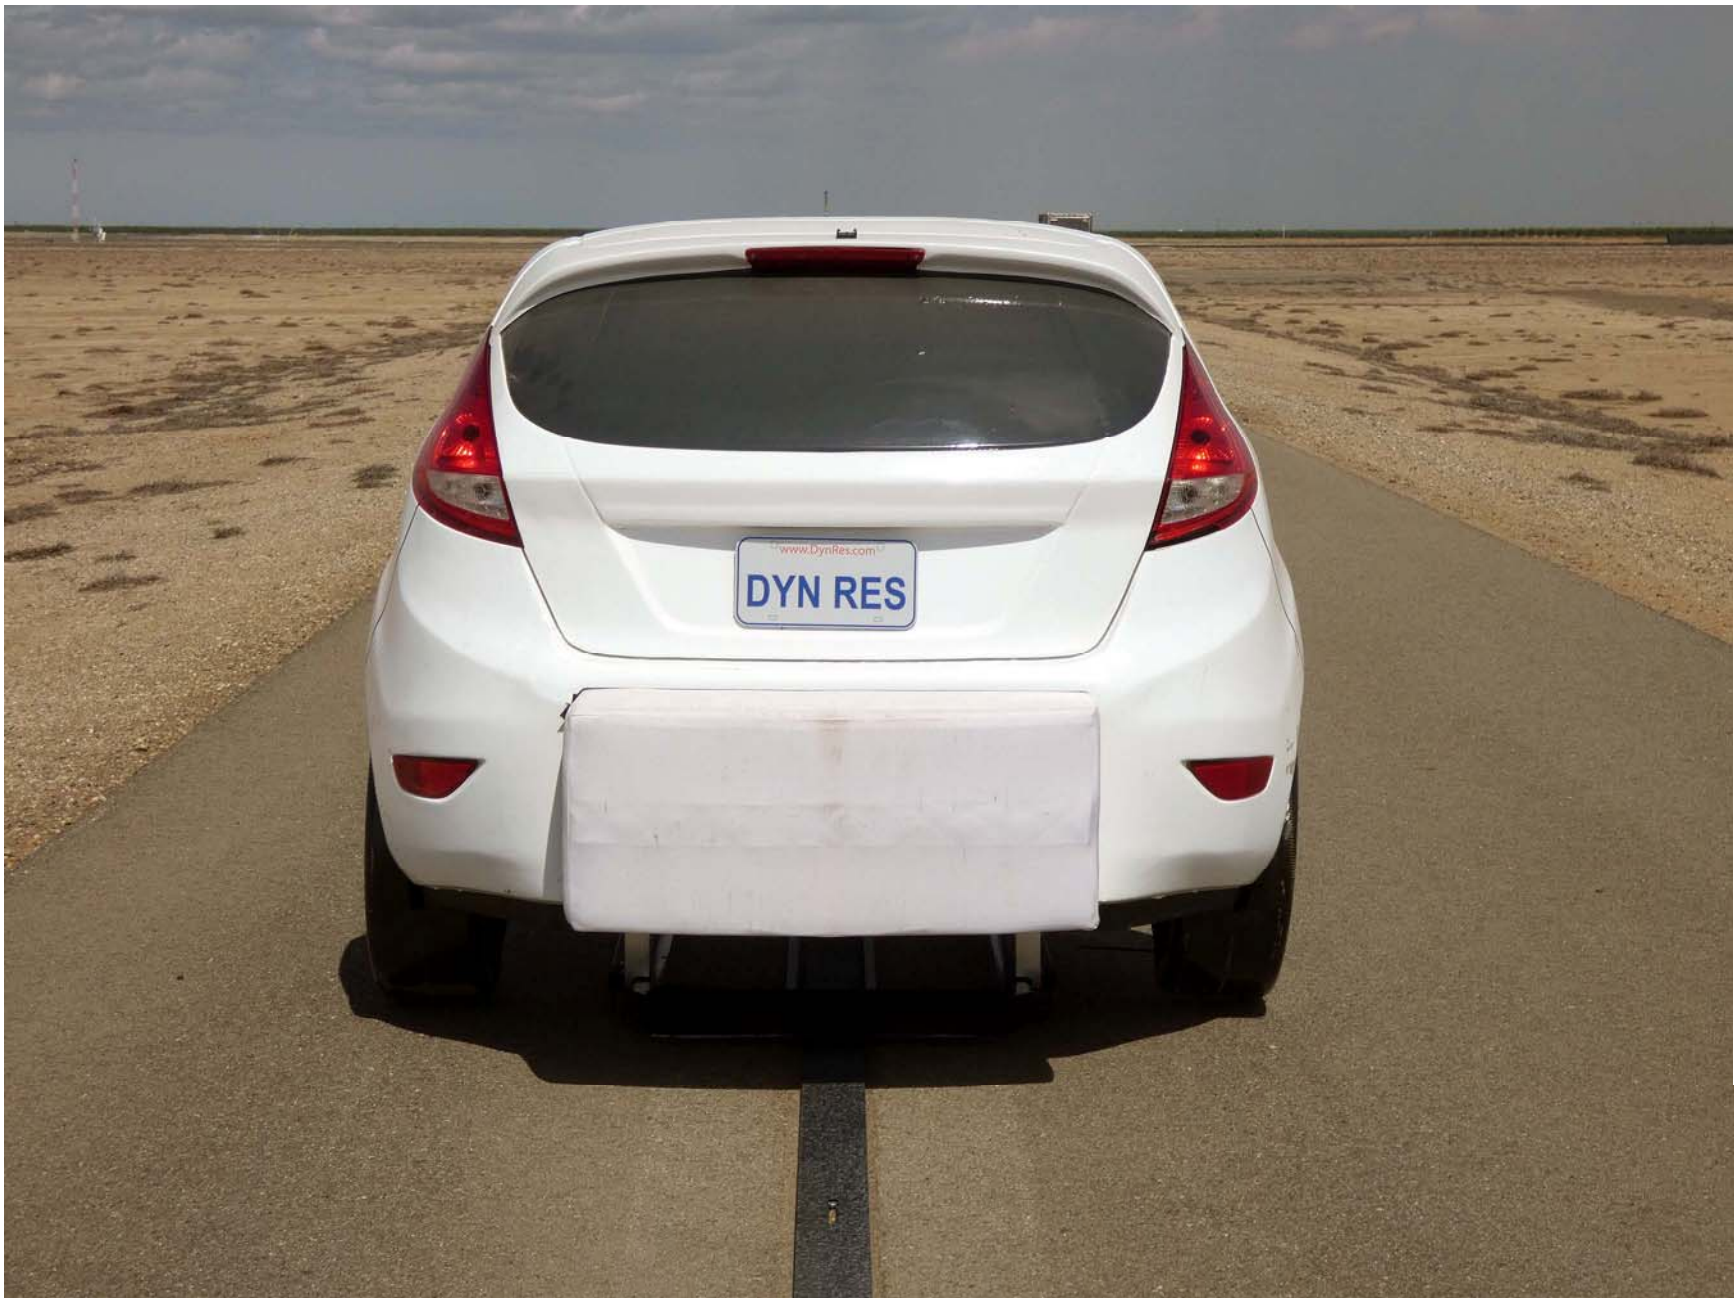
Figure A6. Rear View of Principal Other Vehicle (SSV)

CIB testing requires a POV that realistically represents typical vehicles, does not suffer damage or cause damage to a test vehicle in the event of collision, and can be accurately positioned and moved during the tests. The tests reported herein made use of the NHTSA developed Strikeable Surrogate Vehicle (SSV).

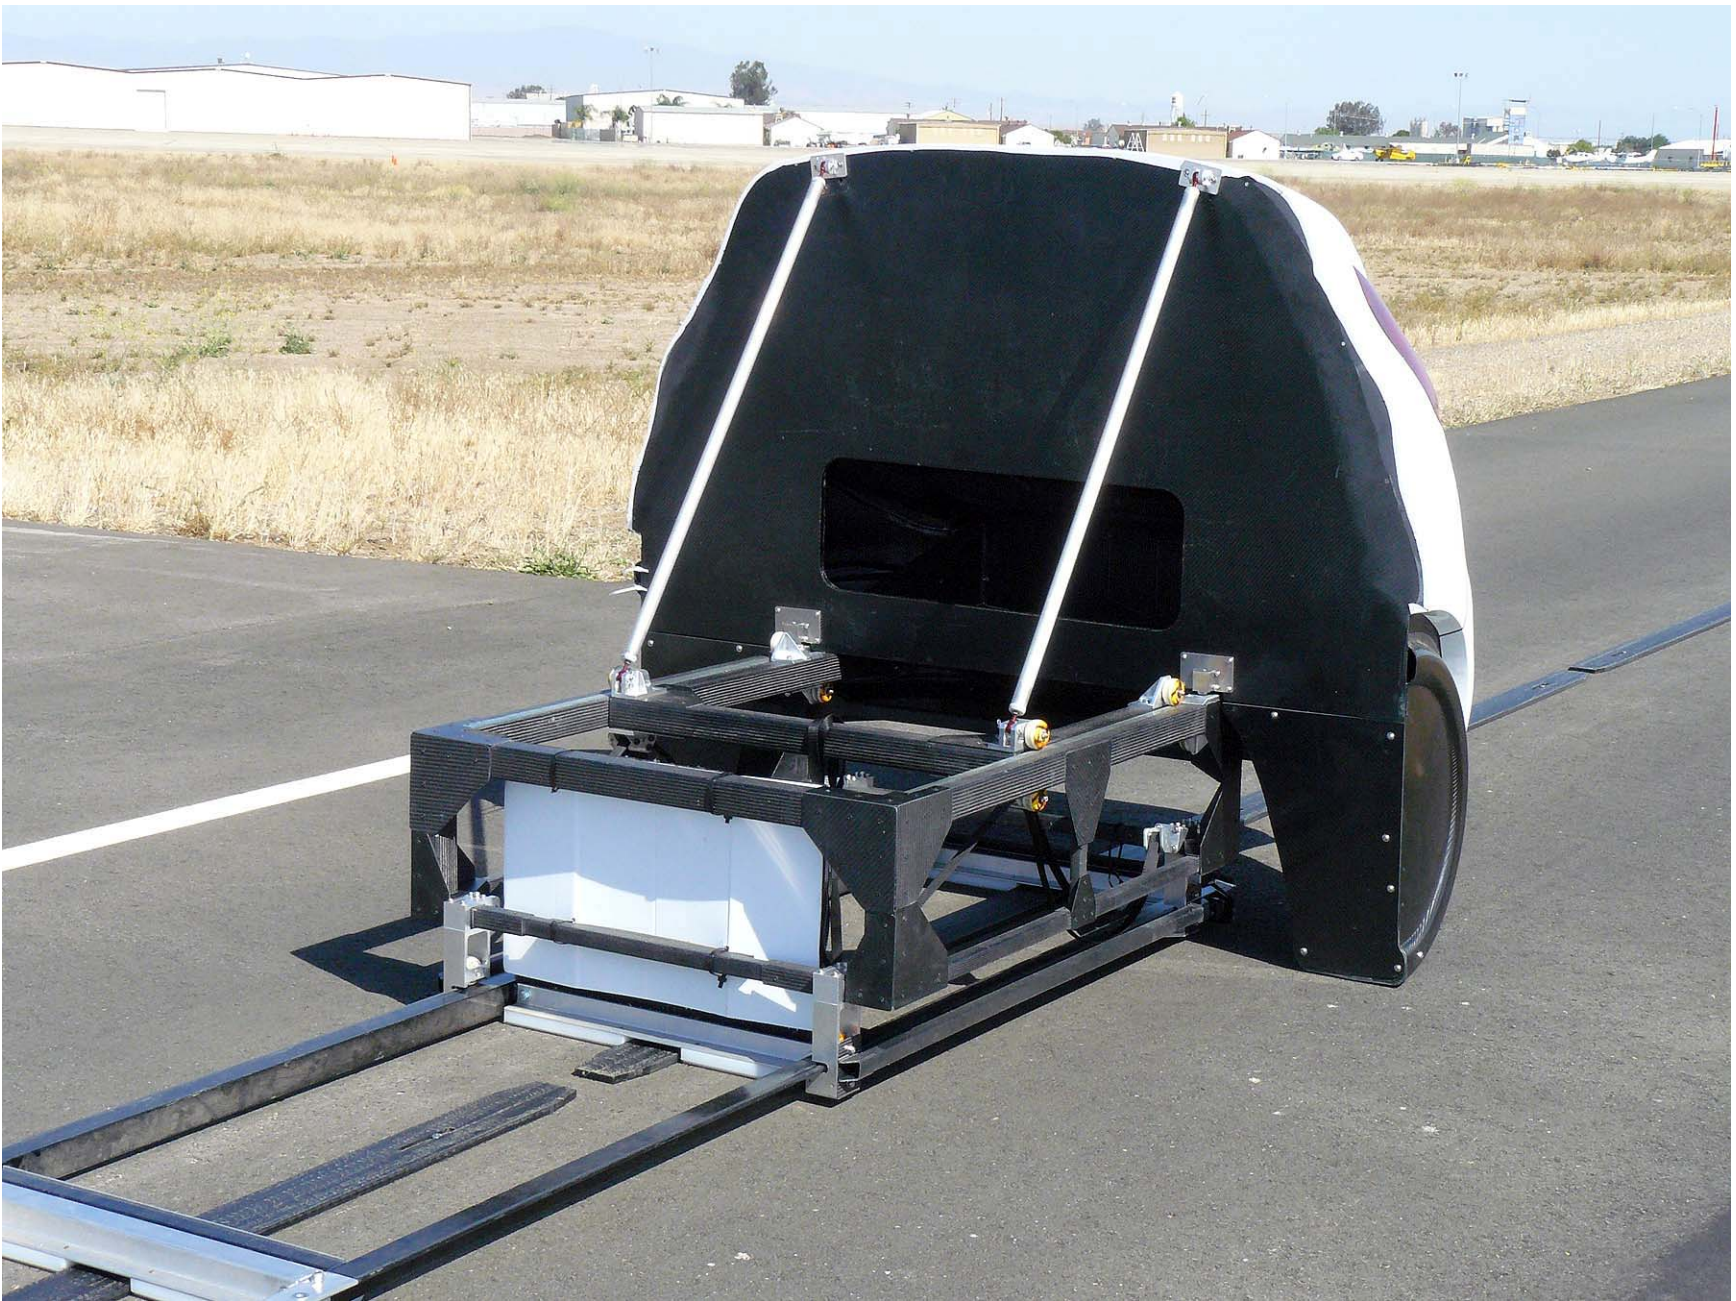
Figure A7. Load Frame/Slider of SSV

from the SV. The forward end of the rail has a cushioned stop to restrain forward motion of the shell/roller assembly. After impacting the SSV, the SV driver uses the steering wheel to maintain SV position in the center of the travel lane, thereby straddling the two-rail track. The SV driver must manually apply the SV brakes after impact. The SSV system is shown in Figures A6 through A8 and a detailed description can be found in the NHTSA report: NHTSA'S STRIKEABLE SURROGATE VEHICLE PRELIMINARY DESIGN + OVERVIEW, May 2013.

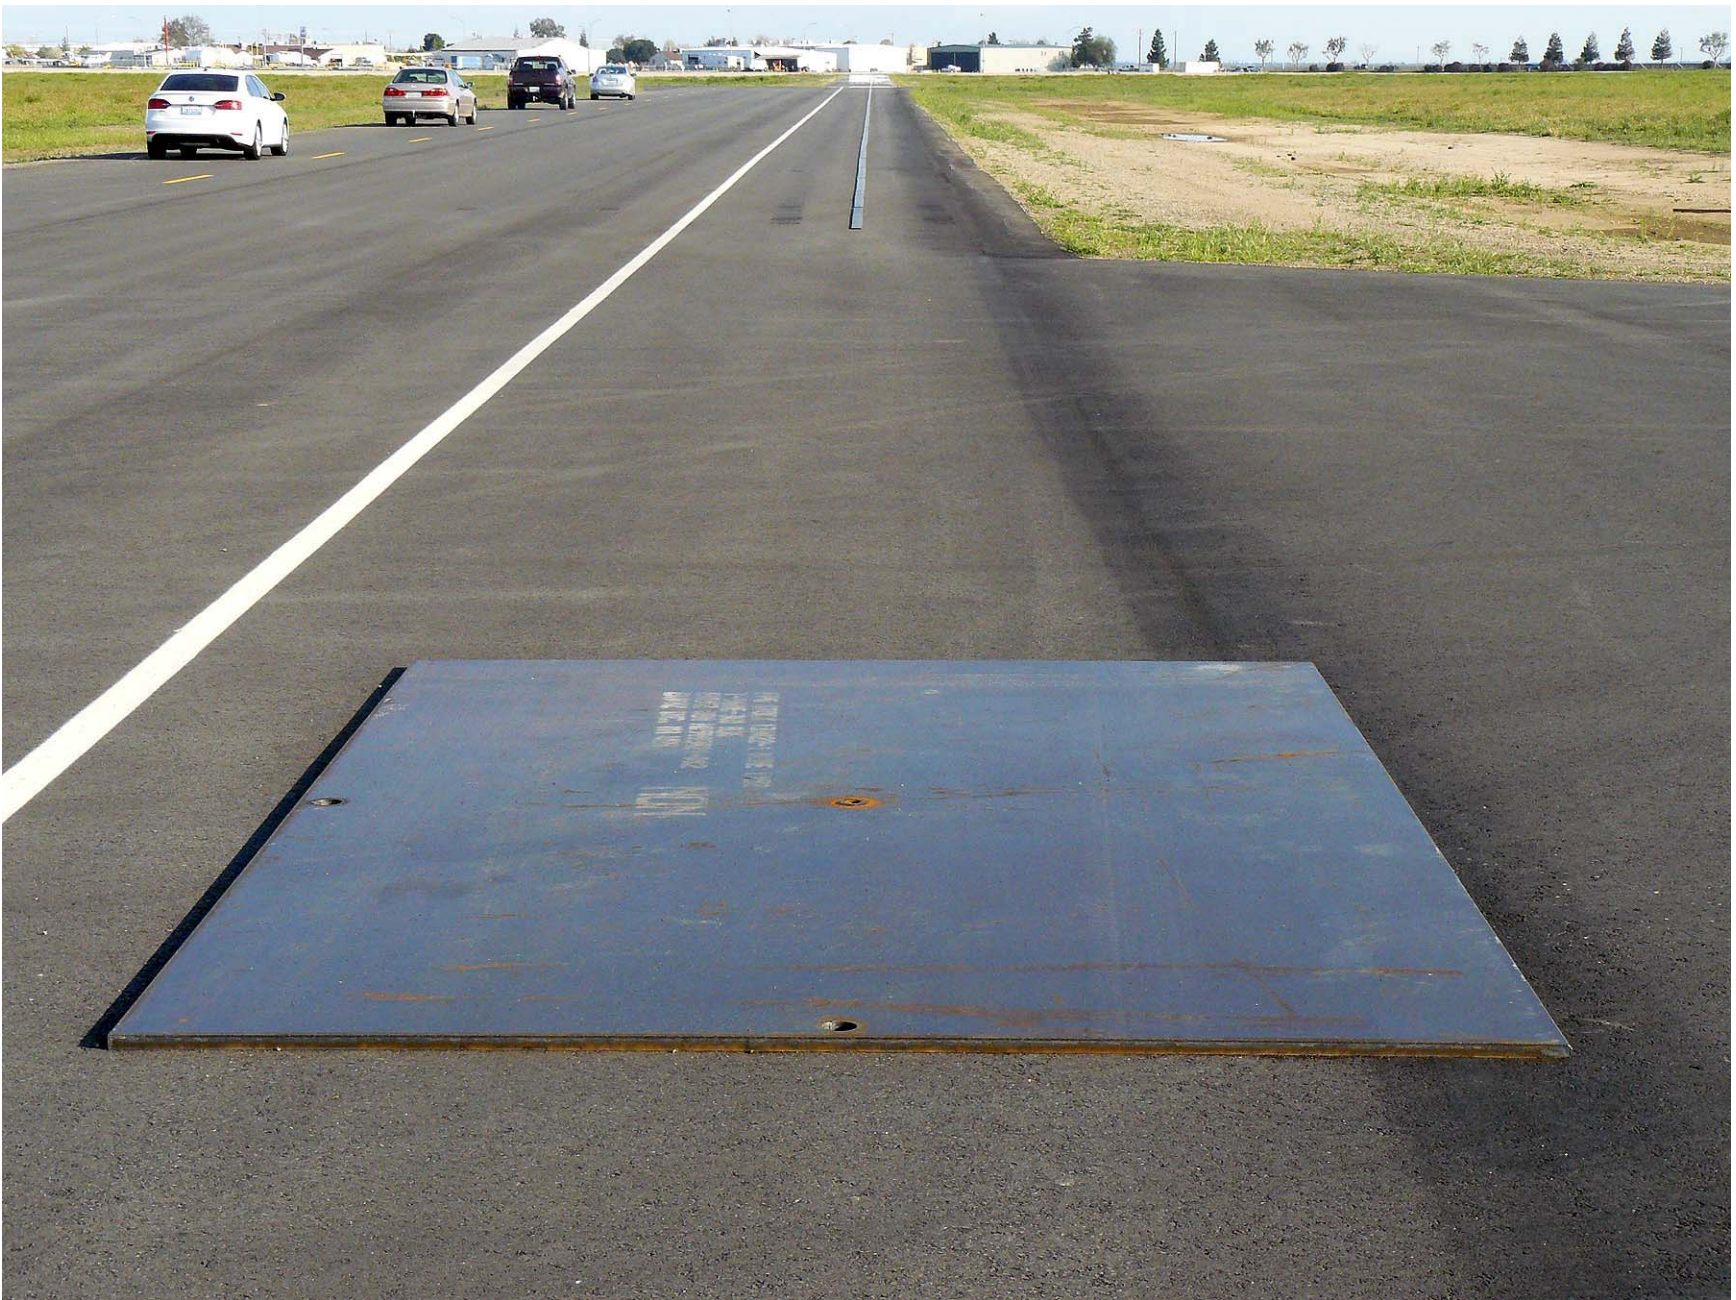
Figure A9. Steel Trench Plate

The false positive suppression test series evaluates the ability of a CIB system to differentiate a steel trench plate (STP) from an object presenting a genuine safety risk to the SV. Although the STP is large and metallic, it is designed to be driven over without risk of injury to the driver or damage to the SV. Therefore, in this scenario, the automatic braking available from CIB is not necessary and should be suppressed. The test condition is nearly equivalent to that previously defined for Test 1, the stopped POV condition, but with an STP in the SV forward path in lieu of a POV.

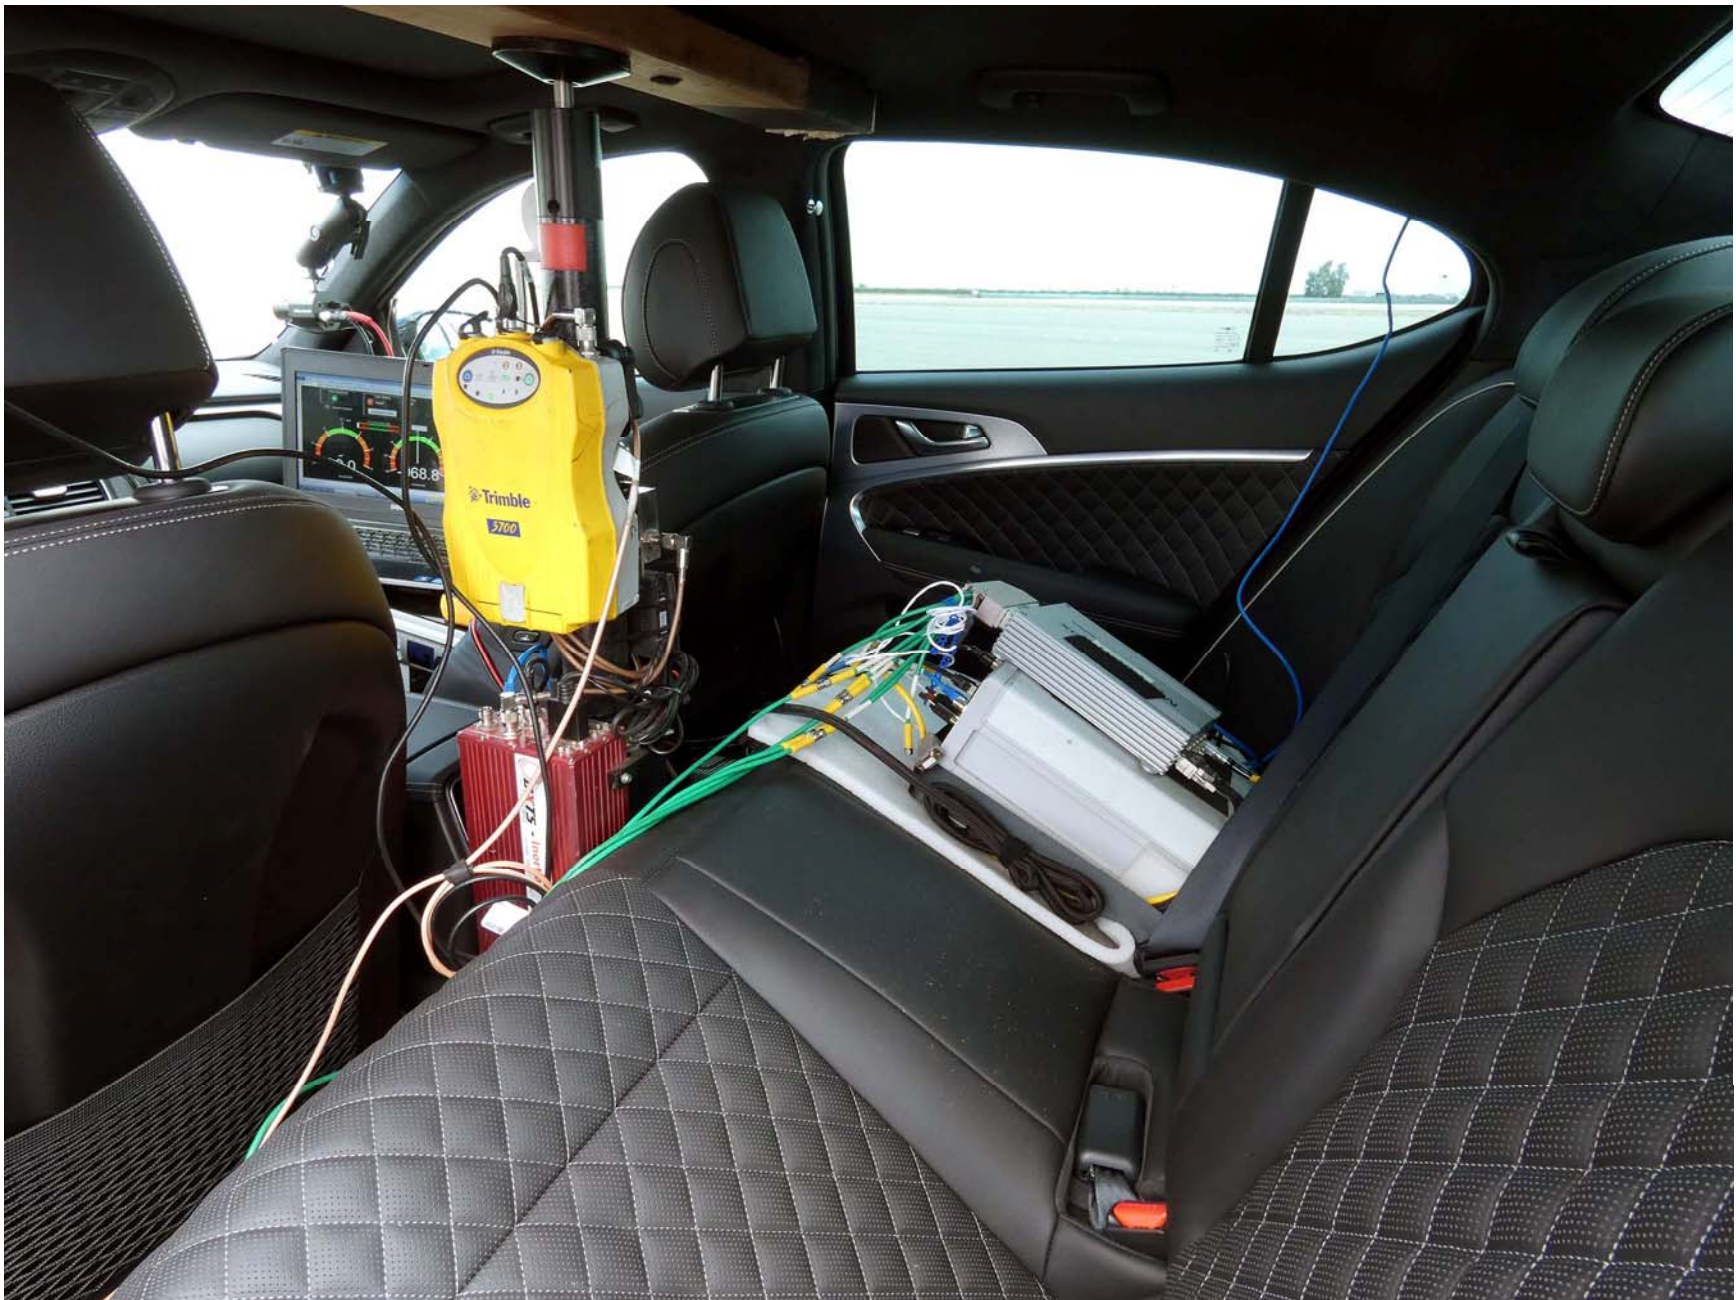
Figure A10. DGPS, Inertial Measurement Unit and MicroAutoBox Installed in Subject Vehicle

Table 2 lists the sensors, signal conditioning, and data acquisition equipment used for these tests.

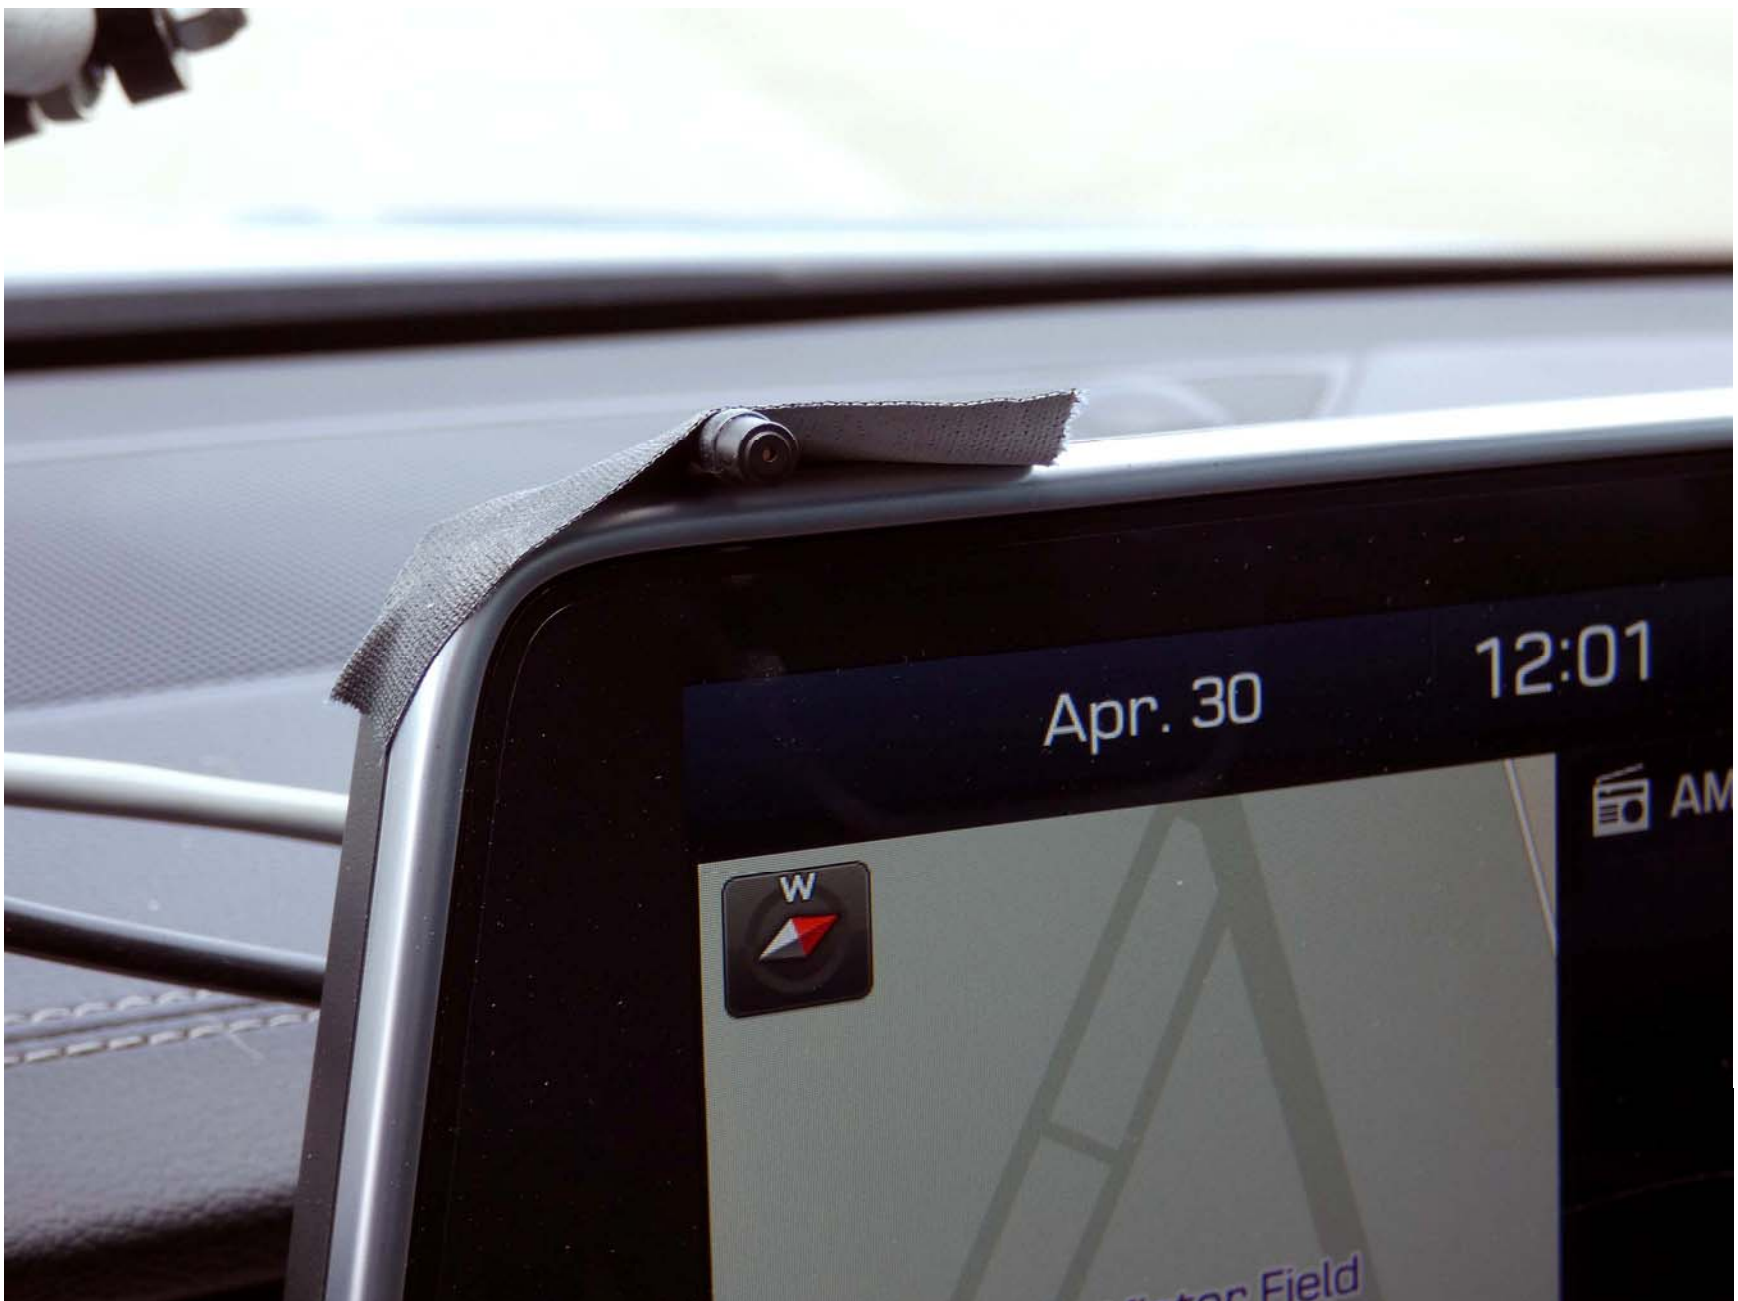
Figure A11. Sensor for Detecting Auditory Alerts

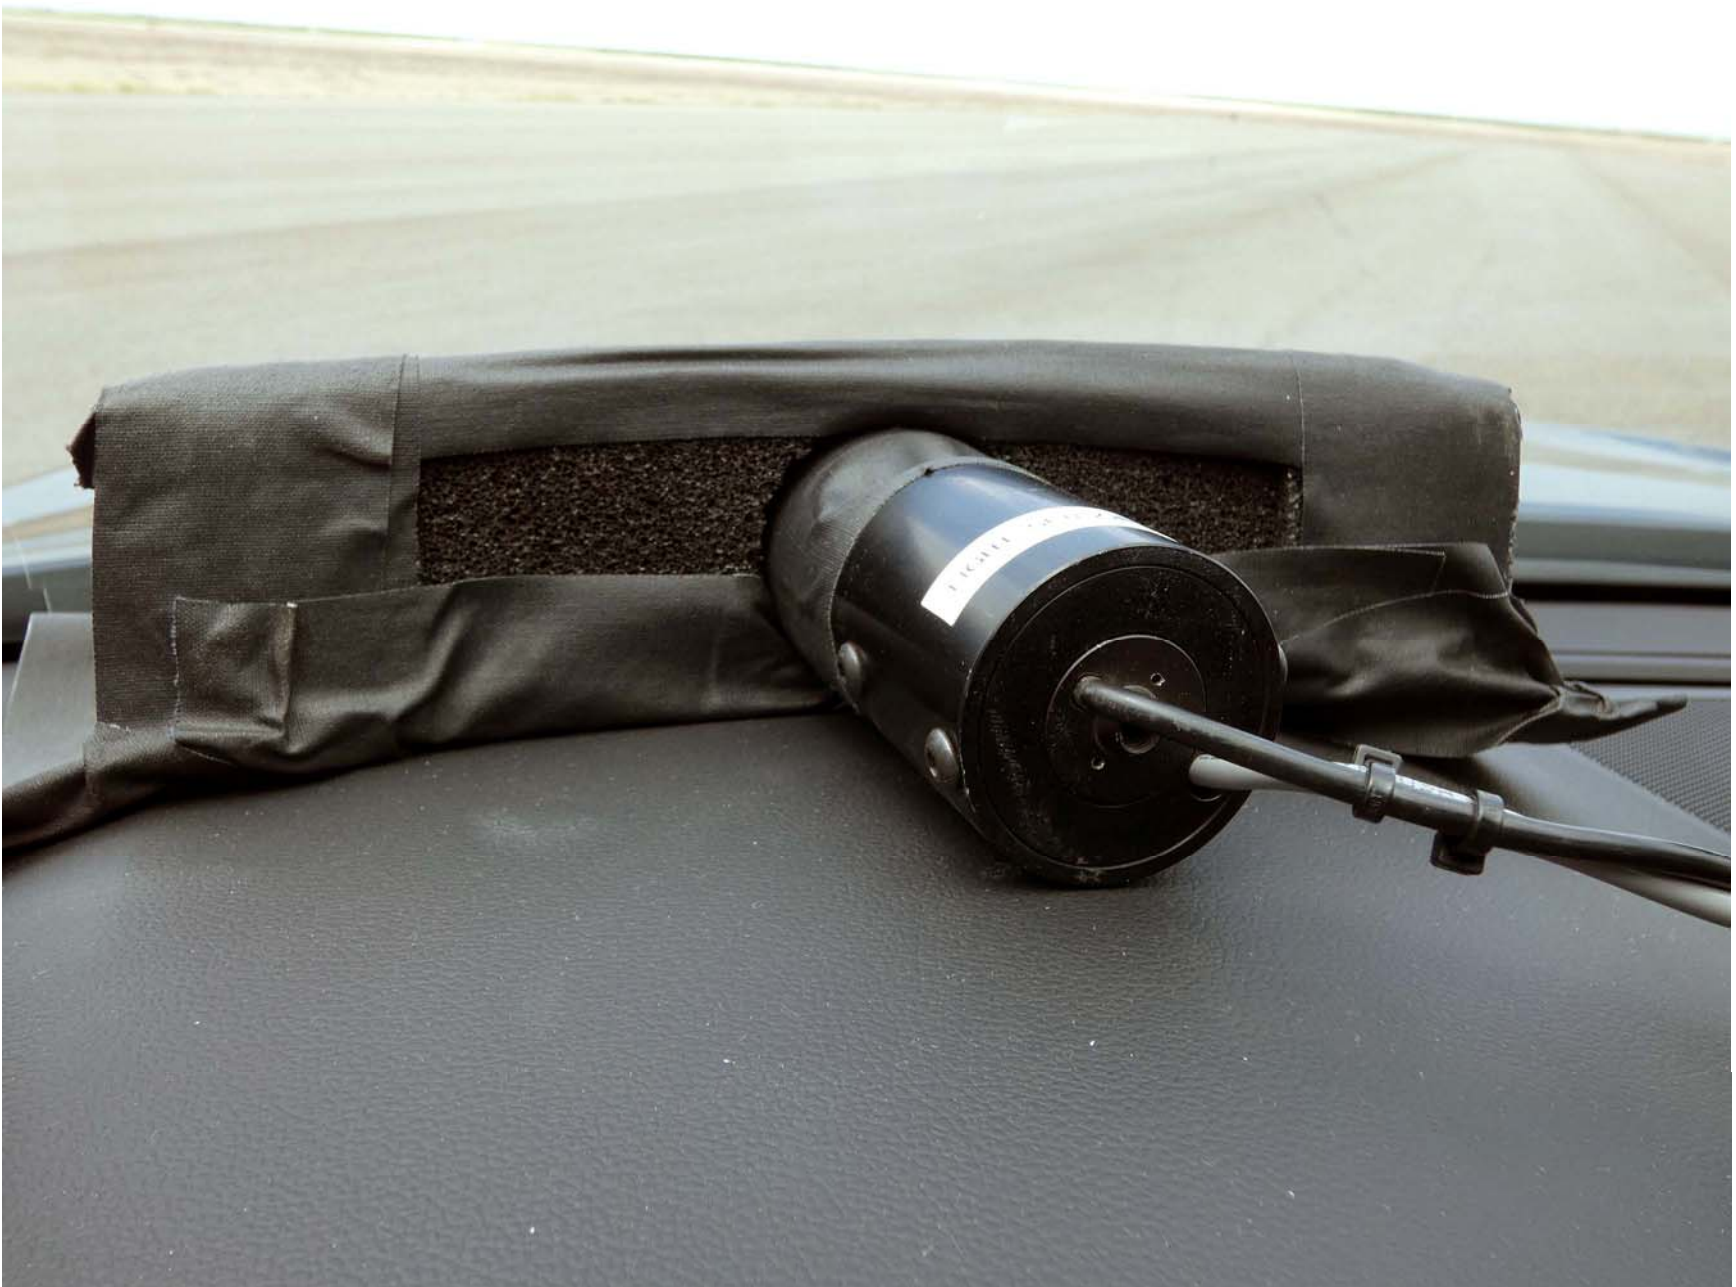
Figure A12. Sensor for Detecting Visual Alert

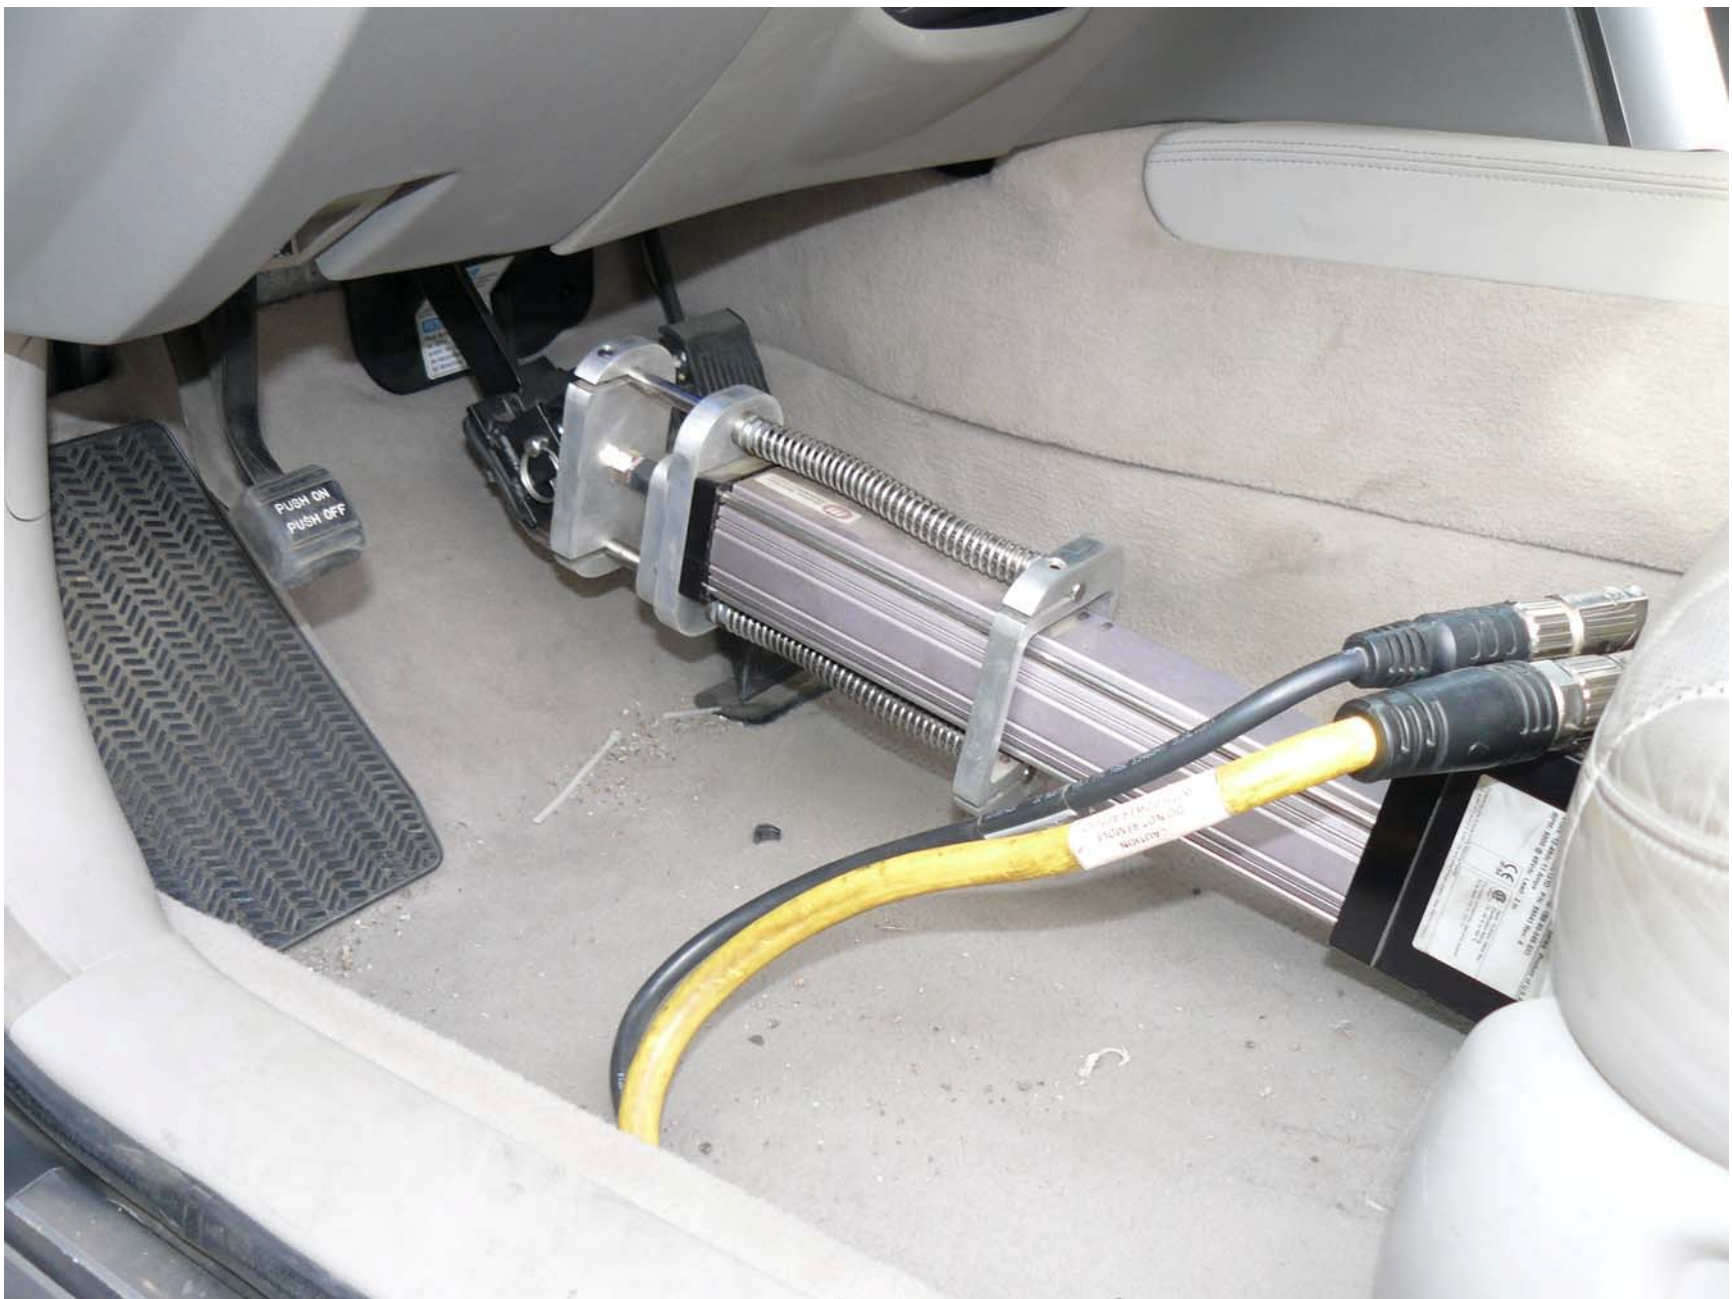
Figure A14. Brake Actuator Installed in POV System

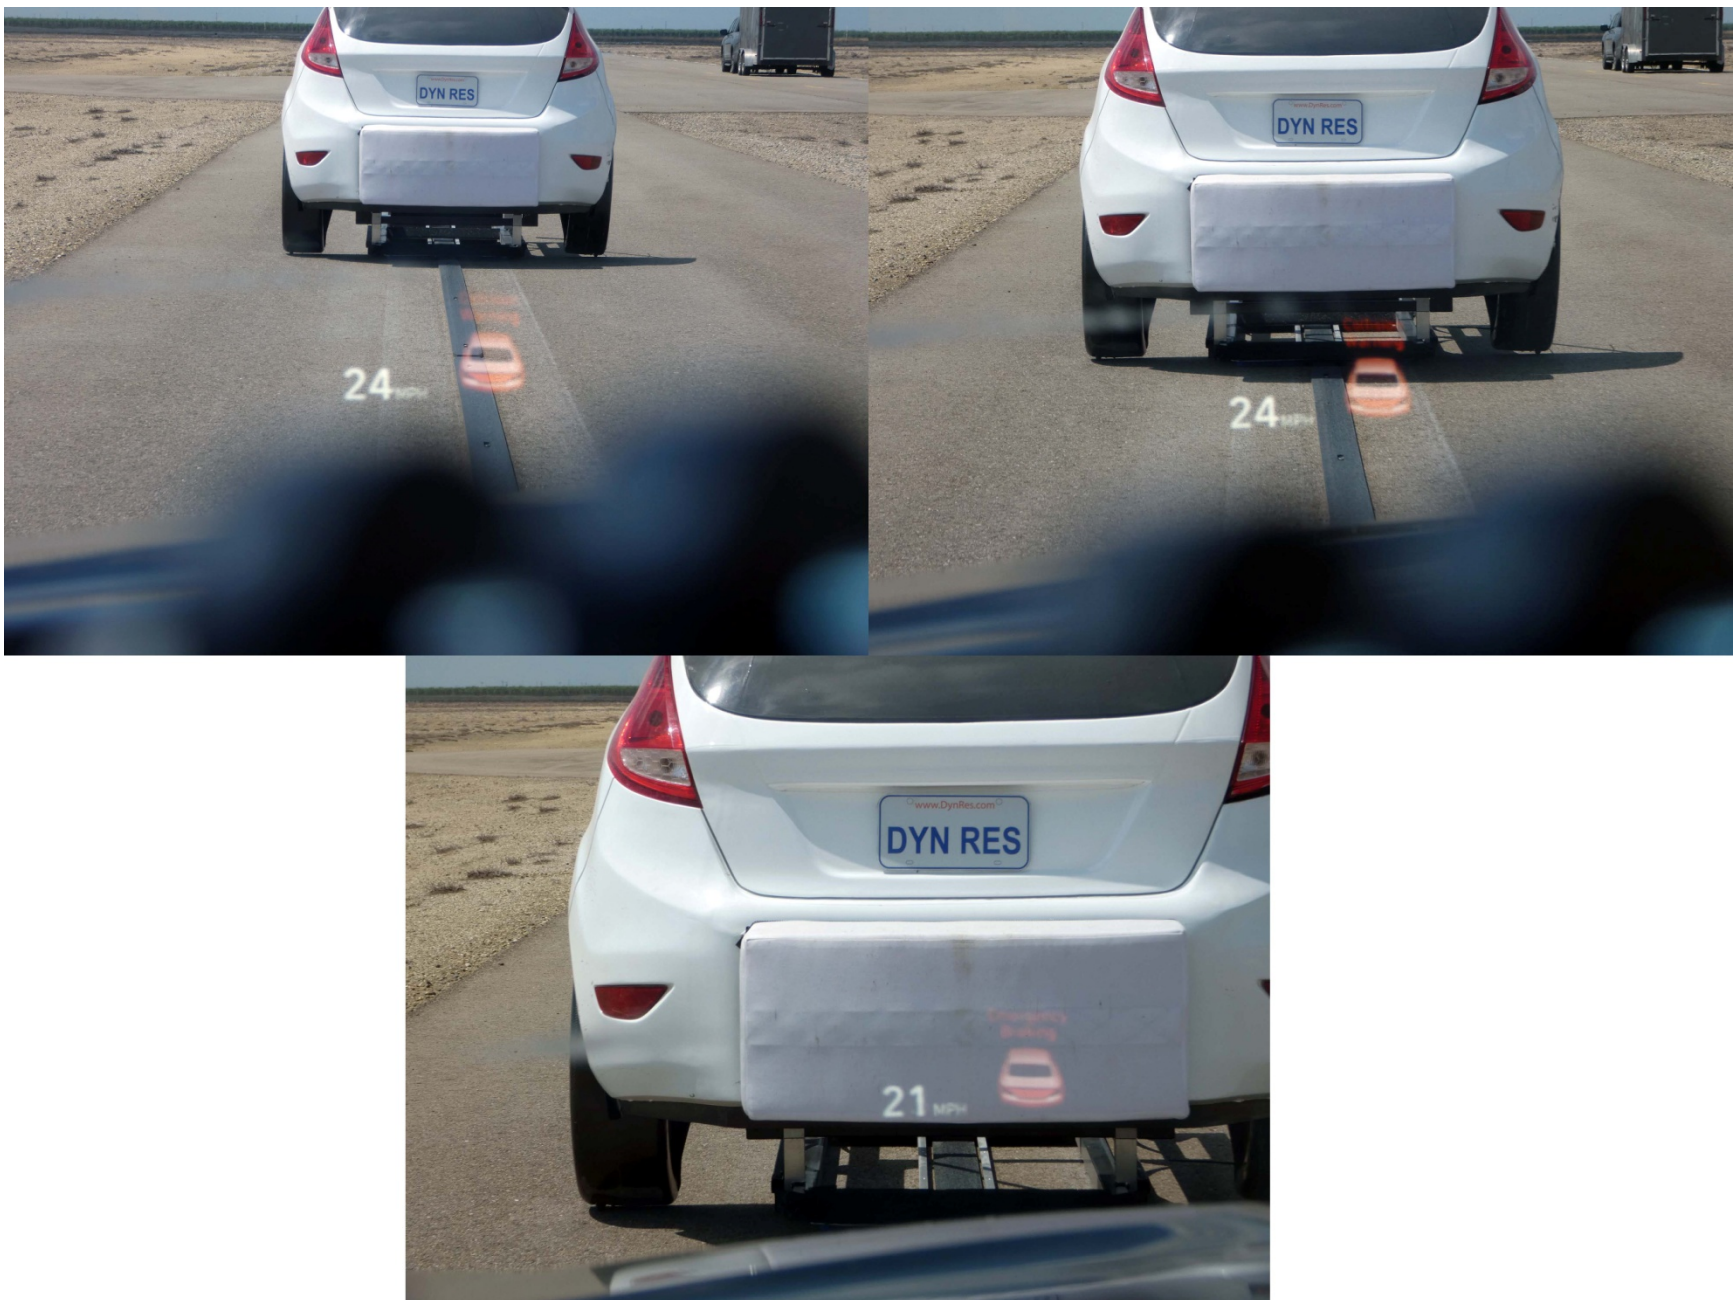
Figure A15. AEB Heads-Up Visual Alert

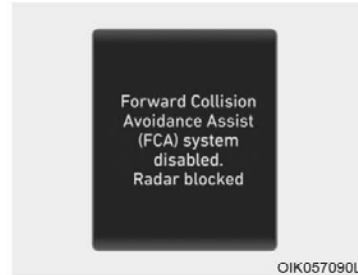
Forward Collision Avoidance Assist (FCA) system disabled.
Radar blocked

When the sensor cover is blocked with dirt, snow, or debris, the FCA system operation may stop temporarily. If this occurs, a warning message will appear on the LCD display. Remove any dirt, snow, or debris and clean the radar sensor cover before operating the FCA system.
