REPORT NUMBER: NCAP-CAL-20-004

**NEW CAR ASSESSMENT PROGRAM (NCAP)
FRONTAL BARRIER IMPACT TEST**

**General Motors LLC
2020 Chevrolet Malibu
Four Door Sedan**

NHTSA No: M20200110

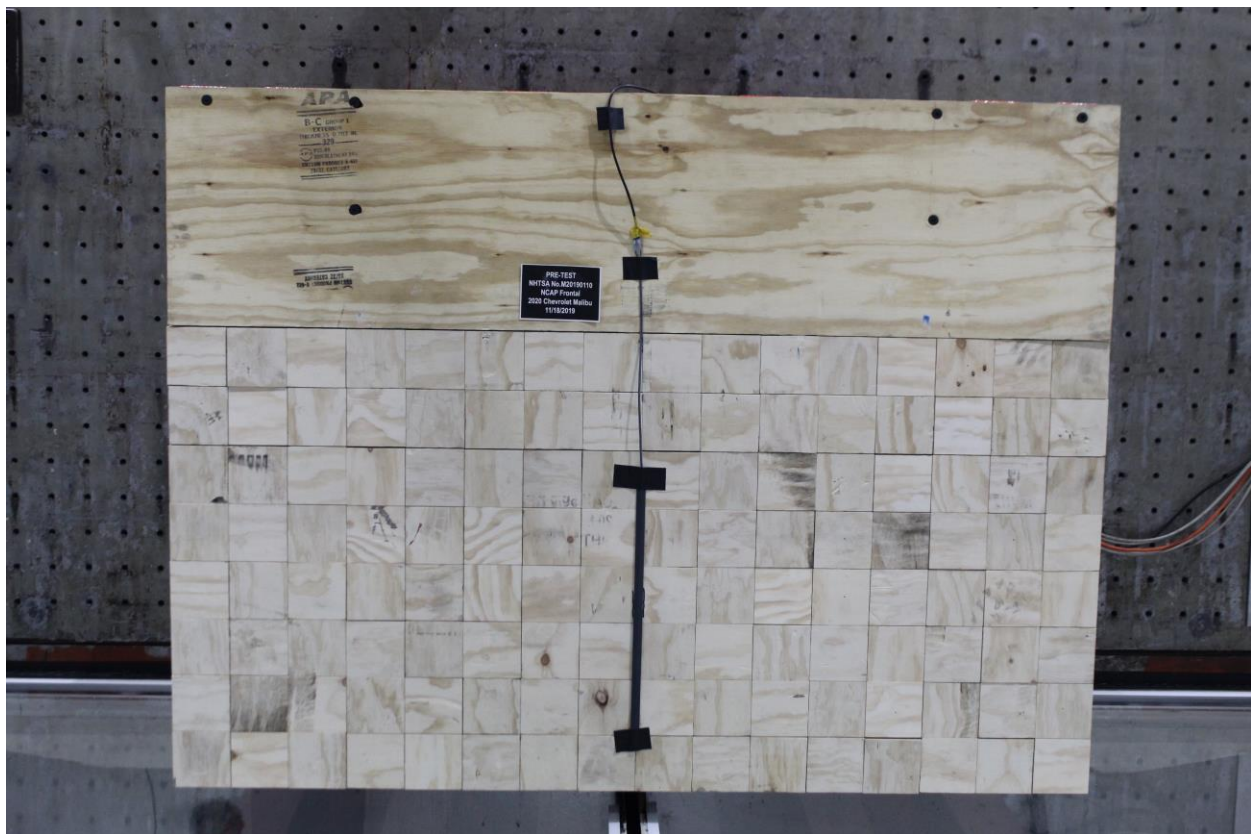
Figure A-1: Load Cell Location

A load cell barrier consisting of 128 load cells was impacted by a 2020 Chevrolet Malibu four door sedan at a velocity of 56.24 km/h. The test was performed at Calspan Corporation's Transportation Test Operations facility in Buffalo, New York on November 18, 2019. Pre- and post-test photographs of the vehicle and dummies to document the test can be found in Appendix A. One real-time camera and 16 high-speed cameras were used to document the frontal barrier impact event. Camera locations and other pertinent camera information can be found in Data Sheet 6 of this report.

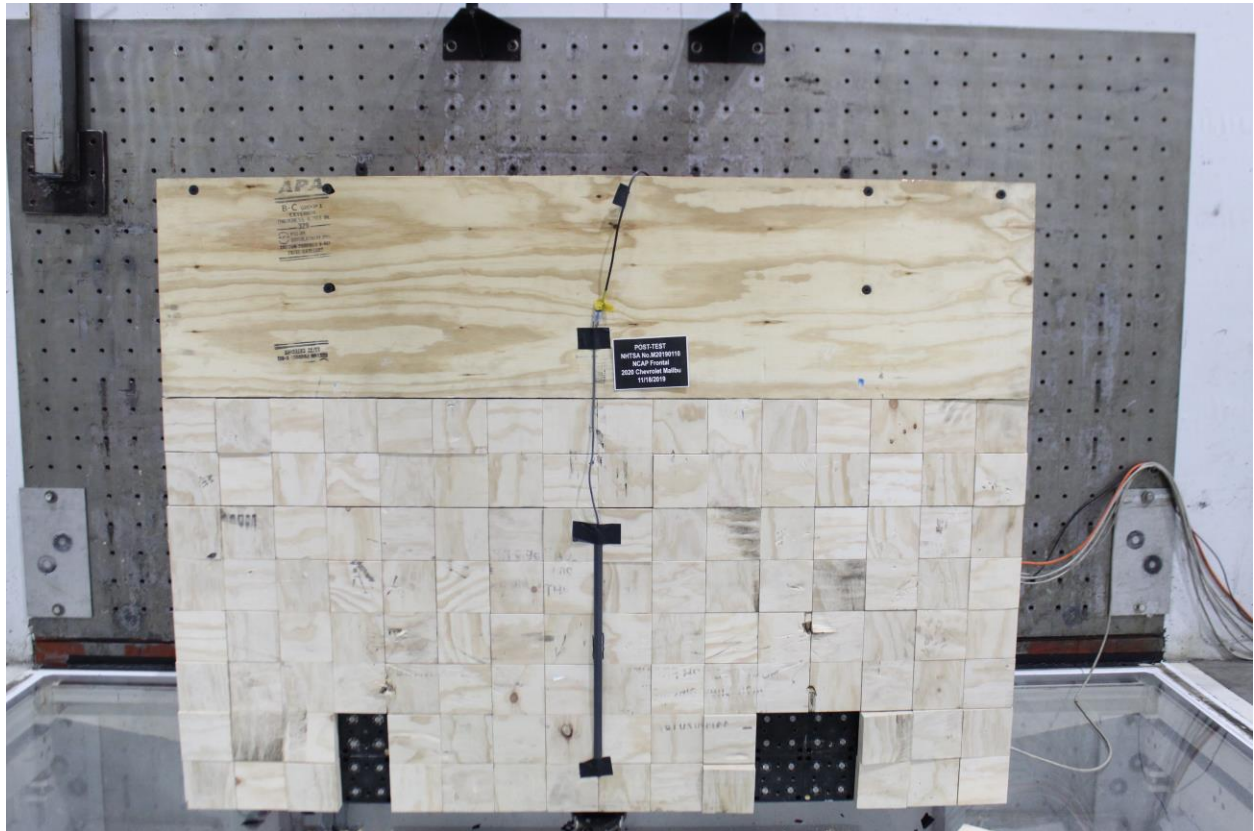
Figure A-2: Pre-Test Load Cell Wall

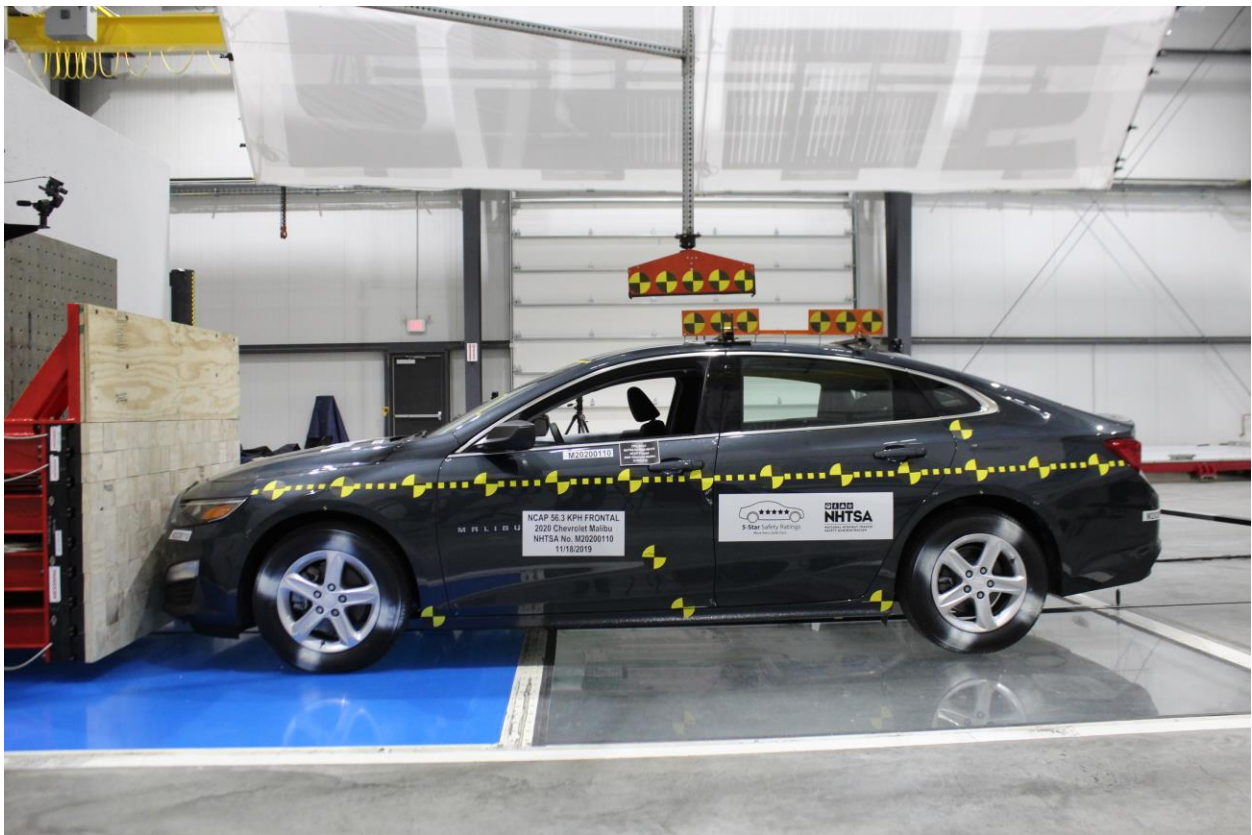
Figure A-9: Post-Test Front View of Test Vehicle

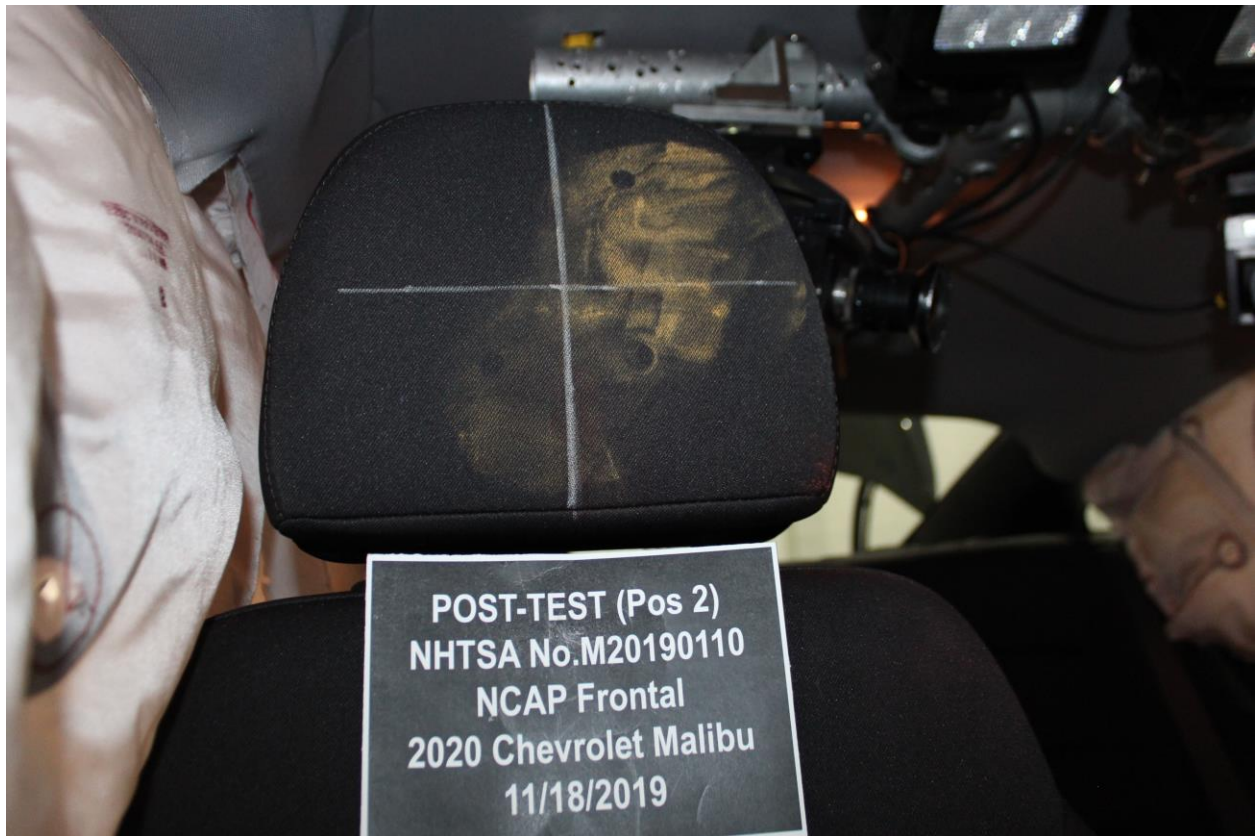
Figure A-72: Post-Test Passenger Dummy Contact With Airbag

The passenger's visible contact points were as follows: The passenger's head contacted the frontal airbag and then the head restraint. The upper torso contacted the frontal airbag. Both knees contacted the knee airbag.
