REPORT NUMBER: NCAP-CAL-20-003

NEW CAR ASSESSMENT PROGRAM (NCAP) FRONTAL BARRIER IMPACT TEST

FCA US LLC 2020 Jeep Wrangler SUV

NHTSA No: M20200310

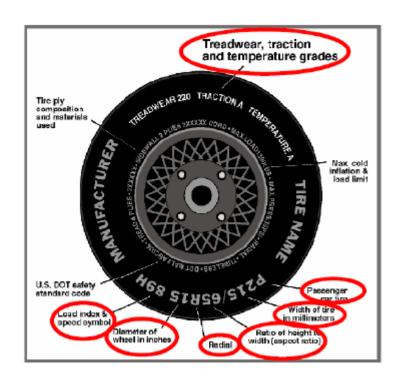
VEHICLE TIRE INFORMATION

Collect items circled in red, tire manufacturer, and tire name.

Measured Parameter	Front	Rear
Maximum Tire Pressure (kPa)	350	350
Cold Pressure (kPa)	250	250
Recommended Tire Size	245/75R17	245/75R17
Tire Size on Vehicle	245/75R17	245/75R17
Tire Manufacturer	Goodyear	Goodyear
Tire Model	Wrangler	Wrangler
Treadwear	640	640
Traction	А	Α
Temperature Grades	В	В
Tire Plies Sidewall	2 Polyester	2 Polyester
Tire Plies Body	2 Polyester, 2 Steel, 1 Polyamide	2 Polyester, 2 Steel, 1 Polyamide
Load Index / Speed Symbol	112T	112T
Tire Material	Rubber	Rubber
DOT Safety Code Left	4BM1IB1R3519	4BM1IB1R3519
DOT Safety Code Right	4BM1IB1R3519	4BM1IB1R3519

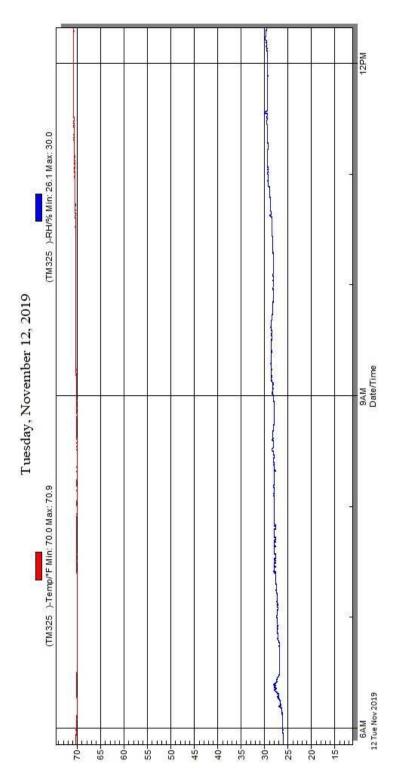
Temperature and Humidity Stabilization Chart/Data for Dummies and Test Vehicle

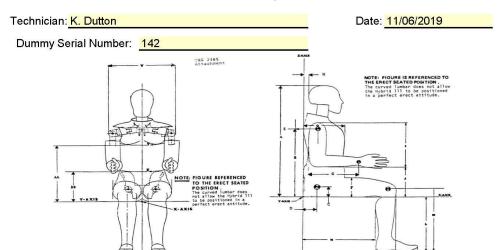
External Measurements - Hybrid 3 - 50th Male

Z-AXIS HYBRID III Exterior Body Diseasions - Front View		NTBRID III Exterior Redy Dimensions - Side View			
Т	<u> </u>	Specification	Result	Г

Symbol	Description		ication n)	Result (in)	Pass/Fail
Α	Sitting Height	34.6	35.0	34.8	Pass
В	Shoulder Pivot Height	19.9	20.5	20.2	Pass
С	H-Point Height	3.3	3.5	3.4	Pass
D	H-Point from Backline	5.3	5.5	5.4	Pass
Е	Shoulder Pivot from Backline	3.3	3.7	3.5	Pass
F	Thigh Clearance	5.5	6.1	5.6	Pass
O	Back of Elbow to Wrist Pivot	11.4	12.0	11.8	Pass
Н	Head Back to Backline	1.6	1.8	1.7	Pass
T	Shoulder to Elbow Length	13.0	13.6	13.5	Pass
7	Elbow Rest Height	7.5	8.3	8.2	Pass
K	Buttock to Knee Length	22.8	23.8	23.3	Pass
L	Popliteal Height	16.9	17.9	17.3	Pass
М	Knee Pivot Height	19.1	19.7	19.4	Pass
Ν	Buttock Popliteal Length	17.8	18.8	18.4	Pass
0	Chest Depth without Jacket	8.4	9.0	8.6	Pass
Р	Foot Length (right)	9.9	10.5	10.3	Pass
V	Shoulder Breadth	16.3	17.2	16.8	Pass
W	Foot Breadth	3.6	4.2	3.9	Pass
Υ	Chest Circumference with Jacket	38.2	39.4	38.9	Pass
Z	Waist Circumference	32.9	34.1	33.7	Pass
AA	Reference Location (Chest Circumference)	16.9	17.1	17.0	Pass

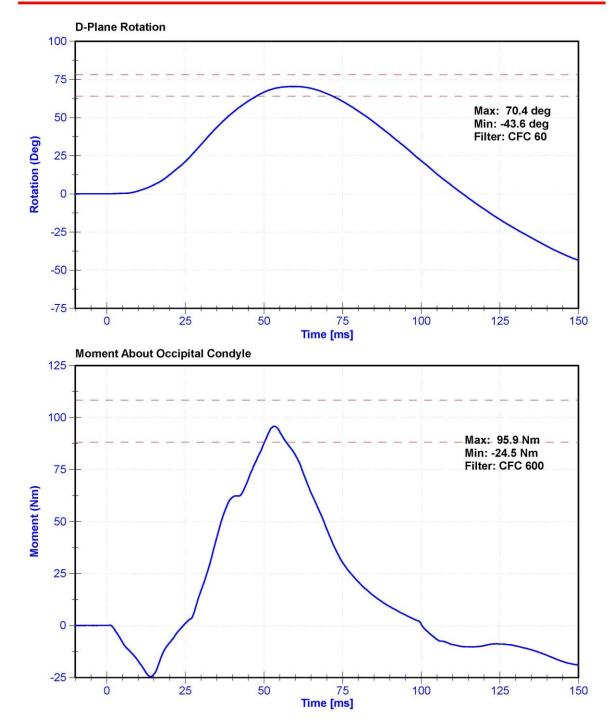
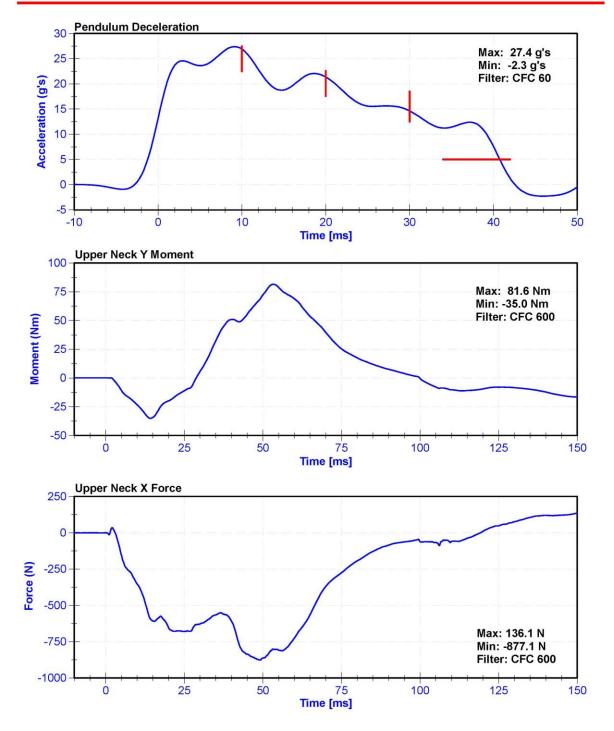
Certification Report Hybrid 3 - 50th Male Neck Flexion - CFR 572

Test Parameter	Minimum Specification	Maximum Specification	Unit	Result	Pass/Fail
Temperature	20.6	22.2	°C	21.5	Pass
Humidity	10	70	%	28.0	Pass
Velocity	6.89	7.13	m/s	7.013	Pass
Pendulum Deceleration at 10ms	22.5	27.5	g's	26.91	Pass
Pendulum Deceleration at 20ms	17.6	22.6	g's	21.37	Pass
Pendulum Deceleration at 30ms	12.5	18.5	g's	14.64	Pass
Max. Pendulum Deceleration After 30ms	0	29	g's	27.4	Pass
Pendulum Deceleration Time to 5 g's	34	42	ms	40.8	Pass
Maximum D Plane Rotation	64	78	deg	70.4	Pass
Time to Maximum Rotation	57	64	ms	59.5	Pass
Rotation Decay to Zero	113	127	ms	113.2	Pass
Moment About Occipital Condyle	88.1	108.4	Nm	95.86	Pass
Time to Maximum Moment	47	58	ms	53.2	Pass
Moment Decay to Zero	97	107	ms	100.2	Pass

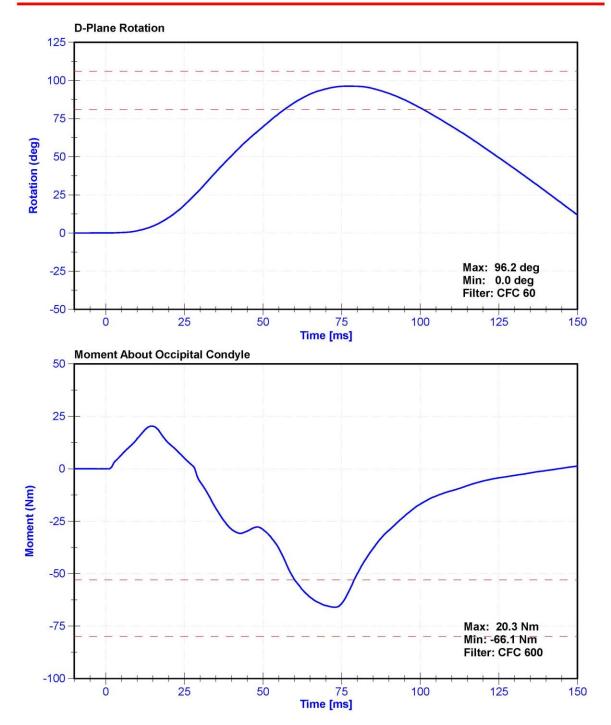
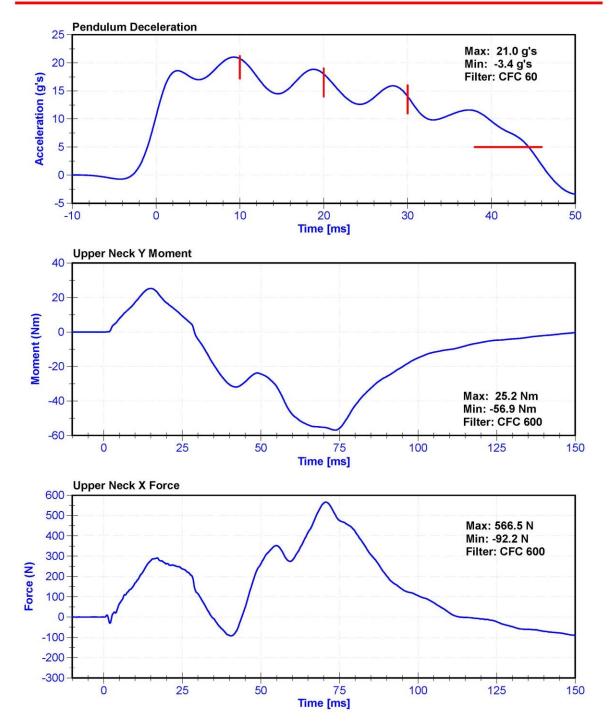
Certification Report Hybrid 3 - 50th Male Neck Extension - CFR 572

Test Parameter	Minimum Specification	Maximum Specification	Unit	Result	Pass/Fail
Temperature	20.6	22.2	°C	21.5	Pass
Humidity	10	70	%	28	Pass
Velocity	5.94	6.19	m/s	6.005	Pass
Pendulum Deceleration at 10ms	17.2	21.2	g's	20.74	Pass
Pendulum Deceleration at 20ms	14	19	g's	18.0	Pass
Pendulum Deceleration at 30ms	11	16	g's	14.0	Pass
Max. Pendulum Deceleration After 30ms	0	22	g's	21.0	Pass
Pendulum Deceleration Time to 5 g's	38	46	ms	44.5	Pass
Maximum D Plane Rotation	81	106	deg	96.2	Pass
Time to Maximum Rotation	72	82	ms	77.1	Pass
Rotation Decay to Zero	147	174	ms	157.8	Pass
Minimum Moment About OC	-80	-52.9	Nm	-66.06	Pass
Time to Minimum Moment	65	79	ms	72.7	Pass
Moment Decay to Zero	120	148	ms	143.9	Pass

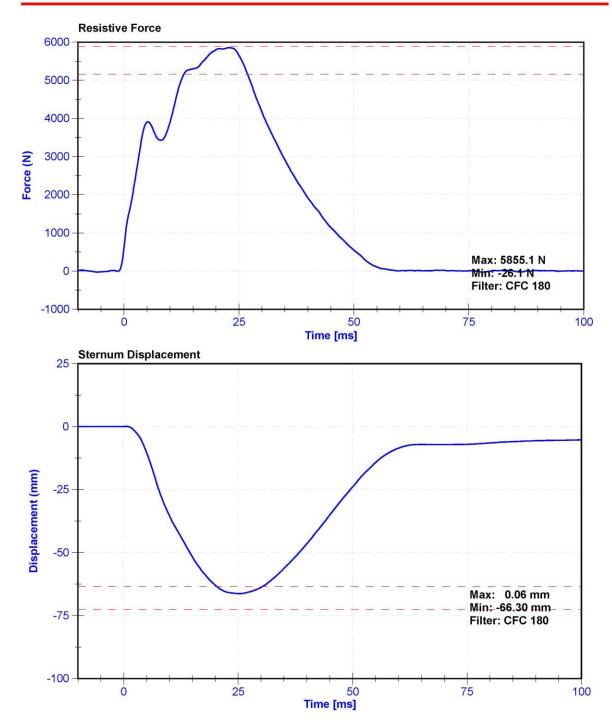
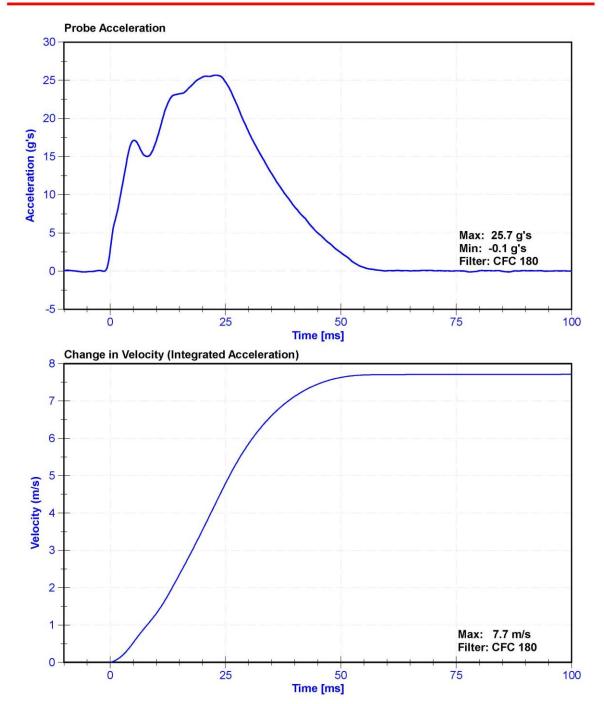
Certification Report Hybrid 3 - 50th Male Thorax Impact - CFR 572

Test Parameter	Minimum Specification	Maximum Specification	Unit	Result	Pass/Fail
Temperature	20.6	22.2	°C	21.5	Pass
Humidity	10	70	%	35	Pass
Velocity	6.59	6.83	m/s	6.788	Pass
Chest Displacement	-72.6	-63.5	mm	-66.30	Pass
Resistive Force	5160	5894	N	5855.1	Pass
Hysteresis	65	85	%	67.9	Pass

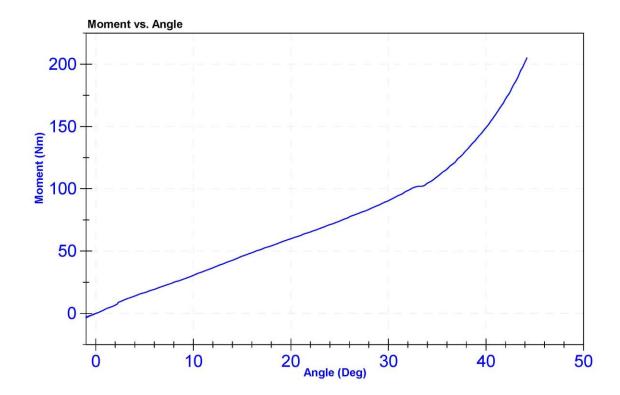
Certification Report Hybrid 3 - 50th Male Hip ROM Left - CFR 572

Test Parameter	Minimum Specification	Maximum Specification	Unit	Result	Pass/Fail
Temperature	18.9	25.6	°C	20.9	Pass
Humidity	10	70	%	32.7	Pass
Average Velocity	5	10	deg/s	7.1	Pass
Angle at 203Nm	40	50	deg	44.1	Pass
Moment at 30 degrees	0	94.9	Nm	90.4	Pass

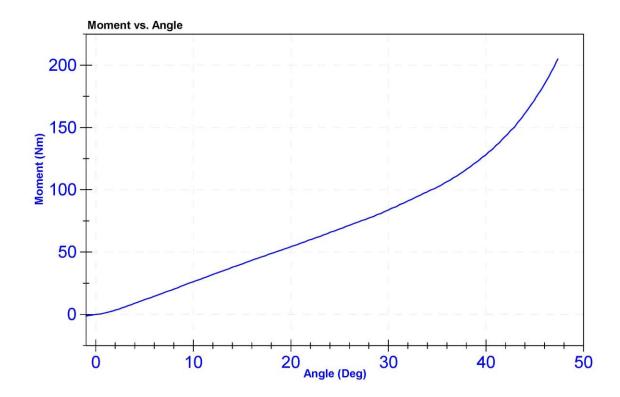
Certification Report Hybrid 3 - 50th Male Hip ROM Right - CFR 572

Test Parameter	Minimum Specification	Maximum Specification	Unit	Result	Pass/Fail
Temperature	18.9	25.6	°C	20.9	Pass
Humidity	10	70	%	32.7	Pass
Average Velocity	5	10	deg/s	7.1	Pass
Angle at 203Nm	40	50	deg	47.2	Pass
Moment at 30 degrees	0	94.9	Nm	83.8	Pass

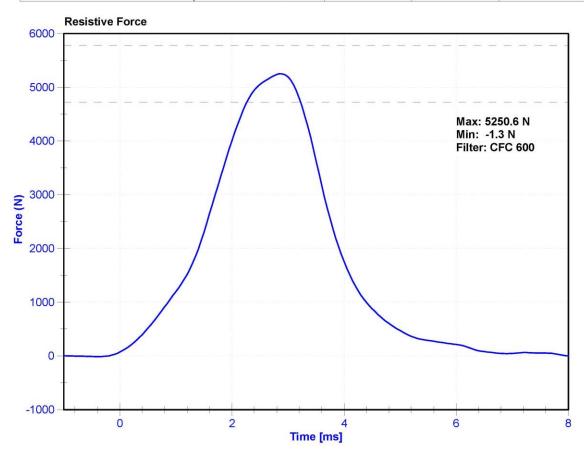
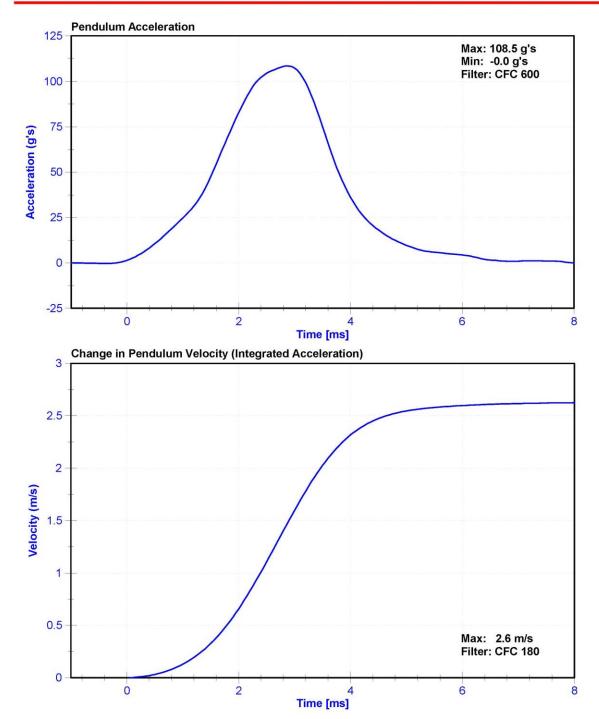
Certification Report 50th Male Left Knee Impact CFR 572

Test Parameter	Minimum Specification	Maximum Specification	Unit	Result	Pass/Fail
Temperature	18.9	25.6	°C	21.2	Pass
Humidity	10	70	%	27.8	Pass
Velocity	2.07	2.13	m/s	2.109	Pass
Maximum Resistive Force	4720	5780	N	5250.6	Pass

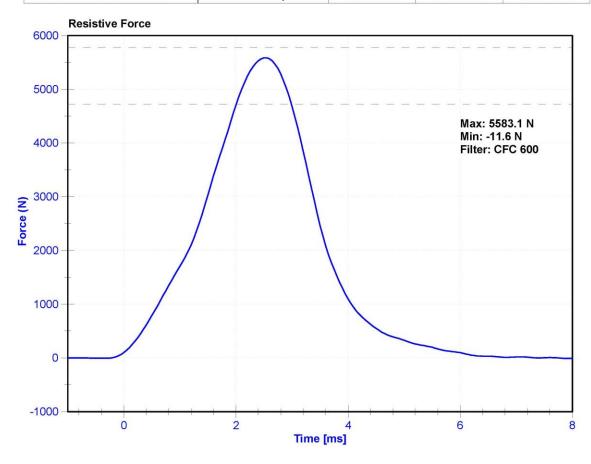
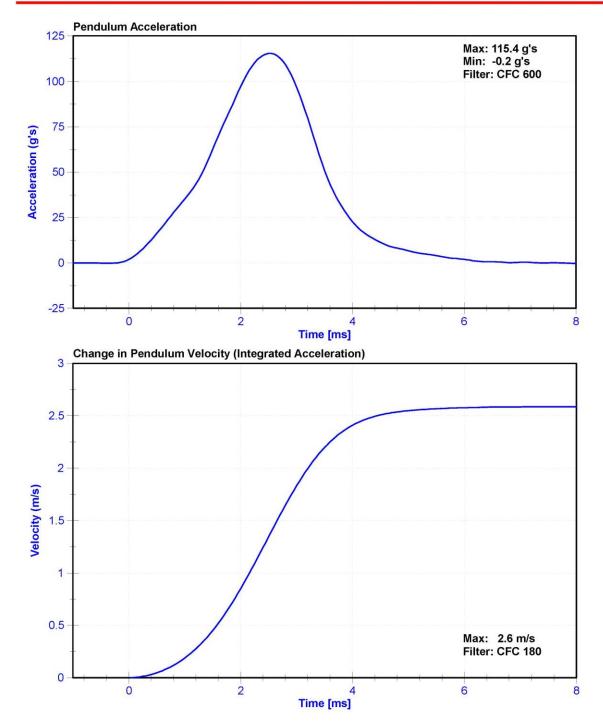
Certification Report 50th Male Right Knee Impact CFR 572

Test Parameter	Minimum Specification	Maximum Specification	Unit	Result	Pass/Fail
Temperature	18.9	25.6	°C	21.2	Pass
Humidity	10	70	%	27.8	Pass
Velocity	2.07	2.13	m/s	2.118	Pass
Maximum Resistive Force	4720	5780	N	5583.1	Pass

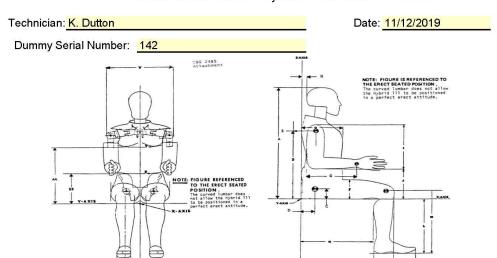
External Measurements - Hybrid 3 - 50th Male

HYBRID III Exterior Body Dimensions - Side View

Symbol	Description	C23(1.83 12) X30(3)	ication n)	Result (in)	Pass/Fail
Α	Sitting Height	34.6	35.0	34.8	Pass
В	Shoulder Pivot Height	19.9	20.5	20.2	Pass
С	H-Point Height	3.3	3.5	3.4	Pass
D	H-Point from Backline	5.3	5.5	5.4	Pass
Е	Shoulder Pivot from Backline	3.3	3.7	3.5	Pass
F	Thigh Clearance	5.5	6.1	5.7	Pass
G	Back of Elbow to Wrist Pivot	11.4	12.0	11.8	Pass
Н	Head Back to Backline	1.6	1.8	1.7	Pass
ľ	Shoulder to Elbow Length	13.0	13.6	13.5	Pass
J	Elbow Rest Height	7.5	8.3	8.2	Pass
K	Buttock to Knee Length	22.8	23.8	23.3	Pass
L	Popliteal Height	16.9	17.9	17.3	Pass
M	Knee Pivot Height	19.1	19.7	19.4	Pass
N	Buttock Popliteal Length	17.8	18.8	18.4	Pass
0	Chest Depth without Jacket	8.4	9.0	8.6	Pass
Р	Foot Length (right)	9.9	10.5	10.3	Pass
V	Shoulder Breadth	16.3	17.2	16.8	Pass
W	Foot Breadth	3.6	4.2	3.8	Pass
Υ	Chest Circumference with Jacket	38.2	39.4	38.9	Pass
Z	Waist Circumference	32.9	34.1	33.7	Pass
AA	Reference Location (Chest Circumference)	16.9	17.1	17.0	Pass
