**OCAS-DRI-LDW-19-05
NEW CAR ASSESSMENT PROGRAM
LANE DEPARTURE WARNING CONFIRMATION TEST**

2019 Subaru Crosstrek Hybrid

Final Report

1. Report No. OCAS-DRI-LDW-19-05	2. Government Accession No.	3. Recipient's Catalog No.	
4. Title and Subtitle Final Report of Lane Departure Warning Testing of a 2019 Subaru Crosstrek Hybrid.		5. Report Date 17 January 2020

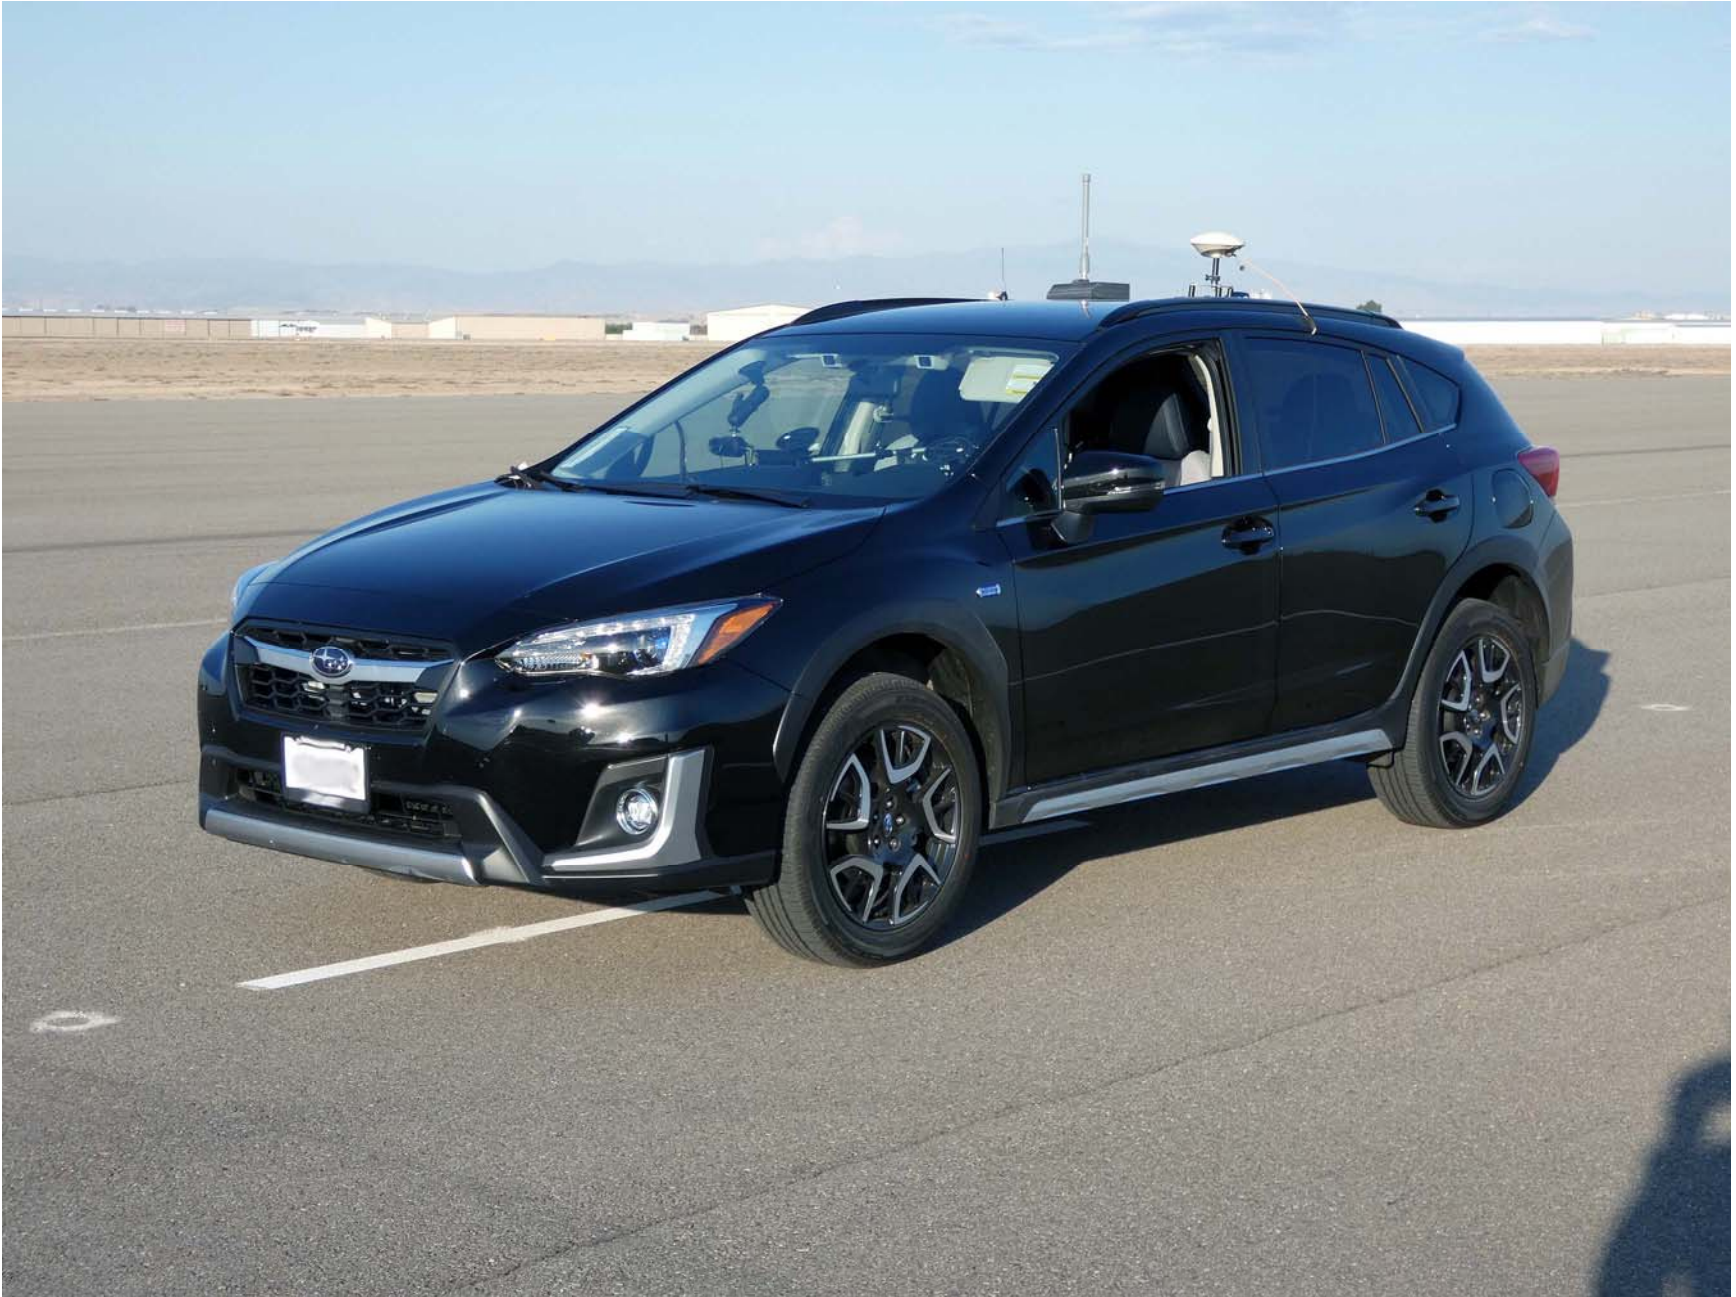
Figure A1. Front View of Subject Vehicle

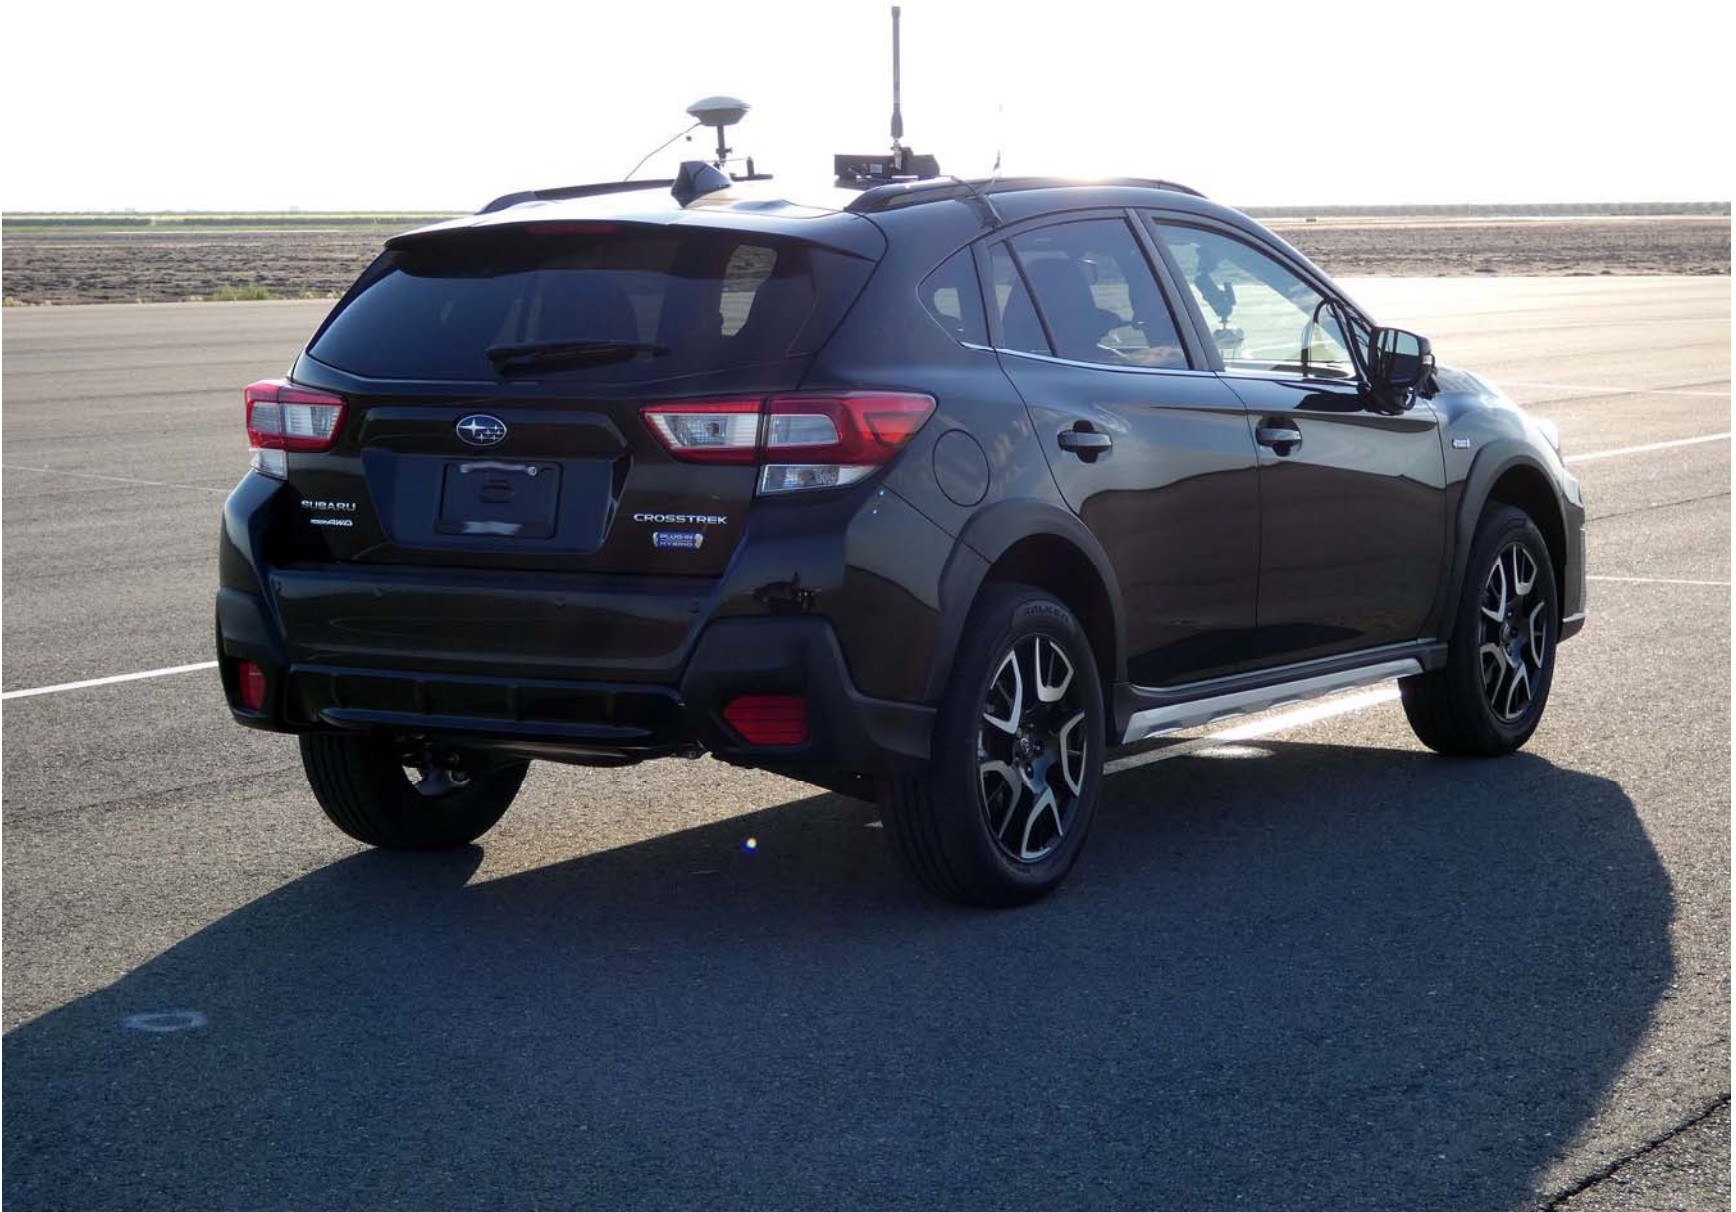
Figure A2. Rear View of Subject Vehicle

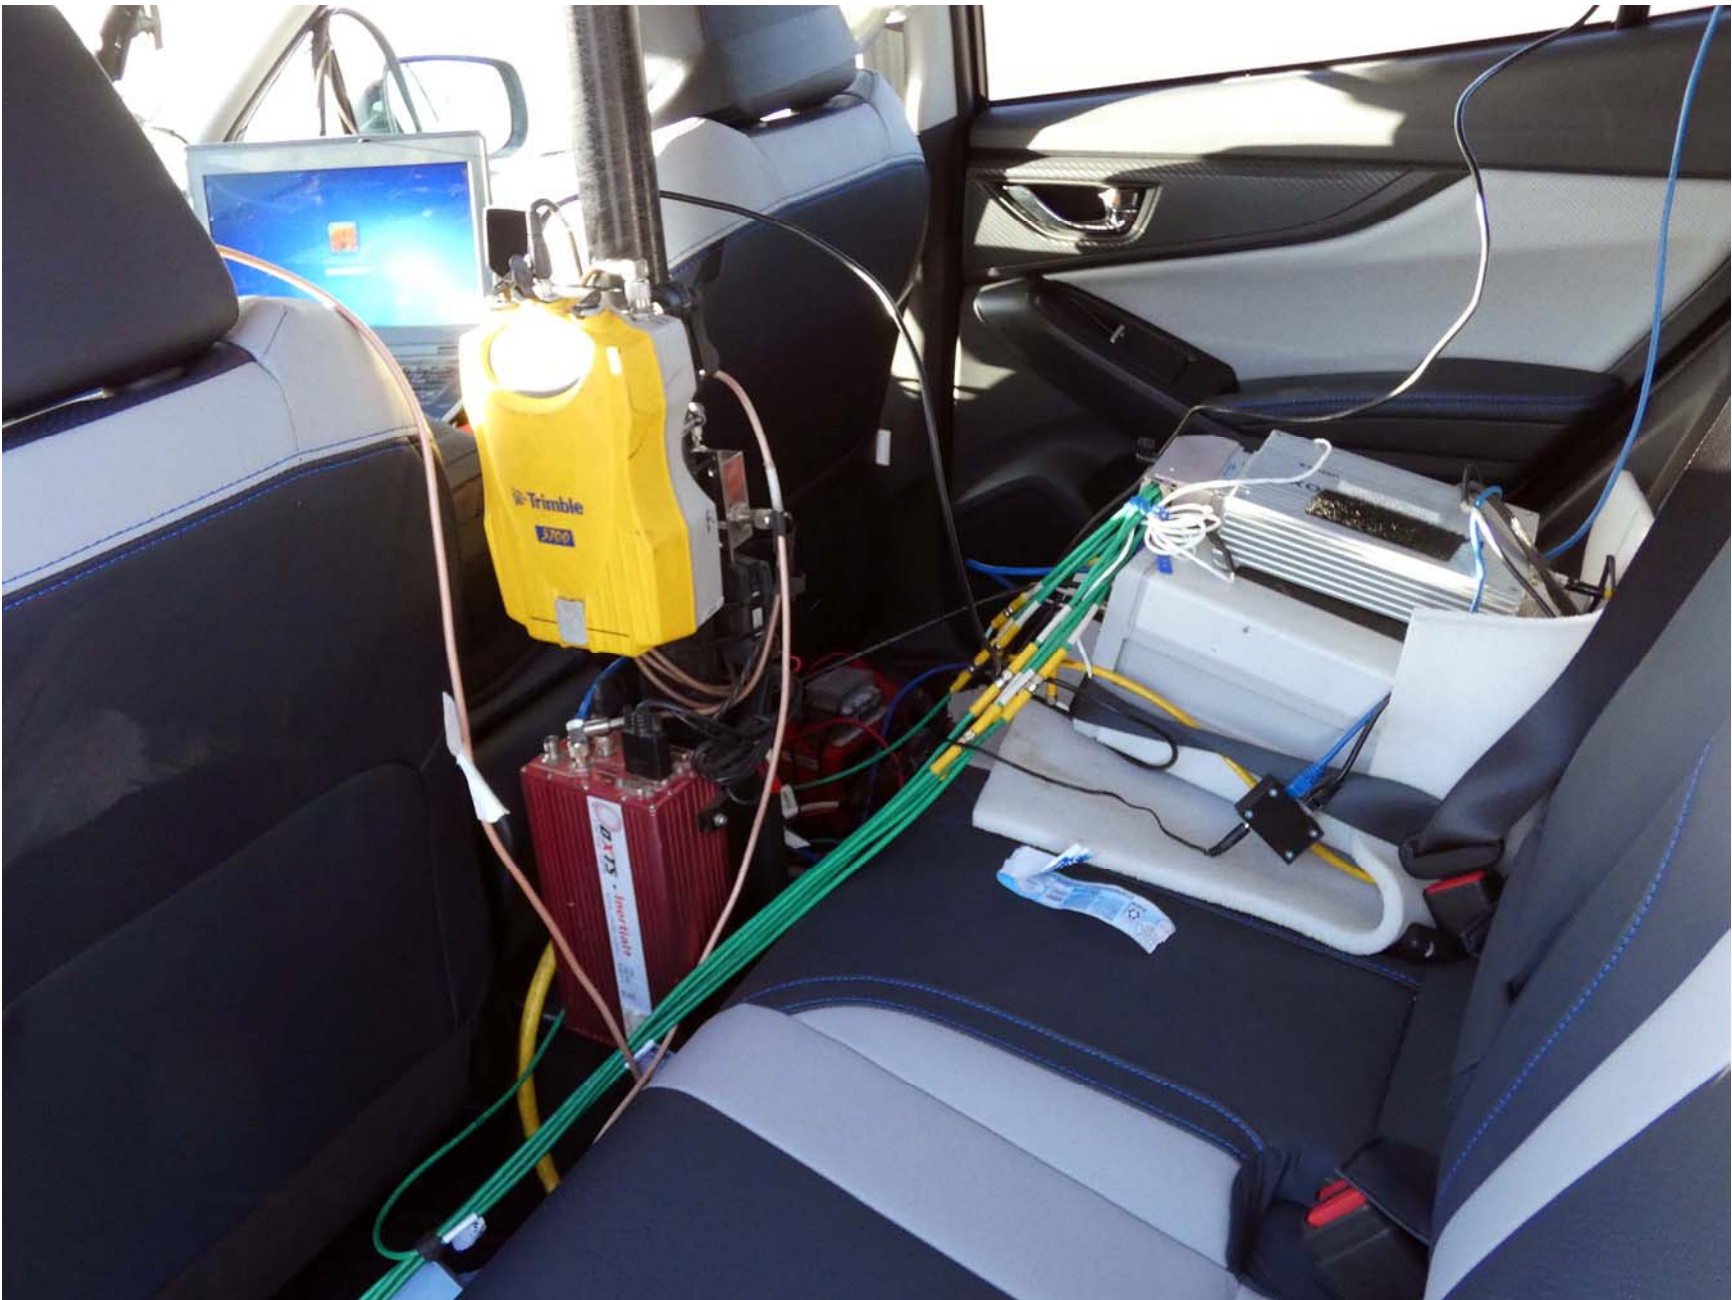
Figure A6. DGPS, Inertial Measurement Unit and MicroAutoBox Installed in Subject Vehicle

Table 2 lists the sensors, signal conditioning, and data acquisition equipment used for these tests.

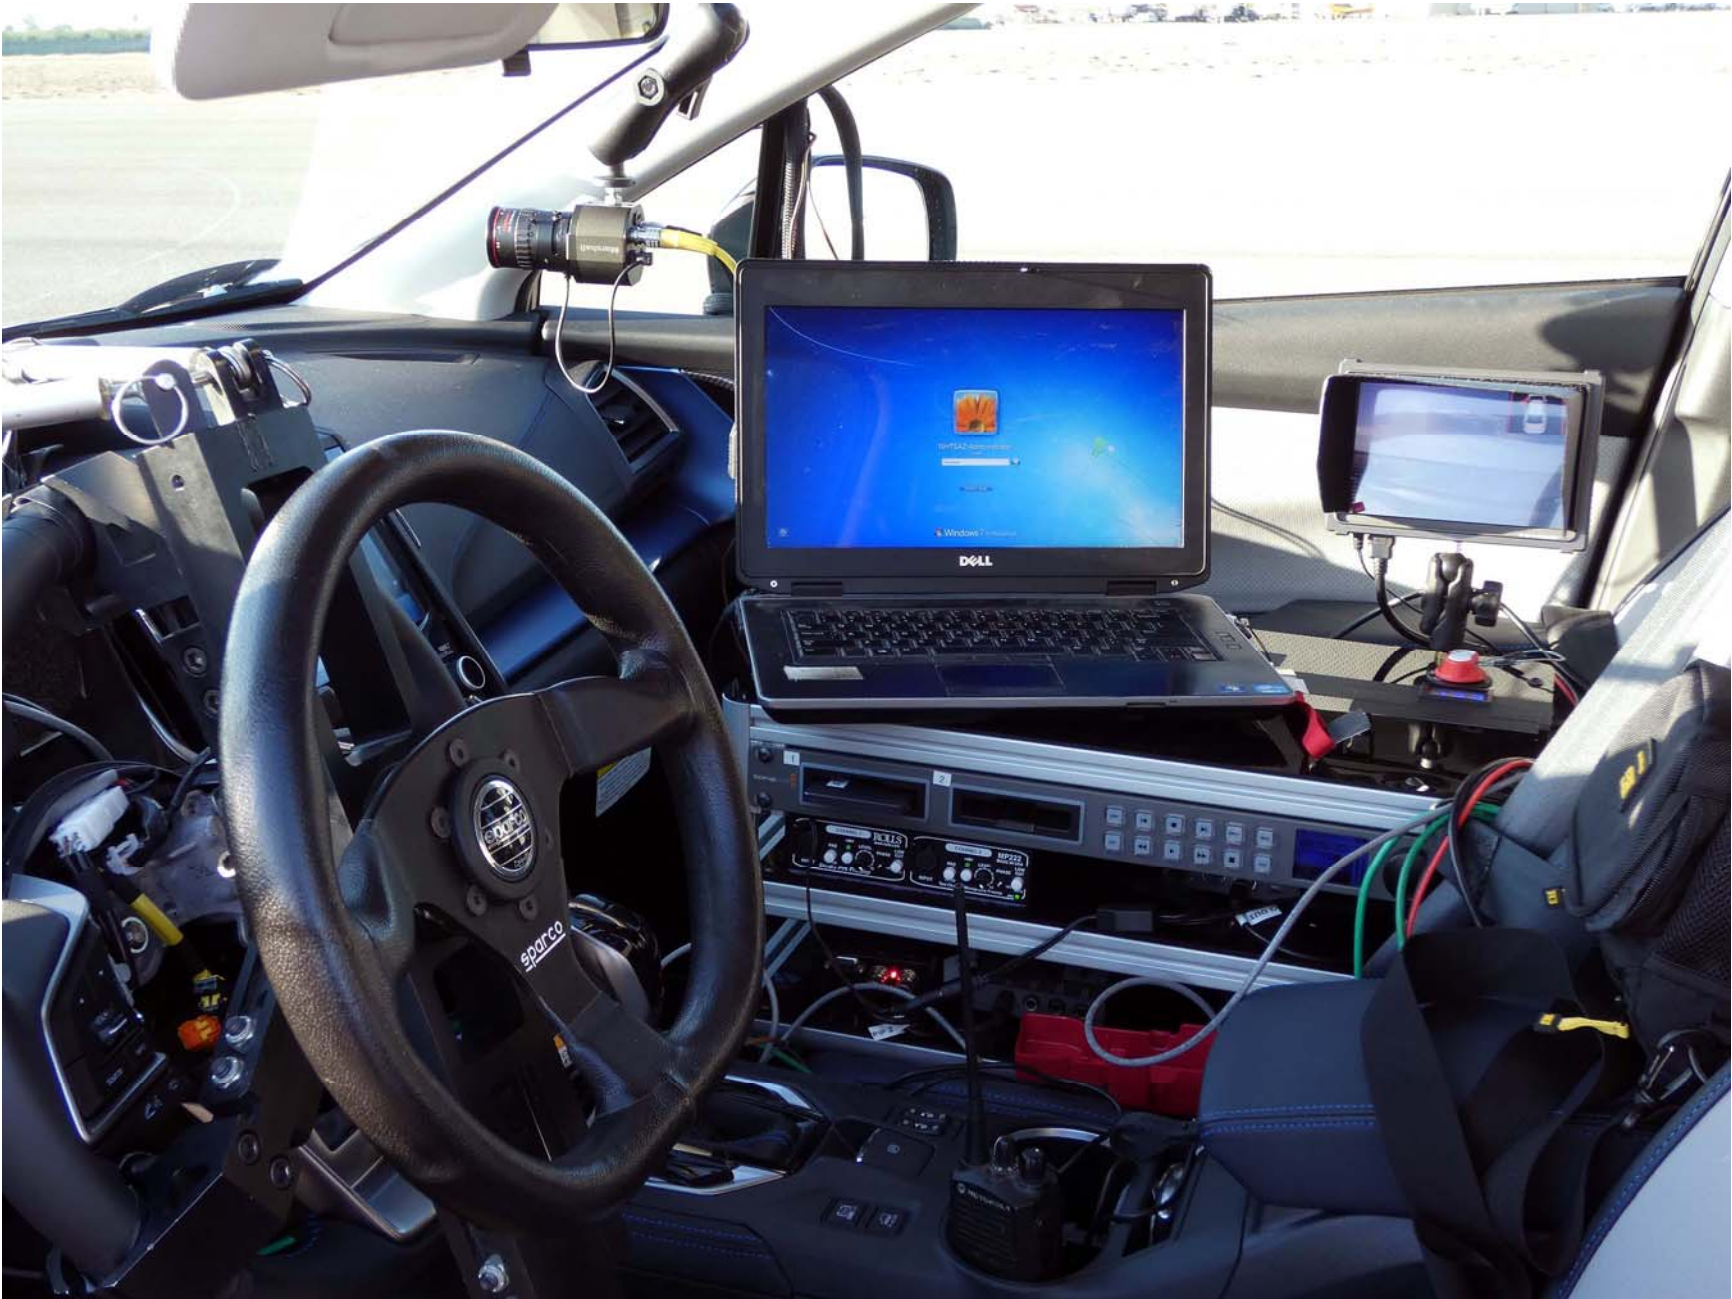
Figure A7. Computer Installed in Test Vehicle

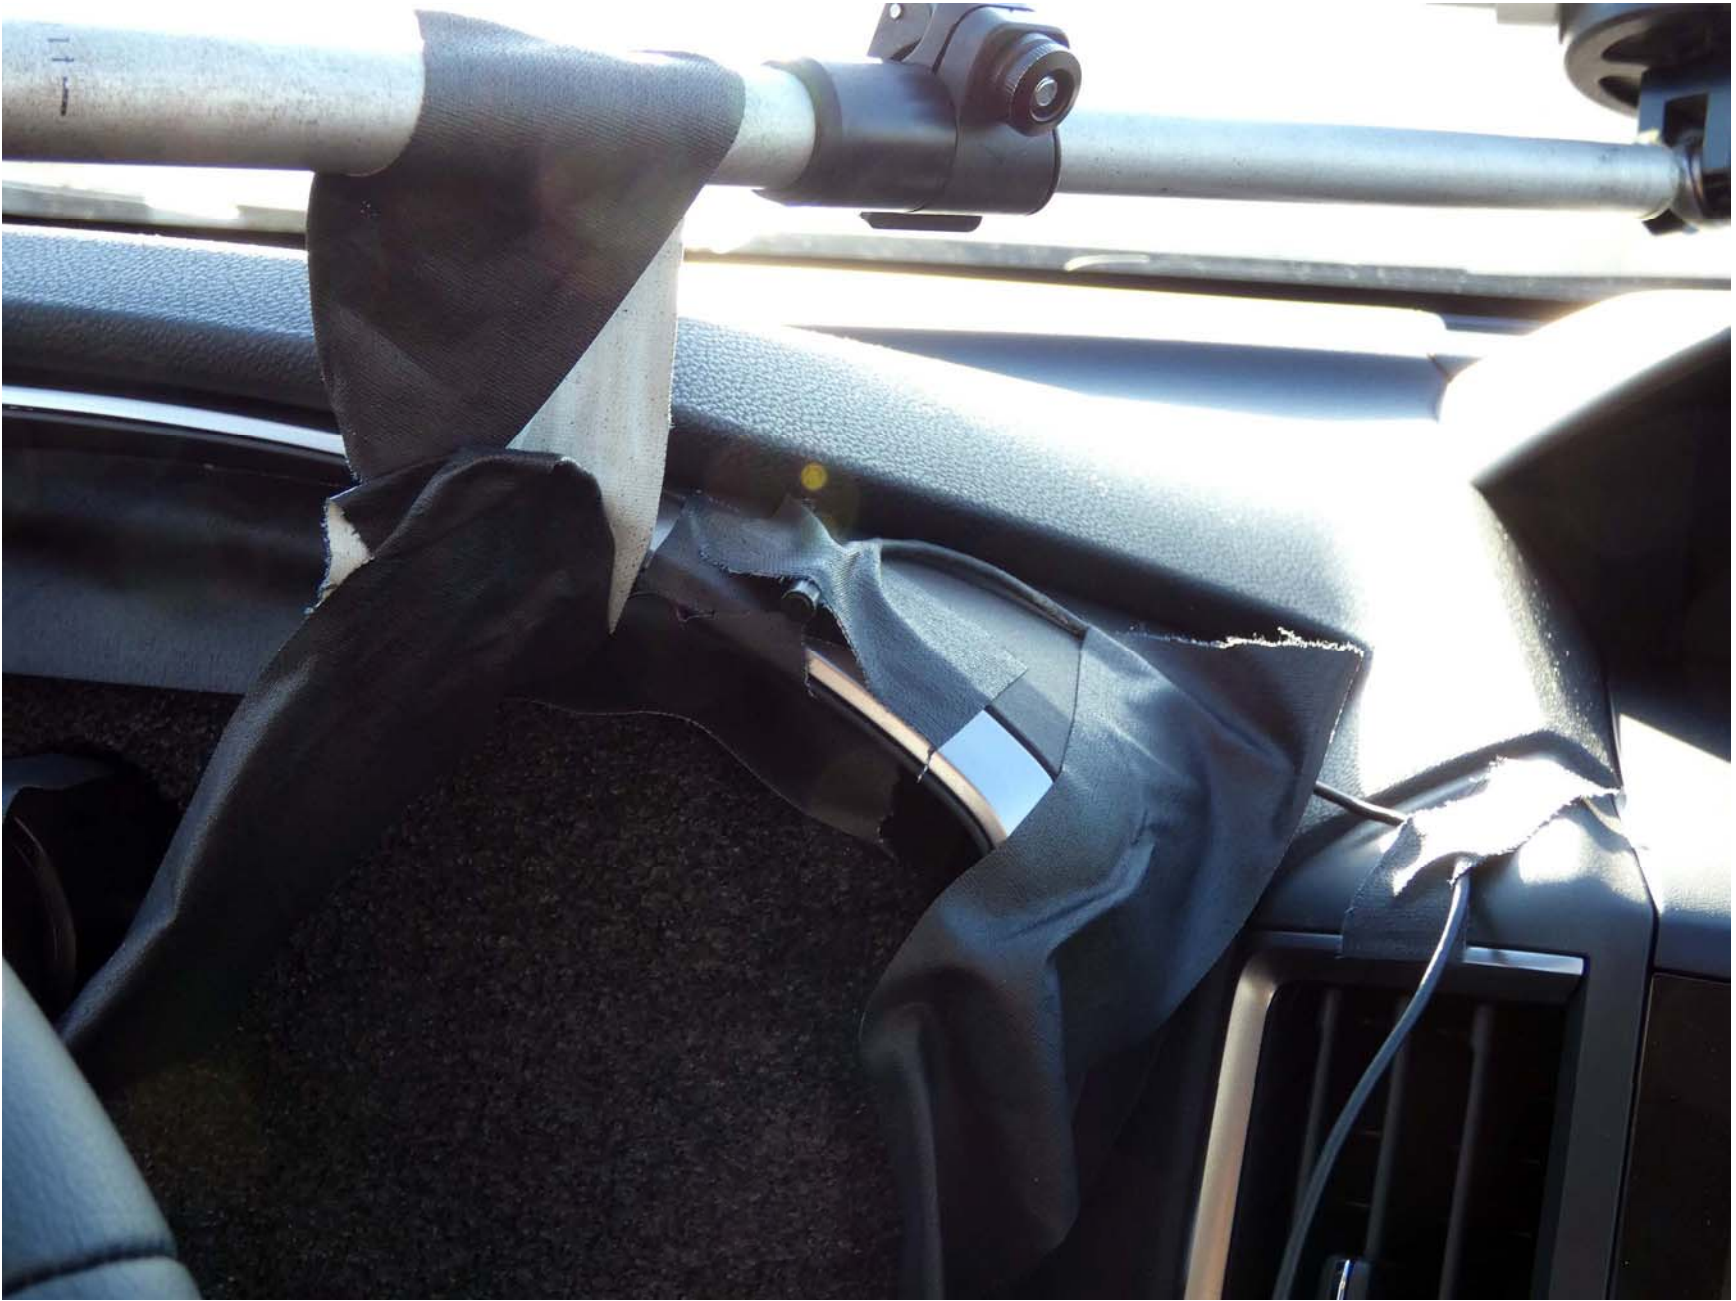
Figure A8. Sensor for Detecting Auditory Alerts

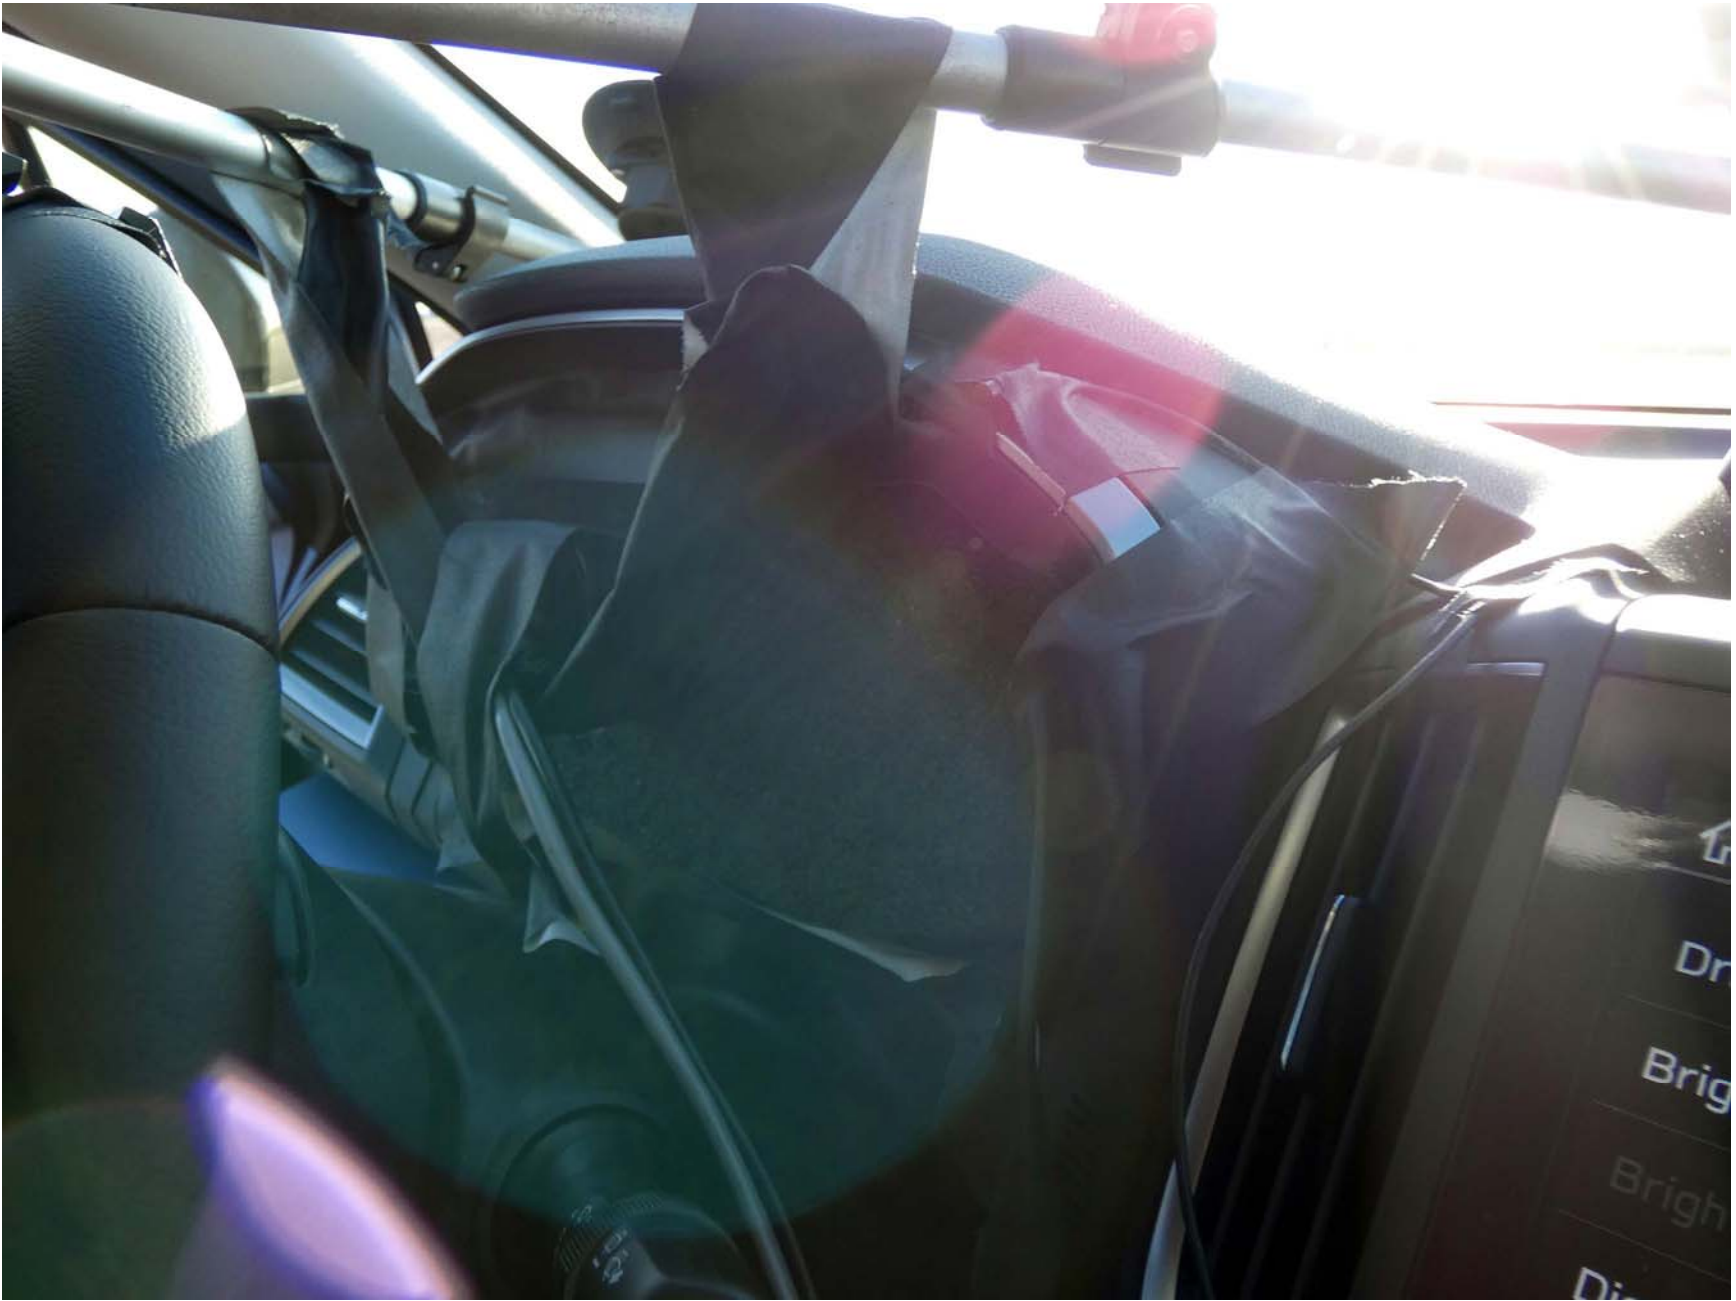
Figure A9. Sensos for Detecting Visual Alerts

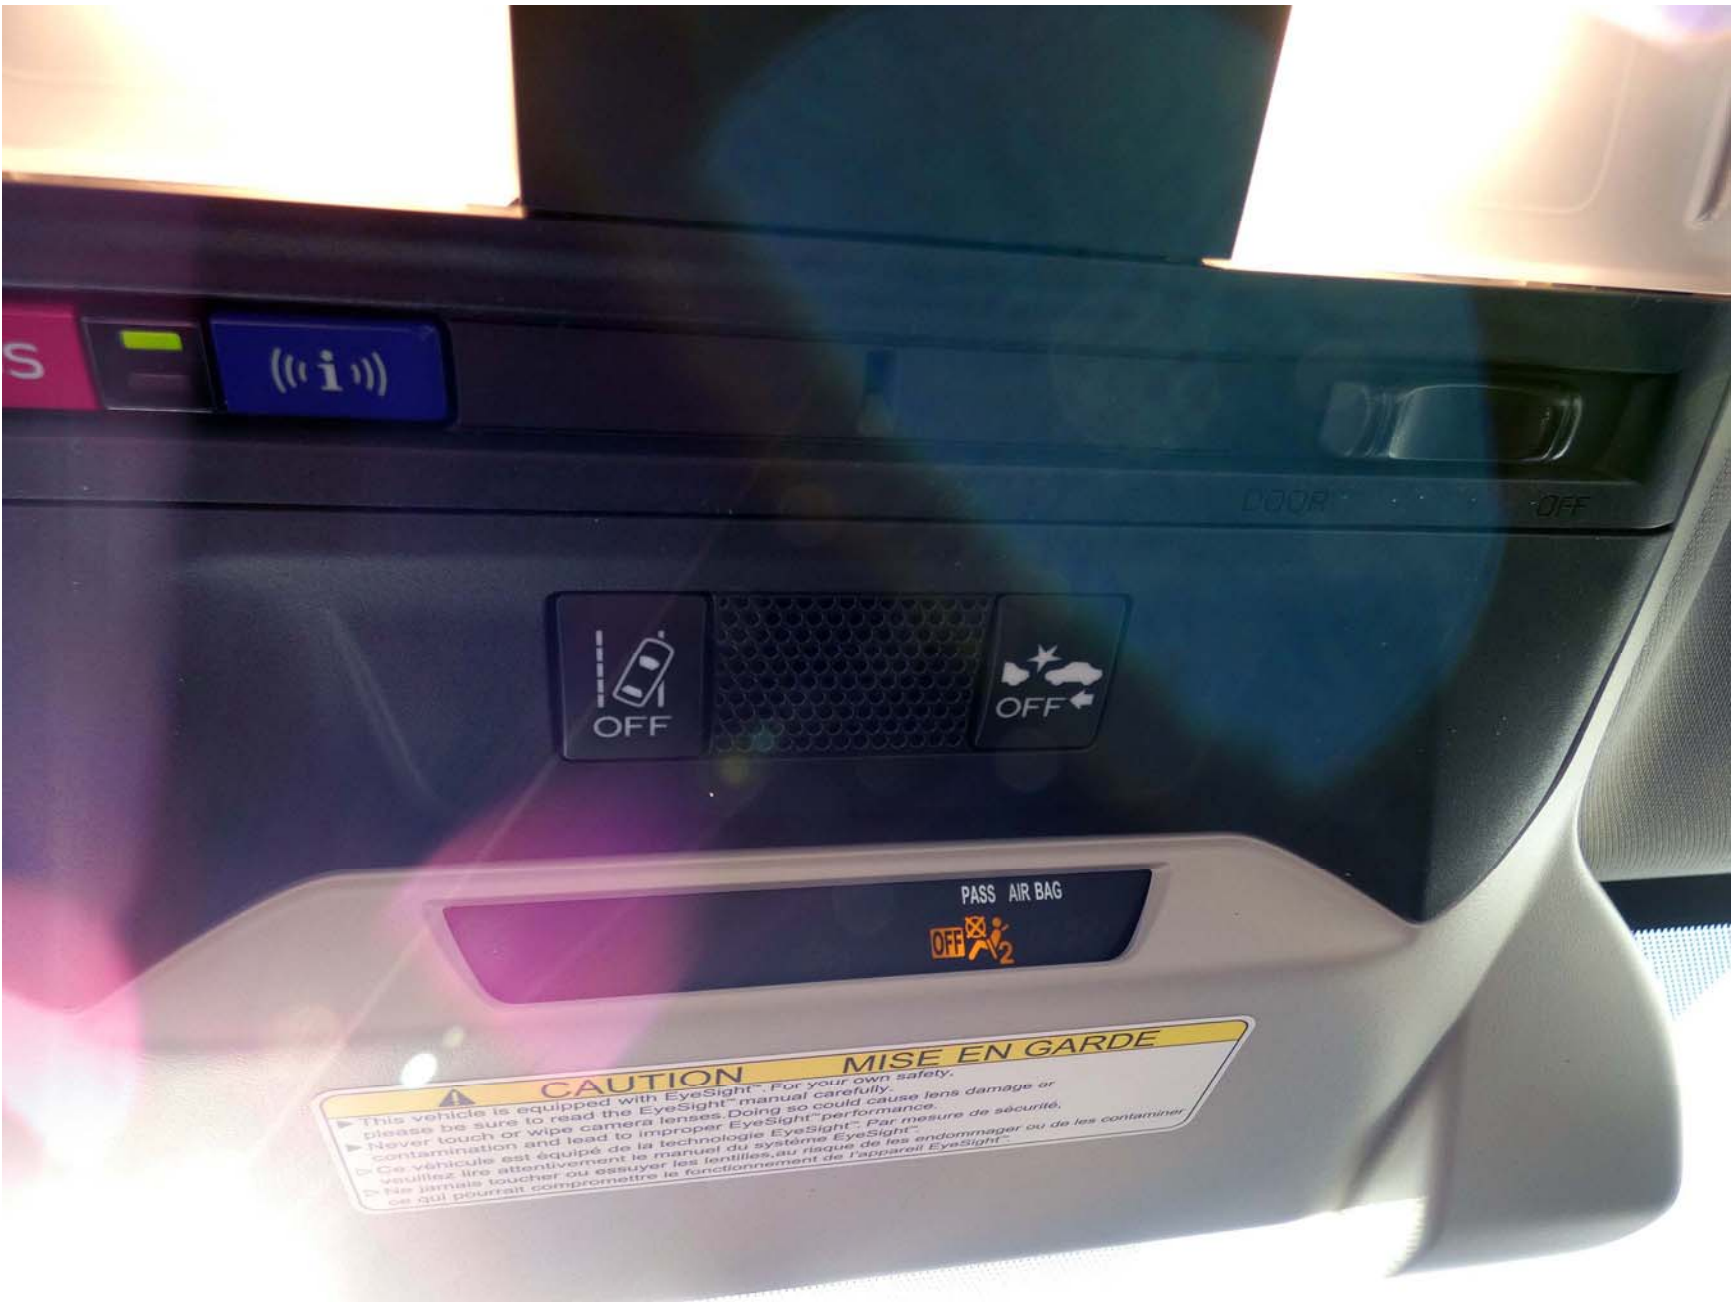
Figure A11. LDW On/Off Switch

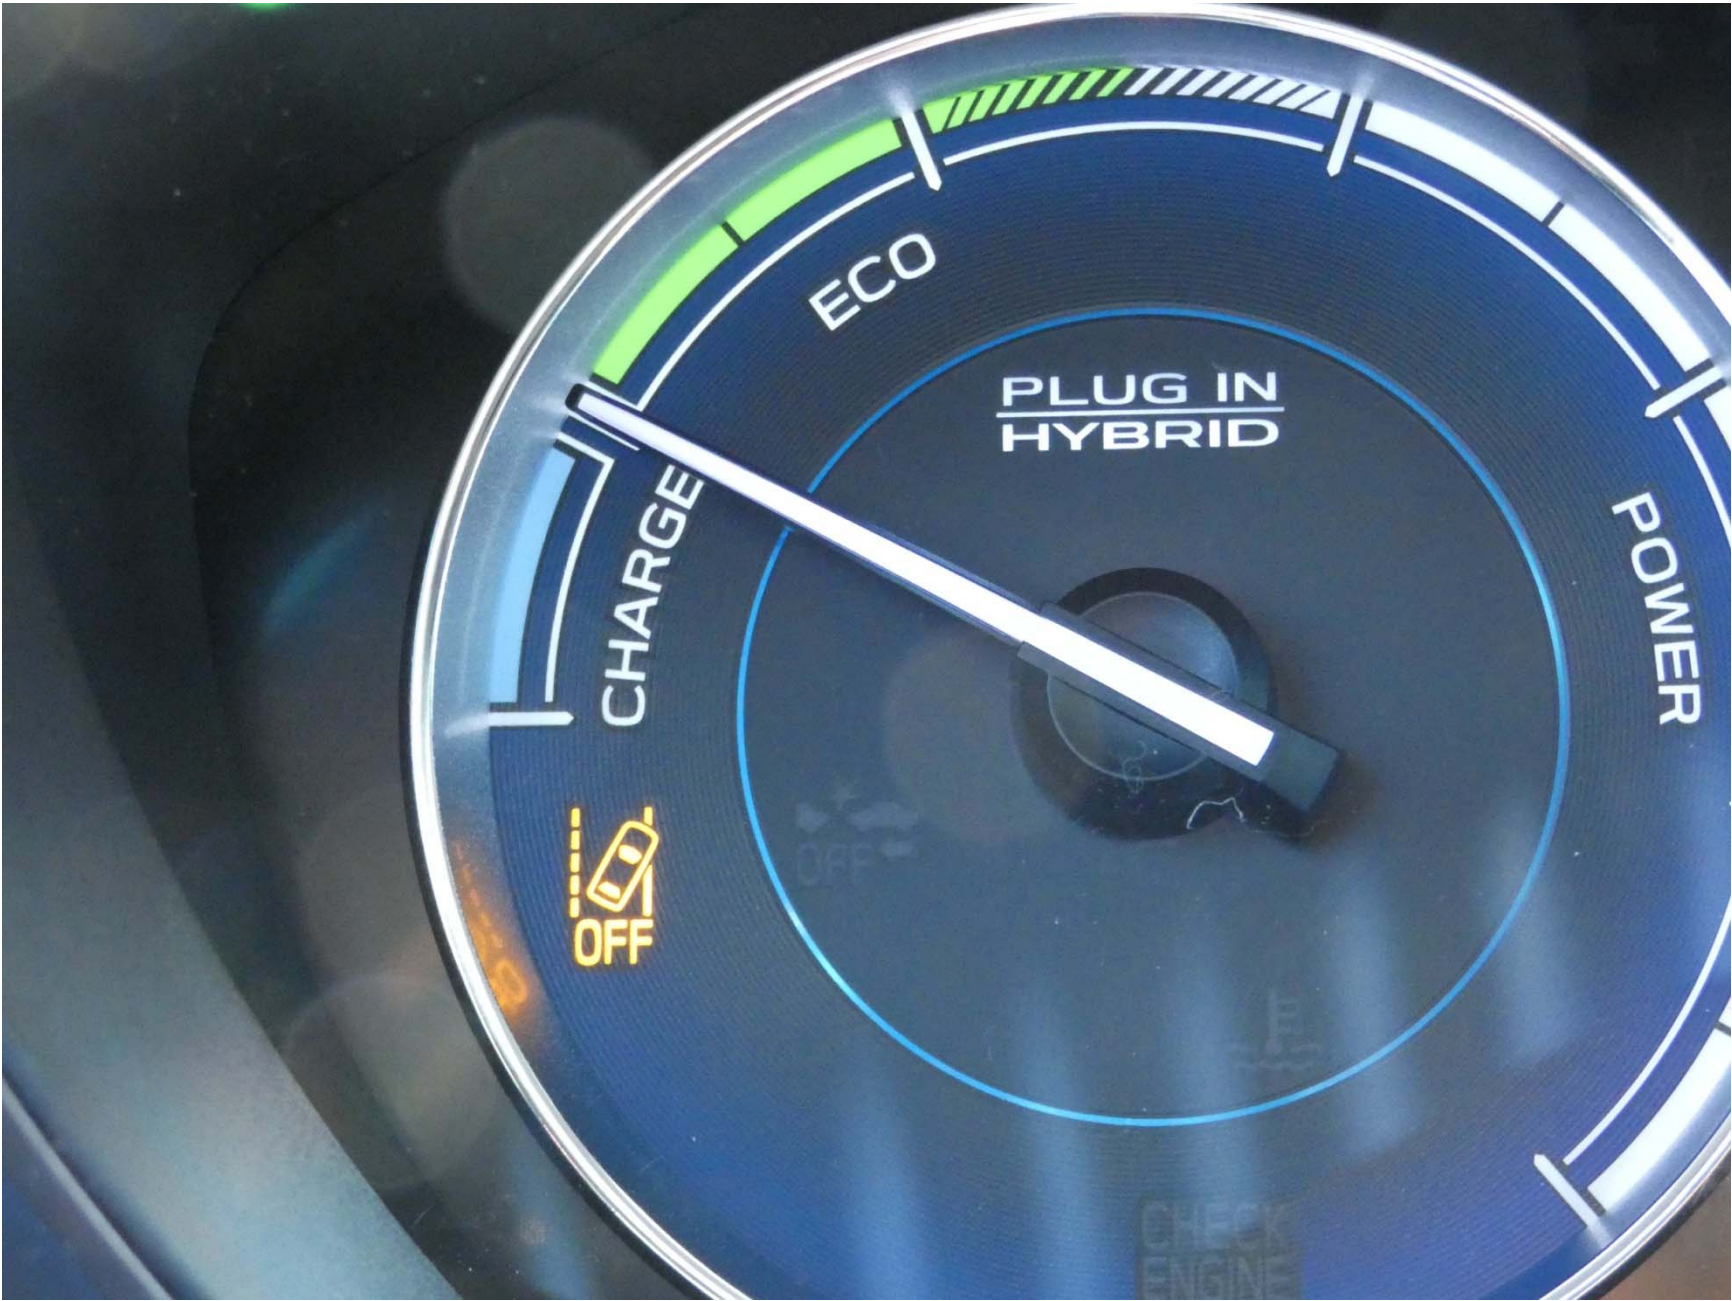
Figure A12. LDW Off Display
