DOT HS 811 797

July 2013

# **Evaluation of Laboratory Tire Tread and Sidewall Strength (Plunger Energy) Test Methods**

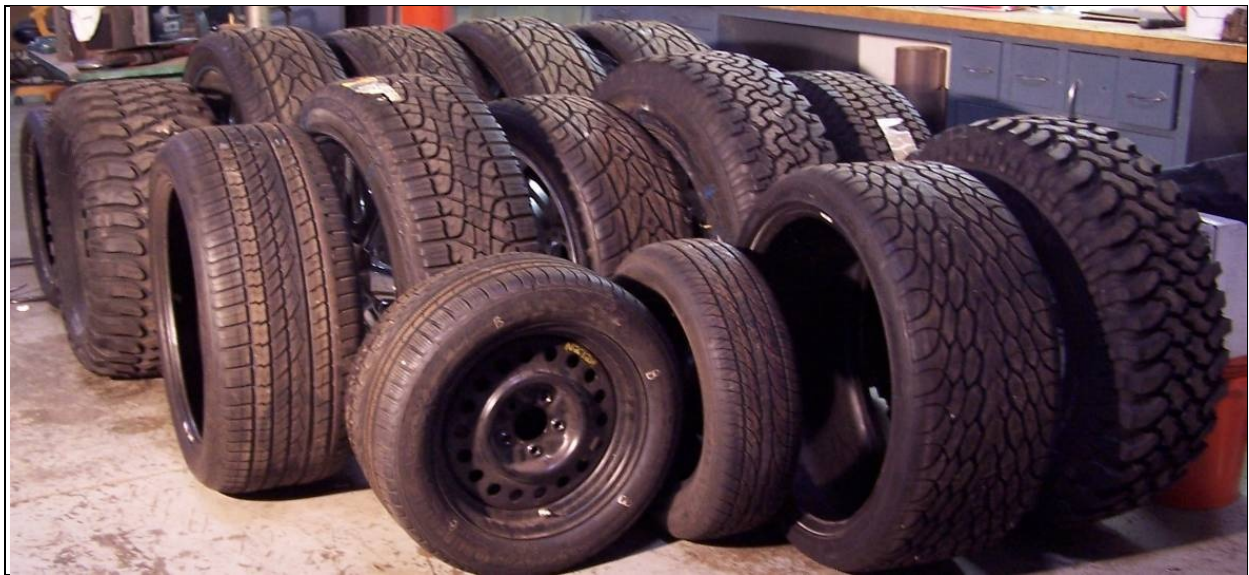
**Figure 2.1 Test Tires**

Eighteen tire models were selected for testing to give a wide range of tire sizes, aspect ratios, and rim codes. The test tires had widths from 155 to 345 millimeters, aspect ratios from 30 to 80, and rim codes from 12 to 28. They were selected to evaluate the limits of the test equipment in terms of physical dimensions and possible forces required to rupture the tire. Five models of commercially available light truck (LT) tires were selected to allow evaluation of the testing for FMVSS No. 119 requirements. The tires focused on the extremes of sizes from those used for off-road high flotation, to those designed for ultrahigh performance applications. The 13 models of commercially available passenger tires were selected to allow evaluation of the testing for FMVSS No. 109 requirements. The passenger tire models included very small (155R12) to very large (325/30R28) tires. All tires tested were DOT-approved for street use. While tires from the smaller rim codes were selected from typical all-season designs, most of the available tires in the 18 to 28-rim codes were high performance designs. A complete list of the tires is found in Table 2.1. Figure 2.1 contains a photograph of most, but not all, of the tires tested.

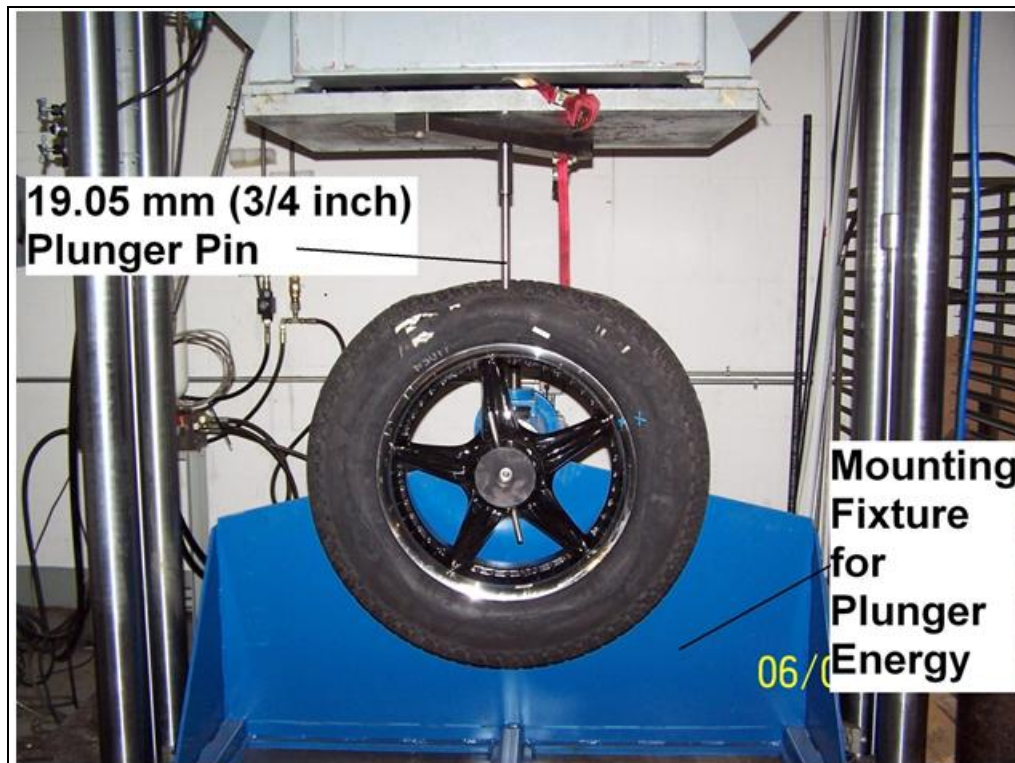
**Figure 3.1 Plunger Energy Machine**

The plunger energy fixture was designed to fit into an existing MTS load frame (see Figure 3.1 and Figure 3.2). The 19-mm ( $\frac{3}{4}$  -inch) diameter cylindrical steel plunger specified in FMVSS No. 109, SAE J 918 and in ASTM F414-06 was obtained for the testing. The FMVSS Nos. 109 and 119 require this one size for passenger tires and light truck tires through load range H. The load frame was computer controlled and programmed to travel at the required 50.8 mm (2.0 inches) per minute. It was also capable of recording the load and deflection during each attempted penetration. Stopping of the test was determined by the test operator, either when the plunger ruptured the tire or bottom-out occurred. When the plunger pushed the tread of tire until contact with the rim was made, the load increased rapidly but the tire may not have ruptured. Often the rim contour caused the plunger to be deflected off to the side, bending the plunger. Therefore, careful operation of the equipment was necessary as the plunger neared bottom-out.

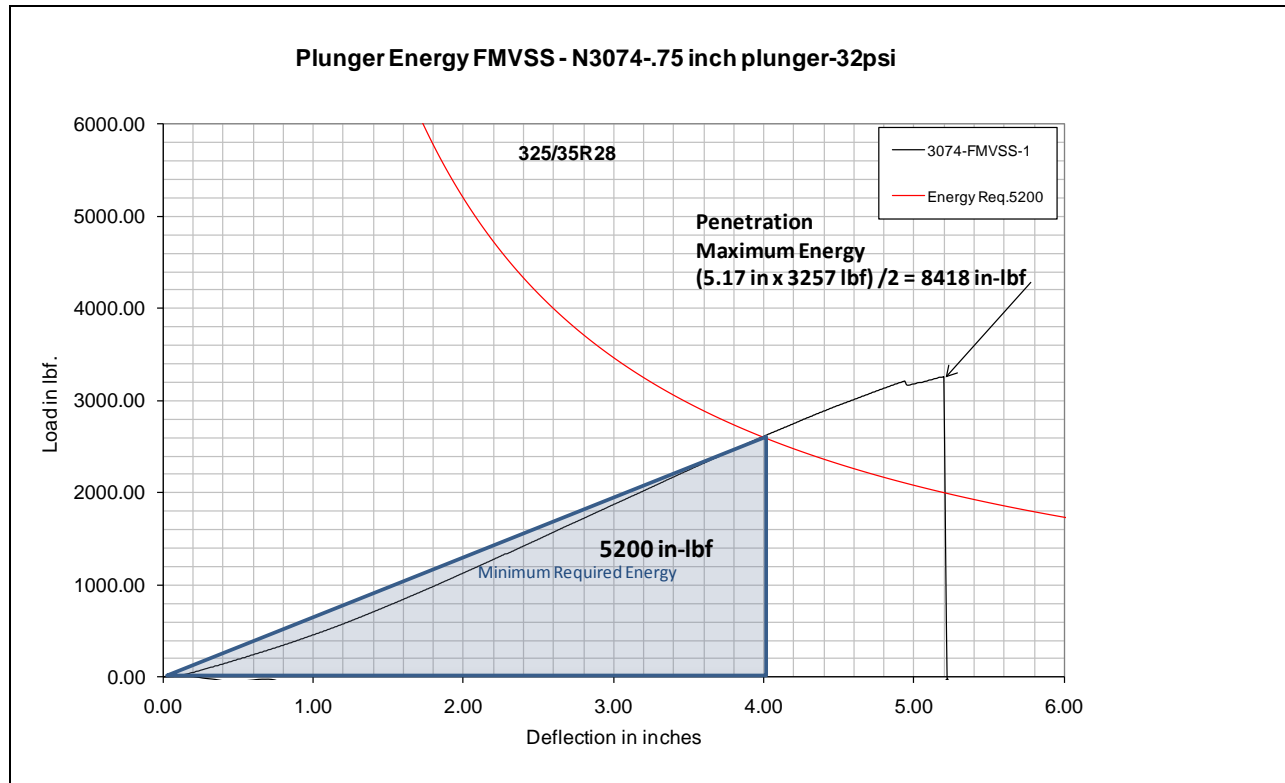
**Figure 3.3 Load Deflection Graph**

To determine the breaking energy value for the tire, the average of the five values is obtained. Figure 3.3 shows a typical load-deflection graph for one test run with penetration taken to rupture. The shaded area is the minimum required energy calculated at the point the test load-deflection curve reaches the minimum. The maximum energy is calculated at the point the tire ruptures.

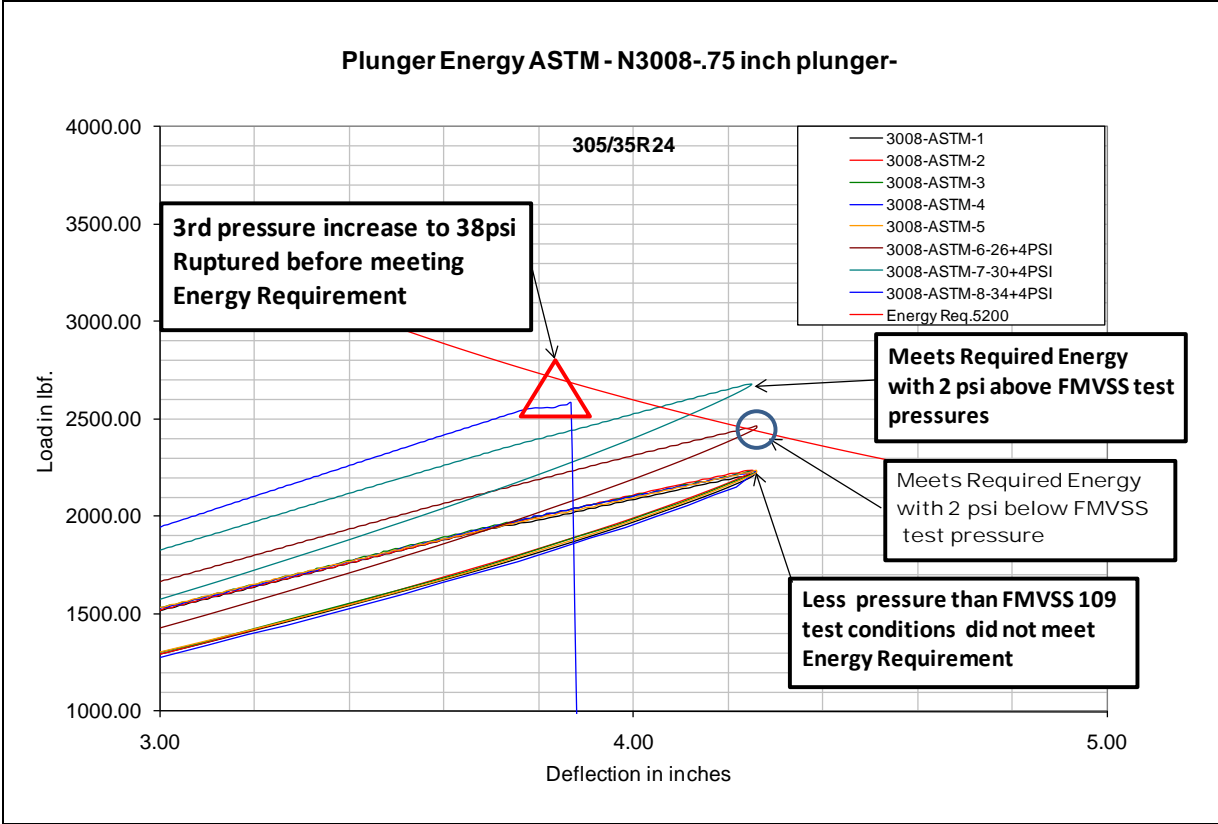
**Figure 5.1 Tests of Tire M8-N3008**

Tests on three passenger tires were also conducted with ASTM F414-06 using a lower-than-specified pressure at the start of testing. One tire (N3008) did not reach the required energy level before bottoming-out in its five test runs at 26 psi. Three more runs were conducted with +4 psi pressure increments for each test. The first and second pressure increases, or 30 and 34 psi, generated enough breaking energy to meet FMVSS minimum requirements. However, the test at the third pressure of 38 psi resulted in the tire rupturing before meeting the minimum energy requirement (Figure 5.1). This was a significant finding, because it suggests that extrapolations of energy levels at lower pressures may not always be predictive of a test at a higher pressure. Another tire (N3028) did not reach the required energy level before bottoming-out in its five test runs at 26 psi. The tire generated increasingly higher energies with each incremental test pressure, eventually reaching the required FMVSS minimum energy in the 38, 42, and 46-psi test runs without any ruptures (Figure 5.2). The final tire (N3020) exceeded the minimum energy requirement on all 26-psi test runs, and also continued to generate higher average energies with each incremental pressure increase (Figure 5.3).

pressure. Tire models Y1 (N3028) and M8 (N3008) did not reach the required energy at 26 psi (Figure 5.2 and Figure 5.1) before bottom-out occurred. Normal testing for these models would have been at 32 psi. All four light truck tires ruptured before rim bottom-out, while none of the four passenger tires ruptured. The taller light truck tires have much more available plunger travel before bottom-out, which may explain these results. Complete graphs can be found in Appendix 2.

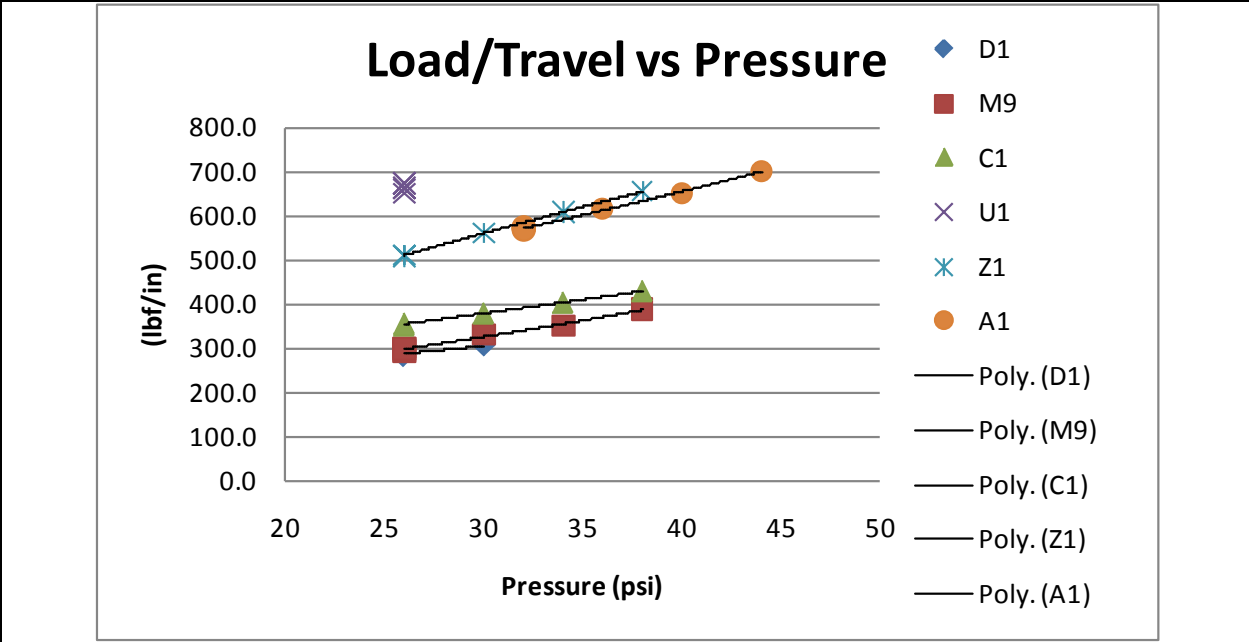
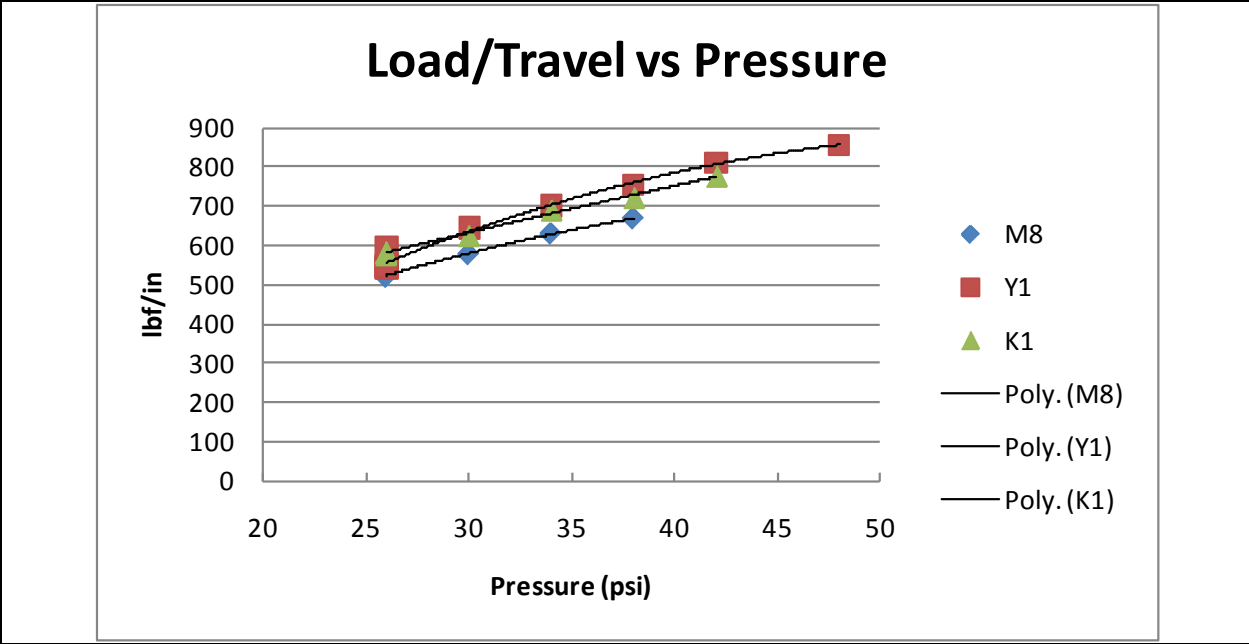
**Figure 5.4 ASTM F414-06 - Maximum Energy/Travel (Spring Rate) Versus Inflation Pressure**

Another effect of pressure observed was that as the pressure was increased, the spring rate of the tire increased as well. This is expected as the increased pressure makes the compression of the tire tread more difficult. This effect was found not to be linear in all cases. The slope of the increase was also not consistent from tire model to tire model. See Figure 5.4 ASTM F414-06 - Maximum Energy/Travel (Spring Rate) Versus Inflation Pressure for a comparison of the result of pressure increases.

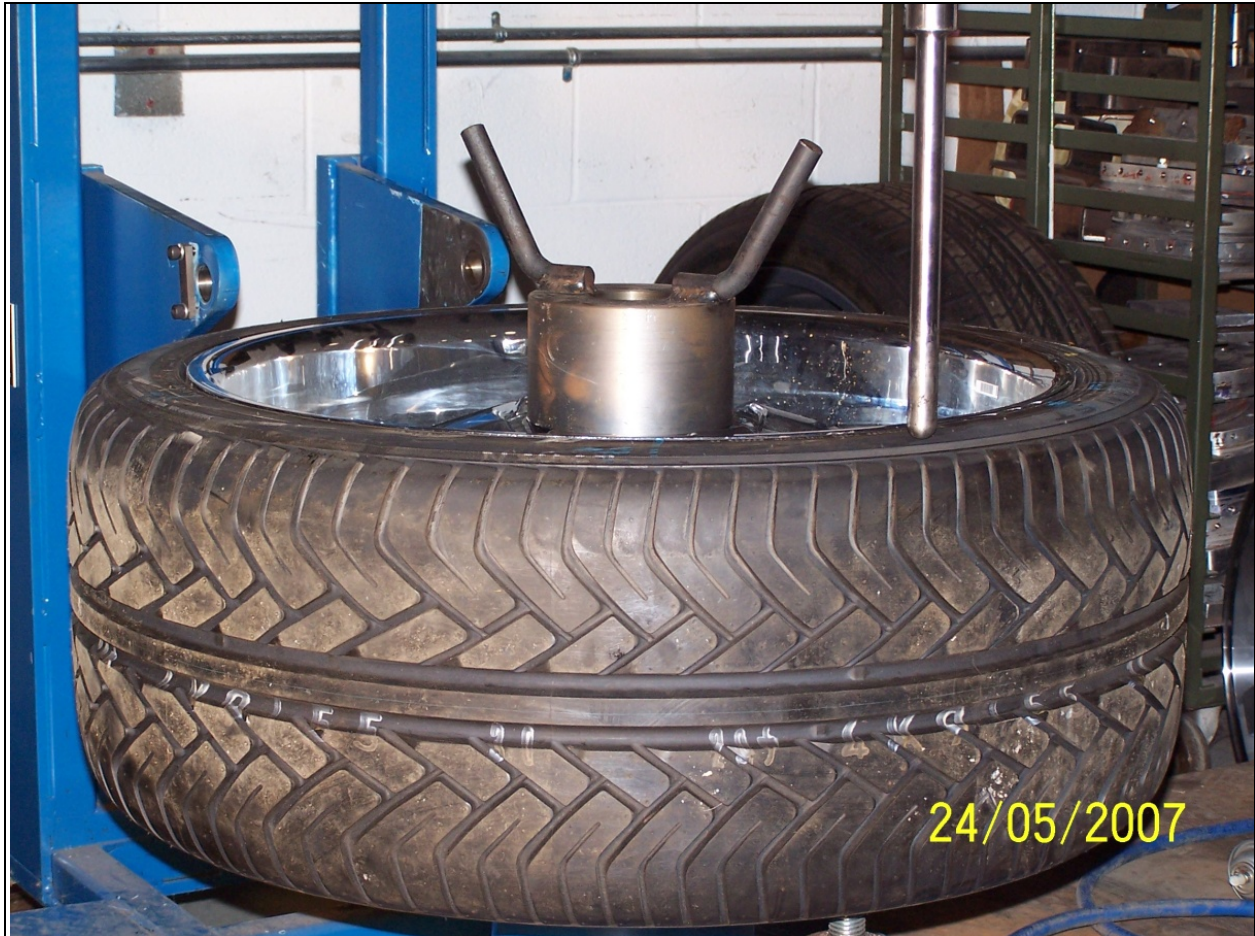
**Figure 6.1 Bead Unseat Fixture with Arm Removed**

During the development of the sidewall plunger test, the tire and wheel were mounted on the base of the bead unseat fixture with the arm removed (see Figure 6.1).

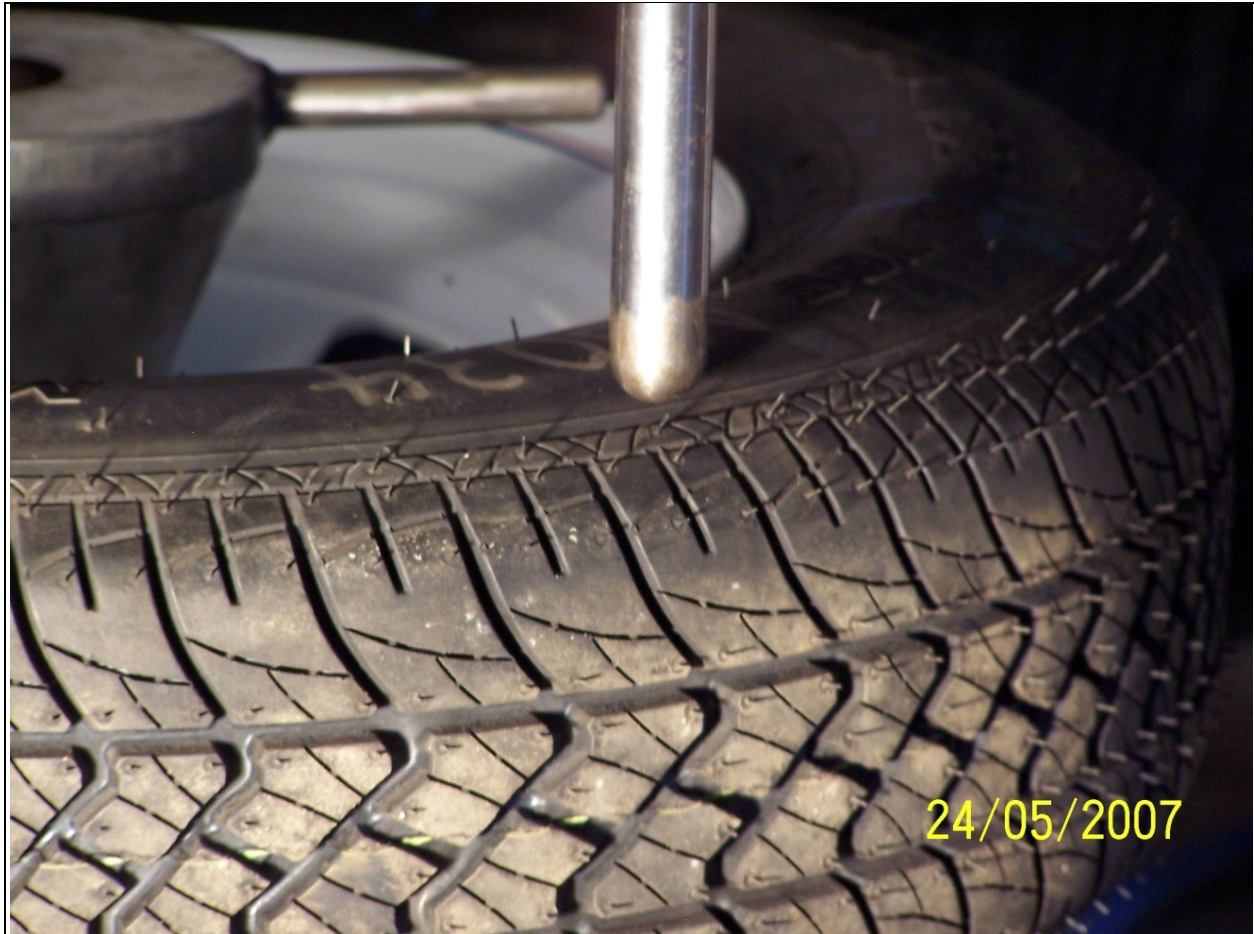
**Figure 6.2 Plunger Placement**

The placement of the plunger was based on the positioning plan from the bead unseating test in ASTM F 2663-07. The location is at the FMVSS NO. 109 dimension “A” setting or 75 percent of the sidewall height, whichever is the least. It is the distance from the axle (rotational) centerline of the tire/wheel assembly and the centerline of the 19-mm (3/4-inch) plunger. The intended location for the plunger should be between the belt edges and the thinnest section of the sidewall. Figure 6.2 shows an example of the plunger placement. Table 5.3 of the prior section lists the tire and plunger placements.

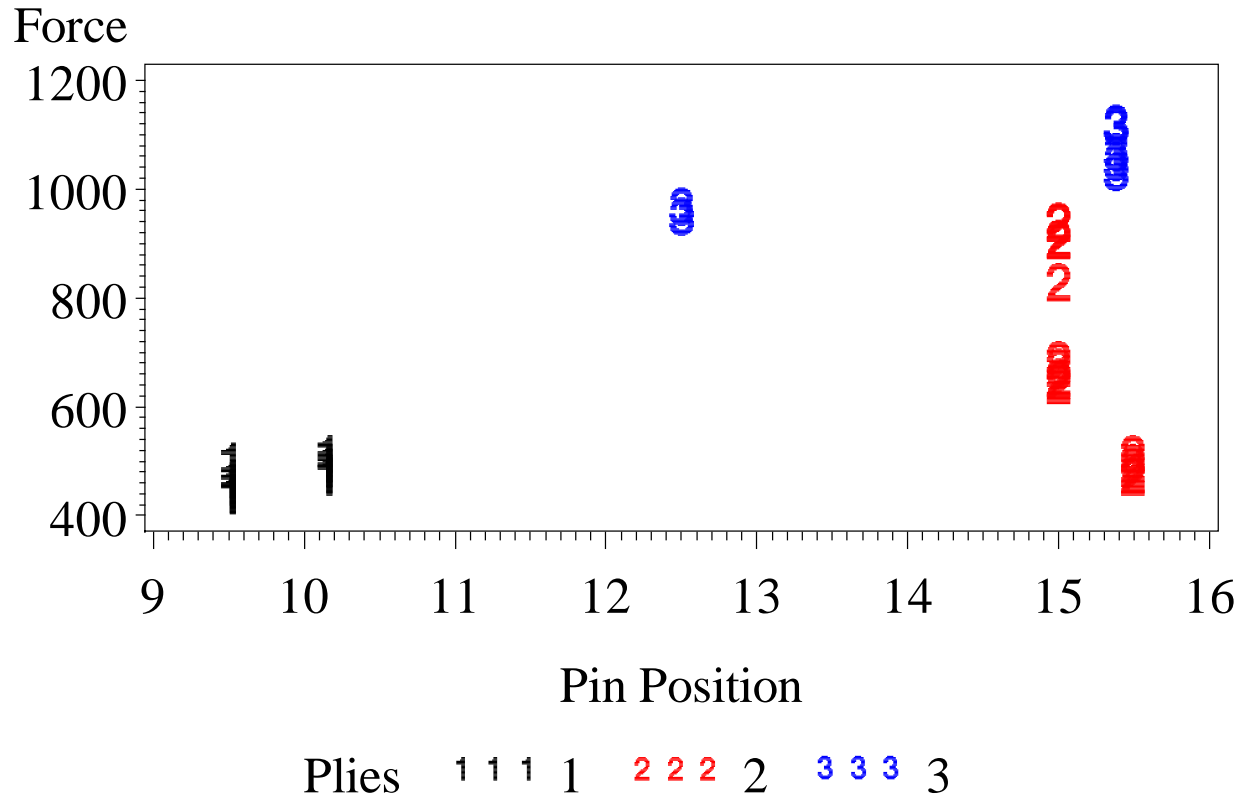
Figure 6.5 Force Versus Plunger Position: Illustrating Covariance With Number of Plies

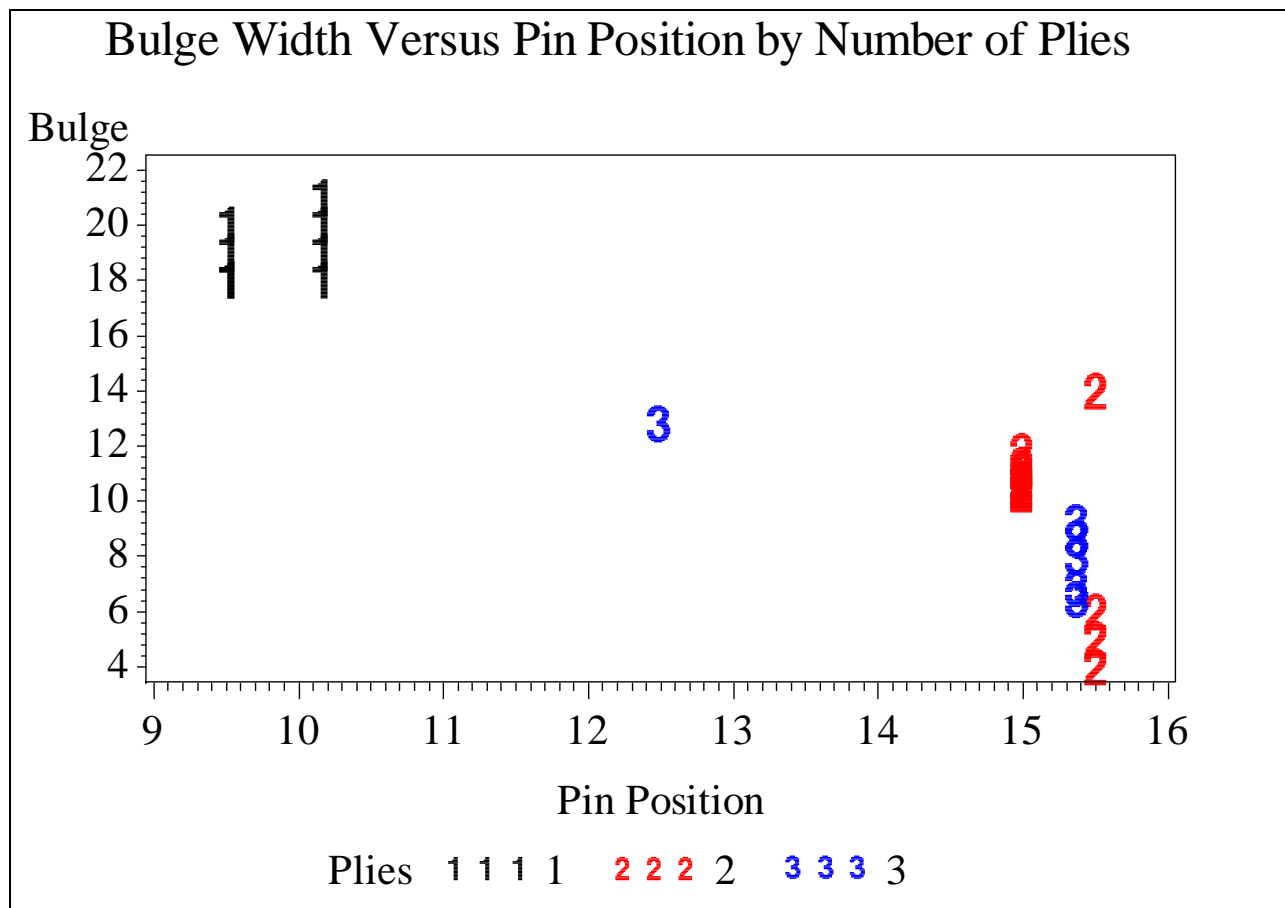
Figure 6.6 Bulge Width Versus Plunger Position and Number of Plies
