**OCAS-DRI-CIB-20-06  
NEW CAR ASSESSMENT PROGRAM  
CRASH IMMINENT BRAKE SYSTEM CONFIRMATION TEST**

**2020 Hyundai Palisade**

**DYNAMIC RESEARCH, INC.**

**Final Report**

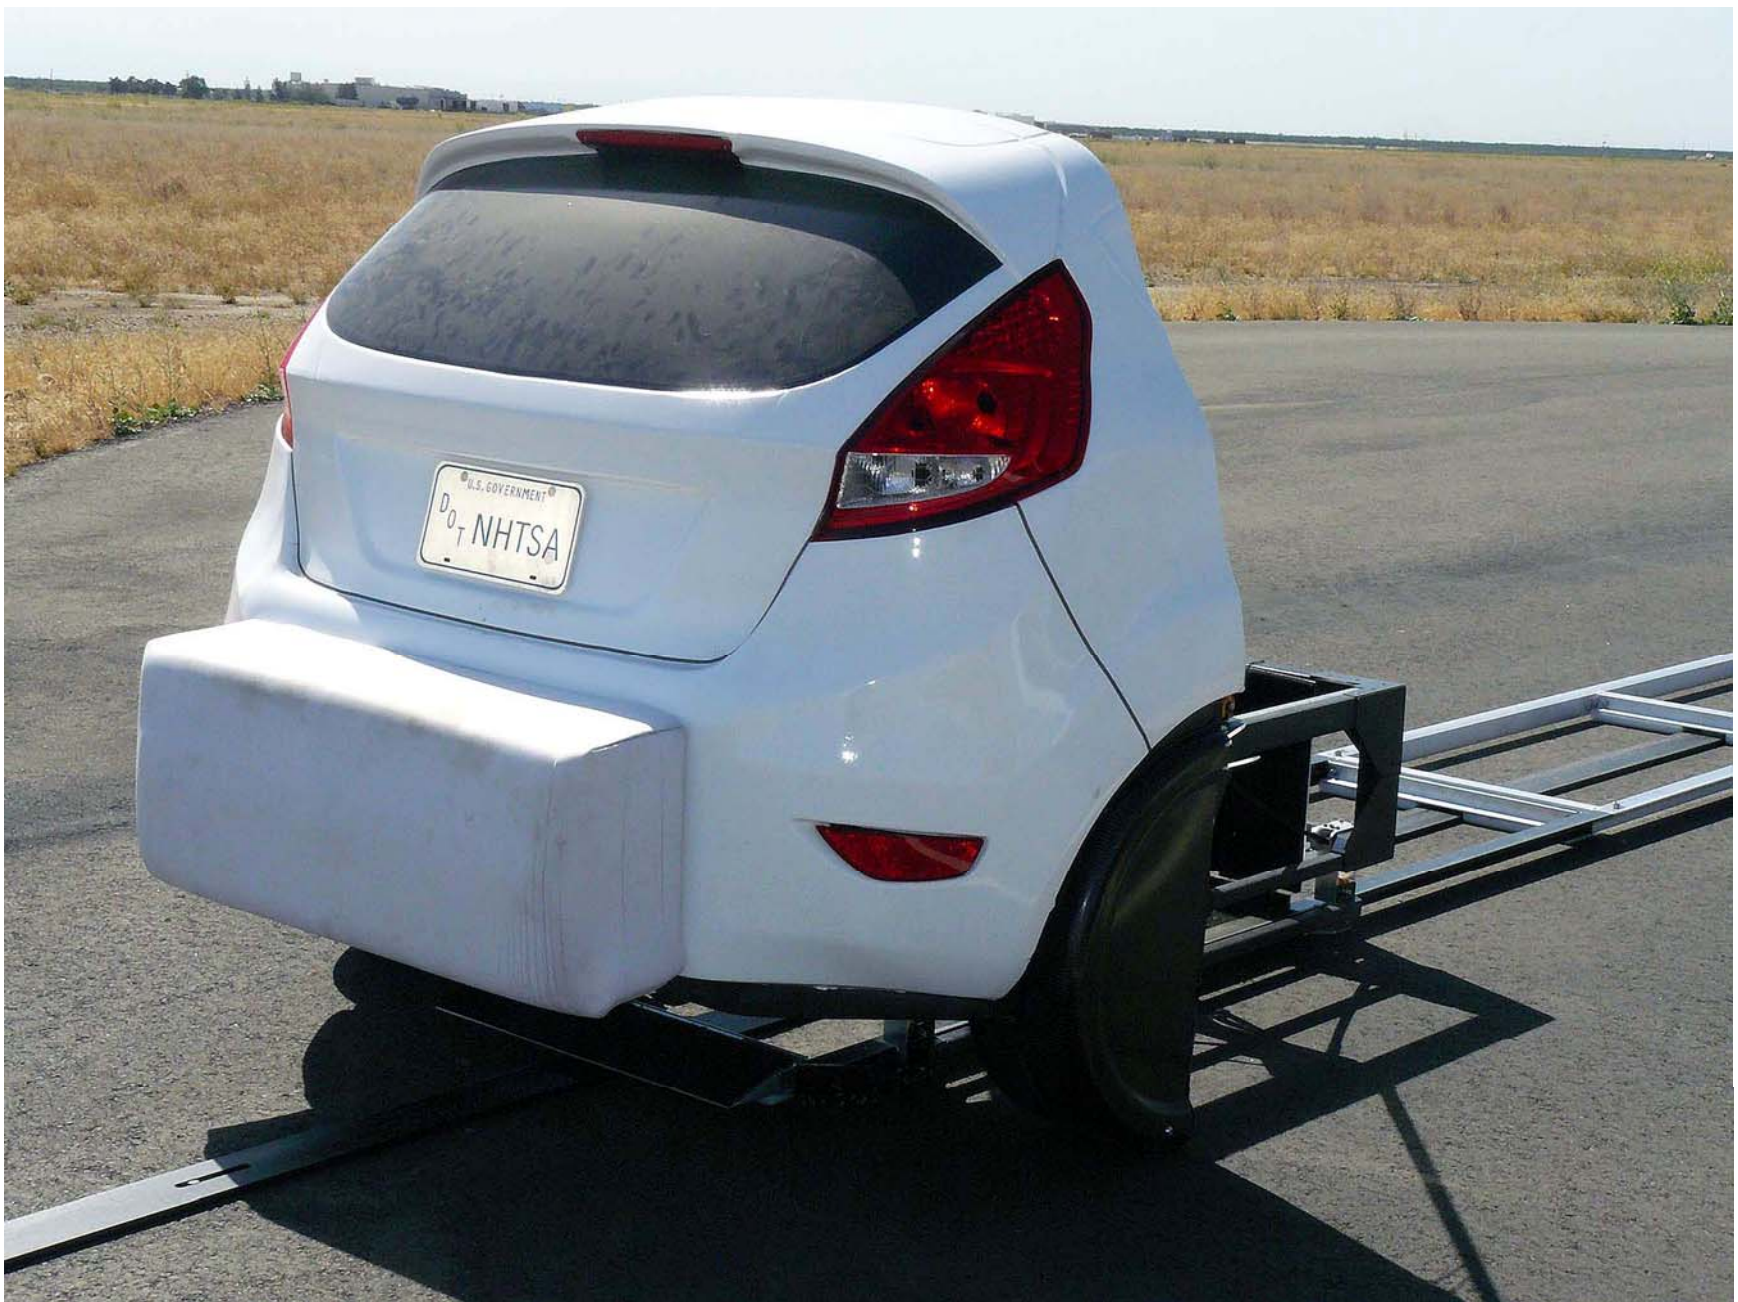
Figure A6. Rear View of Principal Other Vehicle (SSV)

CIB testing requires a POV that realistically represents typical vehicles, does not suffer damage or cause damage to a test vehicle in the event of collision, and can be accurately positioned and moved during the tests. The tests reported herein made use of the NHTSA developed Strikeable Surrogate Vehicle (SSV).

- POV element, whose requirements are to:
  - Provide an accurate representation of a real vehicle to CIB sensors, including cameras, radar and lidar.
  - Be resistant to damage and inflict little or no damage to the SV as a result of repeated SV-to-POV impacts.
- POV delivery system whose requirements are to:
  - Accurately control the nominal POV speed up to 35 mph (56 km/h).
  - Accurately control the lateral position of the POV within the travel lane.
  - Allow the POV to move away from the SV after an impact occurs.

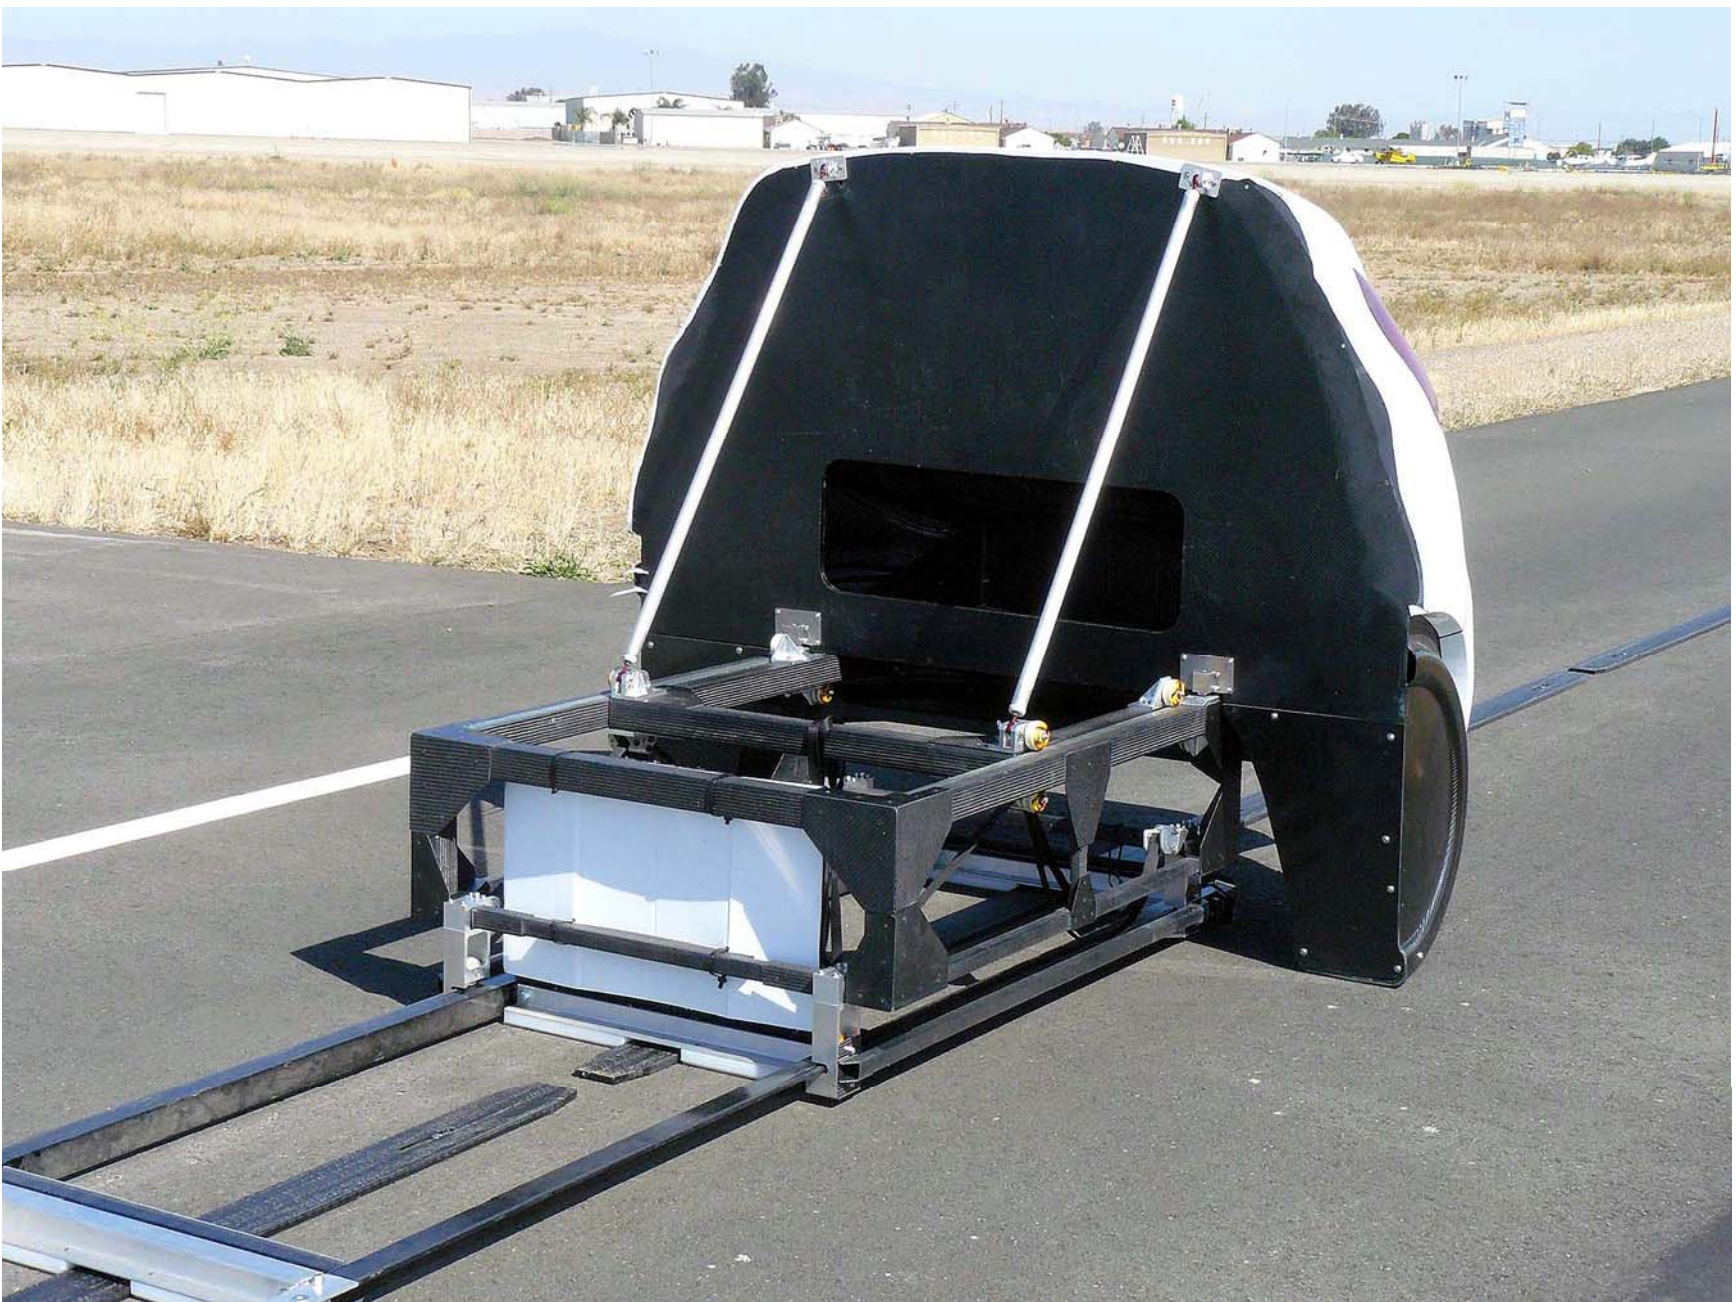
Figure A7. Load Frame/Slider of SSV

motion of the shell/roller assembly. After impacting the SSV, the SV driver uses the steering wheel to maintain SV position in the center of the travel lane, thereby straddling the two-rail track. The SV driver must manually apply the SV brakes after impact. The SSV system is shown in Figures A6 through A8 and a detailed description can be found in the NHTSA report: NHTSA'S STRIKEABLE SURROGATE VEHICLE PRELIMINARY DESIGN+OVERVIEW, May 2013.

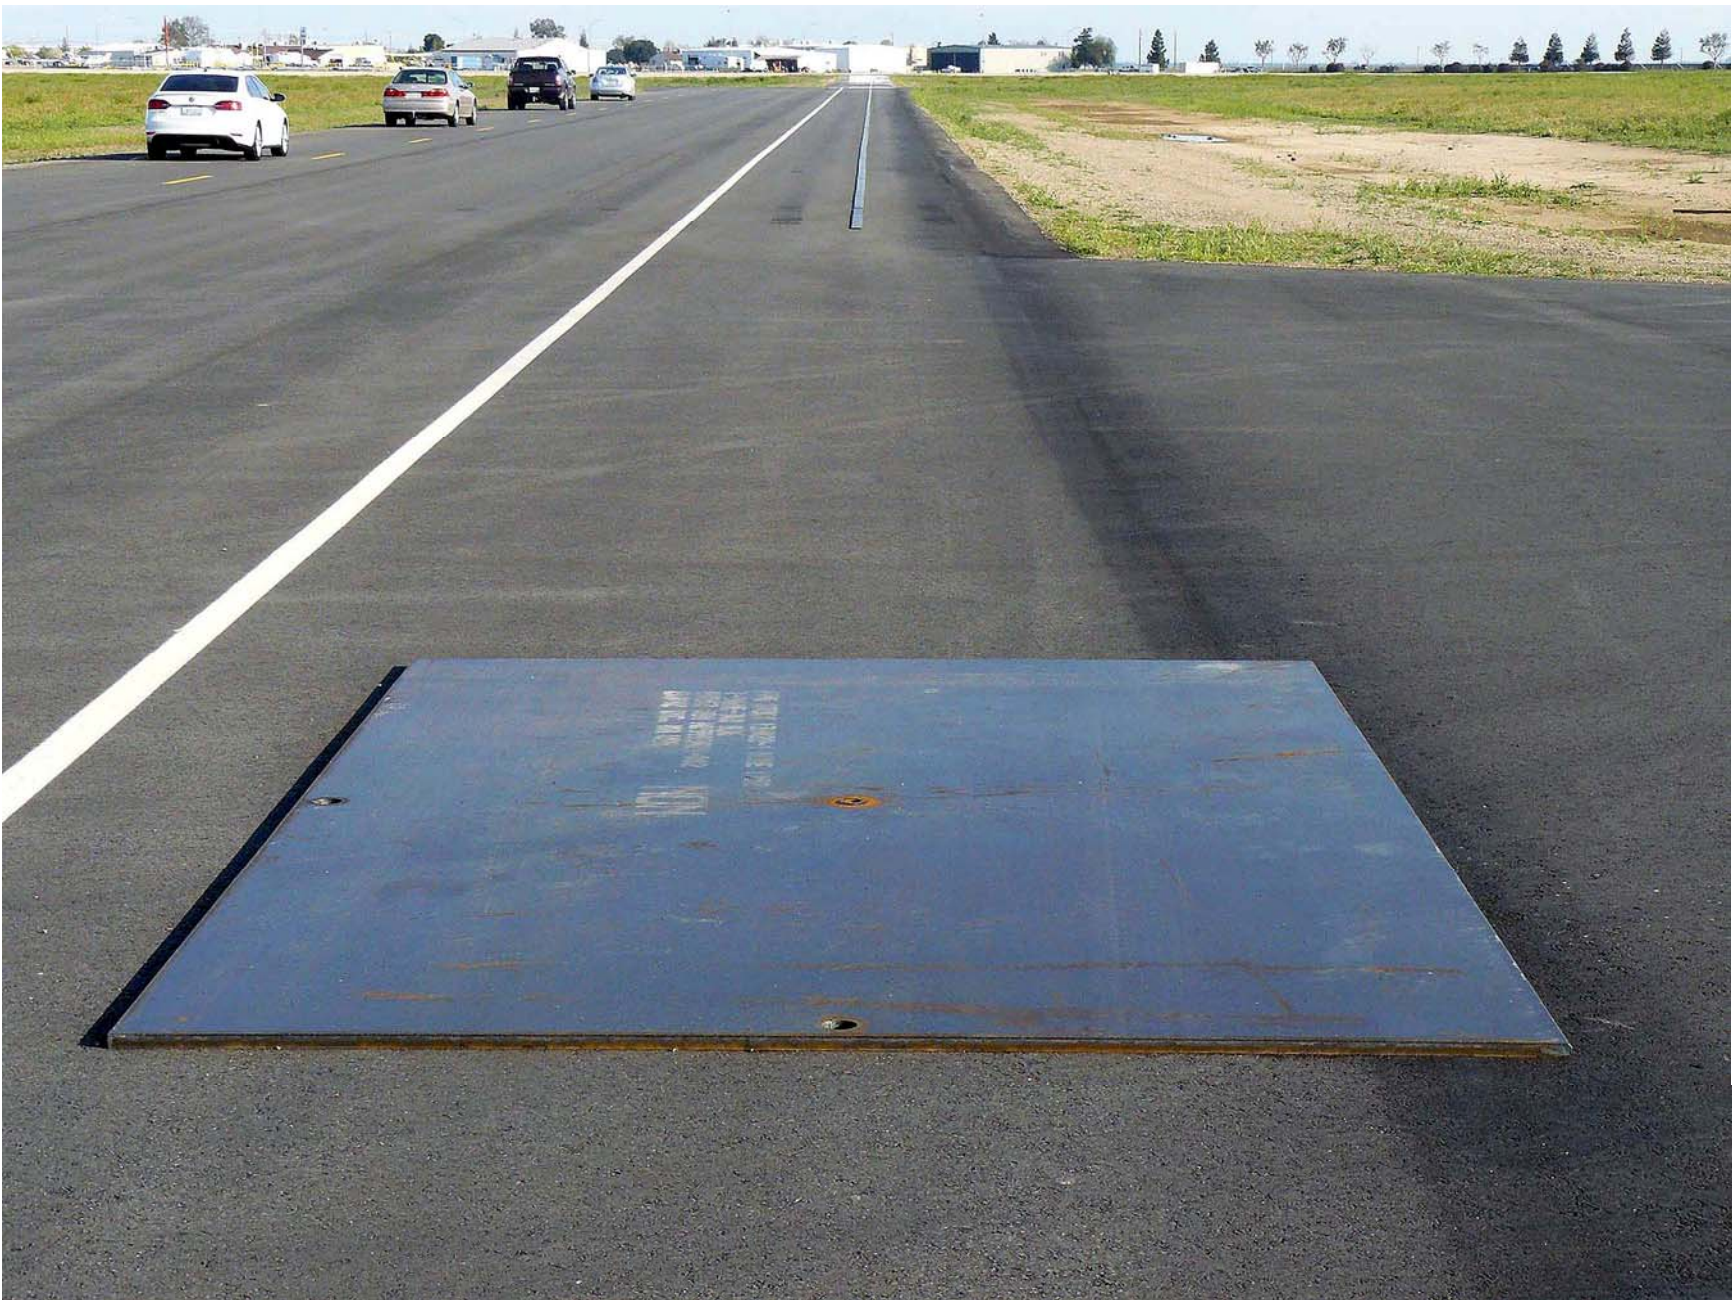
Figure A9. Steel Trench Plate

The false positive suppression test series evaluates the ability of a CIB system to differentiate a steel trench plate (STP) from an object presenting a genuine safety risk to the SV. Although the STP is large and metallic, it is designed to be driven over without risk of injury to the driver or damage to the SV. Therefore, in this scenario, the

automatic braking available from CIB is not necessary and should be suppressed. The test condition is nearly equivalent to that previously defined for Test 1, the stopped POV condition, but with an STP in the SV forward path in lieu of a POV.

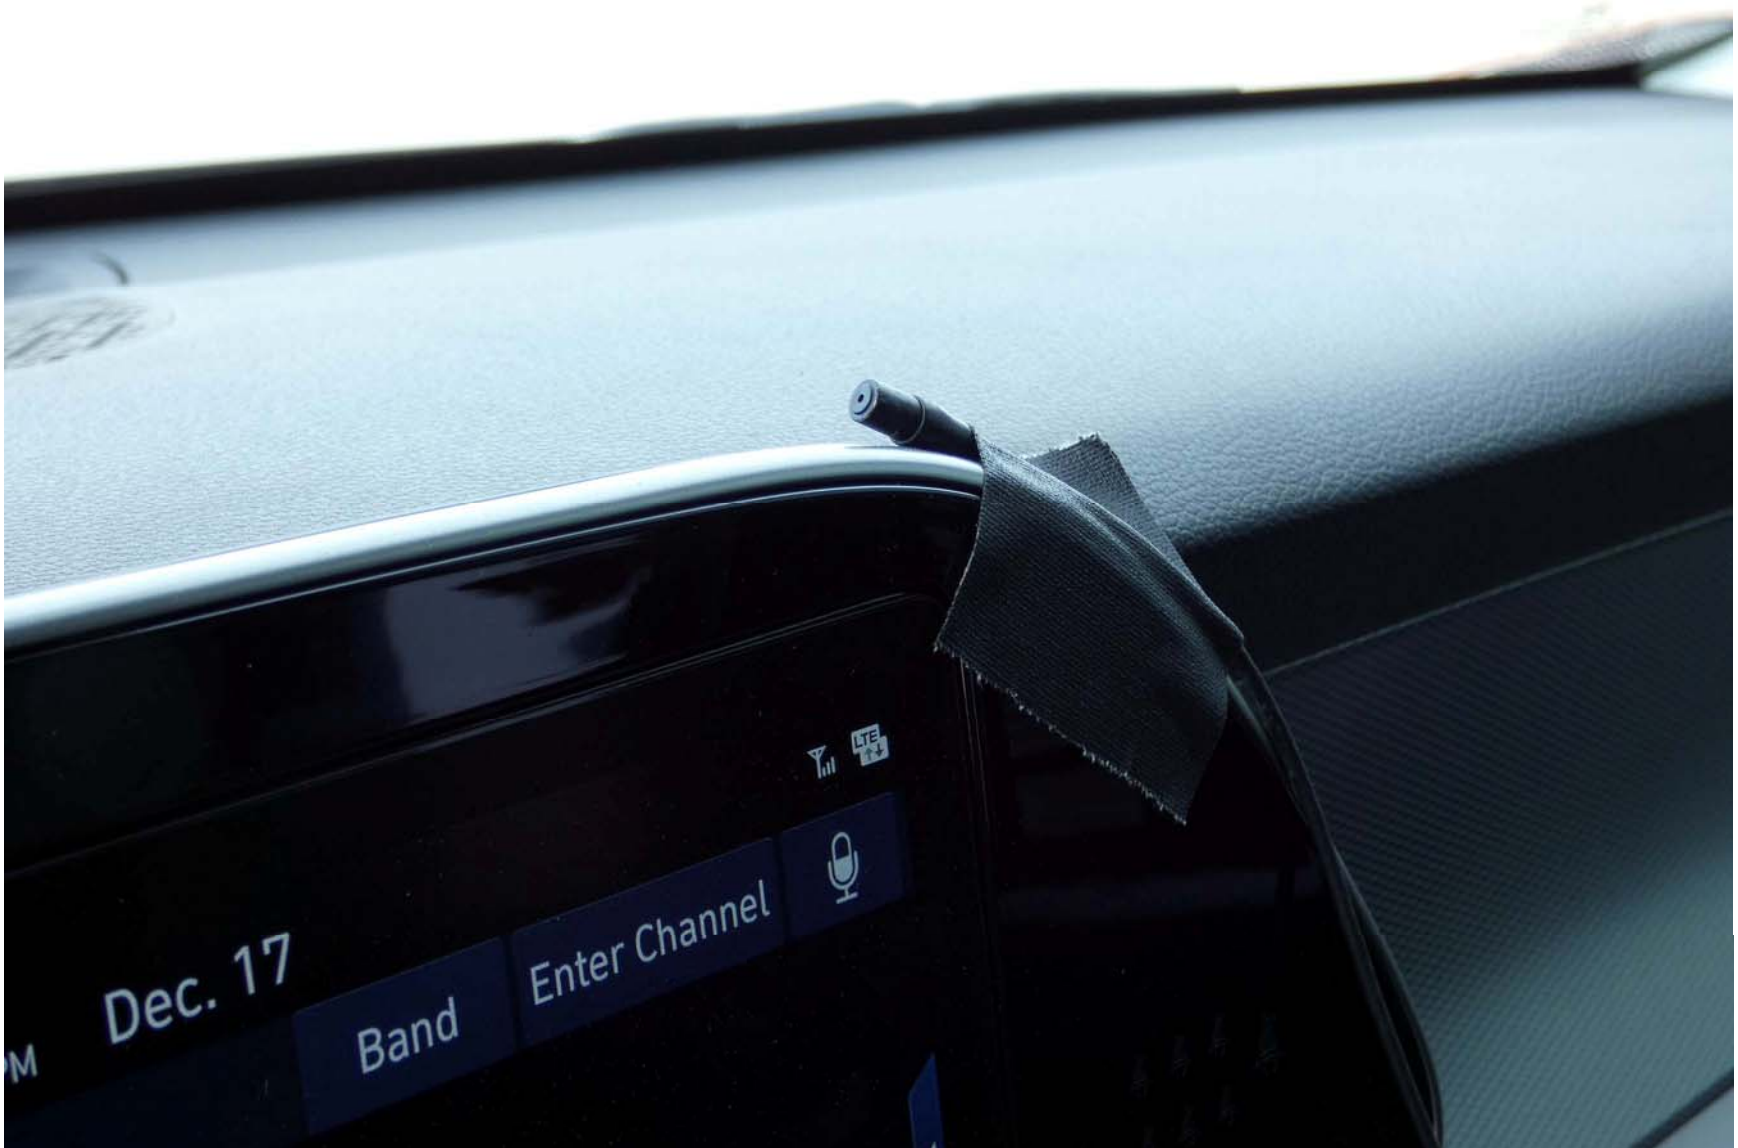
Figure A11. Sensor for Detecting Auditory Alerts

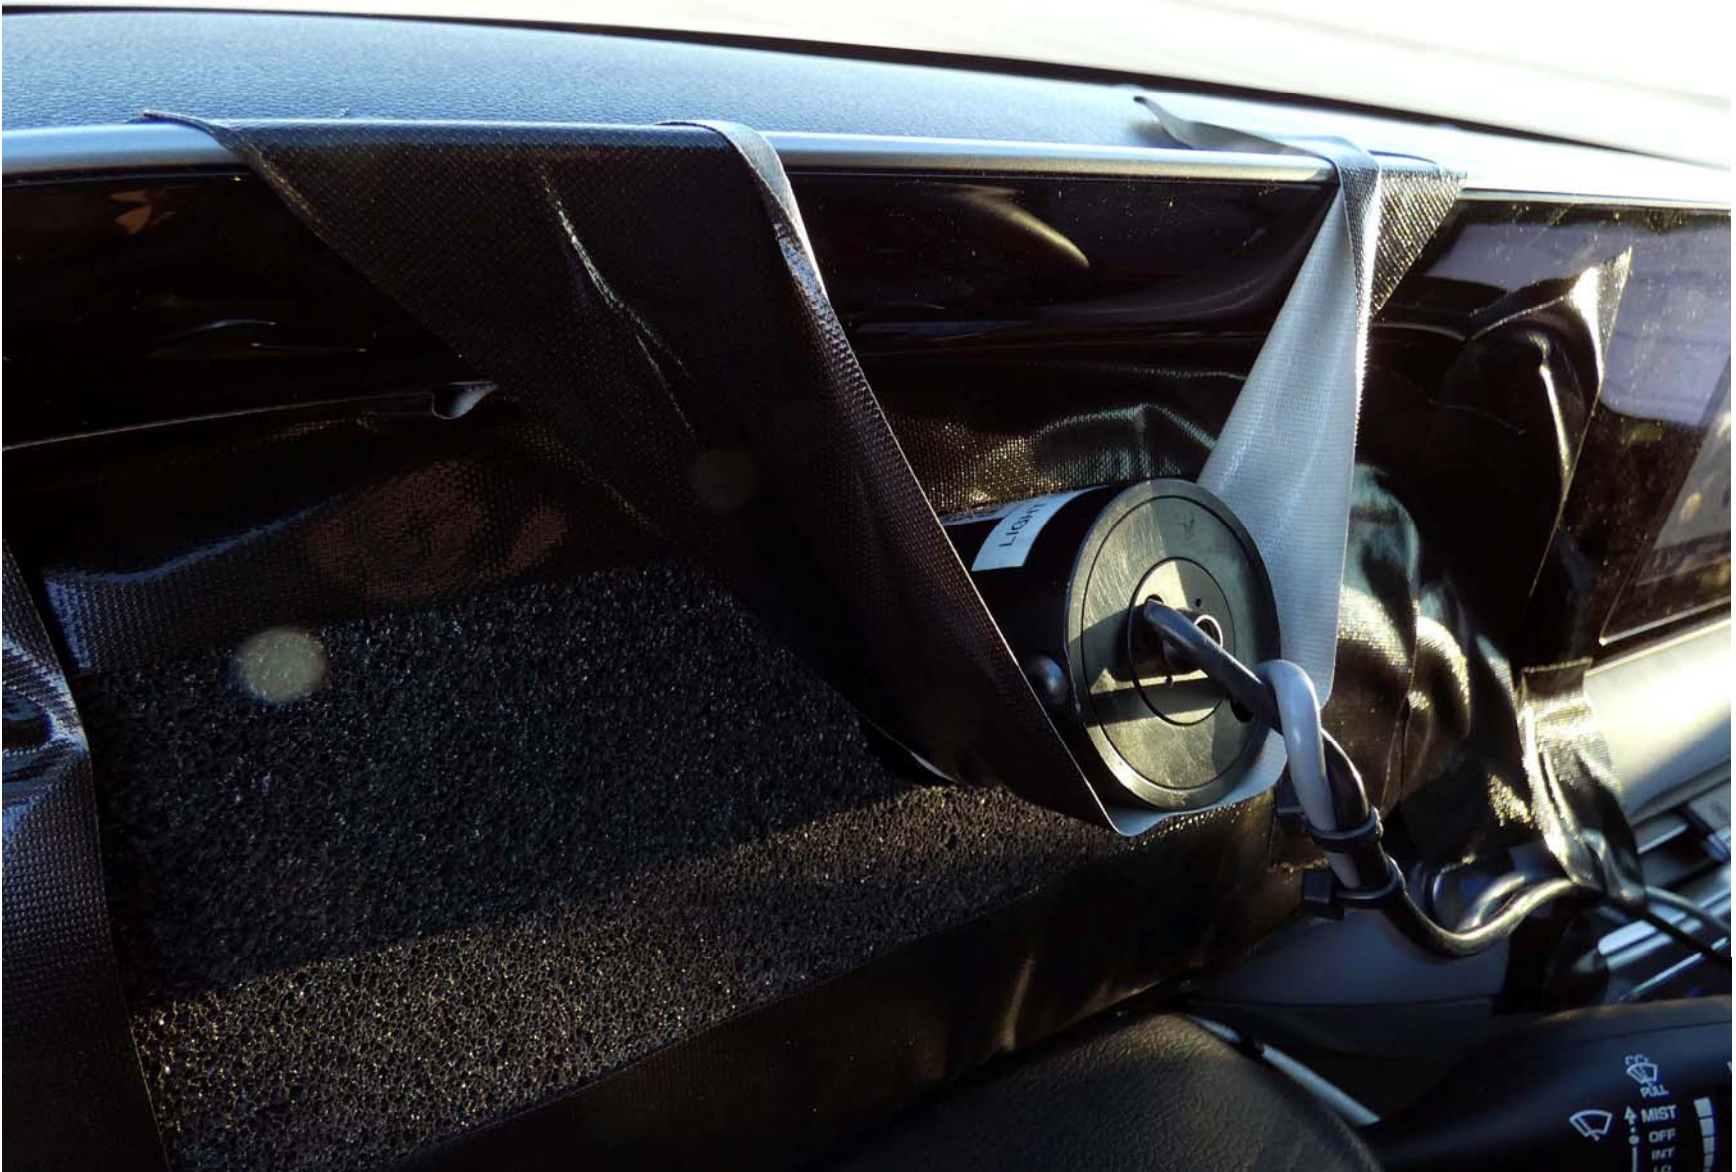
Figure A12. Sensor for Detecting Visual Alerts

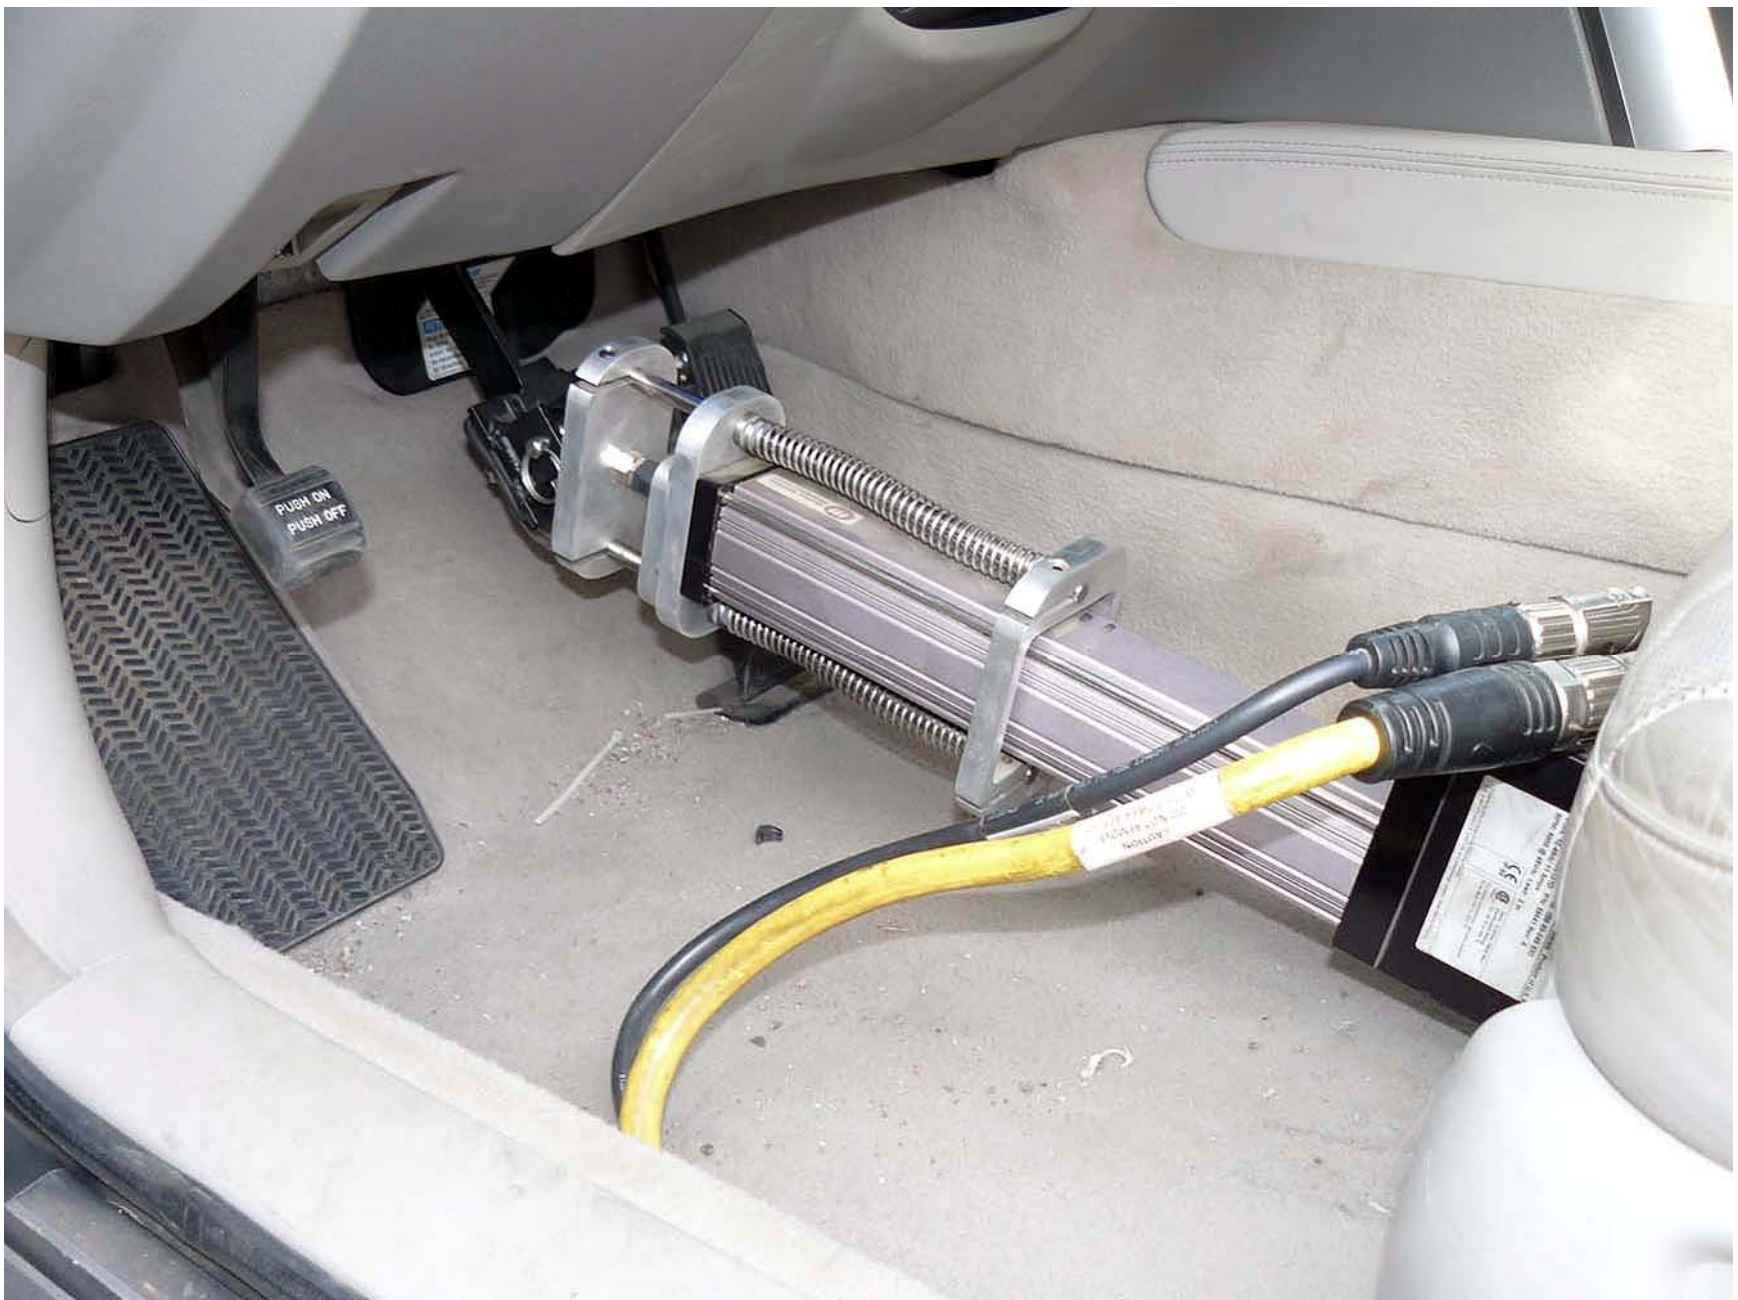
Figure A14. Brake Actuator Installed in POV System

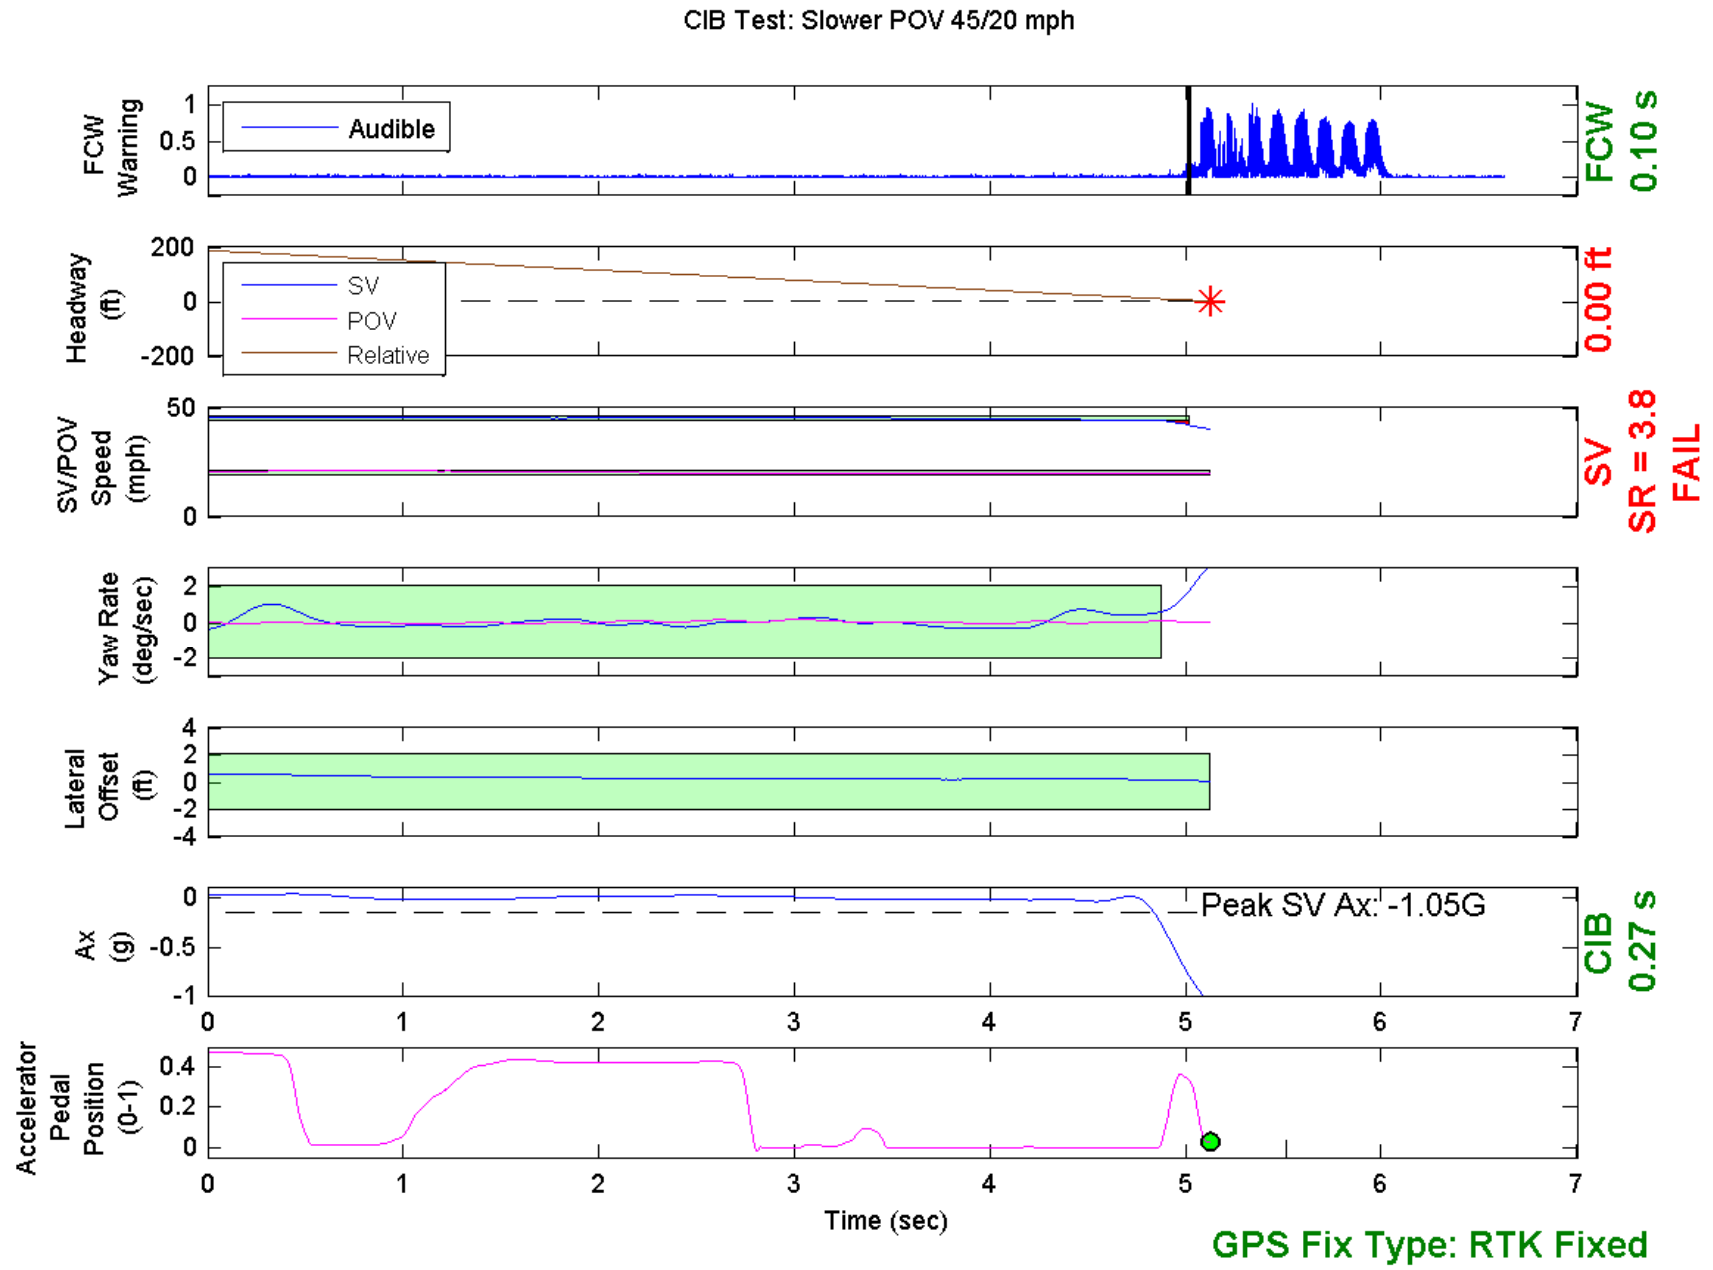
Figure D9. Example Time History for a Failed Run

Examples of time history plots for each test type (including passing, failing and invalid runs) are shown in Figure 1 through Figure 9. Figures 1 through 6 show passing runs for each of the 6 test types. Figures 7 and 8 show examples of invalid runs. Figure 9 shows an example of a valid test that failed the CIB requirements.
