**OCAS-DRI-FCW-18-04
NEW CAR ASSESSMENT PROGRAM
FORWARD COLLISION WARNING CONFIRMATION TEST**

2018 Mazda Mazda3

Final Report

1. Report No. OCAS-DRI-FCW-18-04	2. Government Accession No.	3. Recipient's Catalog No.	
4. Title and Subtitle Final Report of Forward Collision Warning Testing of a 2018 Mazda Mazda3.		5. Report Date 25 July 2018

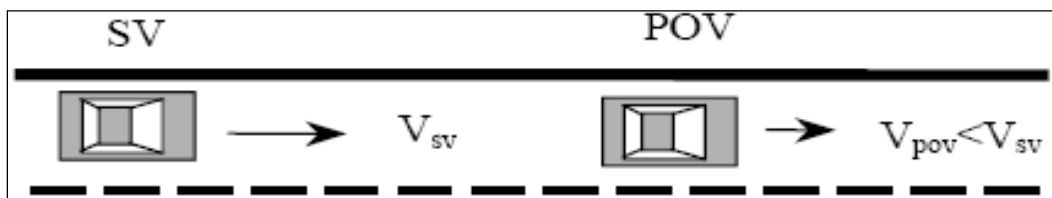
This test examines the ability of the FCW system to recognize a slower lead vehicle being driven with a constant speed and issue a timely alert. As depicted in Figure 3, the scenario was conducted with a closing speed equal to 25.0 mph (40.2 kph).

Figure 3. Depiction of Test 3

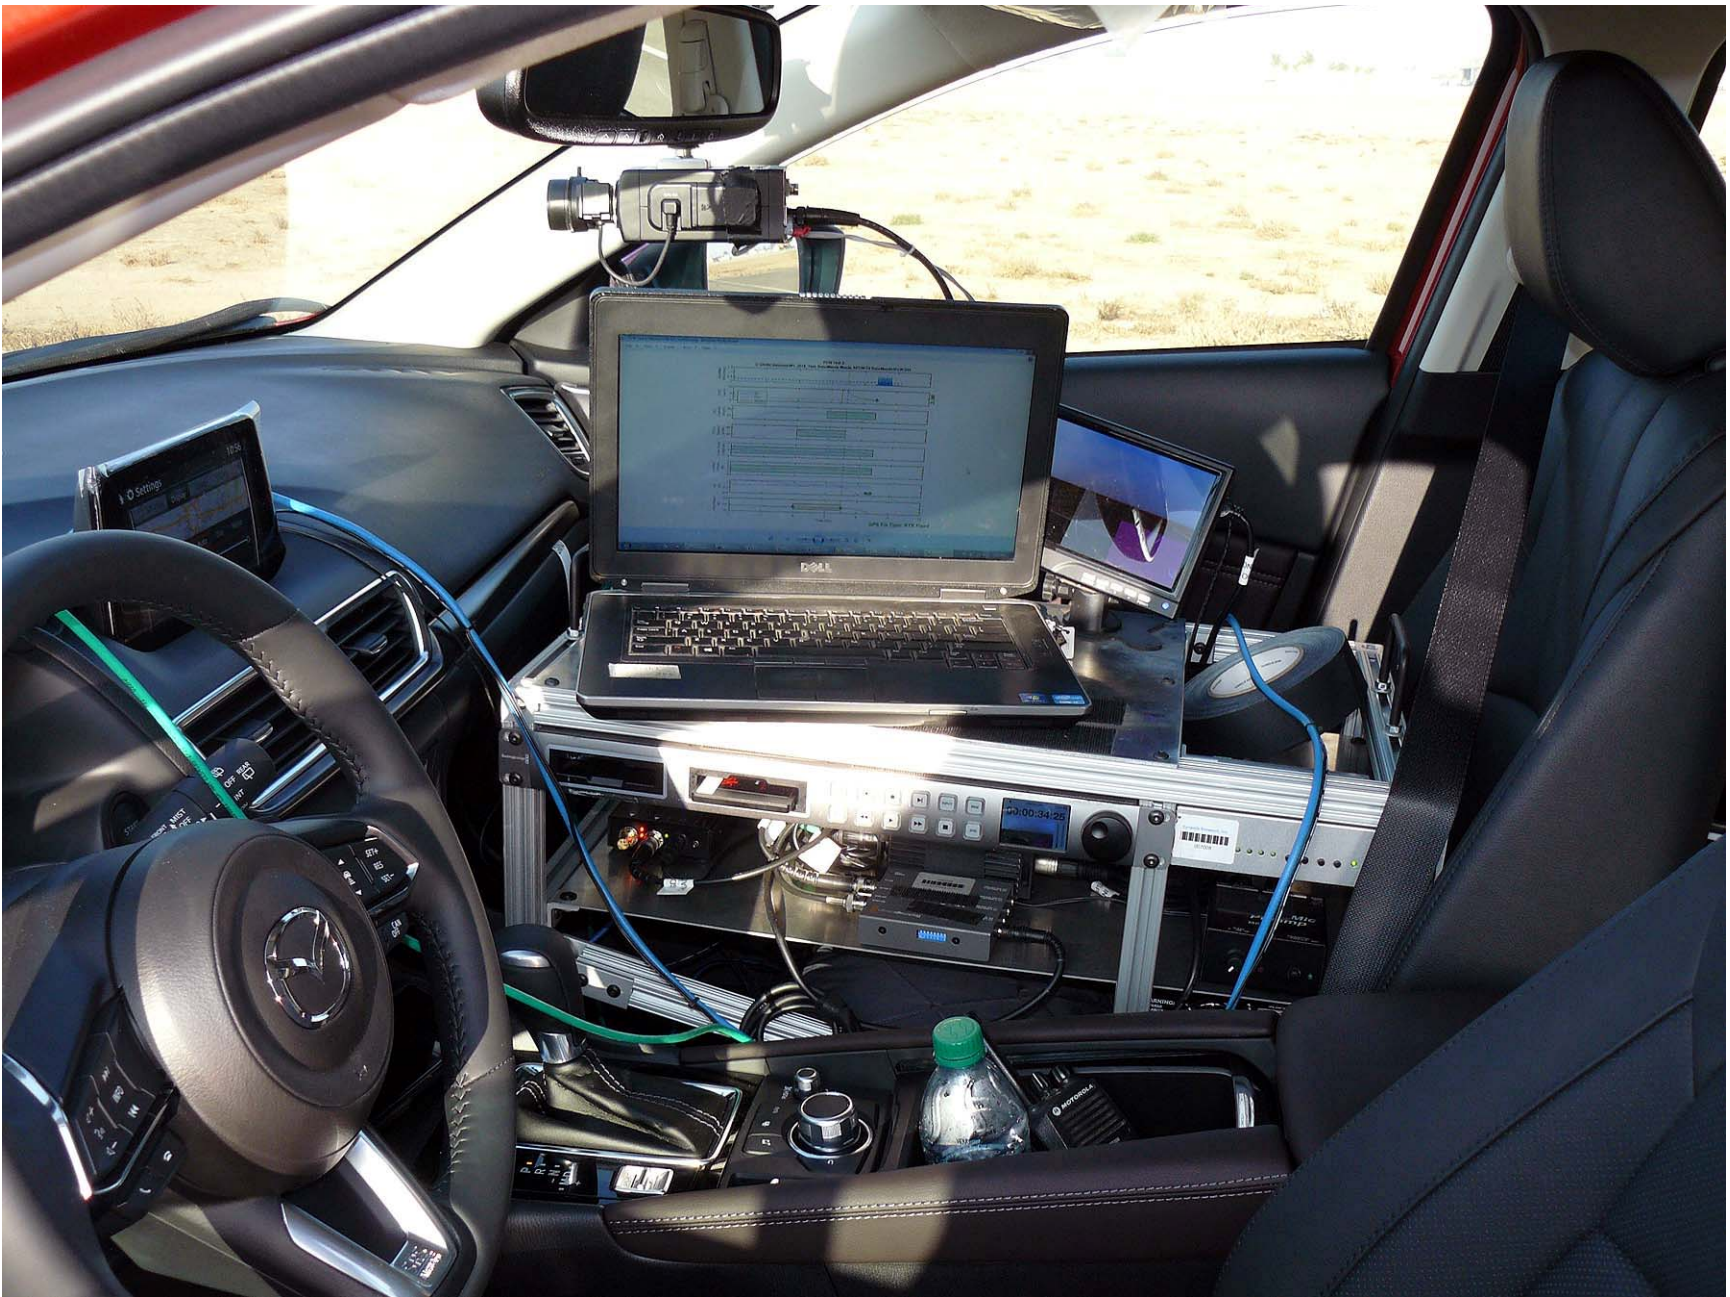
Figure A8. Computer Installed in Subject Vehicle

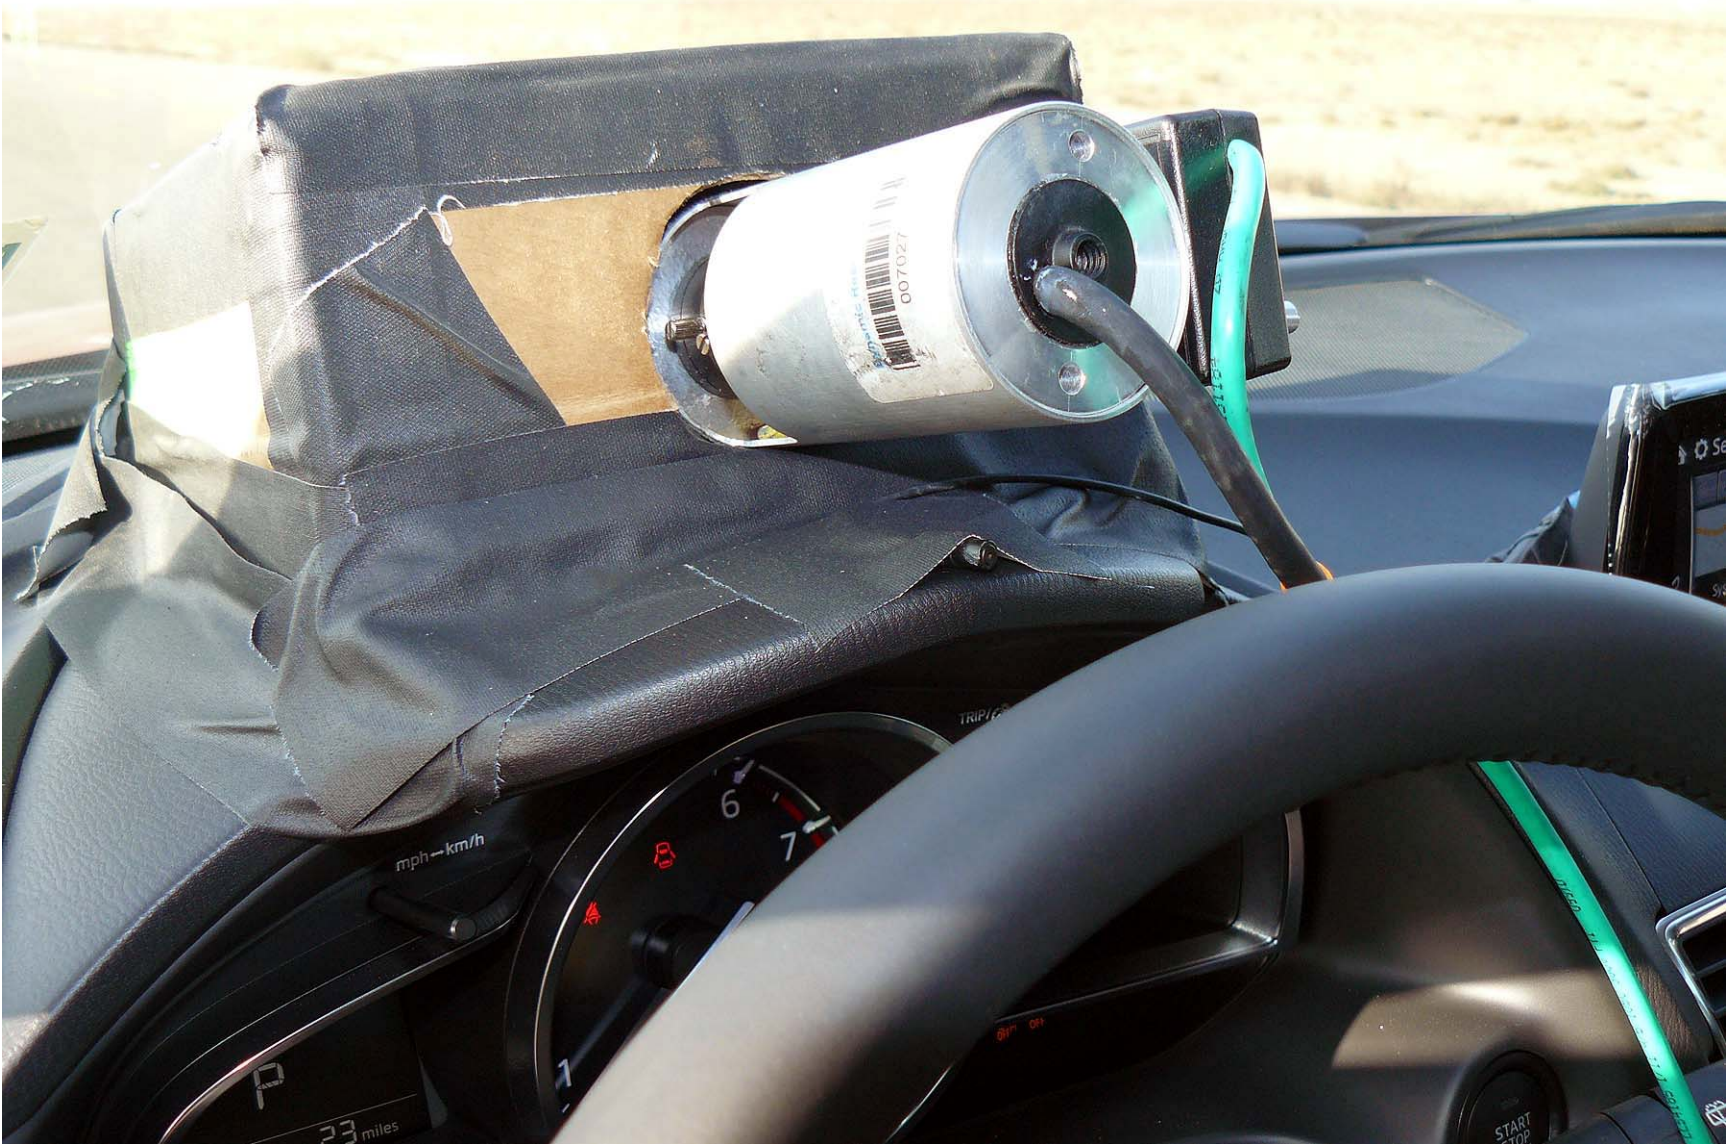
Figure A9. Sensor for Detecting Auditory and Visual Alerts

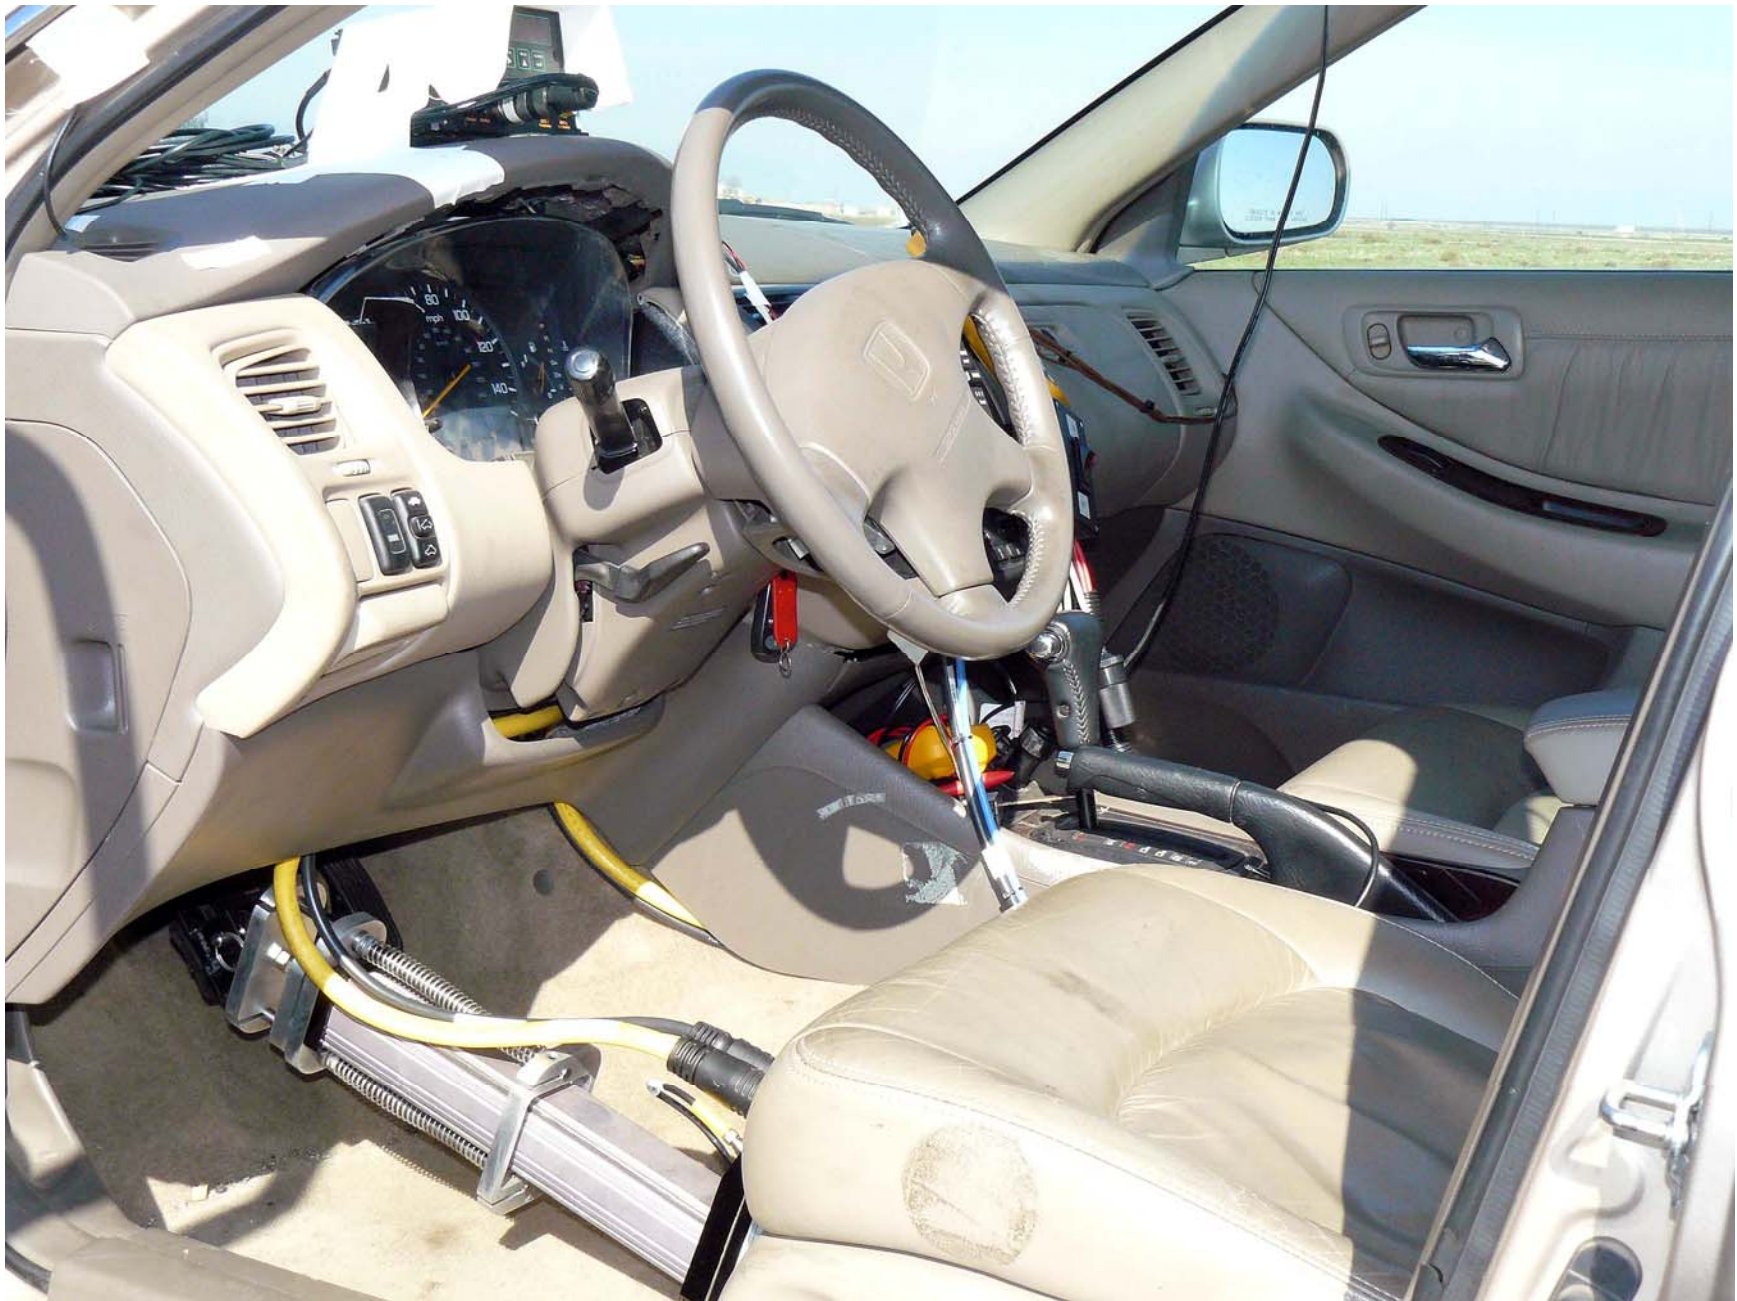
Figure A10. Brake Actuation System Installed in Principal Other Vehicle

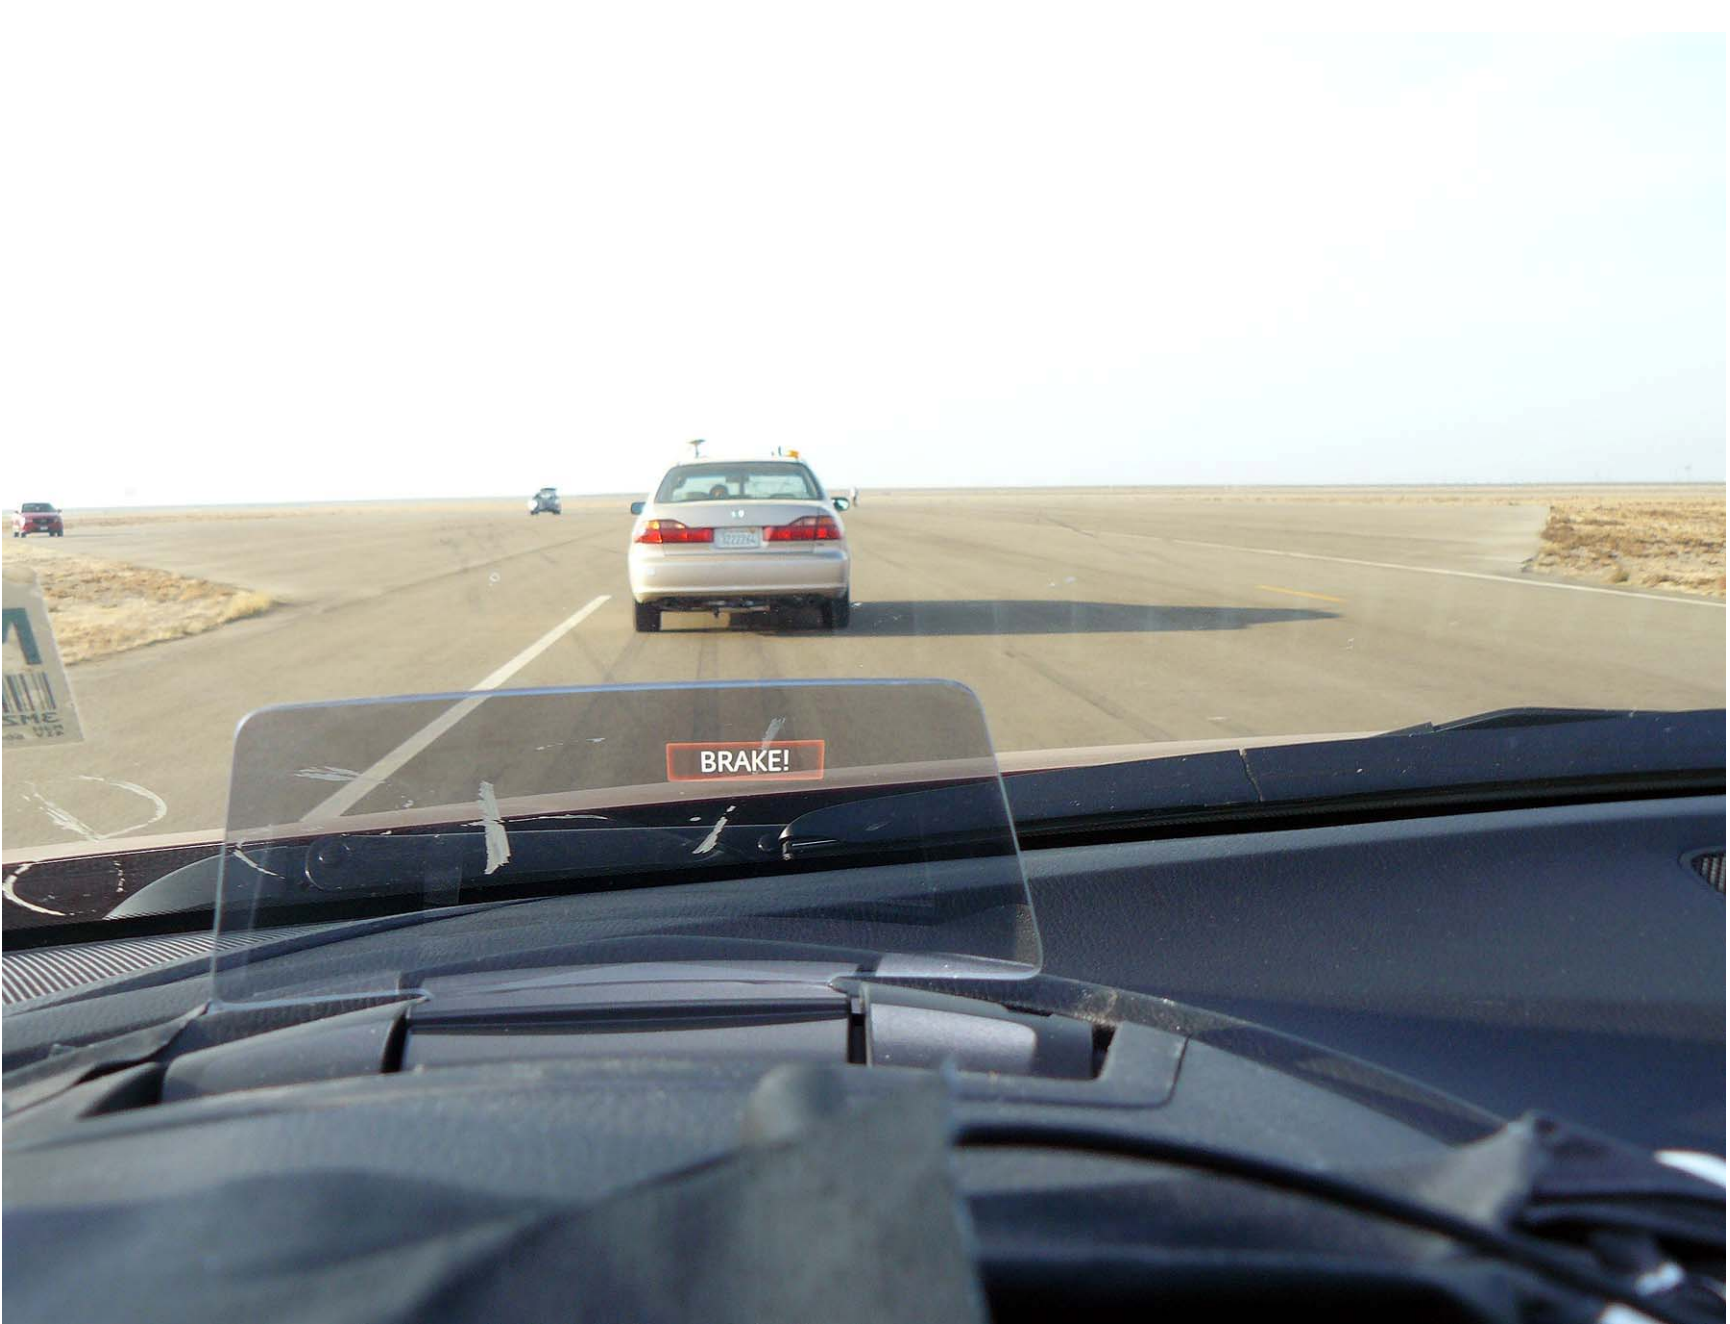
Figure A11. FCW Visual Alert

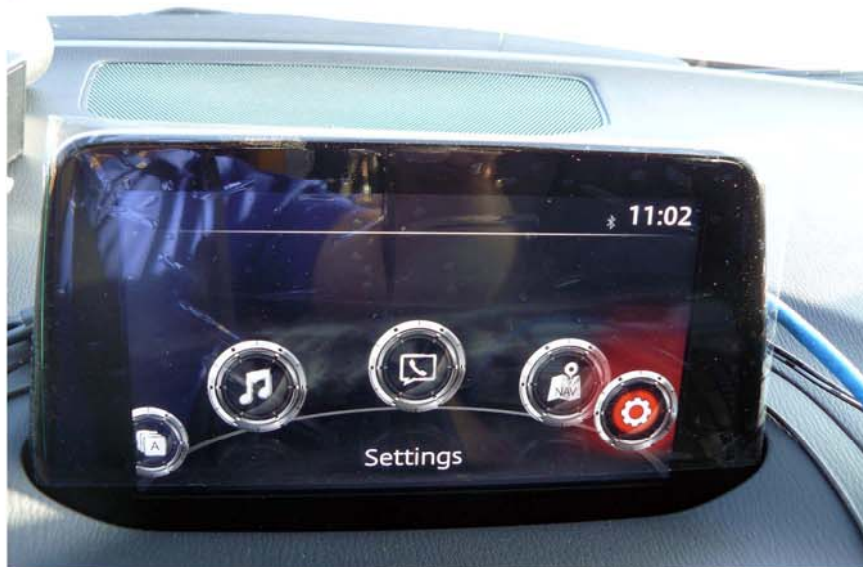
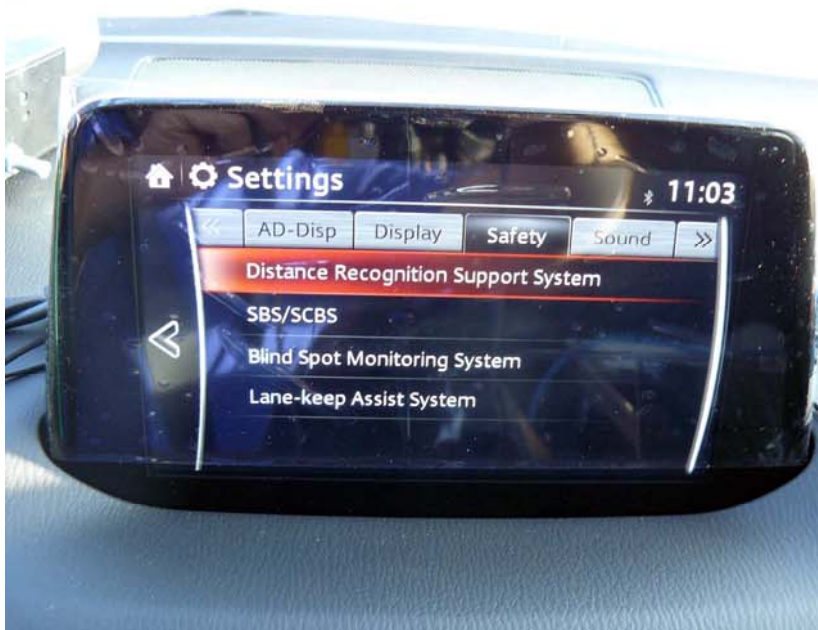
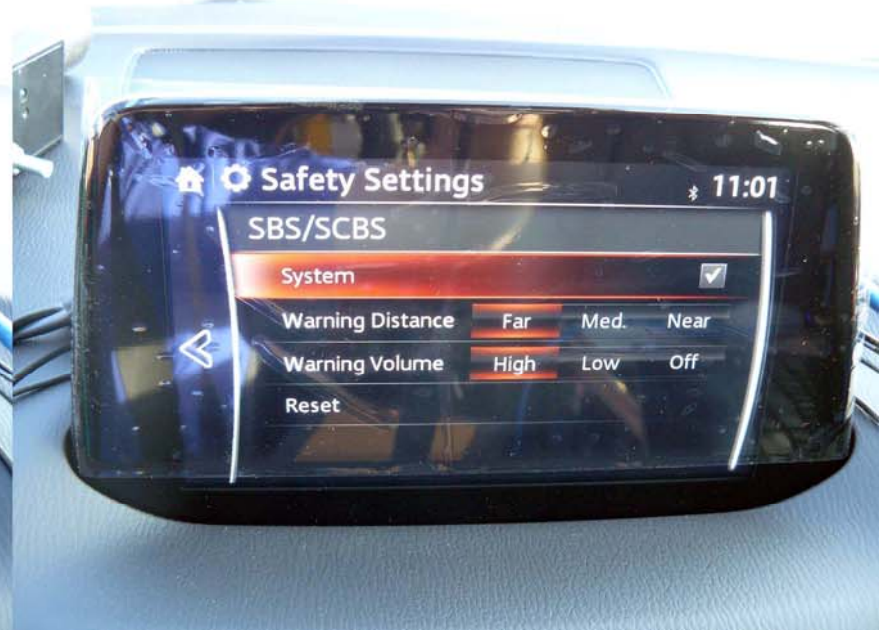
Figure A12. FCW System Setting Menus

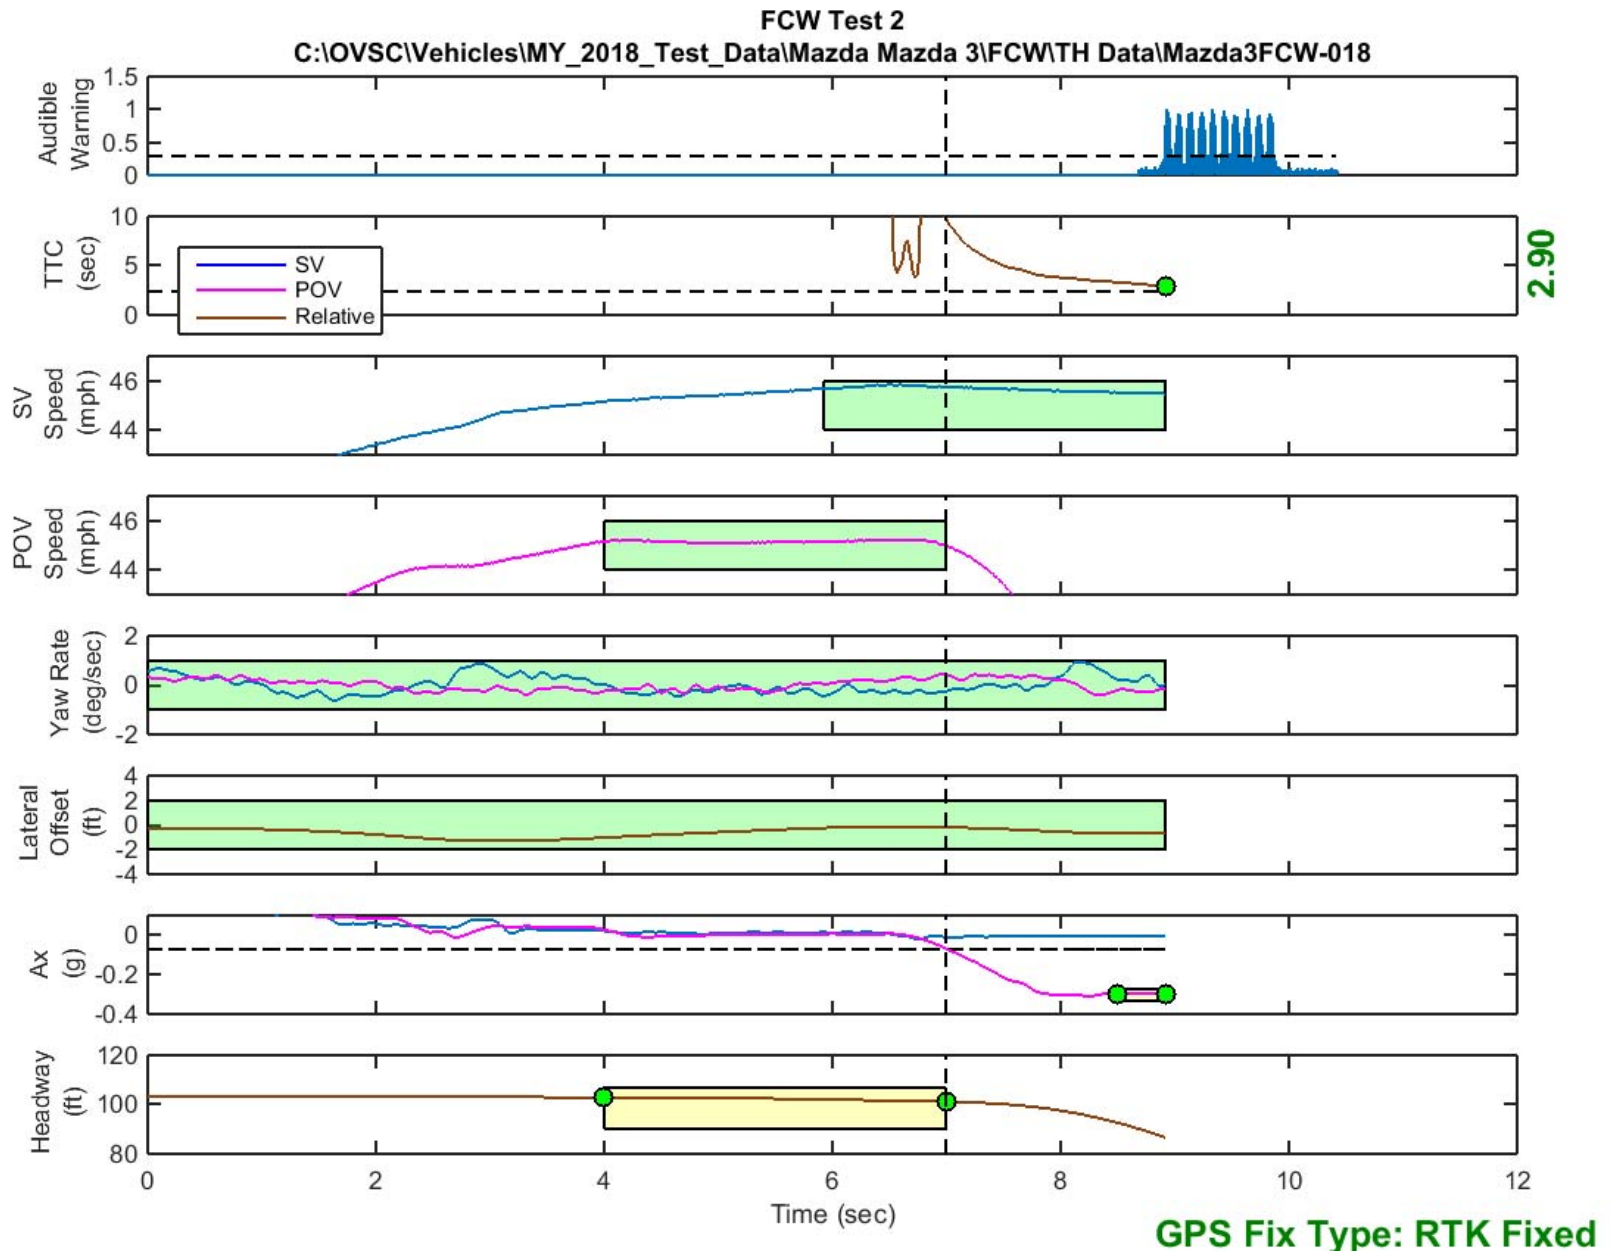
Figure D14. Time History for Run 18, FCW Test 2, Audible Warning
