**OCAS-DRI-FCW-18-03  
NEW CAR ASSESSMENT PROGRAM  
FORWARD COLLISION WARNING CONFIRMATION TEST**

**2018 Hyundai Sonata**

**Final Report**

1. Report No. OCAS-DRI-FCW-18-03	2. Government Accession No.	3. Recipient's Catalog No.	
4. Title and Subtitle Final Report of Forward Collision Warning Testing of a 2018 Hyundai Sonata.		5. Report Date 11 June 2018

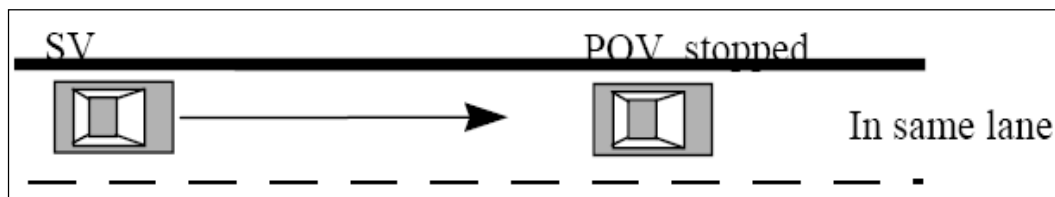
This test evaluates the ability of the FCW function to detect a stopped lead vehicle, as depicted in Figure 1.

Figure 1. Depiction of Test 1

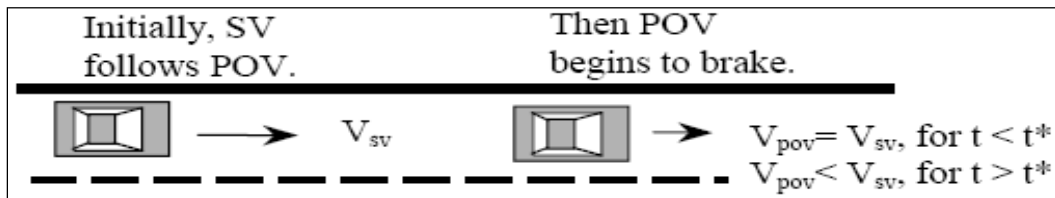
The SV in this test initially followed the POV at a constant time gap, and then the POV suddenly decelerated, as depicted in Figure 2. The test evaluates the ability of the FCW to recognize a decelerating lead vehicle and to issue an alert to SV driver in a timely manner.

Figure 2. Depiction of Test 2

The test began approximately 7 seconds before the driver of the POV started a braking maneuver in which the POV brakes were rapidly applied and modulated such that a constant deceleration of 0.3 g was achieved within 1.5 seconds after braking is initiated. The test ended when either of the following conditions was satisfied:

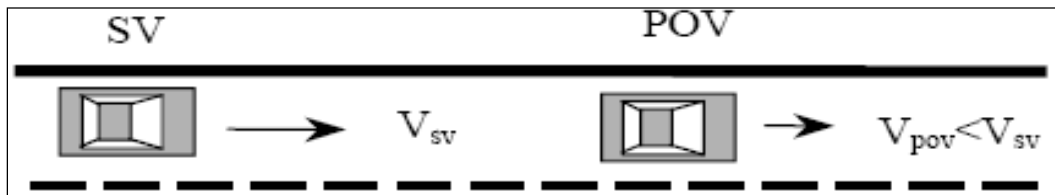
This test examines the ability of the FCW system to recognize a slower lead vehicle being driven with a constant speed and issue a timely alert. As depicted in Figure 3, the scenario was conducted with a closing speed equal to 25.0 mph (40.2 kph).

Figure 3. Depiction of Test 3

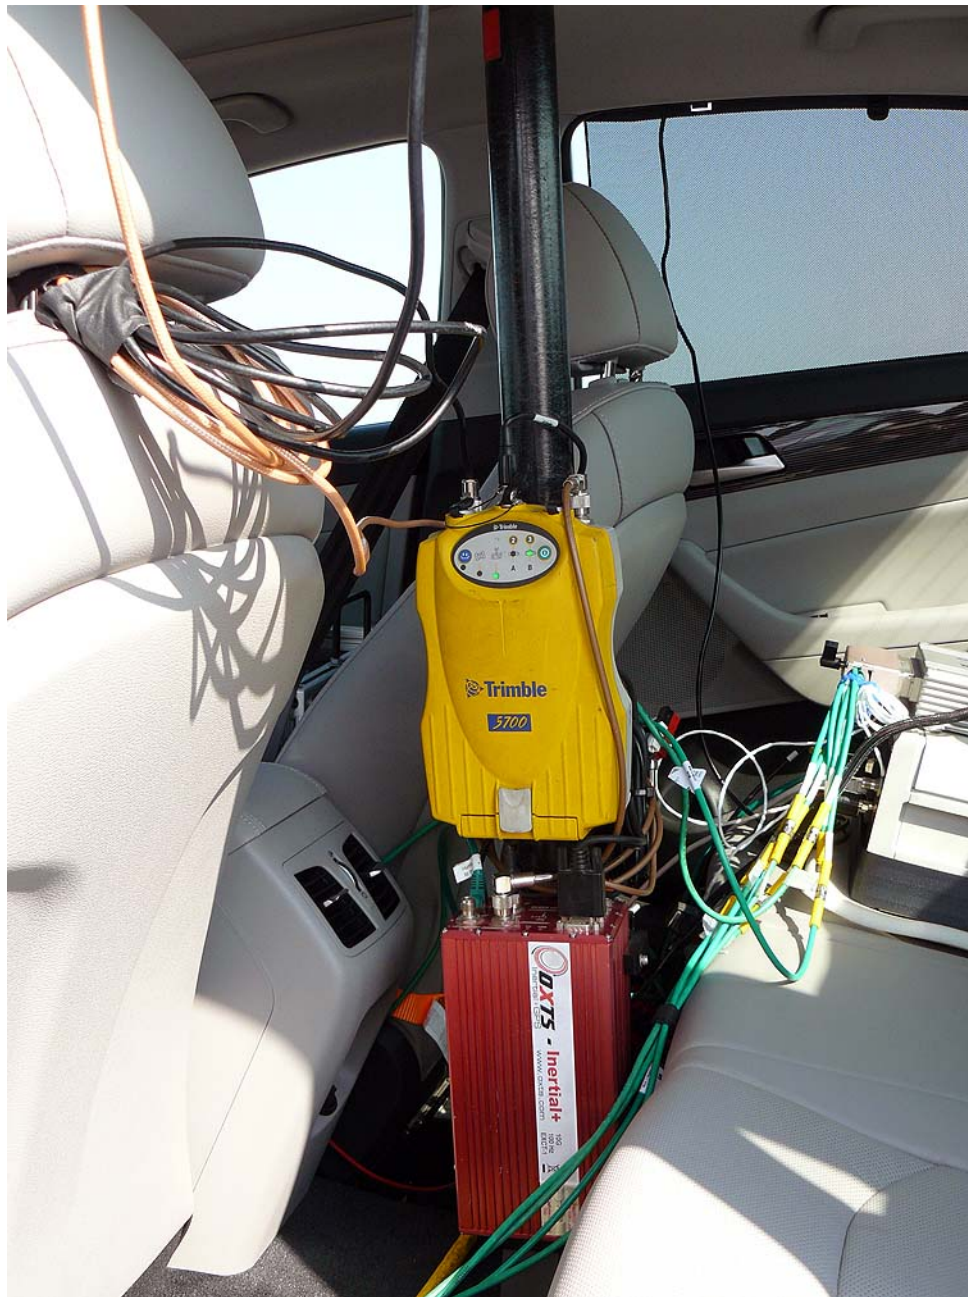
Figure A7. DGPS and Inertial Measurement Unit Installed in Subject Vehicle

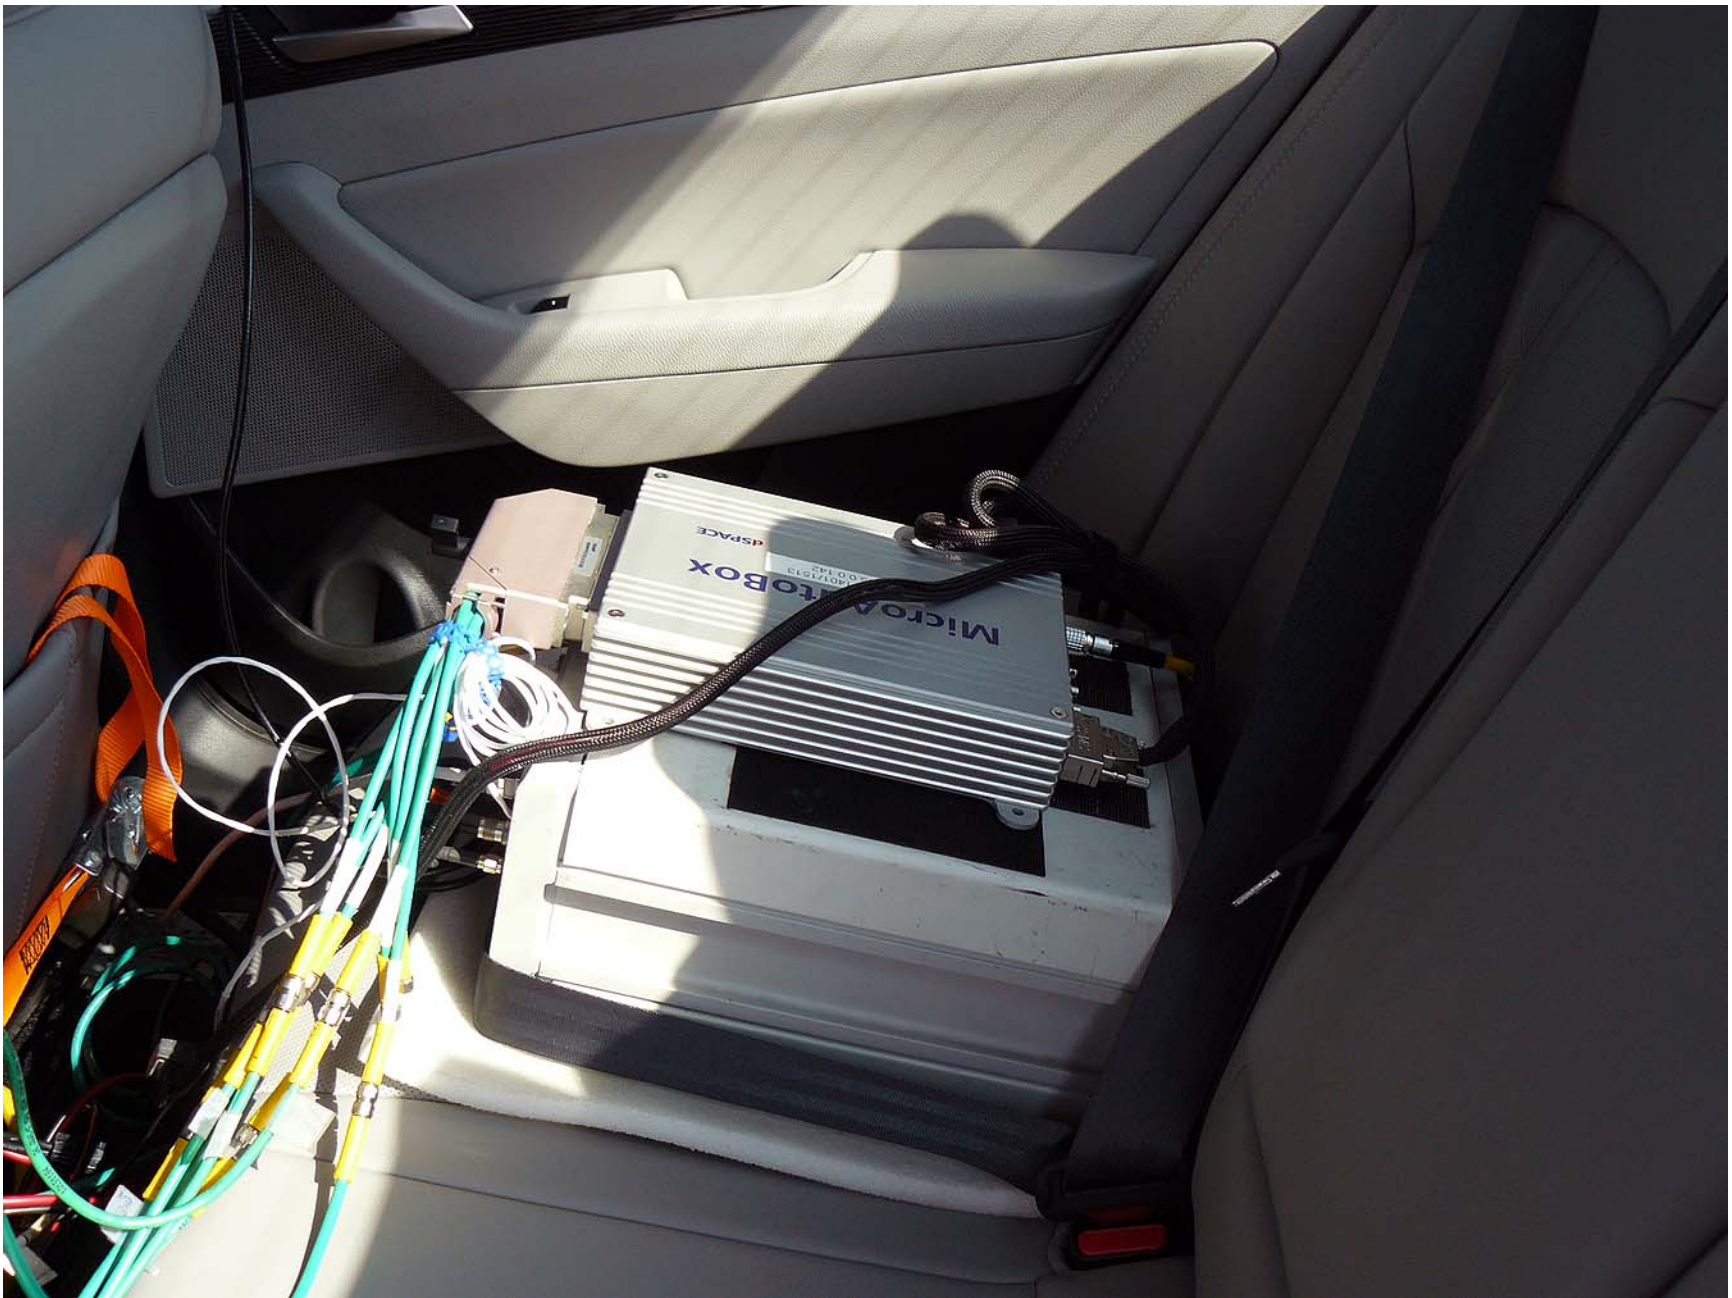
Figure A8. MicroAutoBox Installed in Subject Vehicle

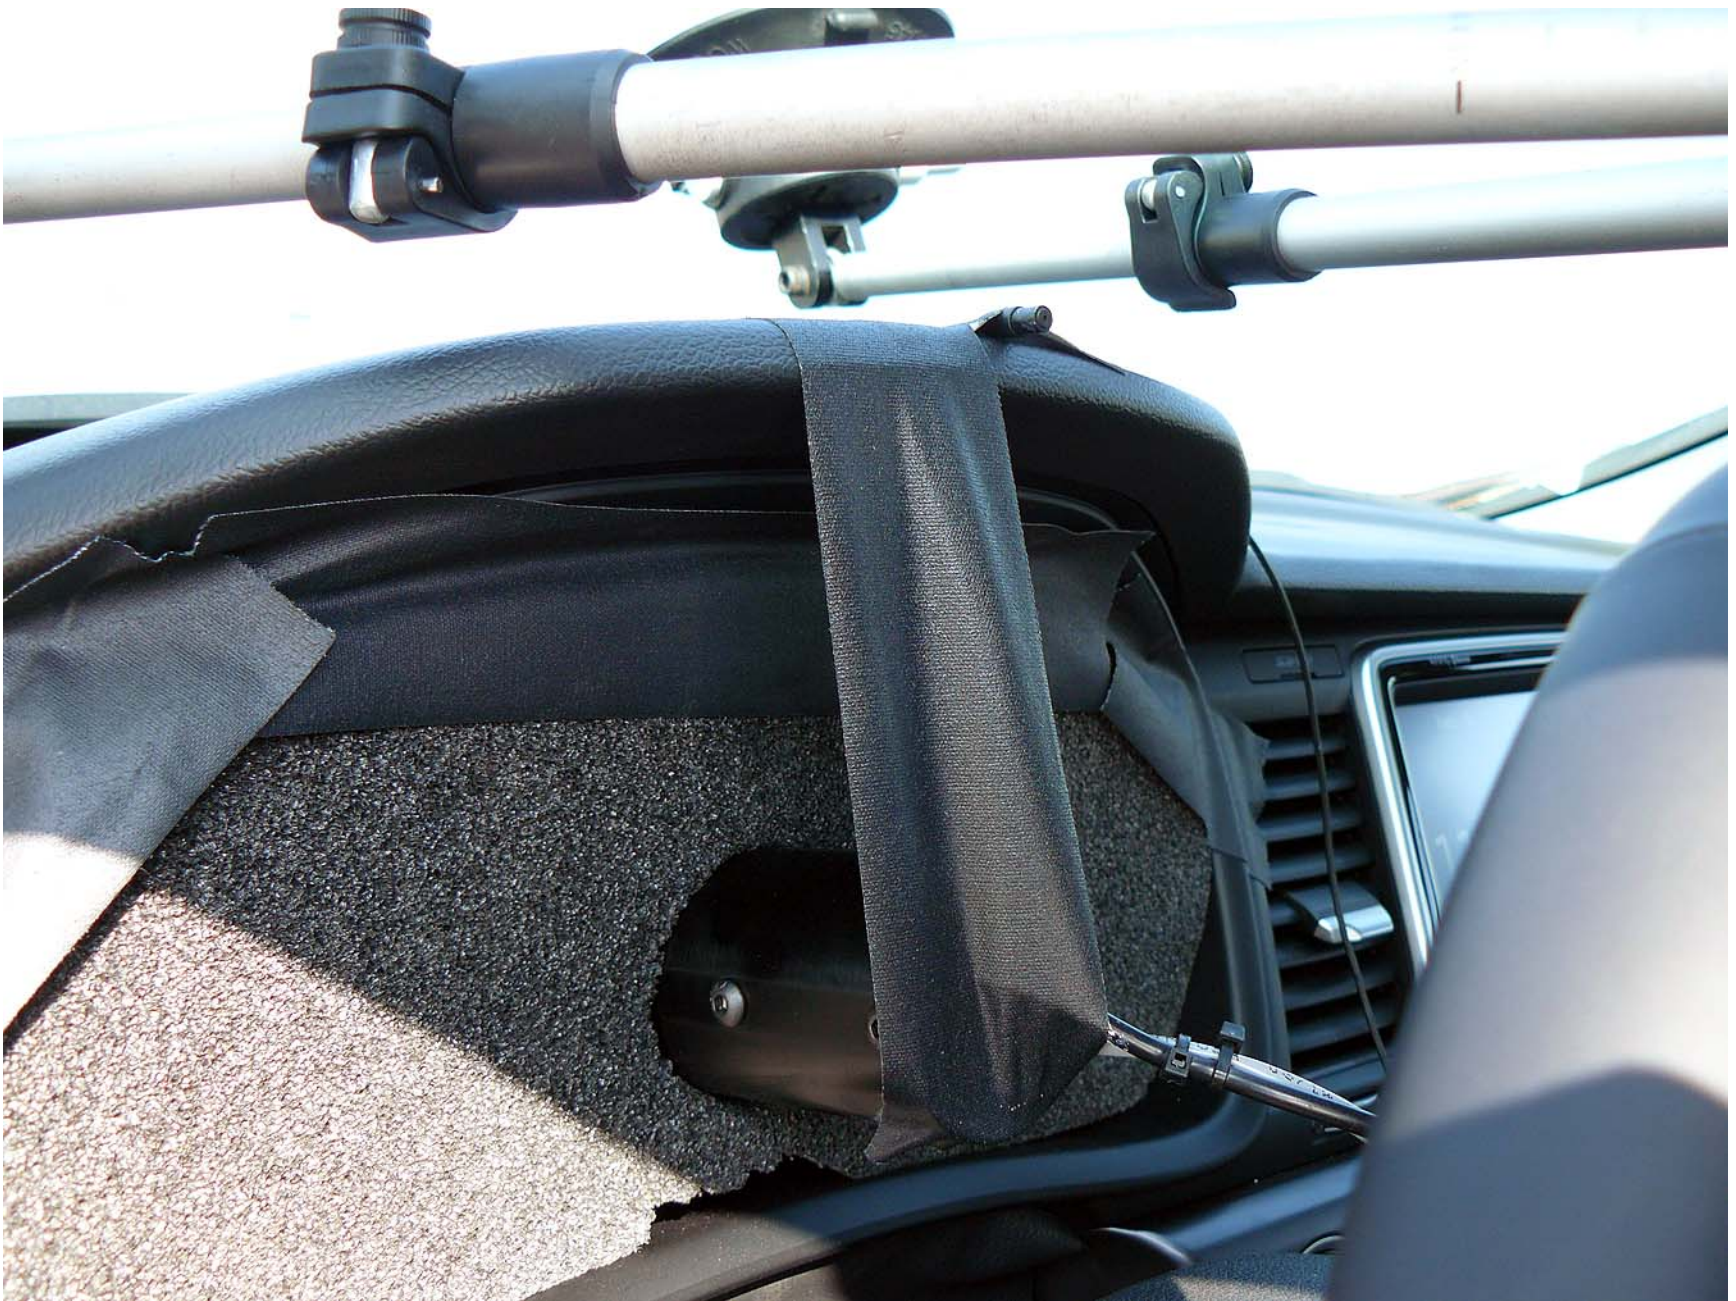
Figure A9. Sensor for Detecting Auditory Alerts

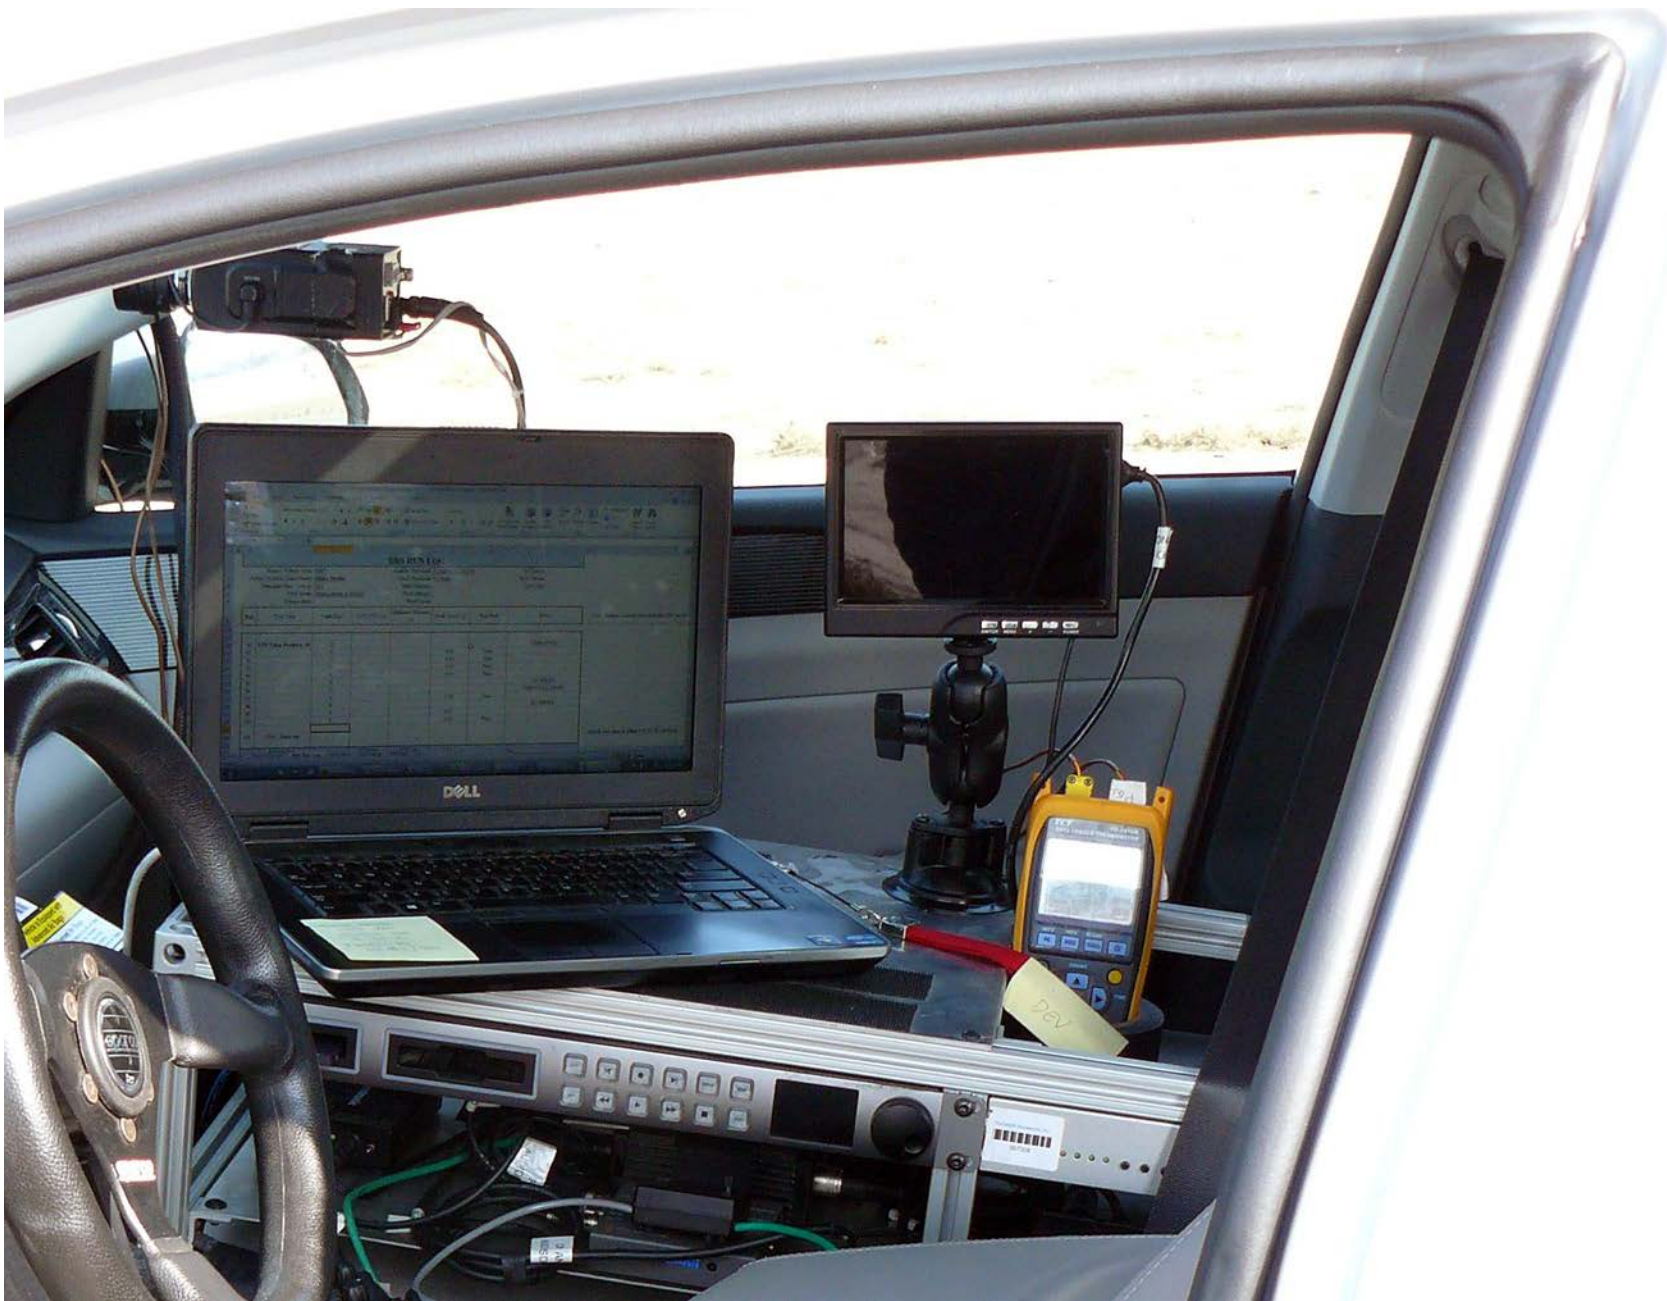
Figure A10. Computer Installed in Subject Vehicle

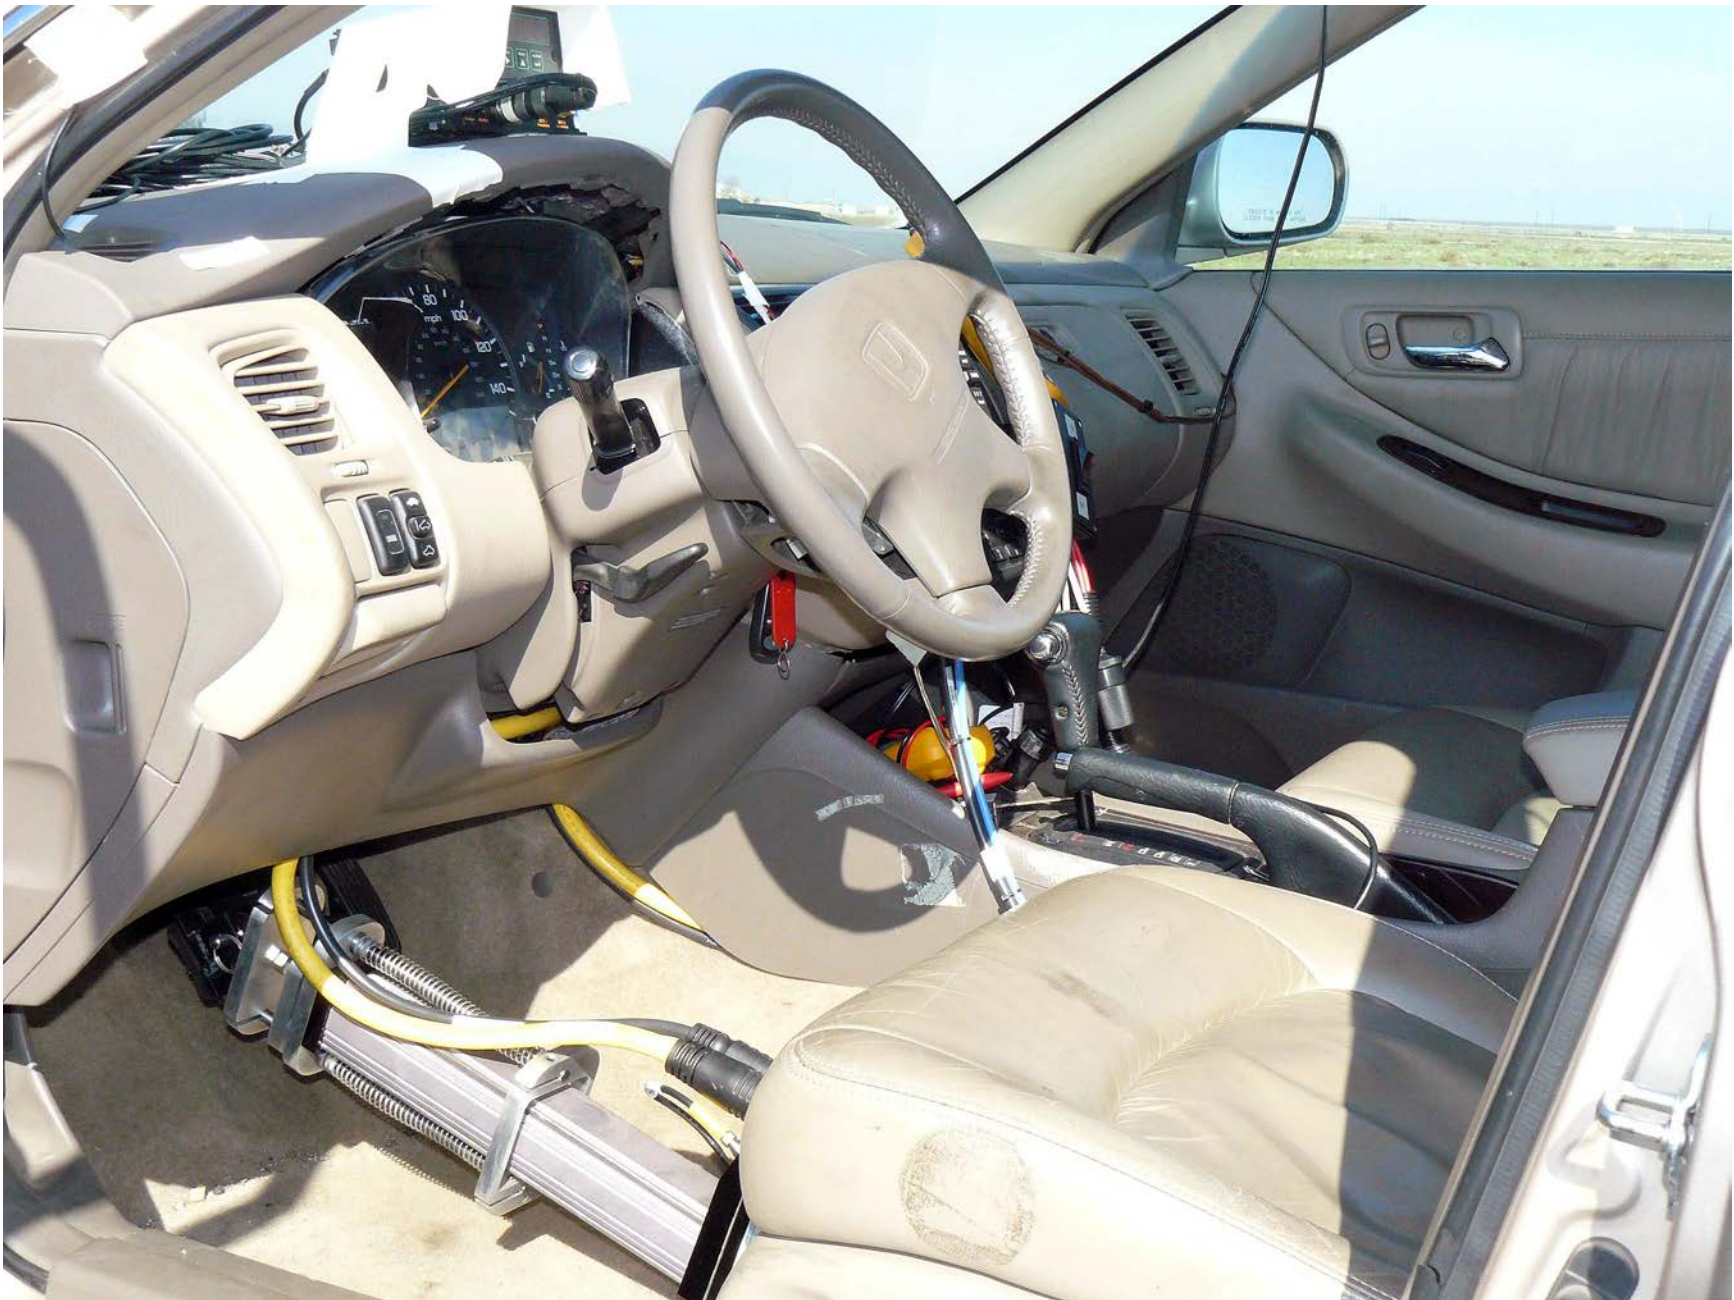
Figure A11. Brake Actuation System Installed in Principal Other Vehicle

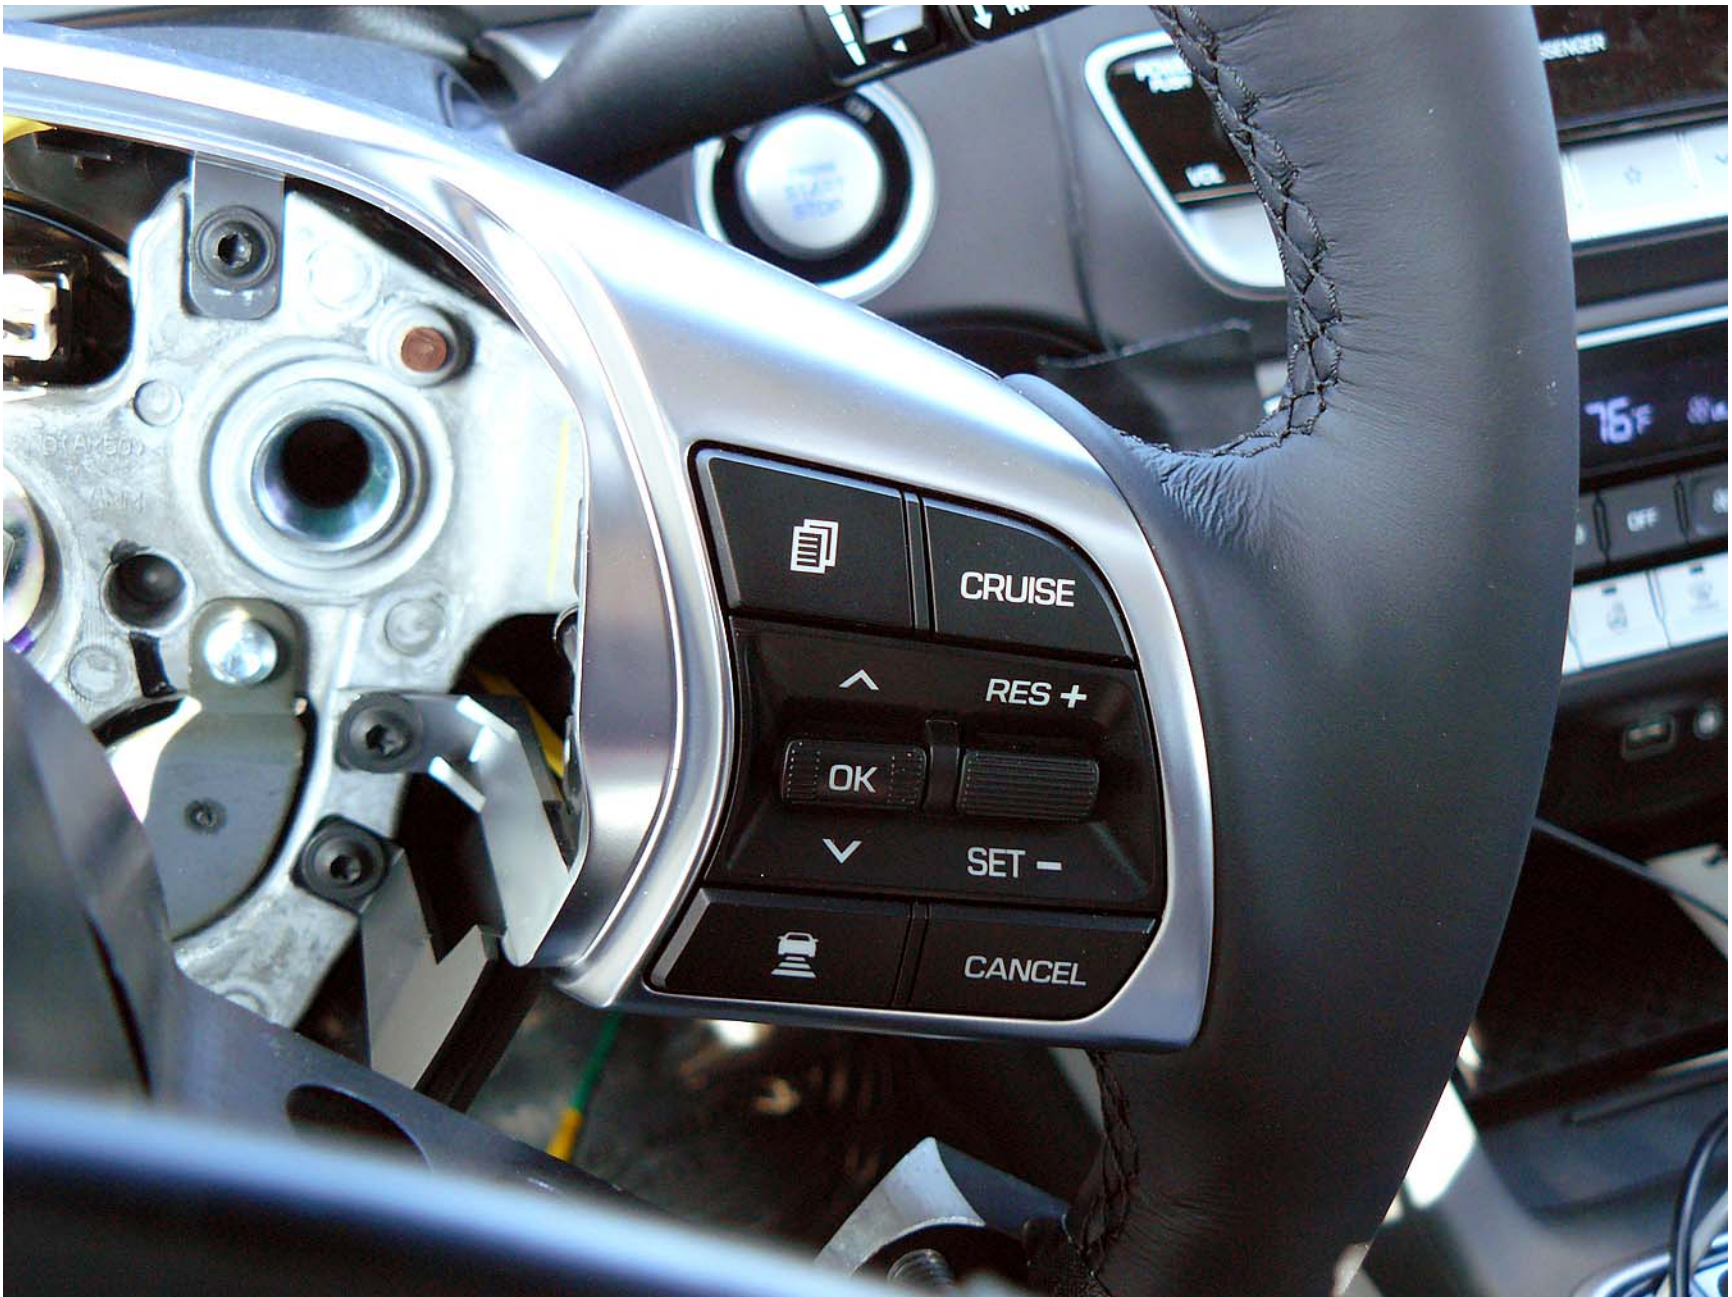
Figure A12. Controls for Interacting With System Setup

Using the buttons located on the right hand side of the steering wheel and the display in the center of the instrument panel in front of the driver select the following: Driving Assist --> AEB (Automatic Emergency Brake) --> check box indicates system on/off.

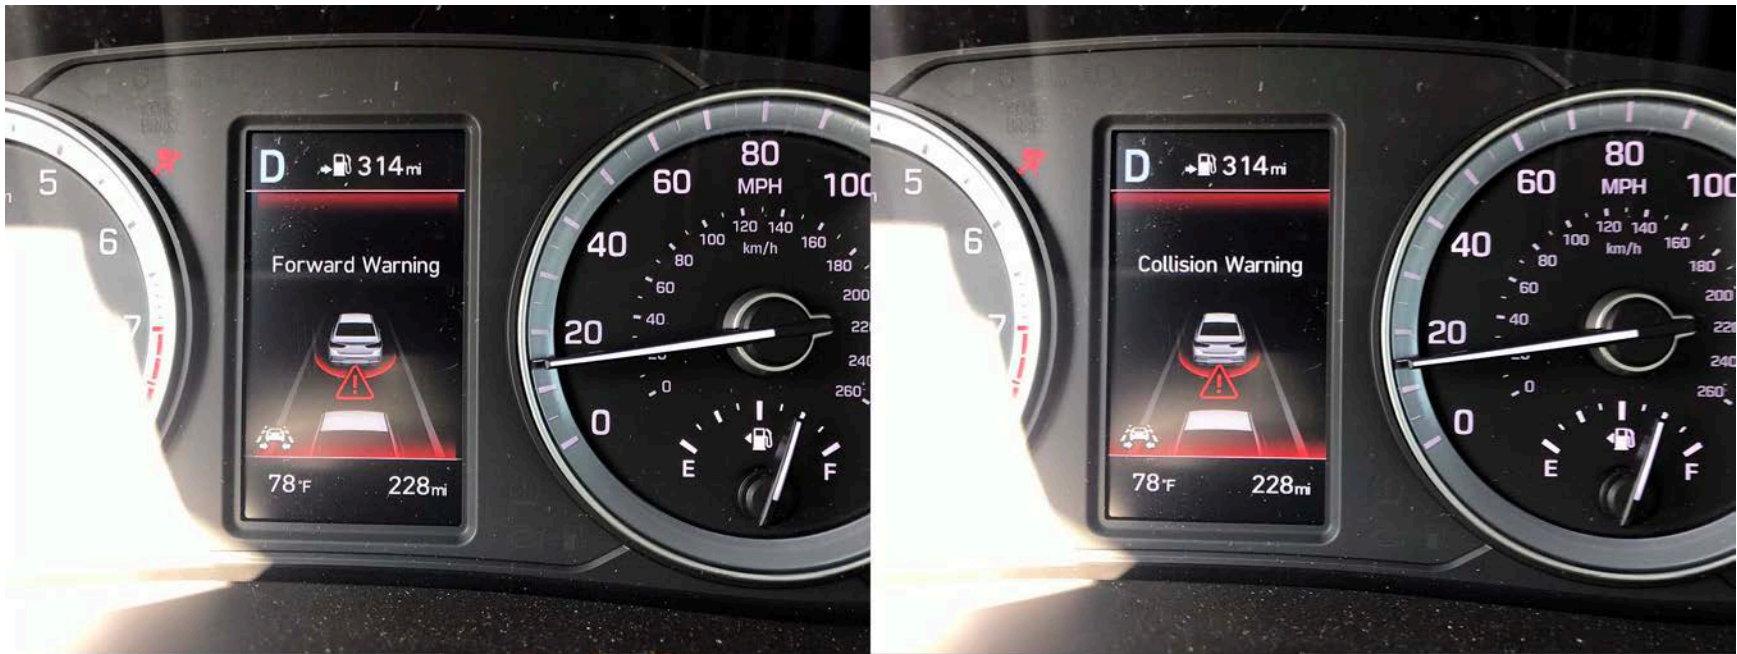
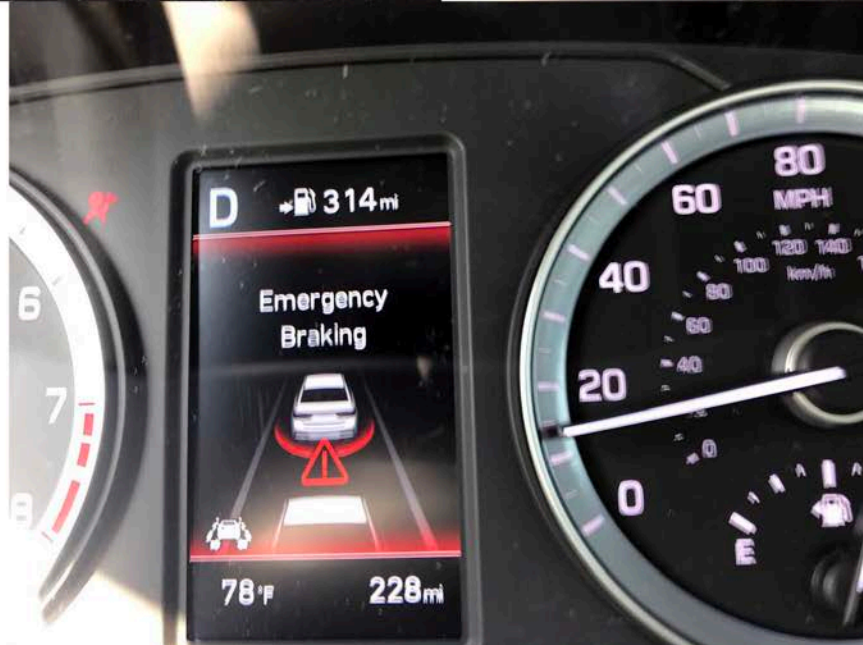
Figure A13. FCW Visual Displays

*The visual alert is provided to the driver via the center of the instrument panel in front of the driver. The visual alert consists of a picture of the front end of a vehicle about to collide with the rear end of a second vehicle with an exclamation point in between and the words "Forward Warning" above.*

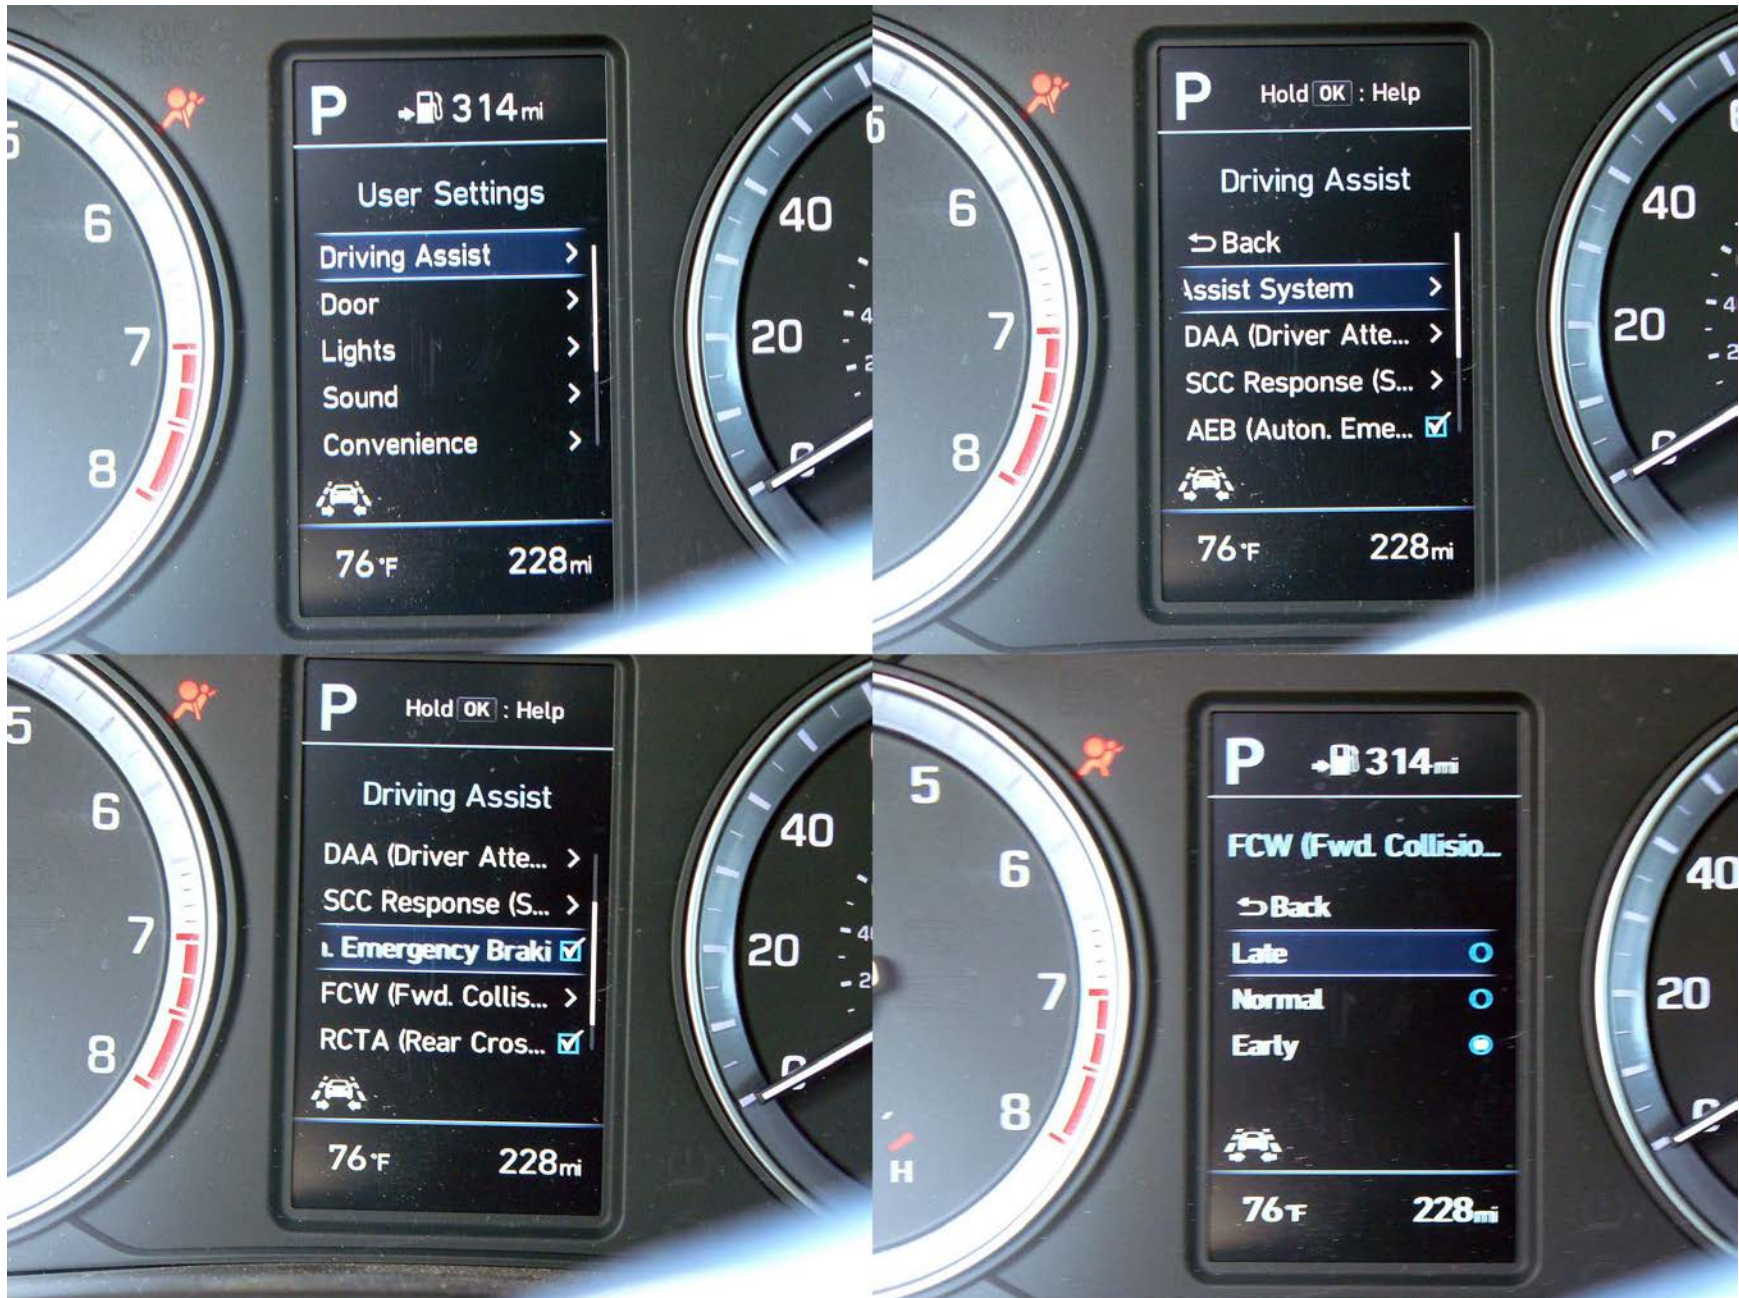
Figure A14. FCW System Setting Menus

The range of the FCW alert can be changed between Early/Normal/Late.

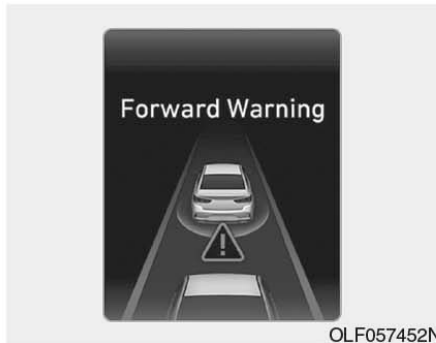
**Forward Warning (1<sup>st</sup> warning)**

This initial warning message appears on the LCD display with a warning chime.

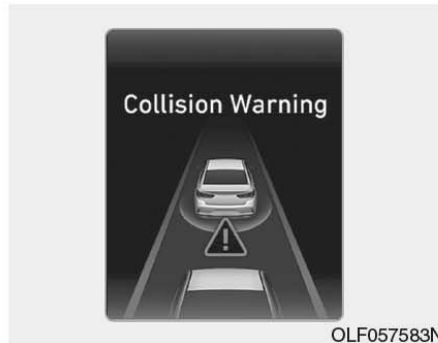
**Collision Warning (2<sup>nd</sup> warning)**

- This warning message appears on the LCD display with a warning chime.

- Additionally, some vehicle system intervention occurs by the engine management system to help decelerate the vehicle.

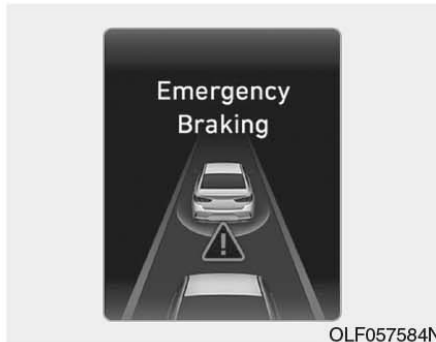
### **Emergency braking (3<sup>rd</sup> warning)**

- This warning message appears on the LCD display with a warning alarm.
- Additionally, automatic emergency braking of the vehicle is applied in order to avoid a collision.
  - If your vehicle is traveling less than 40 mph (65 km/h) and a pedestrian is detected within the Emergency Braking stage, automatic emergency braking of the vehicle is applied. In this condition, your vehicle speed will decelerate sharply to avoid a collision.

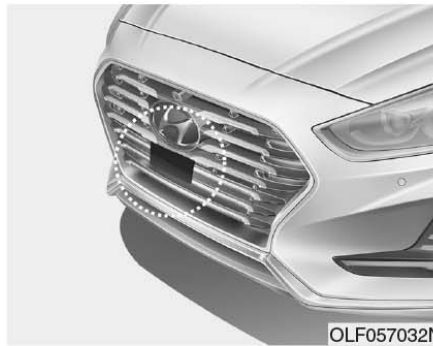
**AEB front radar sensor**

In order for the AEB system to operate properly, always make sure the radar sensor lens cover is clean and free of dirt, snow, and debris. Dirt, snow, or foreign substances on the lens may adversely affect the sensing performance of the radar.

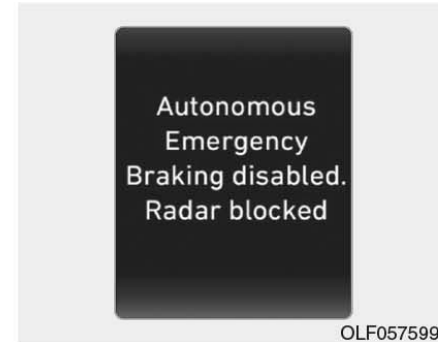
**Warning message and warning light**

When the sensor lens cover is blocked with dirt, snow, or debris, the AEB system operation may stop temporarily. If this occurs, a warning message will appear on the LCD display. Remove any dirt, snow, or debris and clean the radar sensor lens cover before operating the AEB system.

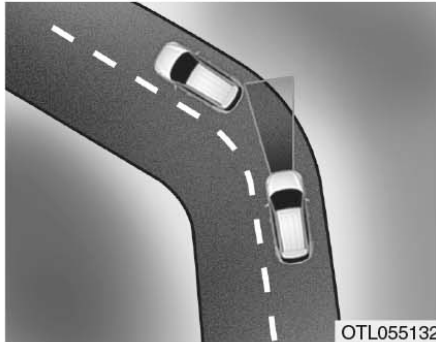
- Driving on a curve

The performance of the AEB system may be limited when driving on a curved road.

Also, in certain instances the front radar sensor or camera recognition system may not detect the vehicle traveling on a curved road.

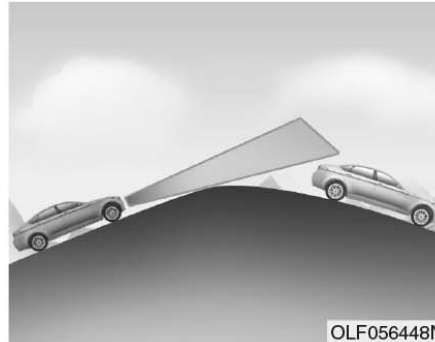
- Driving on a slope

The performance of the AEB decreases while driving upward or downward on a slope, not recognizing the vehicle in front in the same lane. It may unnecessarily produce the warning message and the warning alarm, or it may not produce the warning message and the warning alarm at all.

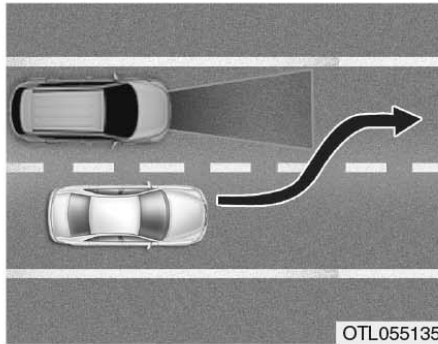
OTL055135

- Changing lanes

When a vehicle changes lanes in front of you, the AEB system may not immediately detect the vehicle, especially if the vehicle changes lanes abruptly. In this case, you must maintain a safe braking distance, and if necessary, depress the brake pedal to reduce your driving speed in order to maintain a safe distance.

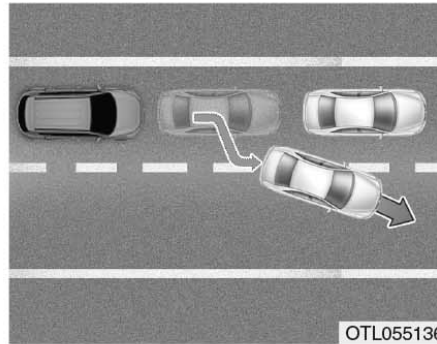
OTL055136

When driving in stop-and-go traffic, and a stopped vehicle in front of you merges out of the lane, the AEB system may not immediately detect the new vehicle that is now in front of you. In this case, you must maintain a safe braking distance, and if necessary, depress the brake pedal to reduce your driving speed in order to maintain a safe distance.

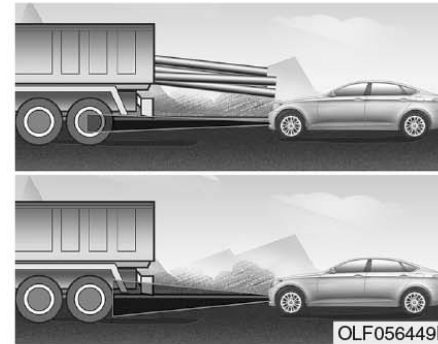
OLF056449N

- Detecting the vehicle in front of you  
If the vehicle in front of you has cargo that extends rearward from the cab, or when the vehicle in front of you has higher ground clearance, additional special attention is required. The AEB system may not be able to detect the cargo extending from the vehicle. In these instances, you must maintain a safe braking distance from the rearmost object, and if necessary, depress the brake pedal to reduce your driving speed in order to maintain distance.

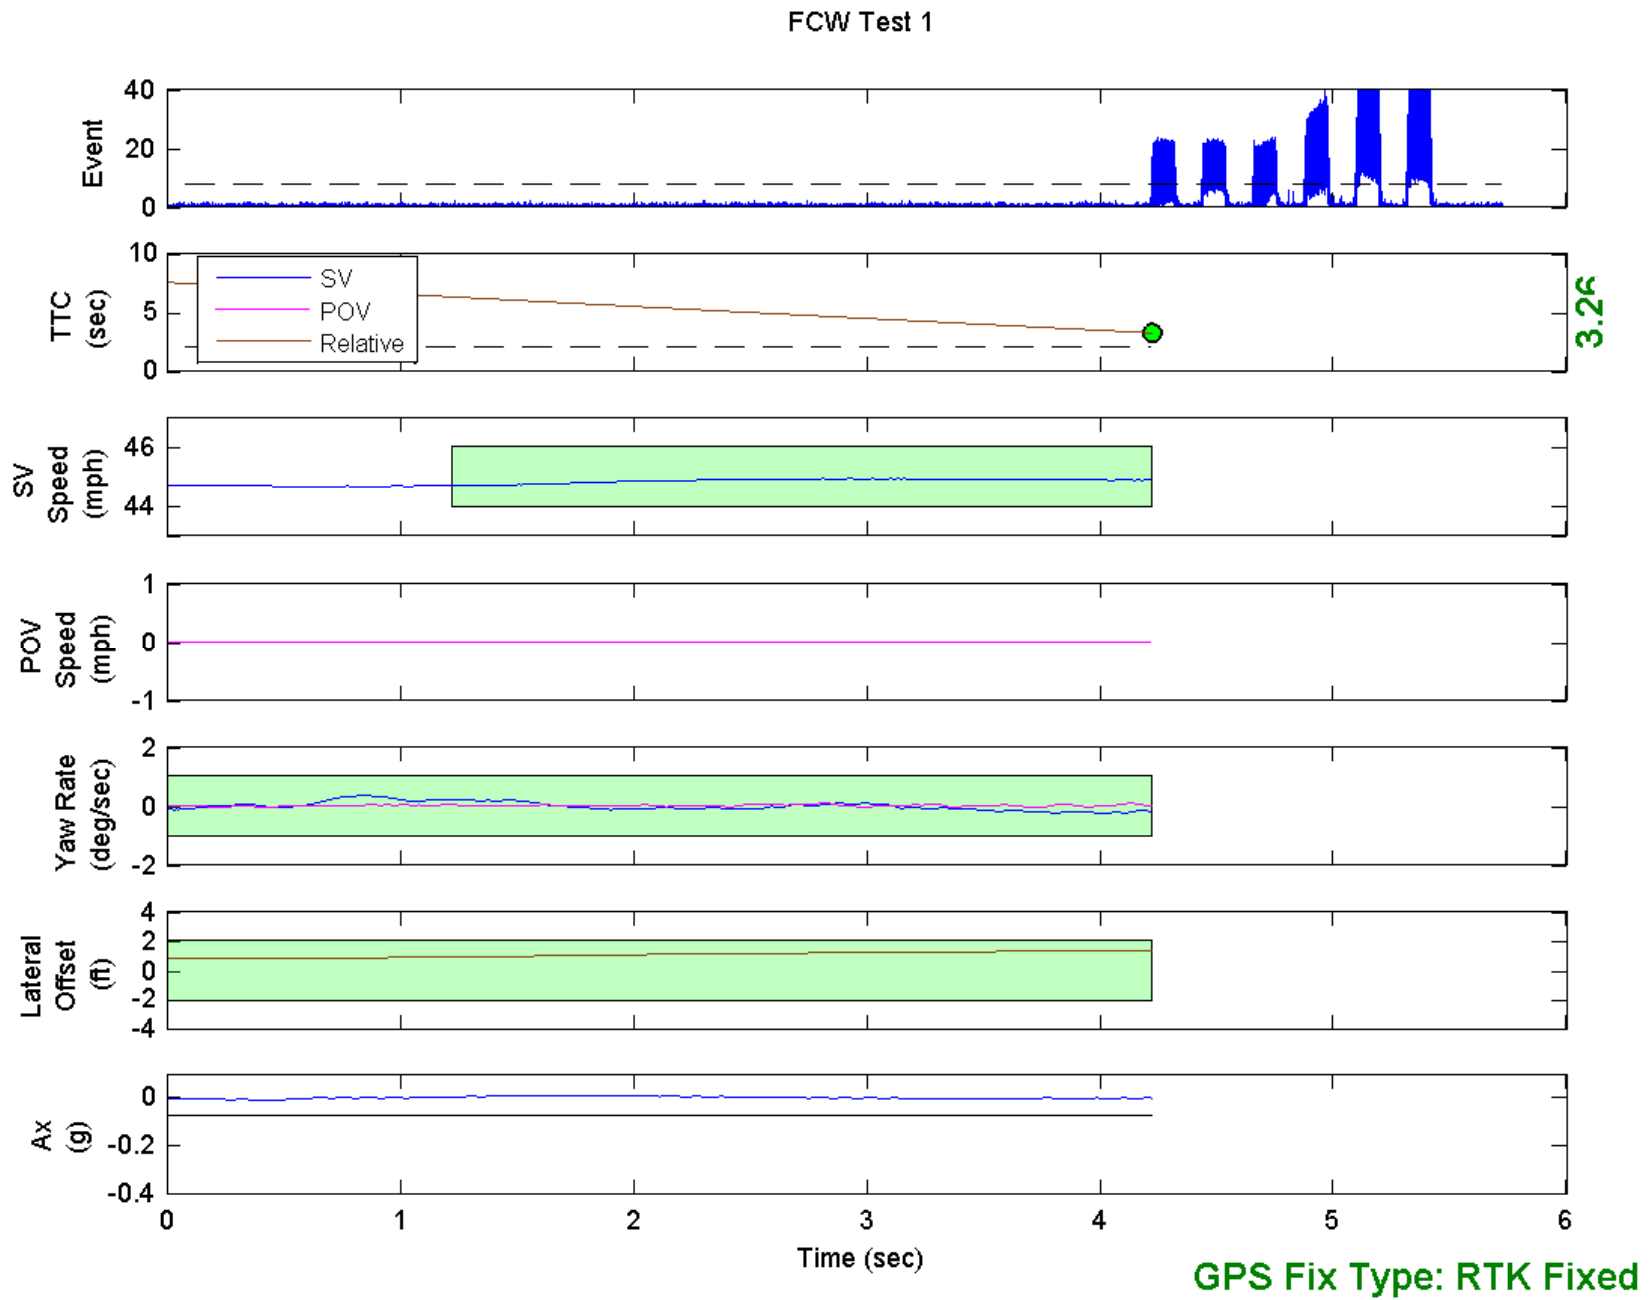
Figure D1. Example Time History for Test Type 1, Passing

Examples of time history plots for each test type (including passing, failing and invalid runs) are shown in Figure D1 through Figure D6. Actual time history data plots for the vehicle under consideration are provided subsequently.
