**OCAS-DRI-FCW-18-03  
NEW CAR ASSESSMENT PROGRAM  
FORWARD COLLISION WARNING CONFIRMATION TEST**

**2018 Hyundai Sonata**

**Final Report**

1. Report No. OCAS-DRI-FCW-18-03	2. Government Accession No.	3. Recipient's Catalog No.	
4. Title and Subtitle Final Report of Forward Collision Warning Testing of a 2018 Hyundai Sonata.		5. Report Date 11 June 2018

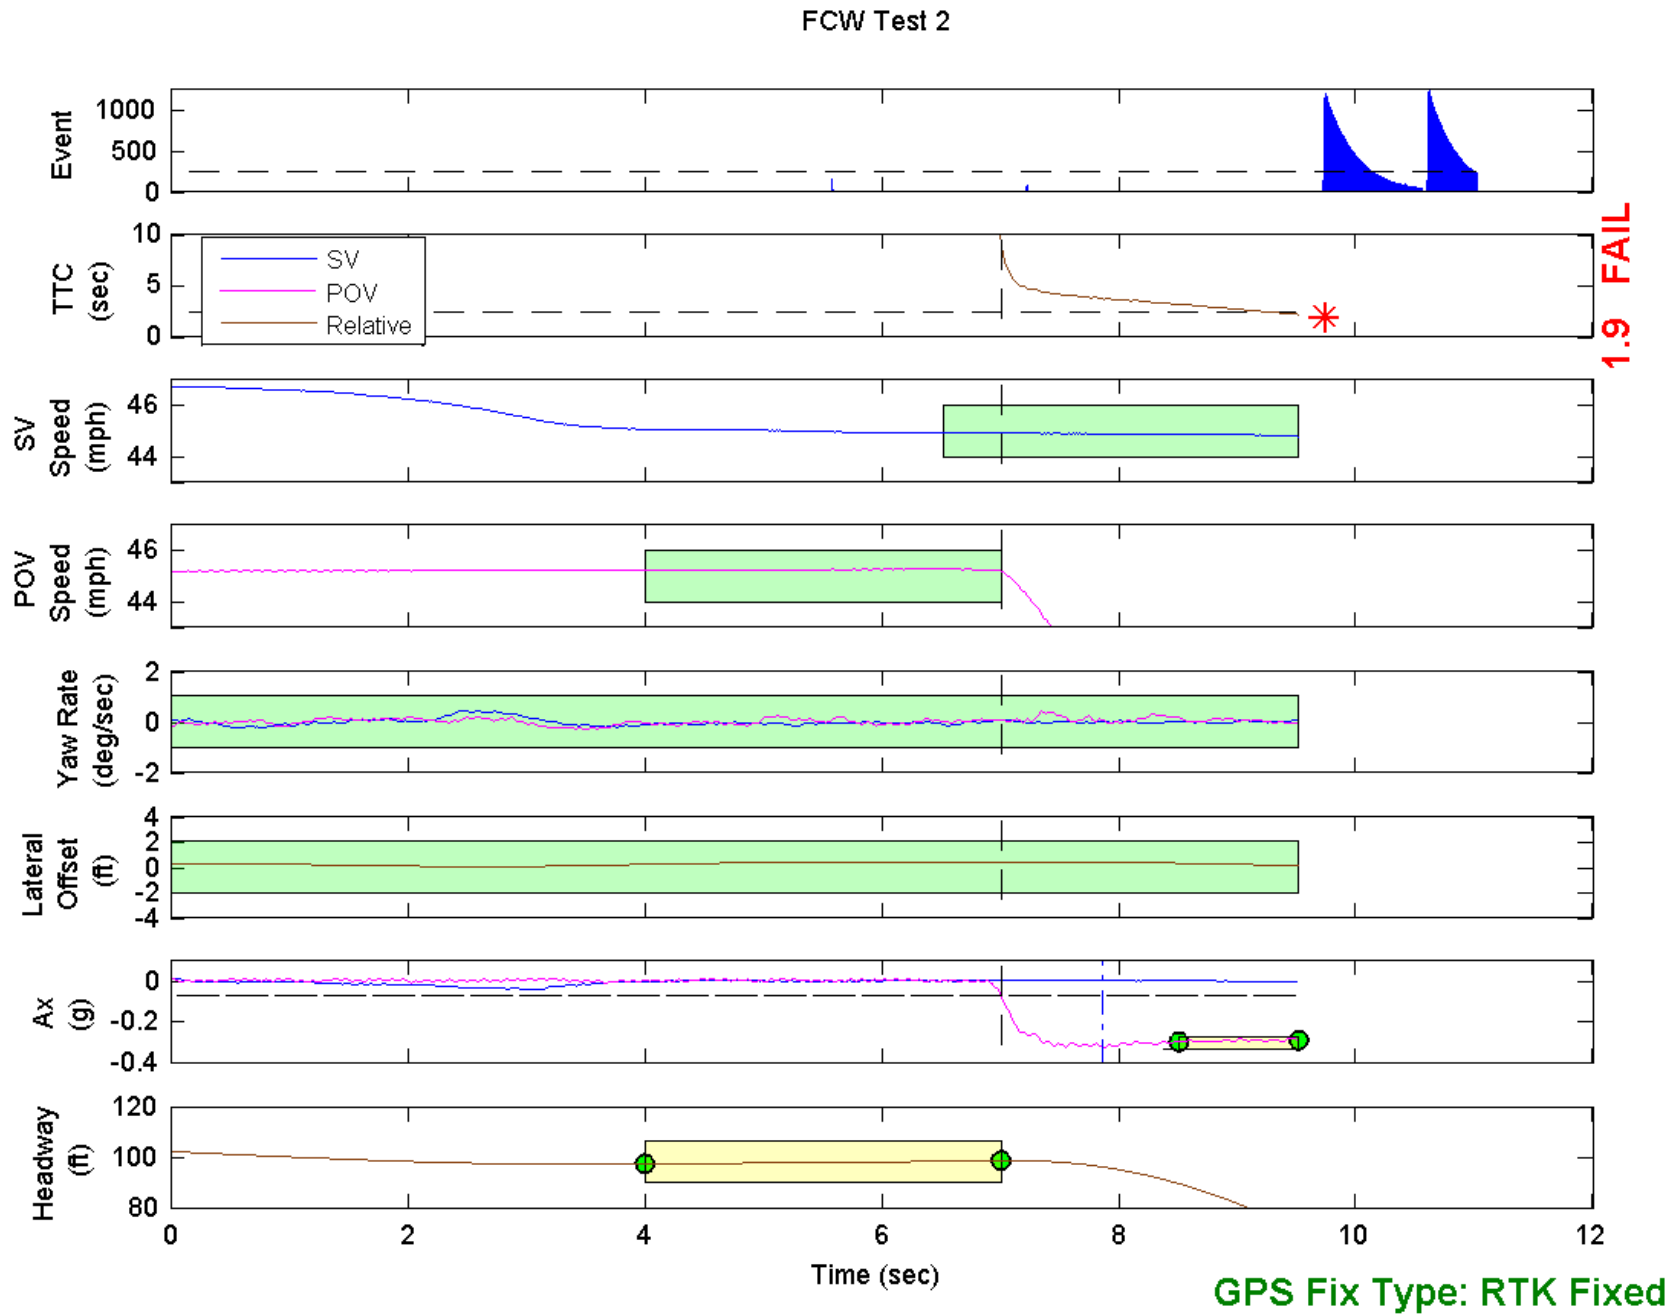
Figure D2. Example Time History for Test Type 2, Failing

Examples of time history plots for each test type (including passing, failing and invalid runs) are shown in Figure D1 through Figure D6. Actual time history data plots for the vehicle under consideration are provided subsequently.

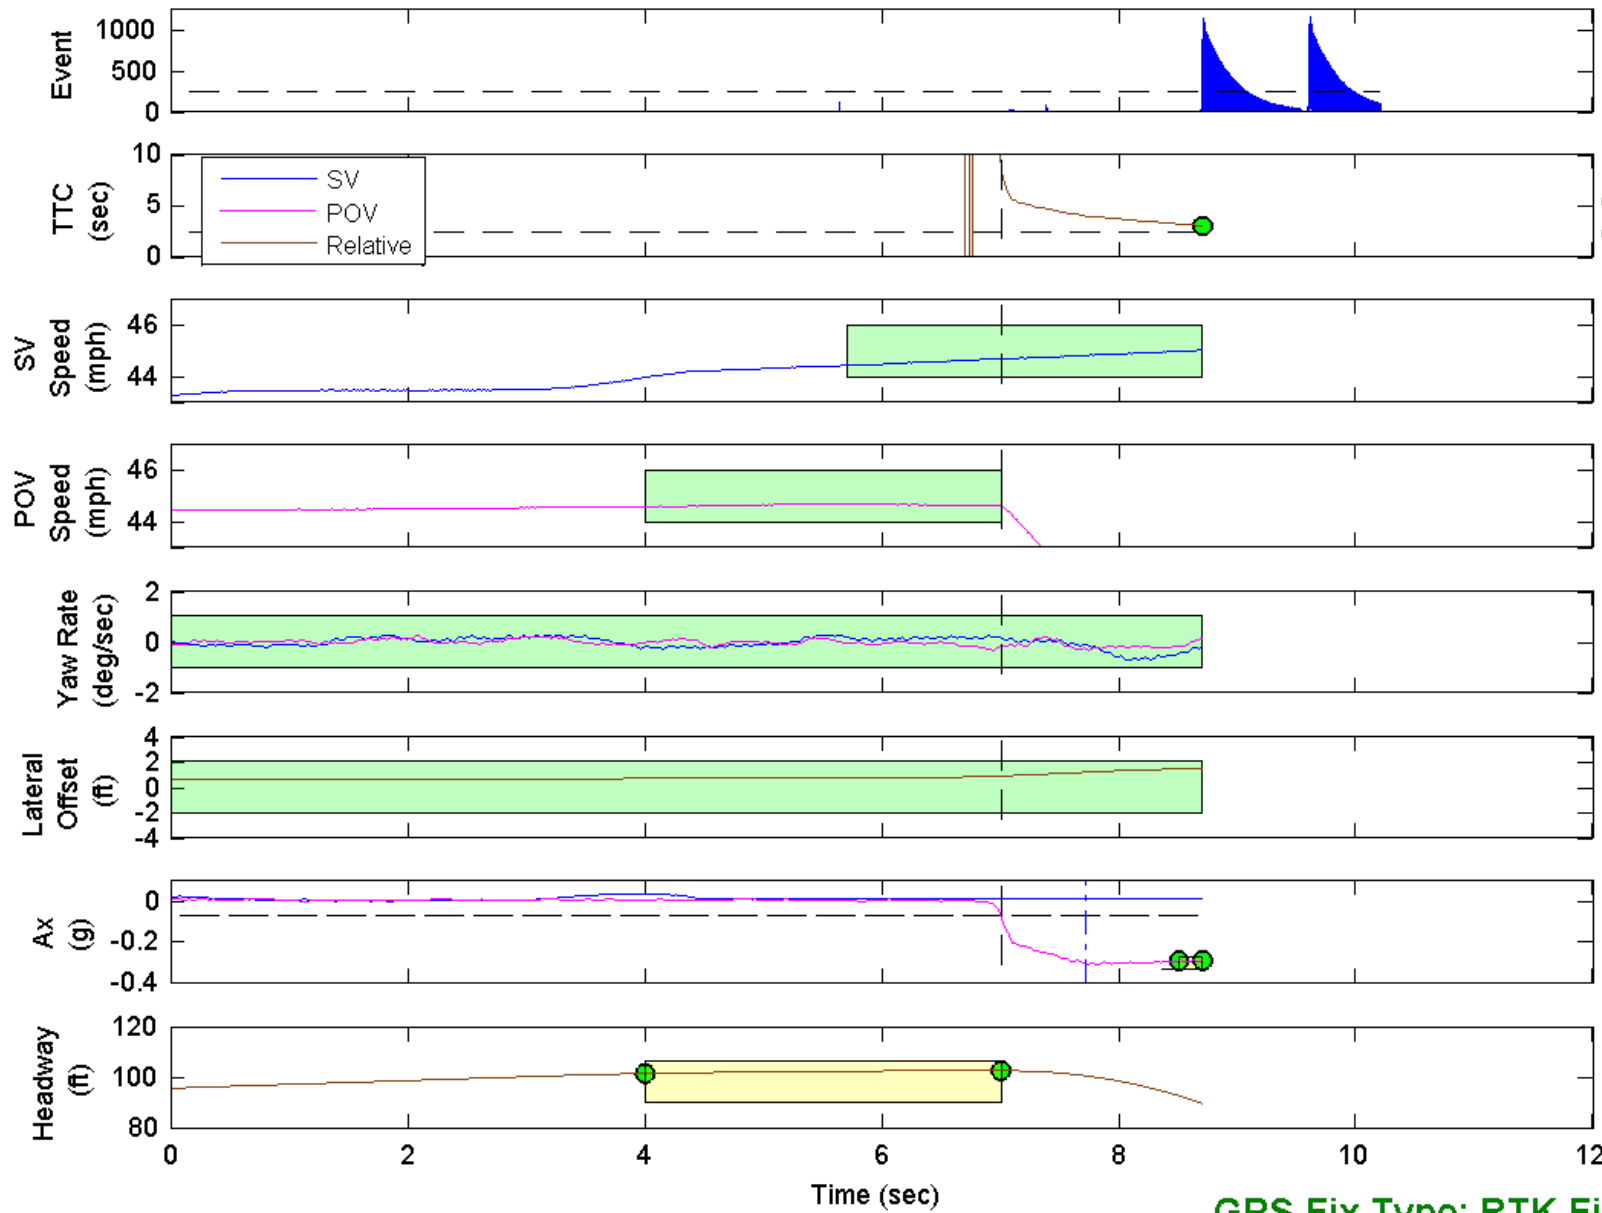
Figure D3. Example Time History for Test Type 2, Passing

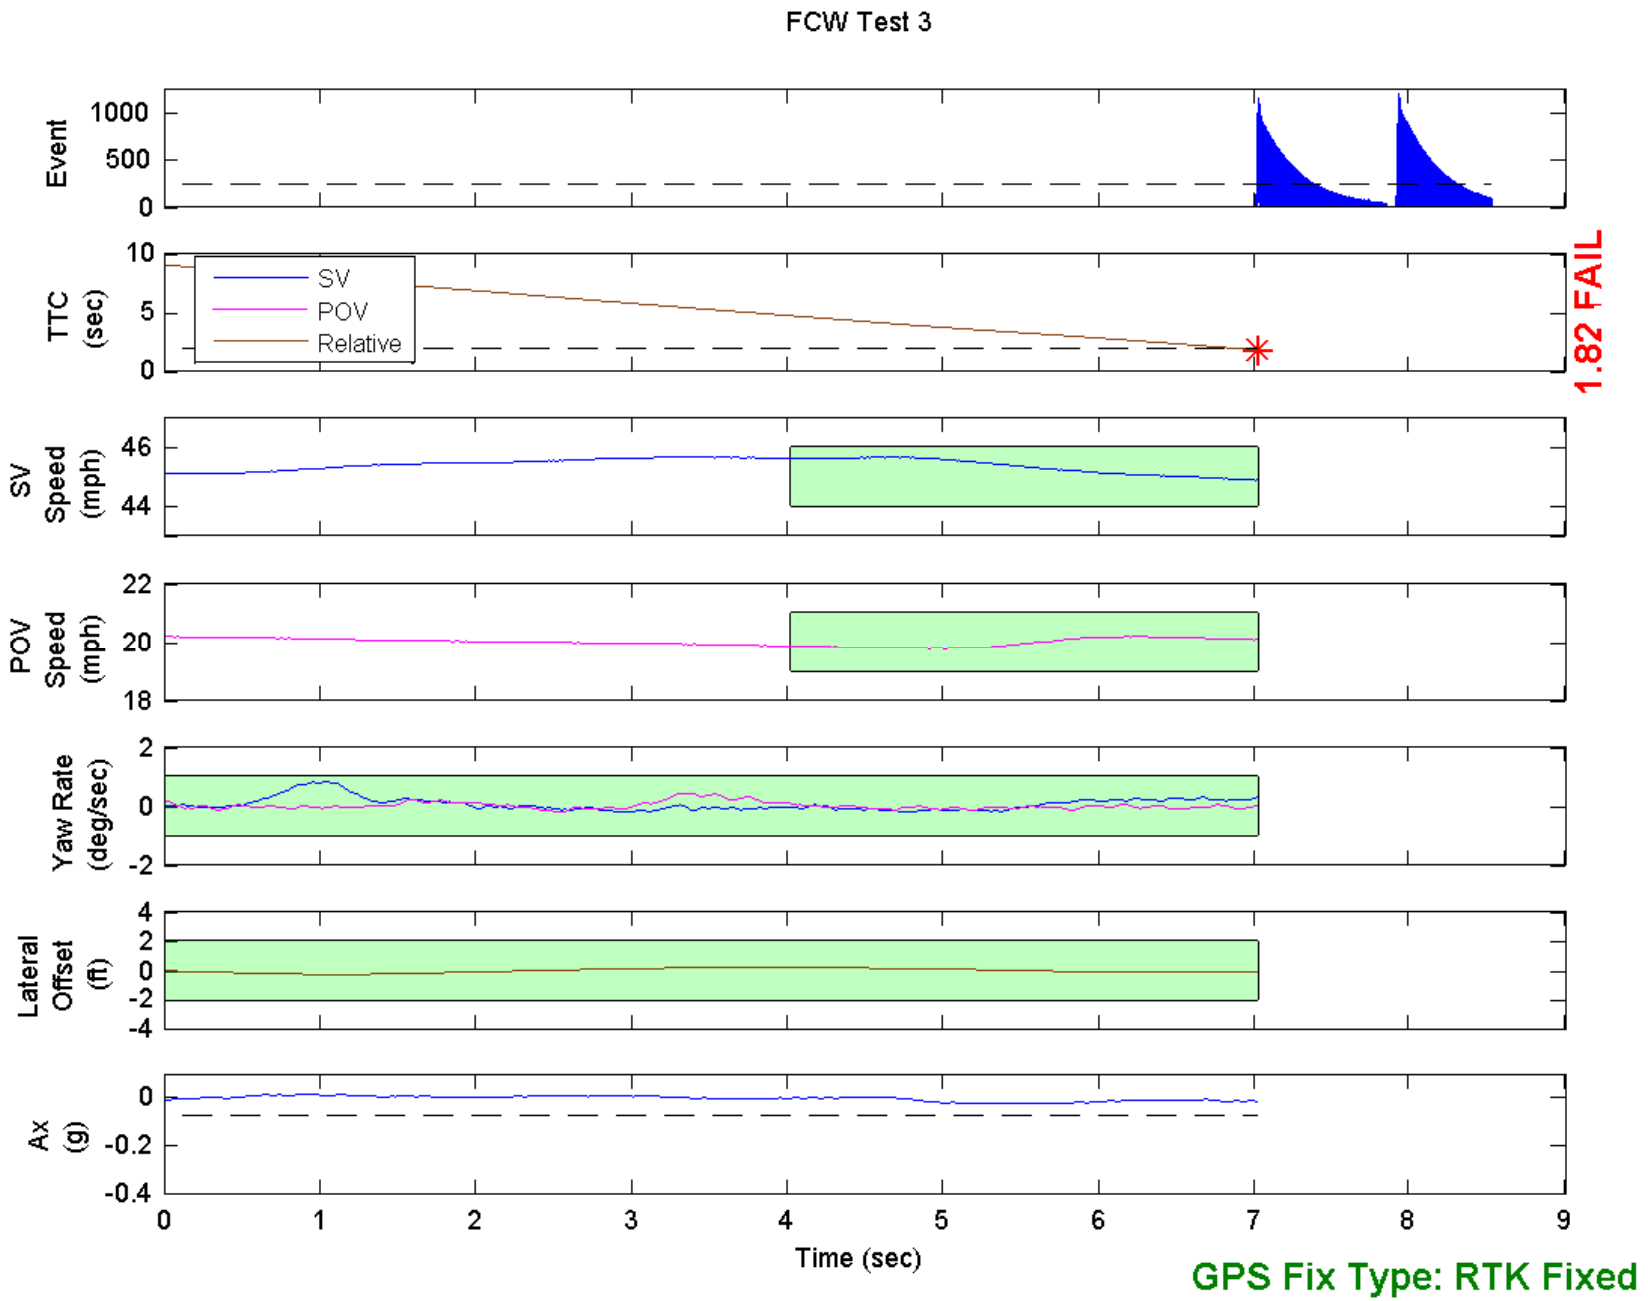
Figure D4. Example Time History for Test Type 3, Failing

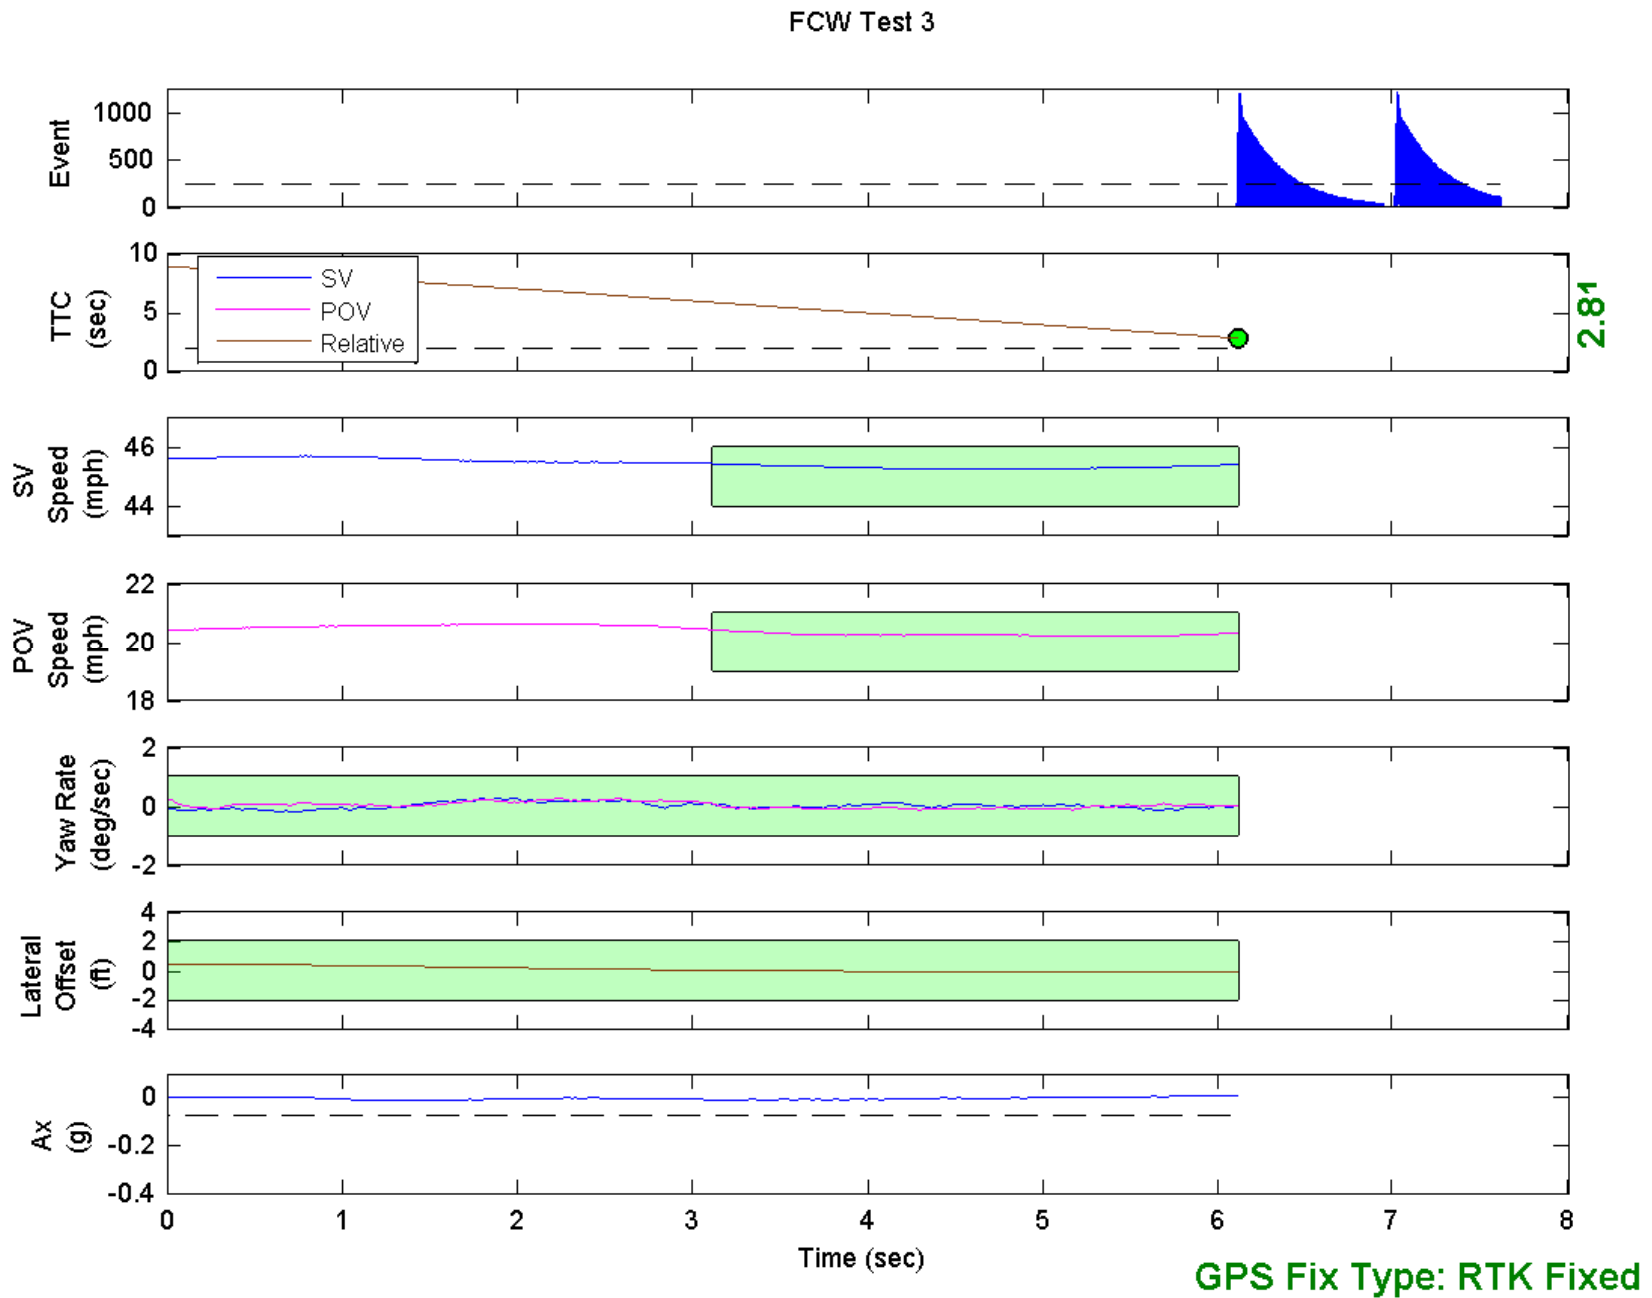
Figure D5. Example Time History for Test Type 3, Passing

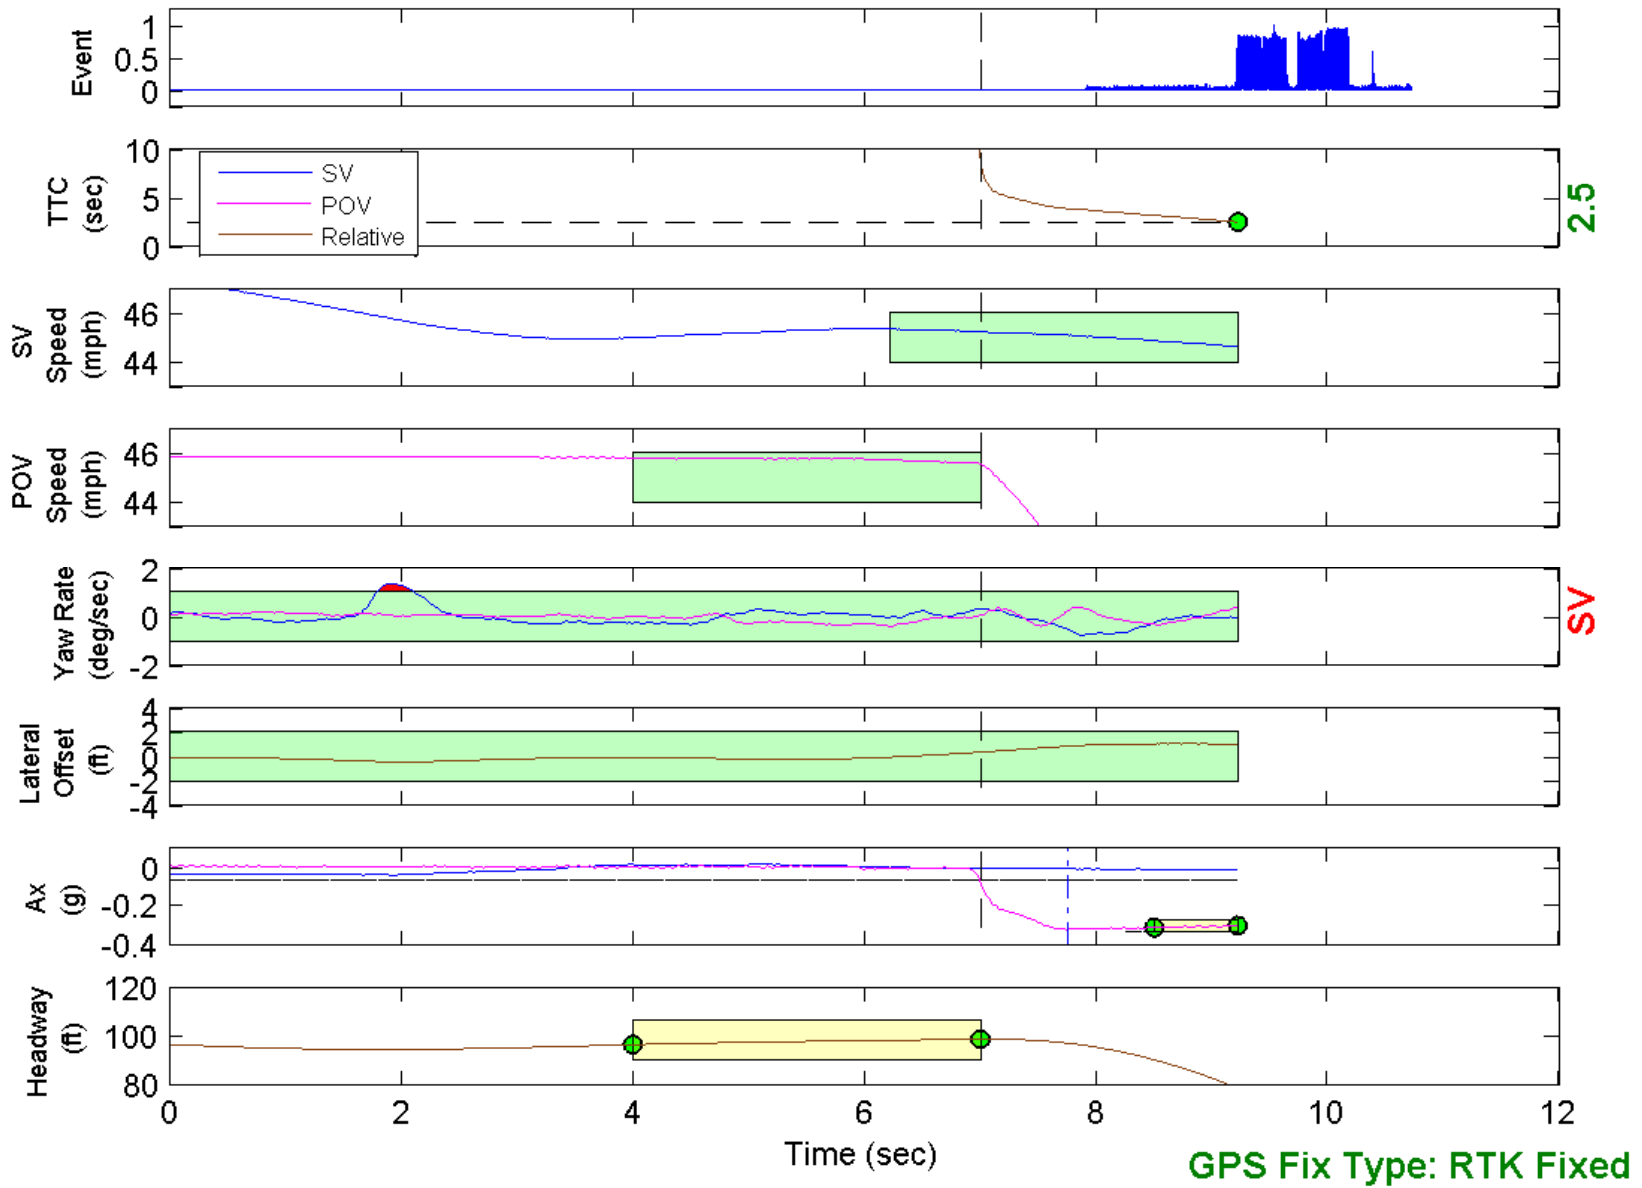
Figure D6. Example Time History for Test Type 2, Invalid Run Due to Subject Vehicle Yaw Rate

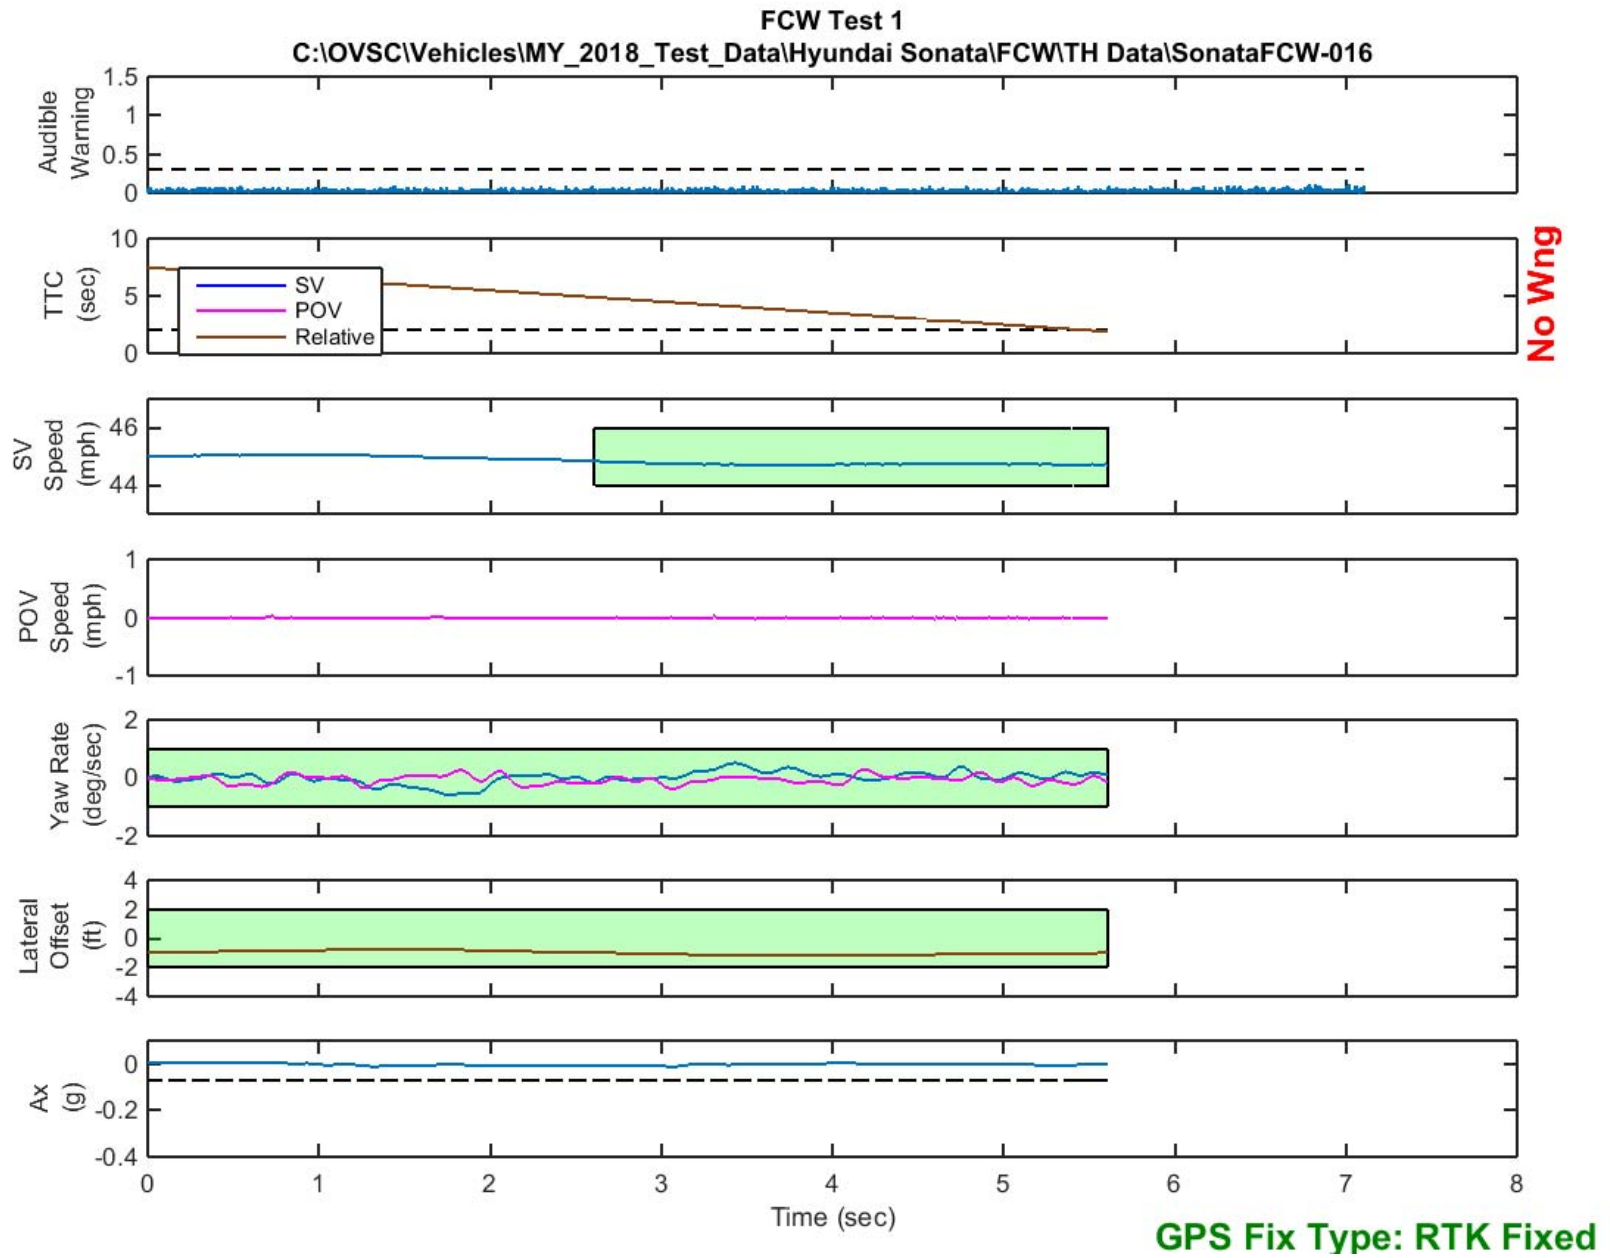
Figure D7. Time History for Run 16, FCW Test 1, Audible Warning

Run	Test Type	Valid Run?	TTCW Sound (sec)	TTCW Light (sec)	TTCW Margin (sec)	Pass/Fail	Notes
16	Stopped POV	Y			-2.10	Fail	No warning issued
17		Y	2.55		0.45	Pass	
18		Y			-2.10	Fail	No warning issued
19		Y			-2.10	Fail	No warning issued
20		Y			-2.10	Fail	No warning issued

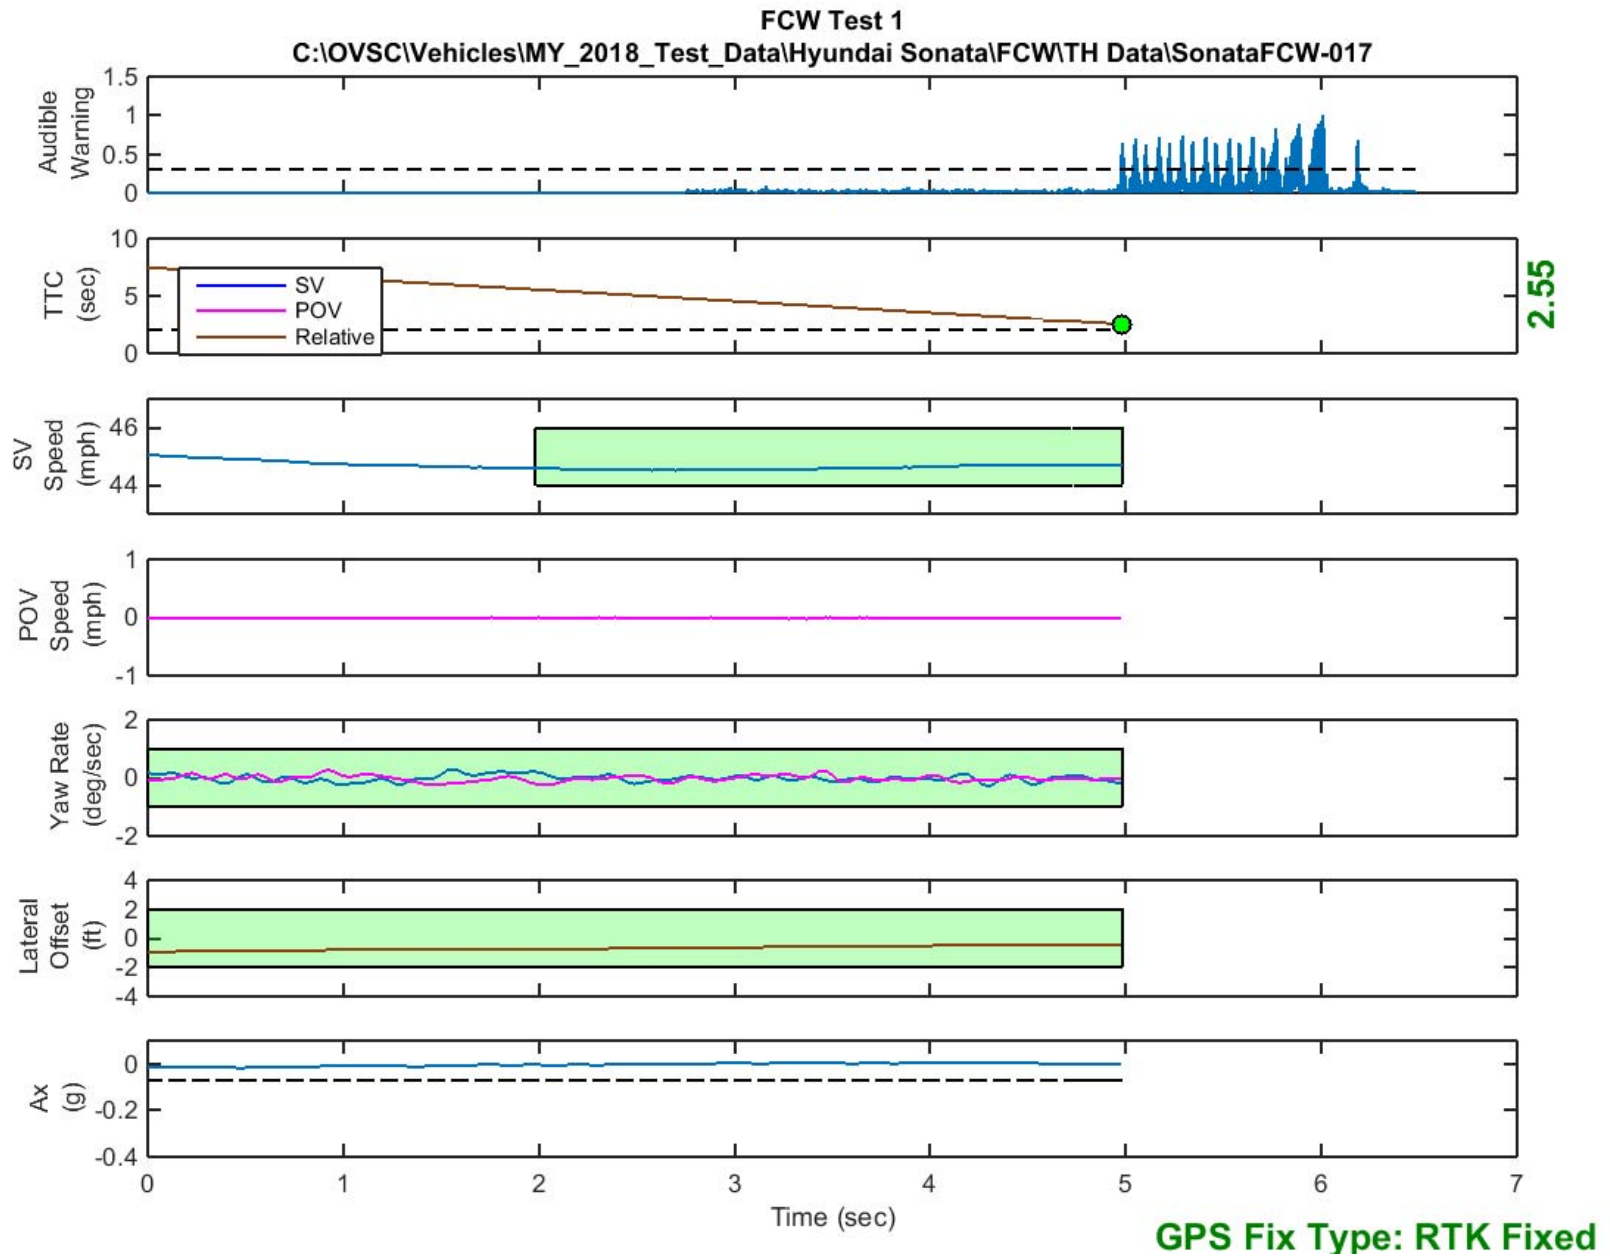
Figure D8. Time History for Run 17, FCW Test 1, Audible Warning

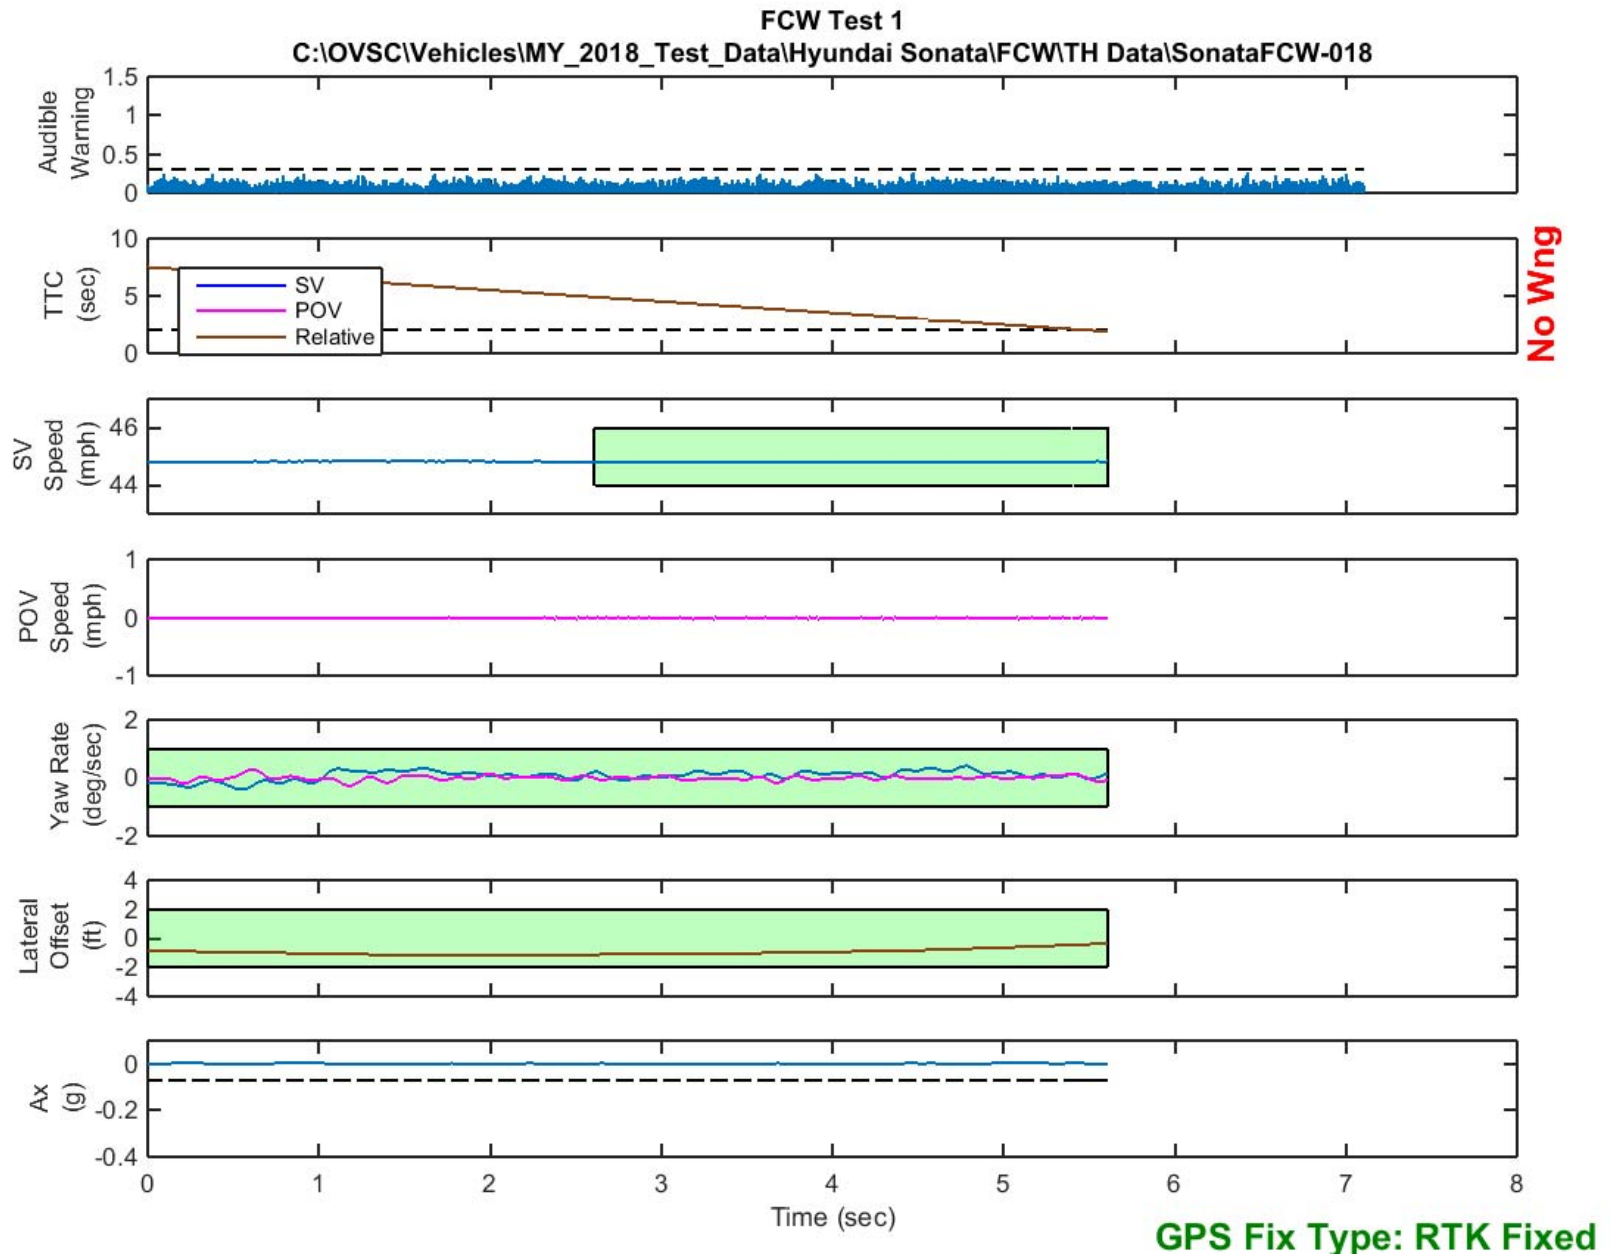
Figure D9. Time History for Run 18, FCW Test 1, Audible Warning

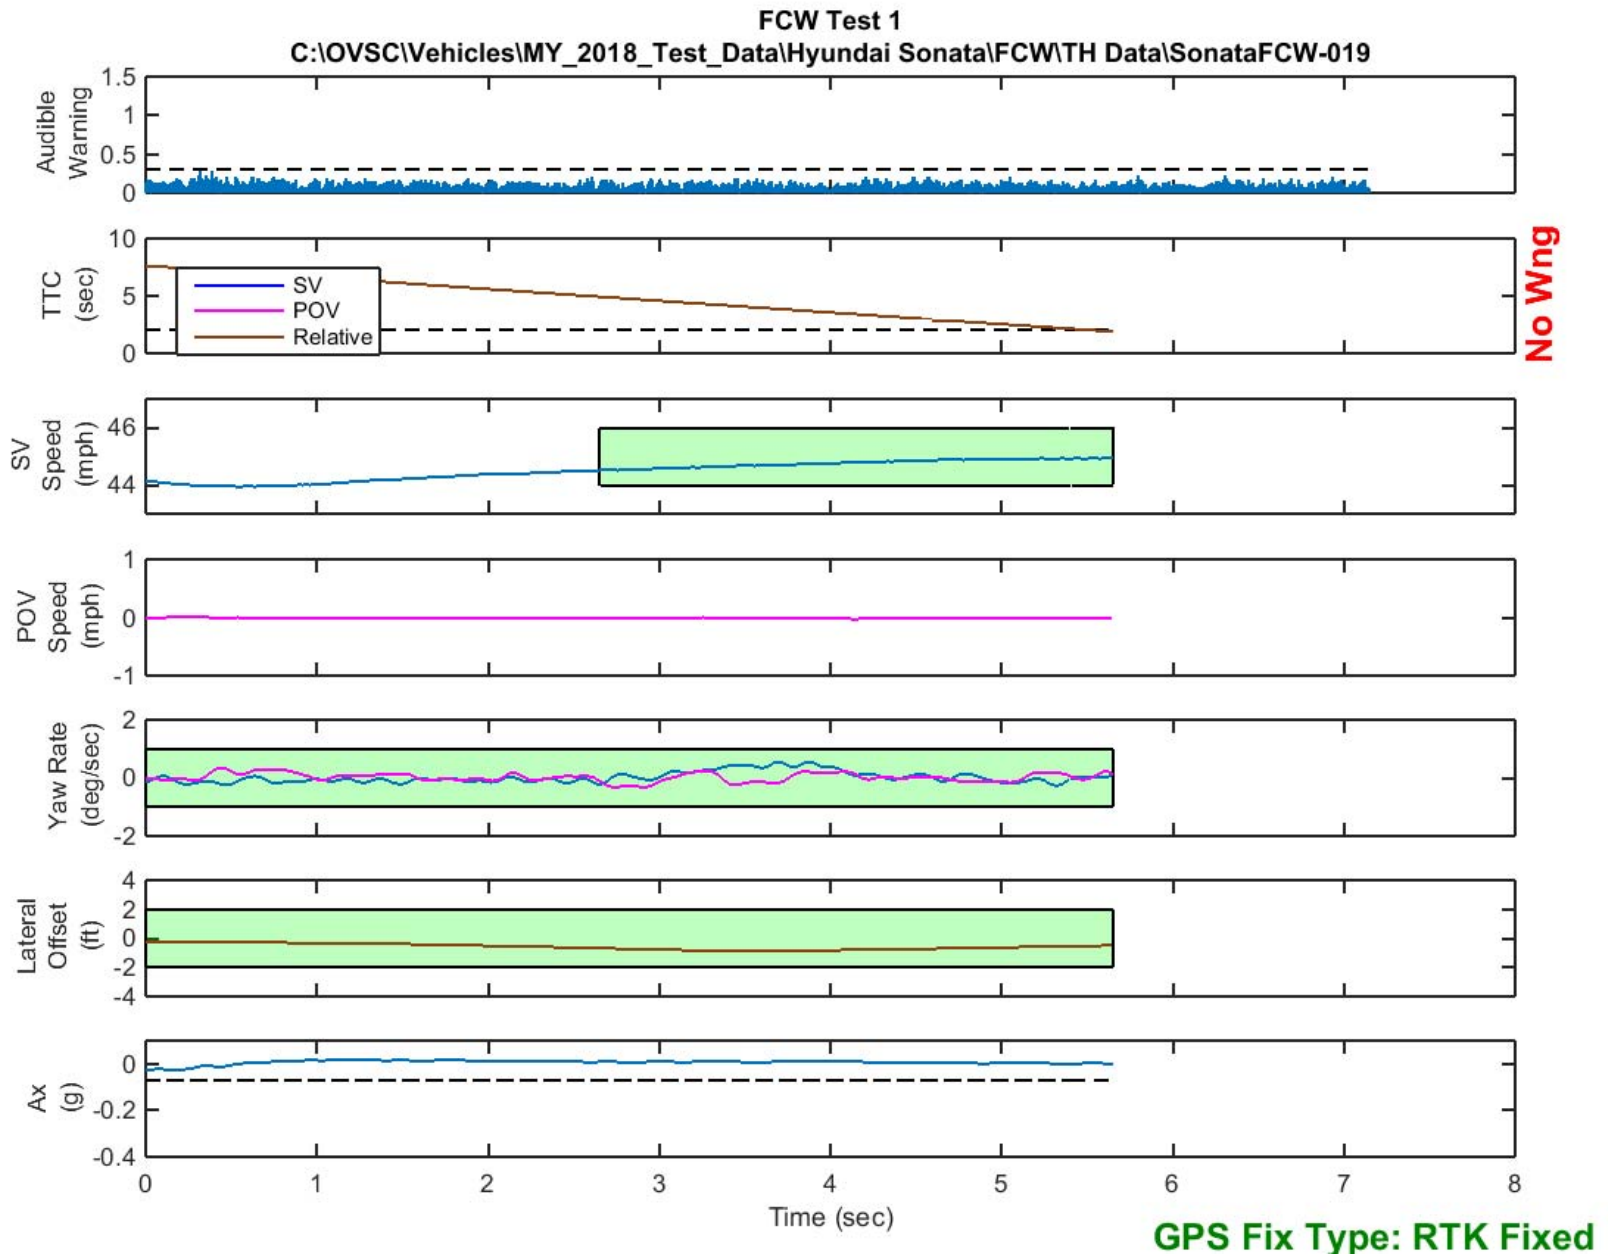
Figure D10. Time History for Run 19, FCW Test 1, Audible Warning

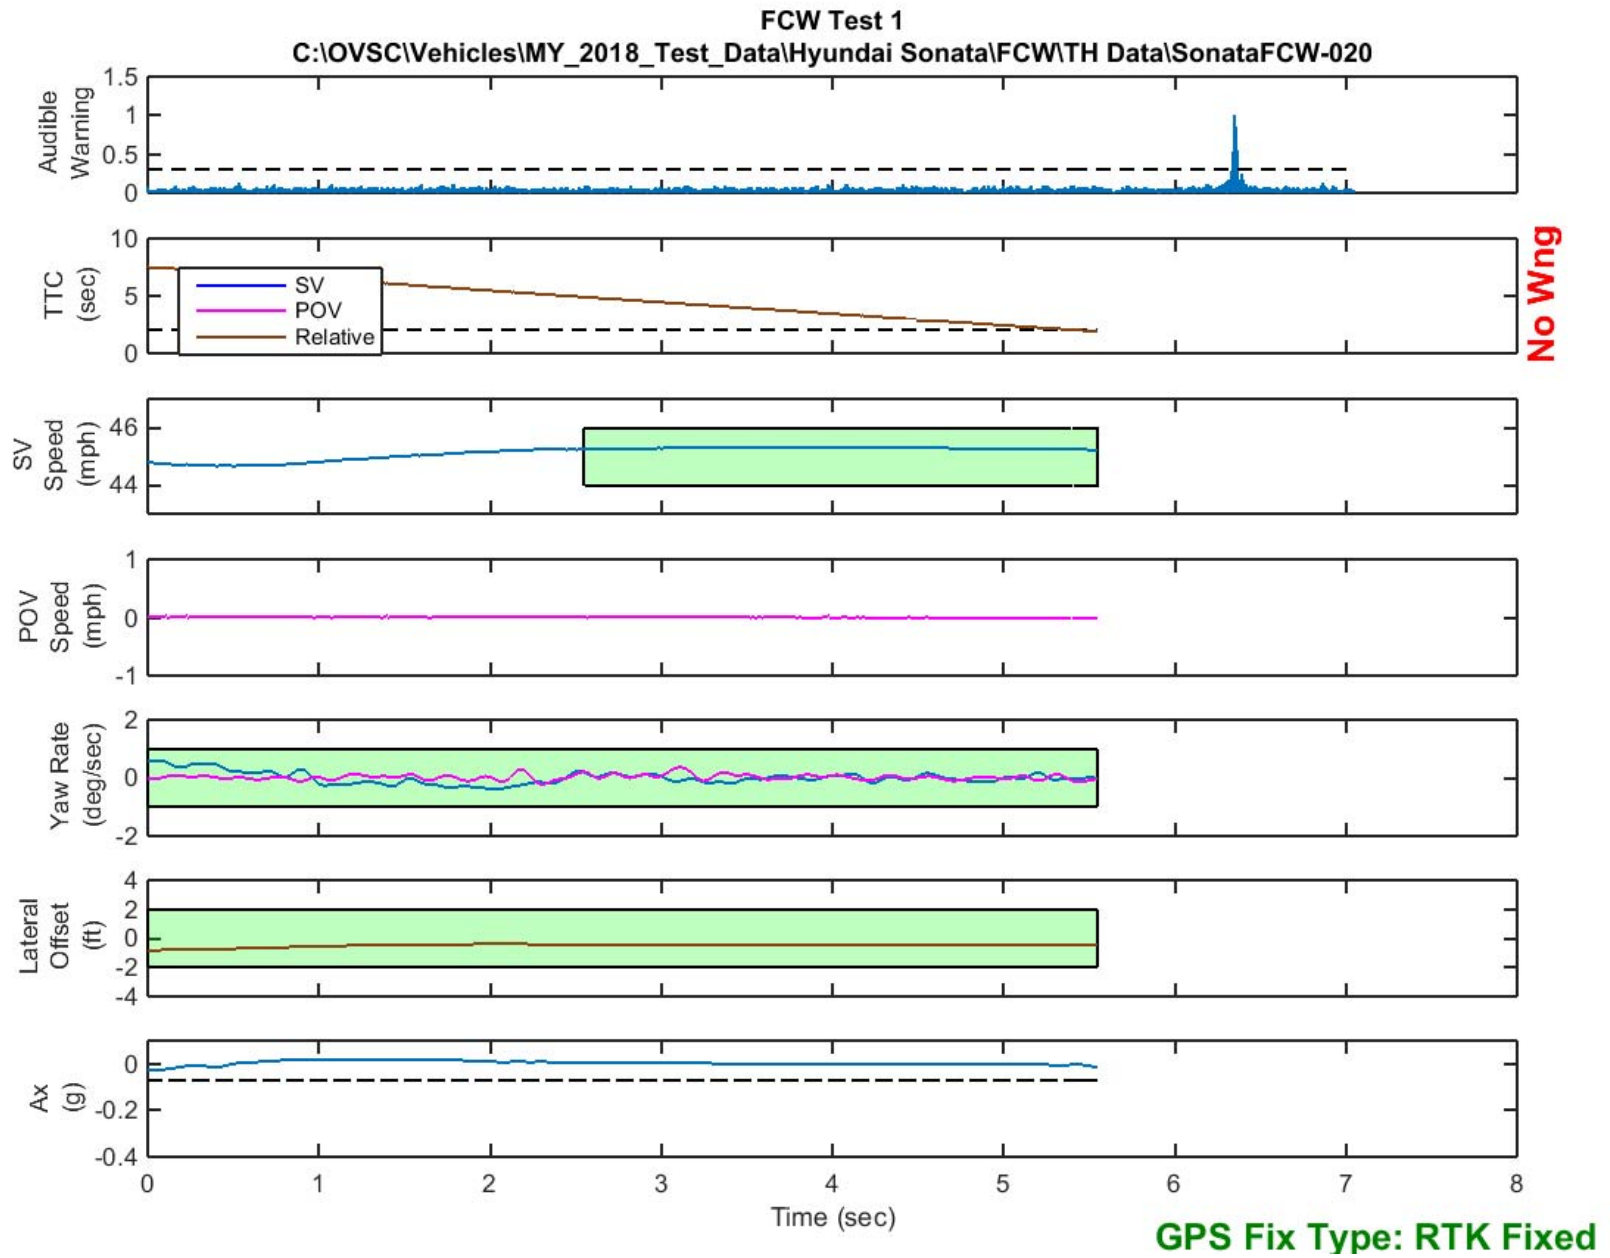
Figure D11. Time History for Run 20, FCW Test 1, Audible Warning
